Building and Timber Pest Inspection Report

Inspection Date: Mon, 9 Feb 2026

Property Address: 8 Karina Ln, Vermont South VIC 3133,
Australia

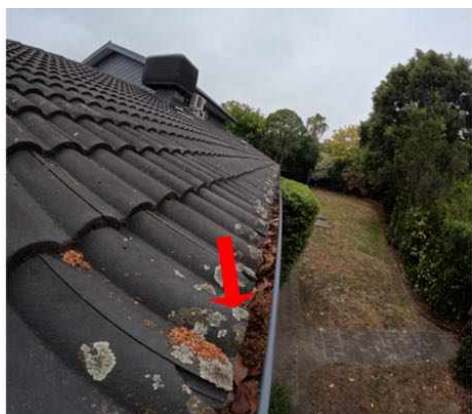
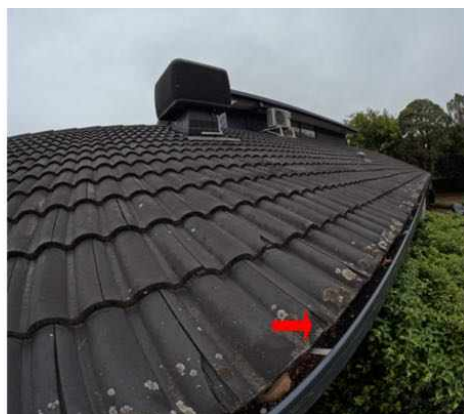
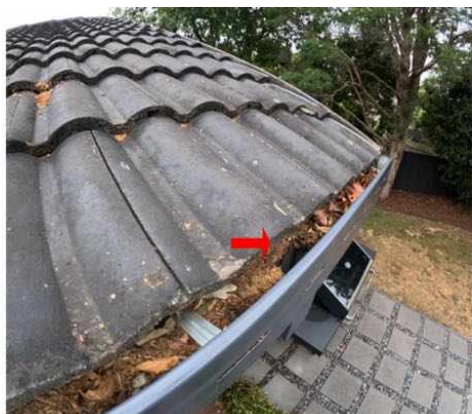
Building:	Main Building
Location:	Roof Exterior
Finding:	Gutter debris accumulation and inadequate drainage
Information:	The gutters exhibit debris accumulation (e.g., leaves, dirt) and green organic growth (algae/moss), indicating water pooling due to inadequate drainage. This poses risks of blockages, overflow during rainfall, and potential damage to fascia boards, walls, or foundations. Prolonged moisture retention may accelerate corrosion and attract pests. Immediate action is advised: clear debris, flush gutters and downpipes, remove organic growth, and inspect gutter slope/downpipe functionality.

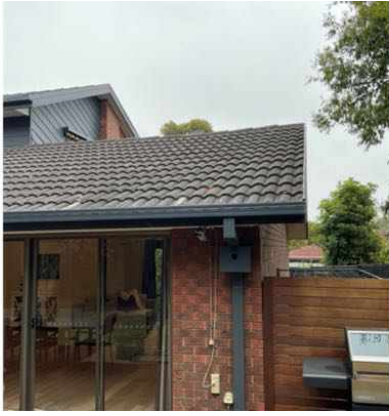
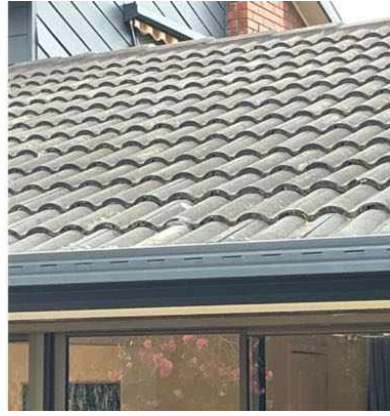
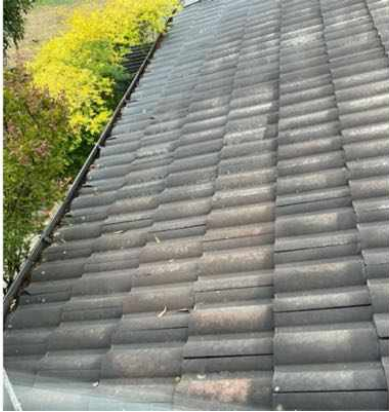
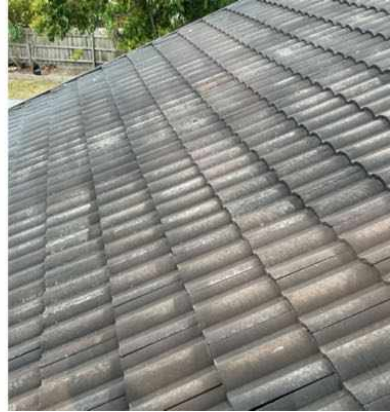
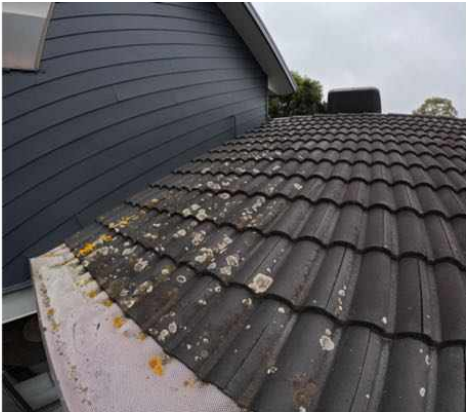
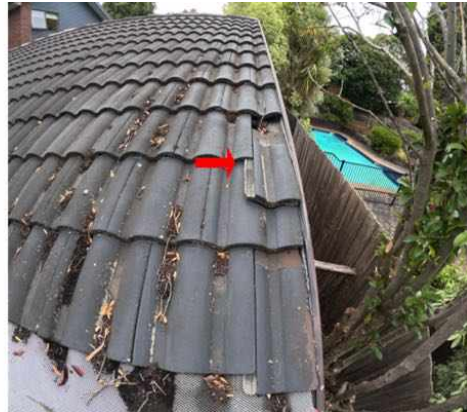
Finding 3.02

Building:	Main Building
Location:	Roof Exterior
Finding:	Roof tiles - Weathered
Information:	Upon inspection of the exterior roofing, the majority of roof tiles were considered to be in a fair condition. While weathering of the tiles is consistent with the age of the property, maintenance works are required.

Isolated areas of mortar have come loose in the valleys and minor cracking is also present. Re-pointing and re-sealing the may be considered as an interim solution by the client to help preserve and extend the life span of the tiles.

Where left unmanaged, deteriorating roof tiles are likely to lead to a number of secondary defects, including minor water leaks and weather exposure to internal roofing structures.

Consultation with a roofing contractor is highly advised to gain advice on cost of remedial works that may be required in the short to medium term. Remedial works are likely to increase the longevity of the exterior roofing structure.

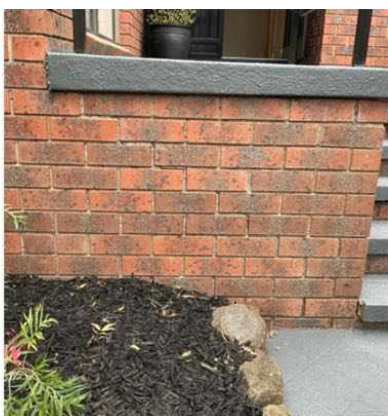
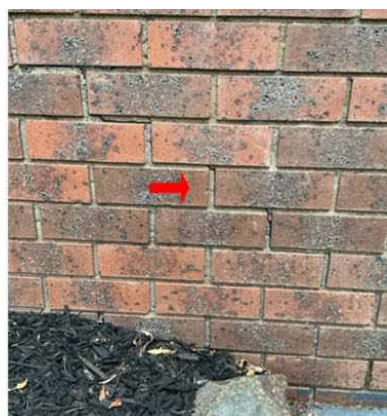
Finding: Brickwork - Step cracking

Information: Step cracking was identified to the brickwork in this area at the time of inspection. Step cracking, which is similar to other forms of cracking, has a variety of possible causes. However, the most common is the subsidence of adjacent footings.

Step cracking is a relatively common defect, and is most likely to occur adjacent to windows, doors and other openings. Mortar failure in the gaps between affected bricks indicates the stresses and tensions affecting the wall.

Where step cracking is extensive or severe, the client is advised to consult a structural engineer. Minor step cracking can be used as a warning sign to address factors causing stress to the wall, which can include the effect of surrounding trees, water leaks, soil erosion, or even the presence of reactive soils in the surrounding area.

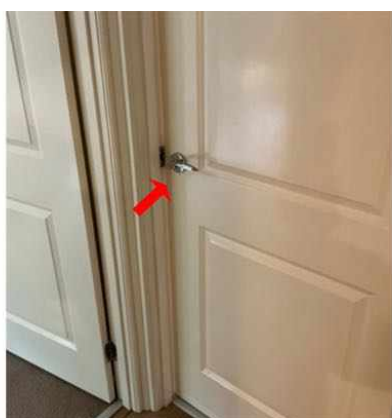
Finding 3.05

Finding: Door handle - Not latching
 Information: It was noted that the door in this area was not latching during operation at the time of inspection. Whilst detracting from the functionality of this building element, this minor defect may also be a security risk, and may therefore have serious implications if left unattended.

It is suspected that this defect has occurred due to minor issues with the associated hinges. Such damage is identified as general wear and tear, which is expected for building elements of this age.

A qualified carpenter or general handyperson may be appointed to perform rectification works as necessary, at client discretion. If left unattended, further functional impairment is likely to occur.

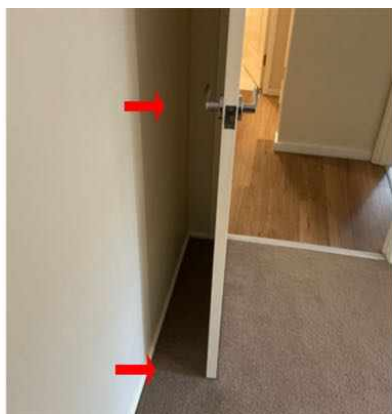
Finding 3.06

Building: Main Building
 Location: Bedroom
 Finding: Door stop - Missing
 Information: The door stop is missing or is inadequate to stop the door handle from damaging the wall. Although some building elements may seem irrelevant or unnecessary, all building elements play a key role in the operation and function of the overall structure and its performance.

Re-installation or replacement of the door stop is advised as soon as possible to prevent any subsequent damage to the door or associated structures. A general handyman may be appointed to perform these works at client discretion.

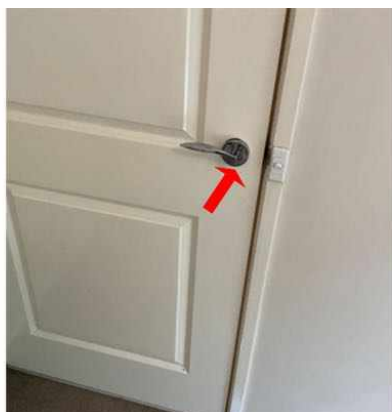
Finding 3.07

Building: Main Building
 Location: Bedroom 2
 Finding: Door handle - Not latching
 Information: It was noted that the door in this area was not latching during operation at the time of inspection. Whilst detracting from the functionality of this building element, this minor defect may also be a security risk, and may therefore have serious implications if left unattended.

It is suspected that this defect has occurred due to minor issues with the associated hinges. Such damage is identified as general wear and tear, which is expected for building elements of this age.

A qualified carpenter or general handyperson may be appointed to perform rectification works as necessary, at client discretion. If left unattended, further functional impairment is likely to occur.

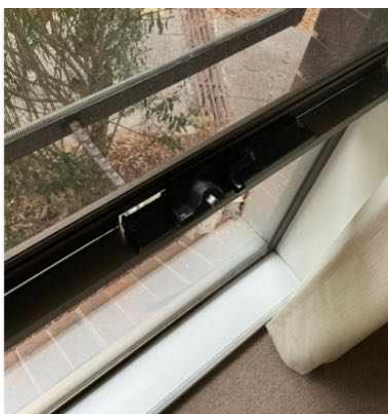
Information: The majority of window winder handles within the property are loose and can easily detach from the spindle during normal operation.

Arrange a qualified handyman or window contractor to inspect the window winders/handles and carry out repair or replacement as required to ensure the handles remain securely fixed and windows operate normally.

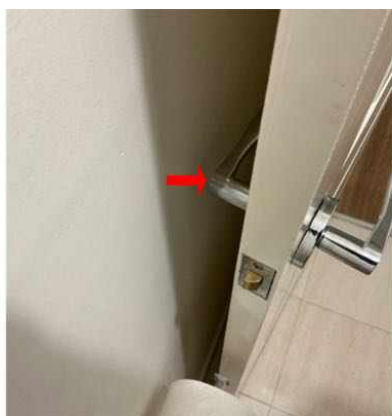
Finding 3.10

Building:	Main Building
Location:	Toilet (WC)
Finding:	Door stop - Missing
Information:	The door stop is missing or is inadequate to stop the door handle from damaging the wall. Although some building elements may seem irrelevant or unnecessary, all building elements play a key role in the operation and function of the overall structure and its performance.

Re-installation or replacement of the door stop is advised as soon as possible to prevent any subsequent damage to the door or associated structures. A general handyman may be appointed to perform these works at client discretion.

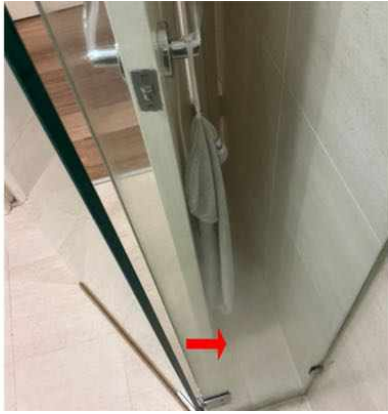
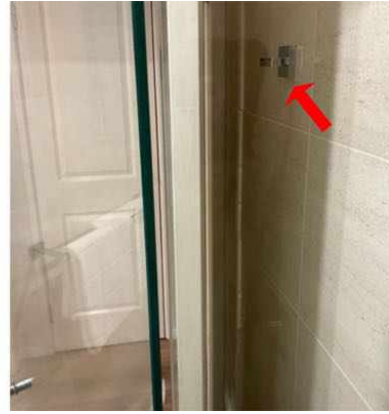
Finding 3.11

Building:	Main Building
Location:	Bathroom
Finding:	Door stop - Missing
Information:	The door stop is missing or is inadequate to stop the door handle from damaging the wall. Although some building elements may seem irrelevant or unnecessary, all building elements play a key role in the operation and function of the overall structure and its performance.

Re-installation or replacement of the door stop is advised as soon as possible to prevent any subsequent damage to the door or associated structures. A general handyman may be appointed to perform these works at client discretion.

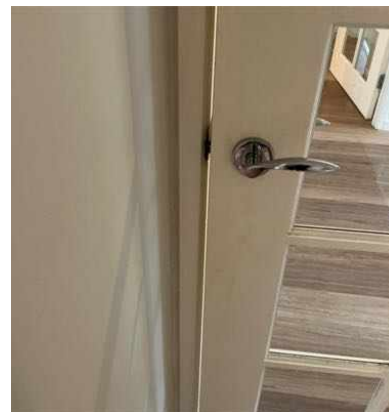
Finding 3.12

Information: It was noted that the door in this area was not latching during operation at the time of inspection. Whilst detracting from the functionality of this building element, this minor defect may also be a security risk, and may therefore have serious implications if left unattended.

It is suspected that this defect has occurred due to minor issues with the associated hinges. Such damage is identified as general wear and tear, which is expected for building elements of this age.

A qualified carpenter or general handyperson may be appointed to perform rectification works as necessary, at client discretion. If left unattended, further functional impairment is likely to occur.

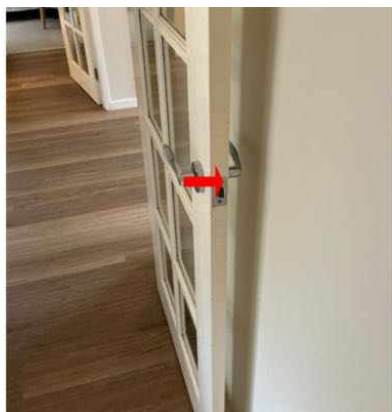
Finding 3.13

Finding: Door stop - Missing

Information: The door stop is missing or is inadequate to stop the door handle from damaging the wall. Although some building elements may seem irrelevant or unnecessary, all building elements play a key role in the operation and function of the overall structure and its performance.

Re-installation or replacement of the door stop is advised as soon as possible to prevent any subsequent damage to the door or associated structures. A general handyman may be appointed to perform these works at client discretion.

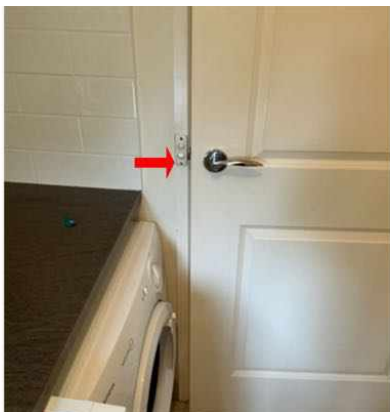
Finding 3.14

Information: It was noted that the door in this area was not latching during operation at the time of inspection. Whilst detracting from the functionality of this building element, this minor defect may also be a security risk, and may therefore have serious implications if left unattended.

It is suspected that this defect has occurred due to minor issues with the associated hinges. Such damage is identified as general wear and tear, which is expected for building elements of this age.

A qualified carpenter or general handyperson may be appointed to perform rectification works as necessary, at client discretion. If left unattended, further functional impairment is likely to occur.

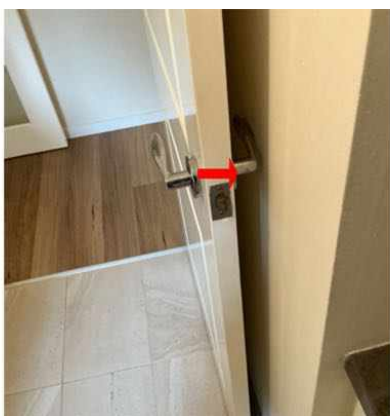
Finding 3.15

Building:	Main Building
Location:	Laundry
Finding:	Door stop - Missing
Information:	The door stop is missing or is inadequate to stop the door handle from damaging the wall. Although some building elements may seem irrelevant or unnecessary, all building elements play a key role in the operation and function of the overall structure and its performance.

Re-installation or replacement of the door stop is advised as soon as possible to prevent any subsequent damage to the door or associated structures. A general handyman may be appointed to perform these works at client discretion.

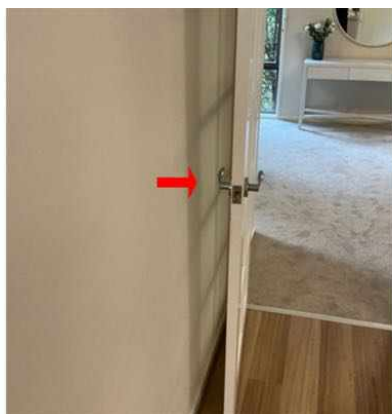
Finding 3.16

Building:	Main Building
Location:	Living Room
Finding:	Door stop - Missing
Information:	The door stop is missing or is inadequate to stop the door handle from damaging the wall. Although some building elements may seem irrelevant or unnecessary, all building elements play a key role in the operation and function of the overall structure and its performance.

Re-installation or replacement of the door stop is advised as soon as possible to prevent any subsequent damage to the door or associated structures. A general handyman may be appointed to perform these works at client discretion.

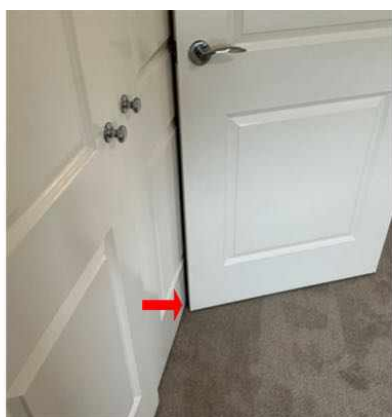
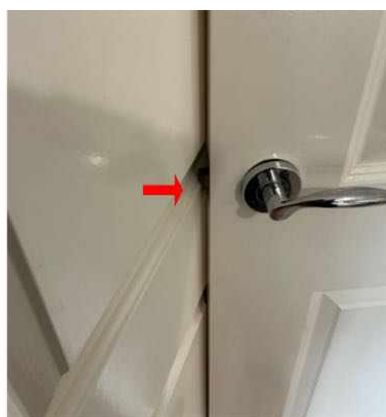
Finding 3.17

Building:	Main Building
Location:	Bedroom first floor
Finding:	Door stop - Missing
Information:	The door stop is missing or is inadequate to stop the door handle from damaging the wall. Although some building elements may seem irrelevant or unnecessary, all building elements play a key role in the operation and function of the overall structure and its performance.

Re-installation or replacement of the door stop is advised as soon as possible to prevent any subsequent damage to the door or associated structures. A general handyman may be appointed to perform these works at client discretion.

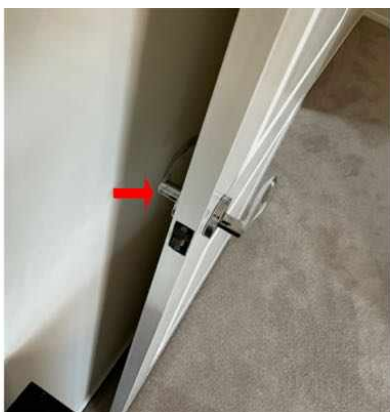
Finding 3.18

Building:	Main Building
Location:	Bedroom - Master
Finding:	Door stop - Missing

Information: The door stop is missing or is inadequate to stop the door handle from damaging the wall. Although some building elements may seem irrelevant or unnecessary, all building elements play a key role in the operation and function of the overall structure and its performance.

Re-installation or replacement of the door stop is advised as soon as possible to prevent any subsequent damage to the door or associated structures. A general handyman may be appointed to perform these works at client discretion.

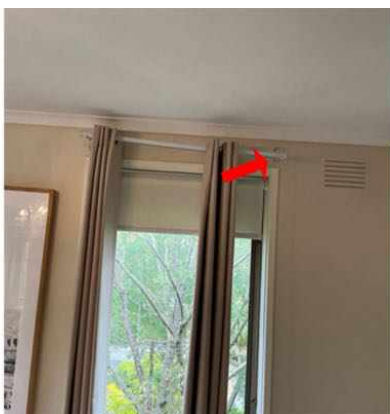
Finding 3.19

Building: Main Building
 Location: Bedroom - Master
 Finding: Curtain rod detached
 Information: The curtain rod bracket has detached/partially detached from the wall, with fixings pulled loose and visible damage around the mounting points.

The curtain rod may become unstable and could fall, creating a minor safety hazard and potentially causing further damage to the wall and window furnishing.

Engage a handyman to reinstate the bracket securely into a suitable fixing point (e.g. stud/toggle anchors as required) and make good the wall surface, ensuring the curtain rod is stable and fit for use.

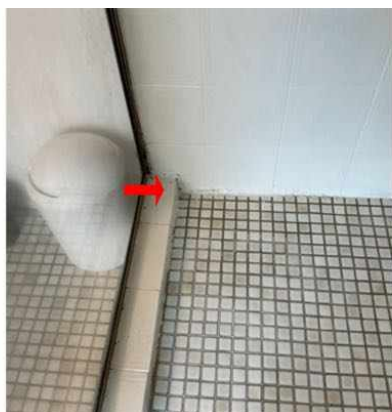
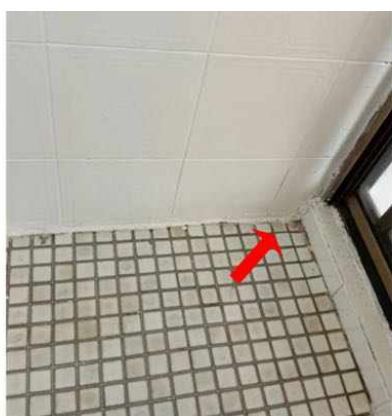
Finding 3.20

Building:	Main Building
Location:	Ensuite - Master
Finding:	Substandard work— shower junction sealant
Information:	Poor-quality and inconsistent sealant was observed to the bathroom wall/floor junctions and shower perimeter, appearing as an unprofessional/DIY application with uneven finishing and localised gaps.

Defective sealant at wet area junctions can allow moisture to penetrate into the substrate, which may lead to ongoing water damage and, over time, compromise the effectiveness of the waterproofing system.

Engage a qualified contractor to remove and re-apply wet-area grade sealant to all relevant junctions, and investigate/repair any underlying moisture damage before cosmetic re-finishing if required.

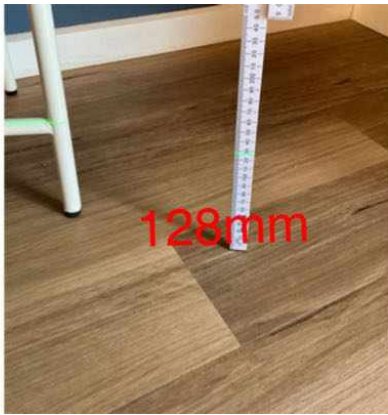
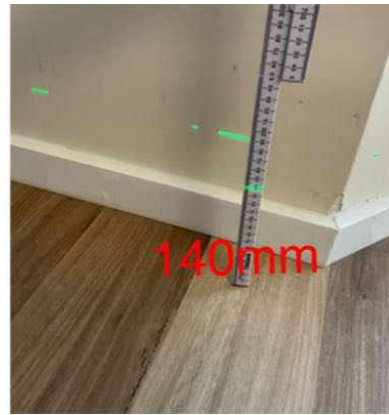
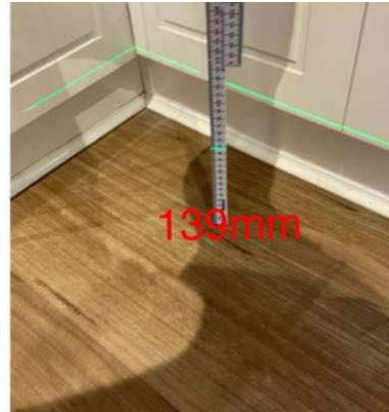
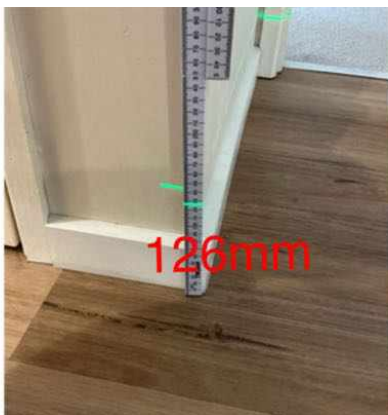
Finding 3.21

Building:	Main Building
Location:	All Areas
Finding:	floor unevenness - v4
Information:	The standard laser level was positioned 125 mm above the floor, as shown in the

Considering the age of the property and no visible significant cracks were observed at time of inspection. This degree of settlement is generally within an acceptable range for a building of its era. However, for buyers who have higher expectations regarding floor levelness or sensitivity to uneven floors, it should be noted that restumping or re-leveling can involve a considerable cost. This should be taken into account when planning the overall purchase budget.

For further information or investigation, contact a licensed builder for cost estimation and a structural engineer to assess the extent of settlement and the condition of the stumps.

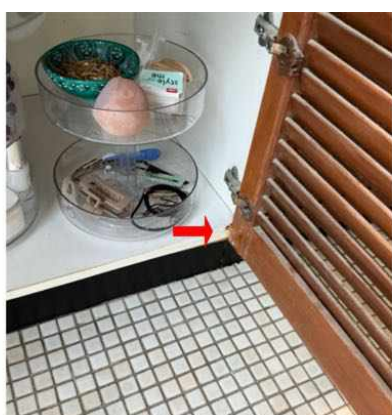
Finding 3.23

Building:	Main Building
Location:	Ensuite - Master
Finding:	Timber swelling- minor
Information:	The swelling observed at the base of the cabinet appears to be caused by moisture exposure, likely due to inadequate sealing or water ingress from nearby wet areas. It may also result from water splashing onto the floor after showering and not being wiped up promptly. Typically, the base of cabinetry should be sealed with a waterproof coating or raised slightly above the floor surface to prevent direct contact with moisture. It is recommended to engage a qualified carpenter to repair or replace the affected timber and ensure appropriate sealing or clearance is provided to prevent future water-related damage.

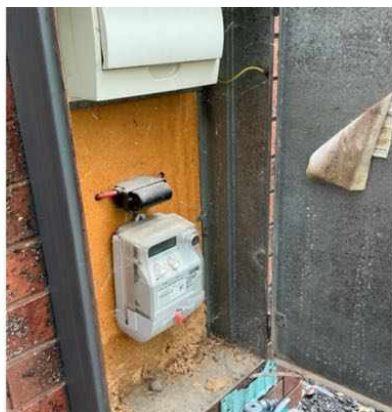
Building:	Main Building
Location:	Electrical switchboard
Finding:	Termite Management System - no evidence of a chemical installation
Information:	The application of a post-construction chemical termite barrier is highly recommended for all properties, particularly if live termite activity has been found on the site previously. Such barriers are highly effective in preventing termite attack on any timber building elements throughout the property.

The client may consider gaining further advice from a pest controller as to the costs and procedures involved with this application. It is recommended that obtaining such advice be a short-term priority.

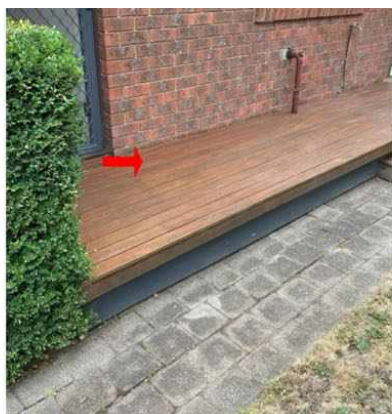
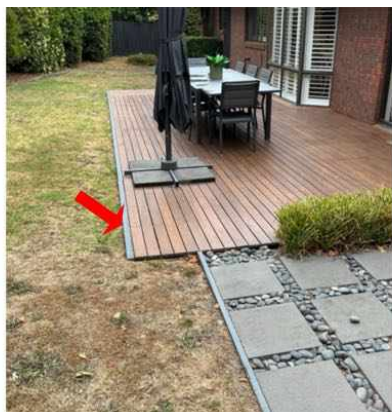
Finding 6.02

Building: Yard
 Location: Yard
 Finding: Bridging- Attachments to buildings
 Information: Bridging occurs when objects or structures in contact with a building create concealed pathways that allow termites to bypass a termite management system and gain access to the structure undetected.

These attachments can provide concealed termite entry and should be regularly inspected for signs of termite activity by a qualified pest inspector.

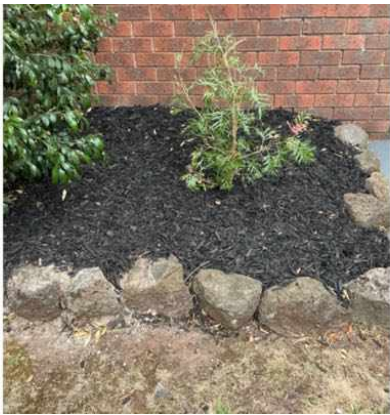
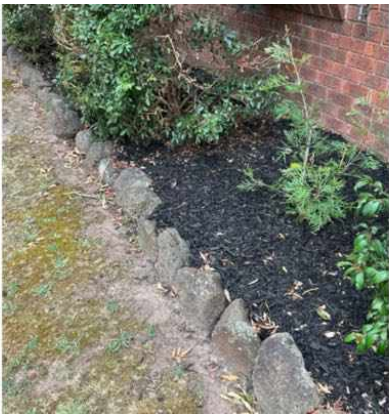
Finding 6.03

Building:	Main Building
Location:	All Areas
Finding:	Stored timbers - subfloor space or external area
Information:	The storing of timbers in the subfloor space or around the external property (including bark mulch) increases the risk of termite activity being present. As they are likely to come into contact with weather conditions or excessive moisture wood rot is likely to develop on timbers that are not treated.

It is highly recommended that any stored timbers be immediately removed from areas in which they may attract any termite / timber pest attack. Minimisation of risk / prevention of termite attack is far more adequate than dealing with the presence of termite activity.

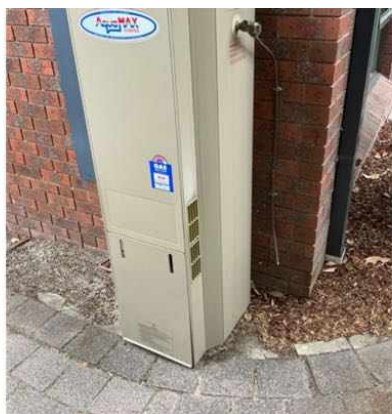
Finding 6.04

Building: Main Building
Location: Hot water/aircon unit(s)
Finding: The air conditioning overflow pipe is not properly connected and discharges directly into the soil adjacent to the building.
Information: This creates a conducive condition for termite activity by providing a constant moisture source near the structure. It may also lead to soil erosion, mould growth, or damage to nearby building materials.

The overflow should be redirected to an appropriate discharge point—such as a stormwater connection or designated drainage area—away from the building foundation, in accordance with plumbing and termite management standards.

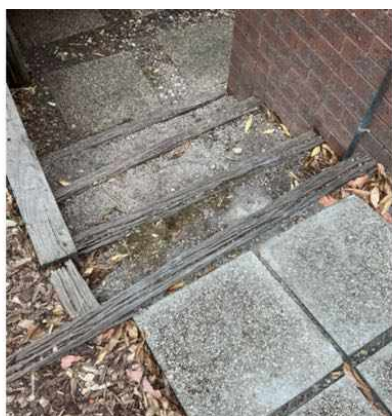
Finding 6.05

Building:	Yard
Location:	Yard
Finding:	Wood rot-external timbers
Information:	Wood rot which is technically known as Fungal Decay occurs when timbers and other cellulose building materials are exposed to damp conditions on an ongoing basis. This could be the result of exposure to weathering in the long term or the pooling of water or absorbed moisture from other abutting building materials. It is advisable to remove these affected timbers to prevent any chance of attack in the future.

Wood decay is more susceptible to termite attack and these timbers should be replaced to limit termite attack.

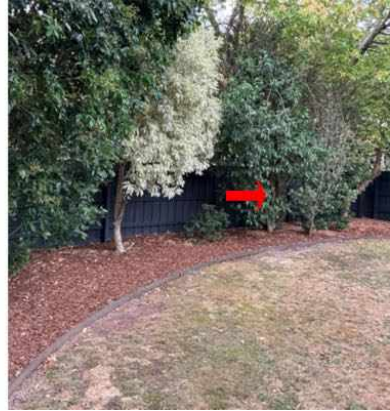
Finding 6.06

Building:	Yard
Location:	Yard
Finding:	Large trees/stumps within 30m of house
Information:	There are a number of large trees/stumps within 30m of the house which may contain natural termite activity. It is important to monitor these areas to ensure no natural activity is allowed to progress into the main house.

Regular inspections are recommended. Consider test drilling any large trees.

A pest controller can be contacted to carry out such testing at the owners discretion.
