Building Inspection Report

Inspection Date: Sat, 10 Jan 2026

Property Address: 39 Monakeeba Bvd, WOODSTOCK, VIC,
3751, Australia

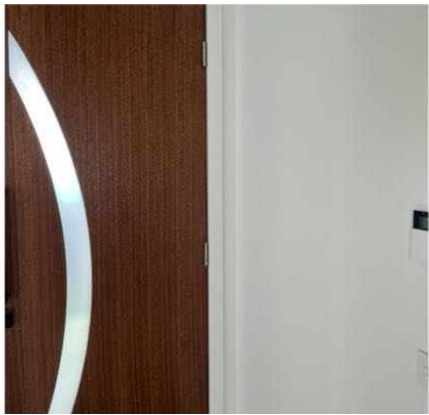
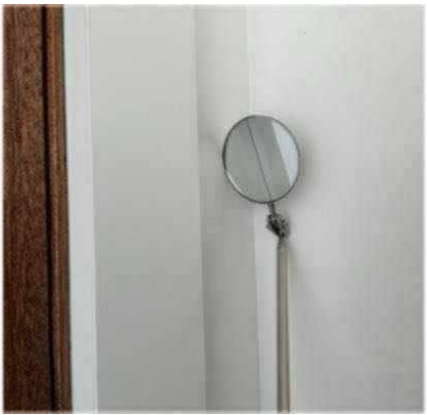
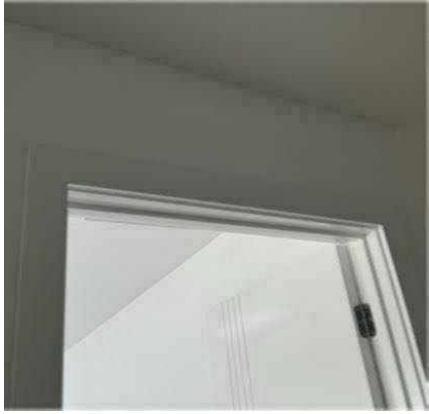
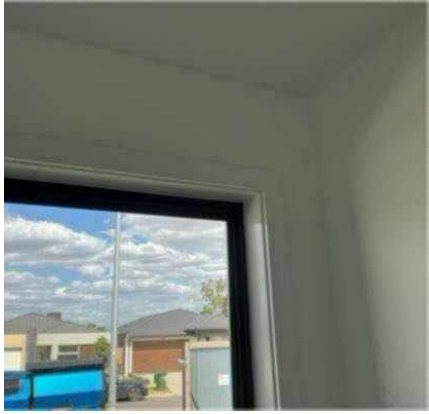
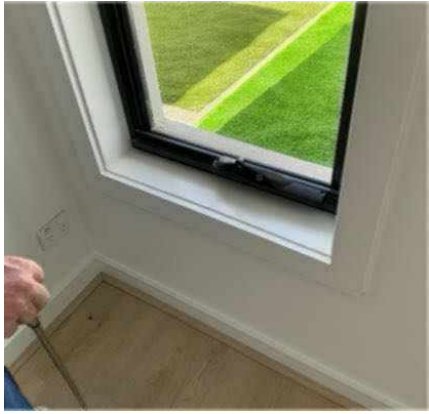
Defects 3.01

Building:	Main Building
Location:	All Internal Areas
Finding:	Unsealed Gaps Around Architraves to Windows and Doors - PCI
Information:	Visible gaps have been identified between the architraves and adjacent plasterwork, particularly above and below window frames and above door heads. These unsealed openings allow for uncontrolled air infiltration, undermining the dwelling's energy efficiency and reducing the overall weathertightness of the internal envelope.

- AS 2047:2014 – Windows in Buildings – Selection and Installation requires window assemblies to be properly integrated into the building envelope to prevent uncontrolled air leakage.
- NCC 2022 Volume Two, Part J5D7 – Sealing of Building Fabric mandates that all gaps around window and door frames must be adequately sealed to maintain airtightness and thermal performance.

The current condition is non-compliant with the relevant Australian Standards and NCC performance requirements. The supplied photos are representative only; a complete review of all window and door installations is recommended to identify and seal all affected areas. All gaps must be properly sealed using an appropriate caulking or sealing product to ensure a durable and continuous air barrier prior to final handover.

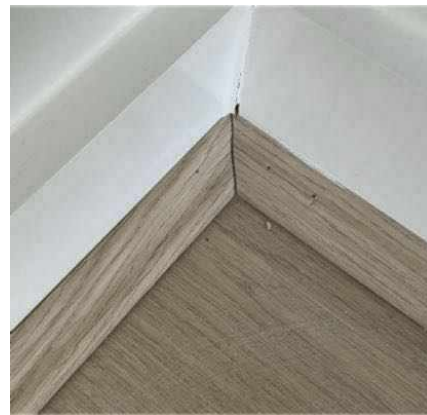
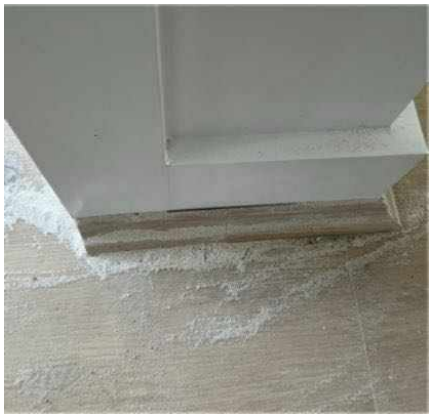
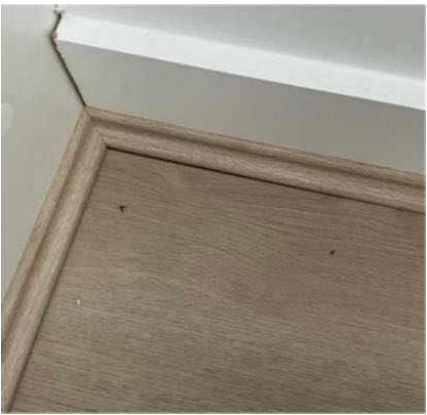
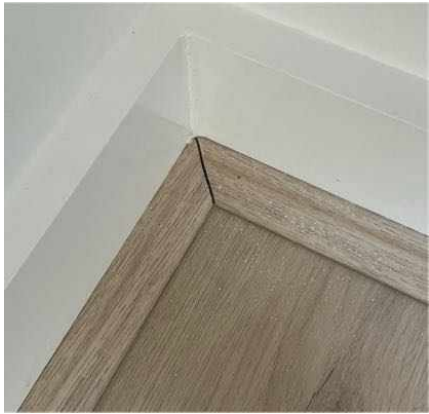
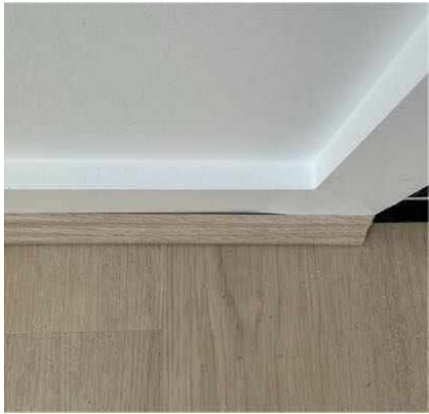
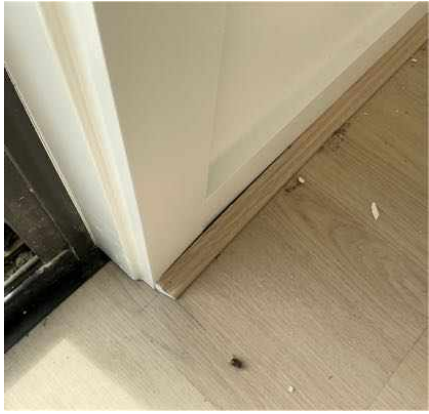
Defects 3.02

Building:	Main Building
Location:	All Internal Areas
Finding:	Substandard Installation of Floating Floor Quad Trim - PCI
Information:	During the inspection, it was noted that multiple areas throughout the property have been finished with floating floor quad trim in a substandard manner. Defects observed may include missing sections of trim, poorly secured (nailed) joints, visible fixings, and exposed or open internal and external corners. These issues detract from the overall finish quality and indicate a lack of workmanship consistency.

- Guide to Standards and Tolerances 2015, Section 12.02 – Finishes to internal joinery and trim must be neat and in accordance with good trade practice.
- NCC Volume Two, Performance Requirement H4P2 – Internal building elements must be installed to avoid loss of amenity due to poor construction quality.

The current installation does not meet the expected standard for new residential construction and requires rework to ensure all trims are securely fixed, neatly joined, and consistently finished throughout. The supplied photographs represent examples only, and a full review of all rooms should be undertaken to identify and rectify similar defects present in other areas.

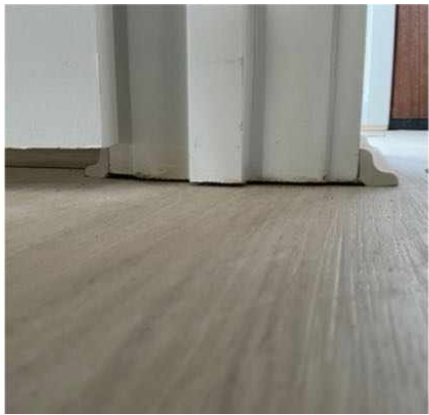
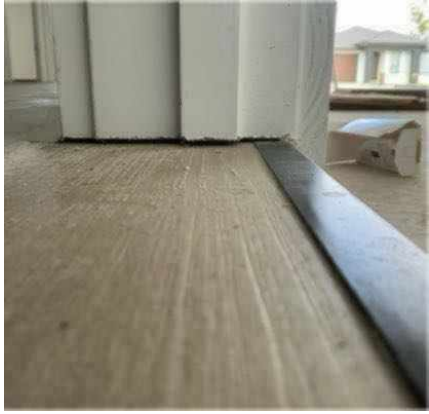
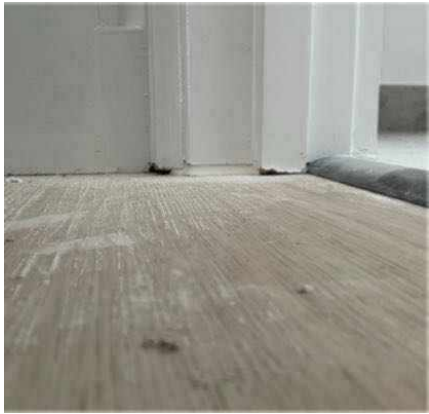
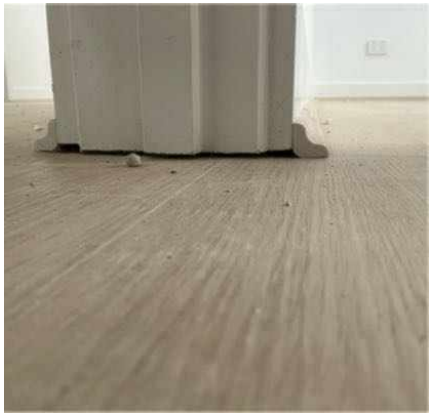
Defects 3.03

Building:	Main Building
Location:	All Internal Areas
Finding:	Gaps Between Floating Floor and Architraves/Door Stiles - PCI
Information:	During the inspection, multiple locations were observed where the floating floor does not meet the architraves or door stiles tightly. While these trims are typically undercut to allow the flooring to slide beneath, several cuts are excessively high, resulting in visible gaps along the junctions. These openings leave the cut edges of the architraves and stiles exposed and create voids that are susceptible to moisture entry during routine floor cleaning or mopping. The termination of the flooring at these points has not been finished to the expected standard and presents as an incomplete installation.

- Guide to Standards and Tolerances 2023 – Section 14.10 requires floor finishes to have neat, consistent, and properly detailed terminations at walls, trims and fixtures.
- Domestic Building Contracts Act 1995 requires all work to be carried out in a proper and workmanlike manner.
- Floating floor manufacturer installation guidelines specify that expansion gaps and undercuts must be concealed or sealed in accordance with finishing requirements to prevent moisture ingress and maintain durability.

The current condition shows incomplete finishing at flooring junctions, with visible gaps and exposed timber edges that may allow moisture penetration and premature deterioration.

Rectification is required to ensure compliance.

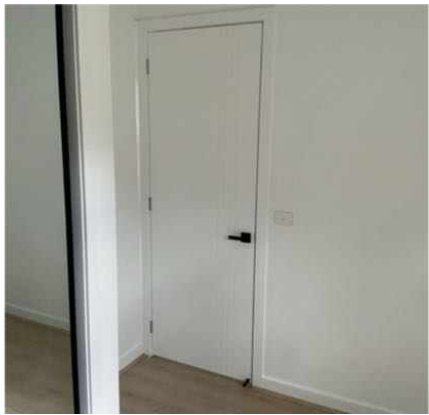
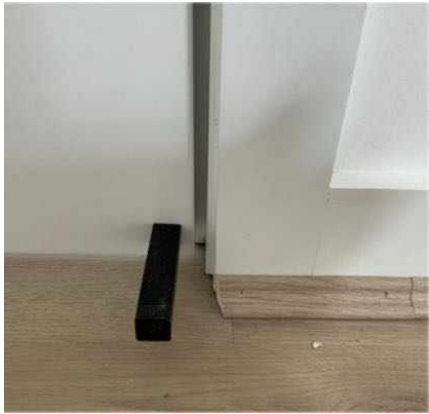
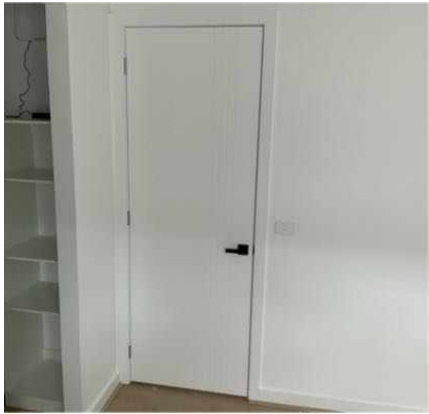
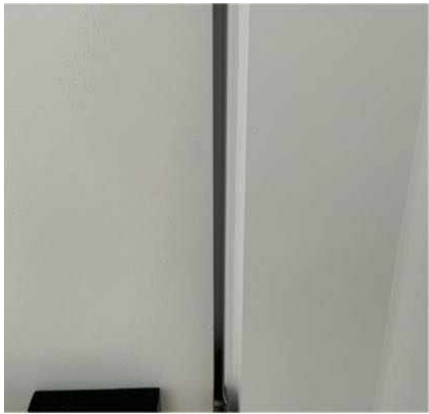
Defects 3.05

Building:	Main Building
Location:	All Internal Areas
Finding:	Inconsistent Door Margins – Non-Compliant Installation - Fix/PCI
Information:	During inspection, the door unit was observed to have inconsistent margin gaps between the door leaf and the surrounding frame and architraves. Visible irregularities were present along the top, sides, and bottom edges, with clearances varying beyond acceptable tolerances. These discrepancies not only detract from the visual presentation but may also interfere with the operation of the door, including risks of binding or hardware misalignment during use.

- Guide to Standards and Tolerances 2017, Section 13.08 – The acceptable tolerance for door clearances is a uniform ± 2 mm unless otherwise specified.
- NCC 2022 Volume Two, Clause 10.7.1 – Fixtures and fittings must be installed to operate as intended and achieve a uniform and functional finish.

Rectification is required to ensure compliance.

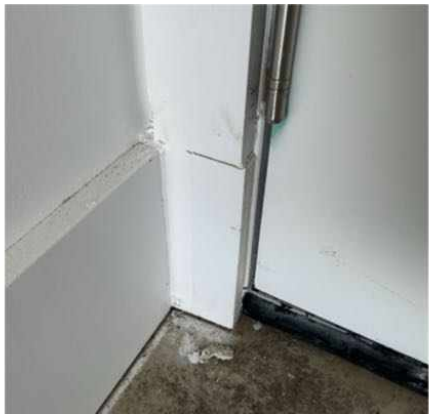
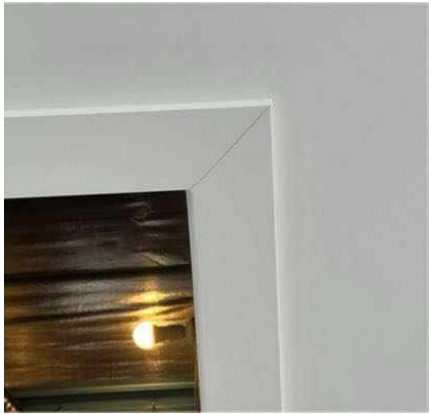
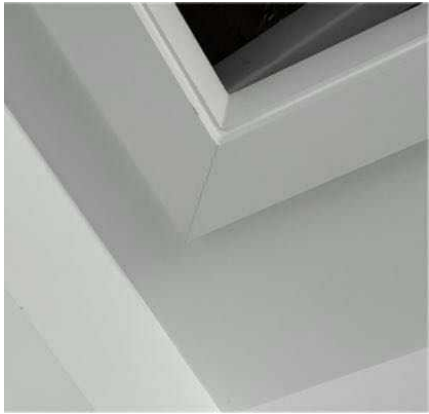
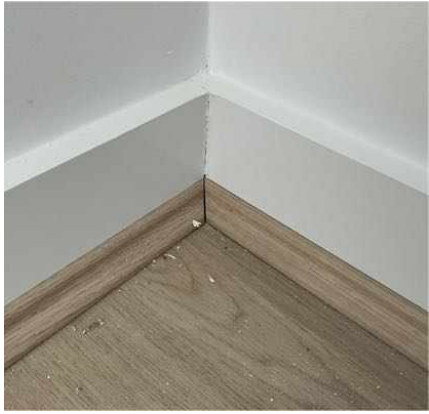
Defects 3.06

Building:	Main Building
Location:	All Internal Areas
Finding:	Cracking to Painted Architraves and Skirting Boards - PCI
Information:	Cracks were observed forming in multiple sections of the painted architraves and skirting boards throughout the property. These cracks are likely the result of minor building movement, natural timber shrinkage, or inadequate surface preparation prior to painting. The defects are visible under normal viewing conditions and detract from the overall internal finish.

- Guide to Standards and Tolerances 2023, Section 10.07 – Surface Damage and Imperfections: Surface cracking that is visible from a normal viewing distance of 1.5 metres under natural lighting is considered a defect.
- NCC Volume Two, Performance Requirement H4P2 – Internal finishes must be completed in a manner that provides an acceptable level of amenity and appearance.

The current condition does not meet the minimum acceptable finish standards for new residential construction. The photos provided show examples only; a full inspection of all internal timber trim should be completed to identify and rectify all affected areas. Cracked sections should be repaired, filled, and repainted to achieve a consistent and professional internal finish.

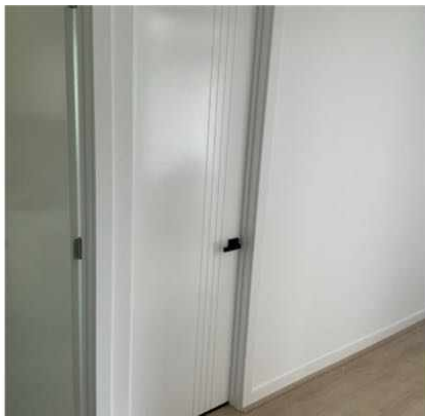
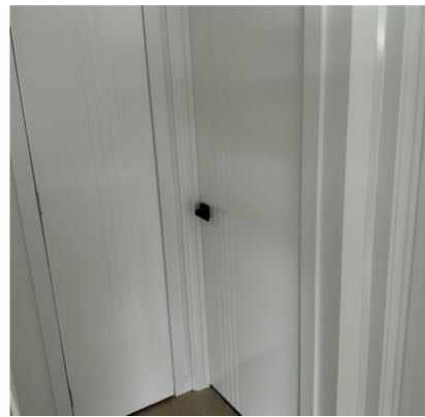
Defects 3.07

Building: Main Building
 Location: All Internal Areas
 Finding: Internal Door Rattle - PCI
 Information: At the time of inspection, one or more internal doors were noted to not latch securely when closed. The affected doors exhibit movement or rattling due to insufficient engagement between the latch and striker plate. This indicates that adjustment is required to ensure the door closes and secures as intended.

- Guide to Standards and Tolerances 2023 – Clause 10.08: Doors and windows must operate as intended without binding, jamming, or failing to latch.
- NCC 2022, Volume Two – Clause 10.7.1: Fixtures and components must be installed to enable proper function and ease of use.

Rectification is required to adjust the door striker and ensure that all internal doors latch securely and operate in accordance with the required performance standards.

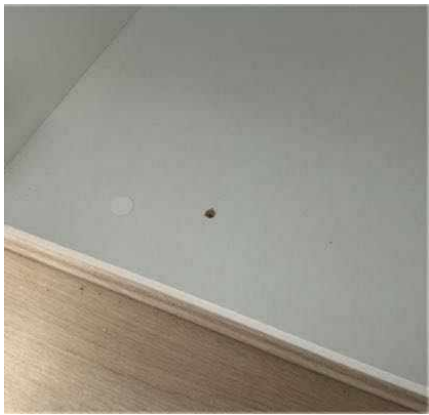
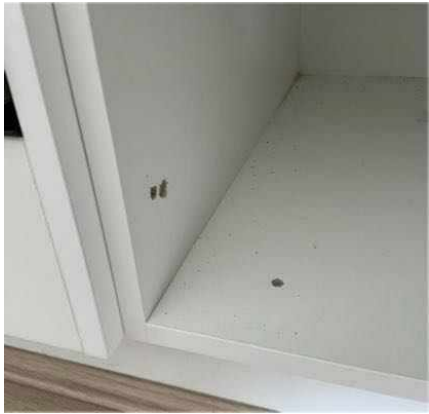
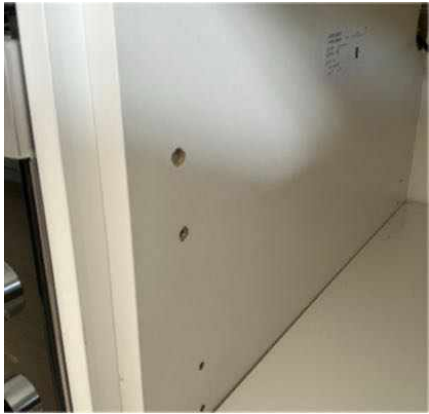
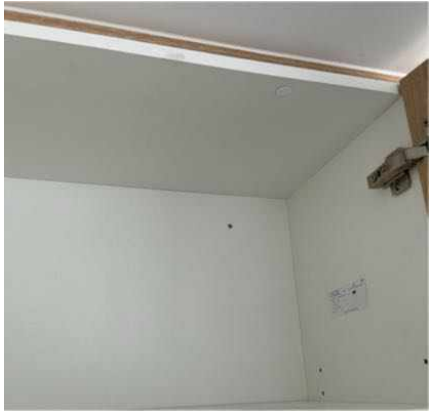
Defects 3.08

Building: Main Building
 Location: All Areas

Finding: Missing Stick-On Screw Caps to Cupboard Shelving - PCI
Information: During the inspection, it was observed that several cupboard shelving units are missing stick-on screw caps. These caps are intended to conceal exposed fixings, providing a neat and finished appearance while also preventing potential snagging hazards or sharp contact points. Their absence detracts from the overall workmanship and fails to meet an acceptable finish for new construction.

- Guide to Standards and Tolerances 2023,
- Section 10.02 – Cabinets and Built-in Furniture requires cabinetry and associated joinery to be installed in a workmanlike manner and be fit for purpose.
- Section 10.07 – Surface Damage and Imperfections states that visible surface blemishes or defects apparent from a normal viewing distance (1.5m under standard lighting) are considered non-compliant.

The missing caps are clearly visible and detract from the quality and presentation of the cabinetry installation. The supplied photographs represent examples only, and a full inspection of all joinery should be conducted to identify and rectify any other affected areas prior to handover.

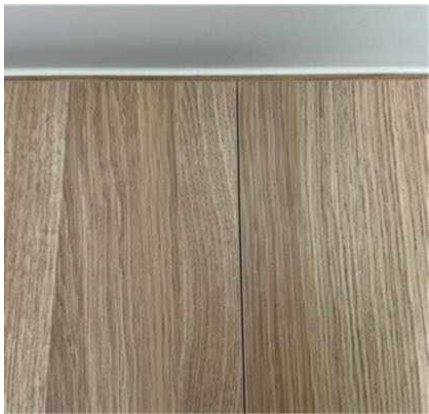
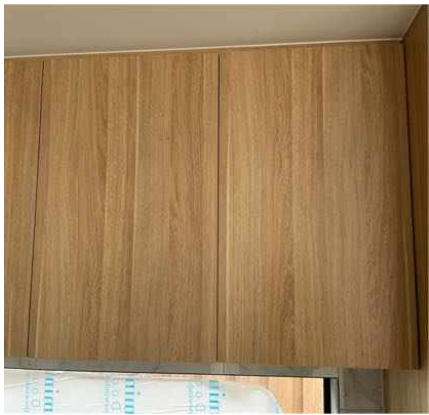
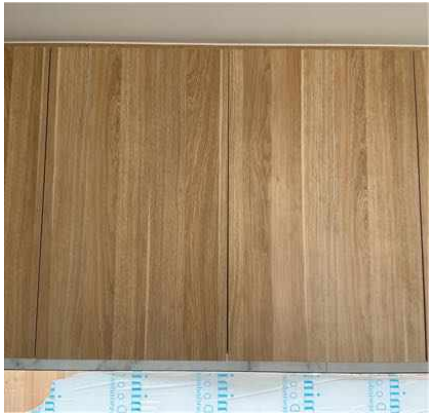
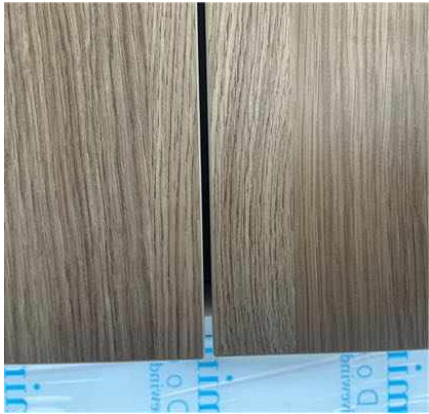
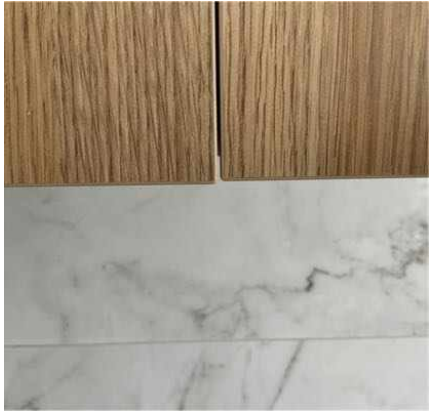
Defects 3.09

Information: During the inspection, it was observed that the kitchen cabinetry presents with visibly uneven margins between adjoining doors, drawers, and panels. These inconsistencies in spacing are apparent under normal viewing conditions and detract from the intended symmetrical and professional appearance of the joinery installation.

Cabinetry must be installed so that doors, drawers, and panels are aligned, flush, and evenly spaced. Variations that are visible and detract from the finished appearance are considered defects.

The observed inconsistencies do not meet acceptable workmanship standards for new residential construction and must be rectified to ensure even alignment and consistent spacing throughout. The supplied photos are provided as examples of the affected areas; a full review of all cabinetry is recommended to confirm and rectify any additional defects.

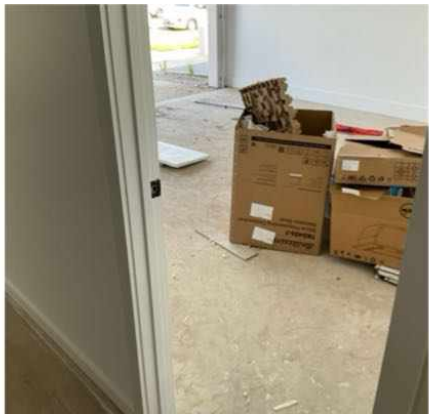
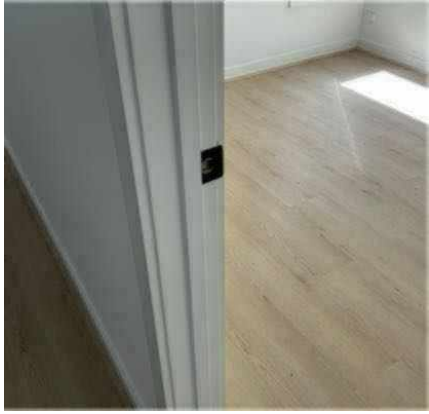
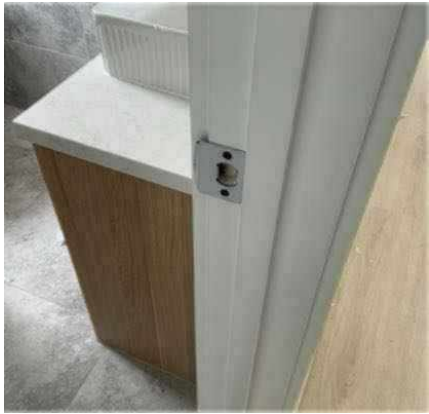
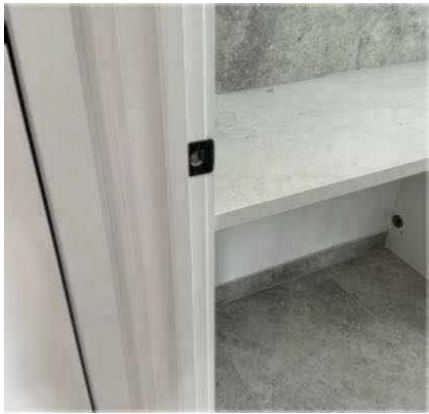
Defects 3.10

Building:	Main Building
Location:	All Doors
Finding:	Striker Plates Not Rebated Into Door Frames - PCI
Information:	At the time of inspection, one or more door striker plates were observed to be surface-mounted to the door frames rather than being rebated flush into the timber. This results in the striker plates sitting proud of the frame surface, causing an inconsistent finish and potential interference with correct door latch engagement and door closure alignment.

Manufacturer installation instructions for door hardware require striker plates to be recessed flush into the frame to ensure correct latch operation, proper alignment, and an acceptable finished appearance. Surface-mounted striker plates do not achieve the intended installation outcome and may contribute to latch wear, poor door operation, and premature hardware deterioration.

Rectification is required to ensure striker plates are correctly rebated into the door frames so that door hardware operates as intended and complies with acceptable installation and finish standards.

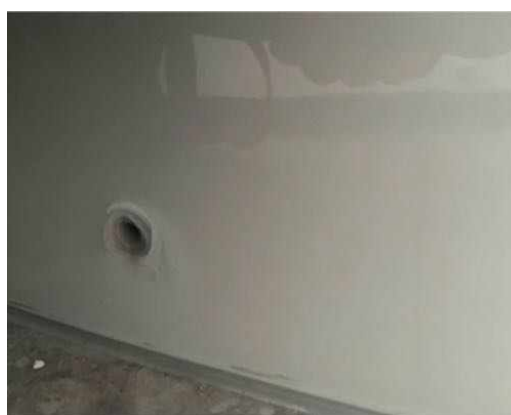
Defects 3.11

Building: Main Building
Location: All Toilets
Finding: Toilets Not Secured to Floor – Incomplete Installation - PCI
Information: During inspection, it was observed that the toilets had not been secured to the floor. Fixing points were visible but had not been fastened, indicating that the sanitary fixtures remain loose and incomplete at the time of assessment. All sanitary fixtures, including toilets, must be fixed in a stable and secure manner to ensure proper function, prevent movement, and avoid damage to adjoining finishes or plumbing connections.

- AS/NZS 3500.2:2021 – Plumbing and Drainage – Sanitary Plumbing and Drainage – Requires fixtures to be installed to prevent movement and ensure long-term stability.
- AS/NZS 6400:2016 – Water Efficient Products – Requires compliance with installation requirements including fixture stability.
- NCC 2022 Volume Three – Plumbing Code of Australia, Clause A2.2(2)(f) – Sanitary fixtures must be installed in a manner that prevents damage, instability, and leakage.

Rectification is required to ensure compliance.

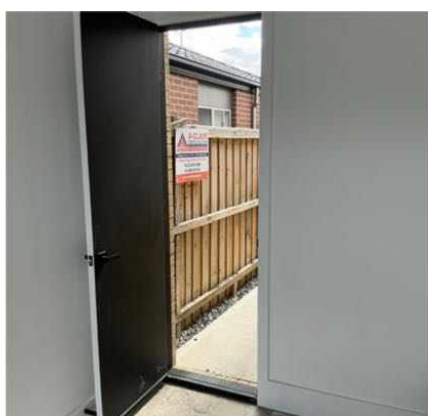
Defects 3.15

- AS 2688:2017 – Timber and Composite Doors, outlines requirements for correct installation and maintenance of door seals to preserve system performance.
- NCC 2022, Volume Two – Clause 3.12.3 requires that external openings, including doors, be adequately sealed to minimise air leakage and water ingress.
- NCC 2022, Volume Two – H1P1 mandates that building elements be installed to maintain their intended performance for the life of the building.

The current condition is non-compliant. All affected door seals must be cleaned or replaced in accordance with the manufacturer's guidelines to restore full performance and maintain compliance.

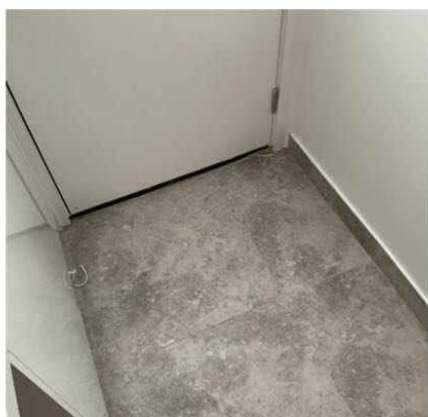
Defects 3.16

The absence of a door stop does not meet the expected standard of internal fit-off and leaves building elements at risk of damage. Installation of a compliant door stop is required to ensure appropriate protection of finishes and to achieve a complete and

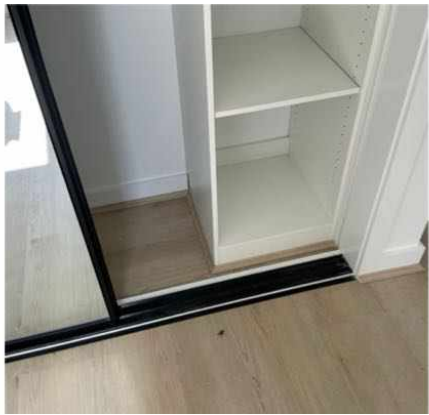
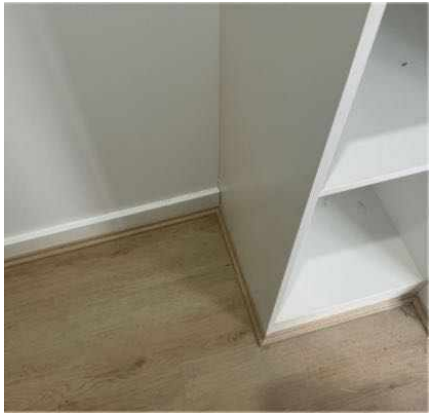
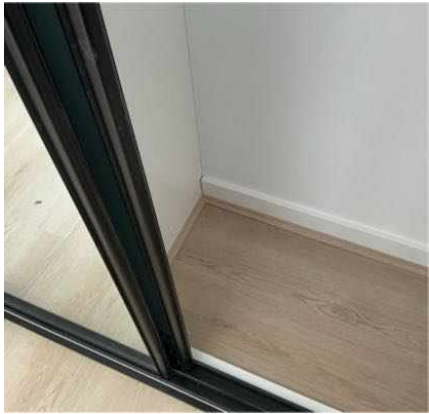
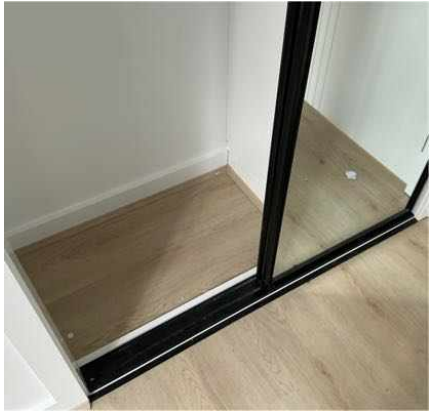
Defects 3.21

Building: Main Building
Location: Kitchen Bench
Finding: Poor Skirting Board Join – Butt Joint Used Instead of Mitre Joint
Information: During the inspection, a poorly finished joint was observed to the skirting board. The joint has been formed as a butt joint rather than a mitred joint, resulting in a visible and uneven junction. The joint is not flush, is visually apparent from a normal standing position, and detracts from the overall quality of the internal finish.

- Guide to Standards and Tolerances 2015 – Section 13.08 requires skirting and other trims to be installed neatly and without visible gaps.

Skirting boards at these locations should be properly adjusted and sealed to provide a consistent and professional finish. Rectification is required to ensure compliance.

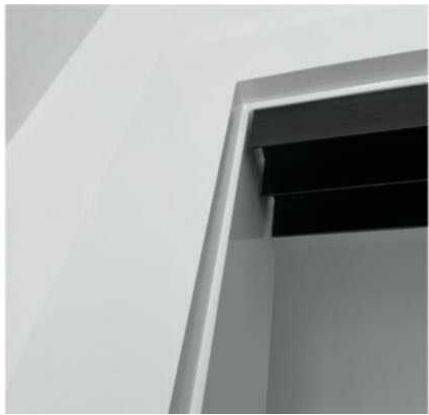
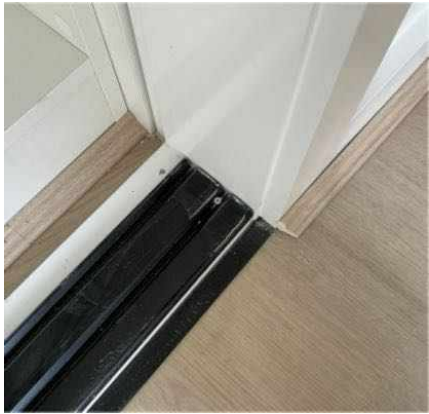
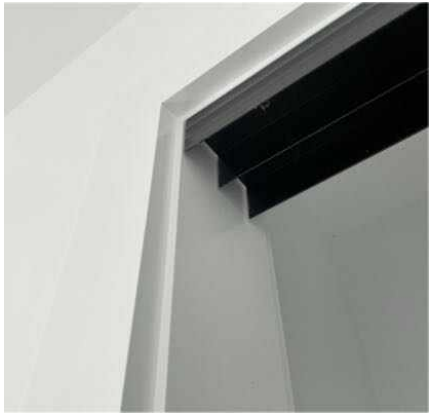
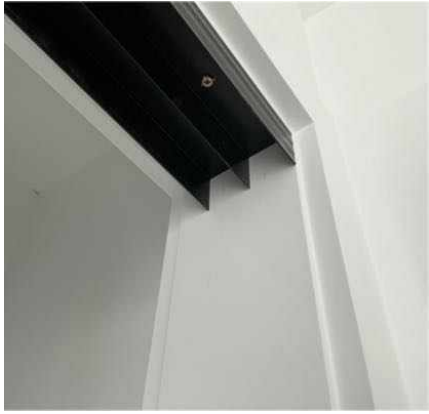
Defects 3.24

Building: Main Building
Location: Built In Robe
Finding: Incomplete Wardrobe Sliding Door Track Terminations - PCI
Information: At the time of inspection, it was observed that several wardrobe sliding door top and bottom tracks were not fitted with the required rubber end caps. Only one wardrobe set was noted to have the correct rubber terminations installed. In multiple locations, the aluminium tracks were also cut short of the door frame, leaving exposed track ends and incomplete terminations. This results in an inconsistent finish and reduces the functional and protective performance of the track system.

Rectification is required to ensure all wardrobe sliding door tracks are correctly terminated with manufacturer-approved rubber end caps and trimmed to suit the door frame dimensions, to achieve a compliant, durable, and consistent finished installation.

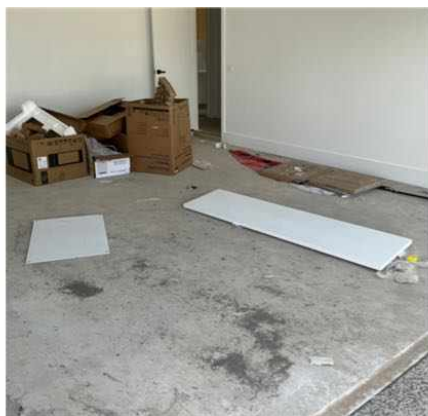
- Guide to Standards and Tolerances 2023 – Clause 18.08: Building works are considered defective if the site is not left in a clean and tidy condition, free of building debris and waste on completion.
- NCC 2022, Volume Two – Clause 3.0.1 Performance Requirements: Construction practices must safeguard the building site to avoid creating hazards for occupants and the surrounding environment.

Rectification is required to remove all builder's waste and ensure the garage area is presented in a clean, hazard-free condition in accordance with completion and presentation standards.

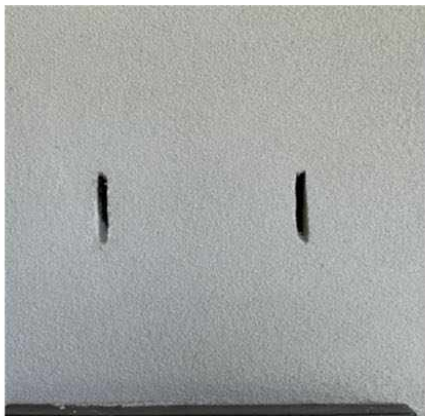
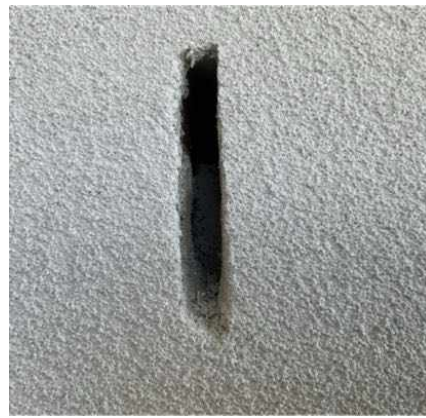
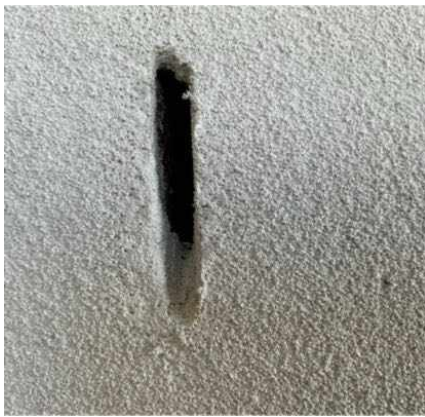
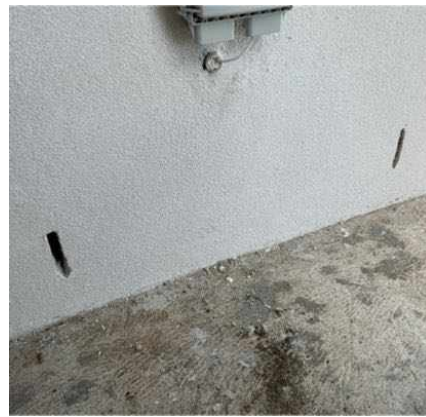
Requires weep holes to remain clear and functional to facilitate moisture egress from the cavity and reduce the risk of moisture accumulation within the wall system.

Rectification is required to ensure all affected weep holes are cleared, reinstated, and left unobstructed so the masonry wall system functions as intended and complies with NCC and Australian Standard requirements.

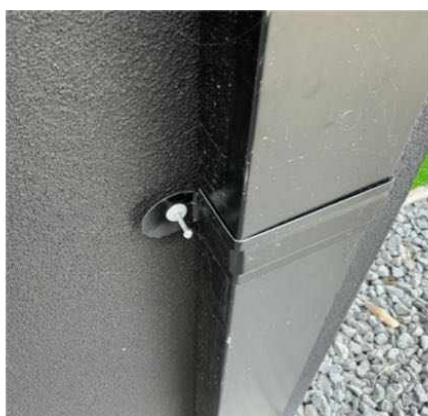
Defects 3.35

- AS/NZS 3500.3:2021 – Plumbing and Drainage – Stormwater Drainage Systems, which requires stormwater pipework and supports to be installed to maintain alignment, stability, and durability.
- NCC 2022 Volume Two – Part 2.2.1, which requires drainage systems to be designed and installed to ensure effectiveness, durability, and structural adequacy.
- Manufacturer installation requirements for downpipe brackets, which require correct fixing types, spacing, and alignment to prevent movement and damage.

Rectification is required to ensure all downpipe brackets are replaced or reinstated where damaged, correctly aligned, and securely fixed using appropriate fixings in accordance with manufacturer requirements and applicable standards to maintain structural support, durability, and drainage performance compliance.

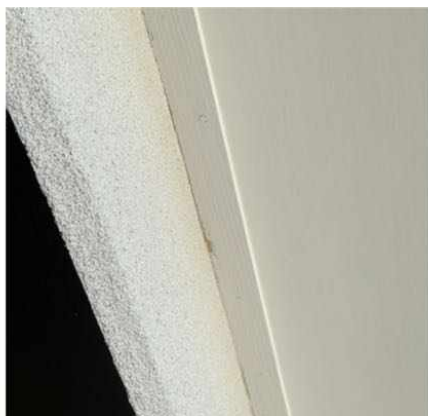
Defects 3.37

- Guide to Standards and Tolerances 2023, Section 13.02 – Painted surfaces must exhibit a uniform and complete finish when viewed from a normal distance of 1.5 metres under standard lighting.
- AS 2311 – Guide to the Painting of Buildings outlines preparation and application standards necessary to ensure a consistent, durable finish to all painted surfaces.

The current condition does not meet acceptable standards for new residential construction. Rectification is required to complete all external painting in a professional manner, ensuring uniform appearance and weather protection. Supplied photos illustrate examples of the affected areas; a full inspection should be undertaken to ensure all incomplete sections are addressed prior to handover.

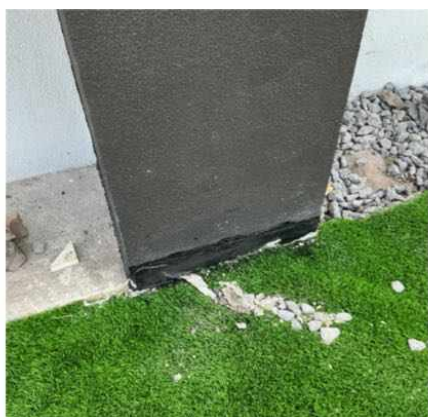
Defects 3.38

- Guide to Standards and Tolerances 2023, Clause 9.09 – Repairs to rendered surfaces must closely match the original in texture, colour, and finish to be considered compliant.
- AS 2311 – Guide to the Painting of Buildings – Requires that surface preparation and finishing result in a consistent and durable appearance.
- NCC 2022 Volume Two, Part 2.1.2 – Materials and finishes must be fit for purpose, maintain durability, and preserve aesthetic integrity.

The current condition is non-compliant and must be professionally rectified. All damaged or poorly finished rendered areas must be repaired to a standard that blends seamlessly with surrounding finishes to restore uniformity and meet regulatory expectations. The attached photographs represent examples only; a full inspection of all rendered surfaces is recommended to identify and address all affected areas.

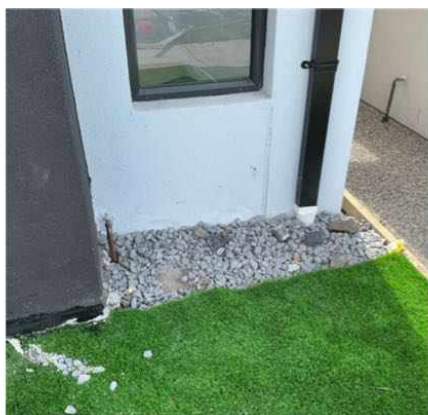
Defects 3.40

Building:	Main Building
Location:	Front Facade
Finding:	Missing and Excessively Spaced Weep Holes to External Masonry Walls - Lock-up/Fix/PCI
Information:	During the inspection, weep holes to the external masonry walls were observed to be missing and/or installed at spacing greater than acceptable construction standards. In several locations, the separation between weep holes exceeds the maximum recommended spacing, and in other areas no weep holes have been provided. This condition was also noted to short wall segments less than 1200 mm in length, where weep holes are still required when cavity flashings are present.
	The absence and excessive spacing of weep holes restricts effective drainage and ventilation of the masonry cavity, increasing the risk of moisture accumulation behind the brick veneer and reducing the long-term durability of the wall system.
Reference:

Rectification is required to ensure weep holes are installed where missing and/or reinstated at compliant spacing, including to short wall segments, so the masonry wall cavity can drain and ventilate as intended and comply with durability and performance requirements.

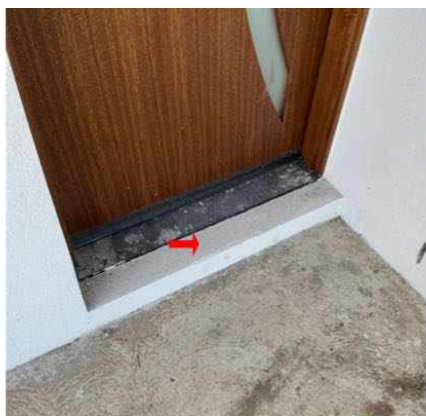
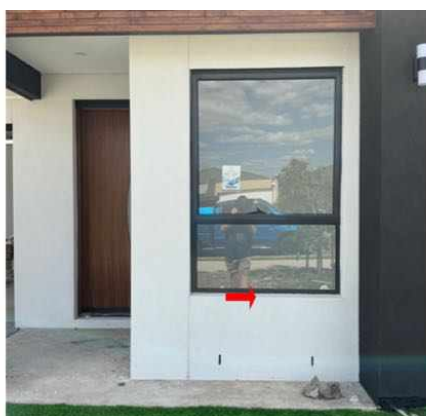
Defects 3.44

Building:	Main Building
Location:	Front Windows & Door
Finding:	Rendered Window and Door Sills Without Fall - PCI
Information:	During the inspection, rendered window and door sills were observed to be finished without a visible fall away from the window and door frames. The sill surfaces appear flat or back-falling toward the frames, which does not allow effective water shedding. This condition increases the likelihood of water ponding against the window and door assemblies and adjacent wall finishes.

Rectification is required to ensure all rendered window and door sills are re-formed to provide an adequate outward fall and are detailed to effectively shed water away from window and door frames to maintain weatherproofing, durability, and compliance.

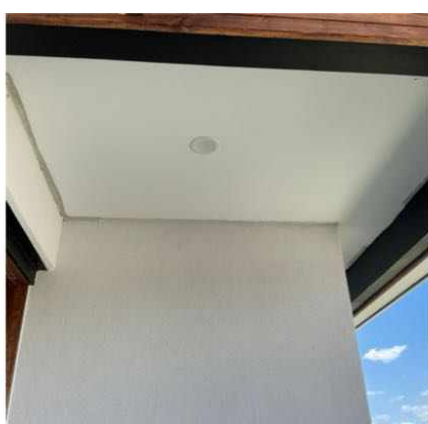
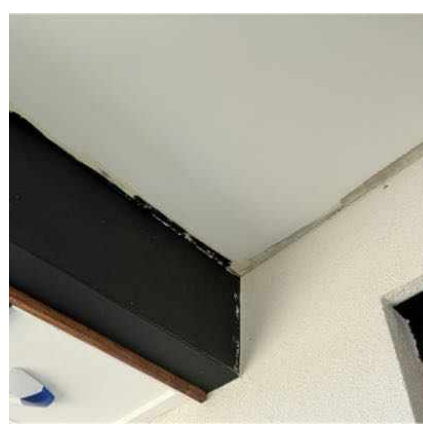
Plasterboard and associated finishes must be installed and finished in accordance with accepted workmanship standards.

Rectification is required to ensure the cornice installation is completed, properly aligned, and uniformly finished to achieve compliance, durability, and an acceptable standard of workmanship.
