Building and Timber Pest Inspection Report

Inspection Date: Thu, 22 Jan 2026

Property Address: 156A Old Canterbury Rd, Summer Hill NSW
2130, Australia

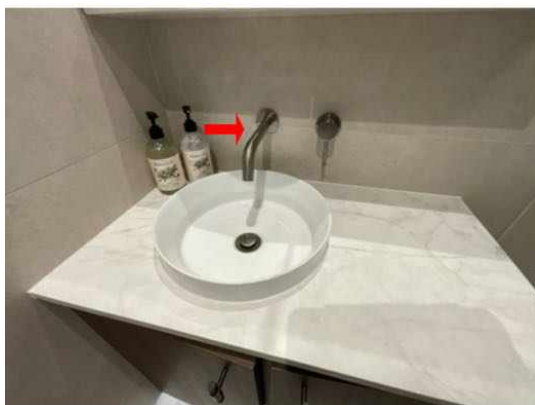
Finding 3.01

Building: Main Building
Location: Bathroom
Finding: Fitting or fixture - Loose (Basin Spout)
Information: The fitting in this area is loose and requires adjustment to tighten.

If left unmanaged, the fitting may further deteriorate, causing potential for the development of other minor secondary defects.

A relevant tradesperson should be appointed to perform these rectification works at discretion of the client.

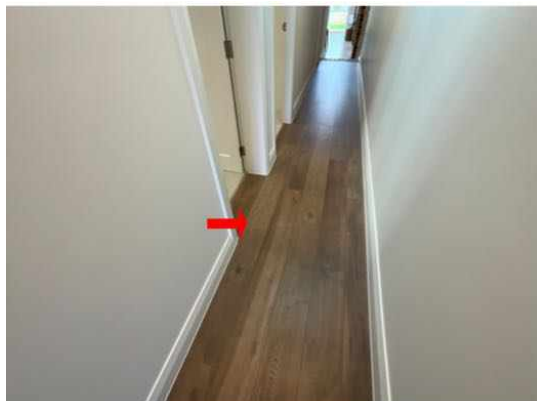
Finding 3.02

Building: Main Building
Location: Hallway
Finding: Floors - bouncy
Information: The internal flooring in this area was identified as being bouncy at the time of inspection. A bouncy floor surface generally presents as a discernible change in level as they are walked across, in noisy or creaking flooring, or in consequent movement of surrounding furniture and fixtures.

Bouncy floors generally indicate that the floorboards or the subfloor structures are coming loose from the joists that they are installed on. Bouncy flooring may also be the result of gaps between flooring and joist structures, which require packing.

The client is advised to seek quotations for required repairs from a Registered Builder.

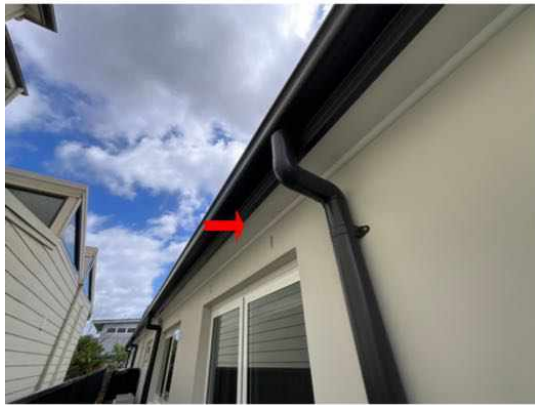
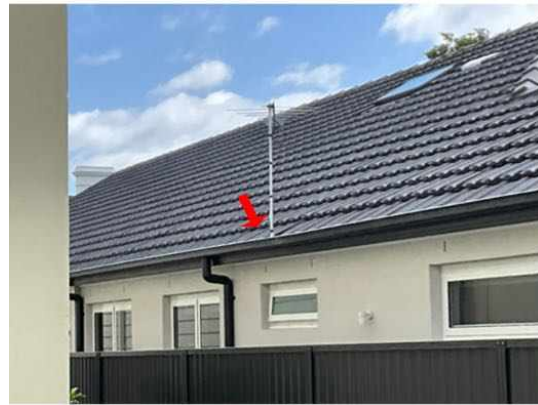
Finding 3.03

Building:	Main Building
Location:	Eaves
Finding:	Water staining - No Moisture Detected
Information:	Water staining was evident in this area at the time of inspection. Water staining indicates that surfaces have been exposed to excessive moisture over time. The minerals and other elements in the water lead to staining, which may graduate to corrosion and deterioration if left unmanaged.

Although there was no moisture I would recommend acting on the following.

Where water staining is active, a licensed roofing plumber must be consulted to identify the cause of the staining and to provide advice on any reparation works that may be required. Replacement of any broken or damaged structures is advised.

Conversely, where water staining is old and inactive, affected building materials may be repaired or replaced at client discretion. A qualified carpenter or registered builder may be appointed to perform these works.

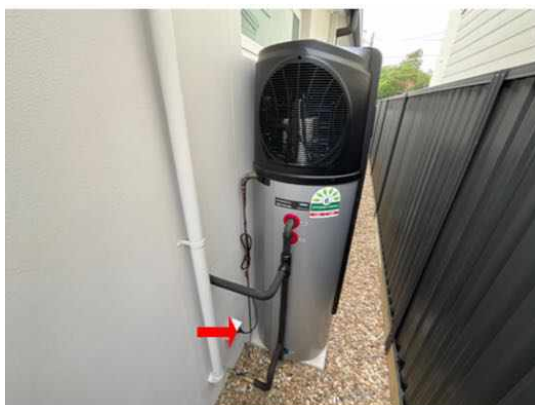
Finding 6.01

Building: Yard
Location: Yard - Side
Finding: HWS Overflow - Not Connected
Information: The Hot Water System (HWS) overflow was found to be disconnected from storm water drainage and is creating excessive moisture in the surrounding area.

It is highly recommended that a licensed plumber be appointed to connect the HWS overflow in order to prevent such an environment from being created.

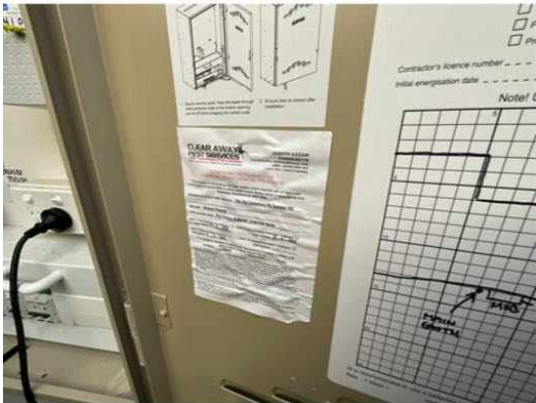
Building:	Main Building
Location:	All Areas
Finding:	Evidence of a previous termite management system was identified
Information:	There are a number of factors which indicate the presence of a previously installed or applied termite barrier. The most common are a durable notice (to the inside of your meter box) observable physical barriers installed to building perimeter and in ground reticulation systems.

Where a Termite Management System has been identified you should refer to the type of barrier date of installation warranty conditions and any documentation provided by a builder or past owner. Consult the company who installed the barrier to confirm whether the system is still under warranty.
