# Building and Timber Pest Inspection Report

Inspection Date: Thu, 12 Mar 2026

Property Address: 19 Patherton Place, Narellan Vale NSW  
2567

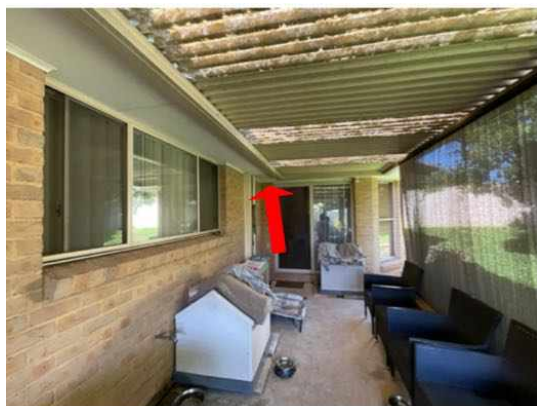
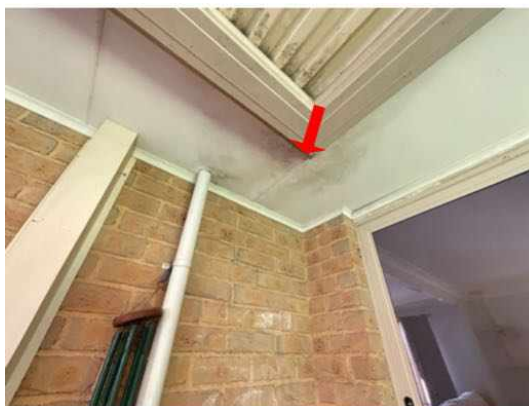
Building: Main Building  
Location: Eaves  
Finding: Defect – Eaves Sheeting Showing Water Staining  
Information: Observation

At the time of inspection, sections of the eaves to the property were observed to be in a visibly poor condition. Water staining was noted to the eaves sheeting in this area. The staining appeared consistent with previous moisture exposure. The inspection of the eaves was limited to a visual assessment from accessible areas only, and concealed cavities within the eaves could not be inspected.

Water staining to eaves sheeting commonly indicates that moisture has previously entered the area. This may occur for a number of reasons including poor roof drainage, overflowing or blocked gutters, leaking roof plumbing, or minor roof covering defects. While the staining currently appears to be primarily cosmetic, ongoing moisture entry can lead to deterioration of the eaves lining, paint failure, and in some cases the development of fungal decay or mould within concealed areas if the source remains unresolved.

The affected areas should be monitored during and following periods of rainfall to determine whether active water ingress is occurring. If further staining, moisture or deterioration is observed, a suitably qualified roofing contractor should be engaged to investigate and identify the source of the leak and undertake any necessary remedial repairs. Once the source of moisture has been addressed, maintenance works such as cleaning, sealing, and repainting of the eaves may be undertaken to restore the appearance of the structure.

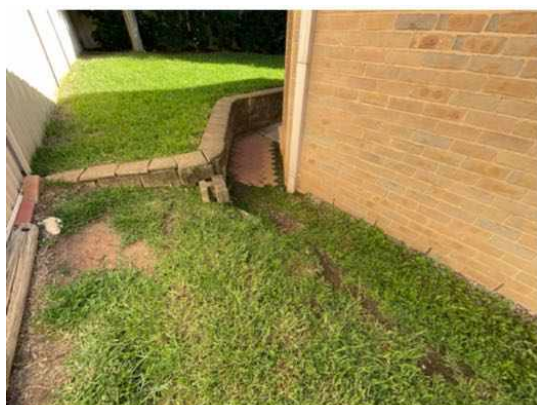
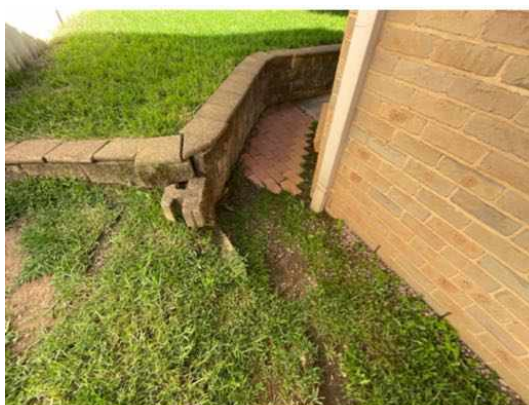
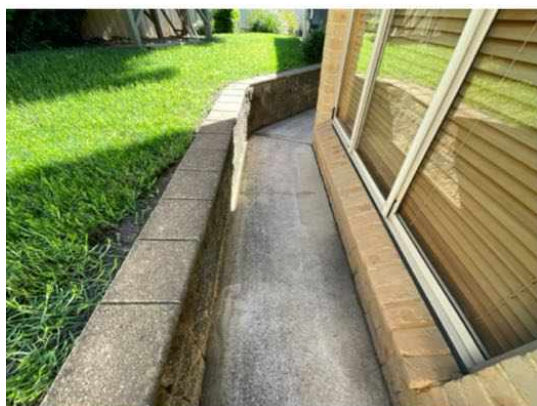
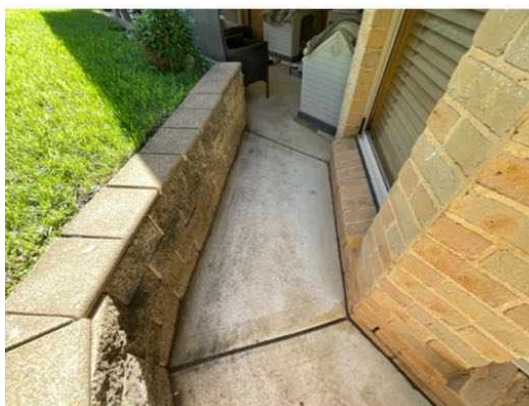
### Finding 3.02

Building: Main Building  
 Location: Exterior - rear  
 Finding: Site/Yard Drainage – Below Average.  
 Information: Defect – Below Average Site Drainage

Site drainage in the inspected areas appears to be below average, with no surface drains observed at the time of inspection. Ground surfaces and paved areas adjacent to the building do not appear to be adequately graded to facilitate effective surface water runoff.

Failure to meet these minimum drainage falls increases the risk of water ingress, foundation issues, and secondary building defects.

- A licensed plumber and/or landscaping contractor should be engaged to:
  - Evaluate the current site grading and surface runoff conditions
  - Install or upgrade surface water drainage (e.g. strip drains, spoon drains, grated channels) as required
  - Improve grading around the building to ensure water flows away from the structure

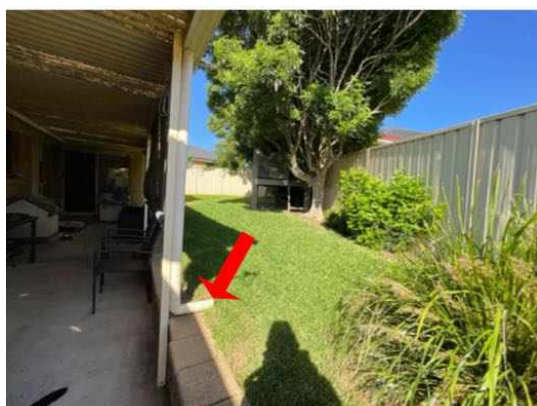
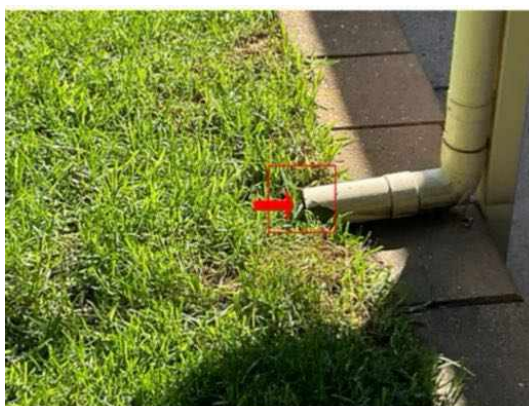
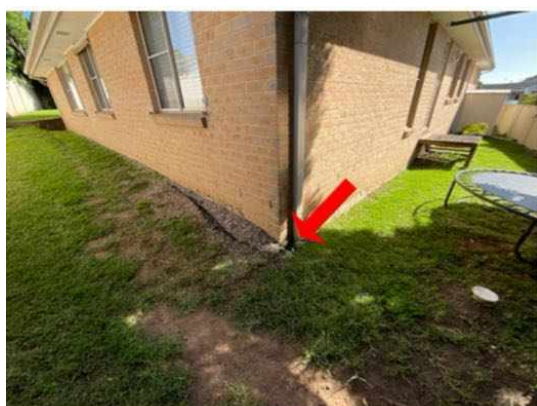
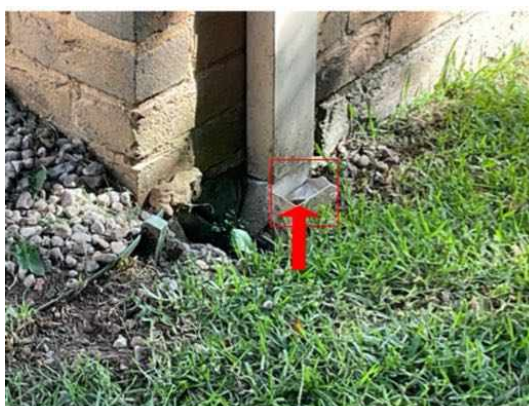
### Finding 3.03

Building: Main Building  
 Location: Exterior - rear  
 Finding: Downpipe – Unconnected.  
 Information: Findings:

Inadequate roof drainage can result in prolonged damp conditions around the foundations, potentially contributing to structural movement, subfloor moisture ingress, and long-term building degradation.

The current roof plumbing setup poses both compliance and moisture-management concerns, with the potential to contribute to structural or pest-related issues. Prompt rectification by a qualified professional is advised to ensure proper water management and protect the integrity of the building.

- Inspect all roof plumbing and stormwater discharge points
- Repair, replace, or install appropriate downpipes and drainage infrastructure to ensure all roof runoff is directed into a compliant stormwater system
- Assess for any secondary effects of prolonged moisture exposure near the building

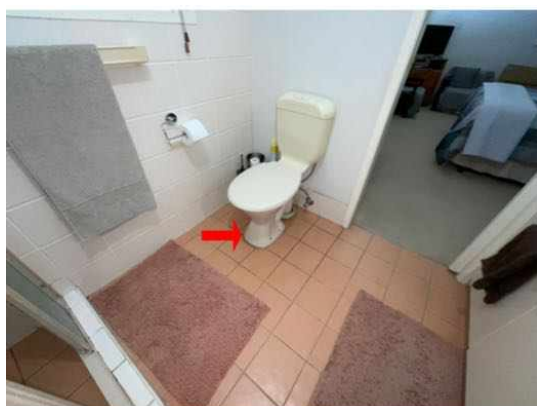
### Finding 3.04

Location: Ensuite  
 Finding: Toilet pan - Loose.  
 Information: Observation:

The toilet pan in this location was found to be slightly loose and unstable at the time of inspection. Movement was noted when gentle pressure was applied.

This minor defect is likely due to the ageing of the toilet fixture, deterioration of original fixings or adhesive, or possible minor impact damage. No visible signs of water leakage were observed during the inspection.

Although this is not considered urgent, it is advisable to have a licensed plumber inspect and secure the toilet pan using appropriate materials such as concrete or sanitary-grade silicone. This will help maintain stability, ensure proper function, and prevent future issues.

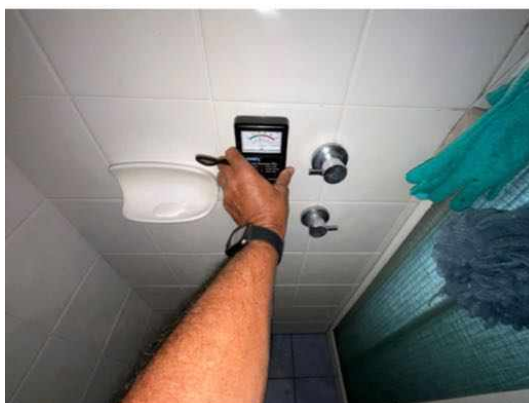
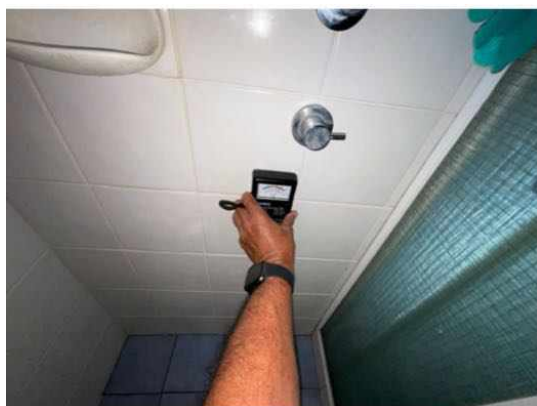
### Finding 3.05

Building: Main Building  
 Location: Bathroom  
 Finding: Minor Defect – Moisture Detected to Shower Alcove Wall.  
 Information: Observation

At the time of inspection, dampness was evident to the wall within the shower alcove. Moisture meter testing indicated minor to moderate elevated moisture readings to sections of the wall below the tap fittings and along the lower wall areas adjacent to the shower.

The condition suggests the possible presence of moisture ingress associated with the shower fixtures or fittings. It is suspected that sealant around the tap penetrations may be inadequate or deteriorated, or that minor leakage may be occurring from plumbing fixtures or associated connections. The inspection was limited to a non-invasive visual assessment and the removal of fixtures or wall finishes was not undertaken.

A licensed plumber should be engaged to inspect the shower tap fittings and associated plumbing to determine the source of the moisture and undertake repairs where necessary. This may include resealing around tap penetrations, tightening or repairing fittings, or rectifying any minor plumbing leaks identified.

In addition, sealant to junctions around fixtures, penetrations, and tiled surfaces should be maintained in good condition and grout lines kept sealed and intact to minimise the risk of moisture ingress in the future. Regular monitoring and maintenance of wet area seals is recommended as part of routine property upkeep.

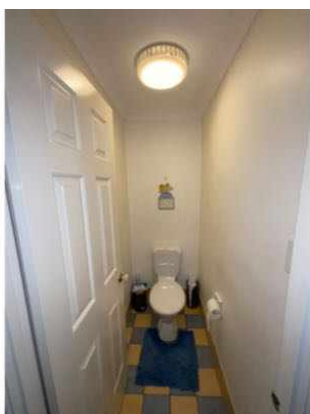
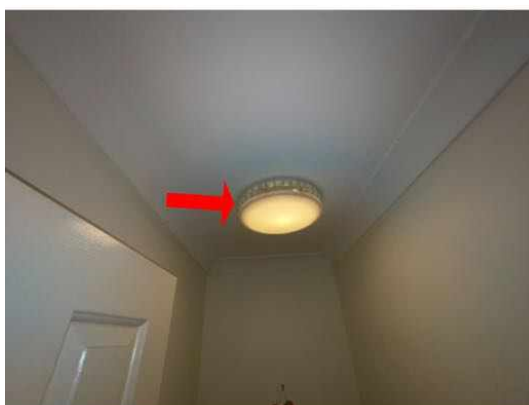
### Finding 3.06

Building:	Main Building
Location:	Toilet (WC)
Finding:	Defect – Inoperative Exhaust Fan and Inadequate Ventilation (Toilet Compartment).
Information:	Observation

At the time of inspection, the exhaust fan servicing the toilet compartment was tested and found to be non-operational. No other form of external ventilation, such as an operable window, was observed within the room.

A licensed electrician and/or suitably qualified ventilation contractor should be engaged to inspect the exhaust fan and associated electrical components to determine the cause of the fault and undertake repairs or replacement as required.

If natural ventilation is not available, a compliant mechanical exhaust fan should be installed or reinstated to ensure adequate ventilation of the toilet compartment. Rectification is recommended to improve ventilation and maintain suitable hygiene conditions within the room.

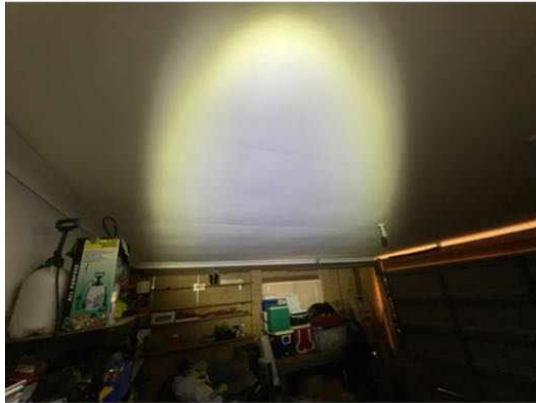
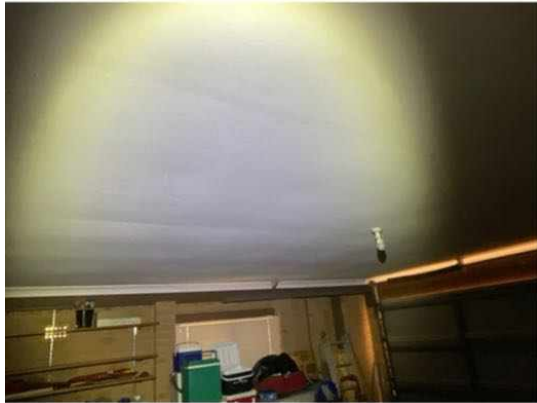
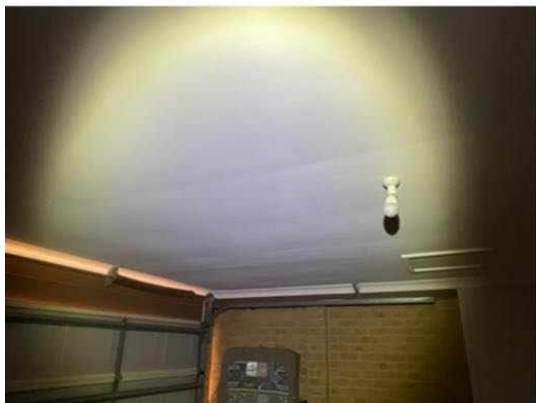
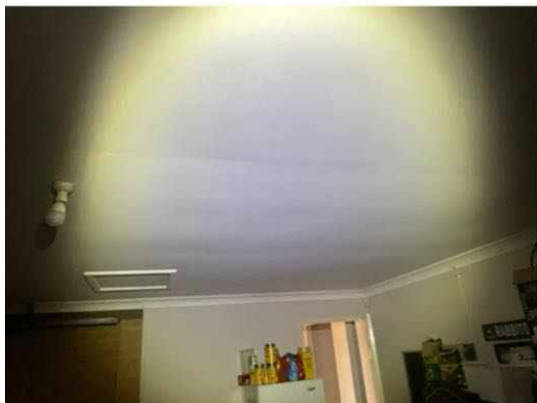
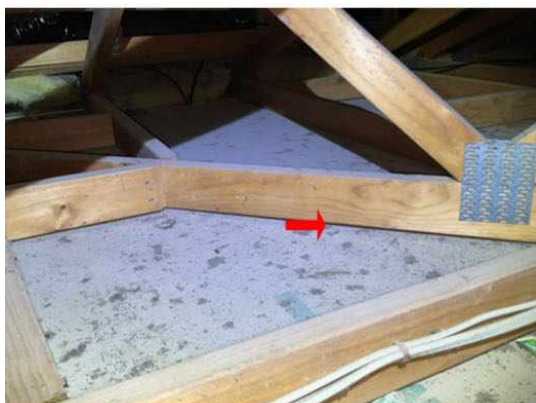
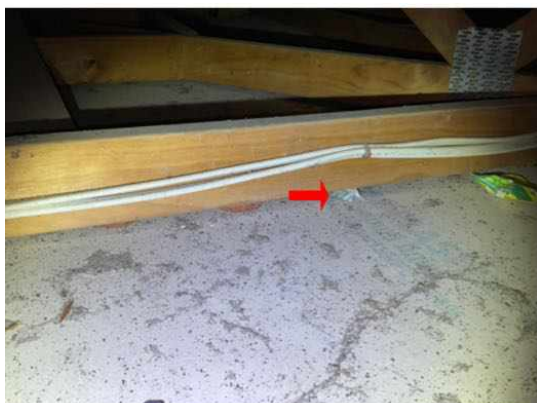
### Finding 3.07

Building:	Main Building
Location:	Garage
Finding:	Ceiling Linings – Uneven or Sagging Surfaces.
Information:	Observation:

Uneven sagging ceiling linings were observed in various areas throughout the property. At the time of inspection, the condition appeared to be minor and cosmetic in nature, however, further investigation in particular the ceiling to the garage area.

This is a common occurrence in homes of similar age and construction, often caused by the gradual deterioration or loosening of original fixings, such as nails, screws, or adhesives used to secure ceiling sheets.

- Re-securing sheets using appropriate modern fixings
- These works can be carried out by a qualified plasterer or painter,
- Ongoing monitoring is advised to detect any worsening of the condition or further movement over time.

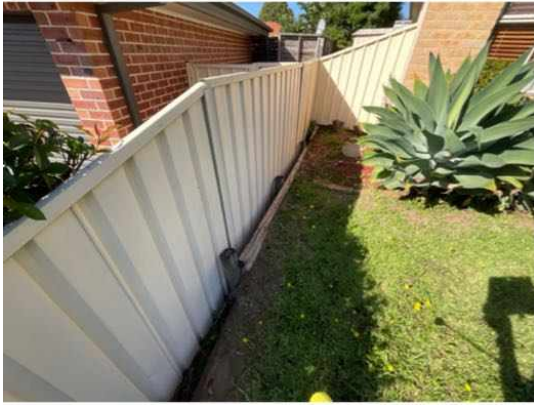
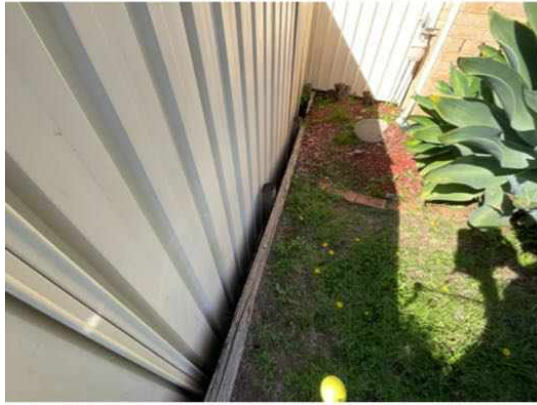
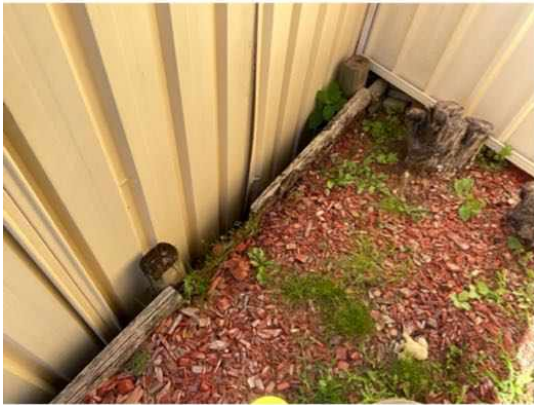
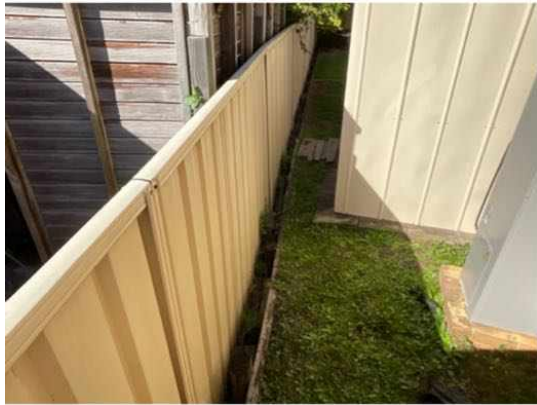
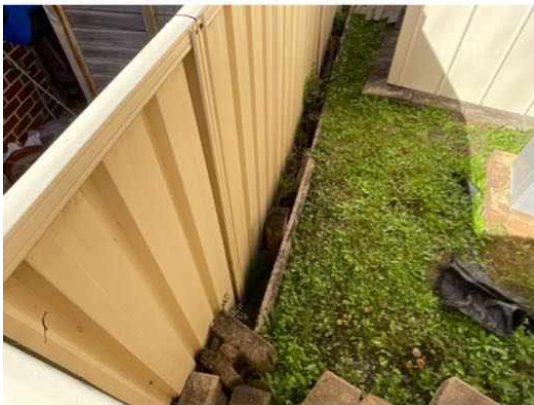
### Finding 3.08

Building:	Yard
Location:	Fencing
Finding:	Retaining Walls – Treated Pine Sleepers.
Information:	The retaining walls on the property are constructed from treated pine sleepers and are currently concealed and assessed to be in average condition.

Minor leaning was noted in some areas, indicative of typical movement and wear expected with this type of construction and its age. While not currently severe, ongoing deterioration is likely over time.

Although the sleepers are treated to resist decay and pests, prolonged exposure to varying weather conditions can diminish the effectiveness of the treatment. As the treatment breaks down, the timber becomes increasingly susceptible to wood rot, general decay, and potential termite activity.

Regular monitoring of the retaining walls is advised. Should further movement, leaning, or signs of timber decay become evident, it is recommended that a qualified landscaping contractor be engaged to assess the structure and undertake repair or replacement as necessary.

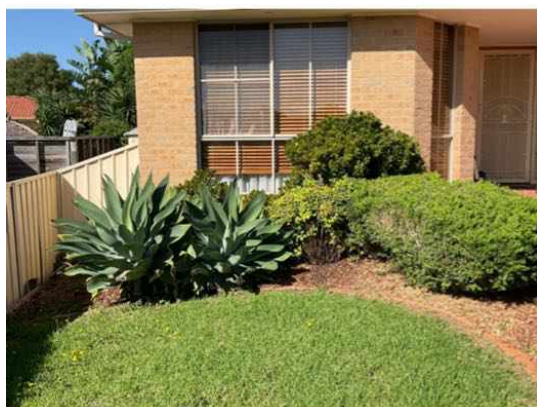
Garden beds were observed directly against the perimeter of the building. This condition can result in water pooling or retention during rainfall or from regular watering/hosing, which may lead to moisture ingress beneath the structure.

It is strongly recommended that garden beds be removed or relocated away from the building perimeter. Maintaining a clear inspection zone around the structure helps reduce moisture retention and improves visibility during regular pest inspections. This preventative measure significantly lowers the risk of termite ingress and related structural damage.

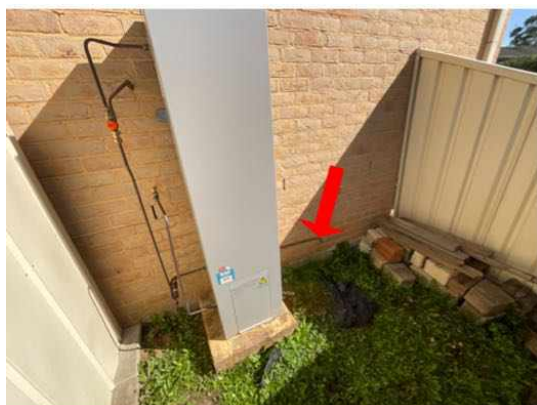
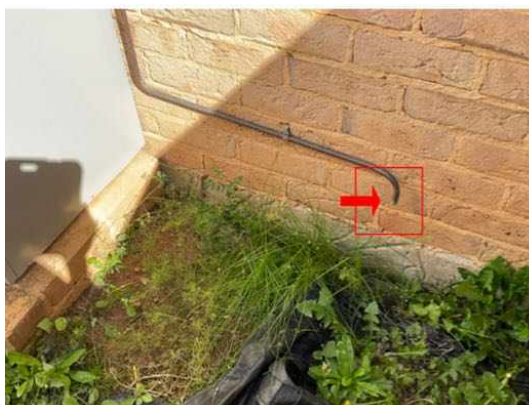
### Finding 6.03

Observation: Water Pooling from HWS and Air Conditioning Overflows

It is highly recommended that all overflows from the HWS and air conditioning units be redirected away from the building, preferably via fixed drainage or extension piping, to prevent water accumulation near the structure.

These minor corrective works should be undertaken promptly to minimise the risk of both termite ingress and potential structural damage due to ongoing moisture exposure.

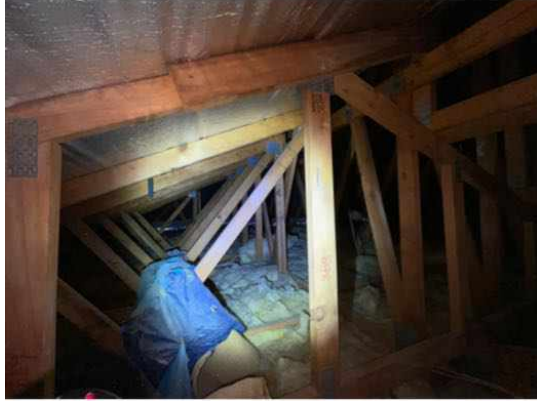
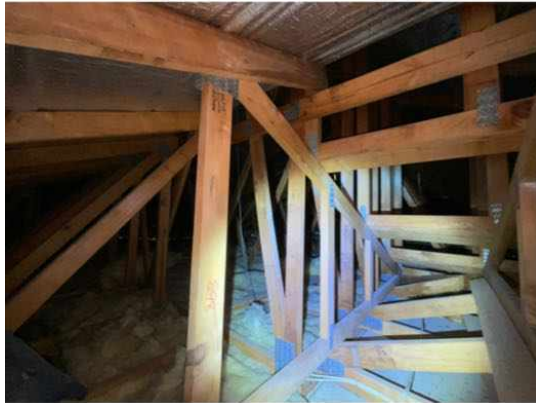
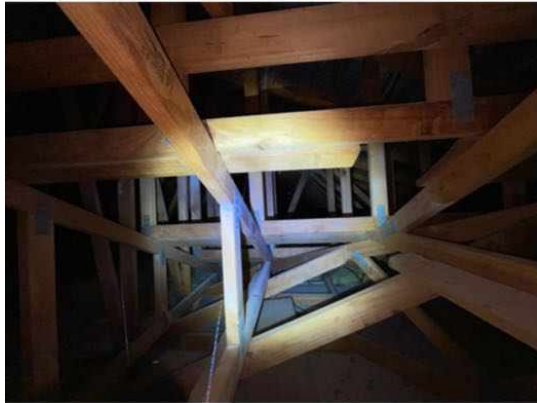
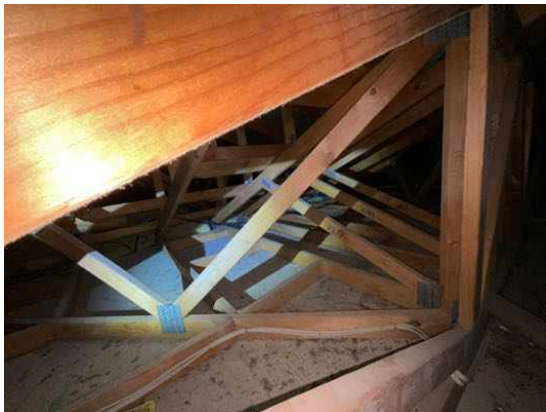
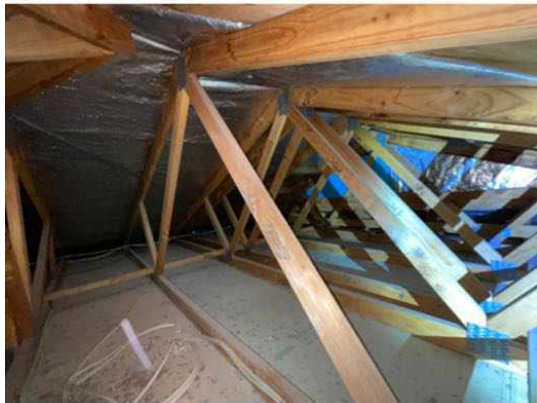
Building: Main Building  
 Location: Roof Void  
 Finding: Roof Void – Limited Accessibility..  
 Information: Observation:

Installation of an additional manhole is recommended to facilitate a re-inspection and enable a more thorough assessment of the roof void in the future. This will help ensure that all structural elements and concealed areas are properly evaluated.
