Building and Timber Pest Inspection Report

Inspection Date: Wed, 18 Feb 2026

Property Address: 4/61 Azalea Ave, Coffs Harbour NSW 2450, Australia

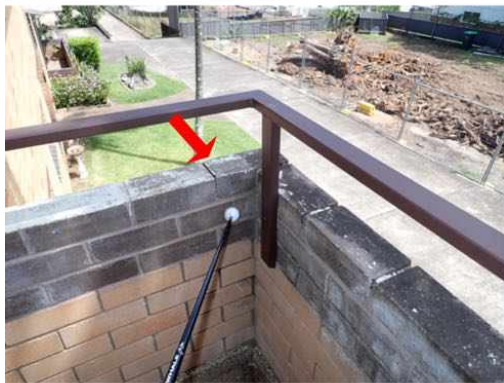
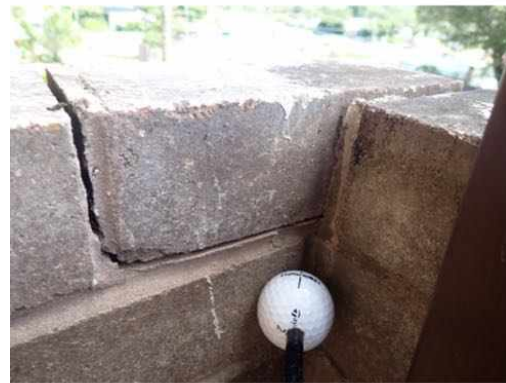
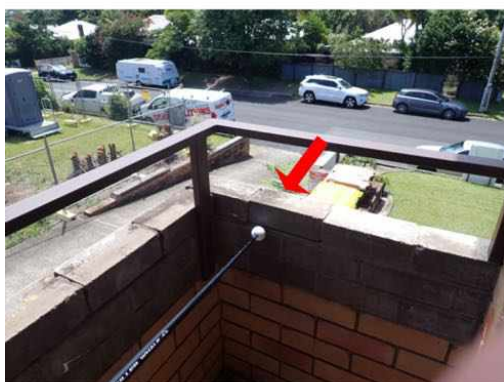
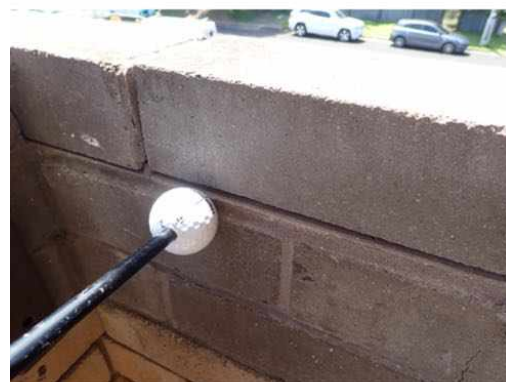
Finding 1.01

Building:	Main Building
Location:	Balcony
Finding:	Loose Bricks To First Floor Balcony Balustrade – Safety Hazard
Information:	Several loose bricks were identified to the first floor balcony balustrade and could be displaced under minimal pressure. This is likely due to age-related mortar deterioration and long-term weather exposure, which is common for masonry of this age. In plain terms, several bricks forming the balcony barrier are loose and could potentially be pushed off, creating a safety risk to people below. A qualified bricklayer or licensed builder should urgently assess and re-bed, re-point the affected section as deemed necessary. Prompt repair is recommended at the owner's discretion due to the safety implications.

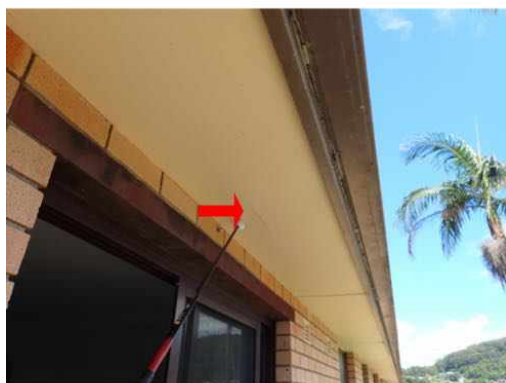
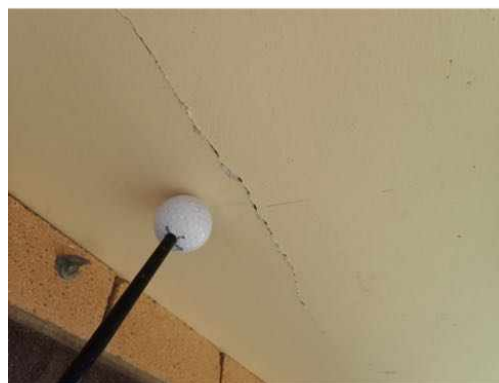
Finding 1.02

Building:	Main Building
Location:	Balcony

Finding: Crack To Eave Sheet Cladding – Possible Asbestos Containing Material
Information: A crack was identified to the eave sheet cladding. Based on the age and appearance of the material, the sheeting may contain asbestos; however, confirmation is outside the scope of this visual inspection and testing would be required to verify. In plain terms, the eave lining is cracked and could be made of older asbestos-type sheeting. Cracking may be associated with age-related brittleness, movement or minor impact damage. Damaged asbestos-containing materials can pose a health risk if fibres become airborne. Preventative measures include avoiding disturbance of the material. A licensed asbestos assessor and/or appropriately licensed removal contractor should be engaged to test and repair or replace the affected sheeting as deemed necessary. Rectification is recommended at the owner's discretion with appropriate safety controls in place.

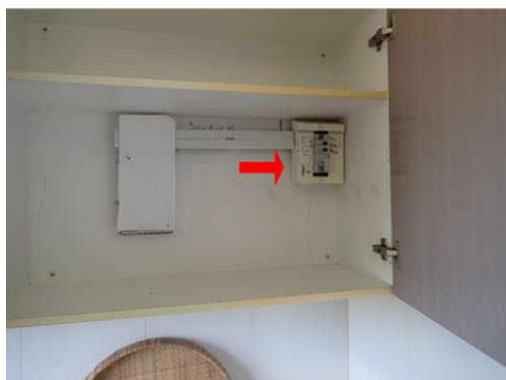
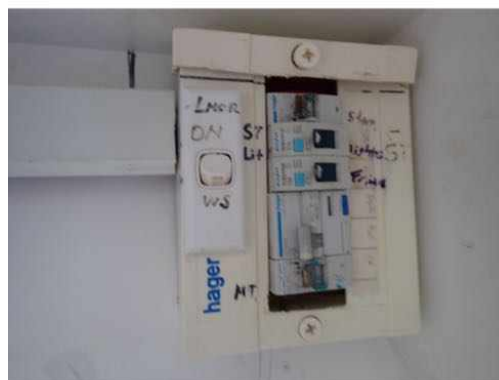
Finding 1.03

Building: Main Building
Location: Kitchen
Finding: Electrical Sub Board In Poor Condition – Replacement Quoted But Not Completed
Information: The electrical sub board was observed to be in poor condition at the time of inspection. The real estate agent advised that a quote has been obtained from a licensed electrician to replace the sub board; however, the works had not been completed at the time of inspection. Deterioration of electrical components may be associated with age, outdated equipment or prior modifications and can present safety and compliance concerns. In plain terms, the switchboard is old or worn and needs replacing, but the job has not yet been done. Electrical defects can pose a risk of electric shock or fire if not properly addressed. A licensed electrician should carry out the recommended replacement and provide certification of compliance upon completion. Rectification is recommended at the owner's discretion prior to settlement to ensure safety and compliance.

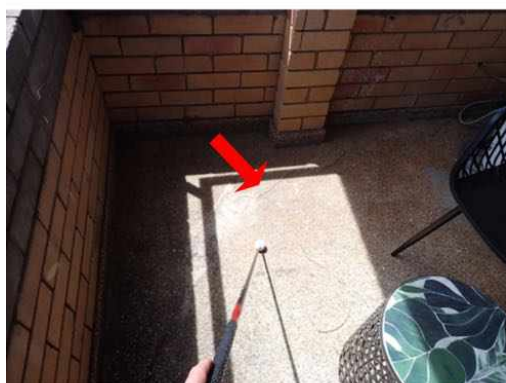
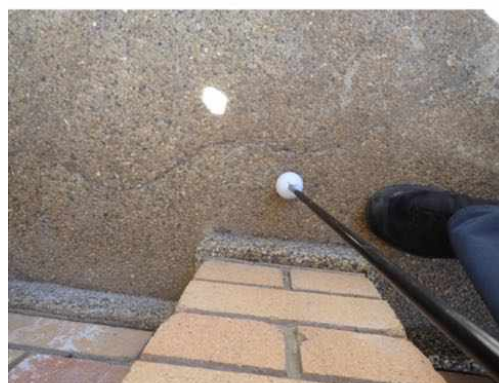
Finding 2.01

Building: Main Building

Location: Balcony

Finding: Crack To Balcony Concrete Floor – Potential Structural And Waterproofing Concern

Information: A noticeable crack was identified to the concrete floor of the balcony. While cracking in concrete can occur due to age-related shrinkage and movement, balcony slabs are exposed structural elements and cracking in these areas may allow water ingress to the substrate and any embedded reinforcement. In plain terms, the balcony surface is cracked and this could allow water to penetrate the slab. Ongoing moisture intrusion can lead to corrosion of reinforcement, concrete spalling and potential structural deterioration over time. Preventative measures include prompt sealing of cracks and ensuring the balcony surface remains adequately waterproofed and graded to drain. A qualified concreter, structural builder or remedial building contractor should assess the crack to determine its extent and carry out appropriate repairs as deemed necessary. Rectification is recommended at the owner's discretion to prevent further deterioration.

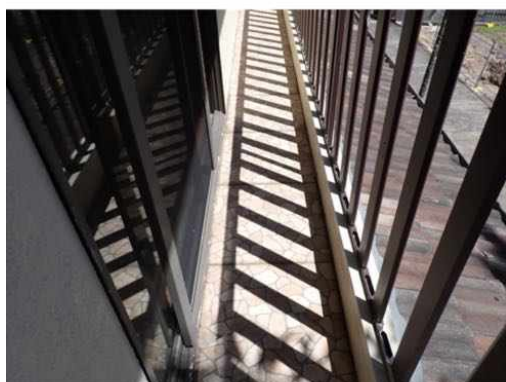
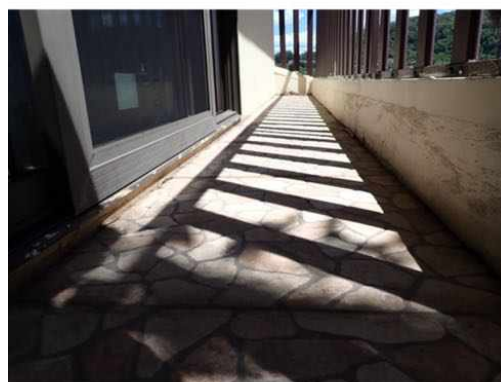
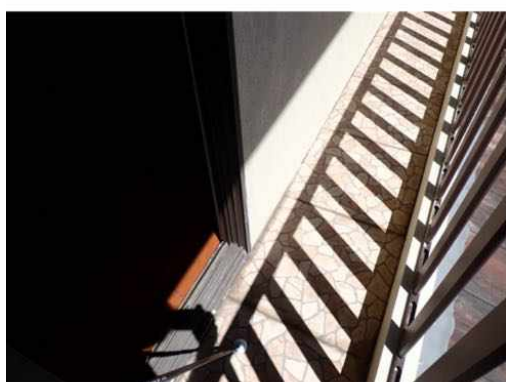
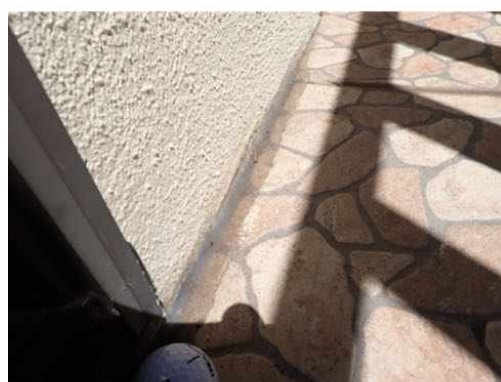
Finding 2.02

Building:	Main Building
Location:	Balcony top floor
Finding:	Inadequate Fall To Top Floor Balcony Floor – Potential Ponding Issue
Information:	The top floor balcony floor was observed to have inadequate fall toward drainage points. Although drain pipes have been installed through the balustrade, the current gradient may allow water to pond on the surface during periods of heavy or wind-driven rain. In plain terms, the balcony does not slope enough to properly drain water, and water may sit on the surface in bad weather. Prolonged ponding can contribute to waterproofing failure, moisture ingress into the slab and potential deterioration of the structure below. Preventative measures include ensuring correct falls are achieved in accordance with relevant standards and maintaining clear drainage outlets. A qualified builder or remedial building contractor should assess and, if required, regrade or resurface the balcony to achieve adequate fall and ensure the waterproofing system is compliant. Rectification is recommended at the owner's discretion to reduce the risk of future water damage.

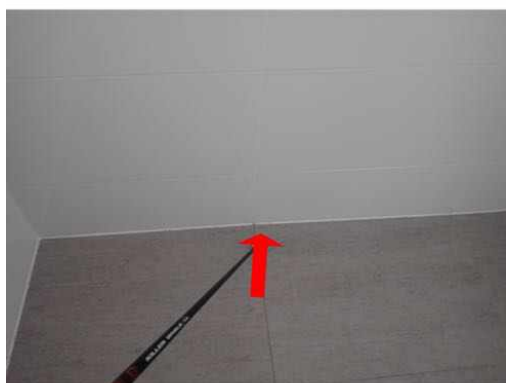
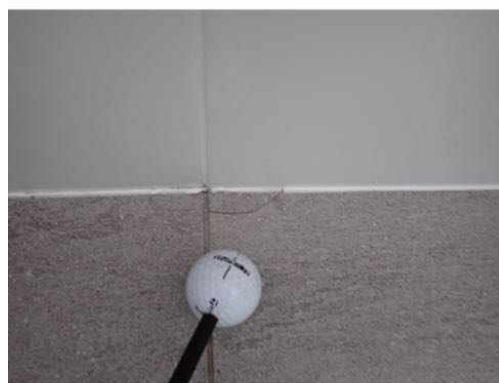
Finding 2.03

Building:	Main Building
Location:	Bathroom
Finding:	Cracked Bathroom Floor Tile To Shower Area
Information:	A cracked floor tile was identified within the shower area. This type of damage is commonly caused by impact, substrate movement, inadequate tile support or age-

related deterioration. In plain terms, one of the shower floor tiles is cracked. Cracked tiles in wet areas can allow water to penetrate beneath the surface, potentially affecting the waterproofing membrane and leading to moisture damage over time. Preventative measures include ensuring tiles are properly supported and maintaining grout and sealants. A qualified tiler should assess and replace the cracked tile and check the condition of the underlying waterproofing as deemed necessary. Prompt repair is recommended at the owner's discretion to prevent moisture ingress and further deterioration.

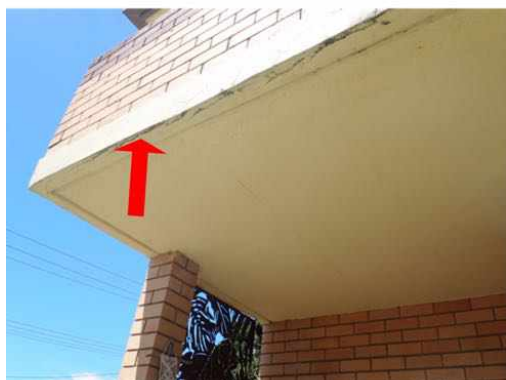
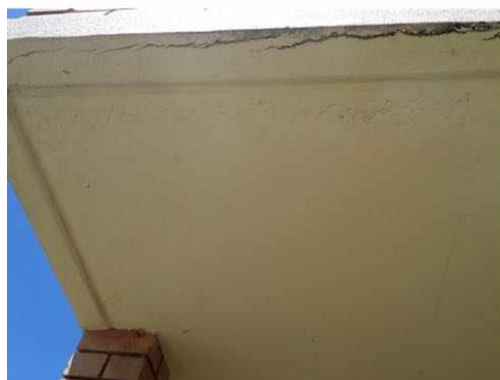
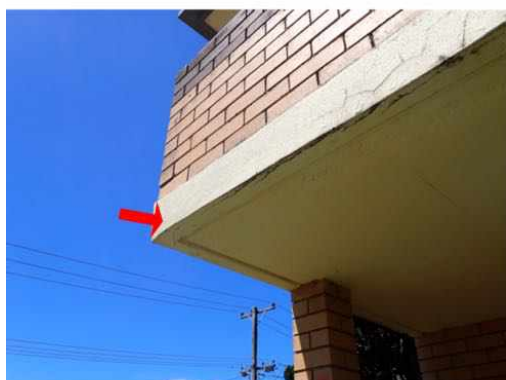
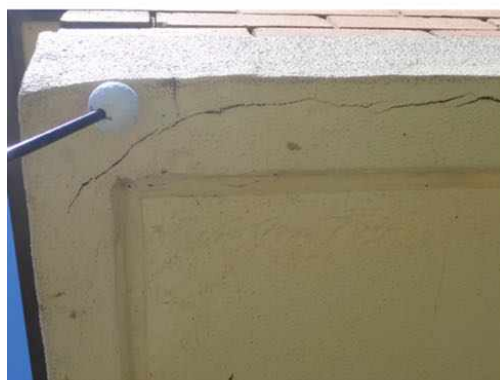
Finding 2.04

Building:	Main Building
Location:	Front entry
Finding:	Noticeable Cracking To Balcony Concrete – Potential Structural And Waterproofing Concern
Information:	Noticeable cracking was identified to the concrete balcony. While cracking in concrete can occur due to age-related shrinkage and movement, balcony slabs are exposed structural elements and cracking in these areas may allow water ingress to the substrate and any embedded reinforcement. In plain terms, the balcony surface is cracked and this could allow water to penetrate the slab. Ongoing moisture intrusion can lead to corrosion of reinforcement, concrete spalling and potential structural deterioration over time. Preventative measures include prompt sealing of cracks. A qualified concreter, structural builder or remedial building contractor should assess the crack to determine its extent and carry out appropriate repairs as deemed necessary. Rectification is recommended at the owner's discretion to prevent further deterioration.

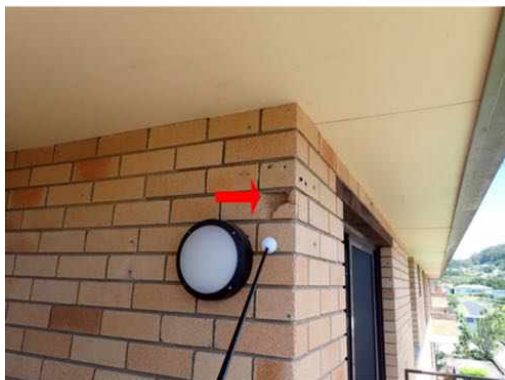
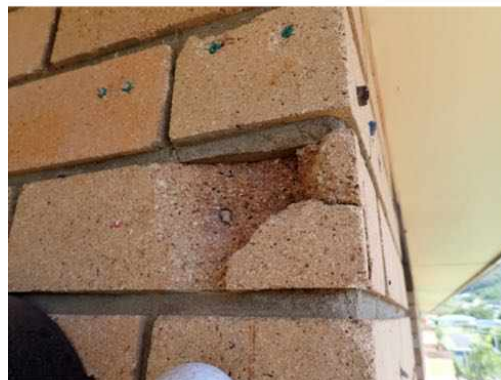
Finding 3.01

Building:	Main Building
Location:	Balcony
Finding:	Damage To Brickwork Likely From Previous Fixing Installation
Information:	<p>Localised damage was identified to the brickwork, most likely associated with the previous installation and removal of a hook or similar fixing. This type of damage commonly occurs when fixtures are mechanically fastened into masonry and later removed without proper repair. In plain terms, a fitting appears to have been attached to the brick and has left it chipped or damaged. While generally cosmetic, exposed or damaged brick faces can allow minor moisture ingress over time. Preventative measures include sealing penetrations and carrying out proper patch repairs when removing fixings. A qualified bricklayer or handyman should assess and repair the damaged area as deemed necessary. Repairs are recommended at the owner's discretion to maintain appearance and prevent further deterioration.</p>

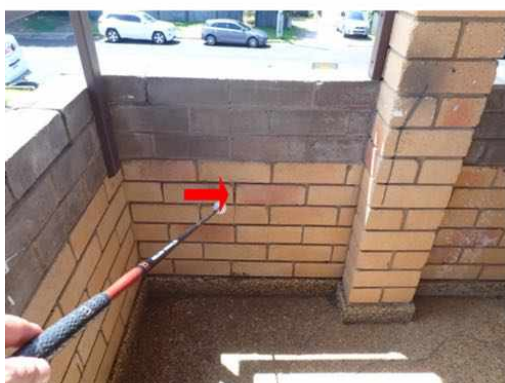
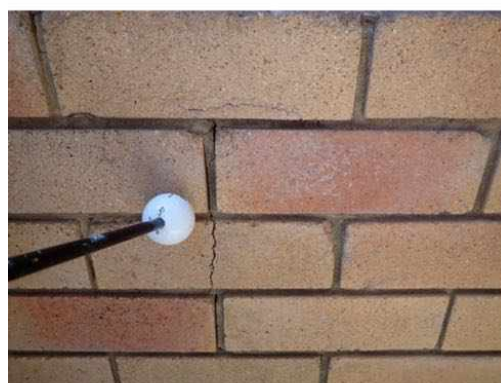
Finding 3.02

Building:	Main Building
Location:	Balcony
Finding:	Minor Cracks To Brickwork Balcony Balustrade
Information:	Minor cracking was identified to the brickwork forming the balcony balustrade. This is commonly associated with age-related mortar shrinkage, minor building movement and long-term weather exposure, and is considered a common defect in masonry of this age. In plain terms, small cracks are visible in the brickwork of the balcony barrier. While currently minor, cracks can allow moisture ingress which may contribute to gradual deterioration over time. Preventative measures include monitoring and re-pointing mortar joints where required. A qualified bricklayer should assess and carry out repairs such as crack sealing or re-pointing as deemed necessary. Repairs are recommended at the owner's discretion to maintain structural integrity and appearance.

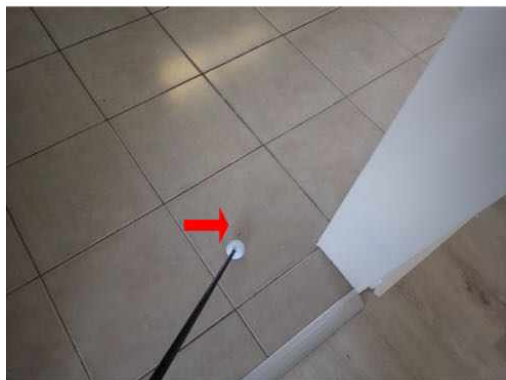
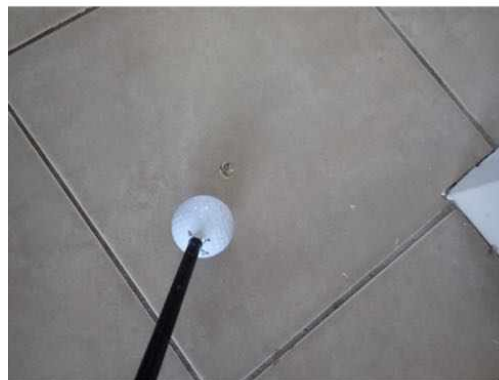
Finding 3.03

Building:	Main Building
Location:	Kitchen
Finding:	Chip To Kitchen Floor Tile
Information:	A chip was identified to a tile within the kitchen area. This type of damage is commonly caused by impact from dropped objects, movement of appliances or general wear

and tear. In plain terms, part of the tile surface is broken or chipped. The defect is primarily cosmetic; however, chipped tiles can worsen over time and may allow minor moisture penetration if located in a wet area. Preventative measures include avoiding heavy impact and replacing damaged tiles where practical. A qualified tiler or handyman should assess and repair or replace the affected tile as deemed necessary. Repair is recommended at the owner's discretion to maintain appearance and prevent further deterioration.

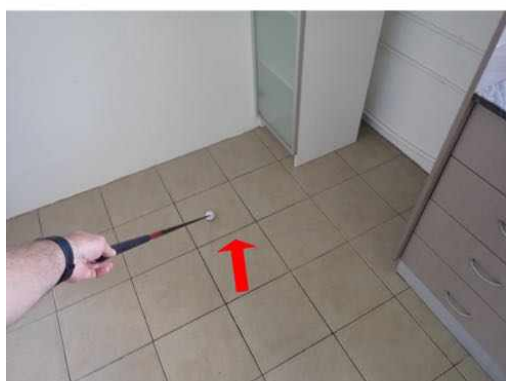
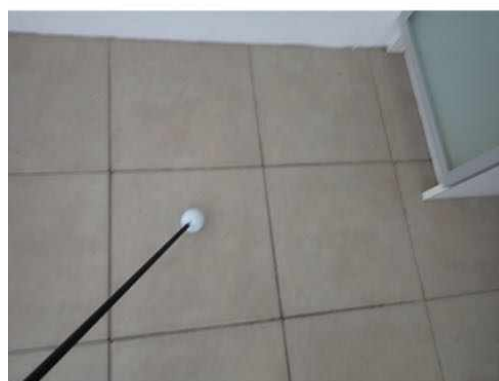
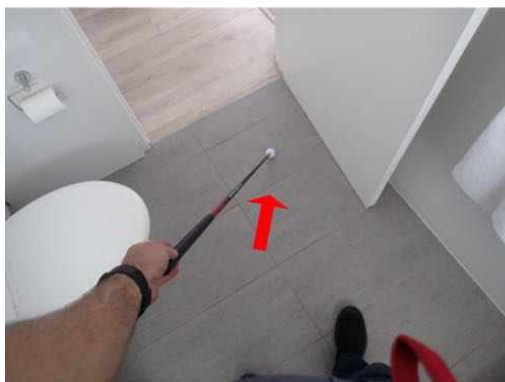
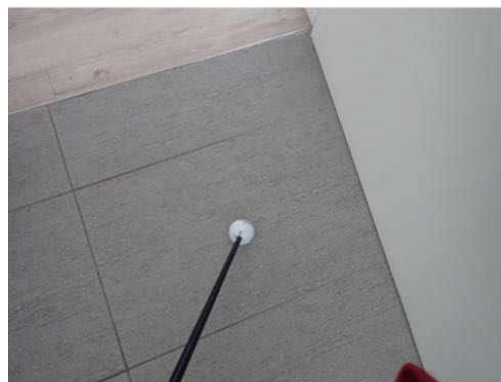
Finding 3.04

Building:	Main Building
Location:	Kitchen and bathroom
Finding:	Drummy Floor Tiles Identified To Bathroom And Kitchen
Information:	Drummy floor tiles were identified to areas of the bathroom and kitchen. Drummy tiles are tiles that sound hollow when tapped, indicating a loss of adhesion between the tile and the substrate. This is commonly caused by inadequate adhesive coverage, substrate movement, moisture ingress or age-related deterioration and is considered a common defect in tiled areas of this age. In plain terms, some tiles are not properly bonded underneath and may lift or crack over time. If left unaddressed, affected tiles can become loose and require replacement. A qualified tiler should assess and re-fix or replace the affected tiles as deemed necessary. Repairs are recommended at the owner's discretion to prevent further deterioration.

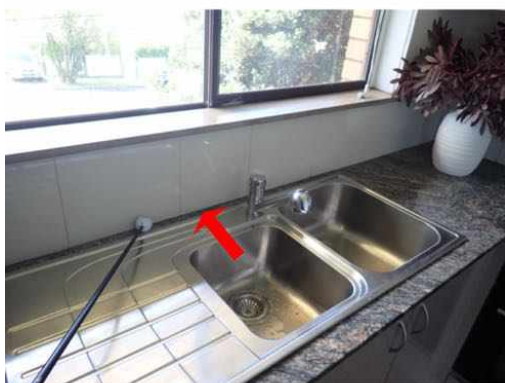
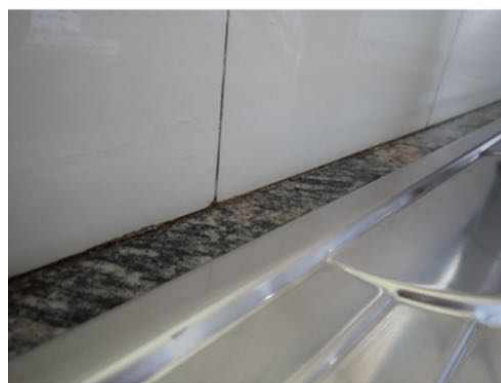
Finding 3.05

Building:	Main Building
Location:	Kitchen
Finding:	Silicone Deterioration To Kitchen Splashback And Benchtop Junction
Information:	Deteriorated and failing silicone sealant was identified to the junction between the kitchen splashback and benchtop. This is commonly caused by age-related shrinkage, movement between materials, cleaning chemicals and general wear, and is considered a common maintenance item. In plain terms, the seal between the wall and benchtop is worn and breaking down. Failed silicone can allow moisture to penetrate behind cabinetry which may lead to swelling or deterioration over time. Preventative maintenance includes periodic removal and reapplication of sealant. A qualified handyman, cabinet maker or tiler should remove and replace the affected silicone as deemed necessary. Repairs are recommended at the owner's discretion to prevent moisture ingress and maintain serviceability.

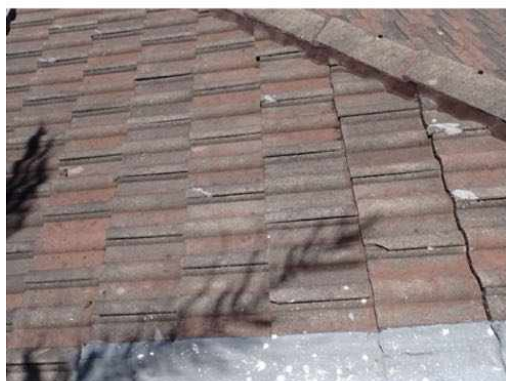
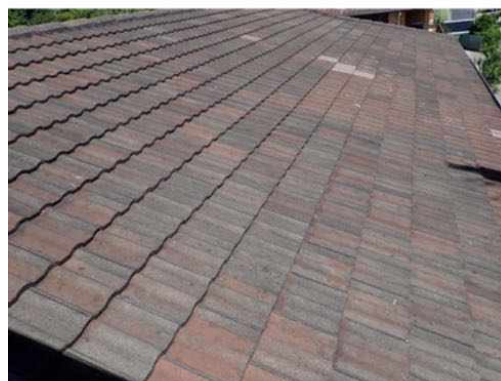
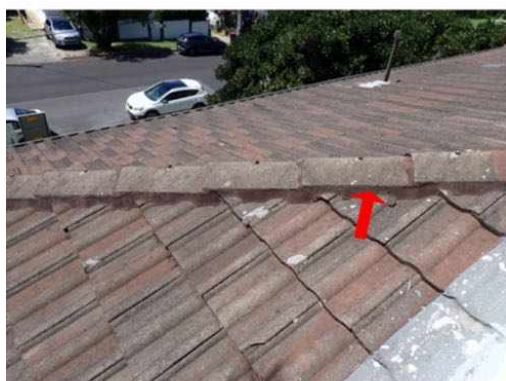
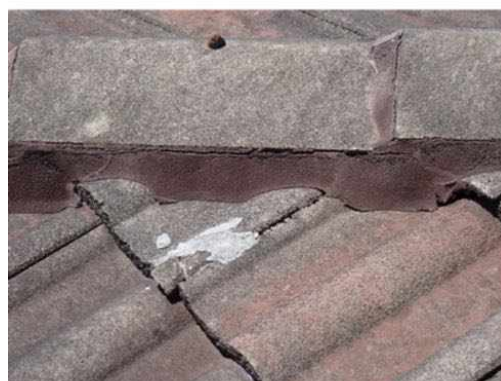
Finding 3.06

Building:	Main Building
Location:	Kitchen
Finding:	Roof Tiles In Fair Condition For Age.
Information:	The roof tiles were observed to be in fair condition for their age, with multiple previously cracked and repaired tiles noted, along with minor cracking to ridge

capping pointing and general age-related fading. These conditions are consistent with long-term weather exposure and normal ageing of tiled roofing materials and are considered common for a roof of this age. In plain terms, the roof shows signs of wear, some past repairs and minor cracking, but overall appears typical for its age. Deteriorated pointing and cracked tiles can allow water ingress if left unmaintained. Preventative maintenance includes periodic inspection, replacement of damaged tiles and re-pointing as required. A qualified roof tiler should assess and carry out repairs as deemed necessary. Ongoing maintenance is recommended at the owner's discretion to preserve the roof's serviceability and prevent future leaks.

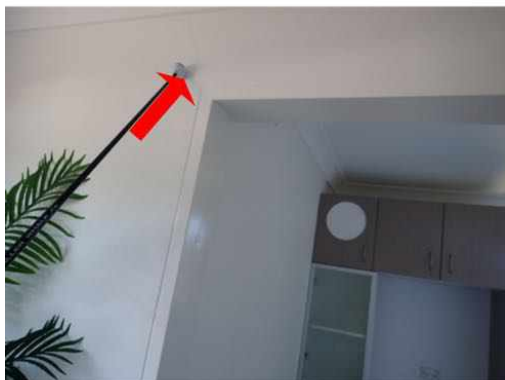
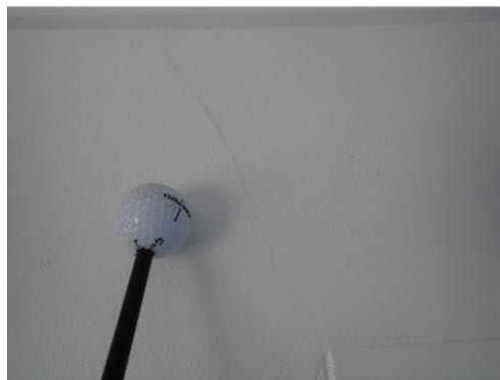
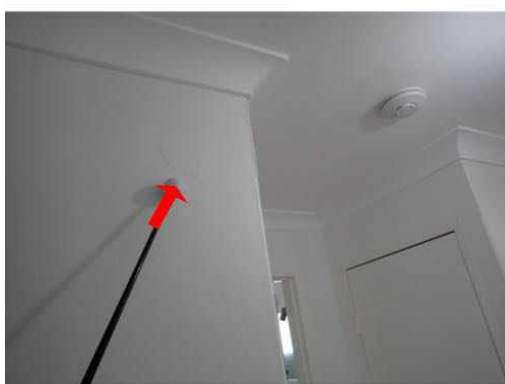
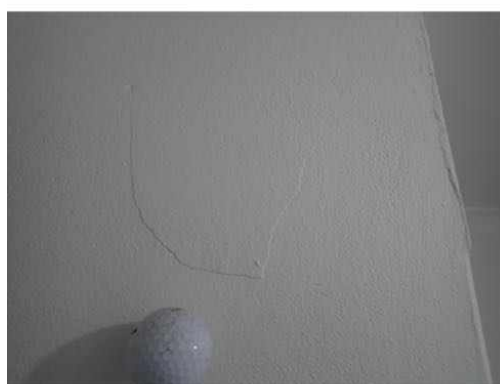
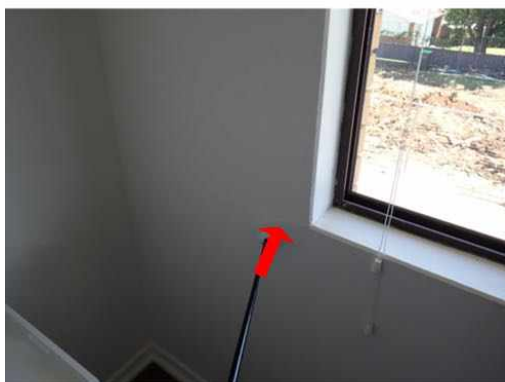
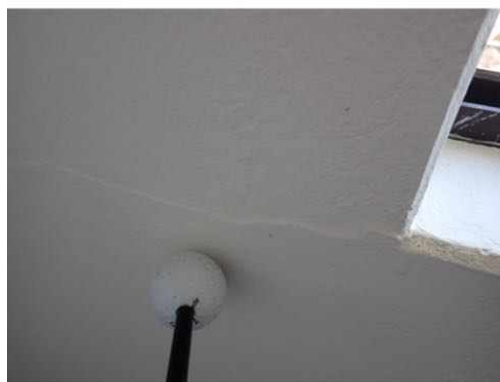
Finding 3.07

Building:	Main Building
Location:	Internal walls
Finding:	Minor Cracking To Internal Wall Render At Several Locations
Information:	Minor cracking was identified to the internal wall render at several locations throughout the dwelling. This is commonly associated with normal building movement, shrinkage of materials and age-related settlement and is considered a common defect for a property of this age. In plain terms, small cracks are visible in the internal rendered wall surfaces. While generally cosmetic in nature, cracks can widen over time if movement continues. Preventative measures include monitoring for further movement and maintaining stable internal conditions. A qualified painter or plasterer should assess and carry out patch repairs and repainting as deemed necessary. Repairs are

recommended at the owner's discretion to maintain appearance and prevent further deterioration.

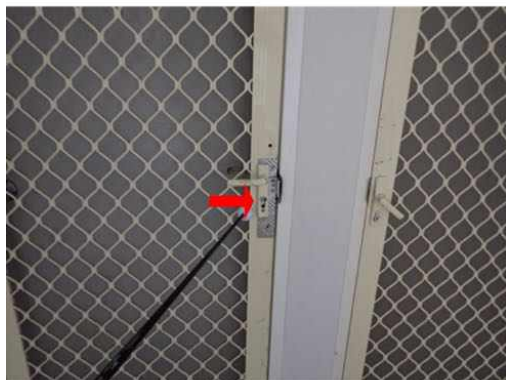
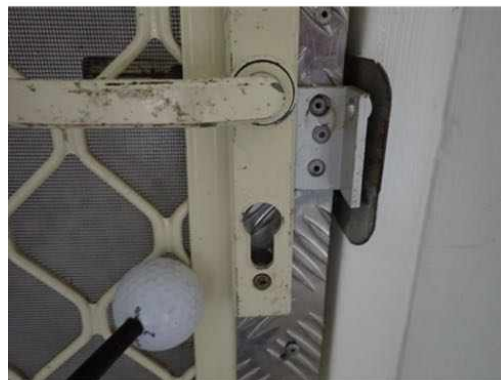
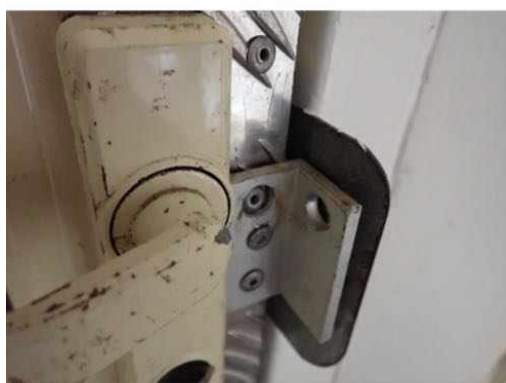
Finding 3.08

Building:	Main Building
Location:	Front entry
Finding:	Front Entry Security Door Lock Barrel Missing – Temporary Locking Arrangement Installed
Information:	The lock barrel to the front entry security door was missing at the time of inspection. An angle bracket has been installed to the door to allow a padlock to be used as an alternative locking method. This appears to be a temporary or non-standard

modification. In plain terms, the proper door lock is missing and the door is currently being locked with a padlock and bracket. This arrangement may not provide adequate security or compliance with standard door hardware requirements. Preventative measures include maintaining functional and compliant locking hardware. A qualified locksmith or licensed builder should install a suitable replacement lock barrel and restore the door to proper working order as deemed necessary. Rectification is recommended at the owner's discretion to ensure adequate security and functionality.

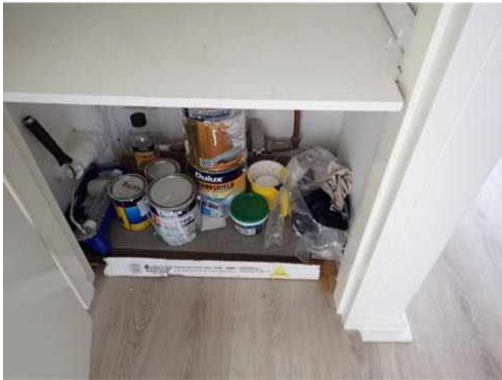
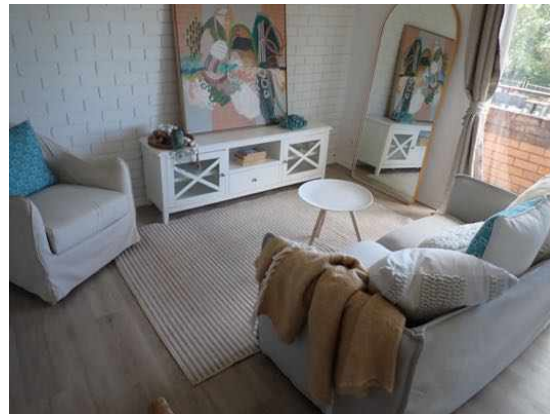
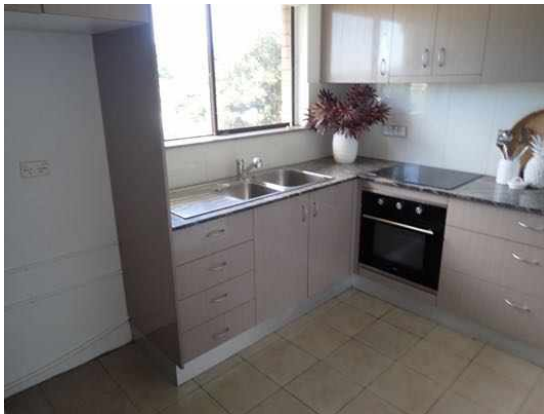
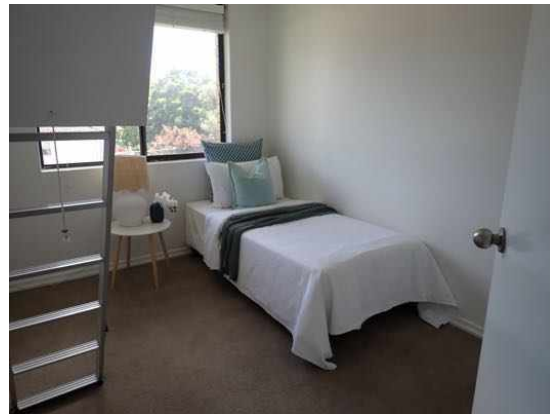
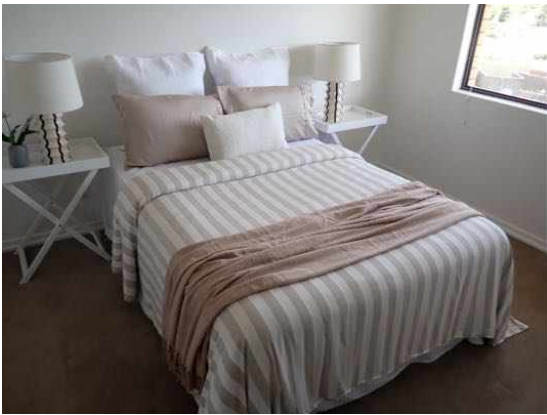
Noted Item

Building: Main Building
Location: All Areas
Finding: Additional Photos - Obstructions and Limitations
Information: These photographs are an indication of the obstructions and limitations which impeded full inspection of the area at the time of inspection. These obstructions can hide an array of defects and should be removed to allow full inspection to be carried out. A re-inspection is recommended once the areas are made accessible.
