Building and Timber Pest Inspection Report

Inspection Date: Thu, 26 Mar 2026

Property Address: 416/133 Botany Rd, Waterloo NSW 2017,
Australia

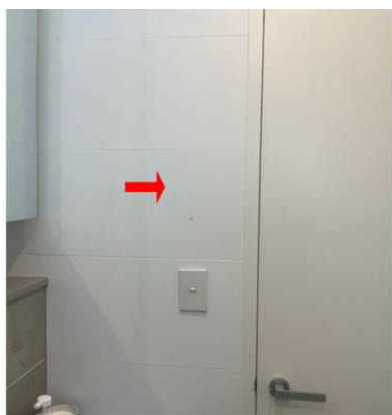
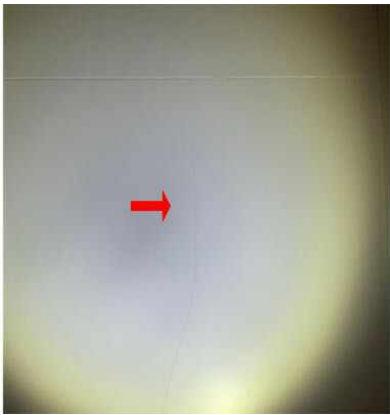
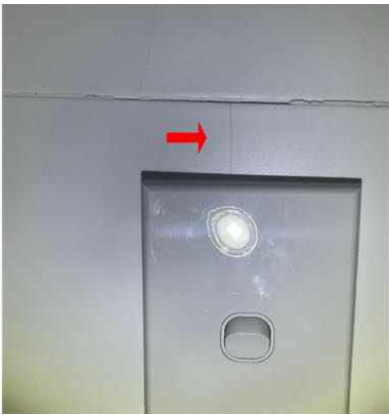
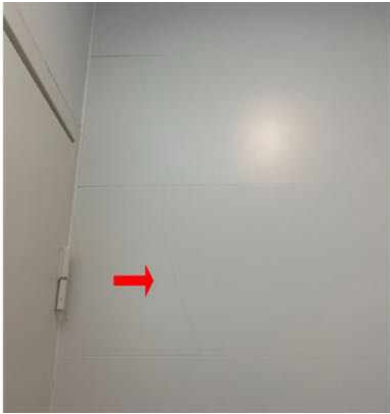
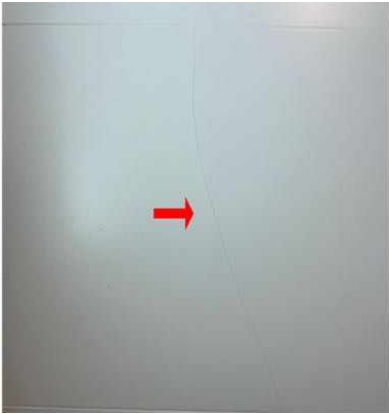
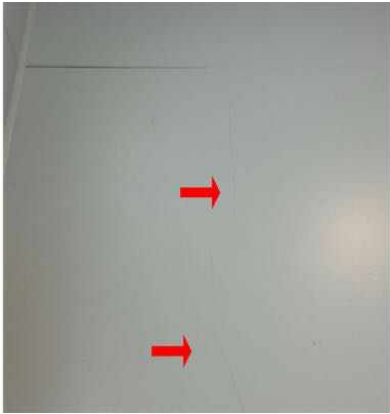
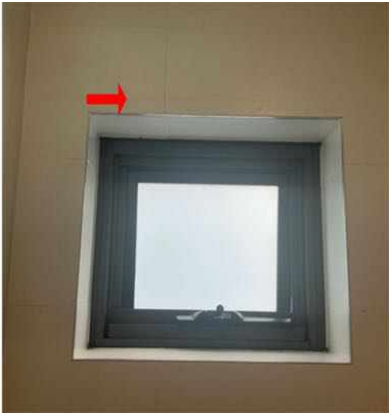
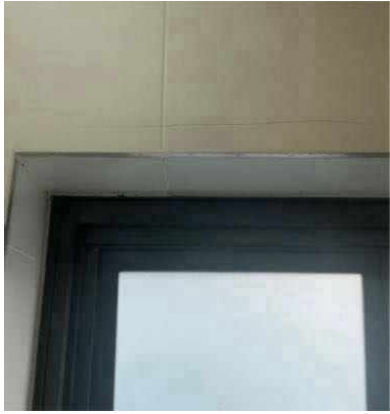
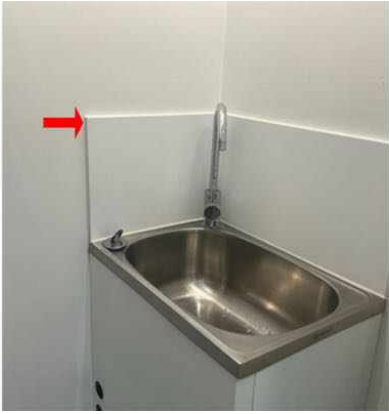
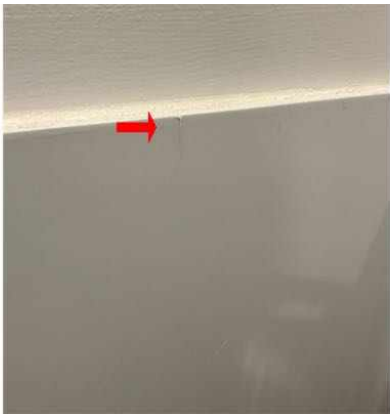
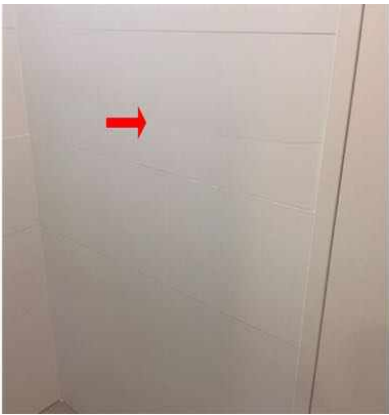
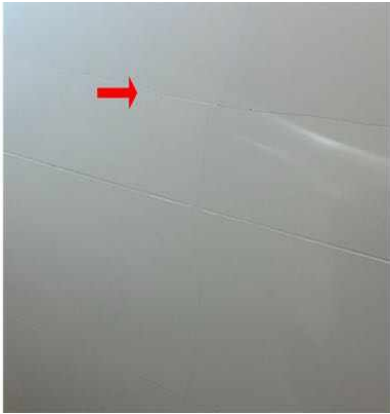
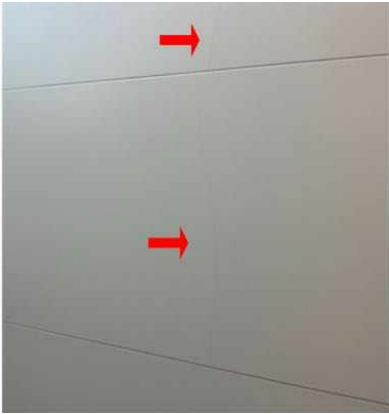
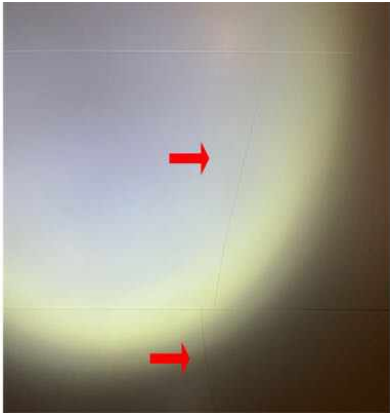
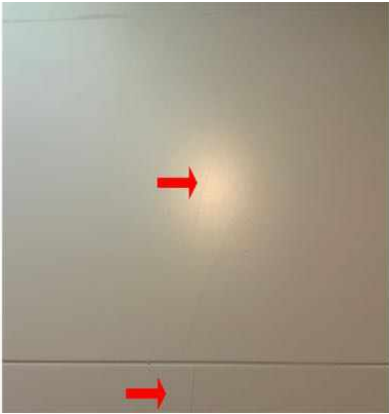
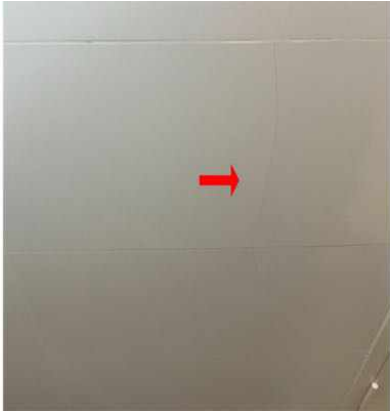
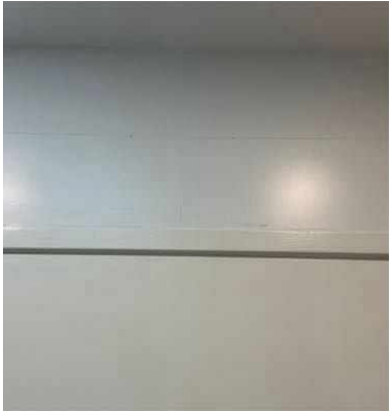
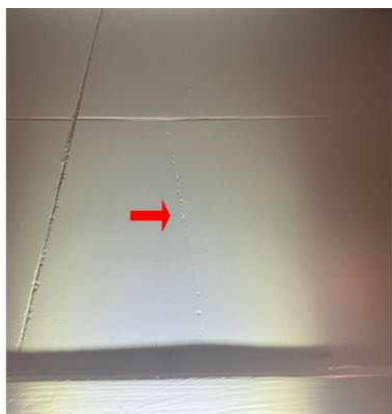
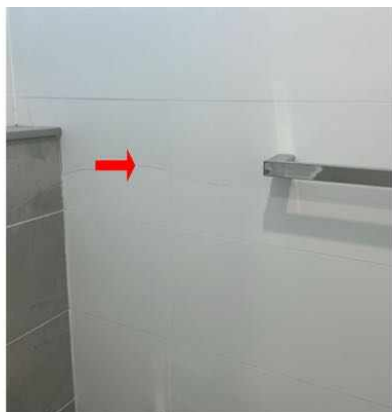
Building:	Main Building
Location:	Bathroom, laundry, ensuite
Finding:	Tiles - Cracked or damaged to some areas (Multiple tiles pattern cracking in both bathrooms)
Information:	Cracking was evident to the tiling in this area at the time of inspection. Tile cracking may occur due to impact, normal wear, or movement within the underlying substrate. In some cases, cracking may indicate issues such as inadequate installation, substrate movement, or stress within the tiled system.

If left unmanaged, water penetration to these areas may lead to subsequent water damage, which is likely necessitate repair work to affected building elements.

A tiling contractor should be appointed to ensure that no further water damage occurs. The re-application of silicone and grouting throughout remaining tile work is also advised, to further protect the area against water penetration.

Where water penetration has led to water damage, appointment of a relevant tradesperson may be required to repair damaged building elements.

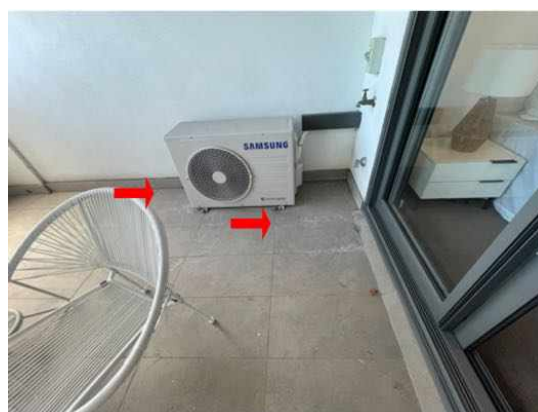
Finding 3.01

Building:	Main Building
Location:	Balcony
Finding:	Efflorescence and grout deterioration - Balcony
Information:	Efflorescence was observed to balcony tiles together with localised grout and sealant deterioration, indicating intermittent moisture movement through the tiled system. Moisture readings were slightly elevated at the time of inspection, the condition suggests past or periodic moisture presence, potentially associated with drainage, waterproofing detailing, or air conditioning discharge. Repairs to grout and sealant and review of drainage are recommended, with ongoing monitoring and further assessment by strata appointed licensed plumber for any progression.

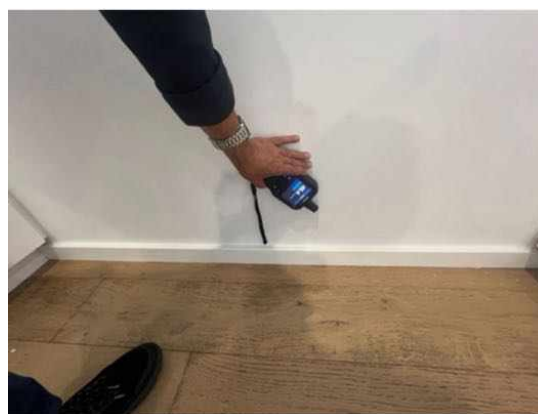
Finding 3.02

Building:	Main Building
Location:	All Internal Areas
Finding:	Elevated Moisture – Further Investigation Recommended
Information:	Slightly elevated moisture readings were detected to lounge left wall with no visible surface issues, although no significant structural damage was evident at the time of inspection, dampness can contribute to deterioration if left unaddressed. Inspector was not able to inspect the external wall due to space constraints. A further investigation by a licensed plumber or waterproofing specialist is recommended to confirm the source and ensure no concealed issues are developing.

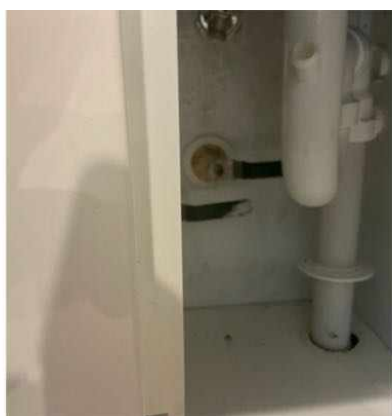
Building:	Main Building
Location:	Laundry
Finding:	Moisture staining
Information:	Water staining was evident in this area at the time of inspection. Water staining indicates that surfaces have been exposed to excessive moisture over time. The minerals and other elements in the water lead to staining, which may graduate to corrosion and deterioration if left unmanaged.

While mostly an appearance defect, water staining can be indicative of more serious defects, which may be currently concealed by other building elements.

Where water staining is active, a licensed plumber must be consulted to identify the cause of the staining and to provide advice on any reparation works that may be required. Replacement of any broken or damaged structures is advised.

Conversely, where water staining is old and inactive, affected building materials may be repaired or replaced at client discretion. A qualified carpenter or registered builder may be appointed to perform these works.

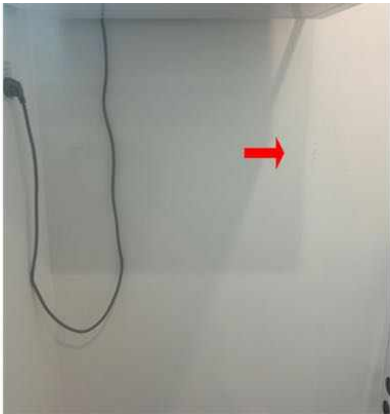
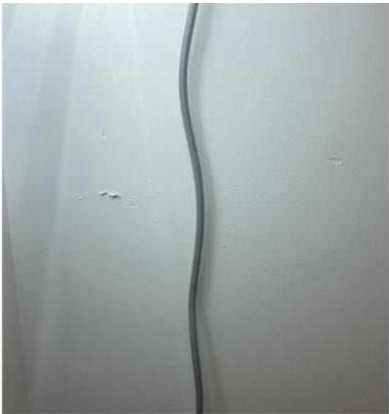
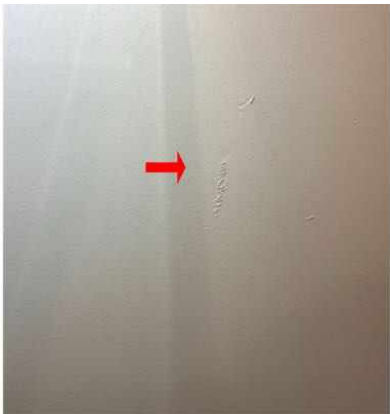
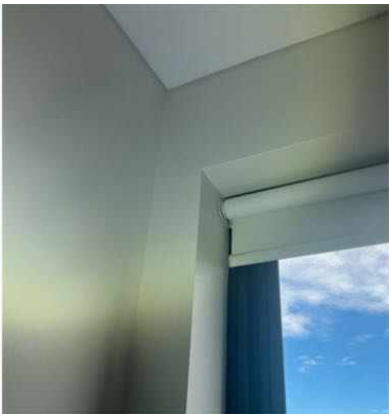
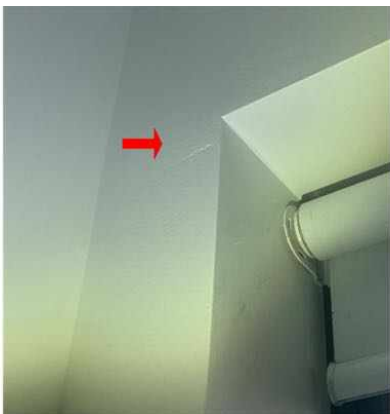
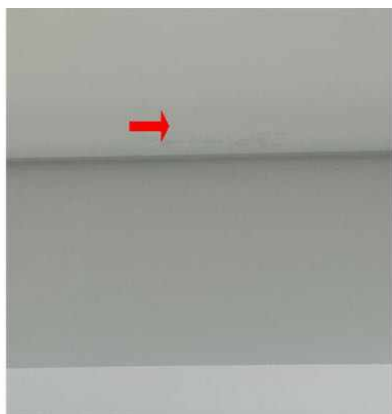
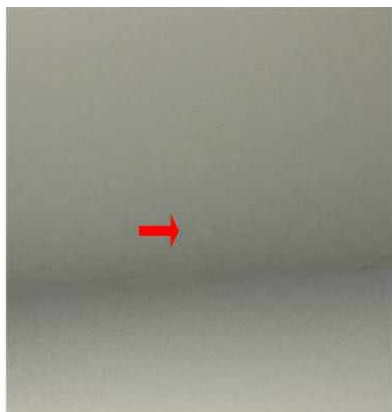
Finding 3.05

Building:	Main Building
Location:	All Internal Areas
Finding:	Paint finish and hairline cracking to some areas
Information:	The paint finish in this area was identified as being incomplete at the time of inspection including some hairline minor cracking.

Whilst incomplete or missing paint and minor cracking and imperfections in finish is generally an appearance defect, it can also lead to the development of secondary building defects over time. Incomplete areas of paint finish expose the area to moisture, potentially accelerating the deterioration of underlying building materials.

Incomplete paint finishes should be sanded back, filled, leveled and painted, as applicable. Where inadequate or missing paint protection has led to the deterioration of the associated building element, repair and/or replacement of this building element

may be required.

A painting contractor should be appointed as soon as possible to perform necessary works to aid the appearance of the affected area and to ensure the area is protected against further deterioration. Alternatively, the homeowner following manufacturer instructions may perform these works.

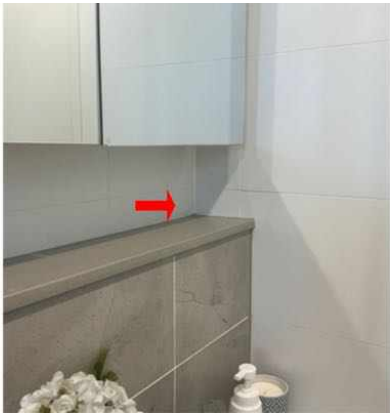
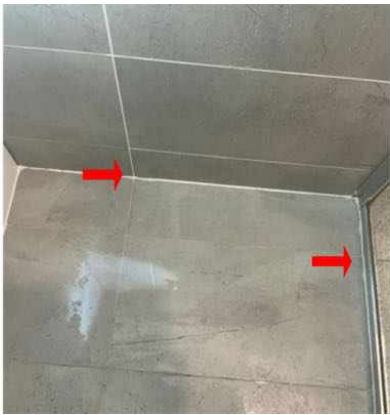
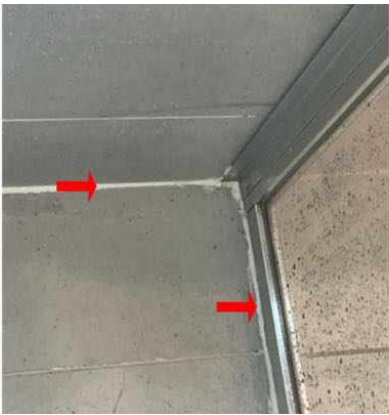
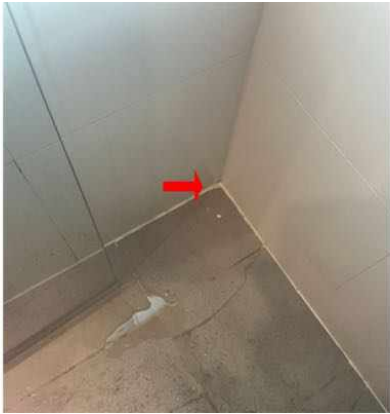
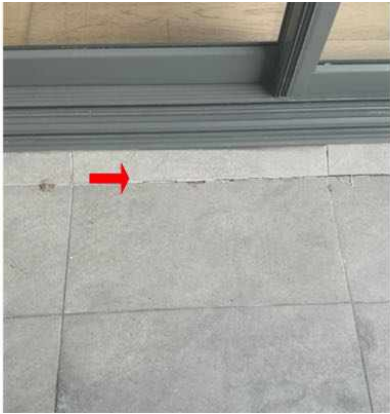
Finding 3.06

Building:	Main Building
Location:	All Internal Areas
Finding:	Sealant and grouting - Missing or degraded to some areas
Information:	It was noted on inspection that sealant or grout is degraded. There is also evidence of poor workmanship and excessive use of sealant. Silicone should never be used as a first line of defence against waterproofing. Further inspection by a licensed waterproofing contractor is highly recommended.

Different materials and floor areas move at different rates, generally causing cracking to grout or sealant at this point. A flexible sealant is required to allow for expected expansion and contraction, while keeping the joint water tight and protective of all associated building materials.

There appears to be excessive mould to the sealant and grout which will likely require scraping out and replacement.

Flexible and mould resistant materials should be applied to affected areas to prevent any subsequent water damage that is likely to occur. Regular maintenance and replacement of damage or missing or damaged sealant and grout is highly recommended to the wet areas, as this is a regular wear and tear defect. Sealant and grouting in areas that come into regular contact with water should be maintained for the long term care of your property.

A sealant specialist or tiling contractor should be appointed to complete these works as soon as possible

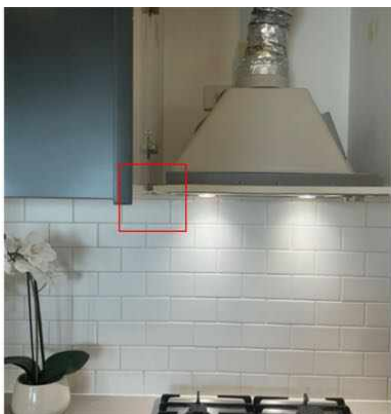
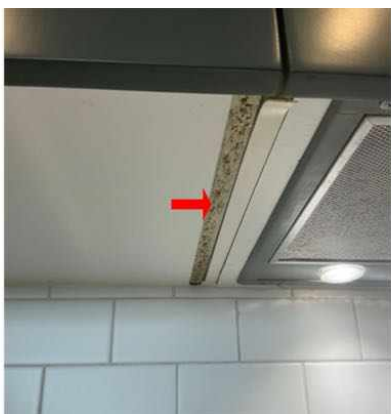
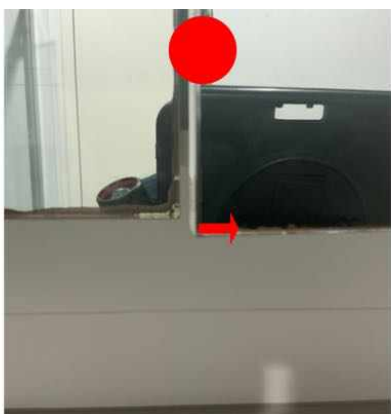
Finding 3.07

Building: Main Building
Location: All Internal Areas
Finding: Building element - Damaged - Kitchen cabinet trim chipped , possible crack window lounge outside, mirror desilvering bathroom
Information: Breakage occurs generally when the building materials have either aged and decayed, or as a result of damage (accidental or deliberate).

Repair and/or replacement of broken elements is advised to ensure that additional secondary defects do not arise as a consequence. Such works are necessary, as all building elements play a key role in the operation and function of the overall structure and its performance.

A relevant tradesperson should be appointed to repair or replace the affected building element prior to any subsequent damage being caused.

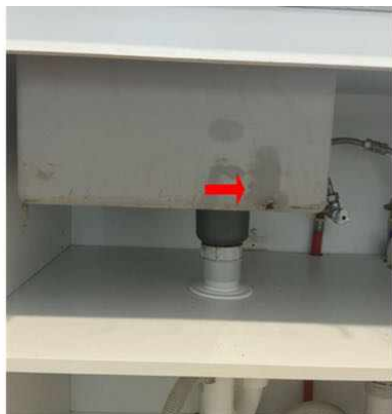
Finding 3.08

Building: Main Building
 Location: Kitchen
 Finding: Building element - Rusted or corroded - Kitchen sink rust staining
 Information: This building element shows evidence of rusting and corrosion, which is likely to have developed as a result of excessive exposure to moisture and or inadequate coatings.

As surface rust provides no protection to the underlying iron, the deteriorating condition is likely to worsen if not addressed in the short-term future.

Where possible, the use of galvanized (treated) metals or aluminium coated metals aid in rust prevention, as does regular general maintenance. Rust formation can be controlled with coatings, such as paint, that isolate the iron from the environment.

Rusting and corrosion should be managed by ideally removing or limiting the affected surface from exposure to moisture. A registered builder may be appointed to replace any building elements that have been severely affected by rust or water damage.

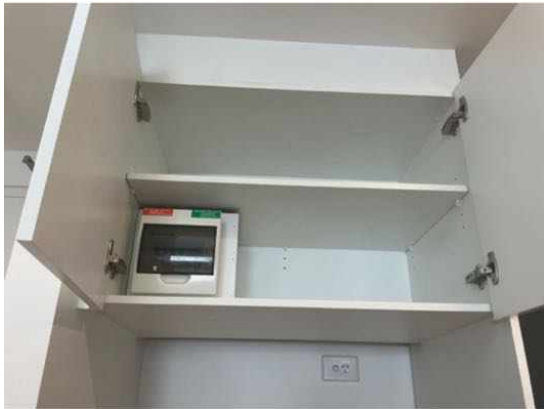
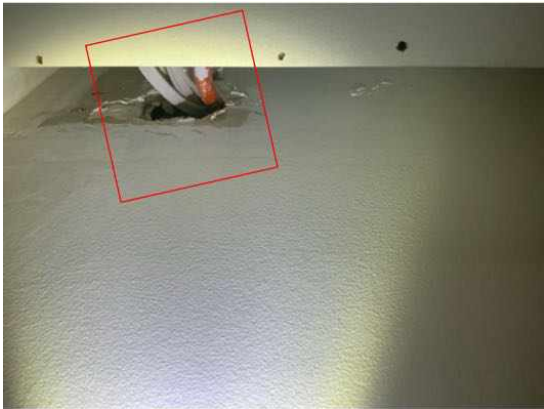
Finding 3.09

Building:	Main Building
Location:	All External Areas
Finding:	Installation - substandard or incomplete - Hole not sealed behind kitchen cabinet try , tiles workmanship (Uneven finish)
Information:	The installation of this building element appears to have been completed to a substandard level of workmanship or is incomplete. Generally substandard repairs or installation are related to poor workmanship, the use of inappropriate materials, or a failure to complete installation to a suitable standard.

Where installation is substandard and/or incomplete, the client should contact the responsible trade to undertake rectification. Unfinished and substandard building works are likely to degrade more quickly and may create potential for secondary defects to associated building elements.

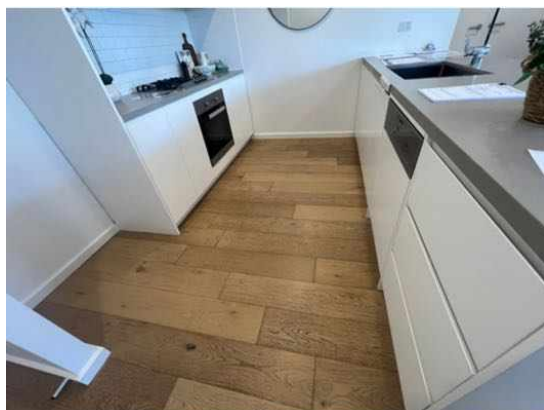
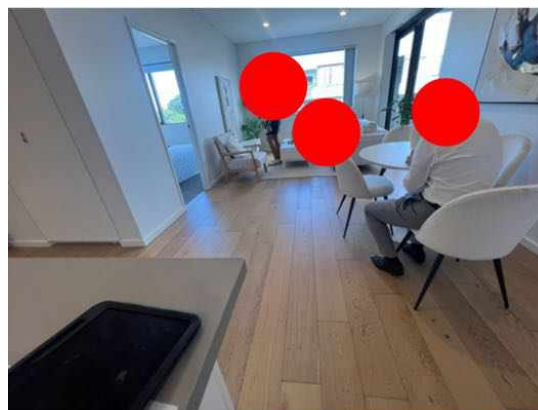
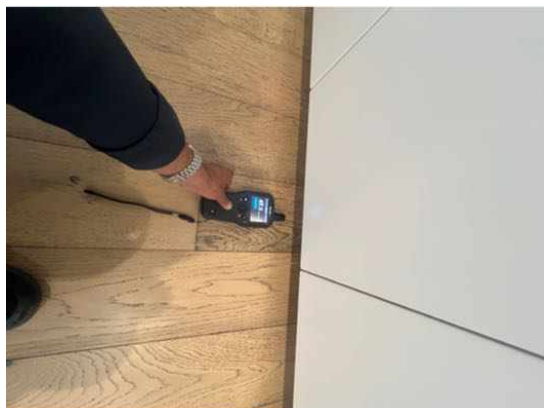
Building:	Main Building
Location:	All Internal Areas
Finding:	Observation – Elevated Moisture Meter Readings (Timber Flooring)
Information:	Moisture meter readings taken to timber flooring using a non-invasive (pinless) meter returned slightly elevated readings across the tested areas.

Pinless moisture meters provide indicative readings only and may be influenced by the type of flooring, subfloor construction, adhesives, and underlying materials. Consistent readings across large areas without visible signs of moisture-related damage typically indicate material characteristics rather than active moisture ingress.

No visible evidence of moisture-related damage to the timber flooring was observed at the time of inspection. Monitoring is recommended for any future signs of distortion, staining, or deterioration. If concerns arise, further assessment using invasive testing methods may be considered.
