Building and Timber Pest Inspection Report

Inspection Date: Tue, 3 Feb 2026

Property Address: 64A Anthony Rd, Denistone NSW 2114,
Australia

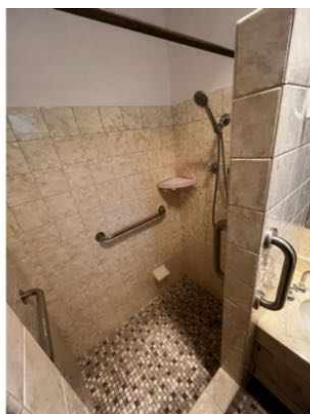
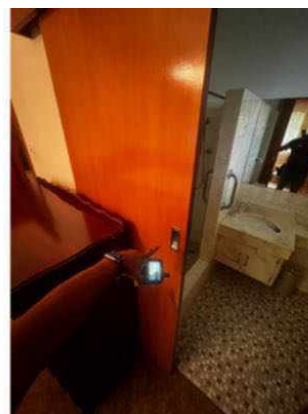
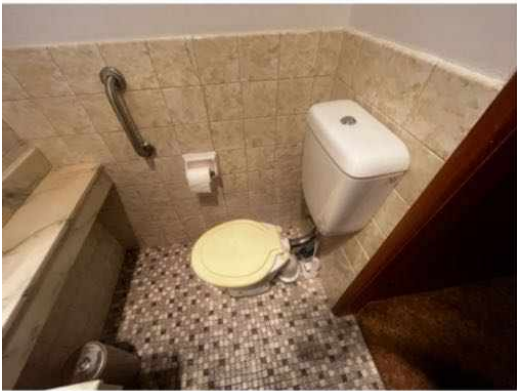
Finding: Cracking - Damage Category 2 - Noticeable (up to 5mm)

Information: Noticeable cracks are a common occurrence as a result of many primary defects. Such causes may include age, general wear and tear, expected building movement, general expansion/contraction of building materials in different weather conditions, and/or minor failings in the installation or application of building materials.

Noticeable cracks may result in minor sticking or jamming of associated doors and windows, which require easement. However, noticeable cracks are easily filled and repaired. A plasterer can be consulted to install an expansion joint at this point to allow for this movement during different weather conditions.

Monitoring of all cracking should be conducted frequently. Always contact a building inspector should cracks widen, lengthen, or become more numerous. Additionally, your building inspector should also be contacted if associated building elements such as doors and windows become more difficult to operate over time.

Relevant tradespeople, such as carpenters, painters and plasterers, should be appointed to perform remedial works, as deemed necessary.

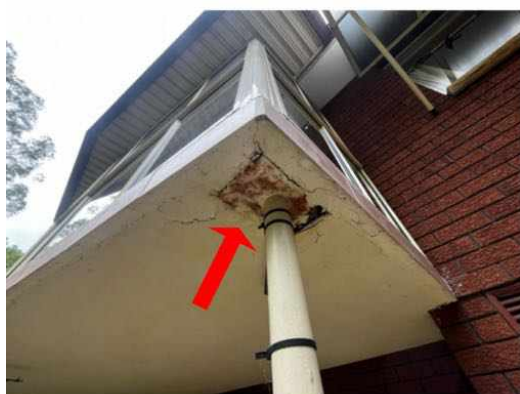
Building:	Main Building
Location:	Yard
Finding:	Building element - Rusted or corroded
Information:	This building element shows evidence of rusting and corrosion, which is likely to have developed as a result of excessive exposure to moisture and or inadequate coatings.

As surface rust provides no protection to the underlying iron, the deteriorating condition is likely to worsen if not addressed in the short-term future.

Where possible, the use of galvanized (treated) metals or aluminium coated metals aid in rust prevention, as does regular general maintenance. Rust formation can be controlled with coatings, such as paint, that isolate the iron from the environment.

Rusting and corrosion should be managed by ideally removing or limiting the affected surface from exposure to moisture. A registered builder may be appointed to replace any building elements that have been severely affected by rust or water damage.

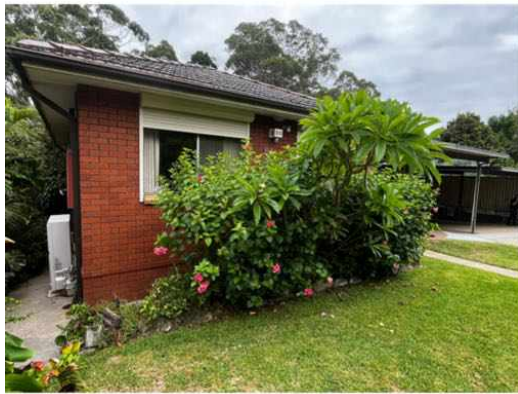
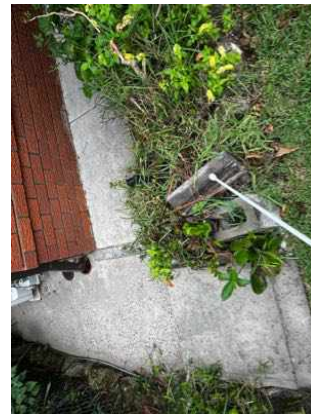
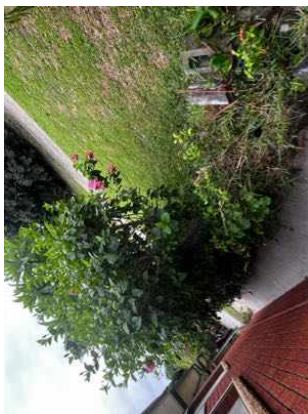
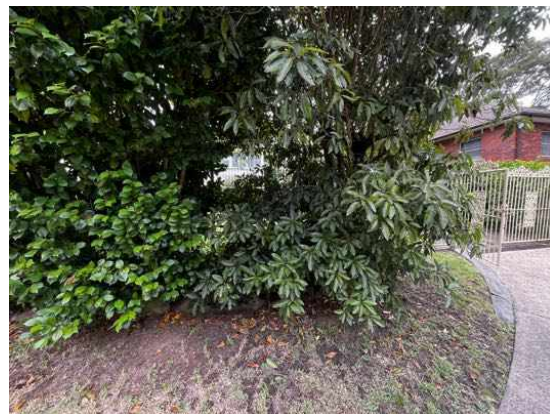
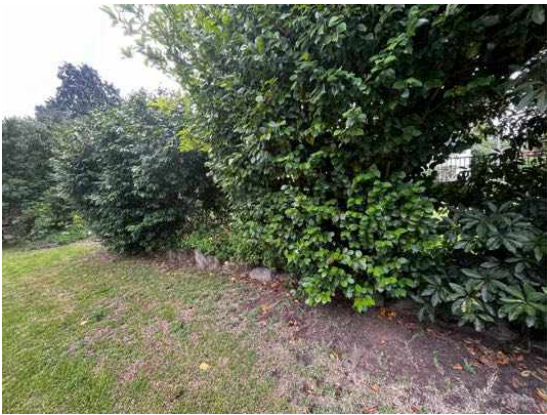
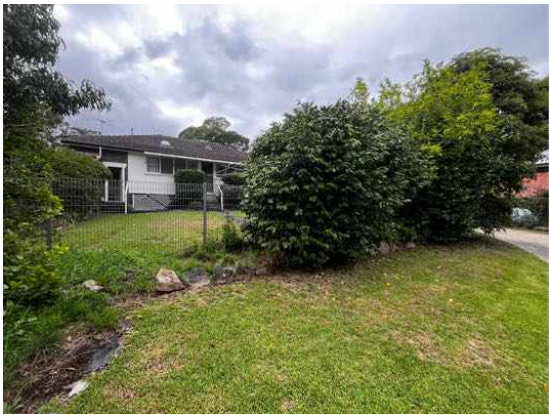
Finding 6.01

Building: Main Building
Location: All Areas
Finding: Additional Photos - Obstructions and Limitations
Information: These photographs are an indication of the obstructions and limitations which impeded full inspection of the property at the time of inspection. These obstructions can hide an array of defects and should be removed to allow full inspection to be carried out. A re-inspection is recommended once the areas are made accessible.

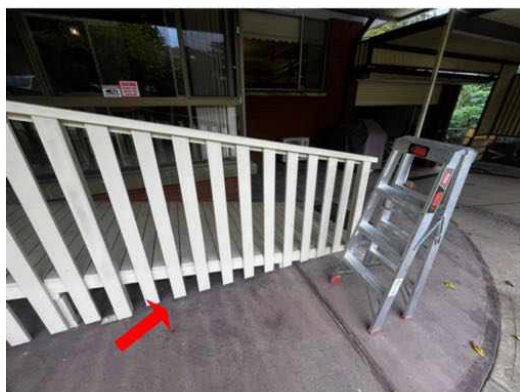
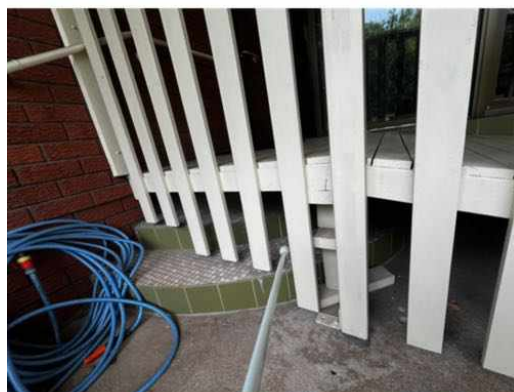
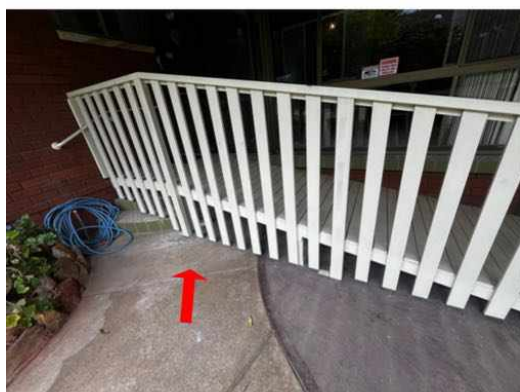
Building:	Main Building
Location:	Entrance walkway
Finding:	Building materials in direct ground contact - conducive to termites
Information:	Where timber elements are in direct contact with the ground and consequently moisture or dampness they become conducive to termite activity. Whether timber is used as a building element part of a fencing structure or stored as an unused item they can provide an environment that is attractive to termite infestation.

When met with excessive moisture timber begins to decay and develop wood rot. Any timbers that are in direct contact with external grounds especially if left untreated or non-durable also provide ingress for subterranean termites into that particular element.

The removal of any such materials that may be conducive to termite activity should be removed as soon as possible to minimise the risk of termite attack.

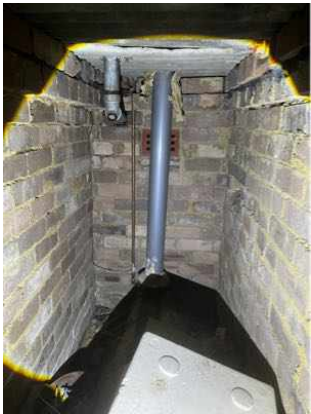
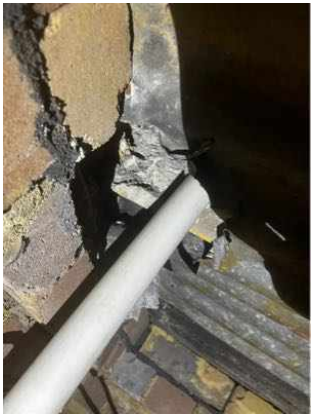
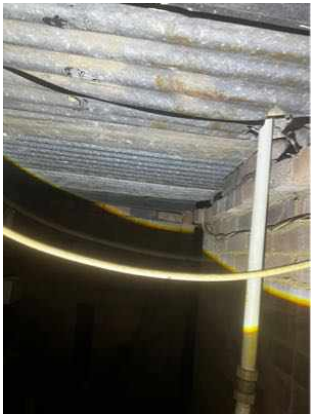
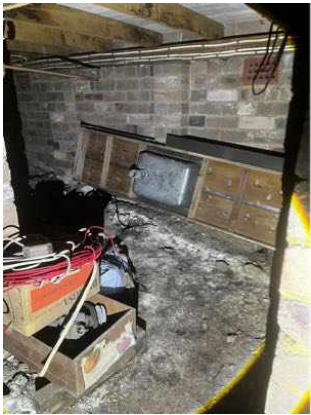
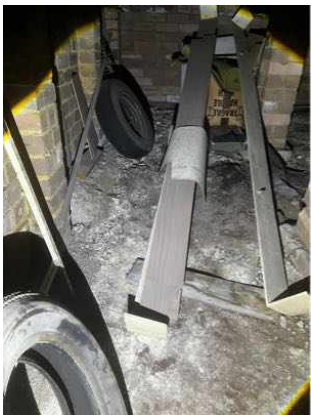
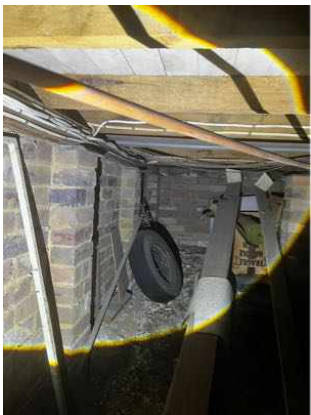
Finding 6.03

Building:	Main Building
Location:	All External Areas/subfloor
Finding:	Bridging - Attachments to Buildings
Information:	Bridging occurs when items against a building provide a concealed entry point for termites into the building or by passing around a termite management system.

These obstructions can hide an array of defects and should be removed to allow full inspection to be carried out.

A re-inspection is recommended once the areas are made accessible.

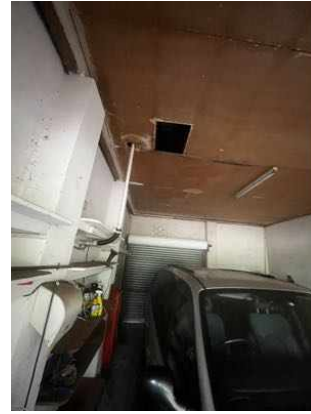
Building:	Main Building
Location:	Roof Void
Finding:	Obstructions and Limitations - Internal Areas
Information:	The garage roof access was not possible to be inspected as there was obstruction in the premises. A re inspection if made possible after clearing the obstacle can be arranged. These photographs are an indication of the obstructions and limitations which impeded full inspection of the property at the time of inspection.the external areas of the property. These obstructions can hide an array of defects and should be removed to allow full inspection to be carried out. A re-inspection is recommended once the areas are made accessible.

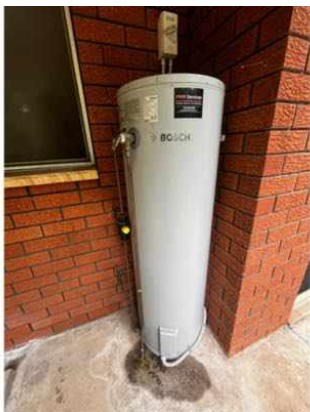
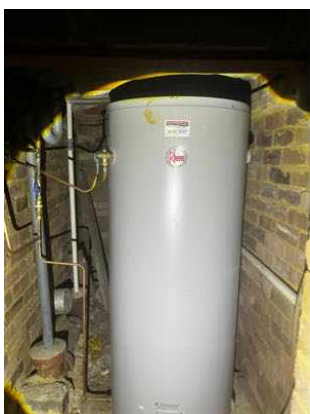
Building: Main Building
 Location: Yard - Side/ Subfloor
 Finding: Hot Water Unit
 Information: The Gas HWS unit appeared to be in good condition during inspection however this is not an opinion on the Licensed Plumber.

No water hammer was noted when taps are turned off fast.

Please consult a licensed Plumber for further information.

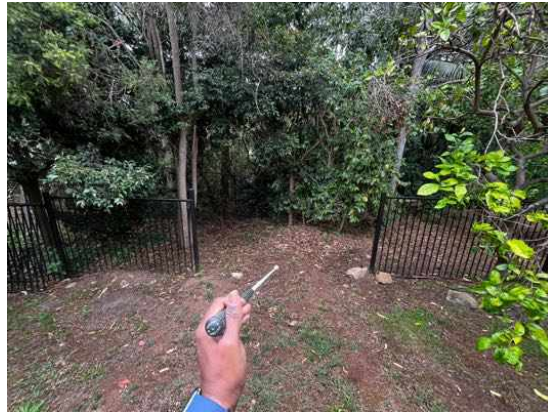
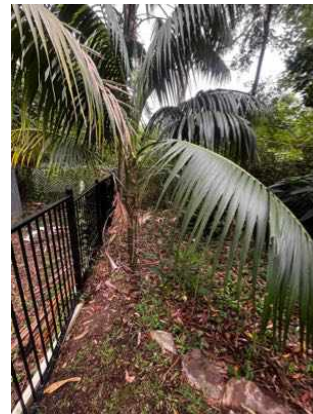
Building: Main Building
 Location: Yard
 Finding: Fencing - Deteriorated
 Information: It was noted at the time of inspection that sections of the fencing throughout the property have deteriorated. Typically fencing deteriorates due to age and or wear, rot and or rust which is generally expected for a structure of this age, due to prolonged exposure to weather conditions. Sometimes inadequate installation or maintenance can be to blame.

If left unattended, it is likely that further damage will occur. It is suspected that repair of several elements of the fencing may be required however replacement may be a

consideration of the client also.

A licensed fencing contractor should be appointed to provide further advice and perform rectification works as necessary.

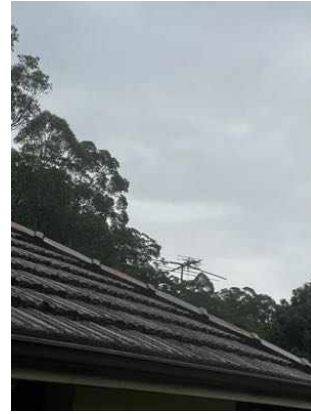
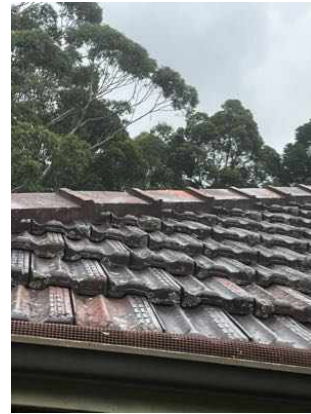
Building: Main Building
 Location: Roof
 Finding: Roof tiles - Weathered
 Information: Upon inspection of the exterior roofing, the majority of roof tiles were considered to be in a fair condition. While weathering of the tiles is consistent with the age of the property, maintenance works are required.

Isolated areas of mortar have come loose in the valleys and minor cracking is also present. Re-pointing and re-sealing the may be considered as an interim solution by the client to help preserve and extend the life span of the tiles.

Where left unmanaged, deteriorating roof tiles are likely to lead to a number of secondary defects, including minor water leaks and weather exposure to internal roofing structures.

Consultation with a roofing contractor is highly advised to gain advice on cost of remedial works that may be required in the short to medium term. Remedial works are likely to increase the longevity of the exterior roofing structure.
