Building Inspection Report

Inspection Date: Mon, 9 Feb 2026

Property Address: 13010/5 The Darling Ave, Broadbeach QLD
4218, Australia

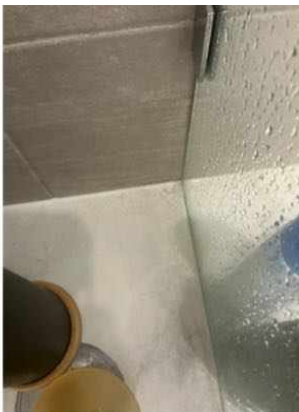
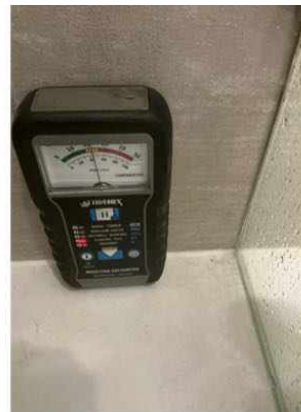
Defects 3.01

Building: Main Building
 Location: Bathroom > Rear
 Finding: Shower screen- leaks
 Information: At the time of inspection it was noted that the shower screen has minor leak.

Although minor leaks to shower screens may seem insignificant, they may cause damage to other fixtures such as grout ,vanities

And create mould damage which may become costly.

Re-Sealing of screen is recommended to be rectified as soon as possible to stop further deterioration.

A handyman may be required to rectify this condition.

Shower screen leaking in bathroom and requires re-sealing.

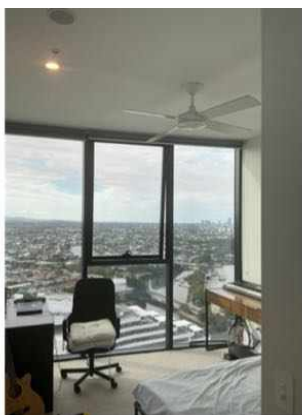
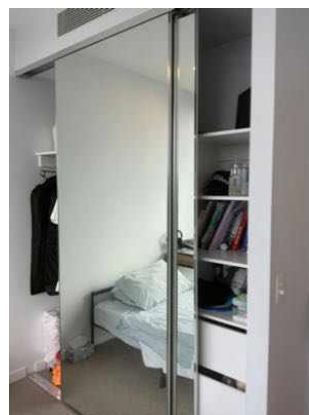
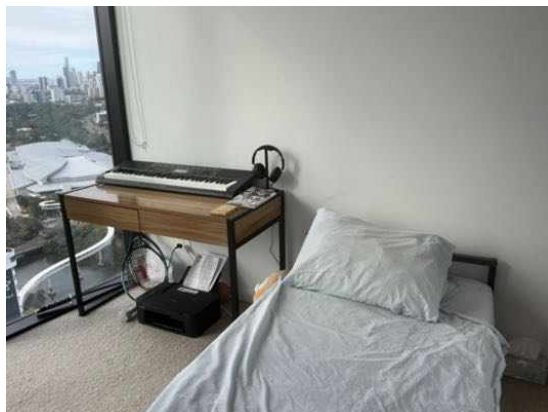
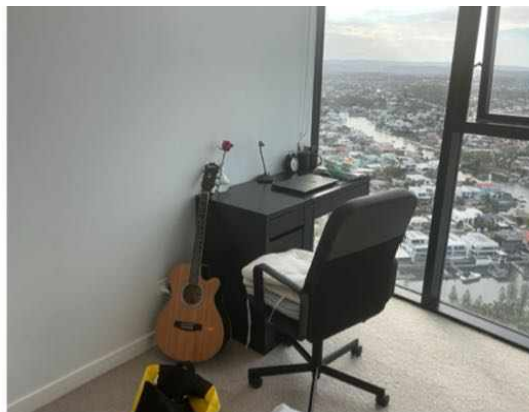
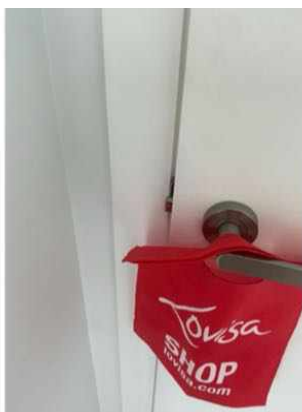
Defects 3.02

Building: Main Building
 Location: Bedroom > Front
 Finding: Door handle - Not latching

Information: It was noted that the door in this area was not latching during operation at the time of inspection. Whilst detracting from the functionality of this building element, this minor defect may also be a security risk, and may therefore have serious implications if left unattended.

It is suspected that this defect has occurred due to minor issues with the associated hinges. Such damage is identified as general wear and tear, which is expected for building elements of this age.

A qualified carpenter or general handyperson may be appointed to perform rectification works as necessary, at client discretion. If left unattended, further functional impairment is likely to occur.

Bedroom door handle not latching and may require rectification works.

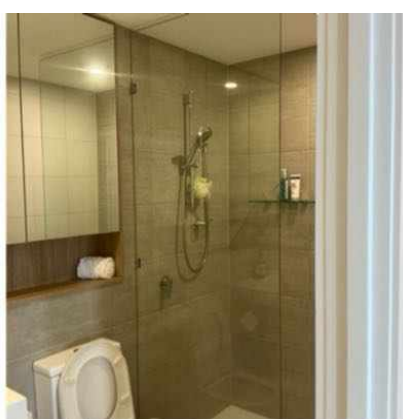
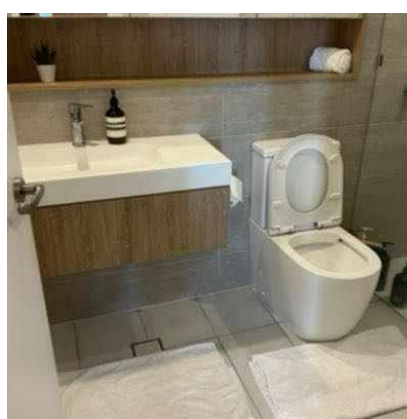
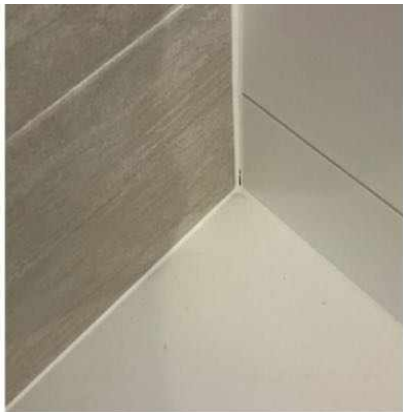
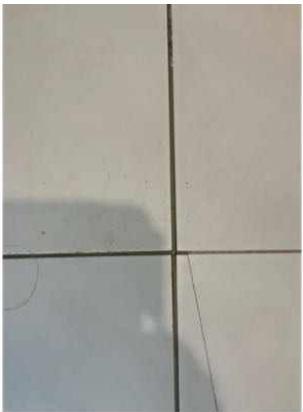
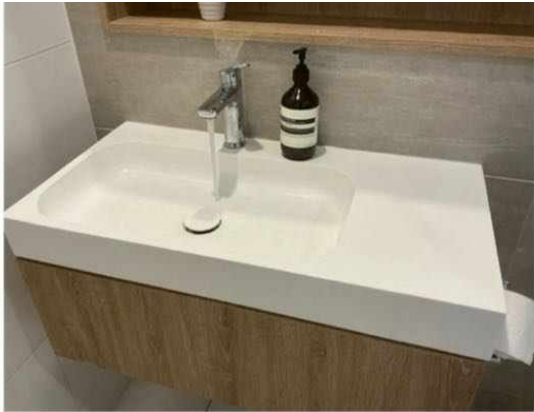
Building: Main Building
Location: Bathroom > Rear Right
Finding: Sealant and grouting - Missing or damaged
Information: It was noted on inspection that sealant or grout is degraded to the tiled shower alcove and or other areas of the bathroom.

Different materials and floor areas move at different rates, generally causing cracking to grout or sealant at this point. A flexible sealant is required to allow for expected expansion and contraction, while keeping the joint water tight and protective of all associated building materials.

There appears to be excessive mould to the sealant and grout which will likely require scraping out and replacement.

Sealant and grout cracked in shower recess and requires rectification works as soon as possible to prevent further damage.

Flexible and mould resistant materials should be applied to affected areas to prevent any subsequent water damage that is likely to occur. Regular maintenance and replacement of damage or missing or damaged sealant and grout is highly recommended to the wet areas, as this is a regular wear and tear defect. Sealant and grouting in areas that come into regular contact with water should be maintained for the long term care of your property.

A sealant specialist or tiling contractor should be appointed to complete these works as soon as possible

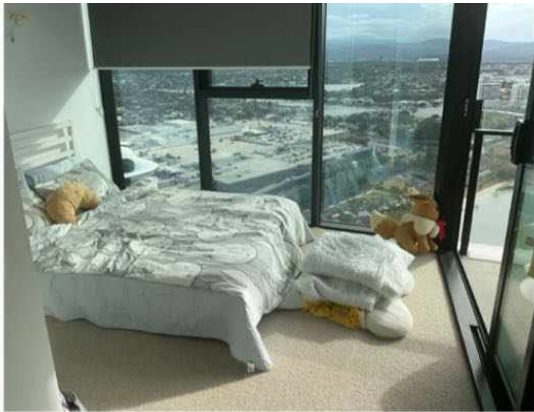
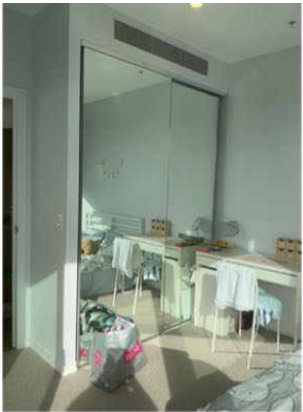
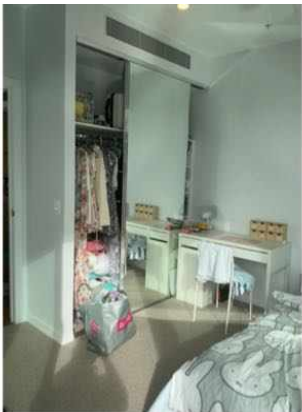
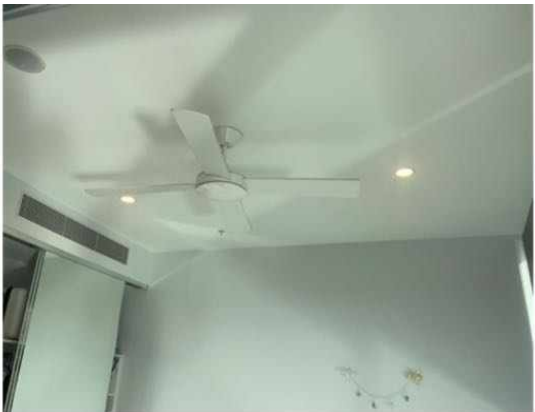
Building: Main Building
Location: Bedroom 2 > Existing
Finding: Bedroom 2 - satisfactory
Information: Bedroom 2 was found to be in satisfactory condition at the time of the inspection.
