Building Inspection Report

Inspection Date: Fri, 30 Jan 2026

Property Address: 33 Tecoma Rd, Risdon Vale TAS 7016,
Australia

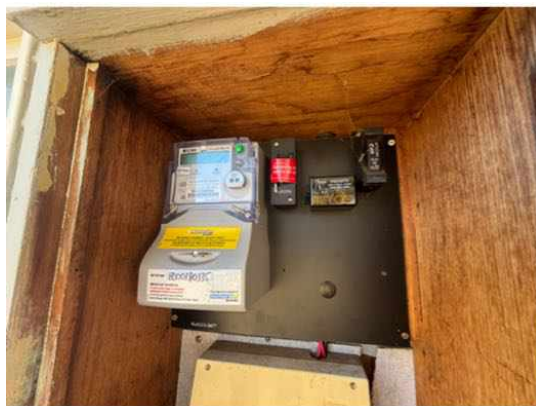
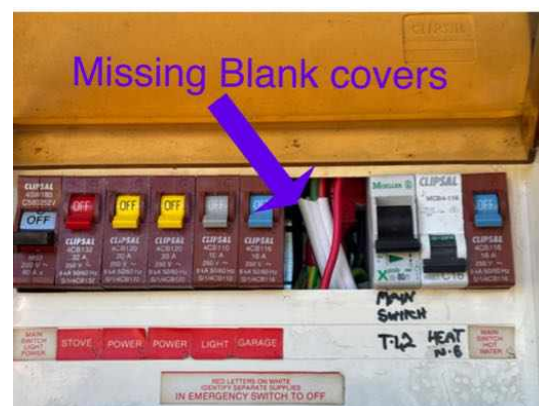
Defects 3.01

Building: Main Building
 Location: Switchboard
 Finding: Minor electrical defects
 Information: On the switchboard there are some blank plates/breakers that are missing covers.

This may cause an electrical safety hazard.

Recommend client engage a Lic Electrician to rectify as soon as possible.

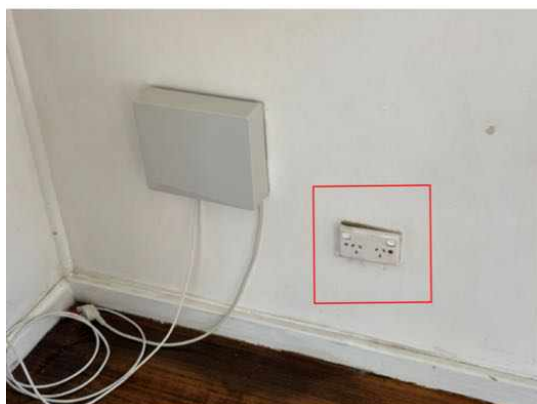
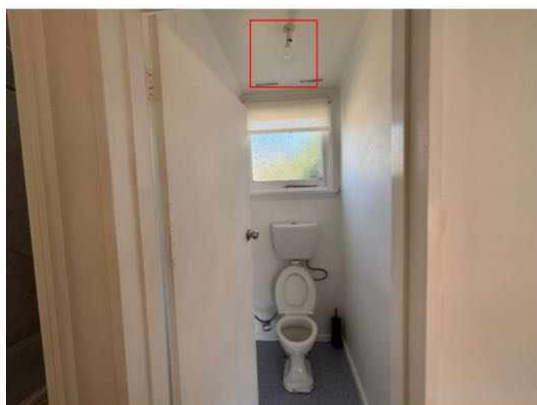
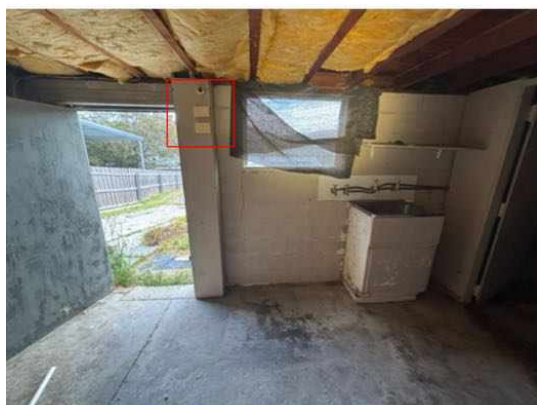
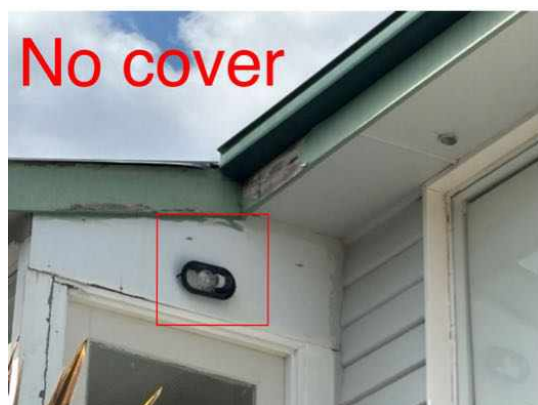
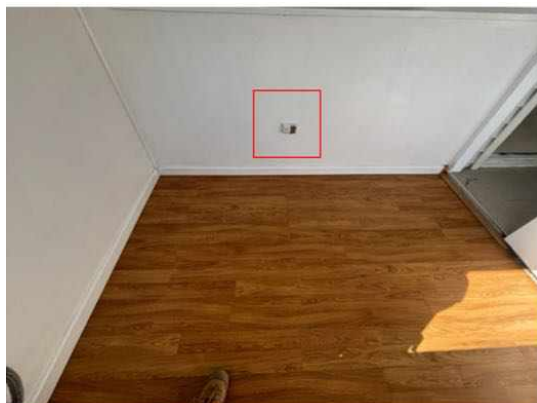
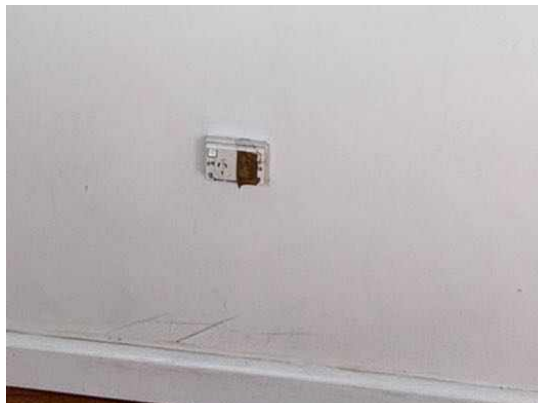
Defects 3.02

Building: Main Building
 Location: Multiple locations
 Finding: Electrical items to be rectified - including unorthodox wiring in the subfloor
 Information: In multiple locations there are electrical items that need to be rectified, as soon as possible. There is a loose power point in the living room, probably damaged batten holder in the toilet. Damaged batten holder in the laundry. A power point has been taped over in the sun room. The back porch light has no cover.

Failure to rectify could lead to a safety hazard.

Recommend client engage Lic Electrician to rectify as soon as possible.

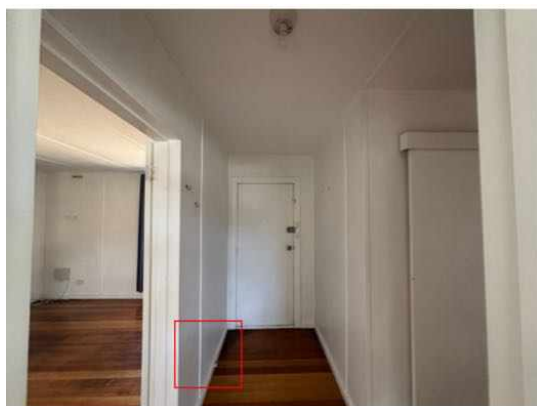
Defects 3.03

Building:	Main Building
Location:	Multiple locations
Finding:	Door stops - missing & damaged
Information:	In multiple locations the door stops are missing or have been damaged.

Recommend client engage a Handy Person to rectify at clients convenience, to prevent any further damage to the doors or walls.

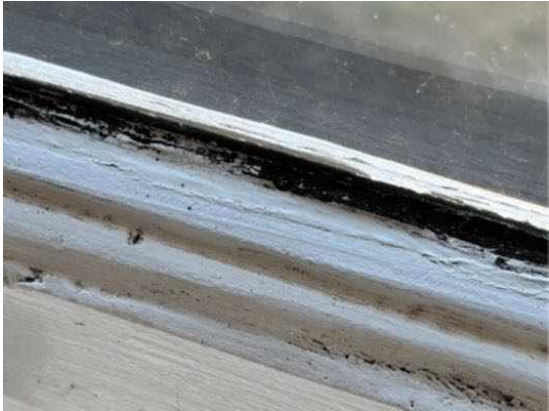
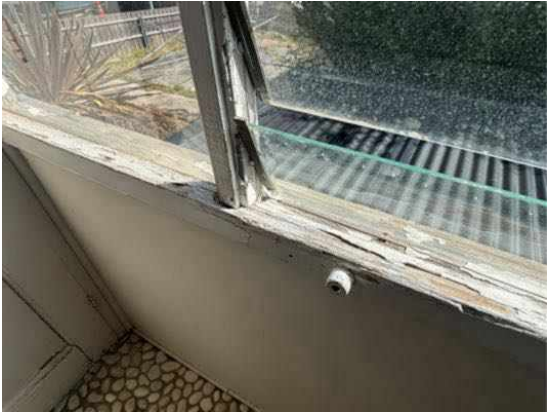
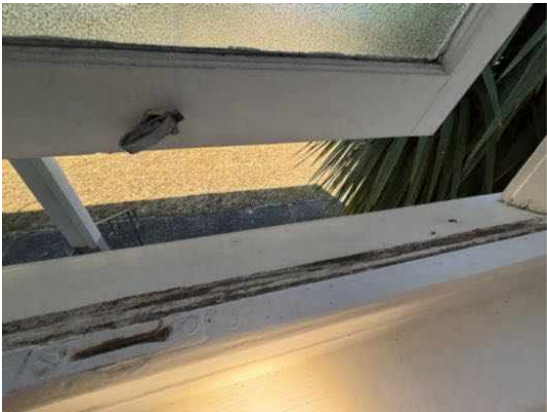
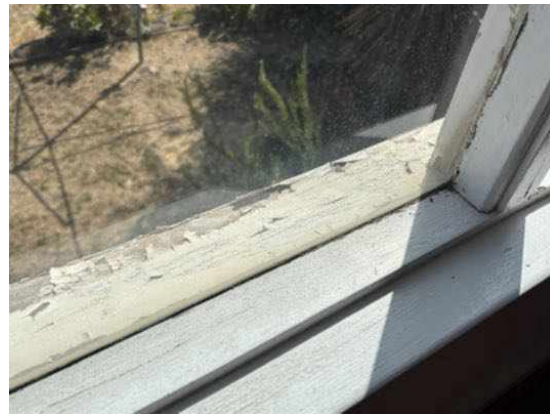
Defects 3.04

Building:	Main Building
Location:	Multiple locations
Finding:	Windows - cleaning & maintenance required
Information:	In multiple locations throughout the property the windows would benefit from cleaning, maintenance and painting.

Windows provide ventilation to the adjoining area and should be at a fully operational level to ensure user comfort. Restricted function of the window may also pose as a potential safety hazard if required for emergency egress from the building.

Generally, factors such as general age of the building element and a lack of maintenance are the usual causes for this type of defect.

Recommend client engage a Handy Person to rectify as soon as practicable.

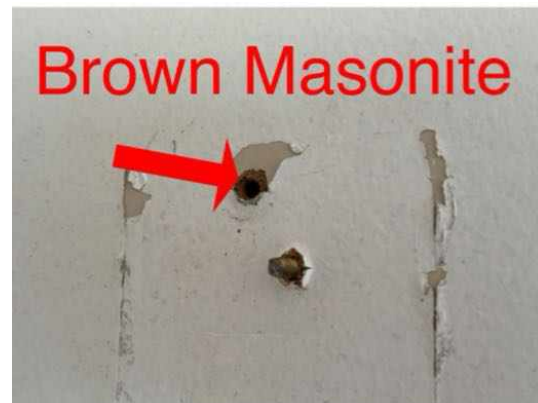
Defects 3.05

Building:	Main Building
Location:	Multiple locations
Finding:	FYI interior walls
Information:	FYI the interior walls are predominately masonite. A timber based products.

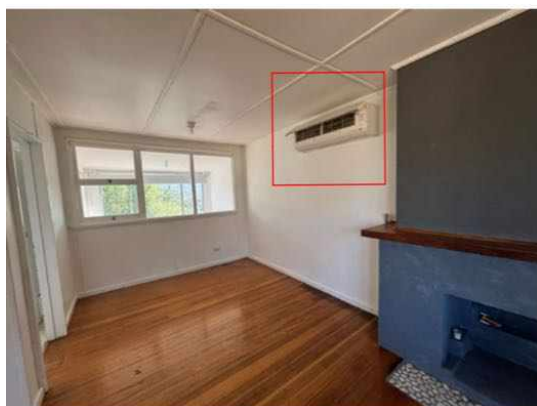
Defects 3.06

Building:	Main Building
Location:	Multiple locations
Finding:	Heat pump filters
Information:	The filters to the heat pump in the living room, appear to be loose. Recommend client engage an Air Conditioning Contractor to rectify as soon as practicable. Failure to rectify could potentially lead to damage to the unit.

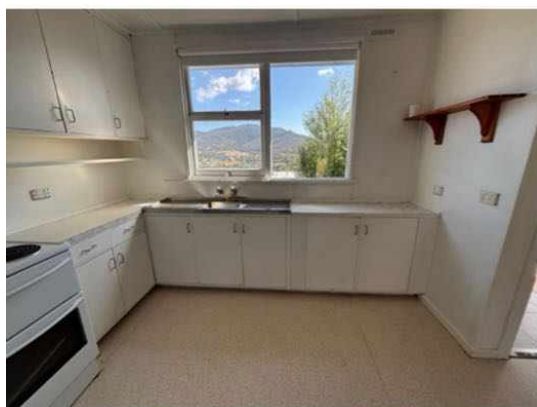
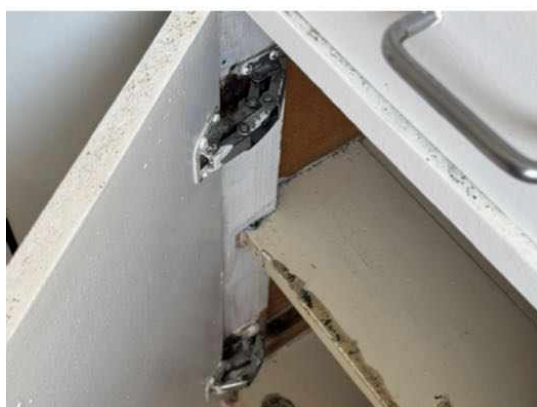
Defects 3.09

Building:	Main Building
Location:	Kitchen
Finding:	Kitchen cabinets maintenance
Information:	The kitchen cabinets require some maintenance. Multiple hinges are loose and doors are sagging.

Recommend client engage a Handy Person to rectify as soon as practicable, to prevent further deterioration to the cabinets.

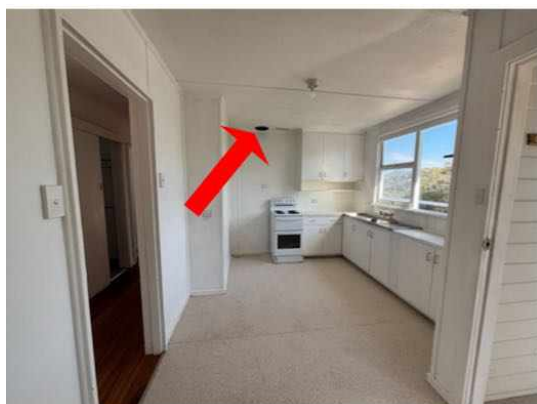
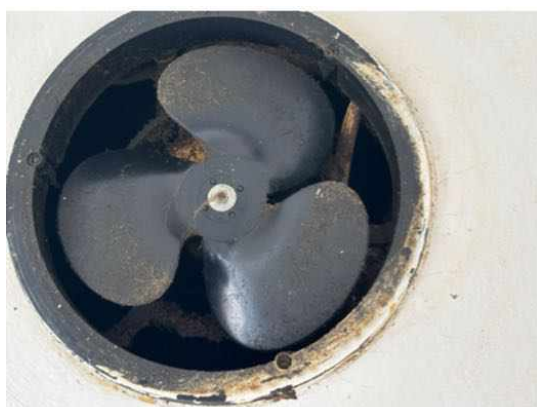
Defects 3.10

Building:	Main Building
Location:	Kitchen
Finding:	Kitchen exhaust fan
Information:	The exhaust fan in the kitchen is very dirty and oily. The cover is also missing. This will

cause a build up of oil in the roof void which is a vermin attractant. Recommend client have the exhaust fan replaced.

Recommend client engage a Lic Electrician to rectify as soon as possible.

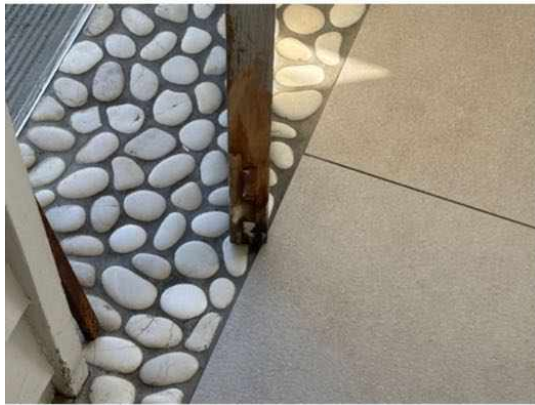
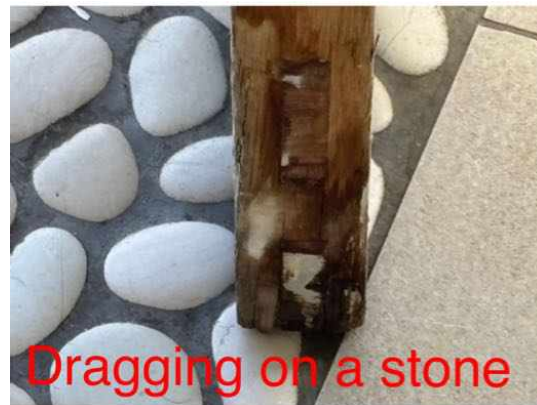
Defects 3.11

Building: Main Building
 Location: Back porch
 Finding: Back door
 Information: The paint to the back door is badly deteriorated, the panelling on the back of the door is water damaged and swollen. The door is also sagging. It is probably more economical to replace the door than to try to repair it.

Failure to rectify will allow further deterioration to the door.

Recommend client engage a Handy Person to rectify as soon as practicable.

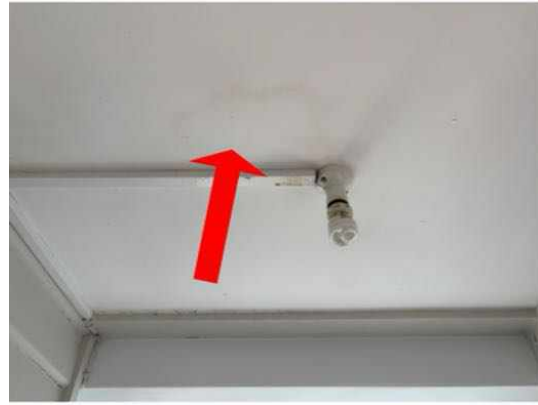
Defects 3.12

Finding: Water staining

Information: In the laundry and sun room there is water staining to the ceilings. They were dry at the time of inspection. There is new roofing installed above these areas. Suspect leaks have been resolved.

Recommend client monitor. Recommend client engage a Handy Person to paint at clients convenience. Client should note that suspected Asbestos containing materials (ACM) was identified in these areas. Client should ensure contractors are made aware of the ACM before any works commence.

If moisture re-occurs recommend client engage a Lic Plumber as soon as possible.

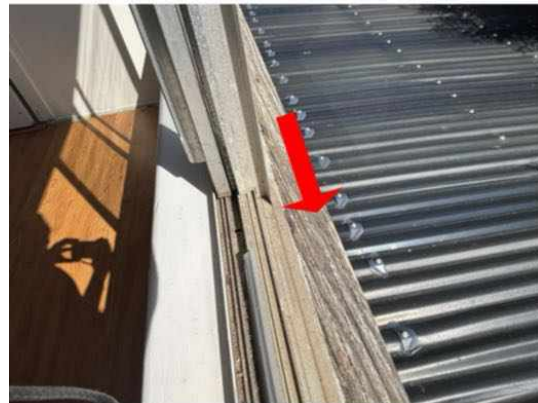
Defects 3.13

Building: Main Building
 Location: Back porch
 Finding: Paint deterioration to windows
 Information: On the interior of the house, the paint is very deteriorated to the back porch windows.

Paint deterioration is due to a lack of regular maintenance. Early intervention will prolong the useful life of these building elements.

Recommend client engage a Handy Person/Painter to rectify as soon as practicable.

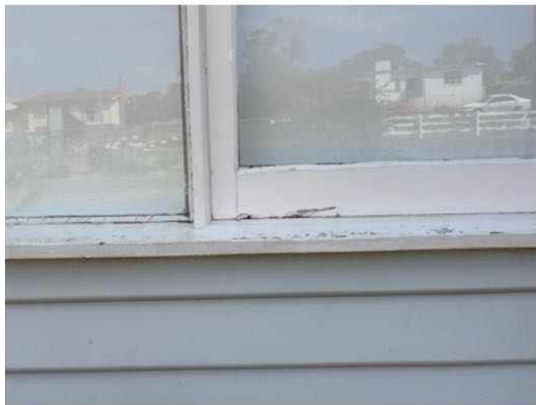
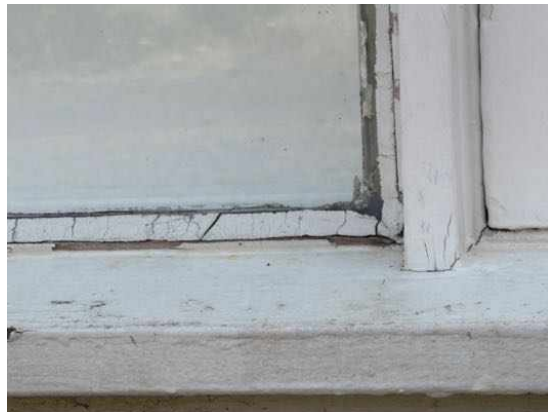
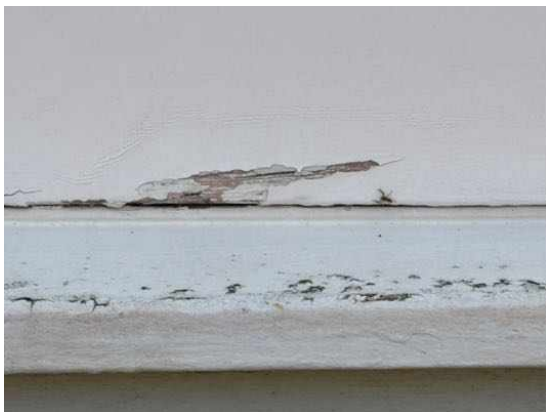
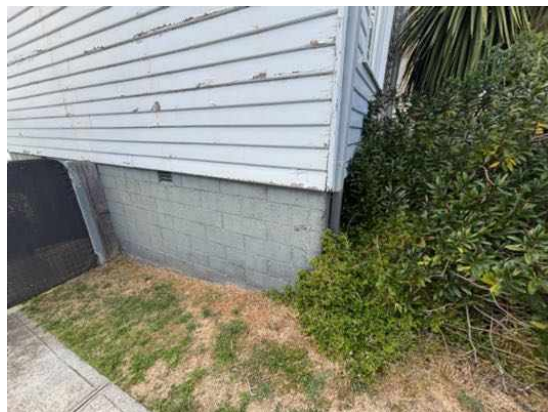
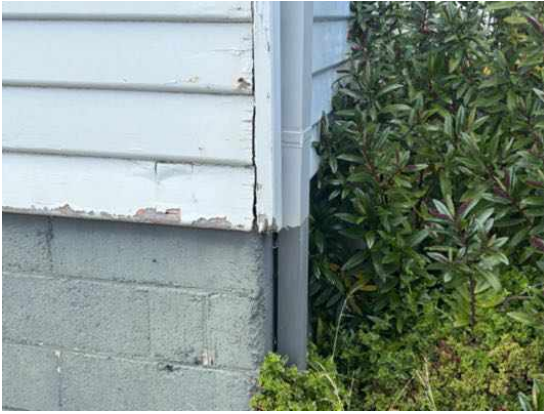
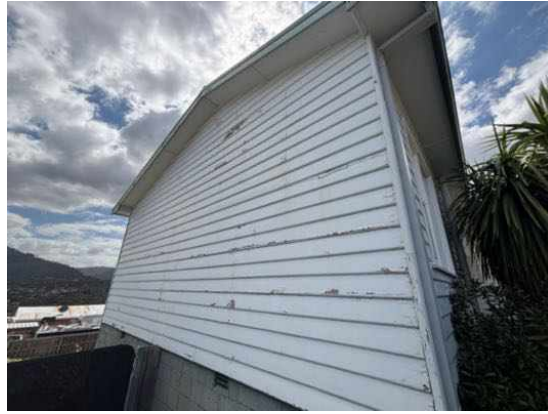
Defects 3.15

Building: Main Building
Location: Multiple locations
Finding: Paint Deterioration to exterior timbers
Information: On the exterior of the house, the paint is very deteriorated to timbers (windows, fascias, fascia infills, barge boards, trims, weatherboards, weatherboard stops etc).

It is likely that paint deterioration has developed as a result of frequent exposure to rain and other weather conditions. It is suspected that failure to maintain the timbers over a prolonged period has resulted in them deteriorating at an accelerated rate, increasing their susceptibility to the development of wood rot. Early intervention and regular maintenance will prolong the useful life of these building elements.

Recommend client engage a Handy Person/Painter to rectify as soon as practicable.

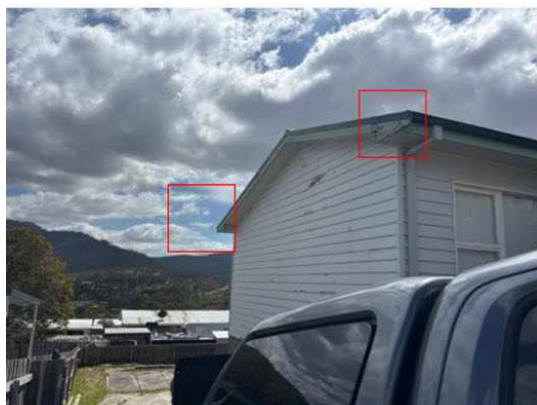
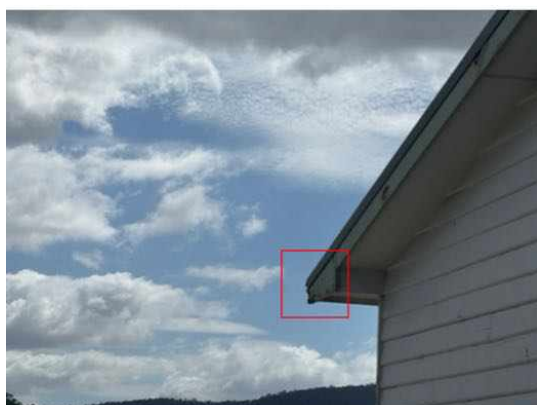
Defects 3.16

Building:	Main Building
Location:	Roof
Finding:	Wood rot & paint deterioration to fascias
Information:	There is wood rot and paint deterioration to the front and back fascias.

Wood rot, also known as Fungal Decay, occurs when timbers and other cellulose

building materials are exposed to damp conditions on an ongoing basis. This could be the result of exposure to weathering over a prolonged period of time, or the attraction of excessive moisture from other abutting building materials.

Recommend client engage a Carpenter to rectify the wood rot as soon as possible.

Once the timbers have been replaced, recommend client engage a Painter to prep and paint as soon as possible.

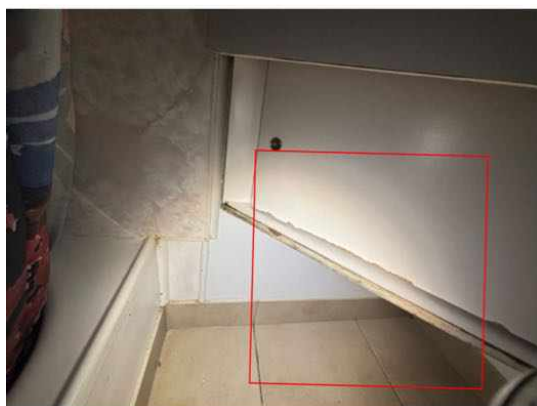
Defects 3.17

Building:	Main Building
Location:	Bathroom
Finding:	Water damage to vanity cabinet
Information:	In the bathroom there is water damage to the vanity cabinet, most likely from water splashes. Recommend these areas are painted to protect from further water ingress.

Recommend client engage a Handy Person to rectify as soon as practicable.

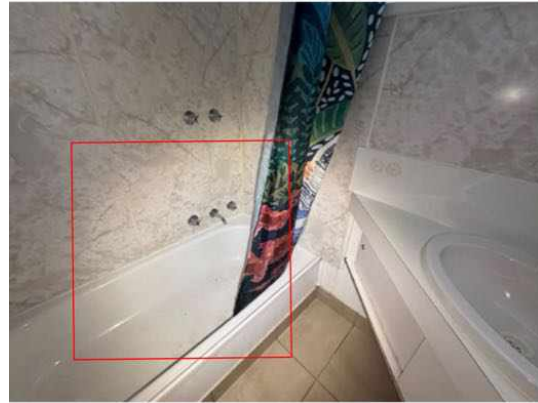
Defects 3.18

Building:	Main Building
Location:	Bathroom
Finding:	Silicone deteriorated to shower over bath
Information:	In the bathroom the shower over the bath silicone has deteriorated. The silicone needs to be removed and re-caulked.

Failure to remedy could result in damage to surrounding building elements.

Recommend client engage a Handy Person to rectify as soon as possible.

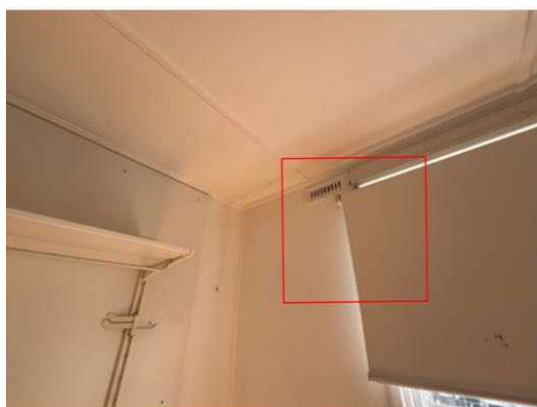
Defects 3.20

Building: Main Building
 Location: Back bedroom
 Finding: Blind
 Information: In the back bedroom the blind mechanism has been disconnected. Therefore you cannot open and close it with a cord, you have to it manually. This defect inhibits the operation of the blind.

Recommend that client engage a Handy Person to rectify as soon as practicable.

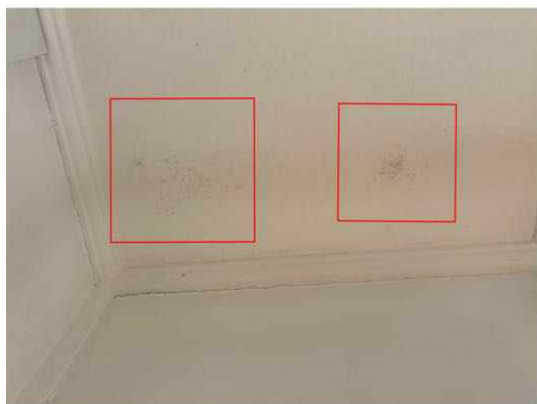
Defects 3.21

Building: Main Building
 Location: Back bedroom
 Finding: Mould, clean, treat and paint
 Information: There is mould staining to the corner of the back bedroom. This needs to be cleaned, treated and painted.

Failure to rectify could cause health related issues.

Recommend client engage a Handy Person to rectify as soon as practicable.

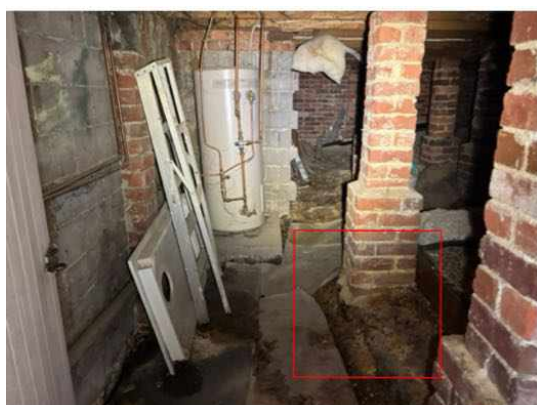
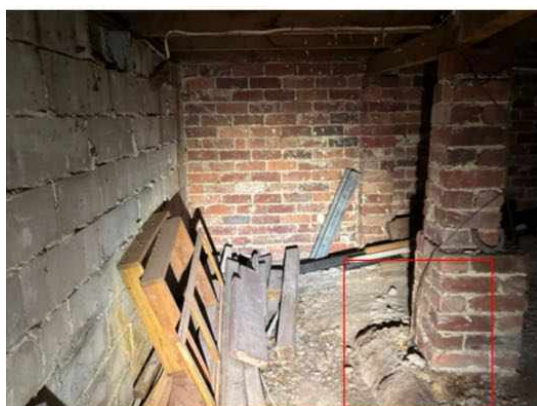
Defects 3.25

Information: In the subfloor there are some piers and footings that have been partially or fully undermined. Dirt has been excavated away exposing portions of the footings, which reduces stability of the foundations and increases the likelihood of subsidence. There was no. Significant damage identified at this time, but there was lots of vegetation obscuring access at the front of the property where the deepest excavation was.

The soil holds up the concrete foundation/ footing which in turn holds up the brickwork, which holds up the house.

Failure to rectify could potentially lead to damage of the structural building elements.

Recommend client engage a Lic Builder to assess and rectify as soon as possible.

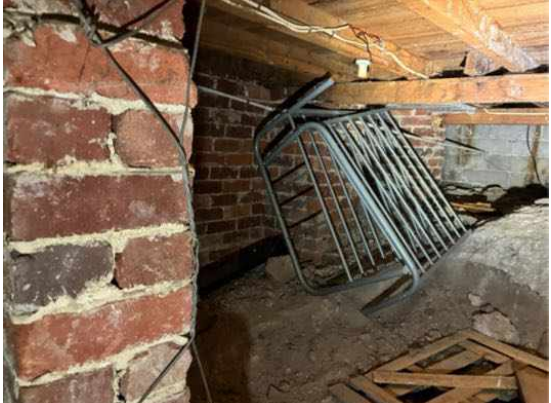
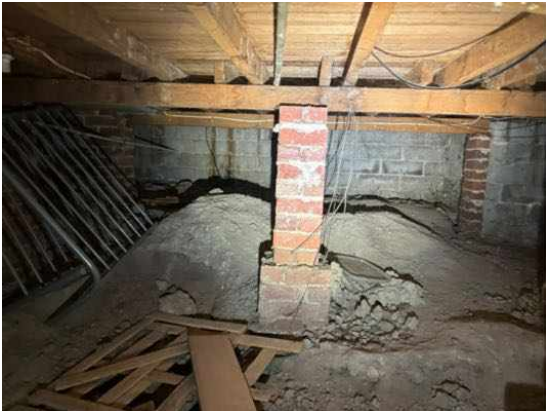
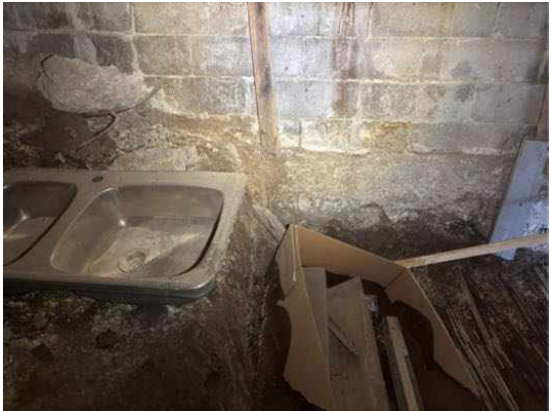
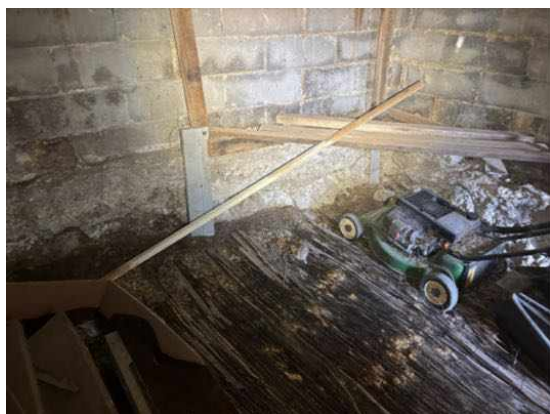
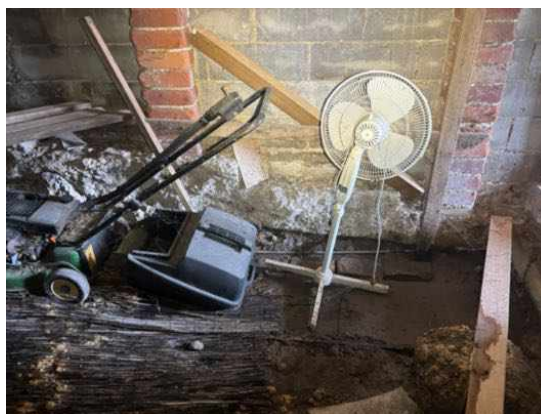
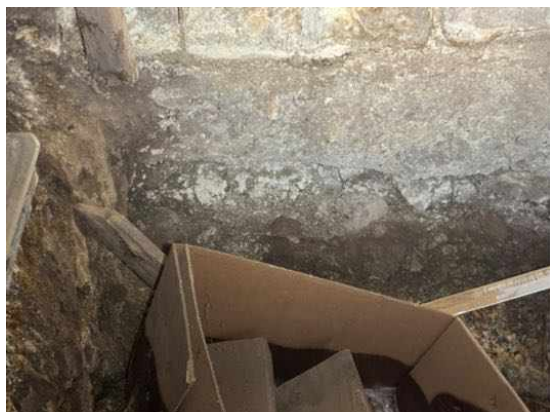
Defects 3.26

Building: Main Building
Location: Subfloor
Finding: FYI Subfloor stored items
Information: FYI there are stored items in the subfloor. This restricts ventilation and creates potential for concealed pest entry. A clear and empty subfloor will be better ventilated and easier to maintain in a dry condition.

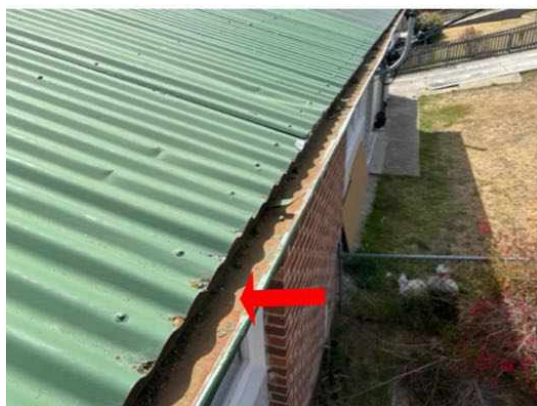
Defects 3.31

Building:	Main Building
Location:	Roof
Finding:	Gutters - debris
Information:	There is some debris in the gutters. FYI the back gutters have been replaced. The front gutters are corroded but are still functioning at the moment, however they will need replacement in the near future.

Blocked gutters are likely to lead to high levels of moisture in the affected areas. Such moisture can cause rust and decay of the associated building materials. Blockages in gutters should therefore be removed immediately to ensure dry conditions are maintained.

Recommend client engage a Handy Person to clean the gutters as soon as possible.

Recommend client ensure that all gutters be maintained on a frequent basis to ensure the condition of roof plumbing.

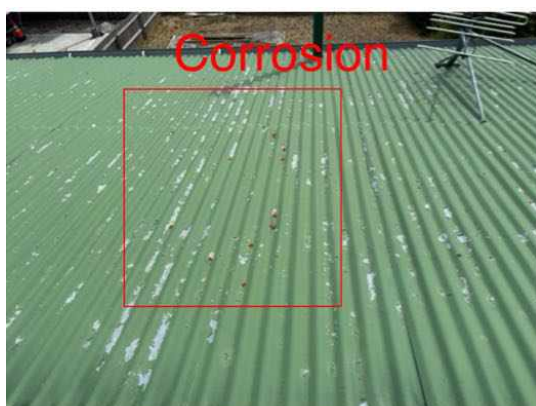
Defects 3.32

Building:	Main Building
Location:	Roof
Finding:	Roof maintenance required
Information:	The roof requires some maintenance work. There are loose nails, corrosion and silicone repairs. There is also an unorthodox flashing to the back porch which is relying purely on silicone.

The roof is held down by nails, which was normal practice at the time of construction. However as the timber dries and shrinks the nails and timber loose friction and the suction of the roof by winds, works the nails loose. Some have been replaced by roof screws.

Recommend client engage a Lic Roof Plumber to rectify as soon as possible.

Any loose nails should be replaced by roof screws which offer superior hold down power.

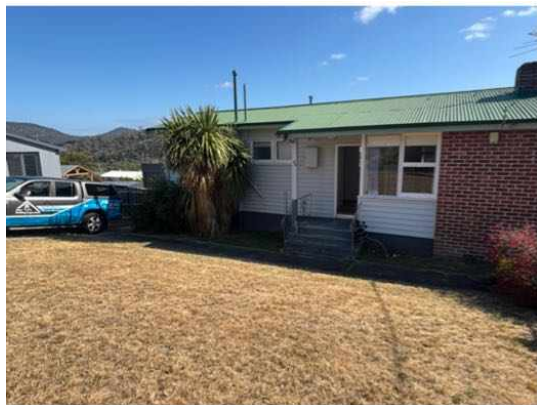
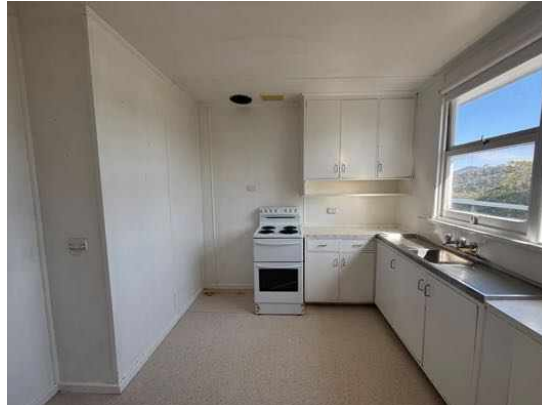
Building: Main Building
 Location: Interior & Exterior
 Finding: Lead Paint
 Information: This is FYI only. We are not saying there is lead paint to this property, as that would need testing and this a non destructive inspection.

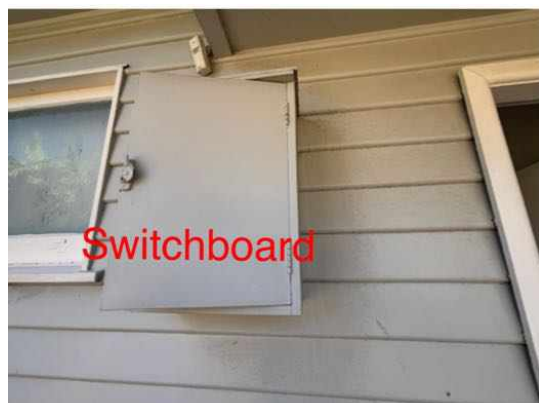
Building: Main Building
 Location: Exterior
 Finding: Asbestos - Suspected ACM Identified on Site
 Information: Suspected Asbestos Containing Material (ACM) was identified in the:

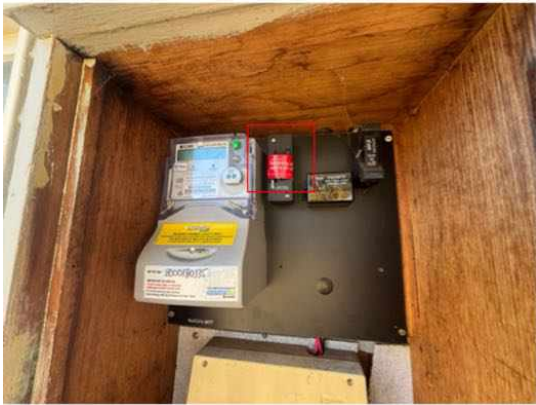
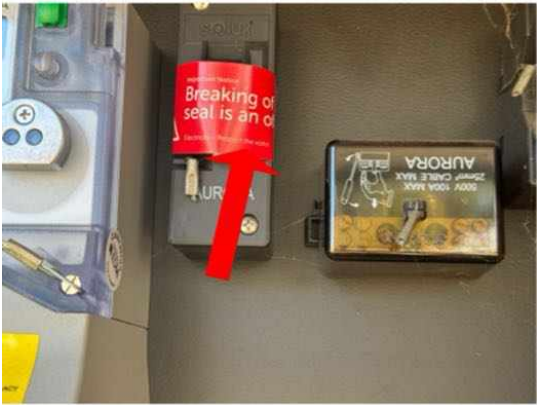
Building: Main Building
Location: Switchboard
Finding: FYI electricity
Information: FYI the electricity was turned off at the switchboard. Therefore I couldn't test anything electrical.
