**BEFORE YOU BUY**  
**BEFORE YOU BUILD**

## Building and Timber Pest Inspection Report

Inspection Date: Fri, 2 Jan 2026

Property Address: 20 Riddell Cres, Blackett NSW 2770,  
Australia

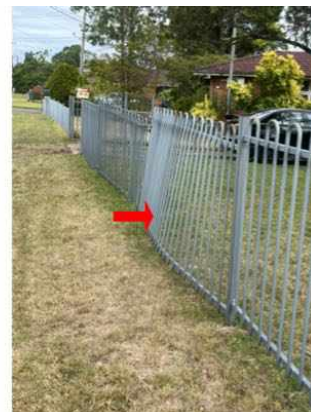
Finding: Fencing - Deteriorated

Information: It was noted at the time of inspection that sections of the fencing throughout the property have deteriorated. Typically fencing deteriorates due to age and or wear, rot and or rust which is generally expected for a structure of this age, due to prolonged exposure to weather conditions. Sometimes inadequate installation or maintenance can be to blame.

If left unattended, it is likely that further damage will occur. It is suspected that repair of several elements of the fencing may be required however replacement may be a consideration of the client also.

A licensed fencing contractor should be appointed to provide further advice and perform rectification works as necessary.

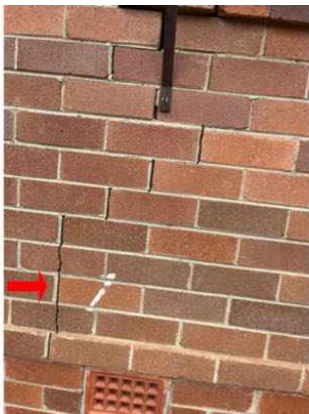
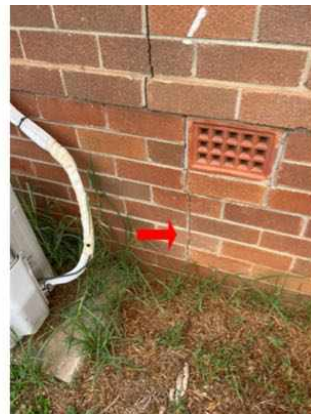
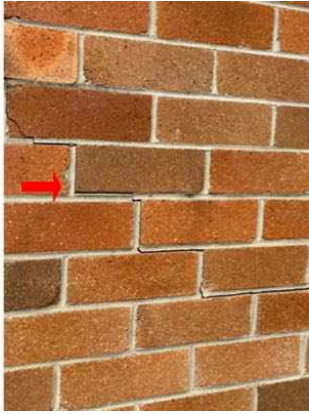
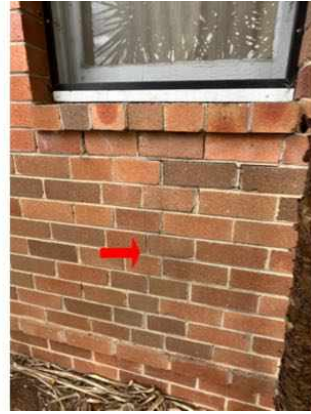
### Finding 3.02

Finding: Minor cracks on Brickwork

Information: Although fine cracks are quite noticeable, they are often only considered to be an appearance defect and usually do not indicate any structural damage. Generally, the cause of a fine crack is indicative of a minor movement on foundation during settlement, separation between brickwork and mortar throughout the structure, but single bricks may also show cracks of this nature.

Cracking of this nature can generally be repaired with minor filling and should be conducted by a qualified bricklayer.

Always contact a building inspector should cracks widen lengthen or become more numerous.

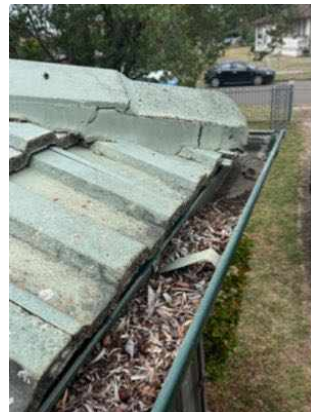
### Finding 3.03

Blocked gutters are likely to lead to high levels of moisture in the affected areas. Such moisture will not only cause rust and decay of the associated building materials, but can also provide conditions that are conducive to termite and timber pest activity. Blockages in gutters should therefore be removed immediately to ensure dry conditions are maintained.

Consult a Licensed Plumber for further specific advice on remedial works that may be required. In the interim, it is highly advised that blocked gutters be removed by the homeowner or a general handyperson as a matter of urgency.

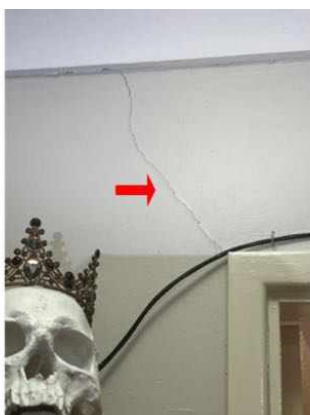
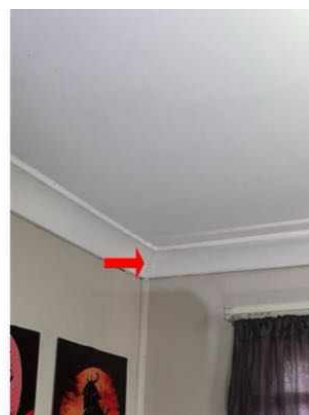
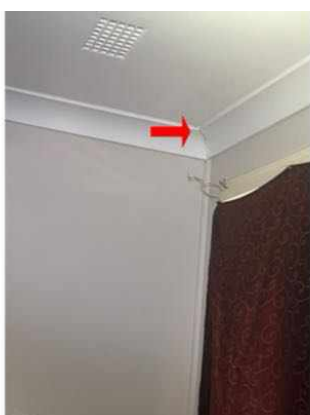
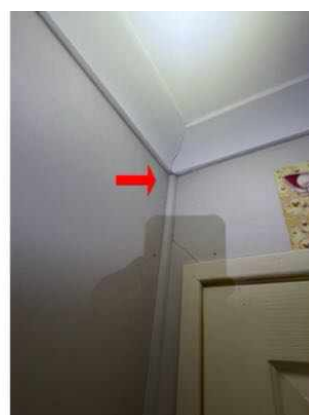
### Finding 3.04

Building: Main Building  
 Location: All Areas  
 Finding: Minor Cracks  
 Information: The interior cracks at wall corners or wall junctures with ceilings may have developed due to the separation of building materials caused by differential moisture levels or wood shrinkage during the framing drying process. Additionally, the cracks around openings, doors, and windows appear to be the result of inadequate installation of timber studs during the construction stage.

While these cracks may be noticeable, they are typically considered to be cosmetic issues and do not usually indicate any structural damage. Repairing such cracks can generally be done through minor sanding, filling, and repainting. It is important to have these repair works carried out by a qualified painter or a licensed handyman.

Regular monitoring of all cracks is recommended. If cracks widen, lengthen, or increase in number, it is advisable to contact a building inspector for further assessment.

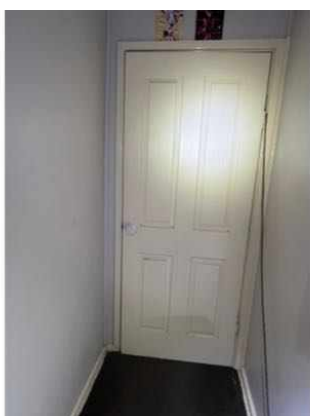
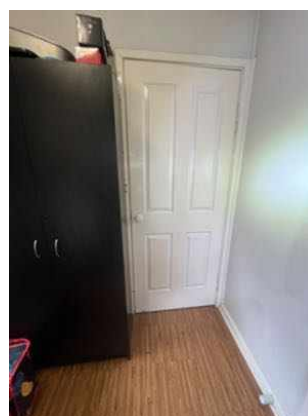
### Finding 3.05

Location: All Areas  
 Finding: Door Binding or Jamming  
 Information: It appears that there is a problem with this door as it is binding or jamming during normal operation. This defect not only affects the functionality of the door but also poses a risk for other building elements such as damage to the floor covering.

There could be various reasons behind the binding of the door, ranging from minor issues like poor installation or damaged hinges to major structural problems such as damage to the subfloor.

For minor issues, it is recommended to hire a qualified carpenter or handyman to carry out the necessary repairs as per the client's discretion.

In some cases, the binding of the door may be caused by termite activities. In such instances, it is recommended to monitor the situation closely or conduct an invasive inspection to identify the root cause of the problem.

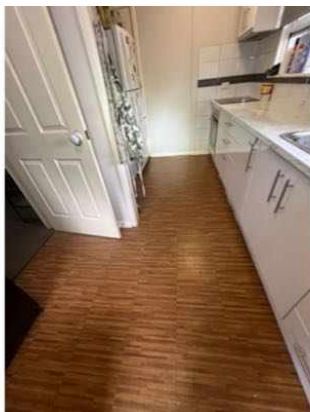
### Finding 3.06

Building: Main Building  
 Location: Kitchen  
 Finding: Squeaking Floors  
 Information: During the inspection, creaking was noted in sections of the floating floor system throughout the upstairs hallway and adjoining bedrooms. The noise appears to occur when pressure is applied to specific boards, which is typically caused by minor movement within the floor assembly. This movement often results from loosened board connections, inadequate underlay support, slight deflection in the subfloor, or friction between board edges when walked upon. The condition is consistent with typical behaviour found in floating laminate or hybrid flooring systems, particularly in high-traffic areas where wear or slight expansion and contraction may occur over time.

Although no significant structural deflection was evident in the surrounding building elements, ongoing creaking may indicate progressive loosening of the boards or deterioration of the underlying substrate. If the noise increases in frequency or if

localized areas begin to feel noticeably soft or excessively bouncy underfoot, it is recommended that the client seek further assessment from a licensed handyman or Registered Builder. Remedial actions may include re-securing affected areas, replacing or adjusting sections of flooring, or installing additional support beneath the impacted boards to restore stability and reduce noise transmission.

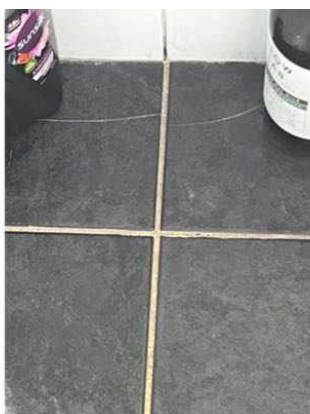
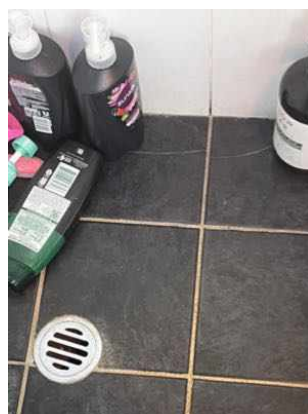
### Finding 3.07

Building: Main Building  
 Location: Bathroom  
 Finding: Cracked tile in the Shower Recess  
 Information: Cracks were observed in the tiles within the shower recess during the inspection. To address this issue, a temporary fix has been applied using sealant. Although the cracks seem minor, it's important to note that this area is constantly exposed to water, which creates the potential for water to seep into adjacent walls and flooring.

If left unaddressed, this could result in water damage, necessitating repairs to affected building components. It is recommended to promptly engage a tiling contractor to prevent further water damage. Additionally, it is advisable to reapply silicone and grout to the remaining tile work to enhance protection against water infiltration. In cases where water damage has already occurred, it may be necessary to enlist the services of a relevant tradesperson to repair the damaged building elements.

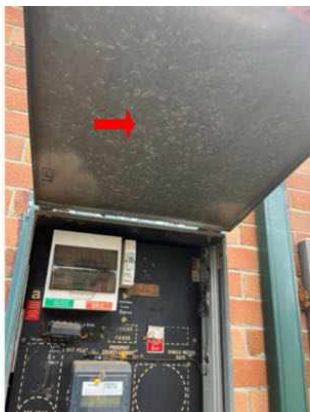
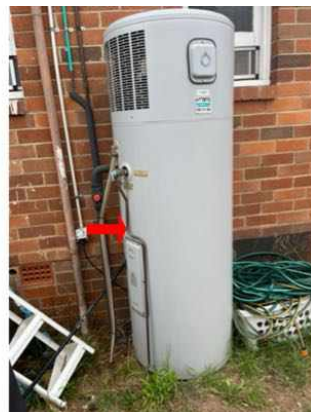
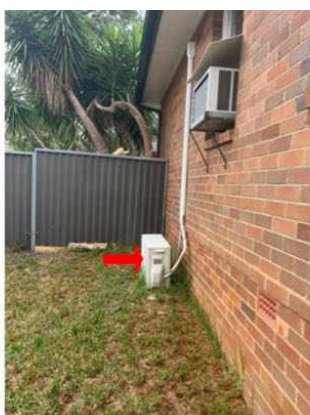
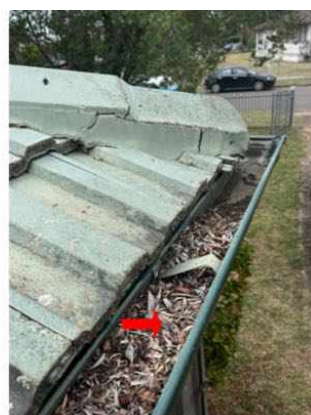
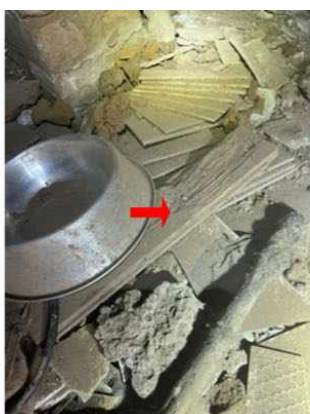
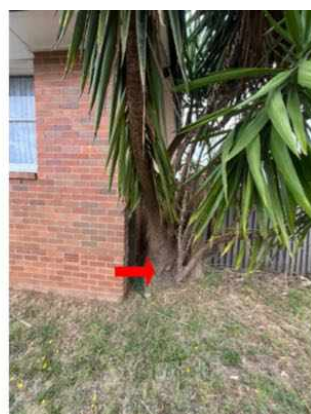
Building: Main Building  
 Location: All Areas  
 Finding: Conditions Conducive to Termite Activity  
 Information: The following areas and environmental conditions were identified as conducive to termite activity. These conditions increase the risk of concealed termite entry and should be addressed through appropriate maintenance, repairs, improved drainage, additional monitoring, or the installation of a compliant termite management system.

The HWS overflow discharges directly to ground, resulting in constant moisture at the building perimeter. Excess moisture provides conditions favourable to termite activity.

Air conditioner condensation lines discharging near walls can cause damp soil conditions, attracting termites.

Blocked gutters were noted to cause overflow, directing water onto walls and foundations. Excess moisture increases termite attractivity.

Stumps and garden beds near the dwelling provide both moisture and cellulose, creating ideal termite feeding sites.

Timber offcuts, cardboard, or loose debris in subfloor or external areas provide an ongoing food source.

Cracks in masonry or foundations may create concealed entry points for termites and moisture.

Recommendation: Where no system exists, install a compliant termite management system and retain all documentation for future reference.

Recommendation: Connect the overflow to suitable stormwater drainage to divert water away from all structural elements.

Recommendation: Ensure AC overflow pipes are connected to appropriate stormwater drainage.

Recommendation: Install a drainage system or concrete plinth that directs runoff away from the structure.

Recommendation: Clean and maintain gutters and downpipes regularly.

Recommendation: Remove decaying stumps and avoid positioning garden beds directly against walls.

Recommendation: Remove all loose timber and maintain the subfloor clear of debris.

Recommendation: Seal all cracks and continue to monitor for ongoing building movement.

- Rectify all identified conducive conditions through appropriate maintenance and repair.
- Implement routine moisture monitoring and schedule regular timber pest inspections.
- Install or upgrade a termite management system for long-term protection.
- Where mature trees are present, test-drill trees over 100 mm in diameter to assess potential termite activity.

- Where high-risk conditions or concealed areas exist, consider invasive inspection prior to purchase or during further investigation.

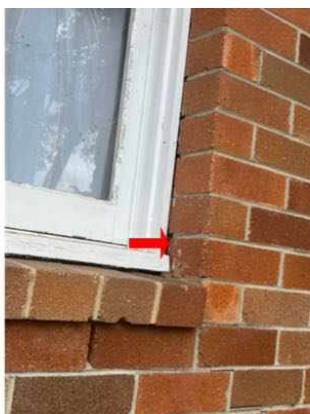
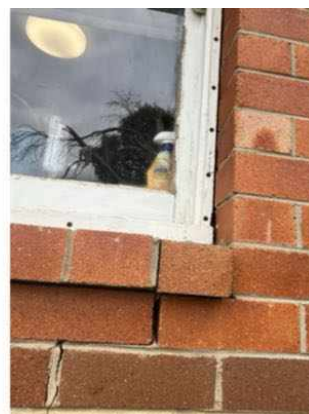
Building:	Main Building
Location:	All Areas
Finding:	Gap Around Window Frames
Information:	A gap was observed between the window frame and the surrounding brick wall, indicating inadequate sealing to the window perimeter. This condition may allow moisture and wind-driven rain to penetrate the wall cavity, increasing the risk of dampness, deterioration of internal finishes, and potential concealed damage to adjacent building elements. Sealing to this junction appears deteriorated or incomplete and should be rectified to reduce the risk of water ingress.

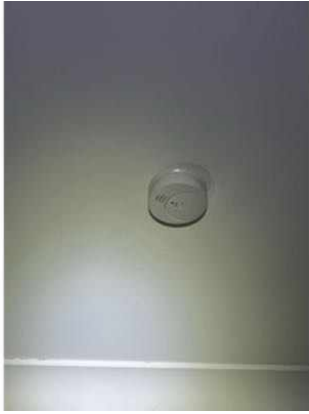
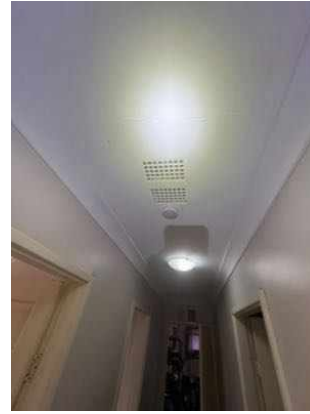
Building:	Main Building
Location:	All Areas
Finding:	Smoke Detector - Not hardwired
Information:	Smoke detectors were installed. It is recommended that mains operated, battery backup smoke detectors be installed in accordance with the Building Code of Australia (Part 3.7.2) and the relevant Australian Standards. The operation of these detectors should be checked and ensure that operational batteries are fitted prior to occupation.

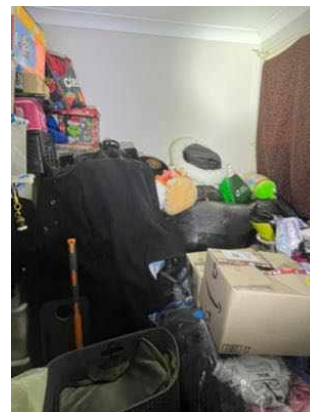
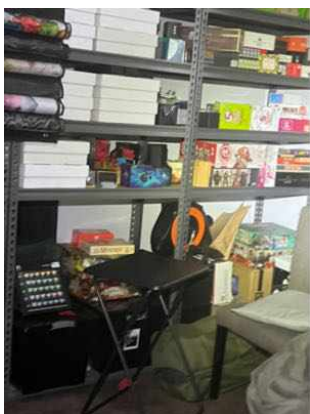
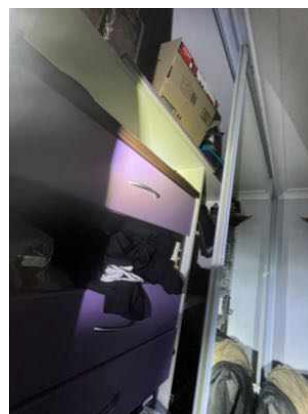
Building: Main Building  
 Location: All Areas  
 Finding: Note Regarding Mould and Staining  
 Information: It should be noted that the presence of furniture or stored items within the dwelling may restrict airflow and ventilation, particularly behind such items, creating conditions conducive to condensation and subsequent mould or staining.

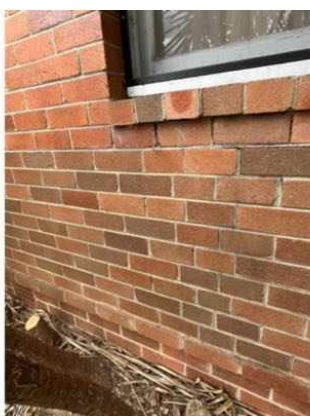
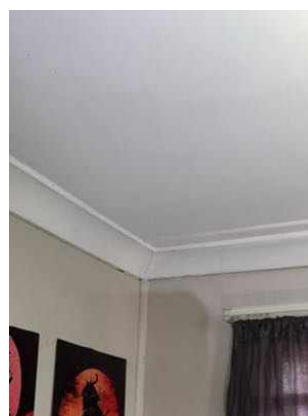
Building:	Main Building
Location:	All Areas
Finding:	Deterioration caused by Fair and Wear and Tear
Information:	Certain forms of deterioration commonly associated with fair wear and tear may not be specifically identified or itemised within this report. Minor cracking to brickwork, mortar joints, render, concrete paving, tiles, plaster linings, and timber beading, along with isolated areas of mortar loss, stiff or tight-operating windows, and similar age-related conditions, are typical of buildings over time and do not necessarily indicate defective workmanship or structural failure.

In accordance with the pre-inspection agreement, these minor and cosmetic conditions are generally excluded from reporting unless they constitute a major defect, safety issue, or significant structural concern. As such, the absence of specific reference to these items in the report should not be construed as an indication that they do not exist, but rather that they fall within the scope of accepted fair wear and tear and normal ageing for a property of this type and age.

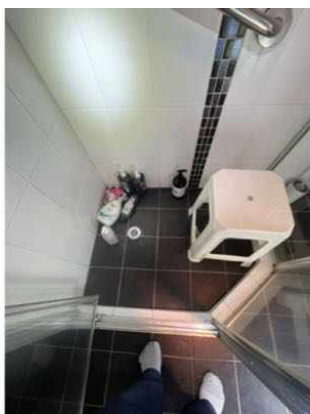
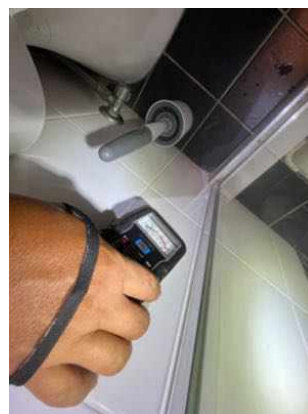
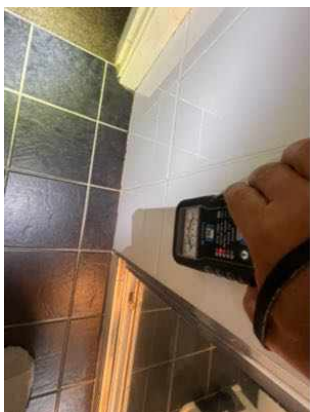
Building:	Main Building
Location:	Bathroom
Finding:	Minimum Moisture Readings Detected
Information:	After assessing the shower recess, the moisture content of the walls within and surrounding the wet area was examined. The readings showed no significant variation between the walls behind the shower and other internal walls, and there were no visible signs of recent moisture-related damage on the surrounding accessible wall surfaces. Based on these findings, the waterproofing system appears to be performing adequately at the time of inspection, with no current evidence of active leakage.

However, it must be acknowledged that if the shower has not been used recently, moisture meter readings may not provide an accurate indication of the waterproofing condition. A lack of elevated readings under these circumstances does not conclusively confirm that the shower is free from leaks.

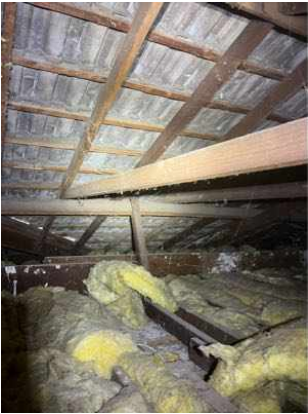
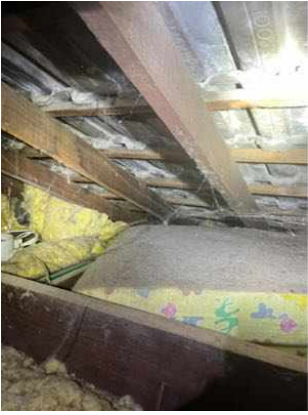
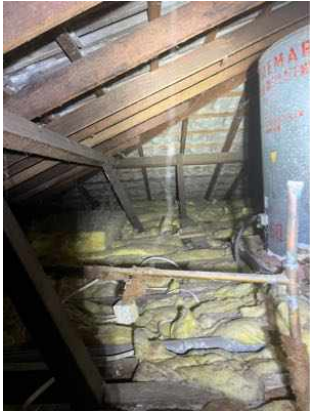
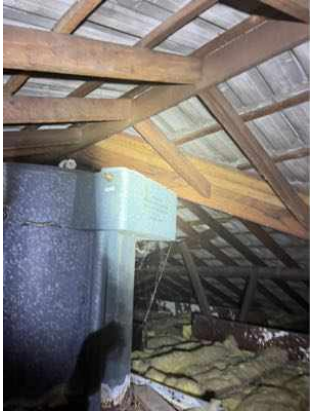
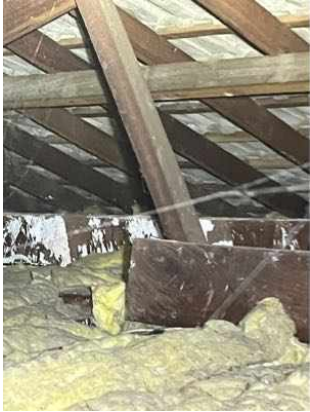
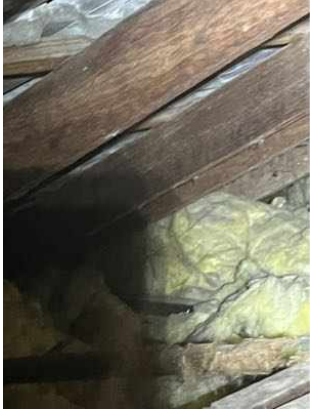
Building:	Main Building
Location:	Roof Void
Finding:	Condition of Building Elements in the Roof Void
Information:	Following completion of the inspection, the roof void was observed to comprise timber-framed roof construction with timber trusses, rafters and battens supporting concrete roof tiles. The primary timber members appeared generally serviceable at the time of inspection, with no visible signs of significant structural failure, active timber decay, or termite damage noted within the accessible areas. However, the roof void was dusty and poorly maintained, with extensive cobwebs present, which is typical of older roof spaces and indicates limited recent access.

The bulk insulation was present but unevenly laid and compressed in areas, reducing its overall thermal effectiveness. Some sections appeared displaced, with gaps and inconsistent coverage across the ceiling joists. No reflective sarking or foil insulation was noted beneath the roof covering, which is consistent with older construction and may contribute to reduced thermal performance and condensation risk. Roof tiles visible from within the roof space appeared generally intact, with no obvious daylight penetration observed at the time of inspection. The hot water storage unit located within the roof void showed advanced surface corrosion to the base, indicating age-related deterioration and a potential risk of leakage, and should be monitored and assessed by a licensed plumber. Overall, while the roof structure appeared functional at the time of inspection, maintenance, insulation improvement, and further servicing

of aged components are recommended.

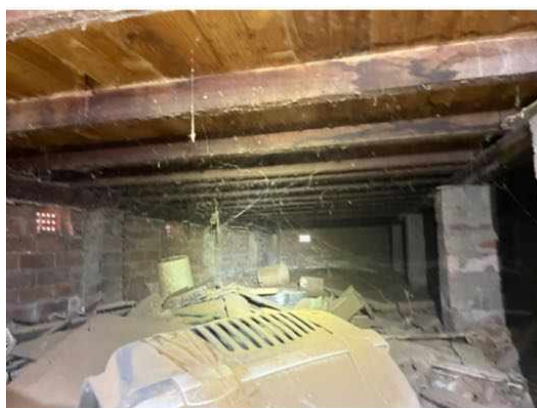
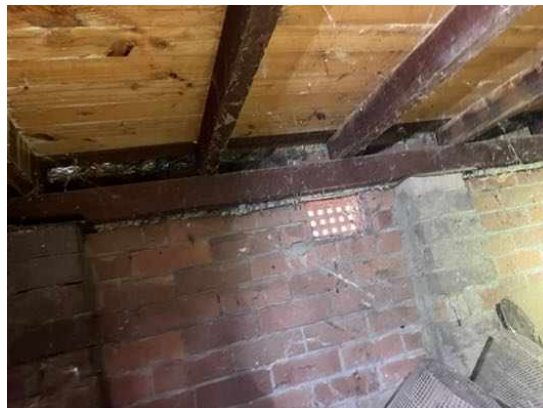
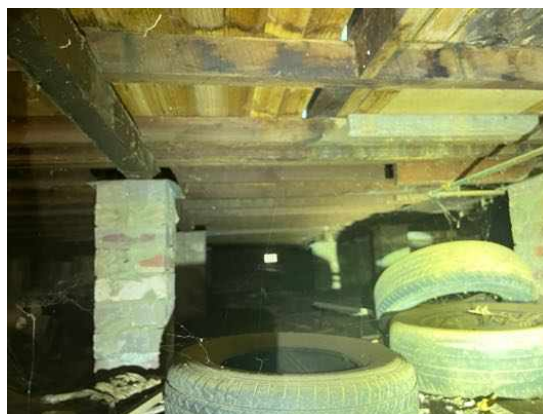
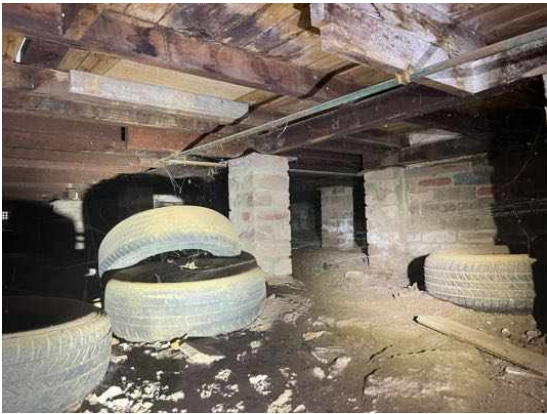
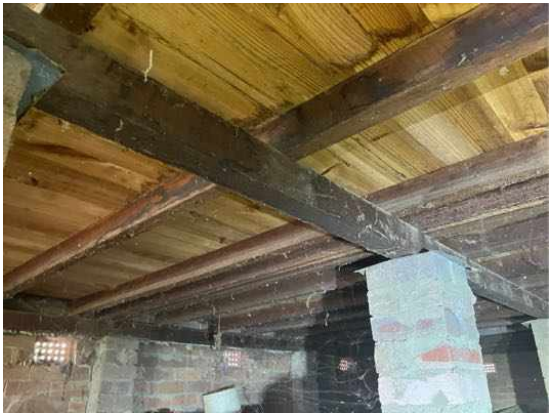
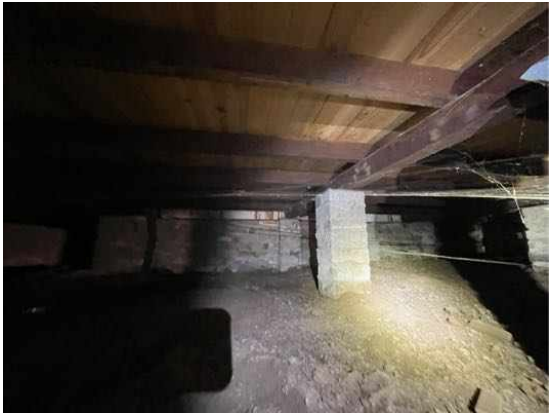
Building: Main Building  
Location: Subfloor  
Finding: Condition of Building Elements in the Subfloor  
Information: Following completion of the inspection, the subfloor area was observed to comprise brick piers supporting timber bearers and joists, consistent with typical older-style construction. The brick piers appeared generally serviceable, although some showed signs of age-related deterioration and minor surface wear, which is common in subfloor environments. The timber bearers and joists were generally intact at the time of inspection, with no visible evidence of significant structural failure; however, some members exhibited age-related staining and surface marking consistent with historical moisture exposure.

The subfloor ground conditions were dry in accessible areas, though debris, stored materials, and limited clearance restricted inspection in parts. Ventilation appeared limited, which may contribute to moisture retention and odour build-up. Notably, an unpleasant odour was detected within the subfloor, particularly in the vicinity of the bathroom area, raising concerns regarding a possible plumbing issue such as a leaking waste pipe, inadequate trap sealing, or sewer gas escape. While no active leaks were visually confirmed at the time of inspection, the presence of odour warrants further investigation by a licensed plumber to identify the source and prevent potential hygiene issues, moisture-related deterioration, or concealed damage to building elements.
