# Building and Timber Pest Inspection Report

Inspection Date: Mon, 23 Feb 2026

Property Address: 9 Clarendon Ave, Wodonga VIC 3690,  
Australia

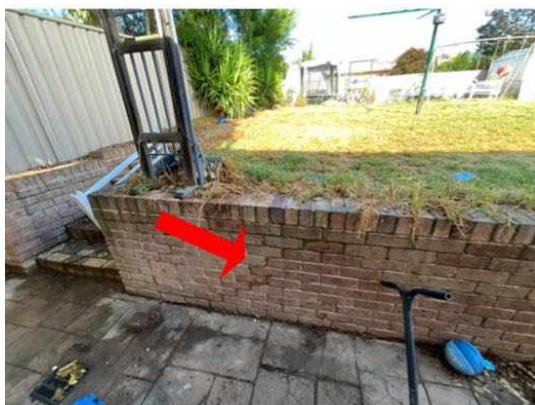
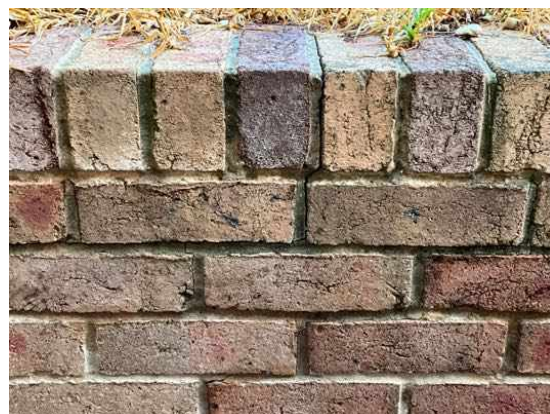
#### Finding 3.01

Building: Building 1  
Location: Yard - Back  
Finding: Brickwork - Step cracking  
Information: Step cracking was identified to the brickwork in this area at the time of inspection. Step cracking, which is similar to other forms of cracking, has a variety of possible causes. However, the most common is the subsidence of adjacent footings.

Step cracking is a relatively common defect, and is most likely to occur adjacent to windows, doors and other openings. Mortar failure in the gaps between affected bricks indicates the stresses and tensions affecting the wall.

Where step cracking is extensive or severe, the client is advised to consult a structural engineer. Minor step cracking can be used as a warning sign to address factors causing stress to the wall, which can include the effect of surrounding trees, water leaks, soil erosion, or even the presence of reactive soils in the surrounding area.

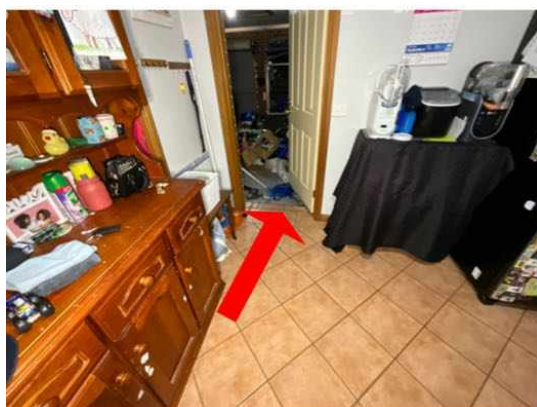
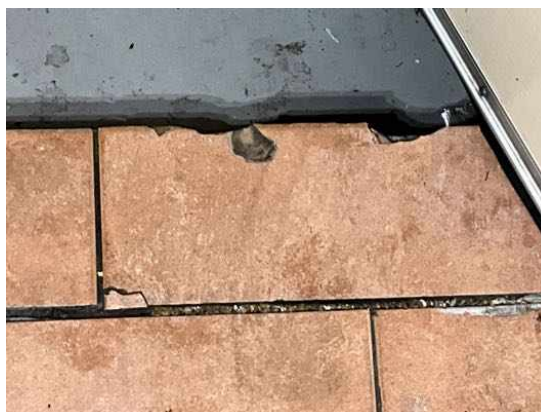
#### Finding 3.02

Building: Building 1  
Location: Garage

Finding: Cracked floor tiles  
 Information: Cracking in the floor tiles was evident in this area at the time of inspection. It is suspected that this cracking has occurred as a result of minor settlement or impact damage.

Cracked tiles throughout the household detract from the overall appearance of the affected areas however it is unlikely to create or lead to any secondary defects.

While not considered a matter of urgency, replacement of cracked floor tiles is recommended at the clients discretion. A tiling contractor may be appointed to perform these works. Where cracks become more numerous, contact a licensed building inspector for further investigation.

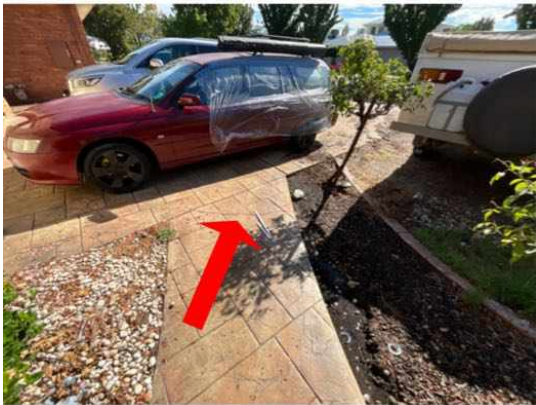
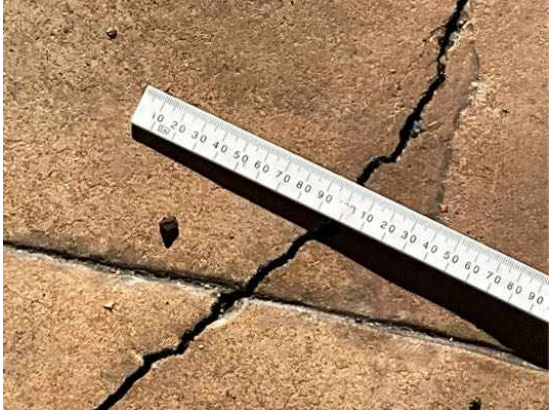
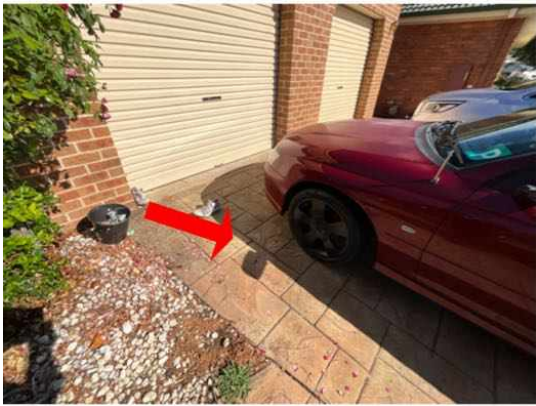
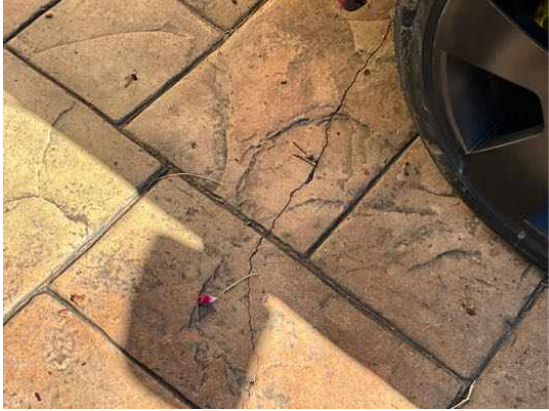
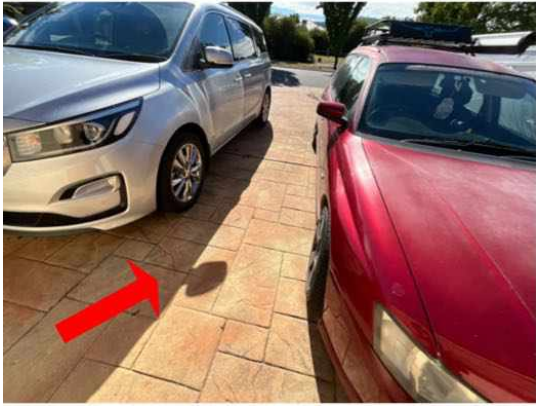
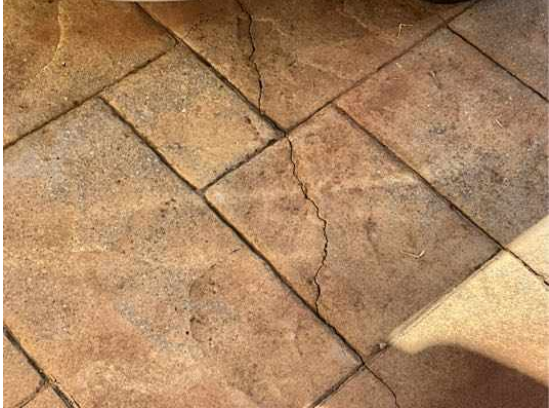
### Finding 3.03

Building: Building 1  
 Location: Driveway  
 Finding: Cracking - External Concrete Paving Damage Category 2 - Distinct (less than 3mm)  
 Information: Distinct cracks were identified in external concrete paving. Distinct cracks are generally found in older concrete paving, and may also present as a trip hazard as consequence of an uneven or curved surface.

General age and expected deterioration of the paved areas is a common cause of this type of cracking. However, expansion and contraction of the slab may also have occurred due to environmental factors. Such factors include variable moisture and weather conditions, the presence of trees and their roots having a settling or lifting affect on the soil, or the effect of load bearing, e.g. heavy vehicles over a sustained period of time.

Cracking to this degree may also be due to poor original installation of the concrete. Factors such as poor compaction of the sub surface and/or inadequate reinforcing of the slab may create cracking and other secondary defects.

Repairs are likely to be required to prevent further cracking and to reduce hazards associated with cracking, such as tripping. Monitoring of all cracking should be

conducted frequently. Always contact a building inspector should cracks widen, lengthen, or become more numerous.

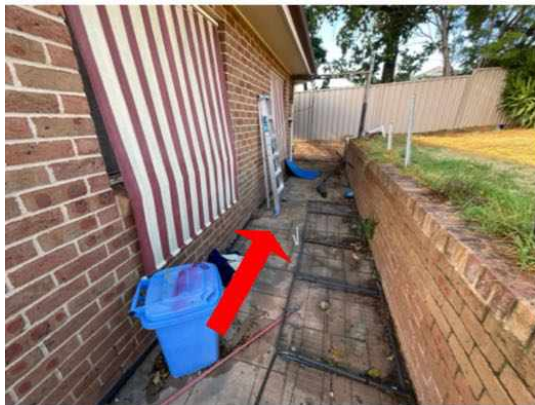
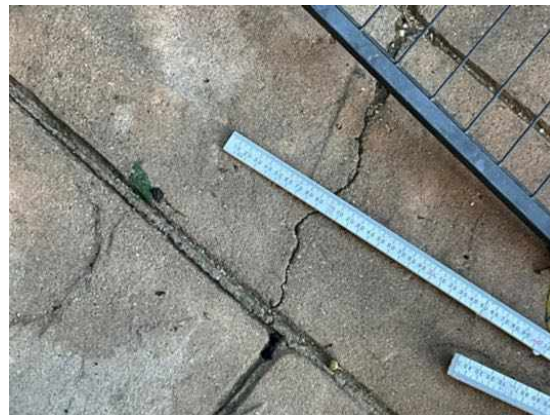
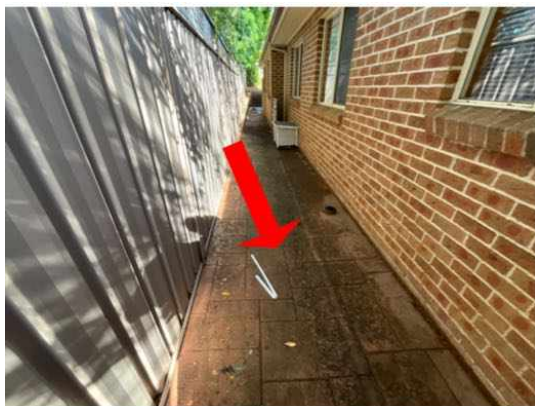
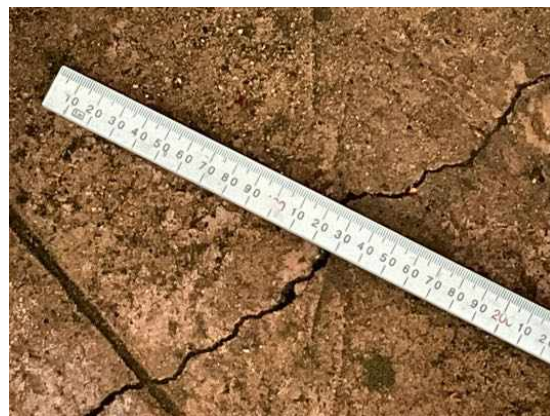
**Finding 3.04**

Building: Building 1  
Location: Yard - Back, side  
Finding: Cracking - External Concrete Paving Damage Category 1 - Fine (less than 2mm)  
Information: Fine cracks were identified in external concrete paving. Although fine cracks are quite noticeable, they are often only considered to be an appearance defect, and usually do not indicate any structural damage. To be considered a Category 1 or fine crack, the crack is found to be less than 2mm in width.

Generally the cause of a hairline crack in existing concrete paving such as driveways and pathways is indicative of the expansion and contraction of the concrete. Such causes are generally due to environmental factors, such as moisture levels, weather conditions, root systems of nearby trees or the soil types on which they are laid.

Fine cracks may also be due to poor original installation of the concrete. Factors such as poor compaction of the sub surface and/or inadequate reinforcing of the slab may create cracking and other secondary defects.

Monitoring of all cracking should be conducted frequently. Always contact a building inspector should cracks widen, lengthen, or become more numerous.

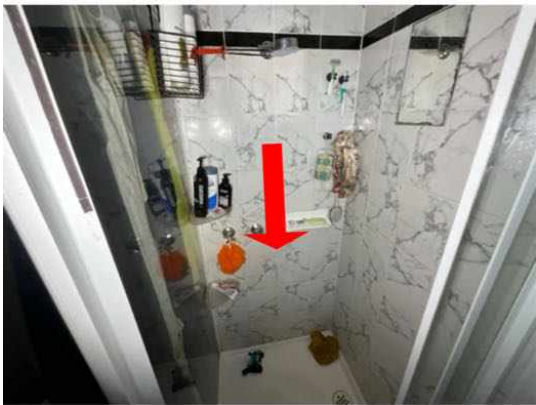
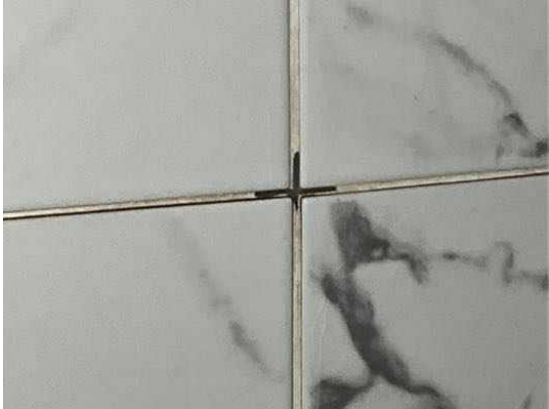
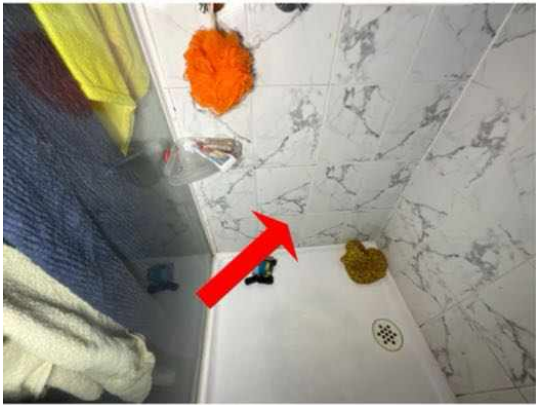
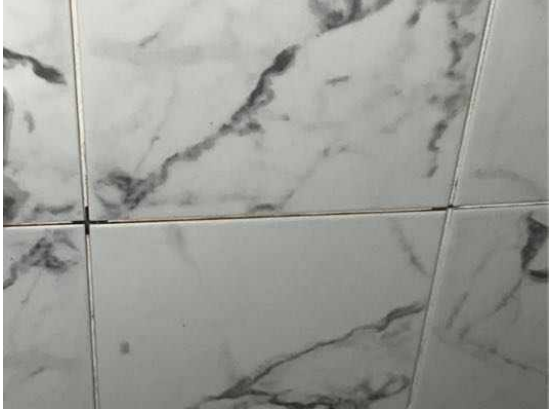
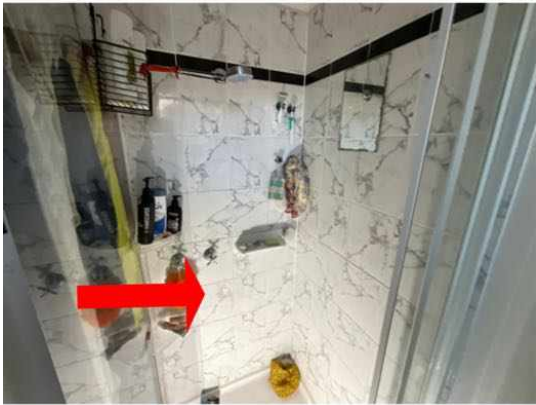
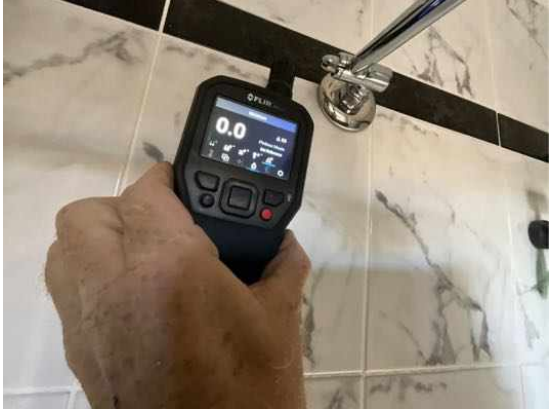
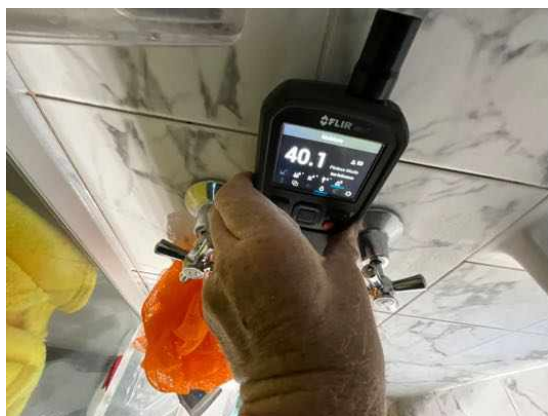
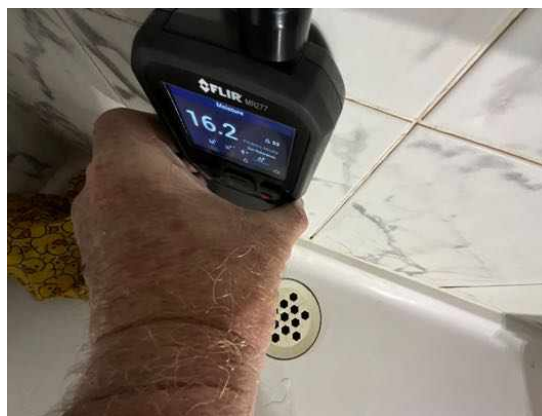
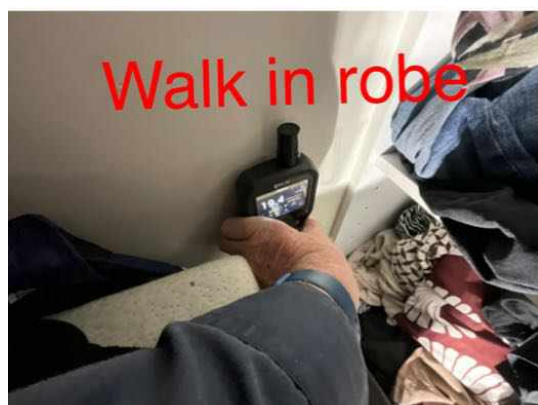
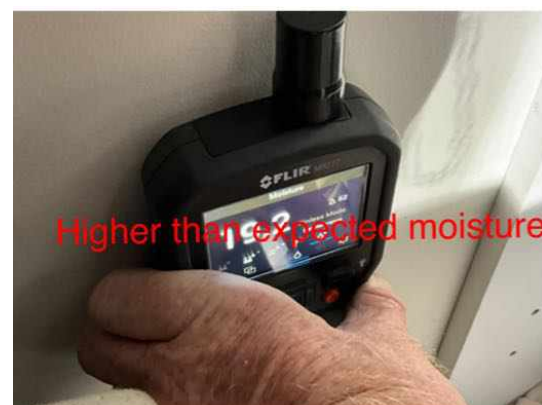
**Finding 6.01**

Building: Building 1  
Location: Ensuite  
Finding: Inadequate sealant or Grout  
Information: This area has a lack of effective Sealant or Grout. This is allowing the ingress of water to the structure inside the wall.

The presence of water encourages Termite attack, Mould and Fungal Decay.

A Tiler or General Handy person must be contacted as soon as possible to effect repairs and prevent further deterioration.

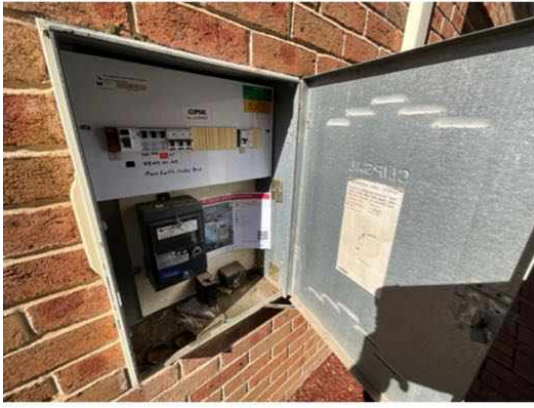
### Finding 6.02

Building:	Building 1
Location:	All External Areas
Finding:	Termite Management System - no evidence of a chemical installation
Information:	The application of a post-construction chemical termite barrier is highly recommended for all properties, particularly if live termite activity has been found on the site previously. Such barriers are highly effective in preventing termite attack on any timber building elements throughout the property.

A durable notice should be placed in the switchboard unit to indicate current termite barriers. At the time of inspection, it appeared as though no termite management system has been installed, with no evidence to suggest preventative works taking place.

The client may consider gaining further advice from a pest controller as to the costs and procedures involved with this application. It is recommended that obtaining such advice be a short-term priority.

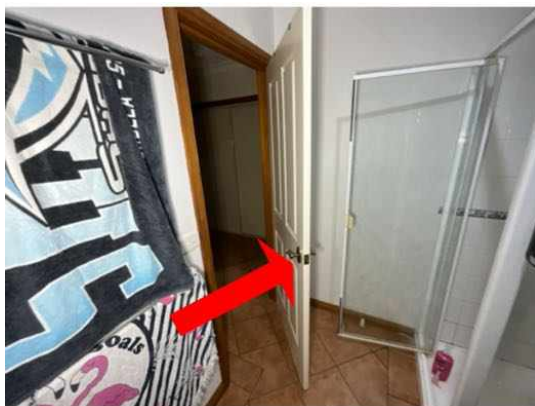
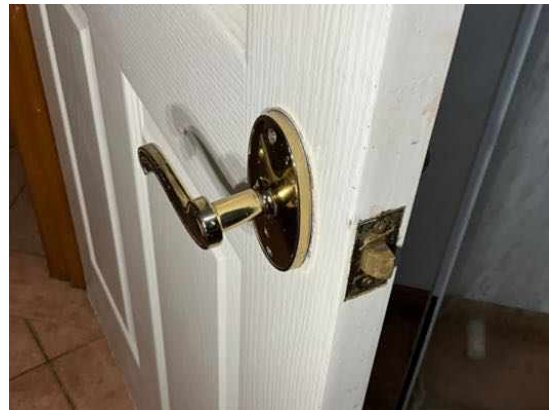
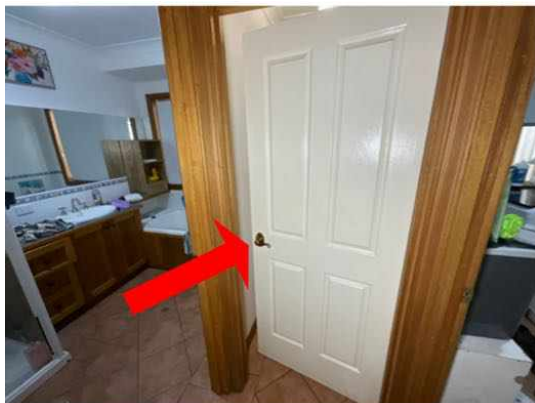
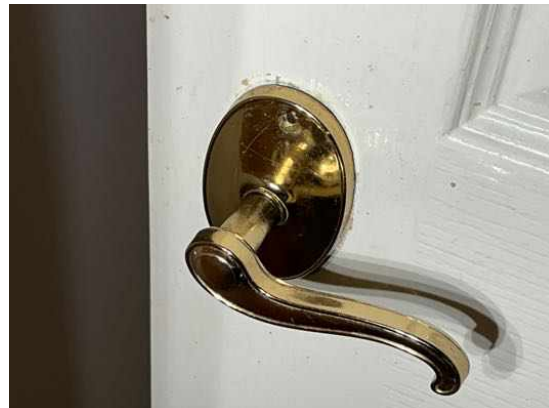
Building: Building 1  
 Location: Bathroom, Wc  
 Finding: Door handle- Poor operation  
 Information: The door handle/ catch in this area was found to be faulty during the visual inspection. This is most probably because of a lack of maintenance or wear and tear over time.

A general Handy person or lock specialist should be contacted to make needed repairs at the discretion of the owner and restore full function.

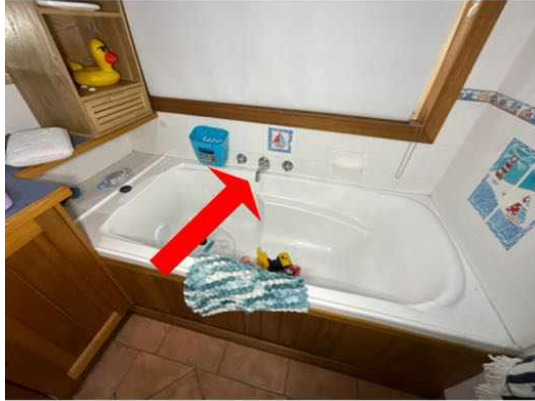
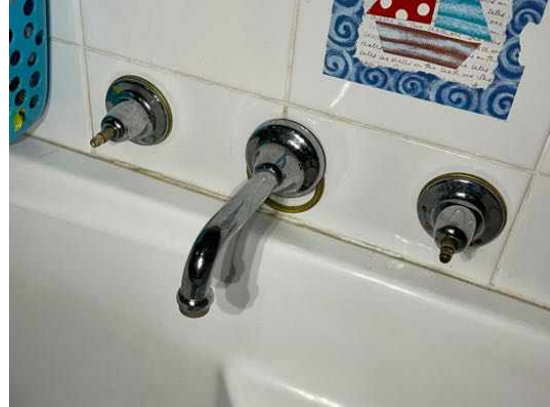
Building: Building 1  
 Location: Bathroom  
 Finding: Plumbing- damaged  
 Information: The plumbing in this area is damaged and does not meet expected standards. This installation should be improved to ensure no damage occurs in the surrounding structure.

The handles are missing and the surrounding support is dislodged.

It is recommended that a Plumber be appointed soon to further inspect and complete any needed works.

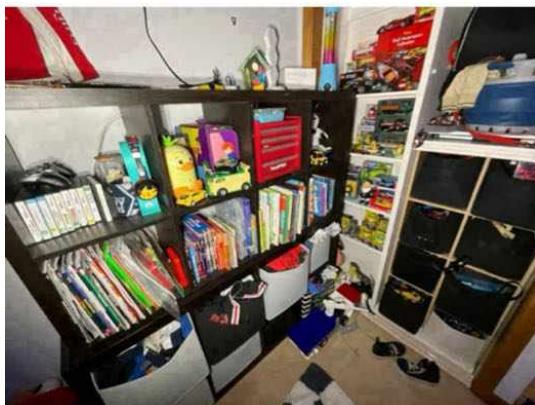
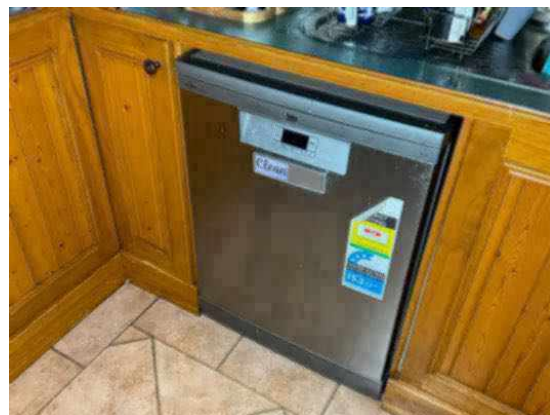
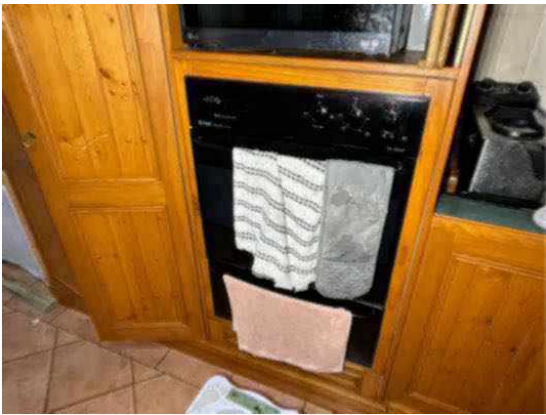
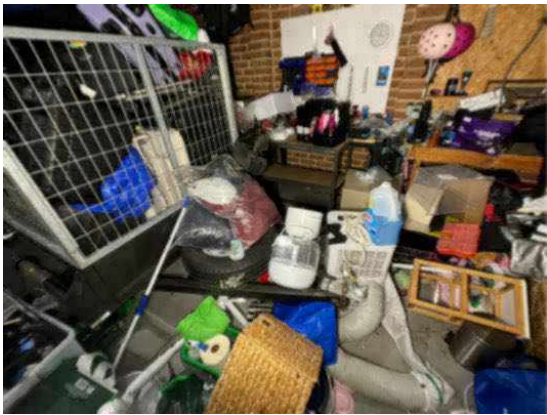
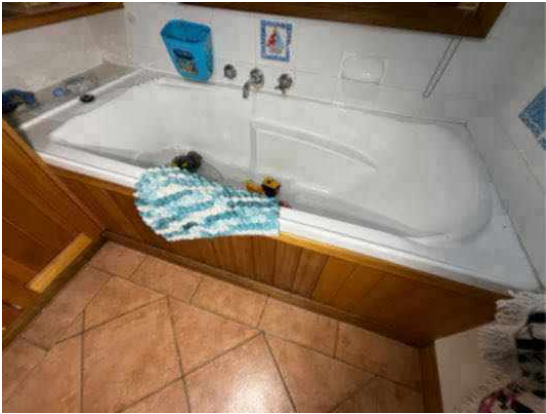
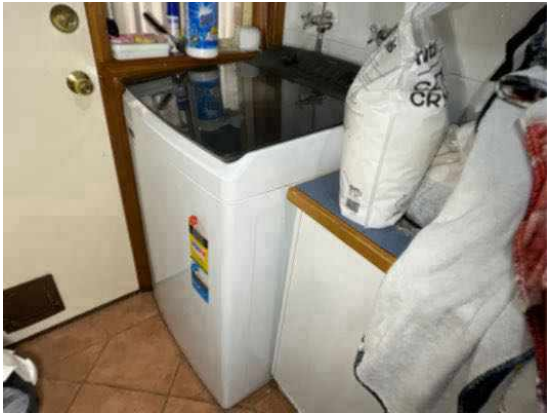
Building: Building 1  
Location: All Areas  
Finding: Additional Photos - Obstructions and Limitations  
Information: These photographs are an indication of the obstructions and limitations which impeded full inspection of the property at the time of inspection. These obstructions can hide an array of defects and should be removed to allow full inspection to be carried out. A re-inspection is recommended once the areas are made accessible.
