Building and Timber Pest Inspection Report

Inspection Date: Fri, 20 Mar 2026

Property Address: 46 Affleck Ave, Petrie QLD 4502, Australia

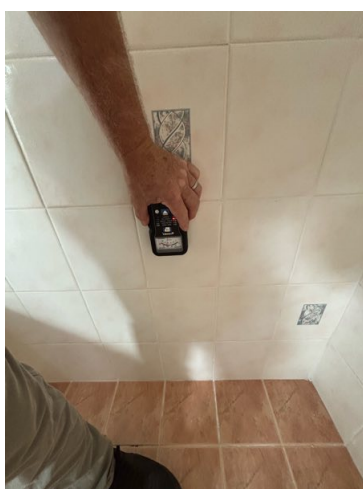
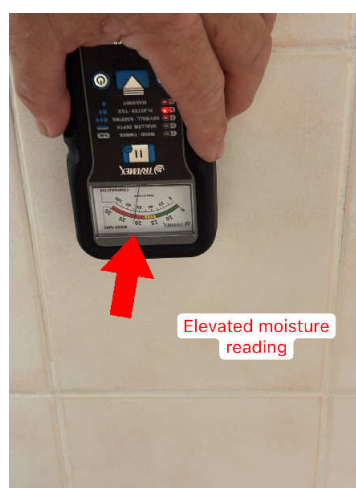
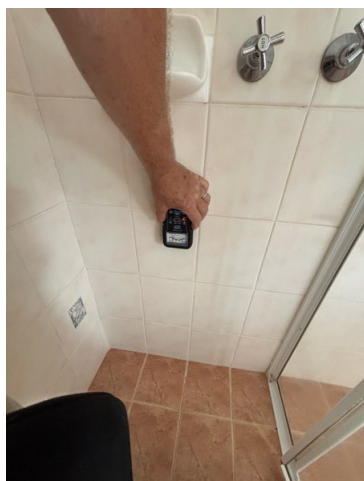
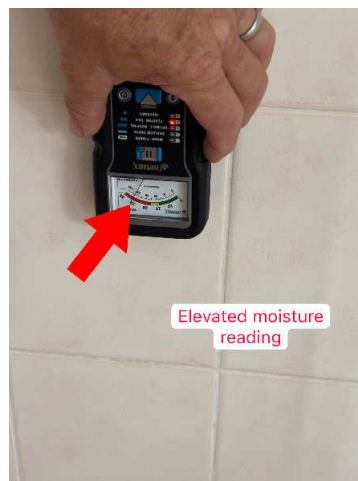
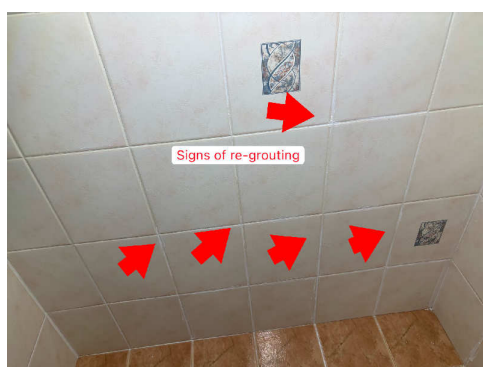
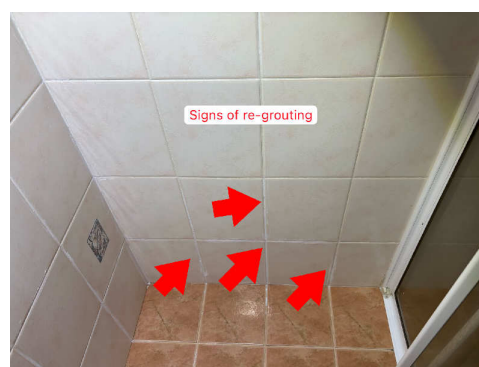
Finding: Familybathroom - elevated moisture readings to shower wall

Information: At the time of the inspection, it was noted that there were elevated moisture readings recorded at point higher than normal on the shower walls in the family bathroom. This may be due to the age of the materials. Grout and certain tiles can be porous. Moisture behind the wall tiles may have a negative affect on the wall tile glue. This could result in loose tiles. Evidence was found of an attempt to re-grout some sections of the shower walls.

A bathroom specialist could be engaged to replace the grout and seal the floor and wall tiles in the shower cubicle. This will give longevity to the bathroom. This can be done at the clients discretion.

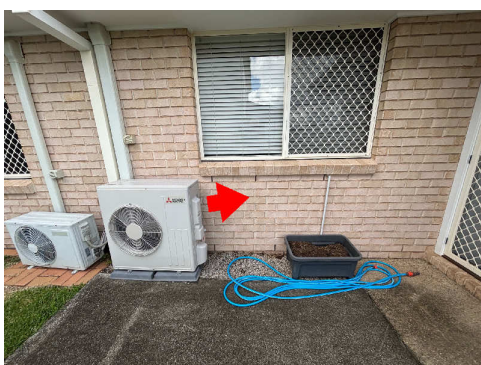
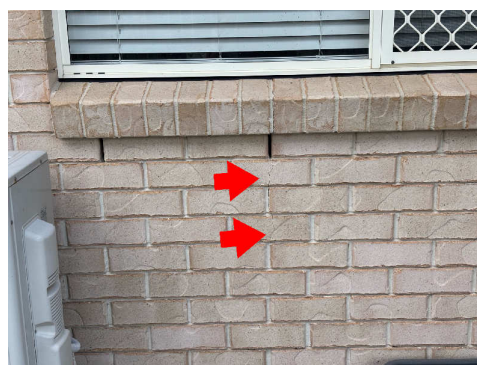
Finding 3.02

Building: Main Building
Location: Side elevation - near garage
Finding: Brickwork - Step cracking

At the time of the inspection, it was noted that there was minor step cracking to the brickwork below a window to the garage. This appears to be historic, the client should monitor these step cracks for any change in appearance.

Step cracking, which is similar to other forms of cracking, has a variety of possible causes. However, the most common is the subsidence of adjacent footings.

Step cracking is a relatively common defect, and is most likely to occur adjacent to windows, doors and other openings. Mortar failure in the gaps between affected bricks indicates the stresses and tensions affecting the wall.

Where step cracking is extensive or severe, the client is advised to consult a structural engineer. Minor step cracking can be used as a warning sign to address factors causing stress to the wall, which can include the effect of surrounding trees, water leaks, soil erosion, or even the presence of reactive soils in the surrounding area.

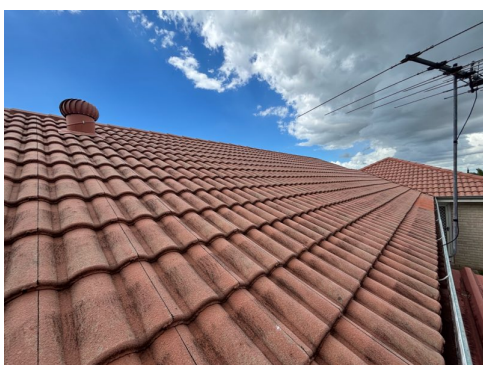
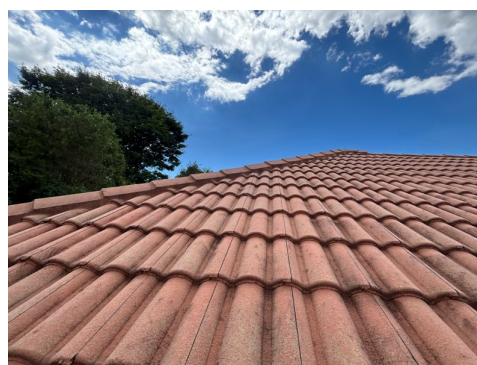
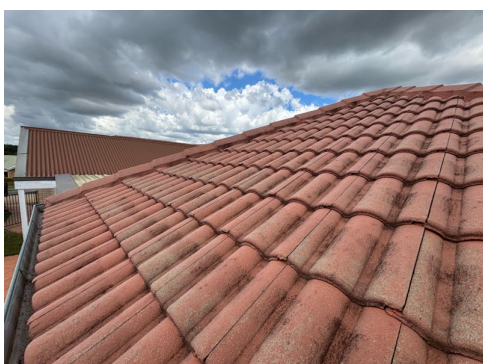
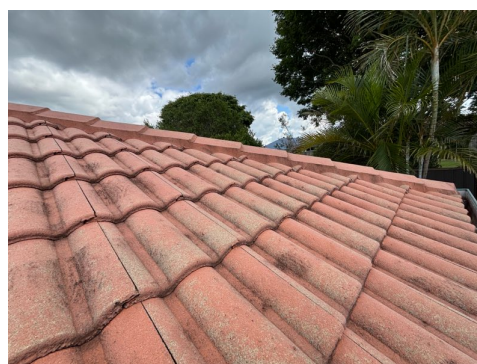
**Finding 3.03**

Building: Main Building
Location: Roof Exterior
Finding: Roof tiles - Weathered

Upon inspection of the exterior roofing, the majority of roof tiles were considered to be in a fair condition. While weathering of the tiles is consistent with the age of the property, preventative maintenance works may be considered. It appears that the ridge caps have been re-pointed, the colour or coating on the tiles is wearing off.

Where left unmanaged, deteriorating roof tiles or roof covering elements are likely to lead to a number of secondary defects, including minor water leaks and weather exposure to internal roofing structures.

Consultation with a roofing contractor is highly advised to gain advice on cost of remedial works that may be required in the short to medium term. Remedial works are likely to increase the longevity of the exterior roofing structure.

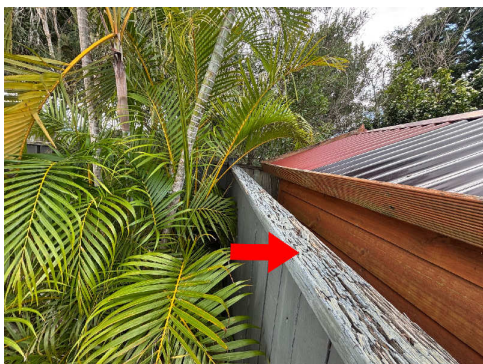
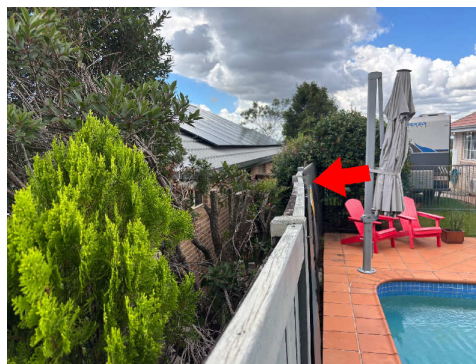
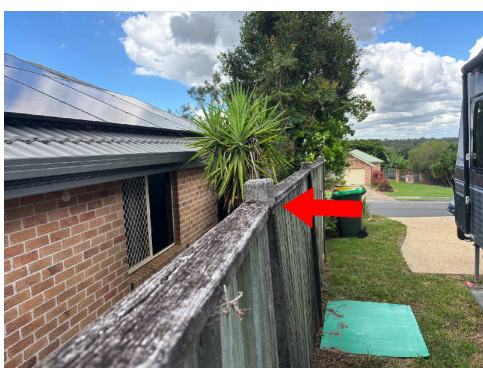
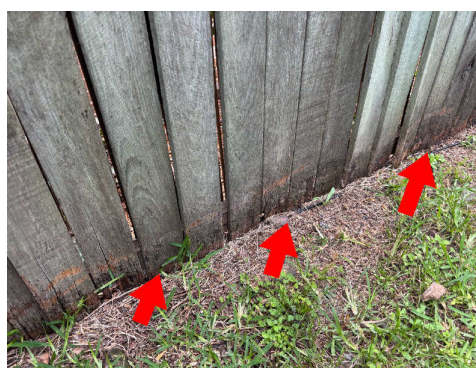
Finding 3.04

Finding: Boundary fence - deteriorating

Information: At the time of the inspection, it was noted that the right hand side timber boundary fence is deteriorating. Several sections have signs of wood rot, a section at the front and in the pool area is starting to lean towards the neighbours yard and has some movement when pressure is applied to it. As part of this timber fence forms one side of the pool safety barrier, it is important that this is in a good condition to avoid it becoming a safety hazard.

A fencing contractor could be engaged to assess the boundary fence and provide a solution for these issues. This can be done at the clients discretion.

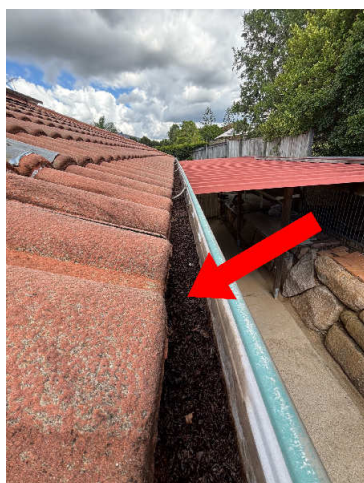
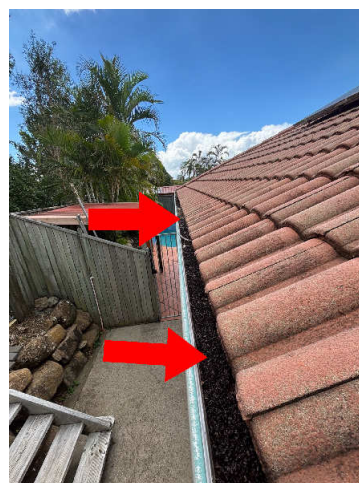
Finding 3.05

Information: At the time of the inspection, it was noted that there was leaf debris in the rear section of the gutters.

If the leaf debris is left in the gutters, moisture may be retained and as a result may cause premature rusting to the gutters.

The leaf debris should be removed from the gutters. A gutter cleaning company could be engaged to carry out this work at the clients discretion.

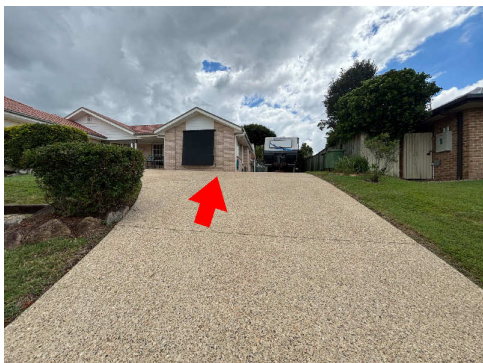
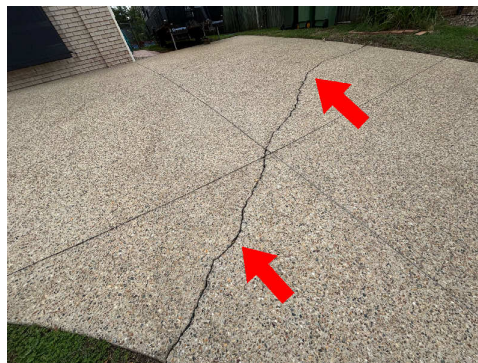
Finding 3.06

Finding: Driveway - crack

Information: At the time of the inspection, it was noted that there was a crack in the concrete driveway. This crack appears to be historic. The client should monitor the driveway for any change in appearance of the crack and for further cracks.

A concreter specialising in driveways may be required to replace the driveway.

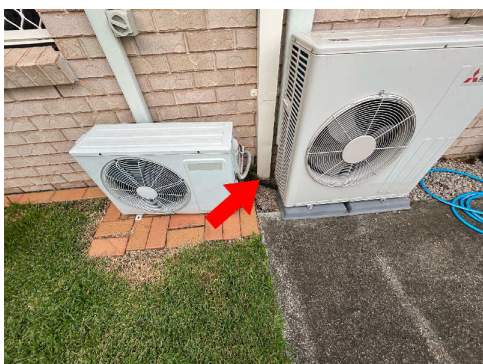
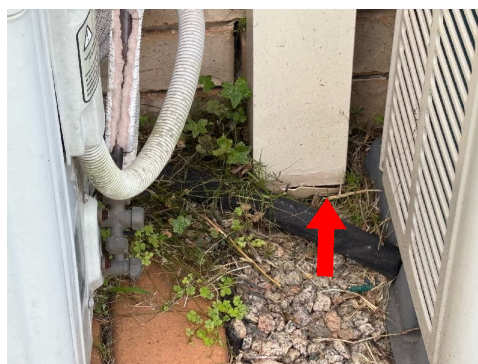
Finding 3.07

Information: At the time of the inspection, it was noted that the bottom section of the down pipe at the side of the dwelling is disconnected. This affects the functionality of the down pipe and allows water to escape near the foundation.

Excessive moisture next the foundations of the dwelling creates a conducive environment for termite activity and can cause damage to the associated building materials.

A licensed plumber should be engaged to carry out this repair. This can be done at the clients discretion.

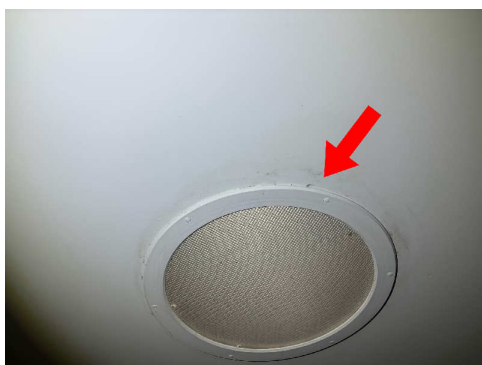
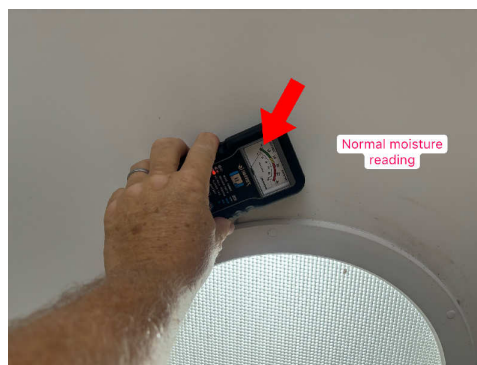
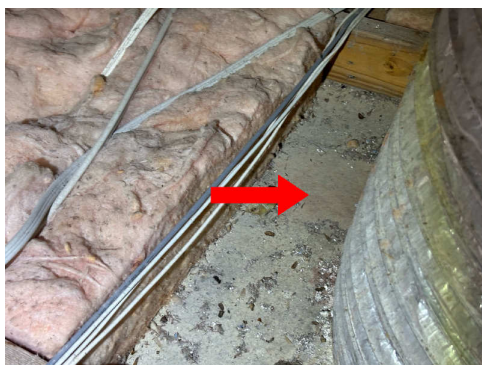
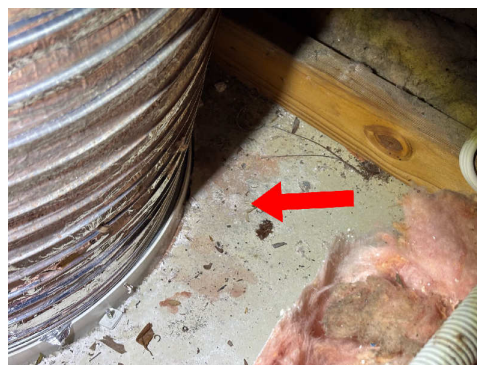
Finding 3.08

Finding: Ceiling - Water stained

Information: At the time of the inspection, it was noted that there was a water stain around the sun tube in the kitchen. Staining can be seen on top of the ceiling lining from inside the roof space. Normal moisture readings were recorded on this stain indicating that the leak that may have caused the stain is inactive.

Water staining indicates that surfaces have been exposed to excessive moisture over time. The minerals and other elements in the water lead to staining, which may graduate to corrosion and deterioration if left unmanaged.

While mostly an appearance defect, water staining can be indicative of more serious defects, which may be currently concealed by interior ceilings.

Where water staining is active, a licensed plumber must be consulted to identify the cause of the staining and to provide advice on any reparation works that may be required. Replacement of any damaged structures is advised.

Conversely, where water staining is old and inactive, affected building materials may be repaired or replaced at client discretion.

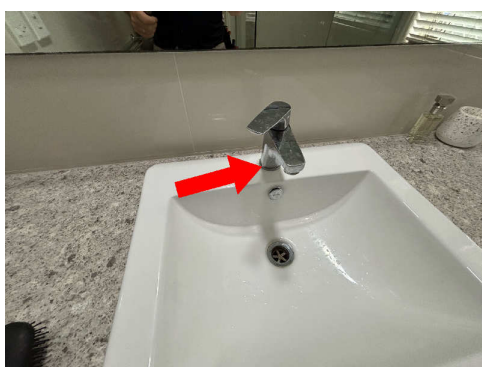
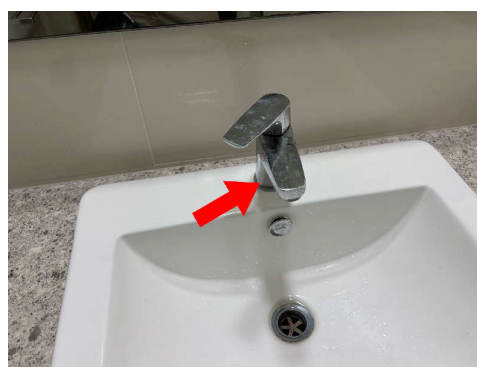
Finding 3.09

Finding: Ensuite - basin mixer tap loose

Information: At the time of the inspection, it was noted that the basin mixer tap in the ensuite was not securely fastened to the basin. If left unaddressed, deterioration of the mixer tap may occur and moisture may get into the vanity cabinet.

A licensed plumber should be engaged to re-secure the mixer tap. This should be done as a short term priority.

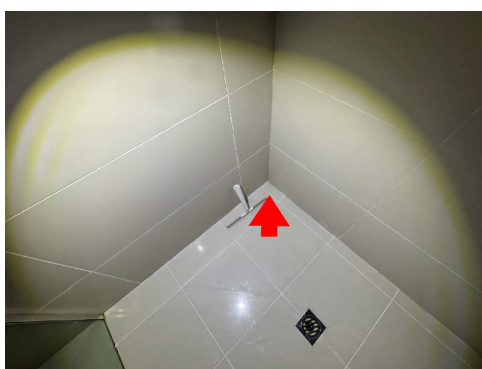
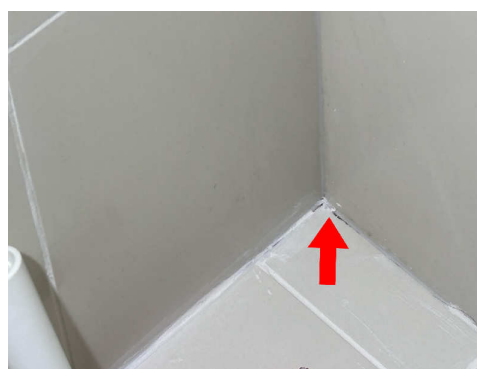
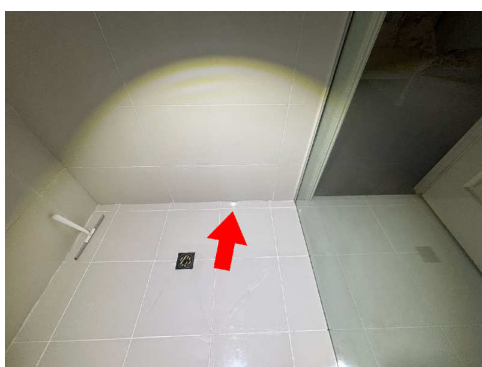
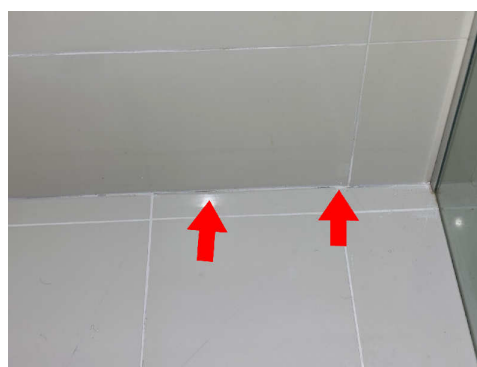
Finding 3.10

Finding: Sealant deteriorating

Information: At the time of the inspection it was noticed that the sealant to the shower in the ensuite was deteriorating.

Sealant is used in tiled areas to prevent moisture from entering the wall cavity and causing damage to the building elements. A moist environment in the wall cavity may also be a conducive condition for termite activity.

If it is not addressed, damage to building elements will occur and would require invasive works to rectify any damage.

A building maintenance professional or sealant applicator should be appointed to replace all sealant as a matter of urgency.

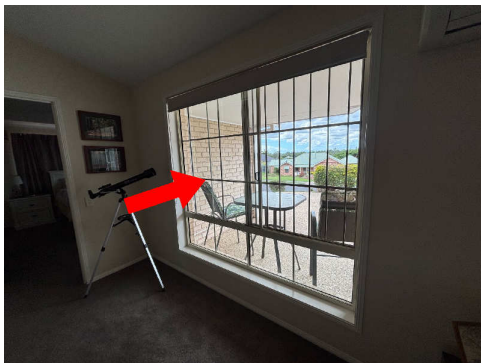
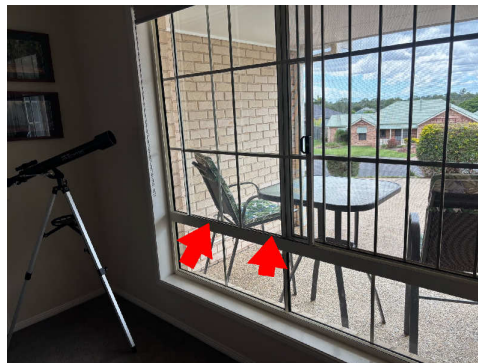
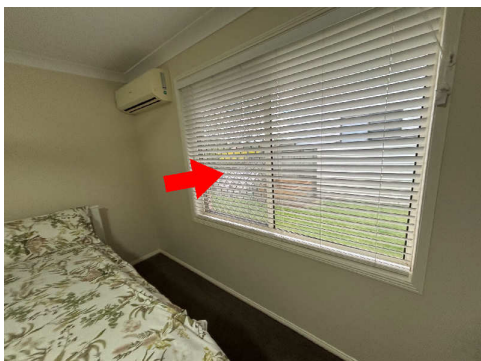
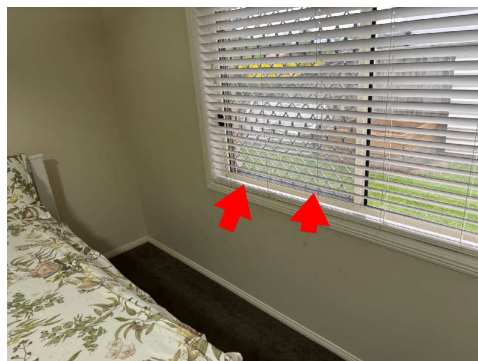
Finding 3.11

Information: At the time of the inspection, it was noted that the sliding window in the family room and in bedroom 2 were stiff to operate. This may be due to general wear and tear of the window runners.

A building maintenance professional could be engaged to assess the window and replace the affected runners. This can be done at the clients discretion.

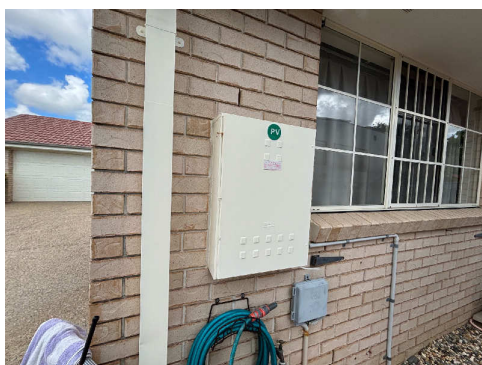
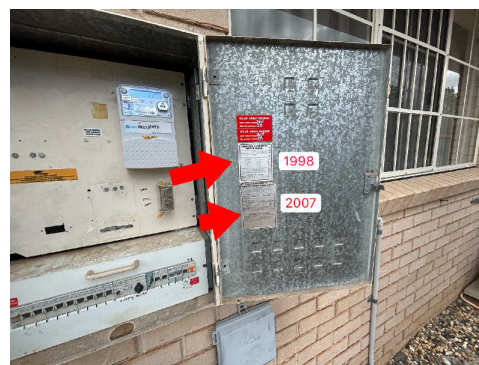
Building:	Main Building
Location:	All External Areas
Finding:	Termite Management System - no evidence of a current chemical installation
Information:	At the time of the inspection, no evidence of a current chemical termite management system was found. There are two durable notices in the meter box showing a chemical treatment was carried out in 1998 and 2007 with an expected lifespan of up to 10 years for both treatments. These treatments will no longer be effective.

A durable notice should be placed in the switchboard unit to indicate current termite barriers. At the time of inspection, it appeared as though no termite management system has been installed, with no evidence to suggest preventative works taking place.

The application of a post-construction chemical termite barrier is highly recommended for all properties, particularly if live termite activity has been found on the site previously. Such barriers are highly effective in preventing termite attack on any timber building elements throughout the property.

The client may consider gaining further advice from a pest controller as to the costs and procedures involved with this application. It is recommended that obtaining such advice be a short-term priority.

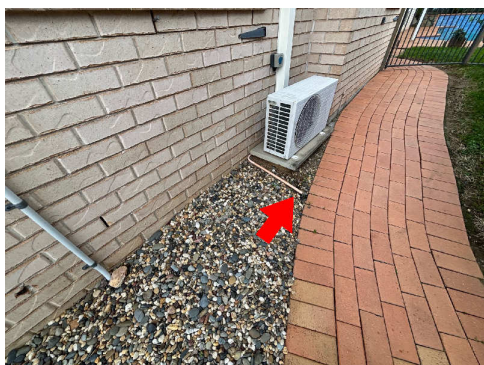
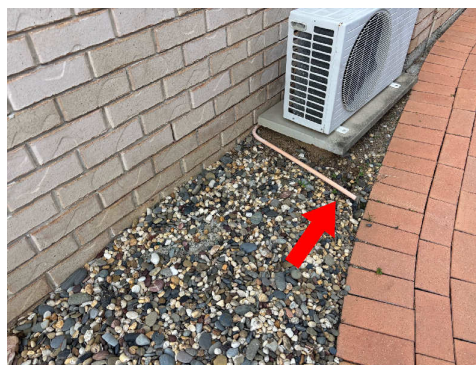
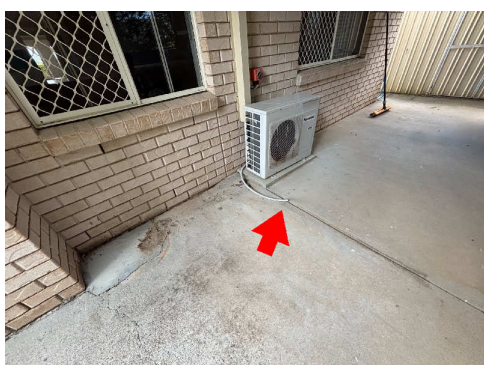
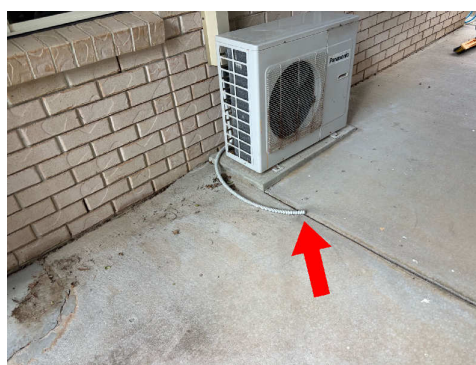
Finding 6.02

Building:	Main Building
Location:	All External Areas
Finding:	Air conditioner - Disconnected overflows

At the time of the inspection, it was noted that the air conditioner drain overflows to all the units were not connected to the storm water drainage and as a result are draining next to the foundations of the dwelling.

Air conditioning overflows that are not connected to the storm water drainage and are draining near the foundation can create excessive moisture in the surrounding area.

Such leaking creates an environment which is conducive to an array of defects, including water damage to associated building elements and the attraction of termite or timber pest infestation.

It is highly recommended that a licensed plumber be appointed to connect the A/C overflow in order to prevent such an environment from being created. These minor works should be carried out as soon as possible.

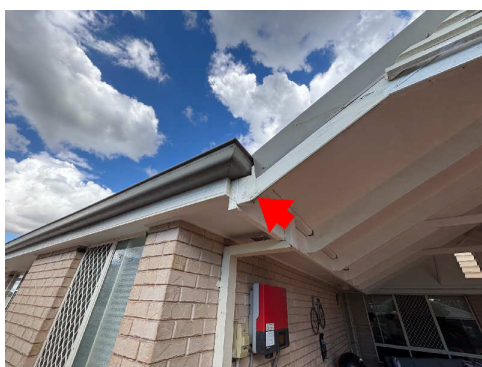
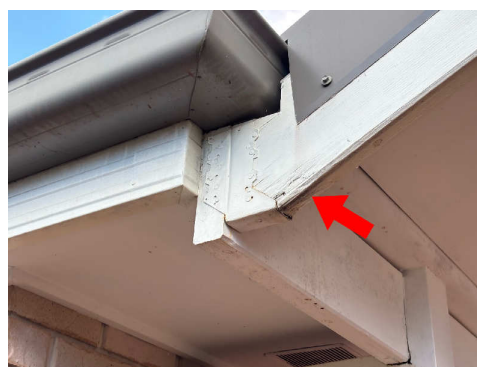
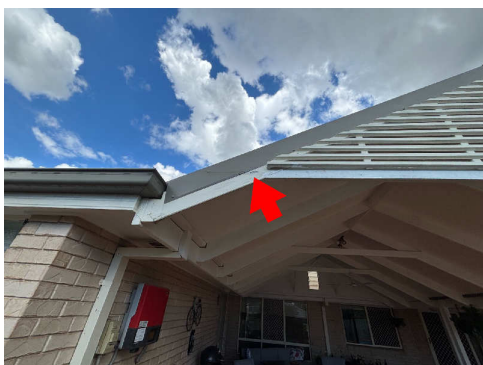
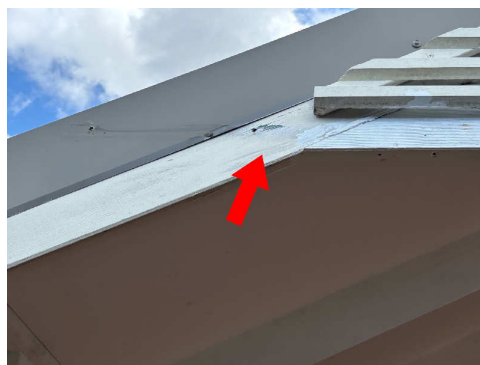
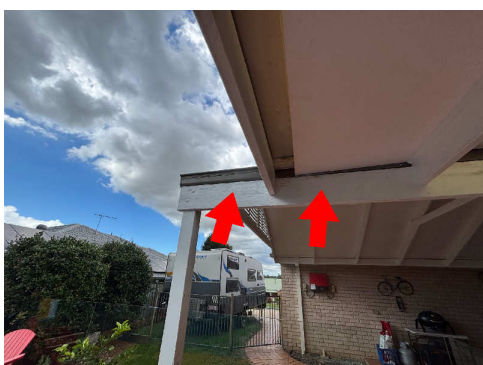
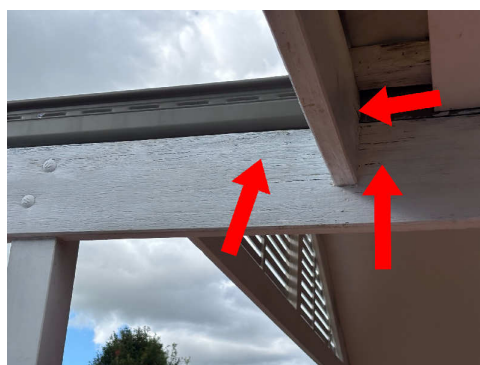
Finding 7.01

Building:	Main Building
Location:	Patio area
Finding:	Wood rot - patio roof structure
Information:	<p>At the time of the inspection, it was noted that there were examples of wood rot to timber building elements of the patio roof structure. This may be due to the age of the timber building elements and general weathering.</p> <p>This building element shows evidence of wood rot. Wood rot, also known as Fungal Decay, occurs when timbers and other cellulose building materials are exposed to damp conditions on an ongoing basis.</p> <p>Wood rot is often associated with general damp problems and is evidenced by a 'musty' smell or mould and mildew occurring on surfaces. If left unmanaged, damp conditions can lead to further health problems and the decay of timbers will continue.</p> <p>Early intervention and regular maintenance, particularly of exterior timbers, will prolong the useful life of these building elements. Prior to any works being performed, the cause of the moisture that has created the visible wood rot should be identified and addressed in a suitable manner. Replacement of affected timbers may then be a necessary step in protecting surrounding building elements from such deterioration.</p> <p>A qualified carpenter or registered builder may also be required to replace affected building materials.</p>
