Building and Timber Pest Inspection Report

Inspection Date: Tue, 27 Jan 2026

Property Address: U3/4 James Ln, Kiama NSW 2533, Australia

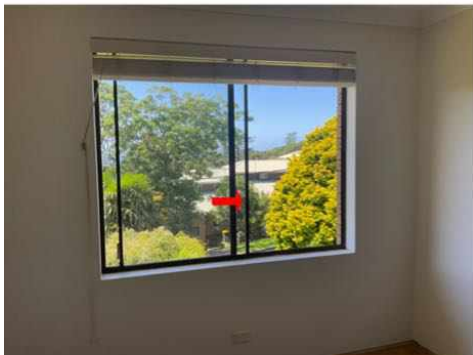
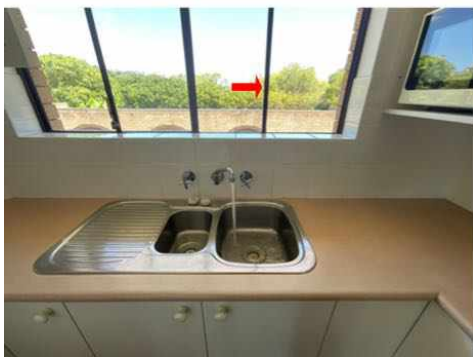
Building:	Building 1
Location:	Many windows
Finding:	Window opening restrictors missing.
Information:	The Building Code of Australia rules require all openable windows (where the internal floor is more than 2m above the ground outside) in residential rooms to be fitted with a suitable screen or restrictor. Windows located 1.7m above the floor level do not require protection.

Window restrictors are required where people who are vulnerable to the risk of falling have access to windows. This means all windows above ground level which do not have another fall prevention safety measure in place, such as a balcony or balustrade should have a restrictor. Some restrictors were found in the unit but not installed.

These need to be added urgently for the safety of all persons.

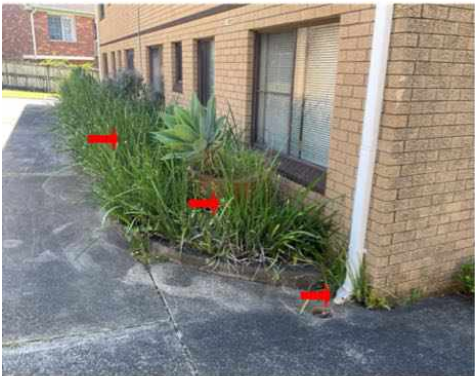
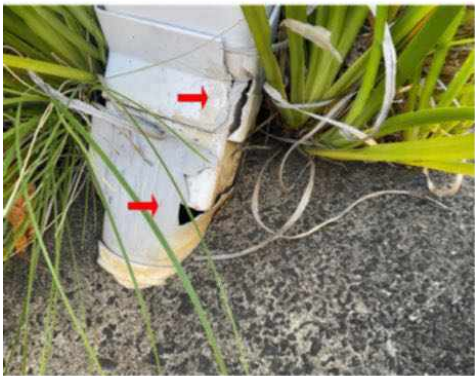
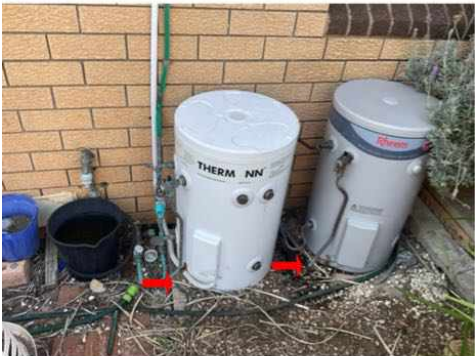
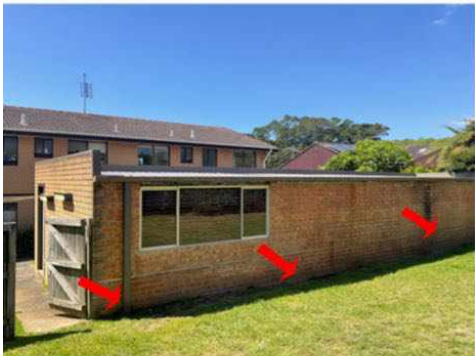
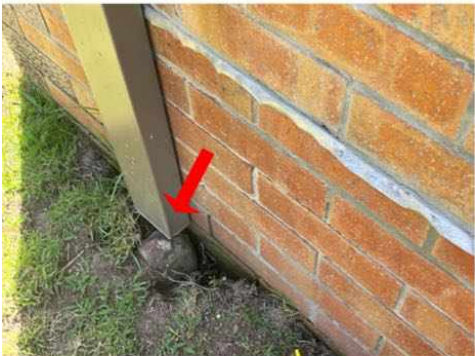
Finding 3.05

Building:	Main Building
Location:	Rear walls of both buildings
Finding:	Site drainage - Inadequate
Information:	The site drainage in these 2 rear wall areas of both buildings was found to be inadequate at the time of inspection, creating potential for subsequent water damage to associated building elements. Both rear walls appear to have no drainage and the rear garage downpipe boot has also cracked.

Where site drainage is inadequate, installation of an Agricultural (Aggie) Drain may be required. A qualified plumber should be appointed to further inspect the property and perform any remedial works as necessary. Water damage and secondary defects are

likely to occur if left unmanaged.

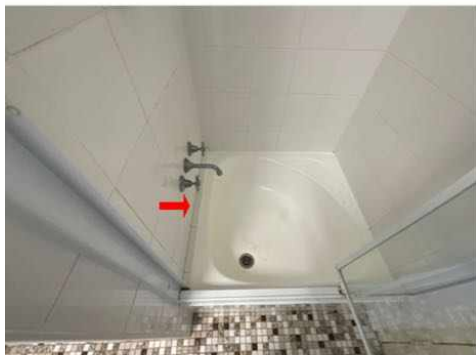
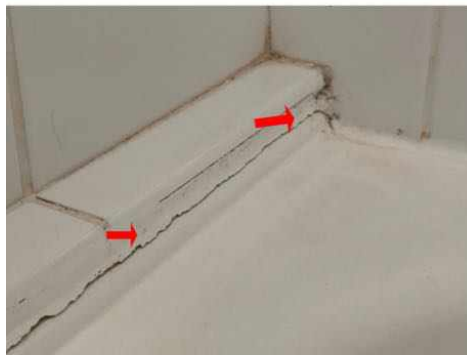
Finding 3.06

Building: Building 1
 Location: Pictured shower and kitchen sink areas
 Finding: Sealant and grouting - Missing
 Information: It was noted on inspection that sealant or grout is missing to these pictured areas of the building.

Flexible and mould resistant materials should be applied to affected areas to prevent any subsequent water damage that is likely to occur.

This needs to be brought to the attention of the builder.

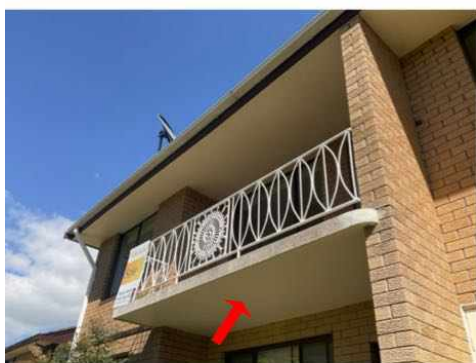
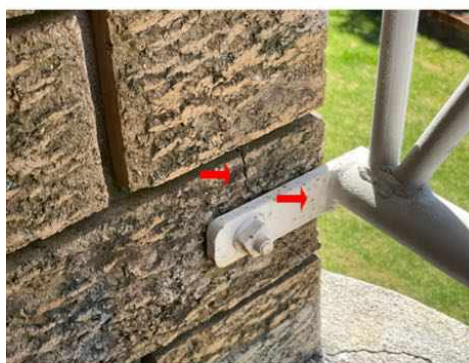
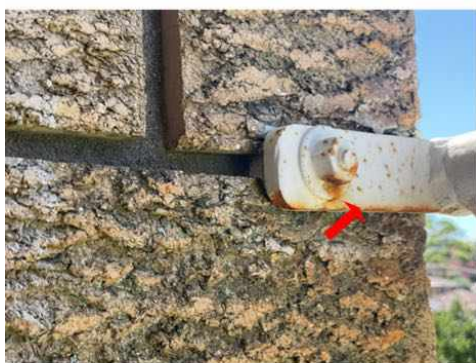
Nothing contained in this report should be taken as an indicator that an assessment has been made, on any elevated structure, as suitable for any specific number of people or purpose. This can only be done by a qualified engineer. For the purpose of this report, the Structure includes the elevated front verandah which shows very minor rust to some brackets cracking to one brick and the corner concrete (2mm) in the easy corner.

You should also arrange annual inspections of the structure by an engineer or other suitably qualified person to ensure any maintenance, that may become necessary, is identified. Care must be taken not to overload the structure.
