Building and Timber Pest Inspection Report

Inspection Date: Wed, 21 Jan 2026

Property Address: 31 Caravan Head Rd, Oyster Bay NSW
2225, Australia

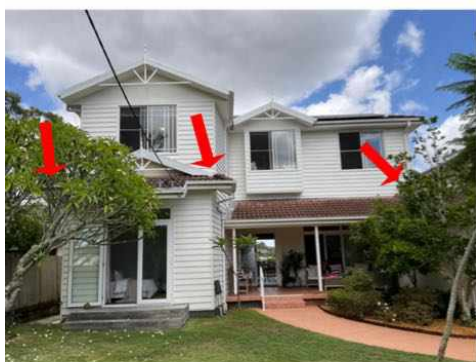
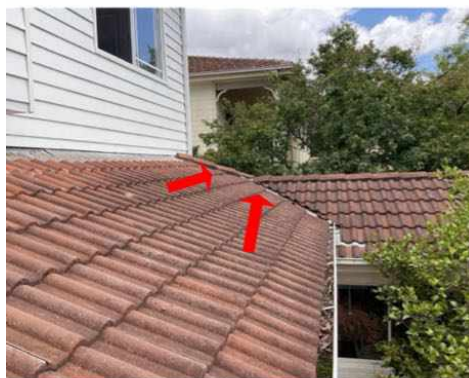
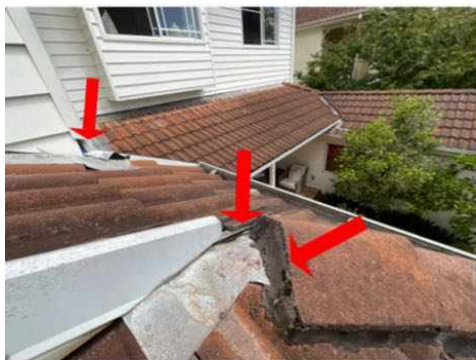
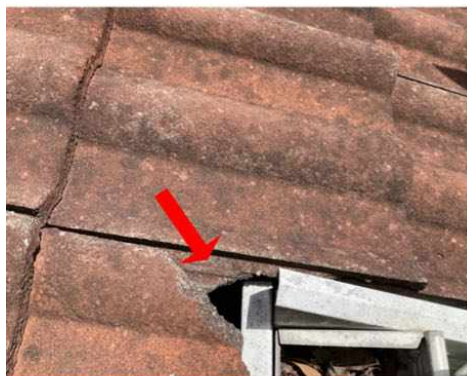
Building: Building 1
Location: All External Areas
Finding: Roofing areas - Weathered
Information: Upon inspection of the exterior roofing, the majority of the roof areas were considered to be in a good condition. While weathering of these pictured areas is consistent with the age of the property, maintenance works are urgently required, particularly on the garage (the upper roof had no safe access).

Re-sealing and replacing some large and small areas of gaps and damage to the roof mortar is required to extend the life span of these roofing areas. Where left unmanaged, deteriorating roofing materials are likely to lead to a number of secondary defects, including minor water leaks and weather exposure to internal roofing structures.

Consultation with a roofing contractor is highly advised to gain advice on cost of remedial works that may be required. Remedial works are likely to increase the longevity of the exterior roofing structure.

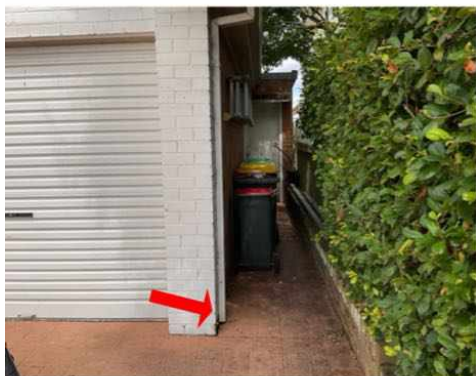
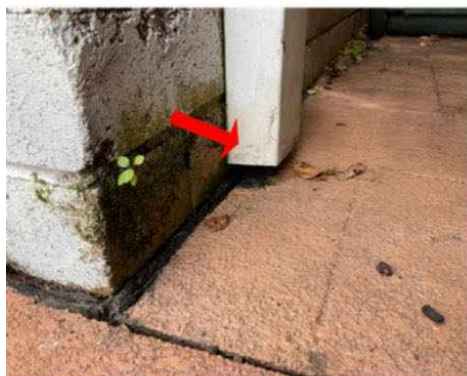
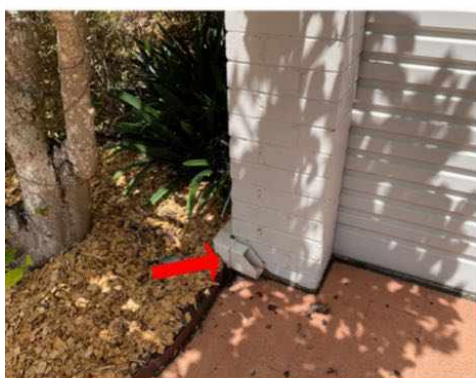
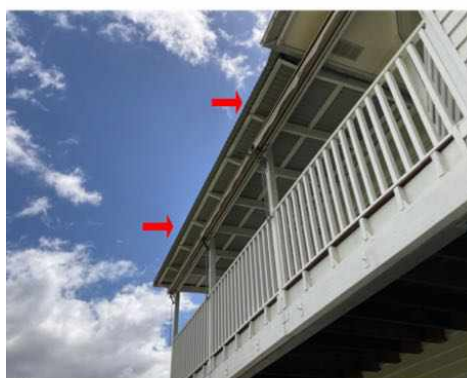
Finding 3.02

Building: Building 1
 Location: Pictured areas
 Finding: Site drainage - Inadequate
 Information: The site drainage in the front yard and front left subfloor area was found to be inadequate at the time of inspection, creating potential for subsequent water damage to associated building elements. Some paths slope toward the house allowing rainwater into the subfloor creating mould. The front garage downpipes do not run into drains. The

It is important that water does not lie against the base of walls; surrounding paths and ground levels should be sloped to drain water away from walls. Downpipes should not discharge stormwater onto lower walls or plinths. Stormwater should be carried away by large, regularly cleaned drains. Ground levels may need to be lowered to expose a buried DPC.

Where site drainage is inadequate, installation of an Agricultural (Aggie) Drain may be required. A qualified plumber should be appointed to further inspect the property and perform any remedial works as necessary. Secondary defects are likely to occur if left unmanaged.

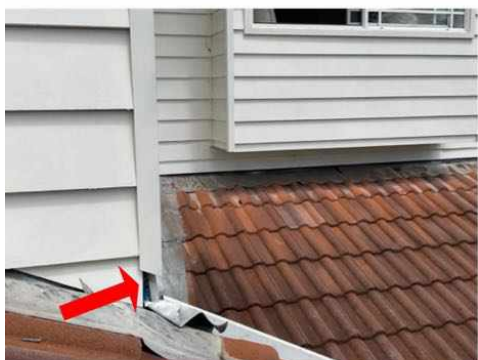
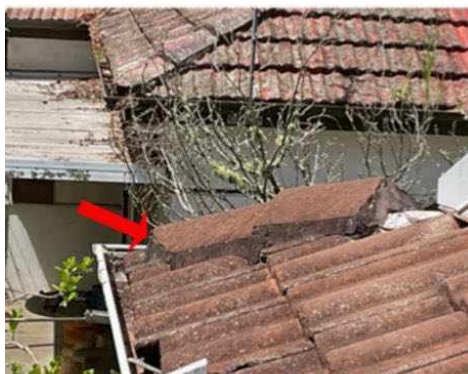
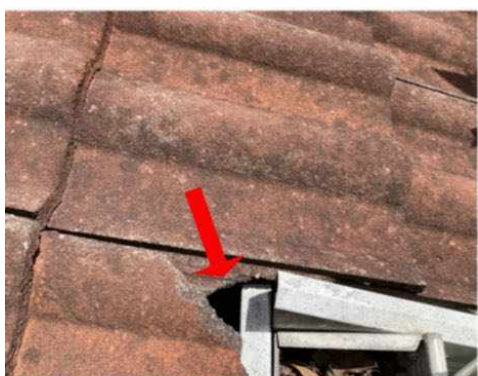
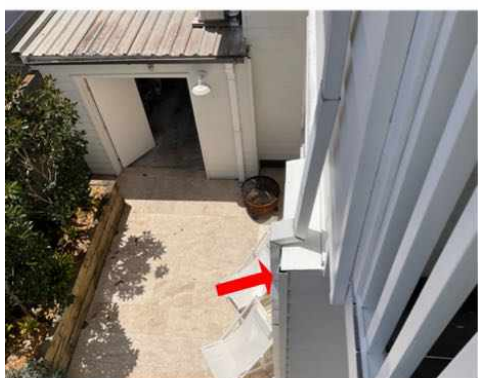
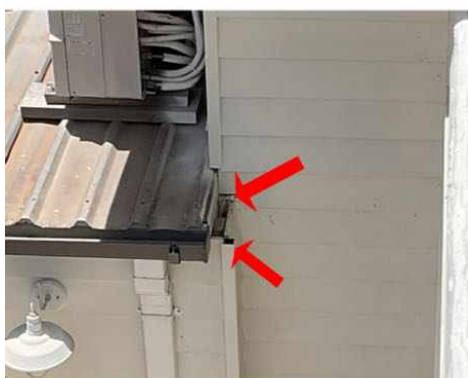
Finding 3.03

| Finding: | Sealant (external) - Missing. |
| Information: | It was noted on inspection that areas of external sealant was missing to small areas of the external walls. |

Flexible sealants should be applied to these affected areas to prevent any subsequent water damage that is likely to occur.

A sealant specialist or skilled handy person should be appointed to complete these works as soon as possible

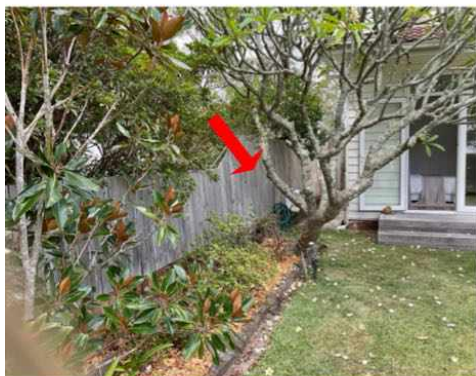
Finding 3.04

Building: Building 1
 Location: Pictured fences
 Finding: Fences damaged - leaning and loose
 Information: Evidence of damage to the pictured fences was identified at the time of the inspection. The likely cause of this fence leaning is not enough concrete used in the post footings.

If left unmanaged this fence may deteriorate further. It is suggest a fencing contractor be engaged for rectification when convenient.

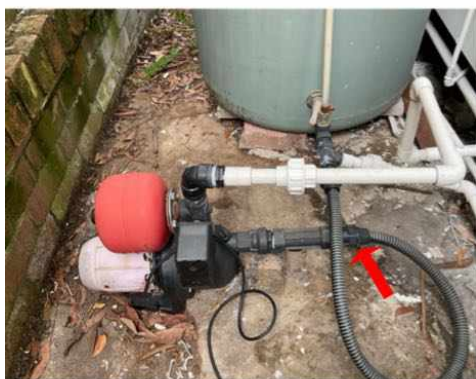
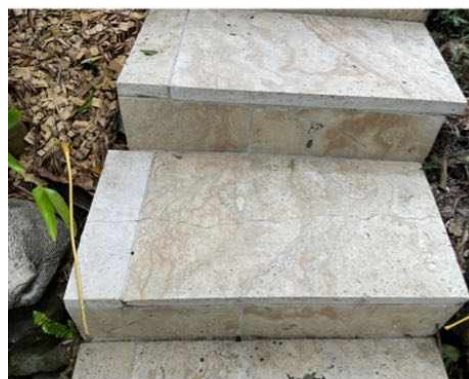
Finding 3.05

| Finding: | Building elements - Damaged |
| Information: | Evidence of minor missing or damaged areas was identified at the time of the inspection. These include - |

1. The water tank pump has a small leak and did not appear to work.
2. One paver in the rear stairs has cracked.

A plumber would be the trade responsible for rectification of these areas when convenient.

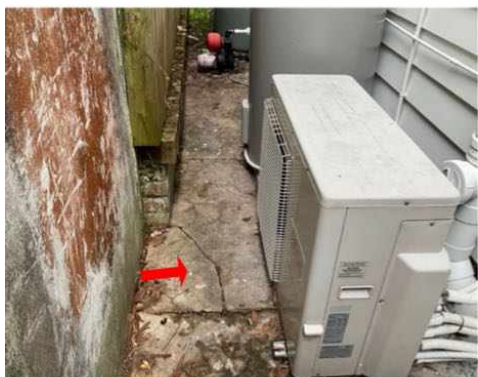
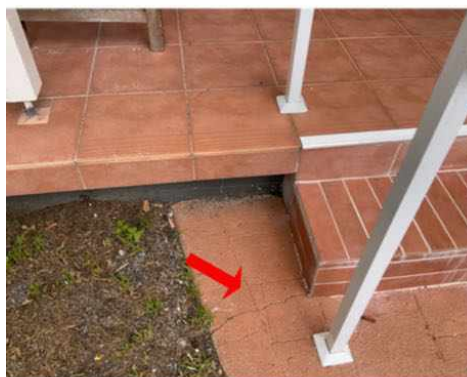
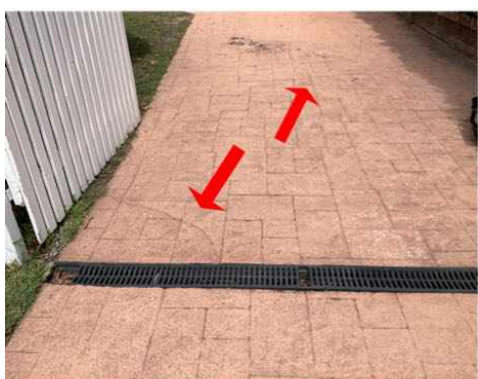
Finding 3.06

| Finding: | Crack in concrete slabs - Category 1 |
| Information: | Cracks coded as Category 1 was identified in these pictured slabs. A Category 1 crack is described as a fine but noticeable crack, with the slab at an otherwise reasonable level. To be considered Category 1, the approximate width of the crack is |

less than 1.0mm, or a less than 10mm change in offset when a 3m straight edge is placed over the defect.

Category 1 cracks should be monitored for a period of 12 months. At the end of the monitoring period, identified cracks that are rated greater than Category 2 are considered defects, and require rectification.

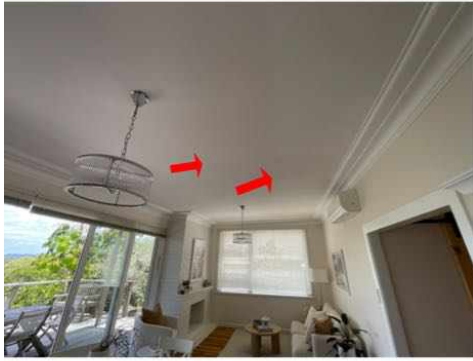
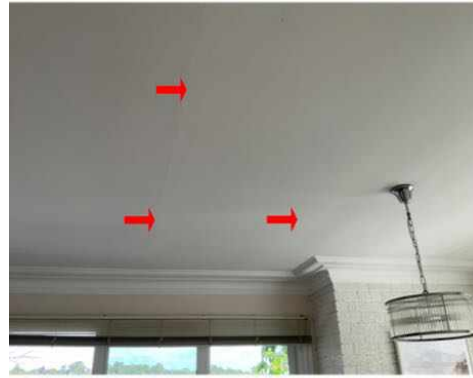
Finding 3.07

| Finding: | Cracking - Damage Category 1 - Fine (up to 1mm) |
| Information: | Although fine cracks (6-8) are quite noticeable, they are often only considered to be an appearance defect, and usually do not indicate any structural damage. Generally, the cause of a fine crack is indicative of a separation between building materials and finishes (e.g. paint, plaster, etc.) along joins. |

Cracking of this nature can generally be repaired with minor sanding, filling and/or repainting. Such works should be performed by a qualified painter or a general handyman.

Monitoring of all cracking should be conducted frequently. Always contact a building inspector should cracks widen, lengthen, or become more numerous.

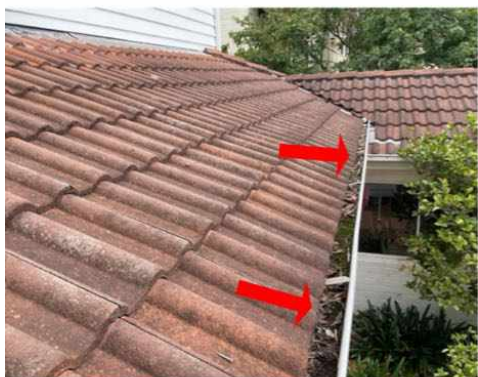
Finding 3.08

| Information: | The guttering on around the roof was found to be blocked at the time of the inspection. Roof plumbing structures, such as guttering and downpipes, should be free of all debris to prevent blockages. Blockages of the guttering and downpipes will lead to pooling and accumulated water overflows, which is likely to subsequently flood eaves and exterior walls. |

Blocked gutters are likely to lead to high levels of moisture in the affected areas which

can cause rust and decay of the gutters and downpipes and wood rot to adjoining timber areas. Blockages in gutters should therefore be removed immediately to ensure dry conditions are maintained.

It is highly advised that gutters be cleaned by the homeowner or a general handyman as a matter of urgency.

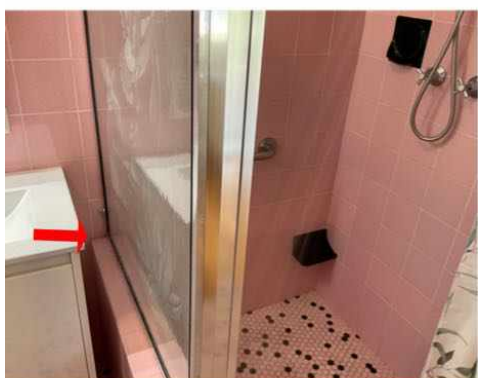
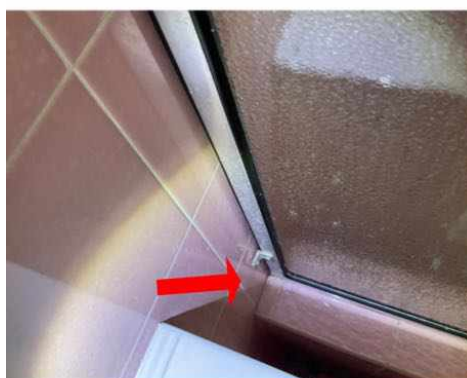
Finding 3.09

Building: Building 1
 Location: Bathroom 3
 Finding: Shower screen - Leaking
 Information: Leaking was evident to the shower screening at the time of inspection. It is suspected that the leaking has occurred as a result missing sealant. Leaking from the shower , where left unattended, is likely to lead to water damage to adjoining flooring and walls. Such damage can lead to water damage and necessitate extensive remedial works being required. Active water leaks may also create an environment that is susceptible to the formation and development of mould.

Appointment of a sealant expert is required to repair or replace this missing sealant. Such works should be performed as soon as possible to ensure that no further damage occurs.

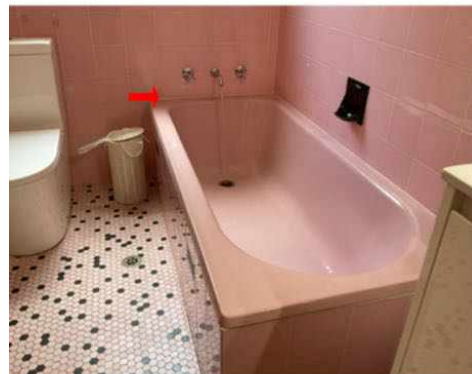
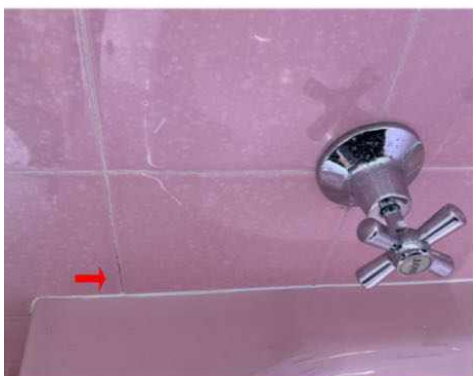
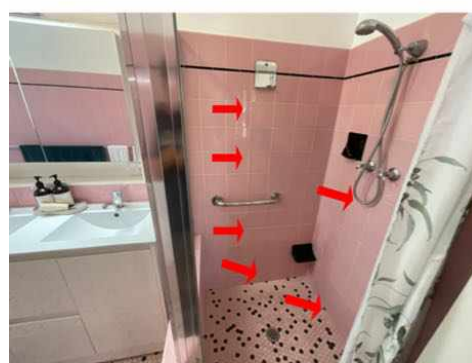
Finding 3.10

Building: Building 1
 Location: Ensuite - Master
 Finding: Sealant and grouting - Missing or damaged
 Information: It was noted on inspection that sealant or grout is degraded to these pictured wet areas.

Different materials and floor areas move at different rates, generally causing cracking to grout or sealant at this point. A flexible sealant is required to allow for expected expansion and contraction, while keeping the joint water tight and protective of all associated building materials.

Flexible and mould resistant materials should be applied to affected areas to prevent any subsequent water damage that is likely to occur. Regular maintenance and replacement of damage or missing or damaged sealant and grout is highly recommended to the wet areas, as this is a regular wear and tear defect. Sealant and grouting in areas that come into regular contact with water should be maintained for the long term care of your property.

A sealant specialist or tiling contractor should be appointed to complete these works as soon as possible

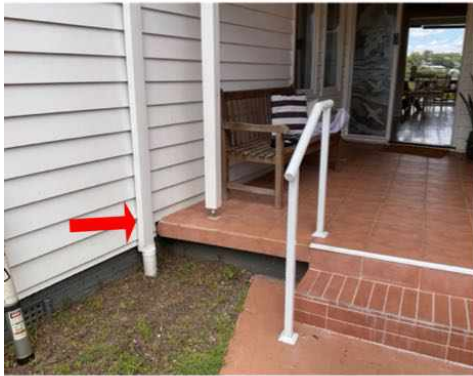
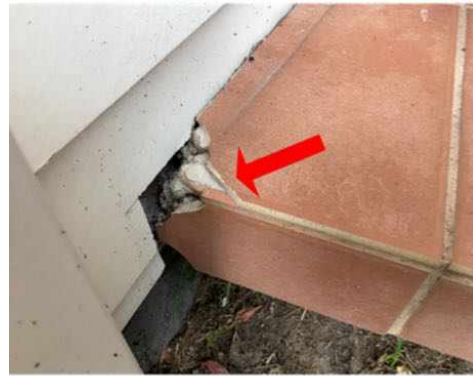
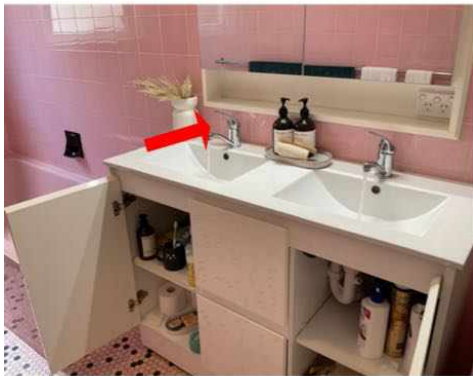
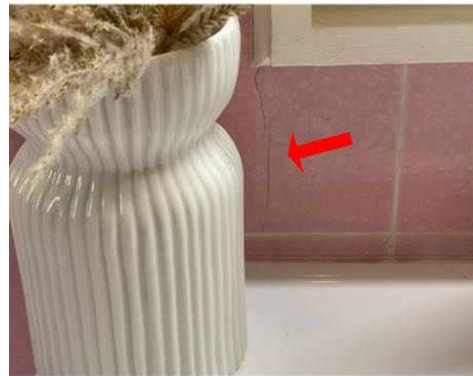
Finding 3.11

Building: Building 1
 Location: Verandah, Bathroom
 Finding: Tiles cracked
 Information: Cracked tiles were evident in these pictured areas at the time of inspection. It is suspected that this cracking has occurred as a result of minor settlement or impact damage.

Cracked tiles throughout the household detract from the overall appearance of the affected areas. In wet areas of kitchens and bathrooms, it can lead to water damage of adjoining walls and floors.

Replacement of cracked tiles is recommended as soon as possible. A tiling contractor may be appointed to perform these works. Where cracks become more numerous, contact a licensed building inspector for further investigation.

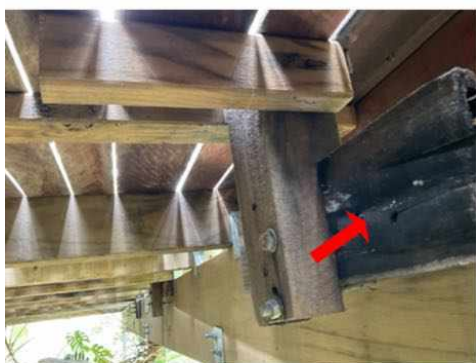
Finding 3.12

Building: Building 1
 Location: Pictured areas
 Finding: Wood rot - one small area
 Information: The building shows evidence of wood rot. Wood rot, also known as Fungal Decay,

occurs when timbers and other cellulose building materials are exposed to damp conditions on an ongoing basis. This could be the result of exposure to weathering over a prolonged period of time, or the attraction of excessive moisture from other abutting building materials.

Early intervention and regular maintenance, particularly of exterior timbers, will prolong the useful life of these building elements. Prior to any works being performed, the cause of the moisture that has created the visible wood rot should be identified and addressed in a suitable manner. Replacement of affected timbers may then be a necessary step in protecting surrounding building elements from such deterioration.

A qualified carpenter or registered builder may also be required to replace affected building materials.

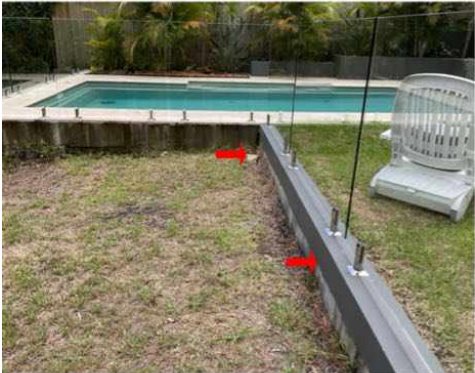
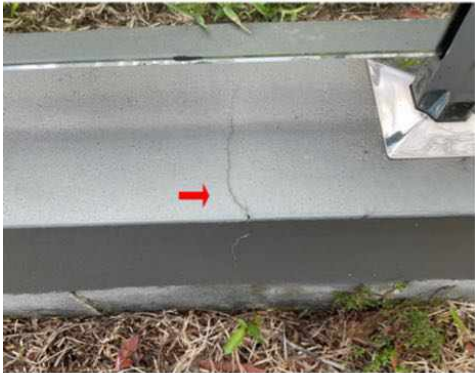
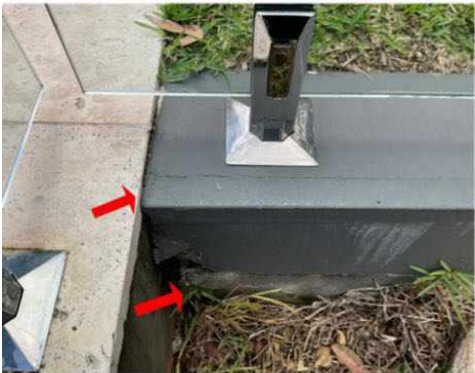
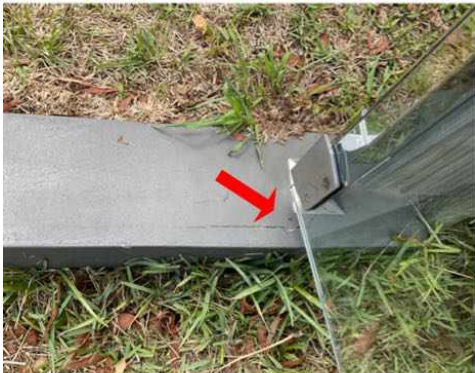
Finding 3.13

| Finding: | Render (external) cracking. |
| Information: | It has been observed that cracking to some external rendered surfaces. The degree of damage is described as “slight” noticeable cracks which are easily filled. Cracking of this size are generally less than 5mm in width. |

Always contact your building inspector should cracks widen, lengthen, or become more numerous.

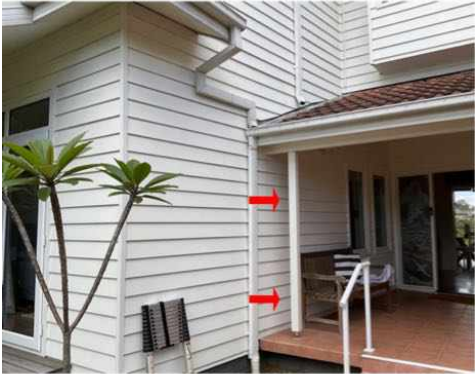
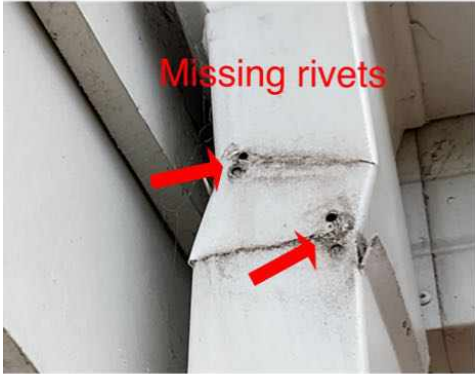
Finding 3.14

Building: Building 1
Location: Yard - front
Finding: Additional fixings to downpipe
Information: Evidence of insufficient fixings were evident to this down pipe. This downpipe need additional fixings to affix to the adjoining wall ensure its longevity.

A carpenter, plumber or handy person should add additional fixings to this area as soon as possible to limit potential damage.

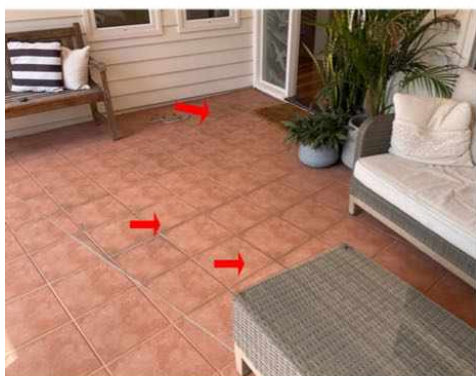
Finding 3.15

Building: Building 1
 Location: Front verandah
 Finding: Tiles - Drummy
 Information: Drummy tiled areas were identified at the time of inspection. The term 'drummy' refers to tiles that have become detached from their fixing, despite otherwise being in relatively good condition. Such defects are generally caused by physical or moisture damage to the area. Drummy tiled areas may also be a direct result of poor workmanship during the construction process.

Tiled areas may swell and shrink with changes in air humidity if the area has sustained moisture damage. Any exposure to moisture is capable of causing tiled areas to become drummy and/or cracked over a prolonged period of time. Drummy tiled areas generally require removal and replacement of affected tiles, with adequate sealant and grouting.

Specialist trades are available for these types of services. A registered builder may be required to undertake works if damage is extensive or if secondary building defects have resulted. Otherwise, it is advised that a tiling contractor be appointed to perform works as necessary. Immediate action is recommended to ensure that no further damage is sustained in the affected area.

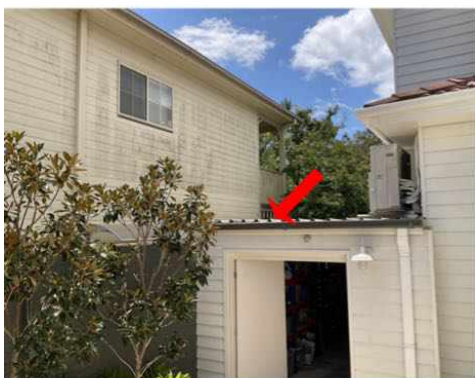
| Finding: | Roof plumbing - Insufficient fall and loose |
| Information: | There is an insufficient fall in the rear garage roof drainage, which means that the angle is inadequate to facilitate movement of rainwater. This is resulting in pooling of water in the area, creating the potential for water damage to associated building elements. |

Without adequate roof drainage, premature rust and decay of the roof plumbing structures is imminent. The development of such deterioration is likely to lead to the formation of secondary defects to adjoining wall sections and roofing elements.

Adjustment by a roofing plumber is required as soon as possible to prevent any further damage to the area.

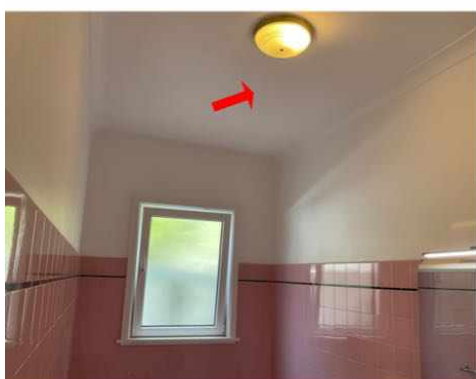
Finding 3.18

| Finding: | Exhaust fan - Missing |
| Information: | An exhaust fan has not been installed in this area. Missing exhaust fans may lead to the development of more significant defects such as moisture damage to surrounding building materials from inadequate ventilation. Inadequate ventilation in internal areas creates an environment that is conducive to the formation and development of mould and other respiratory hazards. It is highly advised that a licensed electrician be appointed to retrospectively install an exhaust fan. Failure to perform works to aid the ventilation of the area may lead to the development of these secondary defects. |

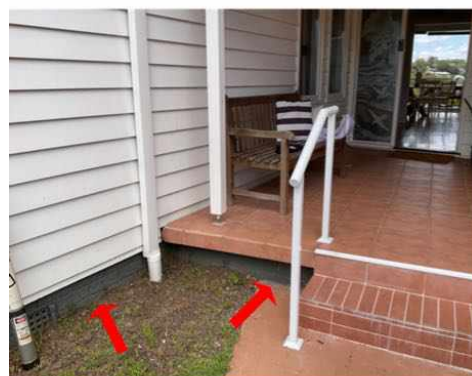
If the slab edge is not properly exposed there is a high risk of termite attack. Sometimes, in order to determine the type of slab, a suitably qualified person such as an architect or builder may be required to consult the construction plans.

Where the slab edge cannot be properly inspected, it is highly recommended that termite or timber pest inspections be carried out every 6-12 months to aid protection of the property against infestation.

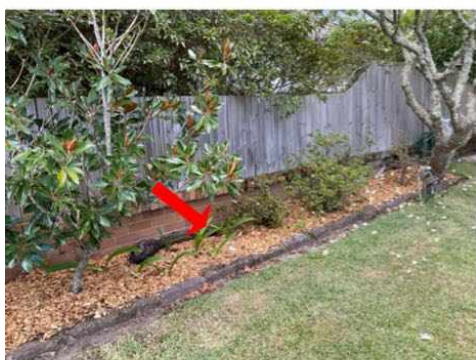
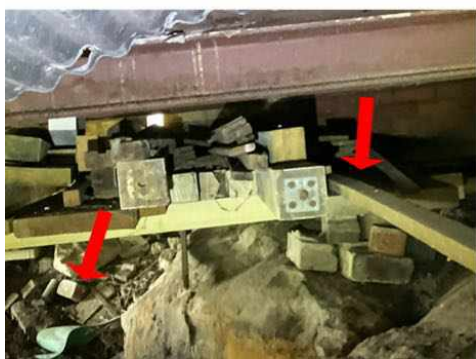
Finding 6.04

Finding: Timber in contact with the ground
 Information: Many dozens of timbers in direct ground contact in the subfloor and other areas provide opportunity for concealed termite entry and are likely to be subject to premature rot and decay as the soil retains moisture or damp conditions against the timbers.

Removal of all waste timber that is in direct contact with ground is highly advised. This timber is promoting mould and wood rot and is very attractive to termites.

Frequent pest inspections are advised to readily identify any termite activity in these areas.

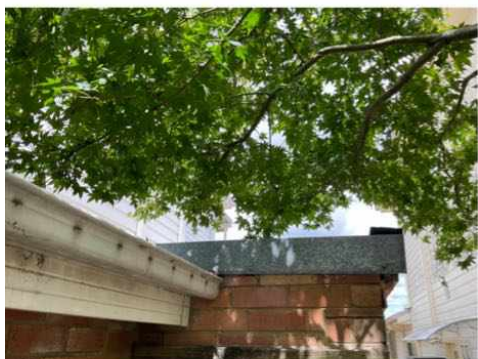
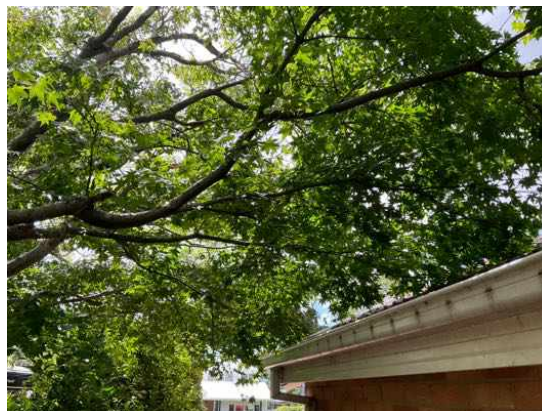
Finding 6.05

Building: Building 1
 Location: Roof areas
 Finding: Trees - Overhanging and filling gutters
 Information: Overhanging trees often result in excessive amounts of leaf debris accumulating in gutters.

Gutters are a critical part of the building's management of storm water and rain. It is therefore important that they be kept clear to prevent secondary damage to associated building elements, including exterior and interior walls, ceiling linings and

any adjoining building elements. Where gutters are blocked, pooling of rainwater is likely to occur, fast-tracking rust and corrosion of the roof plumbing elements.

It is highly advised that all overhanging tree branches be removed as soon as possible to prevent any further damage. Such works should be performed by the homeowner; however, appointment of a landscape contractor or an arborist may be required.

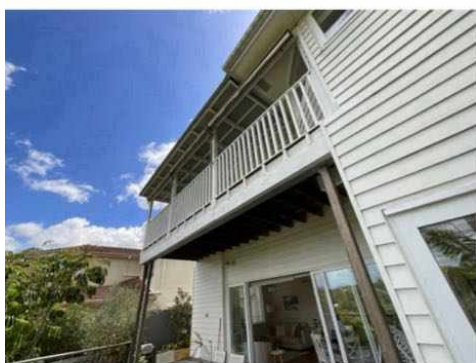
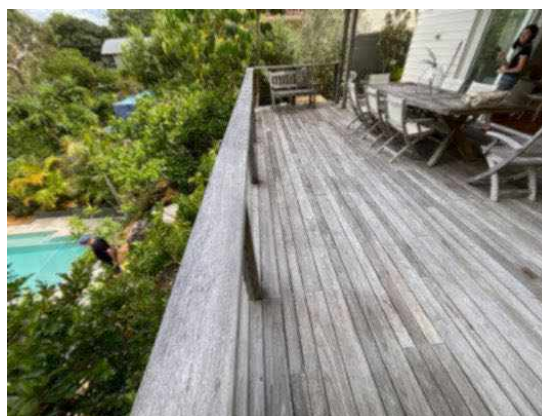
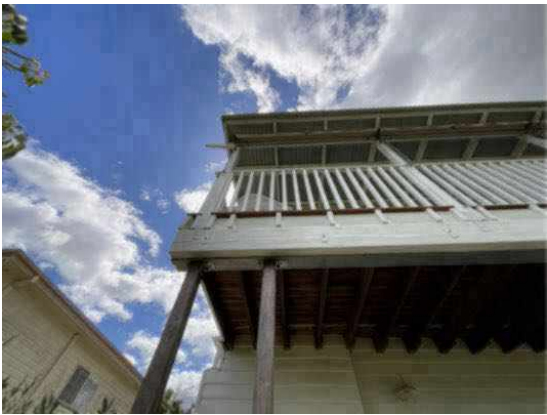
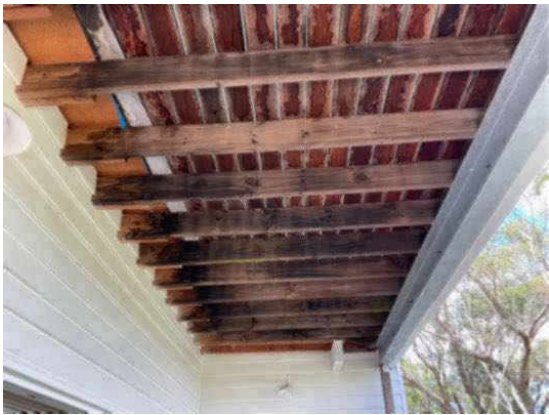
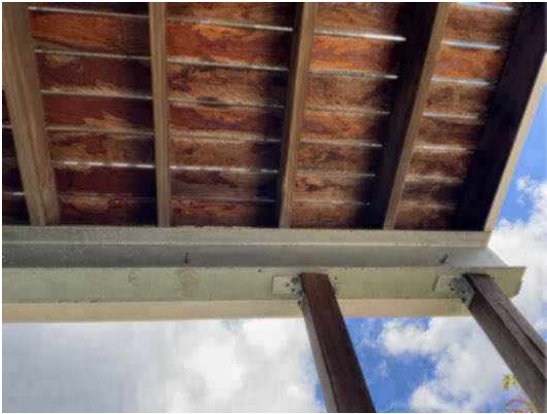
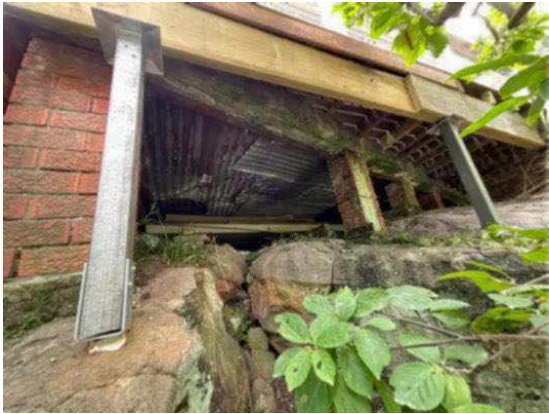
The rear lower deck is supported by both the old concrete verandah and new steel piers. The steel beams supporting the lower end of the north concrete and timber deck show severe rust in some areas requiring an engineers assessment. Minor mortar damage was also found in some piers. One middle rear pier shows very little support from the underlying sandstone (picture 11). One central pier is leaning significantly.

In summary, the building, compared to others of similar age and construction is in Good condition for its age with safety defects, minor defects and a structural engineers assessment required of the elevated rear decks that show damage to two piers and rust to supportive beams.

The rear lower deck is supported by both the old concrete verandah and new steel piers. The steel beams supporting the lower end of the north concrete and timber deck show severe rust in some areas requiring engineers assessment. Minor mortar damage was also found in some piers. One middle rear pier shows very little support from the underlying sandstone (picture 11). One central pier is leaning significantly.

A structural engineer may describe these decks as major or minor defects requiring repair.
