# Building and Timber Pest Inspection Report

Inspection Date: Sat, 21 Feb 2026

Property Address: 197 Meade St, Glen Innes NSW 2370,  
Australia

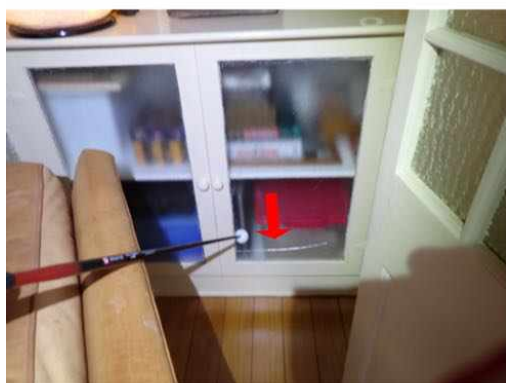
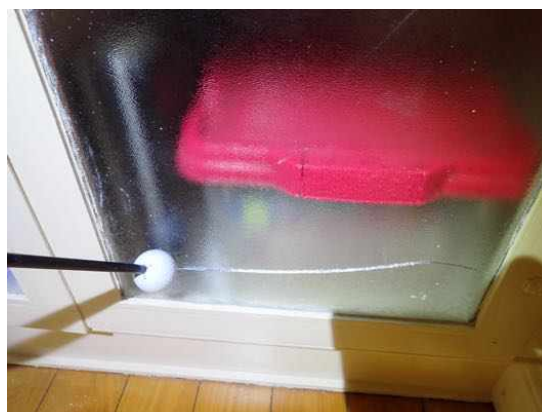
#### Finding 1.01

Building:	Main Building
Location:	Living room
Finding:	Crack in Living Room Cabinet Glass Door Pane
Information:	A crack was identified in the glass pane to the living room cabinet door. The glazing is damaged and may be weakened, increasing the risk of further cracking or breakage. In simple terms, the glass in the cabinet door is cracked and could break if impacted. This type of damage is commonly caused by accidental impact or stress to the glass. It is recommended that a qualified glazier remove and replace the damaged glass pane to prevent injury and further deterioration. Repairs should be undertaken as soon as practicable for safety reasons.

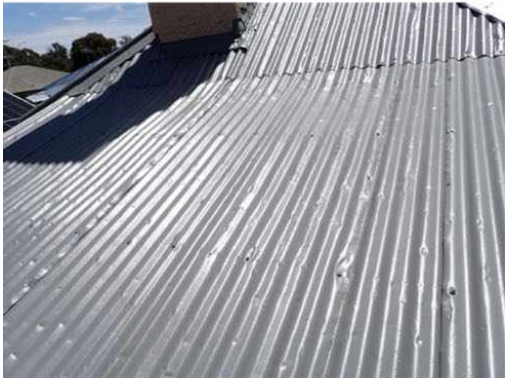
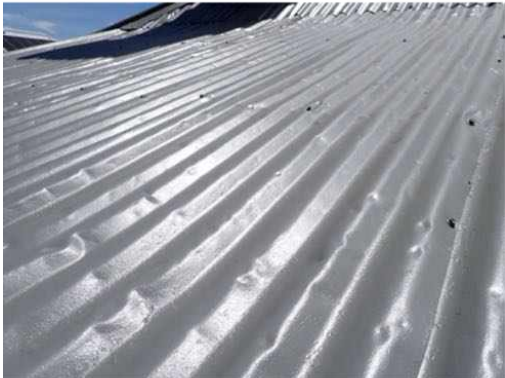
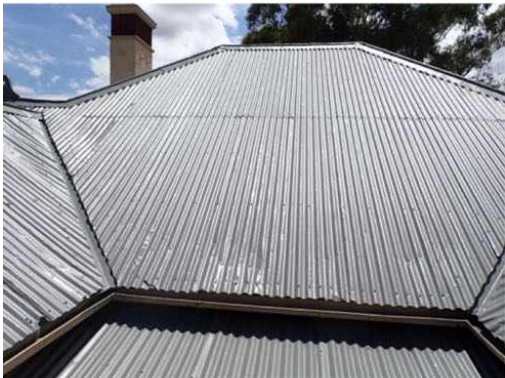
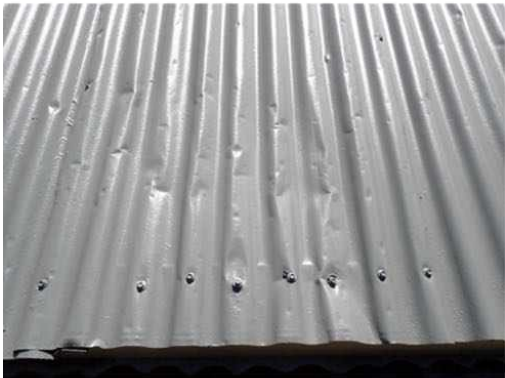
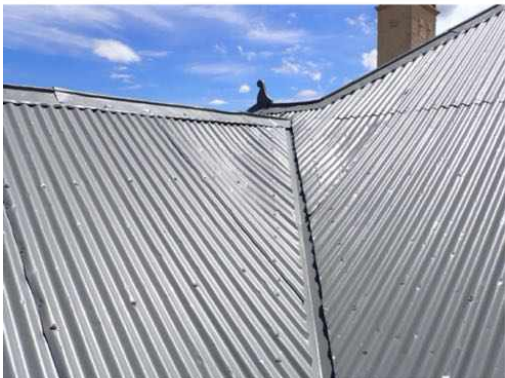
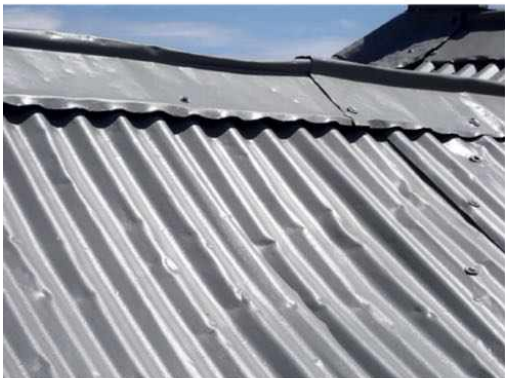
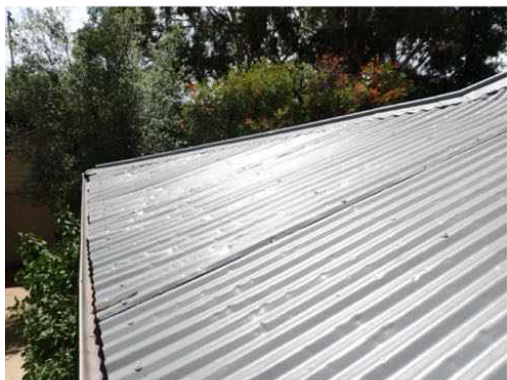
#### Finding 2.01

Building:	Main Building
Location:	Roof
Finding:	Original Roof Cladding in Poor Condition – Treated and Painted
Information:	The roof iron appears to be the original roof cladding. While no active leaking was identified at the time of inspection, the cladding is in poor condition consistent with its age and general wear and tear, including multiple dents and surface irregularities. The roof sheeting has been treated and painted, which may improve appearance and provide short-term protection; however, this does not reinstate the original structural integrity of the metal. In simple terms, the roof is old, dented and worn, and although it has been painted, it is still aged roofing iron. Deterioration of this nature is common in roofs of this age. It is recommended that a licensed roofing contractor monitor the

condition of the cladding and carry out repairs or replacement as required. Ongoing maintenance and budgeting for future replacement should be anticipated, with works undertaken at the owner's discretion.

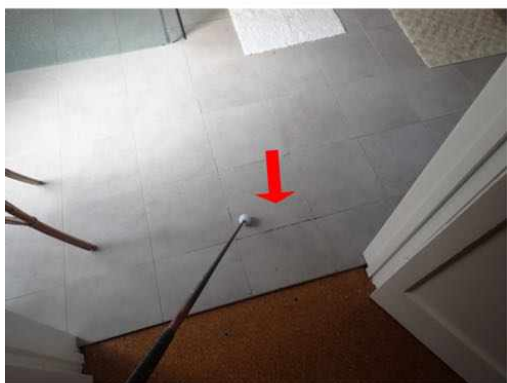
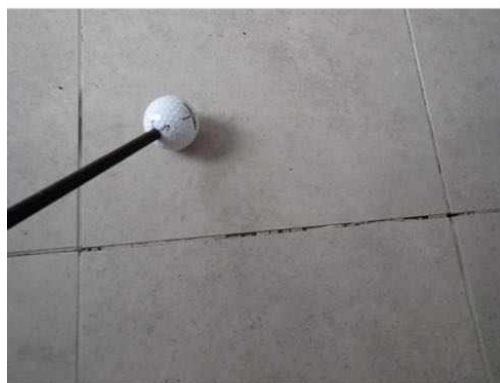
### Finding 3.01

Building:	Main Building
Location:	Bathroom
Finding:	Minor Deterioration to Bathroom Floor Tile Grout
Information:	Minor deterioration to grout was identified at isolated areas of the bathroom floor tiles. The grout is beginning to crack and break down but is currently limited in extent. In simple terms, small sections of the grout are worn and starting to fail. This is commonly associated with age and regular moisture exposure. While minor at the time of inspection, continued deterioration may allow moisture to penetrate beneath the tiles over time. It is recommended that a licensed tiler undertake localised re-grouting as part of routine maintenance. Repairs can be carried out at the owner's discretion to prevent further deterioration.

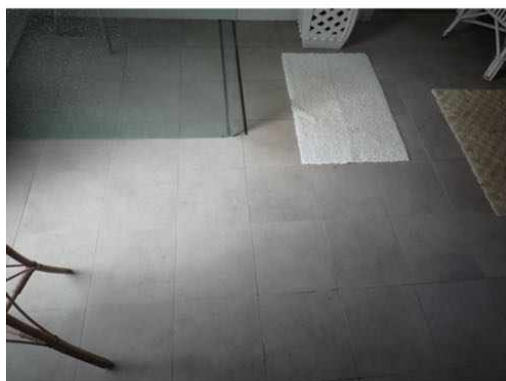
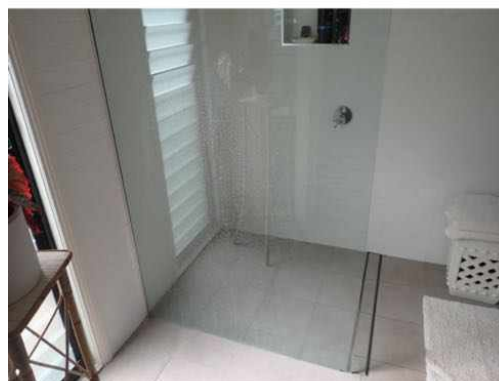
### Finding 3.02

Building:	Main Building
Location:	Bathroom
Finding:	Drummy Floor Tiles to Bathroom
Information:	Drummy (hollow sounding) floor tiles were identified within the bathroom. Tapping of

the tiles produced a hollow sound, indicating possible loss of adhesion between the tiles and the underlying substrate. This is a common defect. In simple terms, some tiles sound hollow underfoot, which can mean they are not fully bonded. This condition is commonly caused by age, minor substrate movement or inadequate adhesive coverage at the time of installation. While minor at the time of inspection, drummy tiles can loosen or crack over time if movement continues. It is recommended that a licensed tiler assess the affected tiles and re-fix or replace as required. Repairs may be undertaken at the owner's discretion, with monitoring for any signs of further movement or cracking.

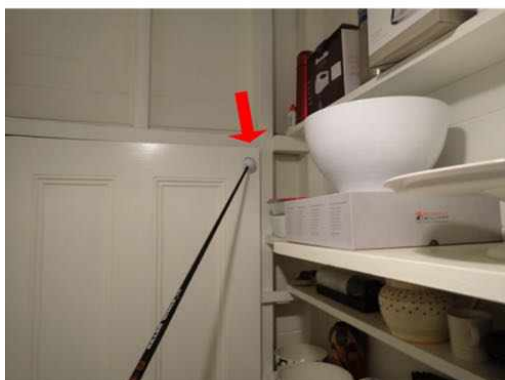
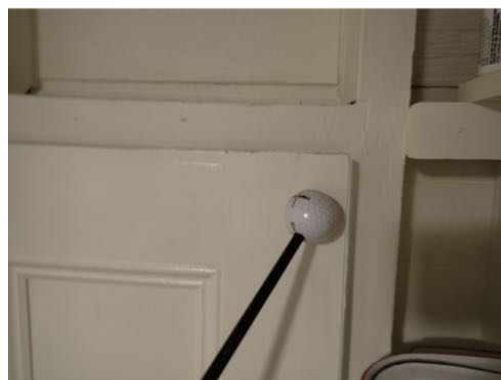
### Finding 3.03

Building:	Main Building
Location:	Walk in pantry
Finding:	Walk-In Pantry Door Catching on Frame
Information:	The walk-in pantry door was found to be catching on the door frame during normal operation. The door appears misaligned, likely due to minor movement in the building structure, hinge wear, or settlement over time. In simple terms, the door rubs on the frame when opening or closing. This is a common defect in properties of this age. While minor at the time of inspection, continued use in this condition may cause damage to the door, hinges or frame. It is recommended that a qualified carpenter or general handyman adjust the hinges, plane the door edge, or realign the frame as required. Repairs can be undertaken at the owner's discretion.

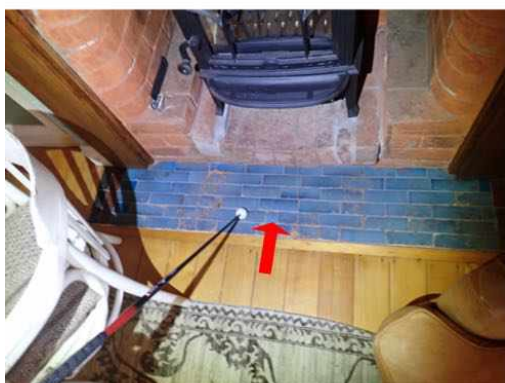
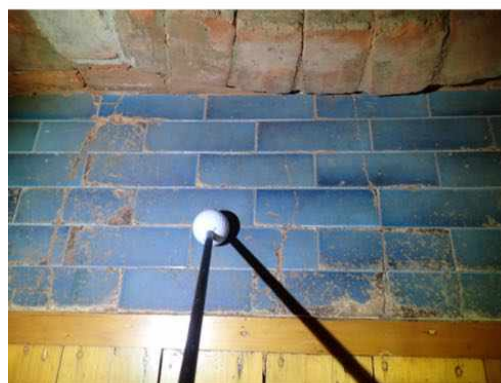
### Finding 3.04

Building:	Main Building
Location:	Living room
Finding:	Cracked and Damaged Tiles to Fireplace Hearth
Information:	Cracked and damaged tiles were identified to the fireplace hearth. The tiles are fractured and chipped, which may compromise their durability and overall condition. In simple terms, the tiles in front of the fireplace are cracked and damaged. This condition is commonly caused by impact, age, or thermal movement associated with heating and cooling. If left unaddressed, the damage may worsen over time. It is recommended that a licensed tiler remove and replace the affected tiles and ensure the hearth surface is secure and properly finished. Repairs may be undertaken at the owner's discretion to prevent further deterioration.

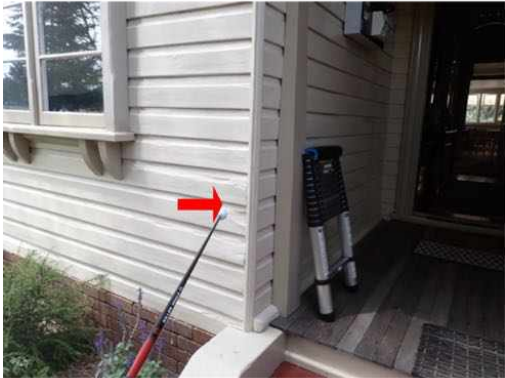
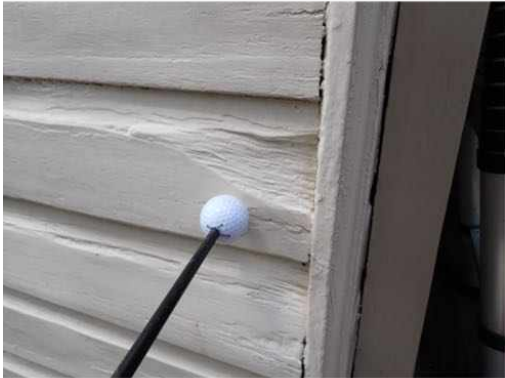
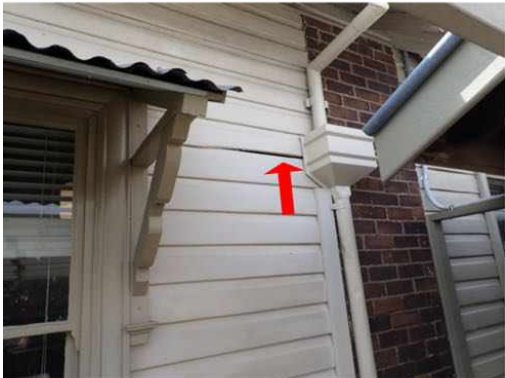
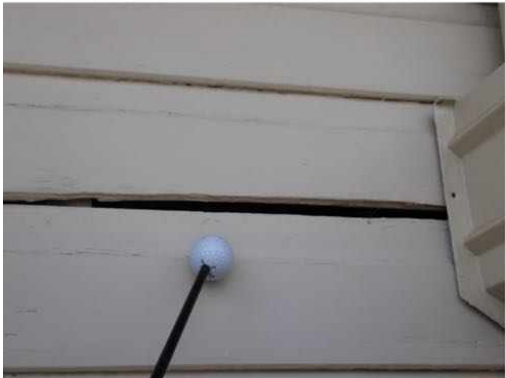
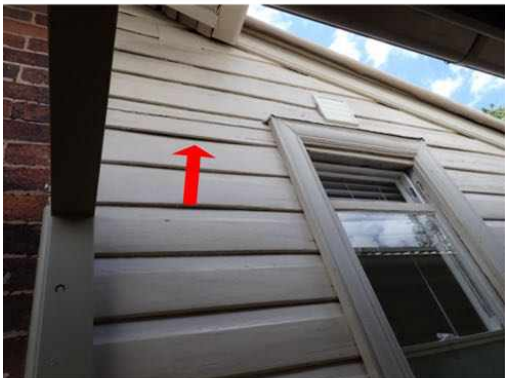
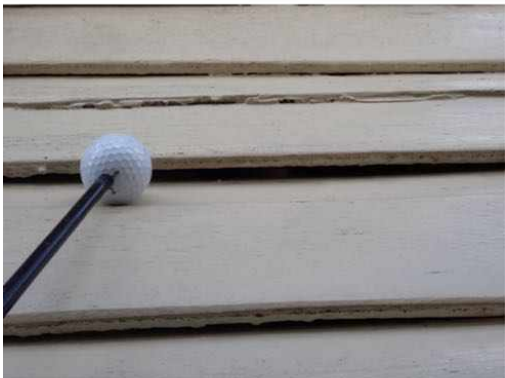
### Finding 3.05

Building:	Main Building
Location:	Front and right hand side of building
Finding:	Isolated Small Areas of Age-Related Damage/Wear to Timber Weatherboards
Information:	Isolated small areas of age-related damage and general wear were identified to sections of the timber weatherboards. The affected boards show minor deterioration consistent with weather exposure and the age of the dwelling. In simple terms, small parts of the outside timber cladding are worn and starting to deteriorate from age and

exposure to the elements. This is a common defect in properties of this age. If left unmaintained, deterioration may progress and lead to timber decay or moisture ingress. It is recommended that a qualified carpenter remove and replace any deteriorated sections as required and that the weatherboards be prepared and re-coated to maintain protection. Repairs and maintenance can be undertaken at the owner's discretion as part of ongoing upkeep.

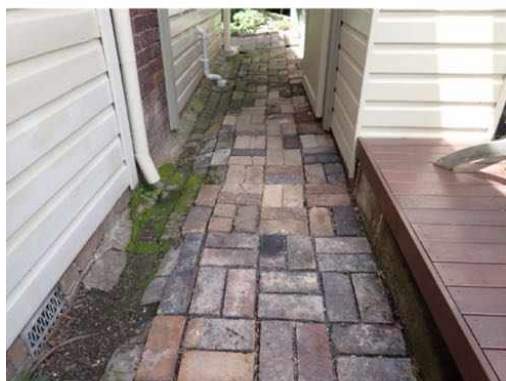
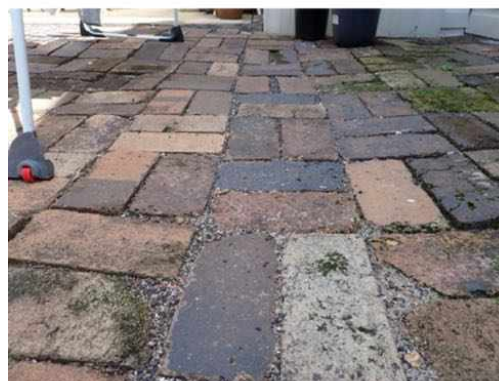
**Finding 3.06**

Building: Main Building  
Location: Paved areas  
Finding: Paved Areas in Generally Poor Condition

**Information:** The paved areas around the property were found to be in generally poor condition. Defects observed include cracking, movement, uneven surfaces and areas of deterioration consistent with age and ground movement. In simple terms, the paving is worn, uneven and showing signs of failure. This condition is commonly associated with long-term settlement, inadequate base preparation and weather exposure. If left unaddressed, deterioration may continue and individual pavers may loosen or subside further. It is recommended that a qualified landscaper or concreter assess the affected areas and repair, re-level or replace paving as required. Rectification works can be undertaken at the owner's discretion as part of property maintenance.

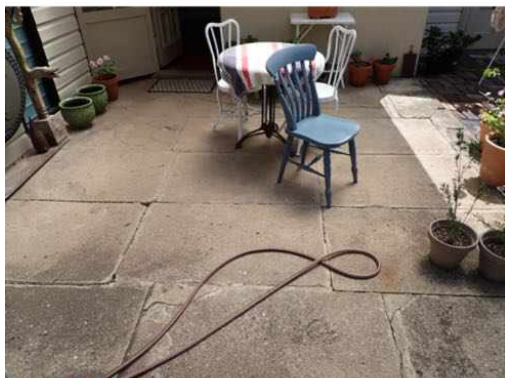
### Finding 3.07

**Finding:** Concrete Area to Rear Alfresco — Poor Condition

**Information:** The concrete floor to the rear alfresco area was found to be in poor condition. Defects observed include cracking, surface deterioration and general wear consistent with age and environmental exposure. In simple terms, the concrete at the back outdoor area is worn and breaking down. This condition is commonly associated with long-term weather exposure, ground movement and/or inadequate original installation. If left unaddressed, cracking and deterioration may worsen over time. It is recommended that a qualified concreter or landscaper assess the concreted area and carry out repairs, resurfacing or replacement as required. Rectification works can be undertaken at the owner's discretion as part of property maintenance.

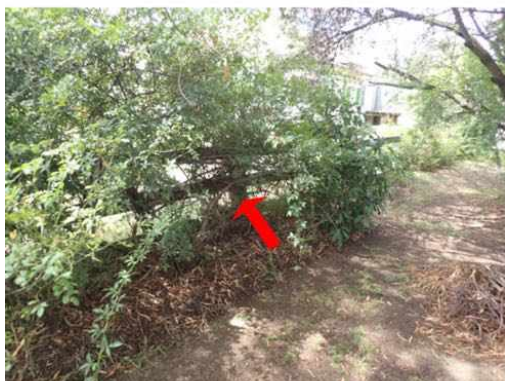
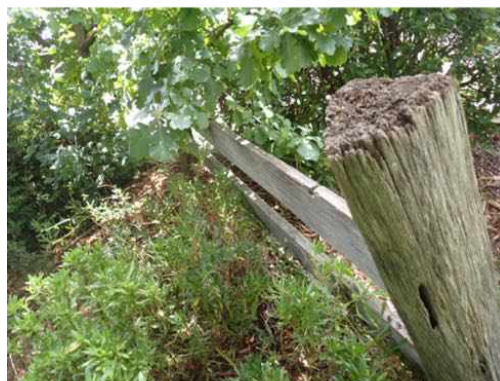
### Finding 3.08

Building:	Yard
Location:	Front left hand side boundary
Finding:	Deteriorated Timber Fence to Front Left-Hand Side Boundary
Information:	The timber boundary fence to the front left-hand side was found to be deteriorated. Sections of the fence show signs of weathering, timber decay and general age-related wear. In simple terms, the fence is old and starting to break down. This is a common defect with a fence of this age due to ongoing exposure to weather conditions and ground contact. If left unaddressed, deterioration may worsen and lead to instability or failure of sections. It is recommended that a qualified fencing contractor or carpenter repair or replace the affected sections as required. Rectification can be undertaken at the owner's discretion depending on the desired standard and remaining service life of the fence.

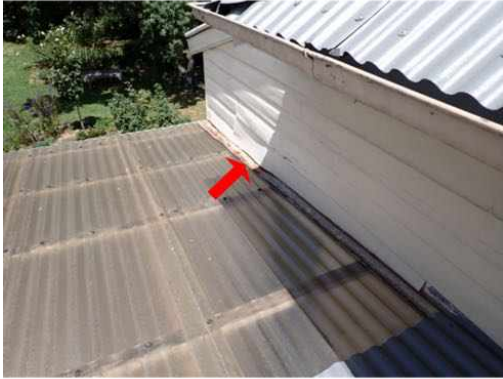
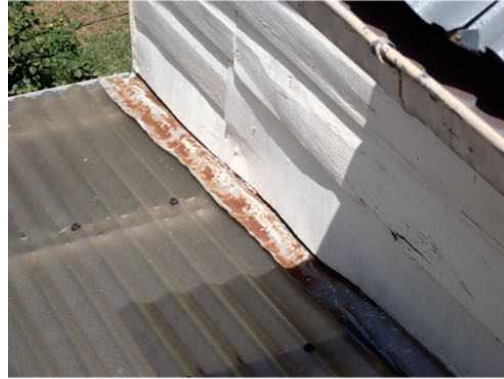
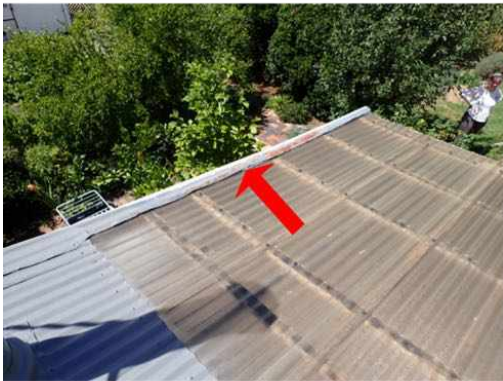
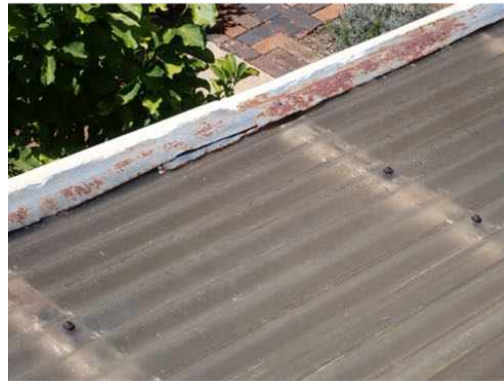
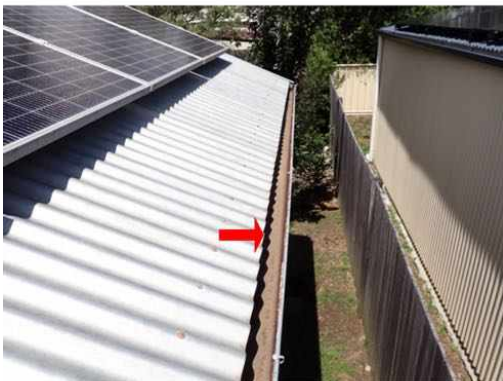
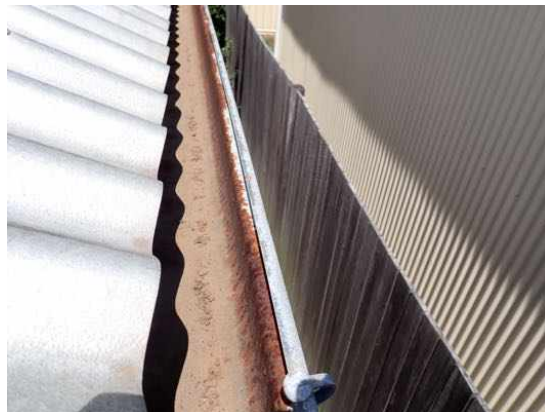
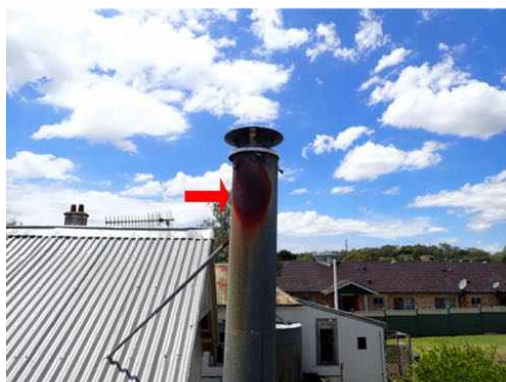
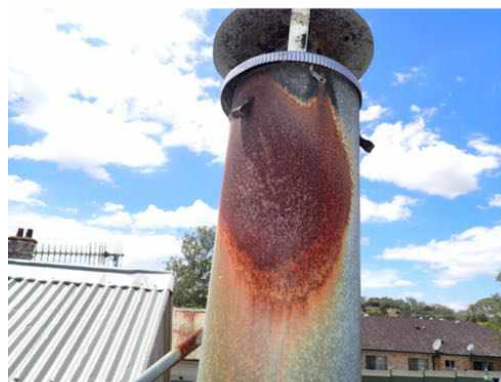
### Finding 3.09

Building:	Main Building
Location:	Roof
Finding:	Surface Rust Identified to Gutters, Flashings and Fireplace Flue
Information:	Surface rust was identified to sections of the roof gutters, flashings and the fireplace flue. The corrosion appears superficial at the time of inspection, with no visible perforation noted to the accessible areas. In simple terms, light rust is present on the

gutters, roof flashings and flue. This condition is commonly associated with age, weather exposure and deterioration of protective coatings. If left untreated, surface rust may progress to more advanced corrosion and eventual failure of the affected components. It is recommended that a licensed roofer or suitably qualified tradesperson clean, treat and apply a rust-inhibiting primer and protective coating to the affected areas, with replacement of sections if deterioration advances. Maintenance can be undertaken at the owner's discretion to prevent further corrosion.

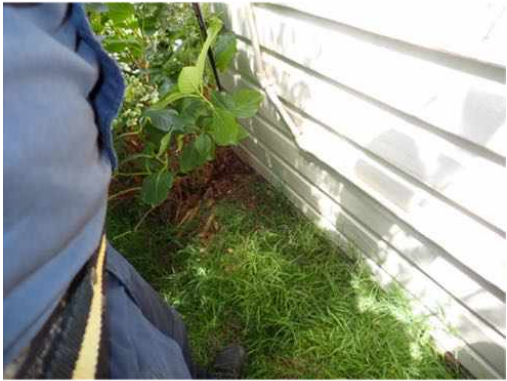
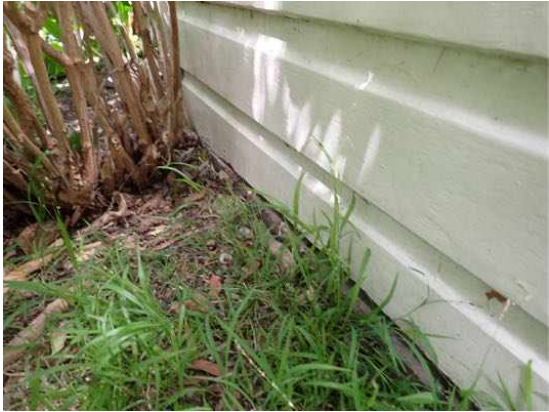
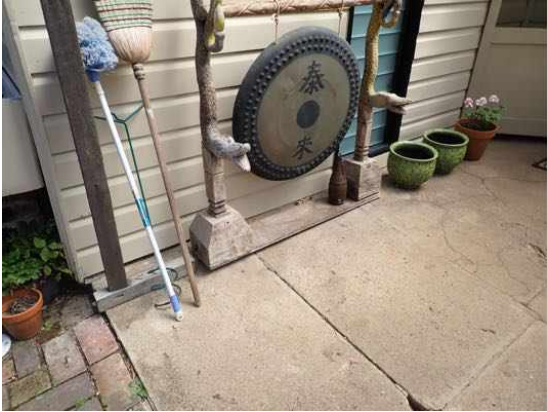
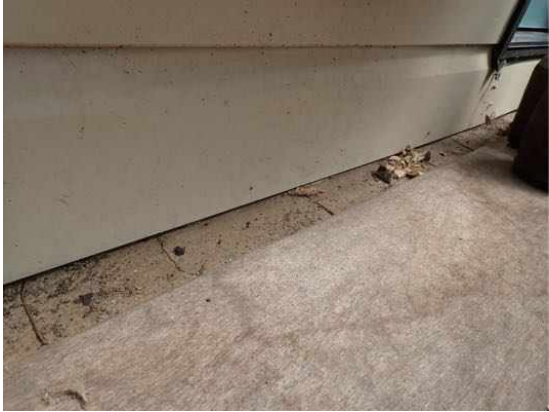
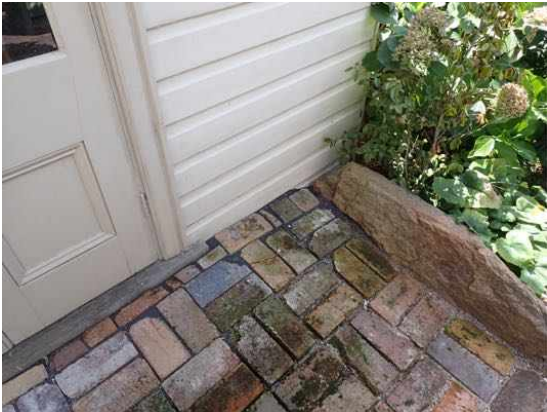
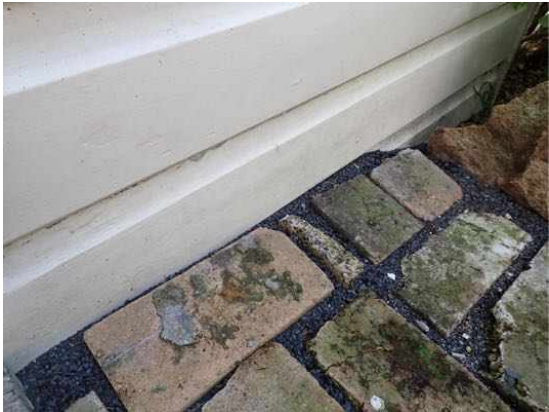
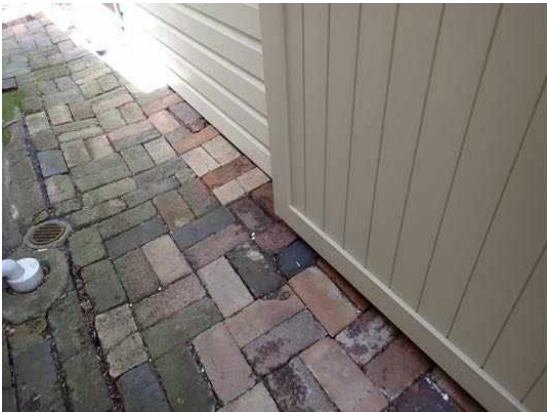
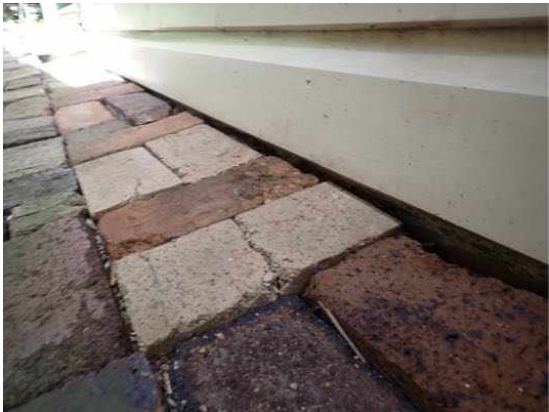
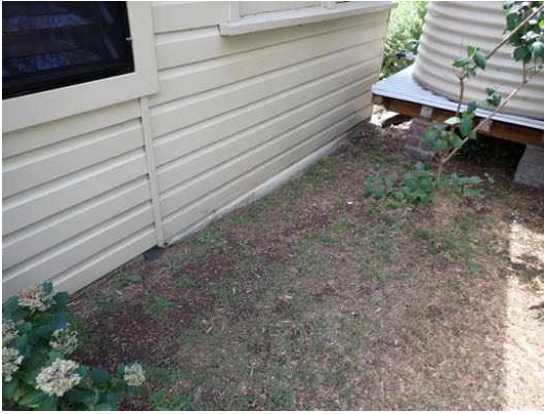
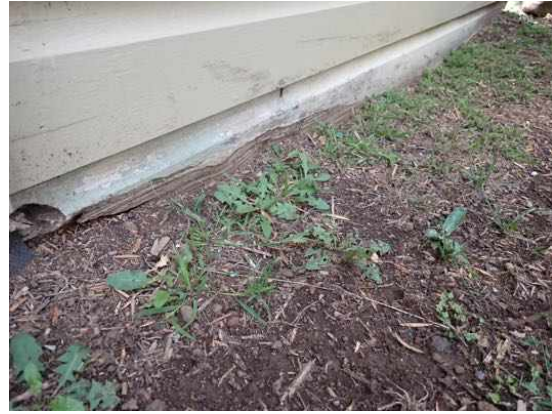
### Finding 6.01

Building:	Main Building
Location:	Perimeter of building
Finding:	Inadequate Termite Inspection Clearance at Several Areas
Information:	Several areas around the building were identified where adequate termite inspection clearance is not present. Ground levels, paving, garden beds and timber wall cladding were observed to be positioned too close to or in contact with the ground, reducing or eliminating the visible slab edge required for effective termite inspection. In simple terms, soil and some of the timber cladding are too close to the ground, making it difficult to detect potential termite entry points. This condition is conducive to concealed termite activity and moisture-related deterioration and is commonly caused by landscaping build-up over time or original installation heights. This is a common defect with a home of this age. It is recommended that a licensed builder or landscaper lower ground levels and ensure timber cladding maintains appropriate clearance from finished ground level in accordance with current standards. A licensed timber pest controller should also be consulted to assess termite risk and provide recommendations for ongoing protection. Rectification can be arranged at the owner's discretion to reduce the risk of concealed termite access and timber decay.

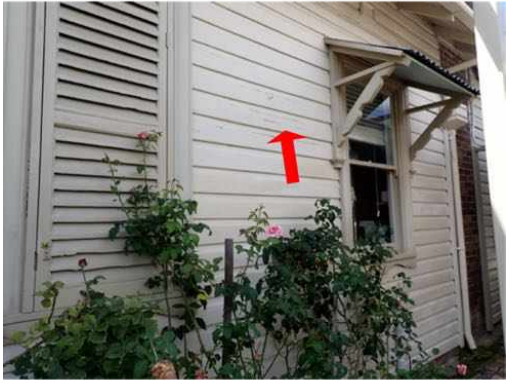
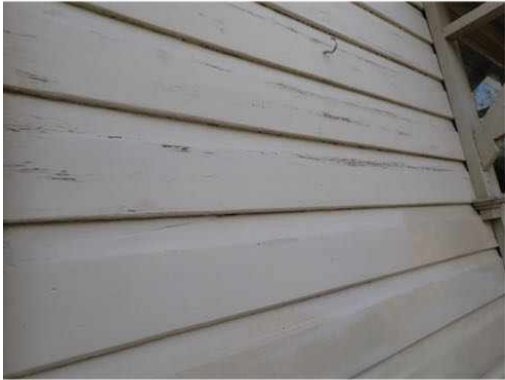
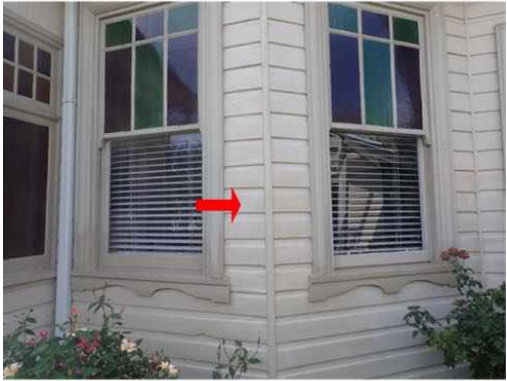
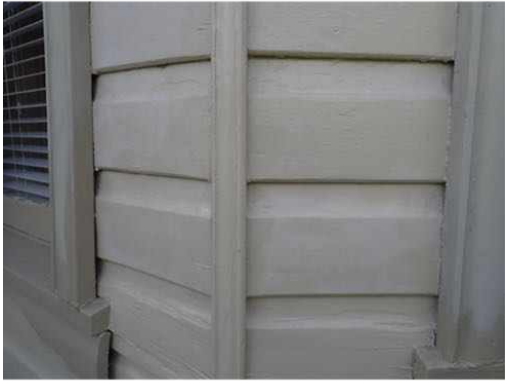
Building: Main Building  
Location: Exterior painted surfaces  
Finding: External Paintwork in Generally Fair Condition  
Information: The external painted surfaces were found to be in generally fair condition at the time of inspection. Minor areas of wear, fading and age-related deterioration were observed, consistent with normal weather exposure. In simple terms, the outside paint is starting to show its age but is still serviceable overall. Ongoing maintenance, including preparation and re-coating where required, will assist in maintaining protection of the underlying materials. Repainting can be undertaken at the owner’s discretion as part of routine property maintenance.

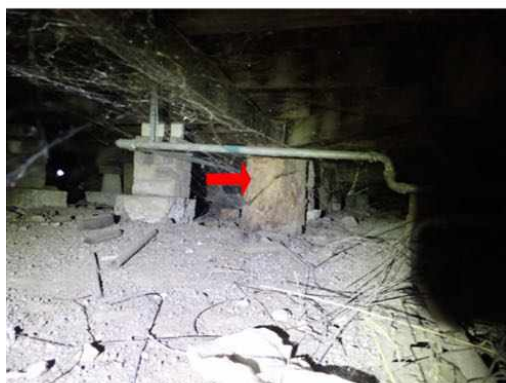
Building:	Main Building
Location:	Subfloor
Finding:	Several Old Timber Subfloor Stumps Identified – Limited Access
Information:	Several old timber stumps were identified within the subfloor area; however, subfloor access was too small to safely crawl into, limiting a full inspection of all supports. The visible areas appeared dry at the time of inspection. The stumps appear aged and may be subject to decay or termite risk depending on site conditions. In simple terms, some of the timber supports under the house are old, but the access opening was too small to get underneath properly and check everything, although what could be seen looked dry at the time. This is a common condition in homes of this age. If deterioration is present or progresses, it may contribute to uneven floors or structural movement. It is recommended that a qualified builder provide improved access if required and carry out a more comprehensive assessment of the subfloor supports, replacing any deteriorated stumps as necessary. A licensed timber pest controller should be consulted to inspect the subfloor area for current or past termite activity and provide advice regarding any treatment or ongoing protection measures. Further investigation and rectification can be undertaken at the owner's discretion.

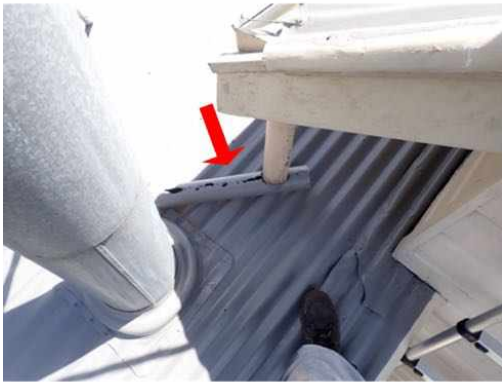
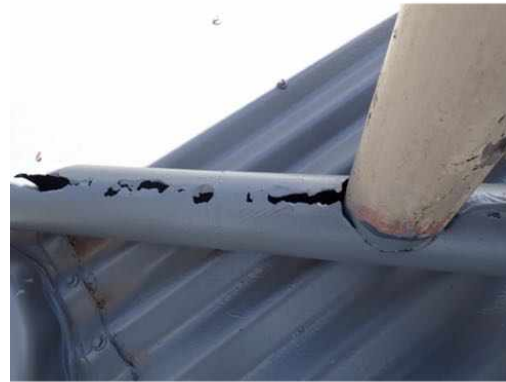
Building:	Main Building
Location:	Roof
Finding:	Rust Identified to Roof Downpipe at This Location
Information:	Rust was identified to the roof downpipe at this location, indicating established corrosion of the metal component. In simple terms, the downpipe is rusted. This condition is commonly associated with age and prolonged exposure to moisture. If left unaddressed, corrosion may continue to progress and lead to perforation, leakage or failure of the downpipe, affecting effective stormwater discharge. It is recommended that a licensed plumber repair or replace the affected section of downpipe as required and ensure all joints and connections are secure and watertight. Rectification can be undertaken at the owner's discretion to prevent further deterioration. This section of

down pipe may be included in with fixing the other gutter and down pipe issues.

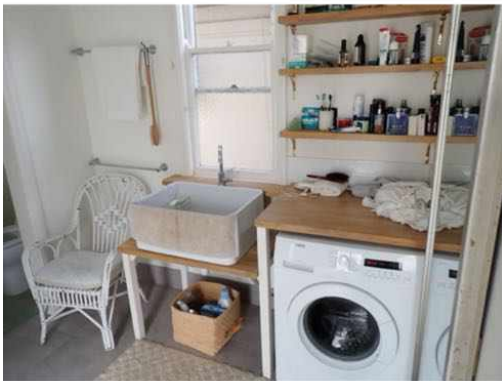
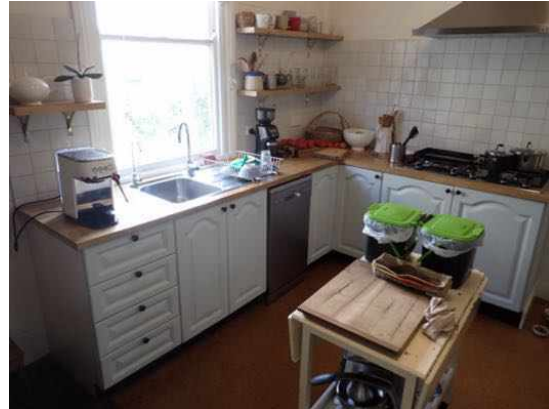
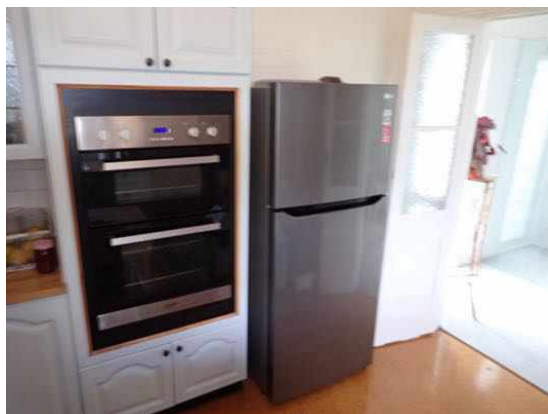
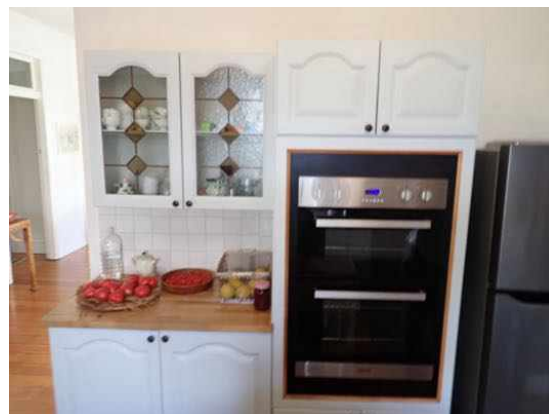
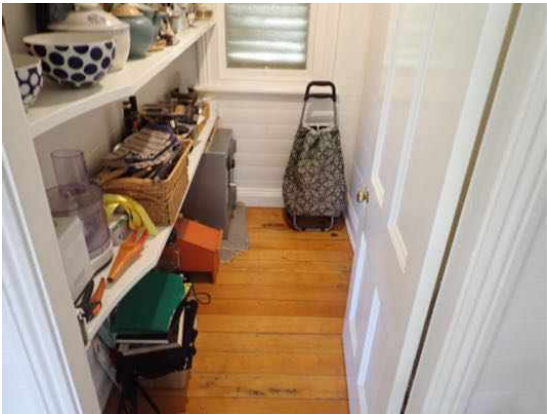
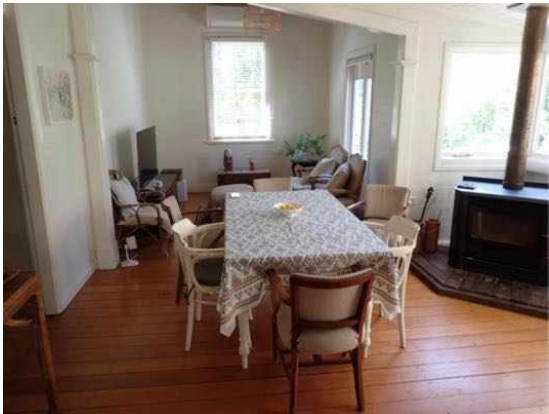
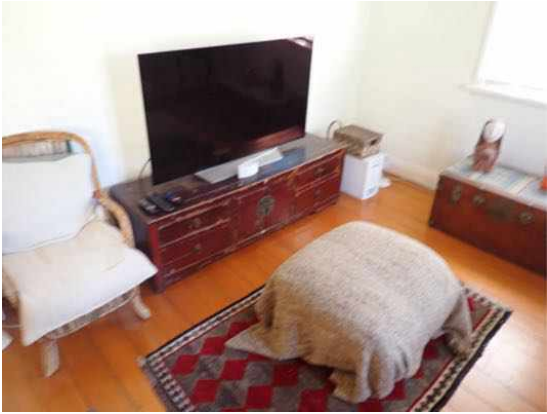
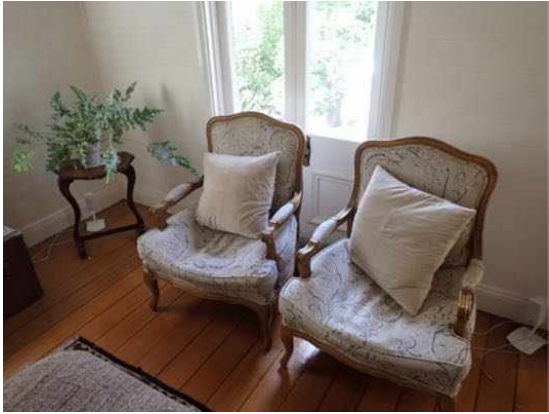
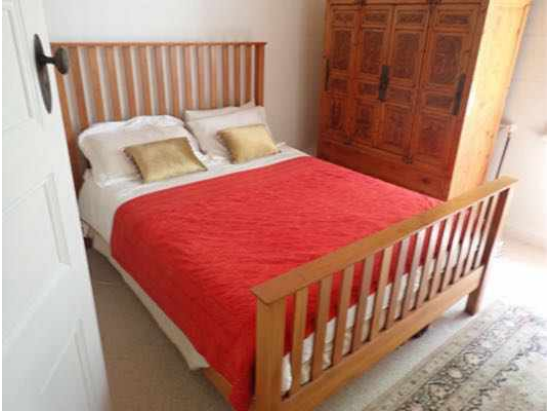
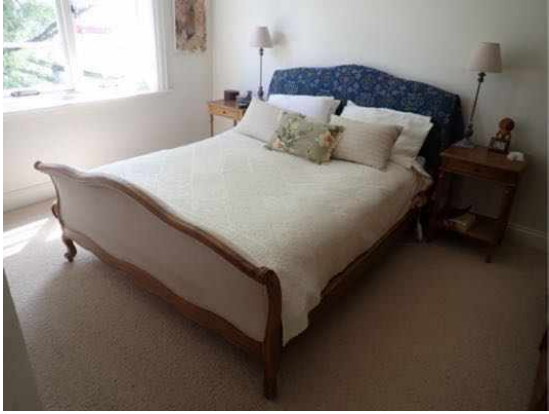
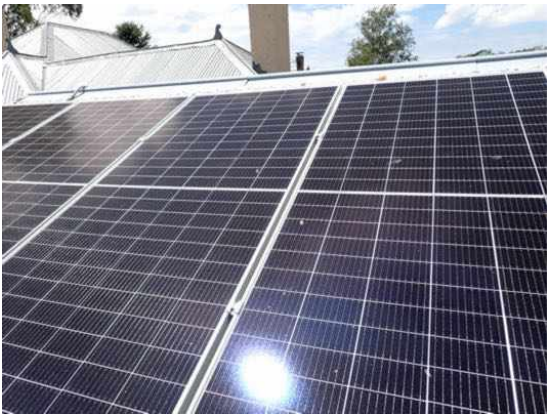
Finding: Additional Photos - Obstructions and Limitations

Information: These photographs are an indication of the obstructions and limitations which impeded full inspection of the area at the time of inspection. These obstructions can hide an array of defects and should be removed to allow full inspection to be carried out. A re-inspection is recommended once the areas are made accessible.
