Building and Timber Pest Inspection Report

Inspection Date: Mon, 23 Feb 2026

Property Address: 31/147 Fryar Rd, Eagleby QLD 4207,
Australia

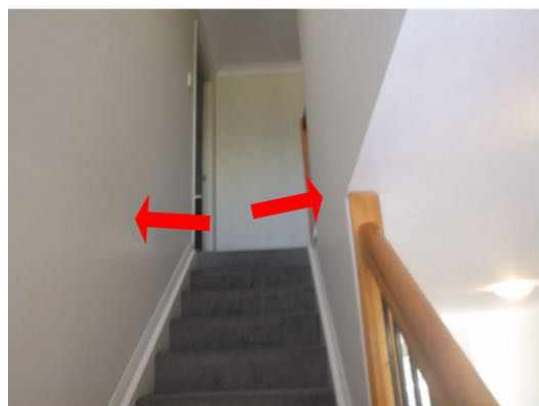
Building: Main Building
 Location: Stairs - Internal > Existing
 Finding: Stairs - Handrail
 Information: At the time of inspection it was noted there was no handrail in the internal stairway. The absence of a handrail in the stairway compromises the safety and accessibility of the stairs for all users.

This is noted as a safety concern and this regulation may not have been in place at the time of construction.

A licensed builder could be consulted for further information on stairway requirements.

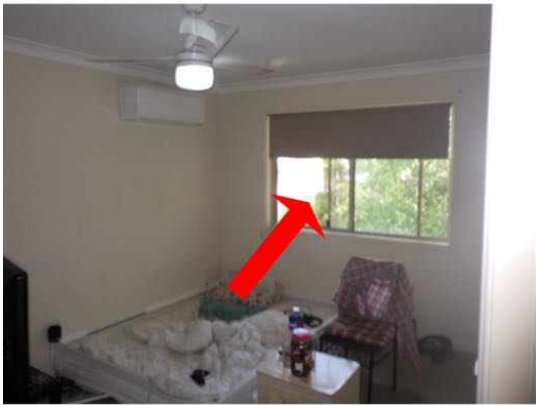
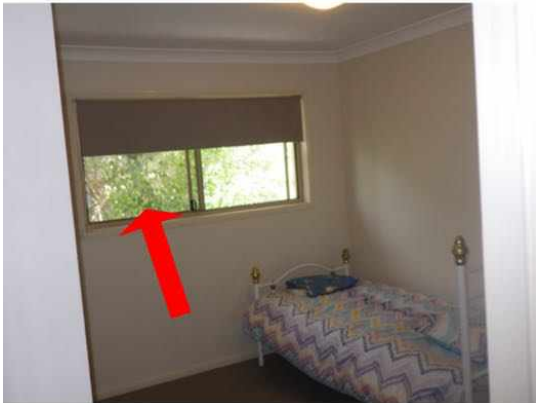
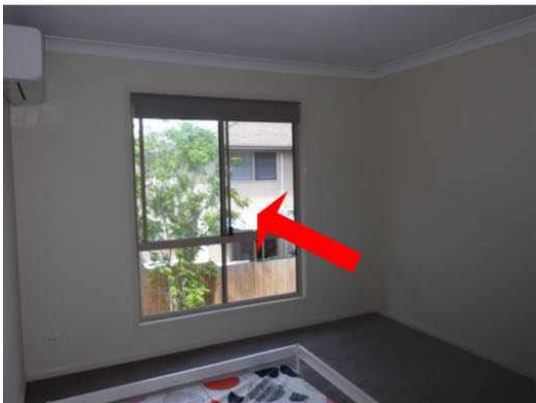
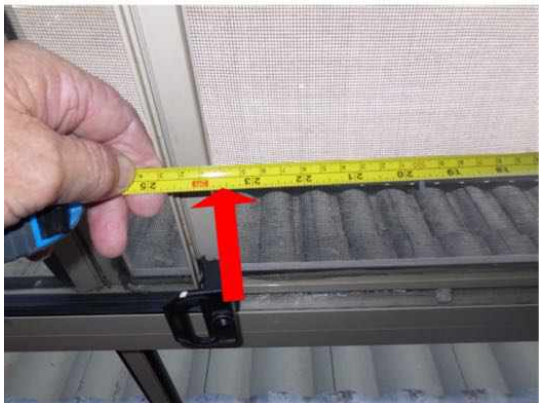
Finding 1.02

Building: Main Building
 Location: Bedrooms > Existing
 Finding: Window safety
 Information: It was noted that the windows of the upper level bedrooms are less than 1.7m from the floor and have a fall greater than 2m on the exterior from the sill and as such are required to only open upto 125mm or have security grills fitted.

This is noted as a safety concern and this regulation may not have been in place at the time of construction.

Windows are defective if they do not comply with provision 3.9.2.5 of Volume 2 of the BCA that requires that a window opening must have protection if the floor below the window in a bedroom is 2 m or more above the ground surface beneath.

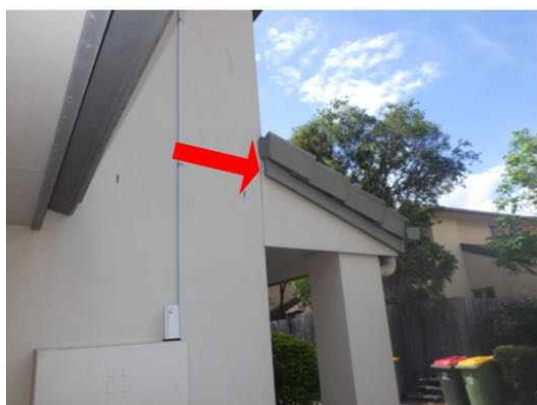
Building: Main Building
Location: Exterior walls - front > Centre Left
Finding: Cracking - Walls
Information: There is cracking to areas of the exterior wall cladding (as per example photos). The cracking appears to be concentrated at the vertical joints of the wall sheeting and is generally minor in nature. It is assumed the cracking is the result of normal building movement or substandard workmanship at the time of construction.

A licensed solid plasterer or qualified painter could be consulted regarding rectification options.

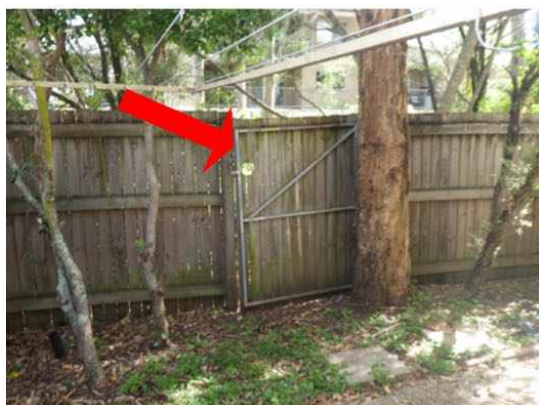
Finding 3.02

Building: Main Building
Location: Yard - Back > Existing

Finding: Gate - Sticking/ jamming
 Information: At the time of inspection the gate to the rear of the property was sticking or jamming during standard operation.

A fencing contractor or general handyman could be engaged to adjust or repair the gate as required.

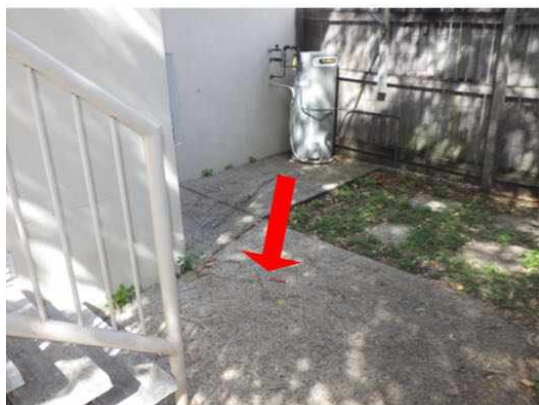
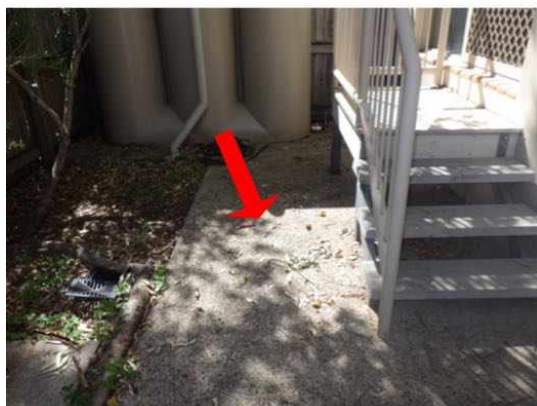
Finding 3.03

Building: Main Building
 Location: Yard - Back > Ground Level
 Finding: Cracking in concrete slab - Category 1
 Information: Cracking coded as Category 1 was identified in the driveway and footpaths concrete slabs (as per example photos). A Category 1 crack is described as a fine but noticeable crack, with the slab at an otherwise reasonable level.

To be considered Category 1, the approximate width of the crack is less than 1.0mm, or a less than 10mm change in offset when a 3m straight edge is placed over the defect.

Category 1 cracks should be monitored for a period of 12 months. At the end of the monitoring period, identified cracks that are rated greater than Category 2 are considered defects, and require rectification.

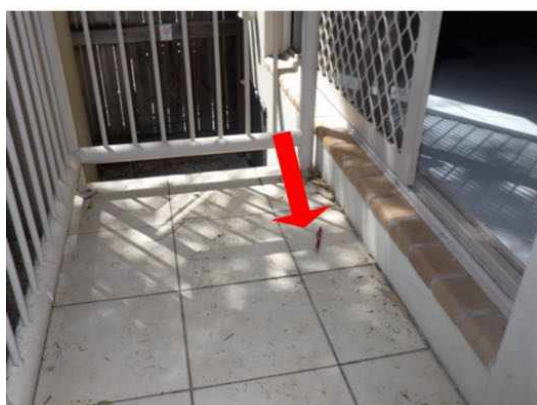
Finding 3.04

Finding: Tile - Cracked

Information: A cracked tile to the rear stair landing area was identified at the time of inspection. Such defects are generally caused by impact. Cracked or broken tiled areas may also be a direct result of poor workmanship during the construction process.

A tiling contractor could be appointed to perform repair works at the clients discretion.

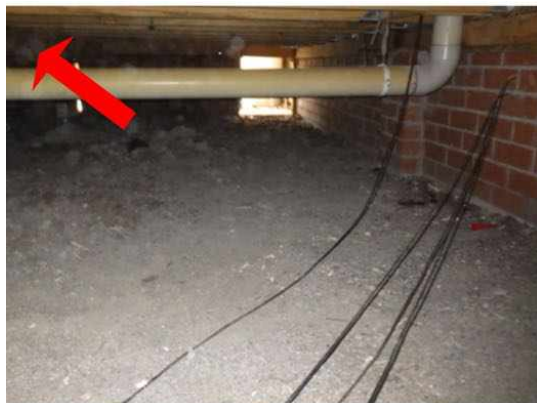
Finding 3.05

Information: At the time of inspection a metal tie down bracket to the subfloor area of the property was disconnected from the timber floor joist or bearer (reason unknown).

A qualified carpenter or general handyman should be engaged to re-attach the metal tie down bracket to the floor structure.

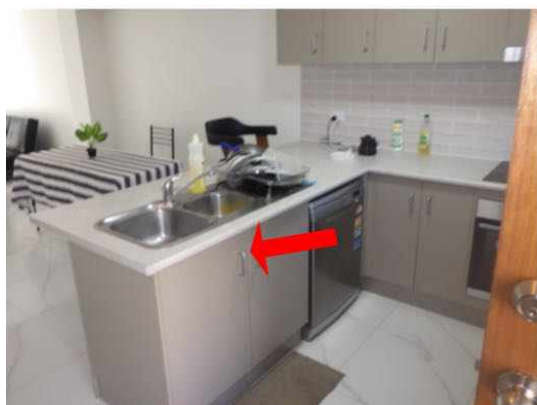
Finding 3.06

Building:	Main Building
Location:	Kitchen > Centre Left
Finding:	Cabinetry - Door jamming
Information:	The undersink cupboard doors in the kitchen area were found to be binding at the time of inspection. To improve operation of the affected cupboard doors, a cabinet maker or general handyman may be appointed to make adjustments to the hinges of the affected door. Such works should be completed at discretion of the client.

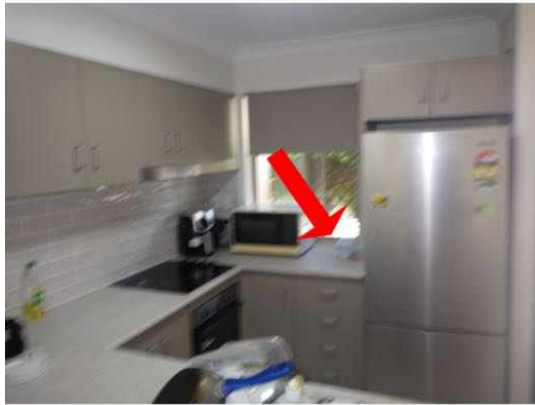
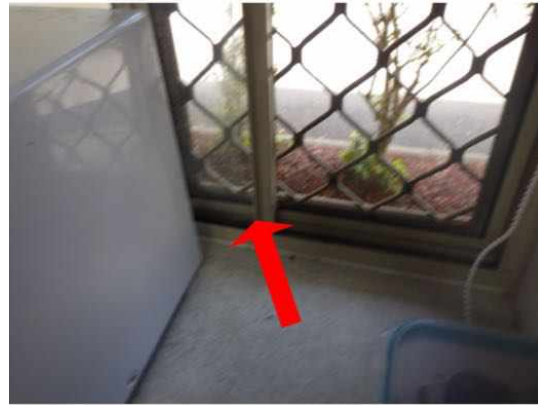
Finding 3.07

Building:	Main Building
Location:	Kitchen > Rear Right
Finding:	Window - Stiff to Slide
Information:	The aluminium sliding window in the kitchen area was stiff to operate at the time of the inspection. Windows provide ventilation to the adjoining area and should be at a fully operational level to ensure user comfort. Restricted function of the window may also pose as a potential safety hazard if required for emergency egress from the building.

Generally, factors such as general age of the building element and a lack of maintenance are the usual causes for this type of defect.

An aluminium window service agent will be required to repair the affected windows.

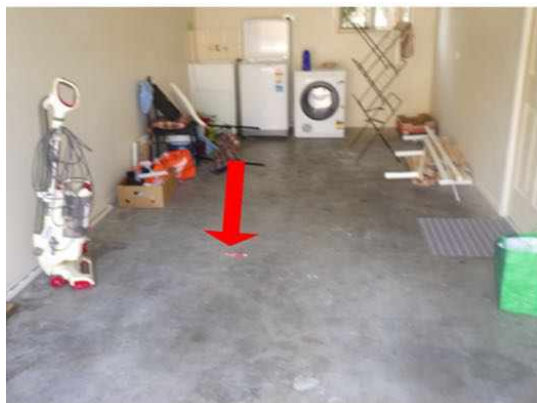
Building:	Main Building
Location:	Garage > Existing
Finding:	Cracking in concrete slab - Category 1
Information:	Cracking coded as Category 1 was identified in the garage floor concrete slab. A Category 1 crack is described as a fine but noticeable crack, with the slab at an otherwise reasonable level.

To be considered Category 1, the approximate width of the crack is less than 1.0mm, or a less than 10mm change in offset when a 3m straight edge is placed over the defect.

Category 1 cracks should be monitored for a period of 12 months. At the end of the monitoring period, identified cracks that are rated greater than Category 2 are considered defects, and require rectification.

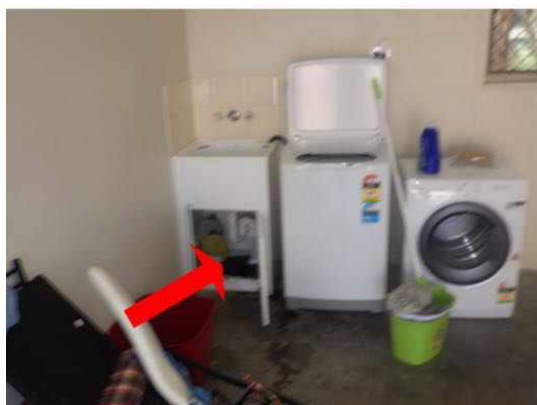
Finding 3.10

Building:	Main Building
Location:	Laundry > Existing
Finding:	Surface requires cleaning
Information:	At the time of inspection there was evidence of a leaking container (contents unknown) affecting the metal laundry tub and concrete floor surface.

The client should notify the real estate agent or occupants of the leaking container for removal and cleaning of the area.

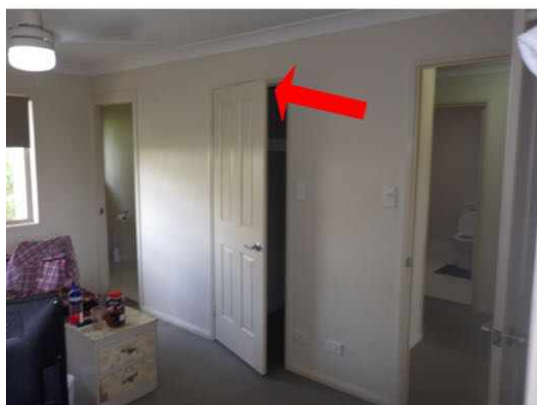
Finding 3.13

Location:	Walk In Robe > Front
Finding:	Door - Broken latch
Information:	The door latch to the walk in robe door was found to be broken at the time of inspection. Breakage occurs generally when the building materials have aged and decayed, but may be indicative of impact damage (accidental or deliberate).
	Replacement of the broken door catch is advised to improve the operational state of the associated door.
	A general handyman could be appointed to replace the door latch at the client's discretion.

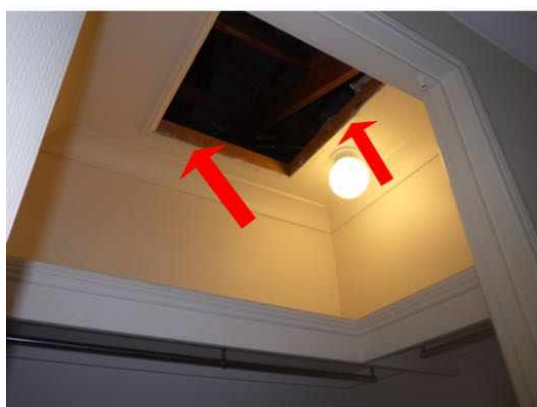
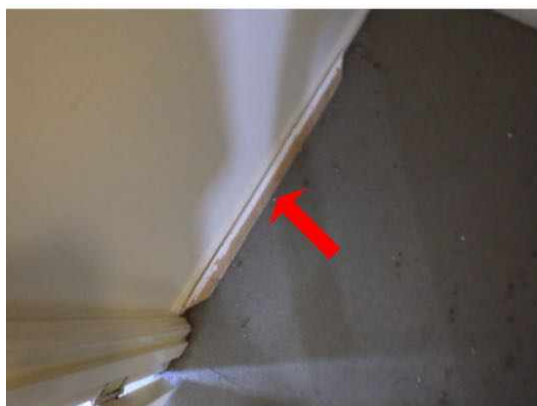
Finding 3.14

Building:	Main Building
Location:	Walk In Robe > Centre
Finding:	Manhole Cover
Information:	At the time of inspection the manhole cover boarding and/or frame showed signs of deterioration.
	A general handyman should be engaged to repair/replace the manhole cover frame.

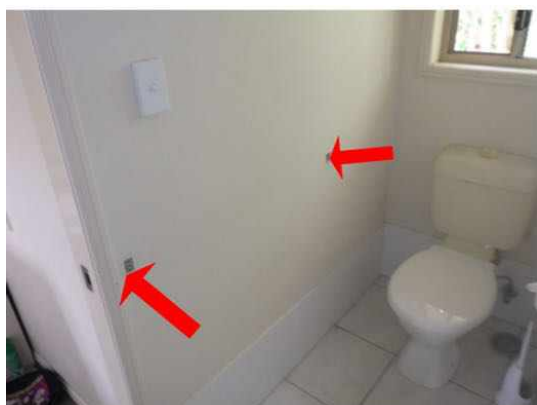
Finding 3.15

Building: Main Building
 Location: Ensuite > Front Left
 Finding: Fitting or fixture - Missing
 Information: A fixture was missing from the ensuite wall at the time of inspection

It is assumed the missing fixture was a towel rail or similar.

A general handyman could be appointed to replace the missing fixture at discretion of the client.

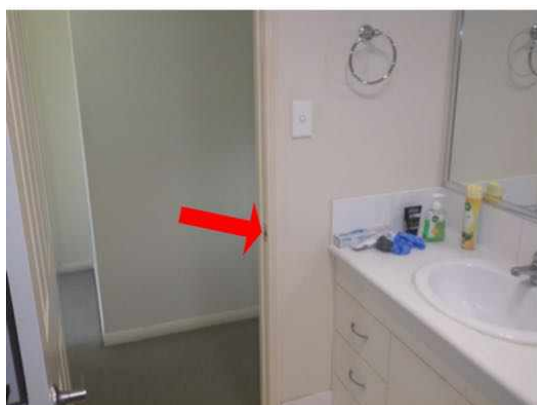
Building:	Main Building
Location:	Bathroom > Front Left
Finding:	Striker Plate - Missing
Information:	The bathroom door handle striker plate was missing from the door frame at the time of inspection. Although some building elements may seem irrelevant or unnecessary, all building elements play a key role in the operation and function of the overall structure and its performance.

Re-installation or replacement of the striker plate is advised to prevent any subsequent damage to the door frame or associated structures. A general handyman may be appointed to perform these works at client discretion.

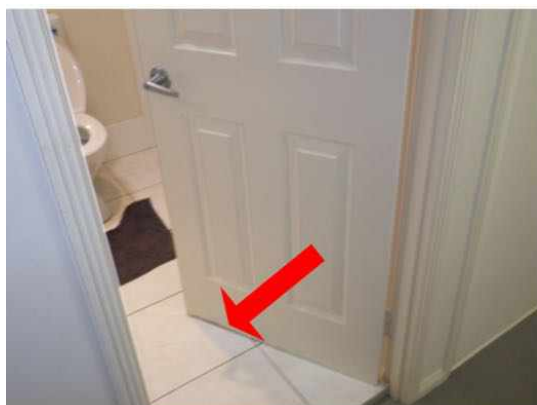
Finding 3.20

Location: Bathroom > Front
 Finding: Damaged Door
 Information: The door leading into the bathroom has suffered damage to the bottom edge.

Damage occurs generally when the building materials have aged and decayed, but in this instance the damage appears to be the result of exposure to moisture, possibly from the bottom and/or top edges of the door not being sealed with a suitable paint or sealant at the time of construction.

A qualified carpenter or general handyman could be appointed to repair/replace the door at the clients discretion.

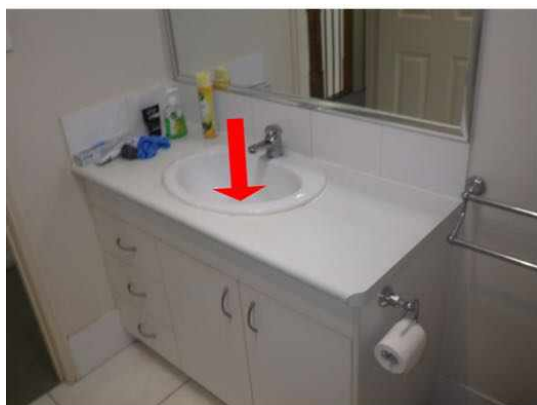
Finding 3.21

Building: Main Building
 Location: Bathroom > Centre Left
 Finding: Basin - Pop up waste
 Information: The bathroom basin pop up waste was damaged or missing at the time of inspection. It is advised that maintenance is carried out on the waste so as it functions as intended.

A handyman could be appointed to perform any remedial works where required.

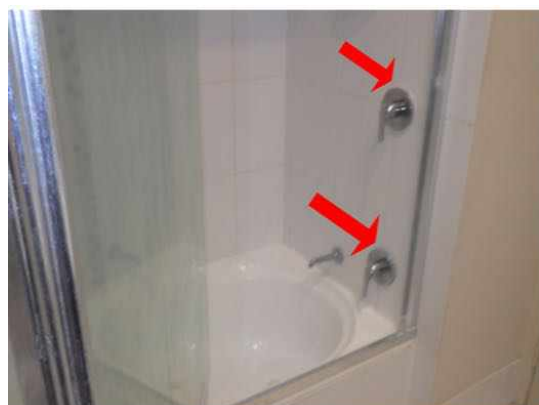
Finding 3.22

Building: Main Building
 Location: Bathroom > Centre Right
 Finding: Sealant
 Information: It was noted on inspection that sealant in the bathroom shower cubicle area has been poorly applied to wall tiles and fixtures. The reason for the sealant application is unknown, but may be to stop water penetrating the shower area flick mixer back plate.

A sealant specialist should be appointed to undertake repair work.

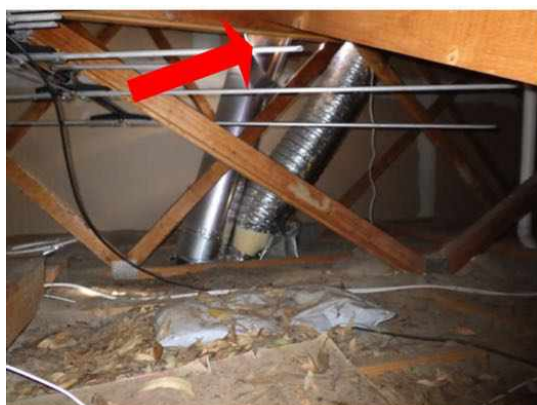
Building:	Main Building
Location:	Attic > Centre
Finding:	Skylight - Damaged/blocked shaft
Information:	It was noted at the time of inspection that the skylight shaft has been blocked/damaged, and is therefore not fully functional.

While seemingly minor, skylights allow natural light to filter into the surrounding area. Without such light, the area may be susceptible to the formation and development of mould, which creates a respiratory health hazard for all persons that come into contact with the area.

Where the skylight shaft has been blocked (even partially) or damaged, it is recommended that a carpenter or general handyperson be appointed to perform rectification works as necessary.

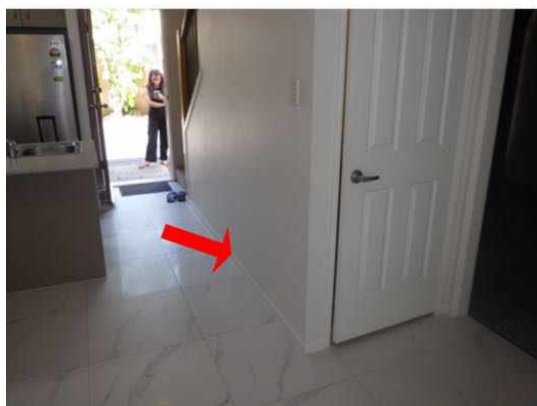
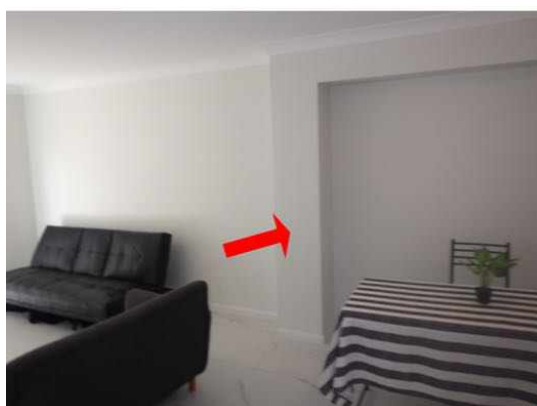
Building: Main Building
 Location: Internal Areas > Existing
 Finding: Wear and Tear
 Information: At the time of inspection the building interior showed signs of minor cracking and/or scuffing to floors, walls, ceilings and cornices (as per example photos).

The level of damage appears consistent with general deterioration and/or wear and tear.

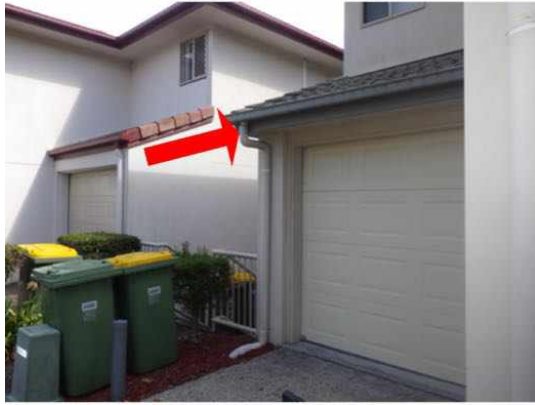
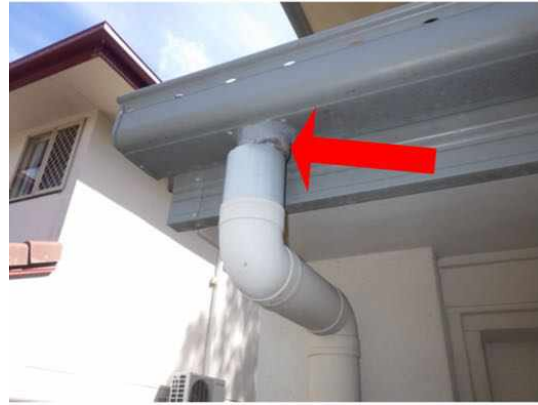
become excessively damp, potentially creating an environment that is susceptible to rust and corrosion of surrounding building elements, as well as attracting termites and other pests.

It is recommended that a plumber or handyman be appointed to further inspect and to extend the down pipe as necessary.

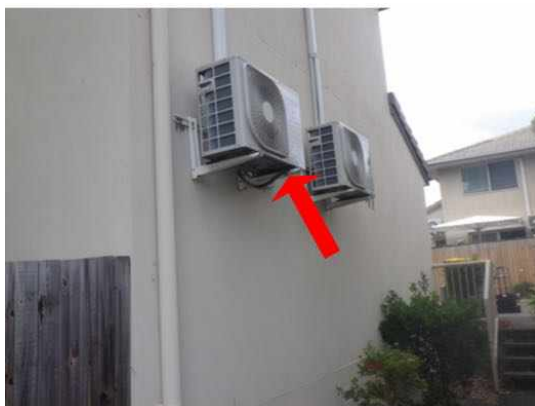
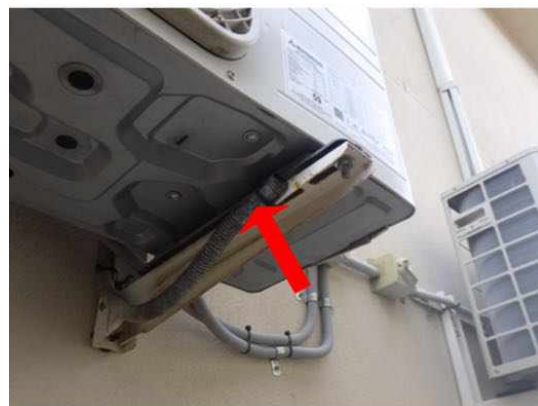
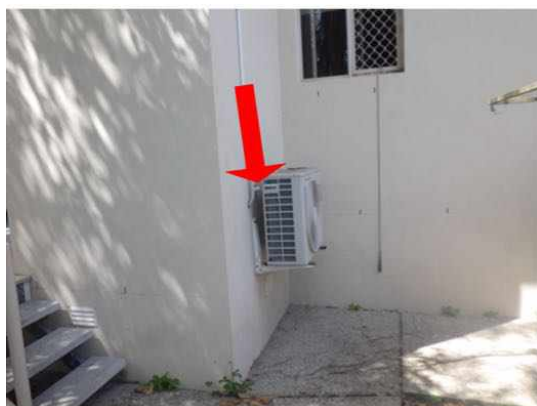
Finding 6.03

Building:	Main Building
Location:	Exterior walls > Existing
Finding:	Overflows - Not plumbed for drainage
Information:	The air conditioning unit overflows are not plumbed or connected to suitable drainage, which can result in the surrounding areas becoming excessively damp. These damp conditions can lead to secondary defects such as rot, rust or corrosion of associated building elements, the formation of fungal decay, or even the creation of potential slip hazards. When coupled with poor site drainage, pooling of water may also attract termite activity to this area. It is highly recommended that a qualified plumber be appointed to install adequate drainage to the overflow. These works will ensure that the area remains dry and free of any secondary defects.

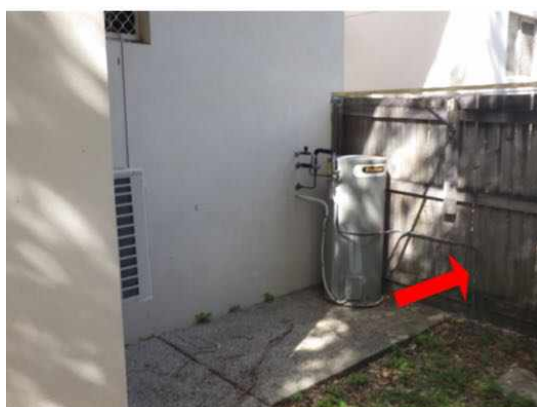
Finding 6.04

Building:	Main Building
Location:	Yard - Back > Rear Left
Finding:	Overflow - Not plumbed for drainage
Information:	The hot water system overflow is not plumbed or connected to suitable drainage, which can result in the surrounding area becoming excessively damp. These damp conditions can lead to secondary defects such as rot, rust or corrosion of associated building elements, the formation of fungal decay, or even the creation of potential slip hazards. When coupled with poor site drainage, pooling of water may also attract termite activity to this area. It is highly recommended that a qualified plumber be appointed to install adequate drainage to the overflow. These works will ensure that the area remains dry and free of any secondary defects.

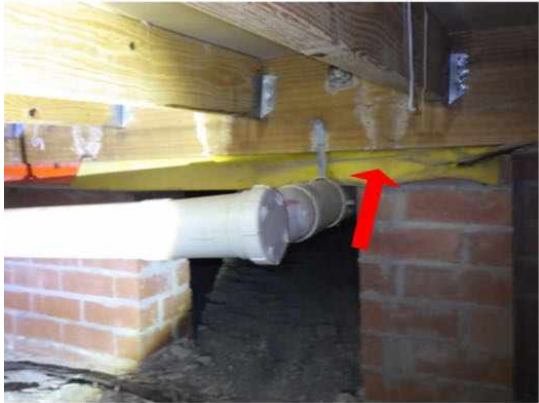
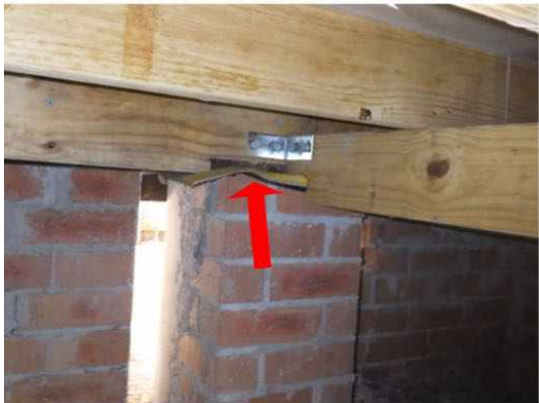
In this instance evidence of previously installed physical and chemical barriers were observed. This system requires regular annual inspections.

No durability notice and no evidence of regular or annual inspections was found.

Where a Termite Management System has been identified you should refer to the type of barrier date of installation warranty conditions and any documentation provided by a past owner or the buildings body corporate managers.
