## Building Inspection Report

Inspection Date: Tue, 24 Mar 2026

Property Address: 39 Links St, Sunshine West VIC 3020,  
Australia

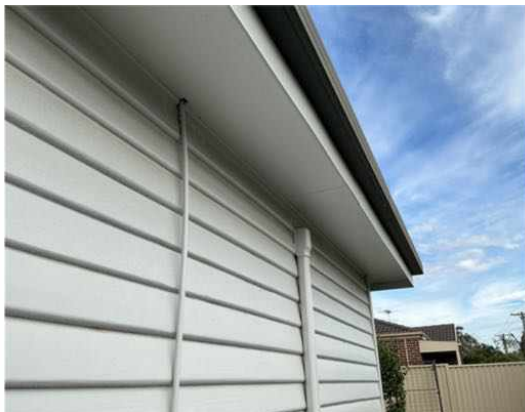
#### Defects 1.01

Building:	Main Building
Location:	Eaves
Finding:	Asbestos - Suspected ACM Identified on Site
Information:	Reporting on Asbestos is outside the Scope of this Report. This suspected defect is highlighted as a caution only. We suspect, based on our experience in the building industry, that there is a higher risk of the identified building element containing asbestos.

As Asbestos Reporting is outside the scope of this report, we advise that you consider a separate Asbestos Inspection and Condition Audit, which can include the taking of samples for definitive confirmation of the presence of Asbestos.

In the interim, the client is advised to act with caution, especially when considering any damage to building materials general wear and tear renovations extensions demolition and general maintenance activities due to the suspected presence of Asbestos.

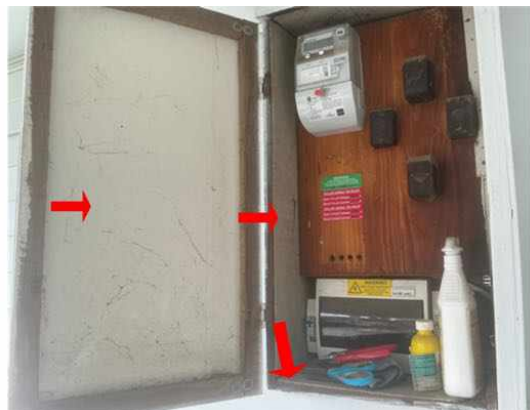
#### Defects 1.02

Building:	Main Building
Location:	Electrical Switchboard
Finding:	Asbestos - Suspected ACM Identified on Site
Information:	Reporting on Asbestos is outside the Scope of this Report. This suspected defect is highlighted as a caution only. We suspect, based on our experience in the building industry, that there is a higher risk of the identified building element containing asbestos.

As Asbestos Reporting is outside the scope of this report, we advise that you consider a separate Asbestos Inspection and Condition Audit, which can include the taking of

samples for definitive confirmation of the presence of Asbestos.

In the interim, the client is advised to act with caution, especially when considering any damage to building materials general wear and tear renovations extensions demolition and general maintenance activities due to the suspected presence of Asbestos.

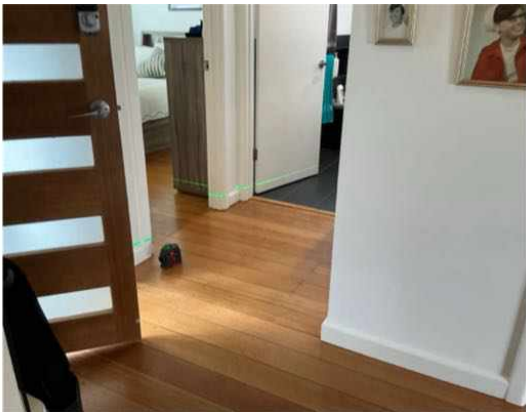
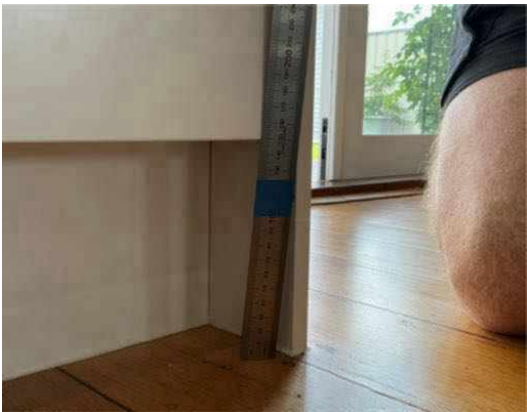
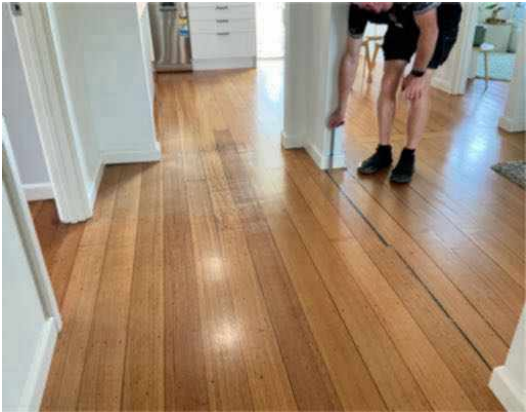
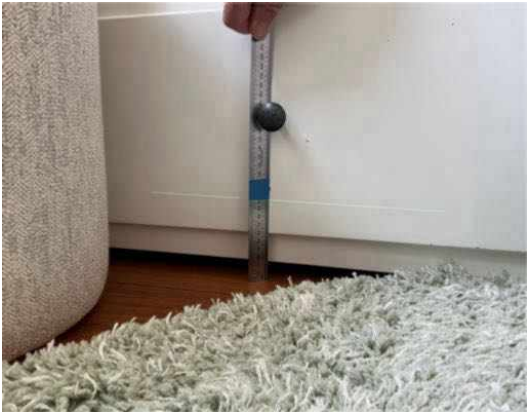
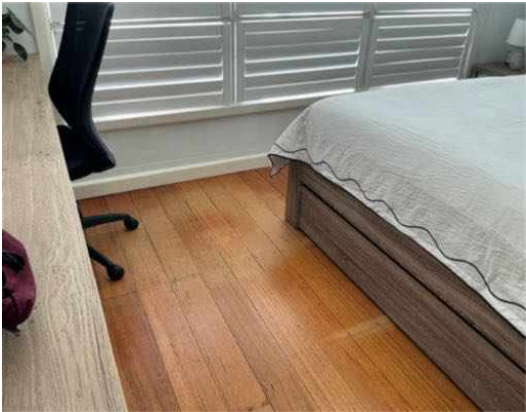
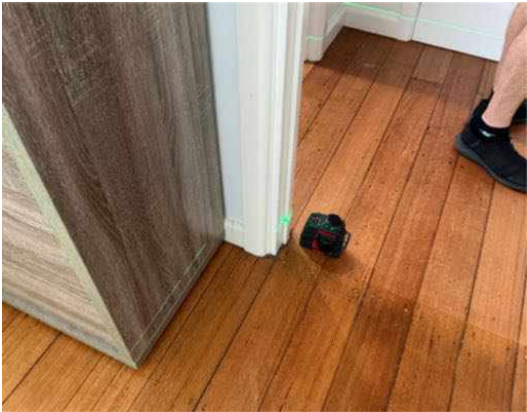
### Defects 2.01

Building:	Main Building
Location:	All Areas
Finding:	Flooring - Uneven and beyond tolerance
Information:	The internal flooring in this area is out of level and uneven. Uneven flooring is likely to may minor defects such as expected movement of the foundations of the property, but may also indicate subsidence of the associated subfloor stumps.

Flooring was found to be out of level and well beyond tolerance in some areas, for this reason the uneven flooring has been classified as a major defect. It appears that the house has been Restumped but not leveled. We recommend monitoring floor levels and if they deteriorate further, inspection and consultation with a professional Restumping Specialist is recommended.

It is advised that the flooring be closely monitored to identify any further movement. Where flooring remains relatively unchanged for an extended period of time (i.e. several months), it is likely that this defect has been caused by expected movement of the foundations of the property.

However, where flooring is uneven further, potentially invasive inspection of the subfloor structures and stumps in this area is required. In this case, works to repair are likely to be required, and would be carried out by a registered builder specialising in re-stumping.

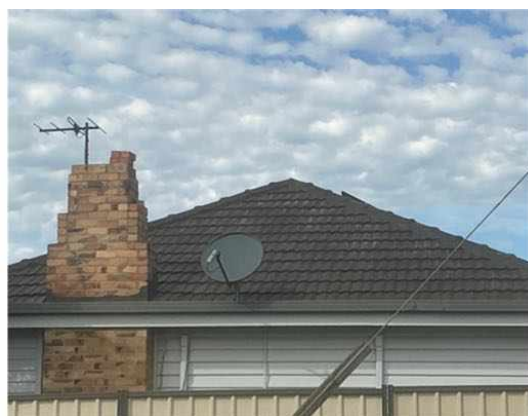
### Defects 3.01

Building:	Main Building
Location:	Roof Exterior
Finding:	Roof tiles - Weathered
Information:	Upon inspection of the exterior roofing, the majority of roof tiles were considered to be in a fair condition. While weathering of the tiles is consistent with the age of the property, maintenance works are required.

Isolated areas of mortar have come loose in the valleys and minor cracking is also present. Re-pointing and re-sealing the may be considered as an interim solution by the client to help preserve and extend the life span of the tiles.

Where left unmanaged, deteriorating roof tiles are likely to lead to a number of secondary defects, including minor water leaks and weather exposure to internal roofing structures.

Consultation with a roofing contractor is highly advised to gain advice on cost of remedial works that may be required in the short to medium term. Remedial works are likely to increase the longevity of the exterior roofing structure.

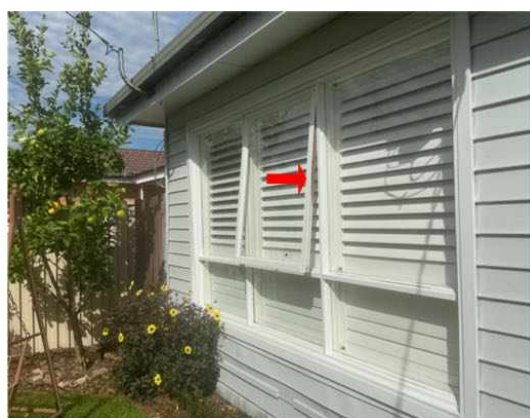
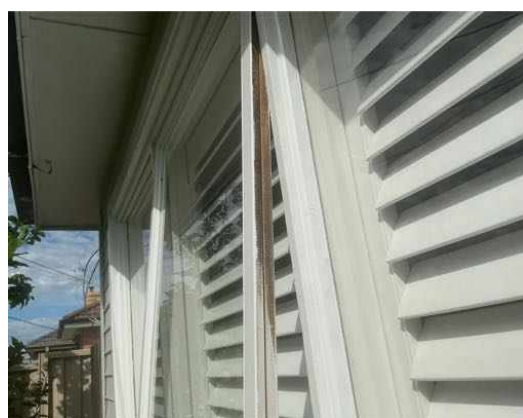
## Defects 3.02

Building:	Main Building
Location:	Windows
Finding:	Paint finish - Incomplete
Information:	The paint finish in this area was identified as being incomplete at the time of inspection.

Whilst incomplete or missing paint finish is generally an appearance defect, it can also lead to the development of secondary building defects over time. Incomplete areas of paint finish expose the area to moisture, potentially accelerating the deterioration of underlying building materials.

Incomplete paint finishes should be sanded back, filled, leveled and painted, as applicable. Where inadequate or missing paint protection has led to the deterioration of the associated building element, repair and/or replacement of this building element may be required.

A painting contractor should be appointed as soon as possible to perform necessary works to aid the appearance of the affected area and to ensure the area is protected against further deterioration. Alternatively, the homeowner following manufacturer instructions may perform these works.

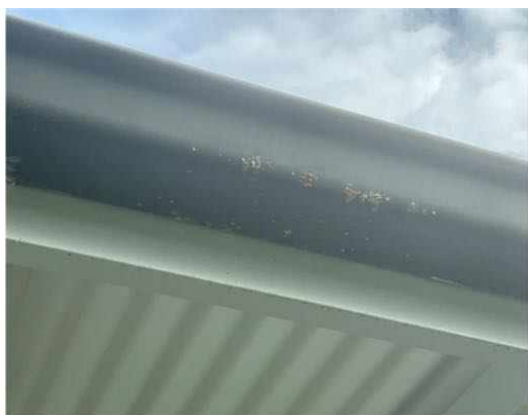
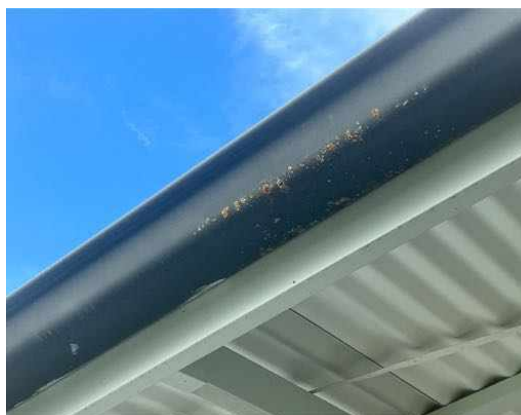
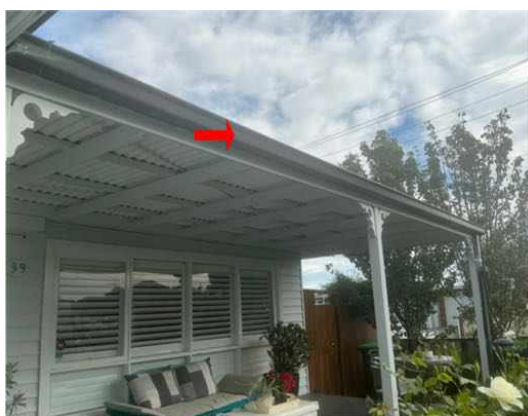
## Defects 3.03

Building:	Main Building
Location:	Gutters
Finding:	Roof plumbing - Rusted or corroded
Information:	The roof plumbing has areas of rust and corrosion. It is suspected that this has been caused by blockages, resulting in pooling or standing water, that have prematurely rusted elements of the roof plumbing.

Rusted roof plumbing will generally develop holes and leaks that can affect other building elements with poor drainage of storm water. Poorly drained roof areas will

also lead to damp conditions surrounding the base perimeter of the building which, if left unmanaged, can lead to a range of secondary building defects.

Repair and/or replacement of rusted roof plumbing is highly required in order to reinstate the roof drainage system to a fully operational level. To further maintain these areas, gutters should be cleaned frequently, allowing the avoidance of any partial blockages.

A licensed plumber or specialist roof restoration company should be appointed to undertake these works. It is advised that such works be completed as soon as possible to prevent any further damage and deterioration.

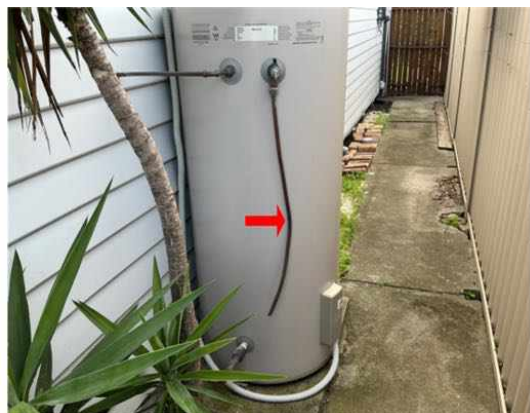
### Defects 3.04

Building:	Main Building
Location:	Exterior walls - left side
Finding:	HWS Overflow - Not Connected
Information:	The Hot Water System (HWS) overflow was found to be disconnected from storm water drainage and is creating excessive moisture in the surrounding area.

These damp conditions can lead to secondary defects such as rot, rust or corrosion of associated building elements, the formation of fungal decay, or even the creation of potential slip hazards. When coupled with poor site drainage, pooling of water may also attract termite activity to this area.

It is highly recommended that a licensed plumber be appointed to connect the HWS overflow in order to prevent such an environment from being created. These minor works should be carried out as soon as possible.

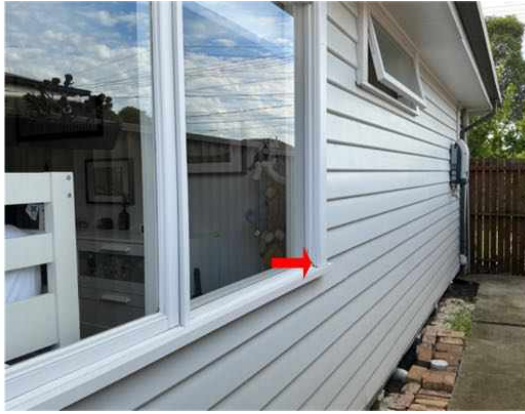
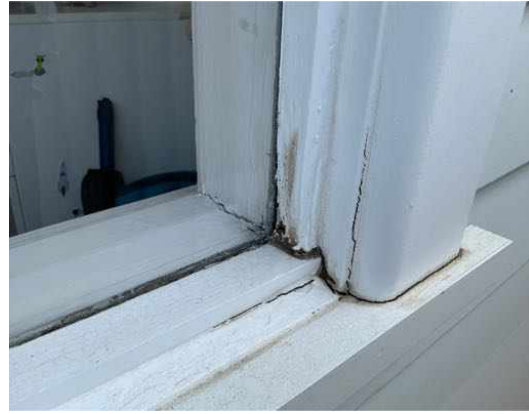
### Defects 3.05

Building:	Main Building
Location:	Windows
Finding:	Windows - Wood rot
Information:	Wood rot was found to be affecting external windows. Wood rot, also known as Fungal Decay, occurs when timbers and other cellulose building materials are exposed to damp conditions on an ongoing basis.

It is likely that this wood rot has developed as a result of frequent exposure to rain and other weather conditions. It is suspected that failure to maintain the window frames over a prolonged period has resulted in them deteriorating at an accelerated rate, increasing their susceptibility to the development of wood rot. Leaks in roof plumbing or associated pipework may have also contributed to the formation of the wood rot in this area.

Early intervention and regular maintenance will prolong the useful life of these building elements. Prior to any works being performed, any associated pipework or roof plumbing should be inspected by a licensed plumber for faults or leaks.

Repair and/or replacement of affected window frames may be a necessary step in protecting surrounding building elements from such deterioration. Remedial works should be performed by a qualified carpenter or registered builder as soon as possible to prevent any further damage.

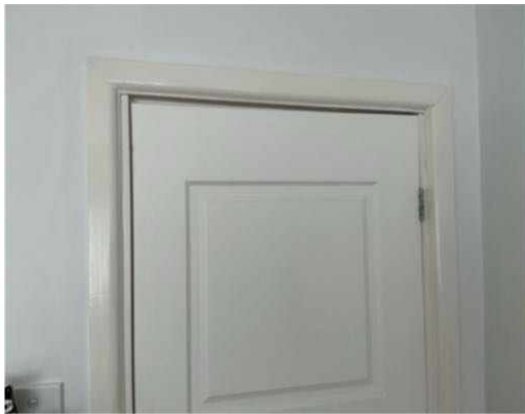
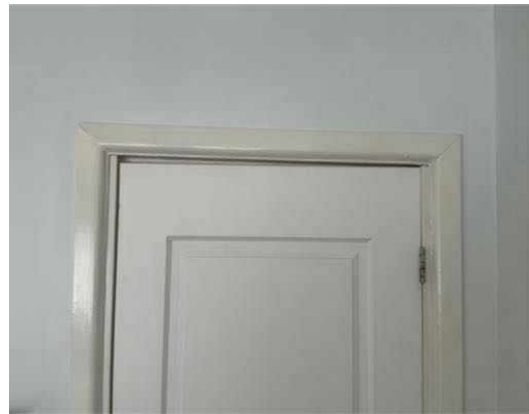
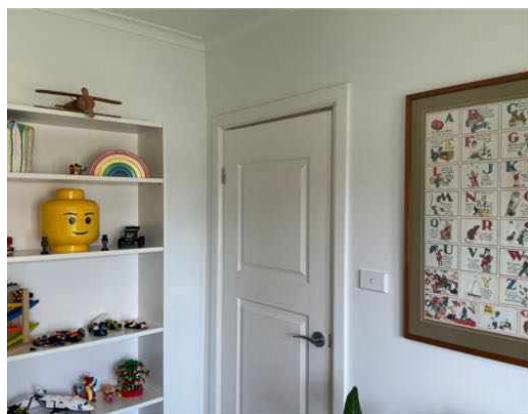
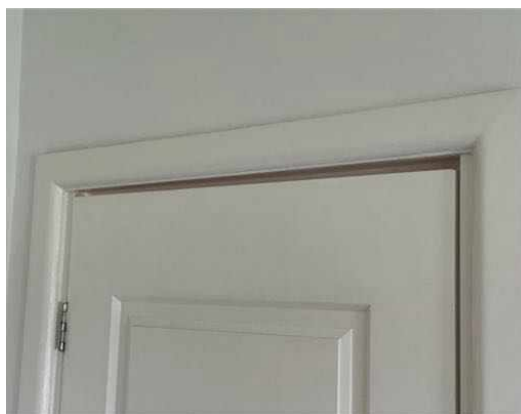
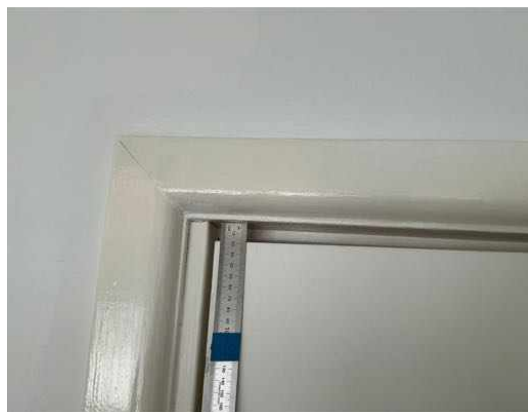
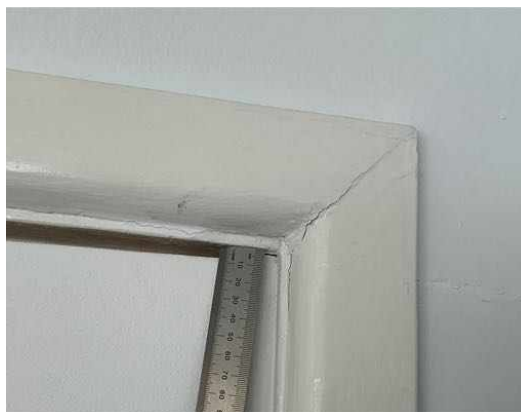
### Defects 3.06

Information: A significant gap was identified between the door and door frame in this area. Where large gaps to the head or foot of door frames appear, it may indicate a variety of defects, ranging from uneven framework, sagging hinges or uneven flooring.

A gap to the head of the door may also indicate movement of the foundation of the property, which is a common occurrence and does not indicate structural damage.

A qualified carpenter should be appointed to perform remedial works to restore the door to a fully operational level.

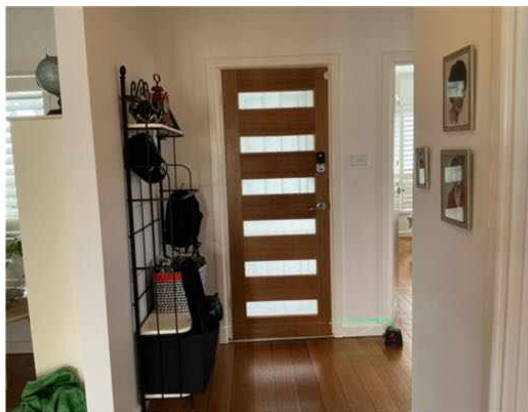
### Defects 3.07

Building:	Main Building
Location:	Entry
Finding:	Door - Binding/jamming
Information:	Binding and/or jamming of this door is evident during standard operation. This defect inhibits the functionality of the affected door as well as creating potential for secondary defects to associated building elements, such as damage to the floor covering.

A door that binds to flooring or to the associated door frame may have several causes, ranging from minor defects, such as poor installation of the door or deteriorated hinges, through to major structural issues, such as damage to subfloor structures.

Where door binding/jamming appears to indicate major structural issues, a registered builder specialising in re-stumping should be appointed to provide an estimate on the cost of rectification.

For minor causes, a qualified carpenter or general handyperson should be appointed to perform minor rectification works at client discretion.

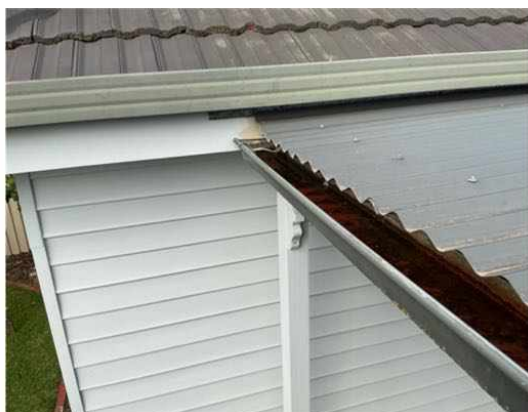
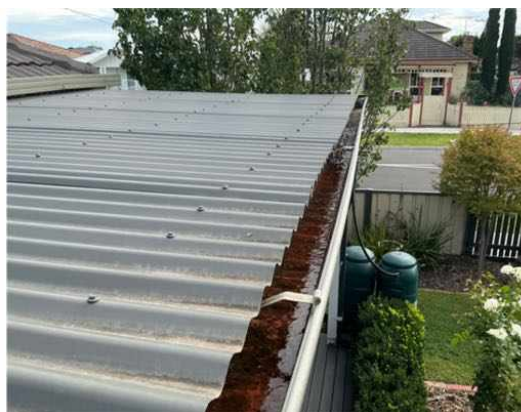
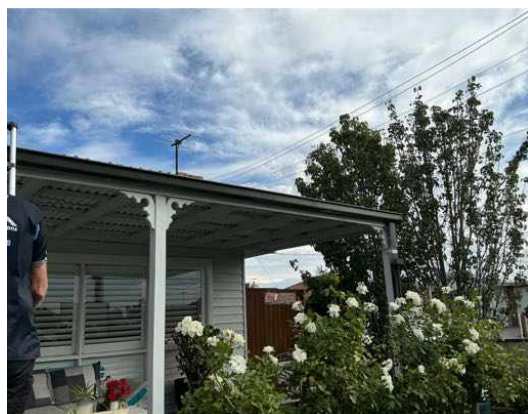
### Defects 3.08

Information: Water was found to be pooling in sections of the roof guttering. This is generally a secondary defect caused by blocked or partially blocked gutters. Such blockages and subsequent water pooling are likely to lead to rust and water damage to associated structures if left unattended.

Any areas of guttering that shows evidence of water pooling should be checked for partial or full blockages and any secondary damage that may have occurred as a result. Depending on the extent of the damage, building elements may require repair and/or replacement to ensure adequate roof drainage and function of exterior plumbing system.

A roofing plumber should be appointed as soon as possible to rectify this issue. It is highly advised that all gutters be maintained on a frequent basis to ensure the condition of roof plumbing.

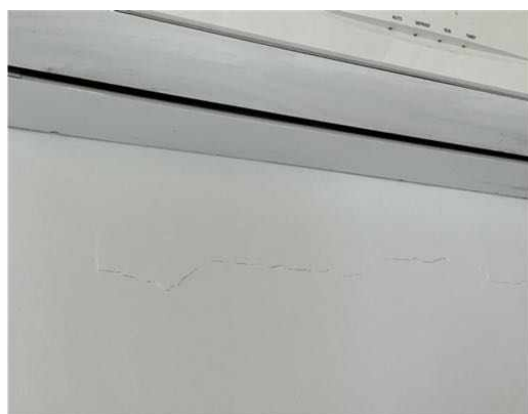
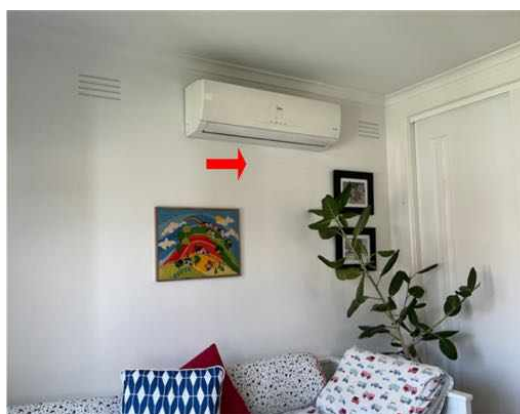
### Defects 3.09

Building:	Main Building
Location:	Bedroom
Finding:	Cracking - Damage Category 1 - Fine (up to 1mm)
Information:	Although fine cracks are quite noticeable, they are often only considered to be an appearance defect, and usually do not indicate any structural damage. Generally, the cause of a fine crack is indicative of a separation between building materials and finishes (e.g. paint, plaster, etc.) along joins.

Cracking of this nature can generally be repaired with minor sanding, filling and/or repainting. Such works should be performed by a qualified painter or a general handyman.

Monitoring of all cracking should be conducted frequently. Always contact a building inspector should cracks widen, lengthen, or become more numerous.

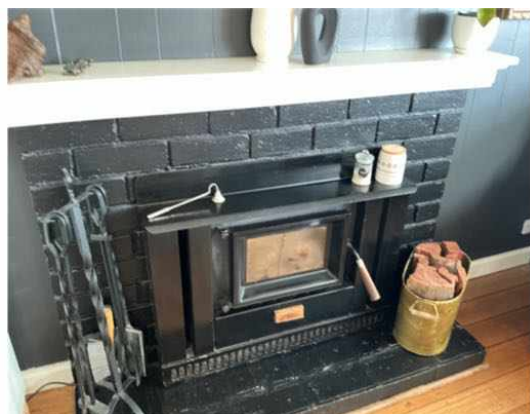
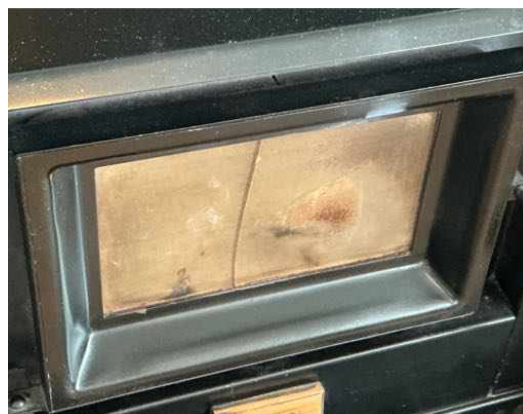
### Defects 3.10

Building:	Main Building
Location:	Fireplace
Finding:	Glass - Cracked
Information:	Cracks were identified in the glass in this area. Cracking is generally the result of

impact damage, and is likely to develop further when left unmanaged.

The likelihood of this glass further cracking and shattering is increased exponentially, providing a safety hazard in the area. The crack also impairs the thermal efficiency.

A qualified glazier is required to repair the glass as soon as possible. Depending on the extent of the cracking, replacement of the window may be required. Please be advised that any persons coming into contact with the cracked window should do so with due caution to avoid any personal injury that may ensue.

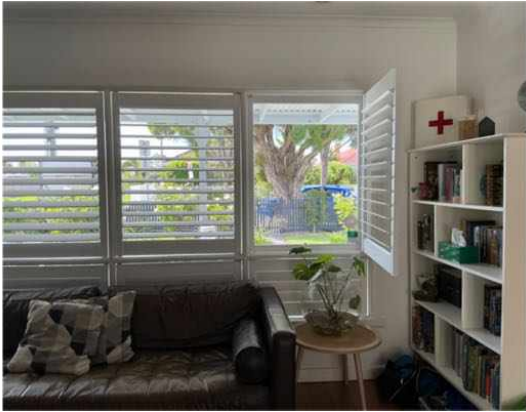
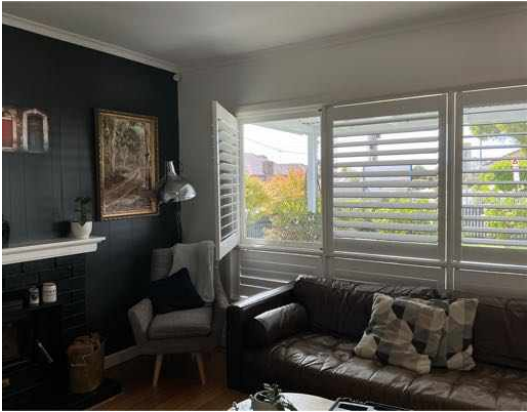
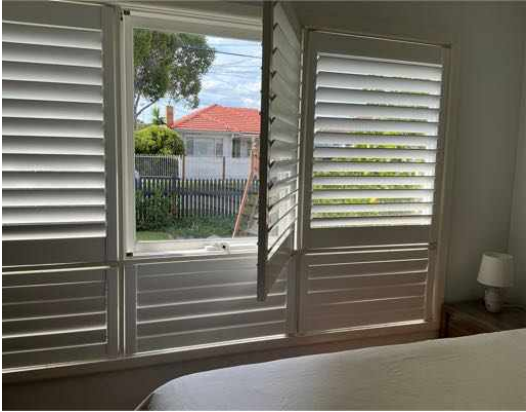
### Defects 3.11

Building:	Main Building
Location:	Windows
Finding:	Sticking or jamming
Information:	Building elements which are sticking or jamming are difficult to operate and don't function as intended. There are a variety of causes for sticking and jamming.

The most usual causes are swelling of timbers due to moisture, bulging or bowing of metal frames, or general material deterioration. Generally, sticking and jamming building elements indicate that their frames are uneven or out of level, generally as result of movement to surrounding walls and floors.

Easement will be required, which usually depends on the building materials used. This may involve some sanding and/or application of a lubricant. It will almost always include ensuring the areas are cleaned and free of any debris that may be detrimental to their operational state.

Appointment of a carpenter or general handyman is recommended to rectify any sticking/jamming building elements.

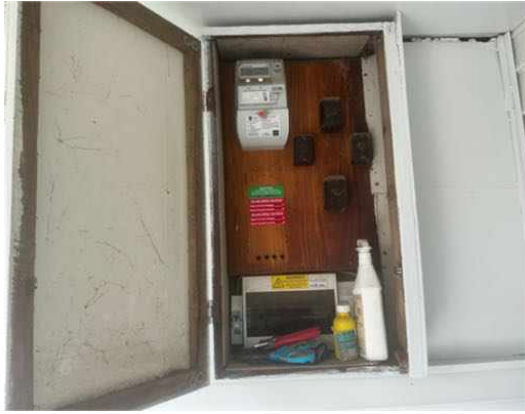
### Noted Item

Building: Main Building  
 Location: Electrical Switchboard  
 Finding: Termite Management System - no evidence of a chemical installation  
 Information: The application of a post-construction chemical termite barrier is highly recommended for all properties, particularly if live termite activity has been found on the site previously. Such barriers are highly effective in preventing termite attack on any timber building elements throughout the property.

A durable notice should be placed in the switchboard unit to indicate current termite barriers. At the time of inspection, it appeared as though no termite management system has been installed, with no evidence to suggest preventative works taking place.

The client may consider gaining further advice from a pest controller as to the costs and procedures involved with this application. It is recommended that obtaining such advice be a short-term priority.

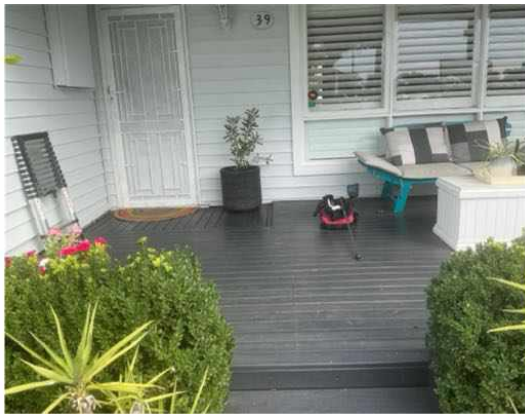
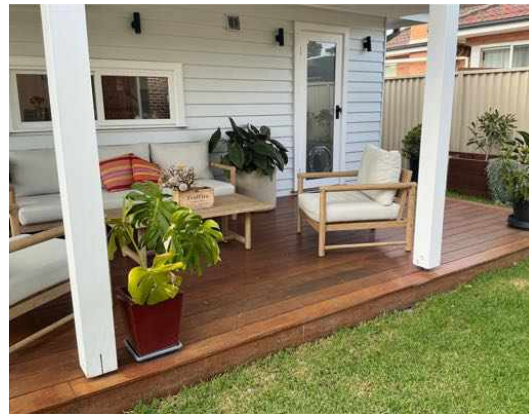
### Noted Item

Building: Main Building  
 Location: Deck  
 Finding: External Timber Balcony or Deck - Structural Stability  
 Information: The load capacity of the external balcony or deck could not be verified during the inspection.

External timber structures are also constantly exposed to weather elements and can deteriorate in an accelerated manner, ongoing assessments are required.

It is highly recommended that a Structural Engineer further assess the external timber balcony or deck to inform the client of its load capacity. Regular maintenance inspections by competent practitioners is needed.

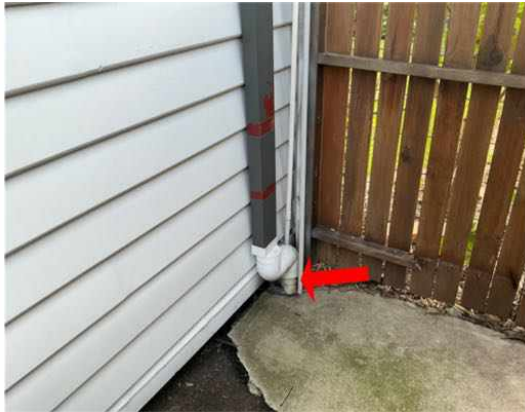
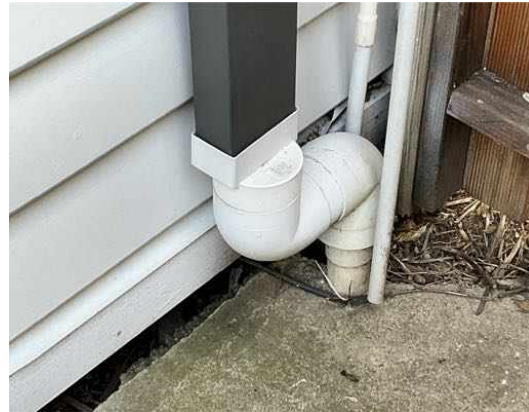
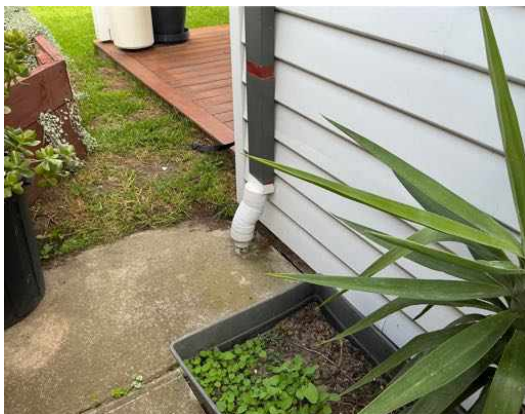
### Noted Item

Building: Main Building  
 Location: Exterior walls - left side  
 Finding: Unconventional handyman plumbing work  
 Information: This handyman work appears to have been completed to a substandard level and does not comply with regular building practices. Where handyman work is not completed satisfactorily, accelerated deterioration of the associated building elements

is likely to occur and secondary defects to surrounding structures may develop.

It is highly recommended that the substandard work be rectified by professional services. Works to improve this area are likely to increase the safety and the operation of the associated building elements.

The client should exercise care when coming into the immediate vicinity of the substandard works. Rectification works are advised as soon as possible by the appropriate trades.
