# Building and Timber Pest Inspection Report

Inspection Date: Thu, 2 Apr 2026

Property Address: 21/30-34 Cambridge St, Epping NSW 2121, Australia

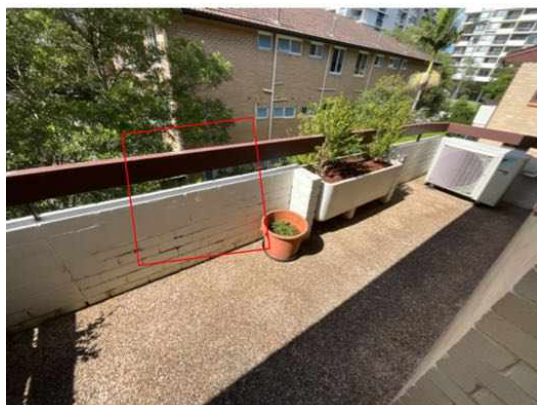
Building:	Main Building
Location:	Balcony
Finding:	Balustrade - Suspected Non-Compliance
Information:	The balustrade was measured and found to be less than the present building regulation requirement of 1000mm high. Additionally the gaps between the balustrade cladding were found to be greater than the present building regulation requirement of 125mm.

This defect creates a potential safety hazard and should be rectified as soon as possible to ensure the safety of the area and to meet present building standards and regulations.

The balcony balustrade was found to be non-compliant, requiring immediate rectifications by a licensed builder.

A licensed builder should be contacted to discuss possible rectification solutions.

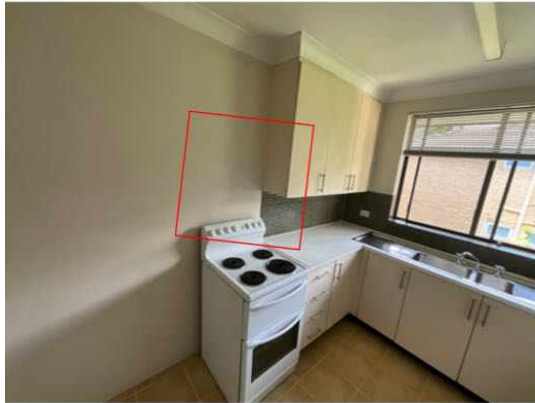
#### Finding 1.02

Building:	Main Building
Location:	Kitchen
Finding:	Exhaust fan - Missing
Information:	An exhaust fan has not been installed in this area. Missing exhaust fans may lead to the development of more significant defects such as moisture damage to surrounding building materials from inadequate ventilation. Inadequate ventilation in internal areas

A complying exhaust fan was missing in the kitchen, requiring urgent works by a licensed electrician.

creates an environment that is conducive to the formation and development of mould and other respiratory hazards. It is highly advised that a licensed electrician be appointed to retrospectively install an exhaust fan. Failure to perform works to aid the ventilation of the area may lead to the development of these secondary defects.

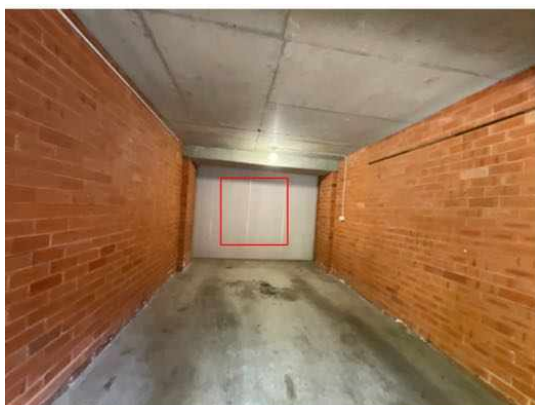
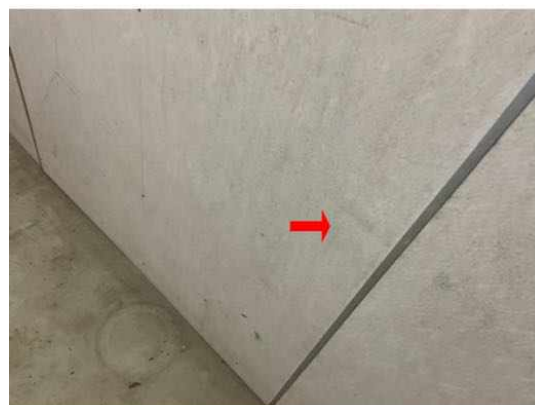
### Finding 1.03

Information: Reporting on Asbestos is outside the Scope of this Report. This suspected defect is highlighted as a caution only. We suspect, based on our experience in the building industry, that there is a higher risk of the identified building element containing asbestos.

A safety hazard was in relation to ACM in the garage. As per outlined in this report it is only suspected, however until it is tested, it will have to be treated as suspected asbestos. We recommend further laboratory testing for verification.

As Asbestos Reporting is outside the scope of this report, we advise that you consider a separate Asbestos Inspection and Condition Audit, which can include the taking of samples for definitive confirmation of the presence of Asbestos.

In the interim, the client is advised to act with caution, especially when considering any damage to building materials general wear and tear renovations extensions demolition and general maintenance activities due to the suspected presence of Asbestos.

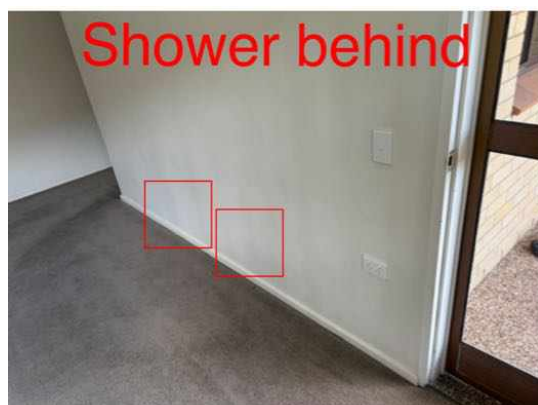
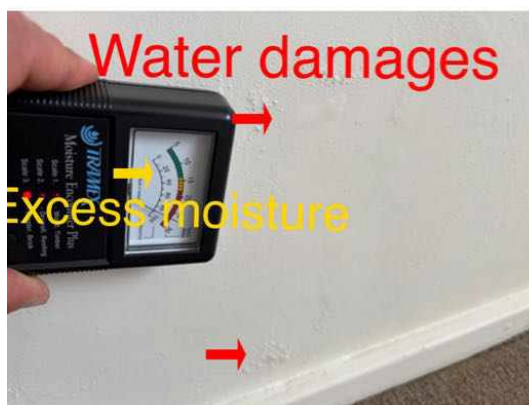
### Finding 2.01

Building:	Main Building
Location:	Lounge Room
Finding:	Water leak suspected - Internal
Information:	A water leak is suspected in this area at the time of inspection. Internal water leaks can be detrimental to surrounding building elements. It is believed that an internal shower leak is presently addressed since the shower internal was found to have been recently sealed. The excess moisture is suspected to be residue moisture in the wall that will eventually dry out.

Rust, corrosion, decay and water damage are potential outcomes where a minor water leak is left unattended. More serious defects may also result, such as electrical hazards, or water damage to structural building elements.

Excess moisture was identified to the lounge room wall behind the shower. Furthermore water damages to the surface indicate an active internal water leak. On further assessment of the shower, recent sealant was identified to the wall and floor junctions, which may represent repair work. A bathroom specialist must be appointed urgently for further assessment and to complete any required rectifications.

In extreme cases, structural damage may develop due to a prolonged water leak. It is highly advised that a bathroom specialist be appointed urgently for further assessment and to confirm adequacy of the recent repairs.

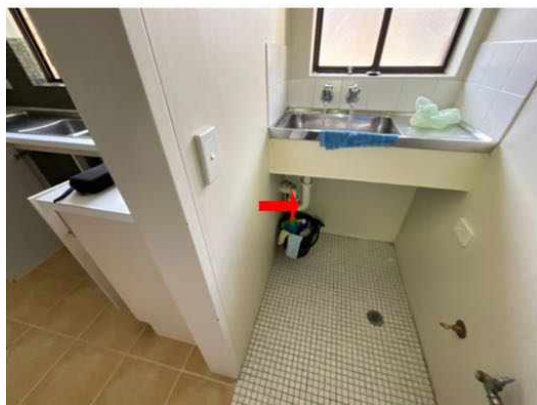
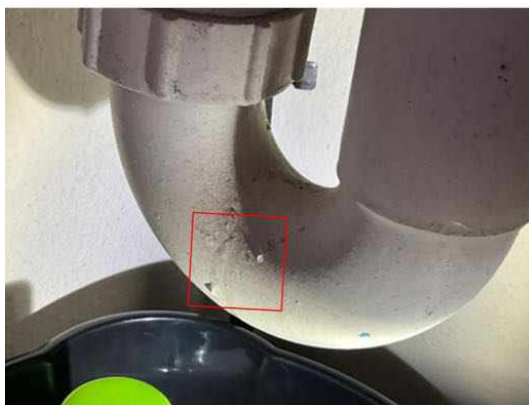
### Finding 3.01

Building:	Main Building
Location:	Laundry
Finding:	Water leak - Active
Information:	Generally, water leaks occur when a particular area of the property is not weather or water tight. As the surrounding area was found to be damp at the time of inspection, the leak is considered ongoing and hence requires urgent action.

Regardless of the location, even minor leaks that are left unmanaged can lead to

serious damage of associated building elements and result in the need for replacement of building materials. Mould and other hazards such as electrical hazards may also arise if the leak is left to develop.

It is highly advised that the cause of the leak be identified and resolved immediately by a licensed plumber to prevent any further damage. Depending on the extent of the damage previously sustained, repair and/or replacement of any affected building materials may be required.

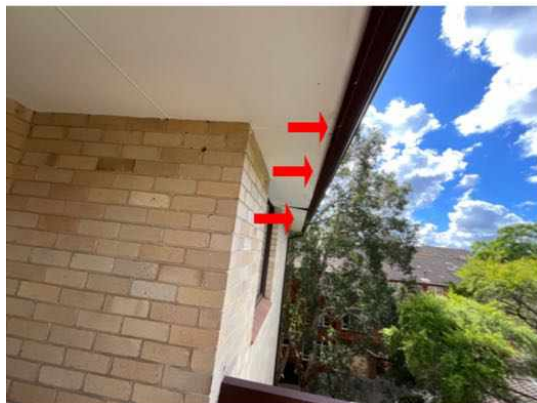
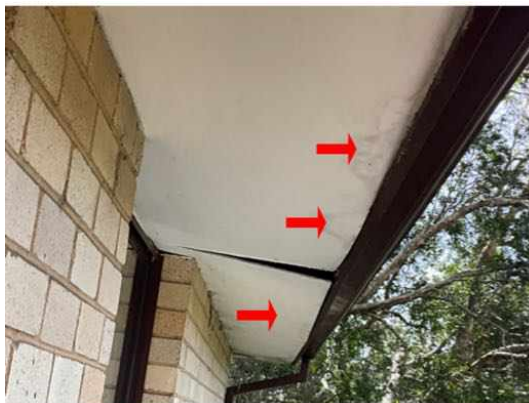
### Finding 3.02

Building:	Main Building
Location:	Eaves
Finding:	Eaves/Roof plumbing -- water damages
Information:	Water damage is generally an indication of excessive moisture being present, usually via a leak. It is suspected that gutter blockages causing stormwater to backflow into the eaves causing water damages. This is additionally conducive to termite activity due to the damp conditions.

Where water damage is evident, the primary requirement is to identify and rectify the source of the leak. Gutters must be kept clear of any blockages moving forward. A roofing plumber should be appointed for further assessment if the problem persists.

Once the leak is repaired, consultation with relevant tradespeople, including carpenters, plasterers and painters, is advised.

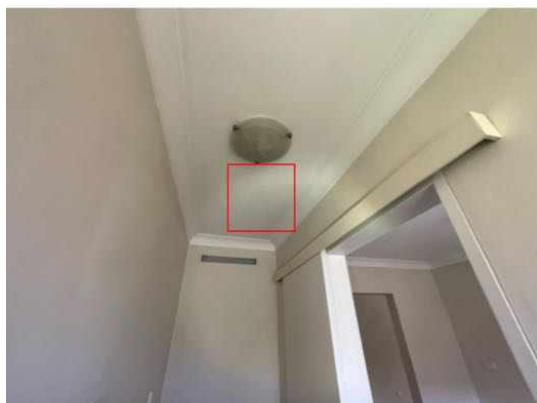
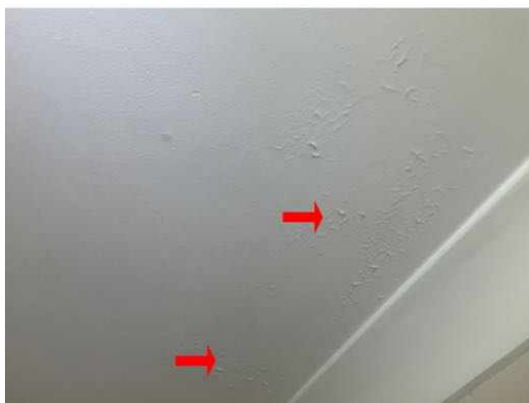
### Finding 3.03

Building:	Main Building
Location:	Laundry
Finding:	Paint cracking and peeling
Information:	Cracking and ultimately flaking of paint can occur for a variety of reasons. Often these failures are due to the fact that the paint has inadequate adhesion and flexibility, both common problems with lower quality exterior flat paints.

When timber is involved, moisture intrusion results in swelling of the wood surface followed by contraction as the wood dries. The expansion and contraction cycles, can result in cracking and subsequent paint failure by flaking and peeling.

Cracking and flaking can also result when paint is applied too thinly due to overspreading (higher-than-recommended spread rate) or excessive thinning. These practices tend to diminish the paint's final film thickness, so that it is more vulnerable to cracking and flaking.

Inadequate surface preparation can also cause these failures, especially when paint is applied to bare wood or a very porous surface without first applying a primer.

A qualified painter should be appointed to rectify the problem.

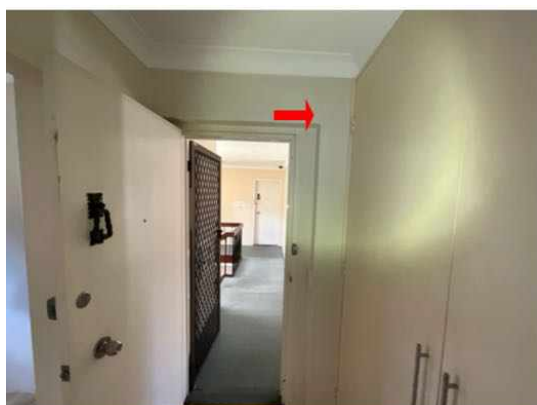
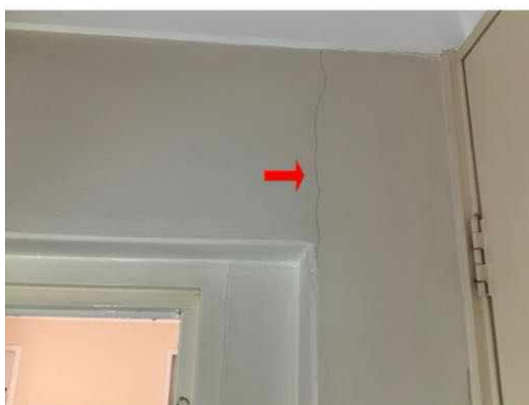
### Finding 3.04

Building: Main Building  
 Location: Entry  
 Finding: Cracks to internal render - Category 0  
 Information: It has been observed that cracking to internal rendered surfaces has occurred. The degree of damage falls within Category 0, and is described as hairline cracking, which is less than 0.1mm in width. Damage of this category is not considered a defect for rectification.

No rectification is required at this time. Always contact your building inspector should cracks widen, lengthen, or become more numerous.

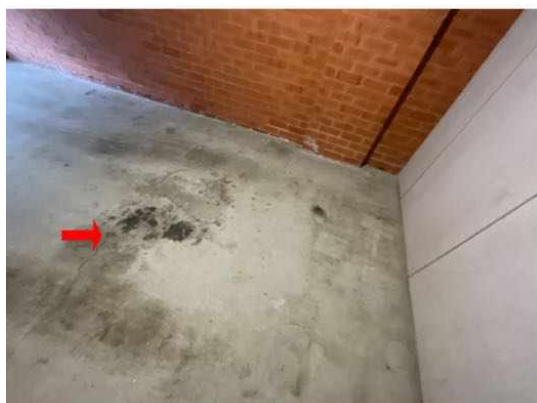
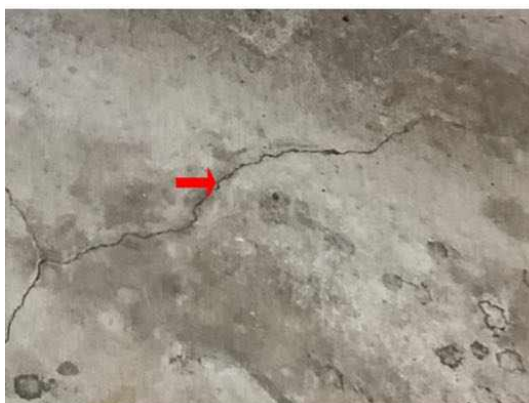
### Finding 3.05

Building: Main Building  
 Location: Garage  
 Finding: Crack in concrete slab - Category 1  
 Information: A crack coded as Category 1 was identified in the slab. A Category 1 crack is described as a fine but noticeable crack, with the slab at an otherwise reasonable level.

To be considered Category 1, the approximate width of the crack is less than 1.0mm, or a less than 10mm change in offset when a 3m straight edge is placed over the defect.

Category 1 cracks should be monitored for a period of 12 months. At the end of the monitoring period, identified cracks that are rated greater than Category 2 are considered defects, and require rectification.

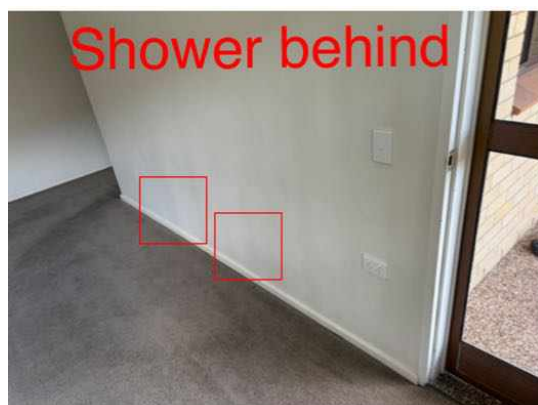
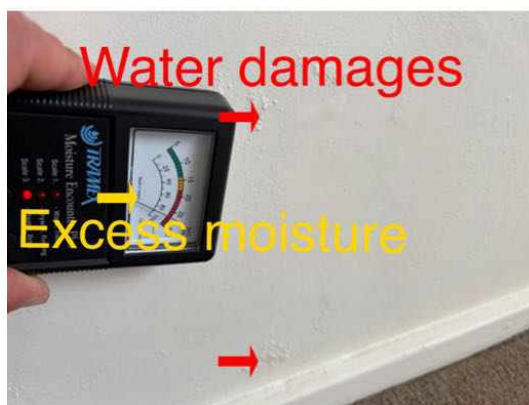
Building: Main Building  
 Location: Lounge Room  
 Finding: Water leak suspected - Internal  
 Information: A water leak is suspected in this area at the time of inspection. Internal water leaks can be detrimental to surrounding building elements. It is believed that an internal shower leak is presently addressed since the shower internal was found to have been recently sealed. The excess moisture is suspected to be residue moisture in the wall that will eventually dry out.

Rust, corrosion, decay and water damage are potential outcomes where a minor water leak is left unattended. More serious defects may also result, such as electrical hazards, or water damage to structural building elements.

In extreme cases, structural damage may develop due to a prolonged water leak. It is highly advised that a bathroom specialist be appointed urgently for further assessment and to confirm adequacy of the recent repairs.

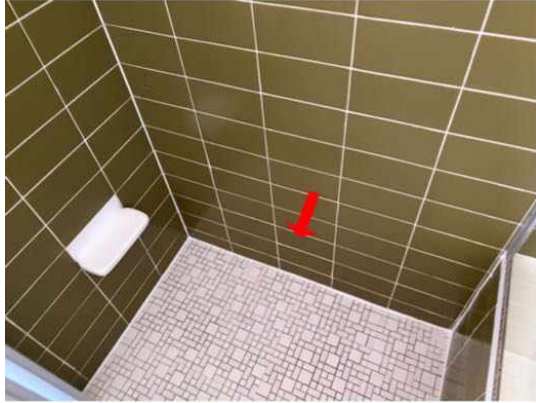
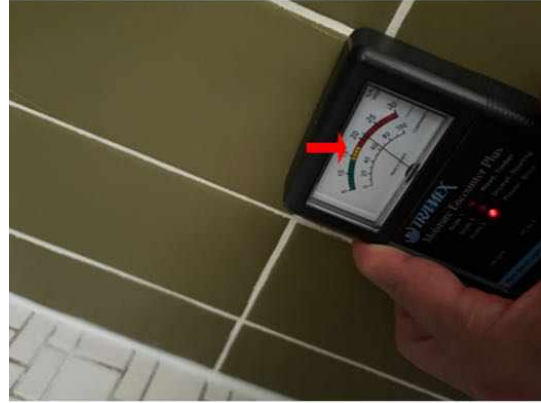
### Finding 6.02

Building:	Main Building
Location:	Bathroom
Finding:	Shower damp - Monitor
Information:	Damp is evident to the lower 400mm of wall to the shower alcove. There is no high reading around the taps nor are there high readings transferring to the other side of the wall. Sealant appears to have been repaired recently and both sealant and grout appear in acceptable condition at present.

This defect is quite common, and is suspected to have been caused by moisture permeating or leaching through the grouting and perhaps gaps in the sealant prior to repair.

Damp (or structural damp) refers to the presence of unwanted moisture in the structure of a building, either as the result of intrusion from outside, or condensation from within the structure. In the shower area, internal water leaks or other sources of excessive moisture are generally the cause of damp.

Unmanaged damp in the shower recess is likely to facilitate the formation and development of mould and fungi growth, decaying associated building materials and compromising their structural integrity. It is important to address damp conditions, as the World Health Organisation notes that excess moisture leads - on almost all indoor materials - to growth of microbes such as moulds, fungi and bacteria, which subsequently emit spores and other matter into the indoor air. Exposure to these contaminants is associated with a wide range of respiratory and other health-related problems.

Monitoring the area is advised and if any visual signs of excessive moisture appear (peeling paint, mould) then consultation with a qualified plumber or bathroom specialist would be advised to identify the cause of damp and to perform remedial works as required.

Always ensure that sealant and grout is in good condition to prevent any moisture issues occurring in the future.
