Building and Timber Pest Inspection Report

Inspection Date: Thu, 2 Apr 2026

Property Address: 50 Richmond St, Earlwood NSW 2206,
Australia

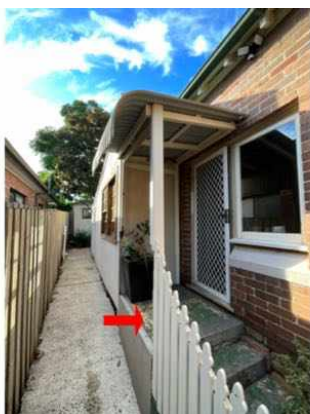
Finding 1.01

Building:	Main Building
Location:	External Areas
Finding:	Wood rot
Information:	This building element shows evidence of wood rot. Wood rot, also known as Fungal Decay, occurs when timbers and other cellulose building materials are exposed to damp conditions on an ongoing basis. This could be the result of exposure to weathering over a prolonged period of time, or the attraction of excessive moisture from other abutting building materials.

A qualified carpenter or registered builder may also be required to replace affected building materials.

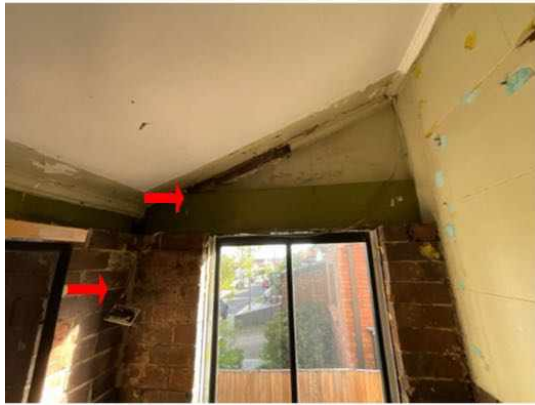
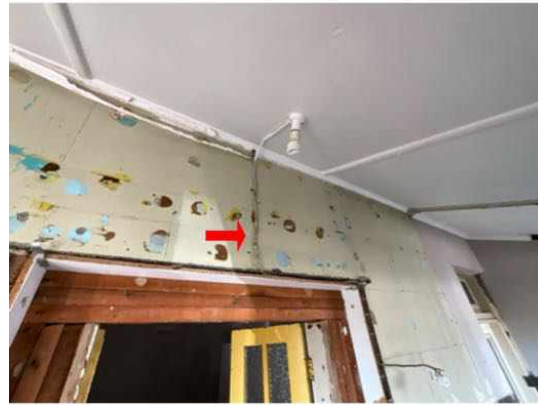
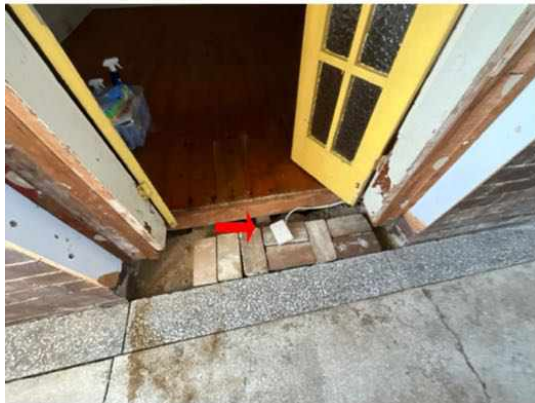
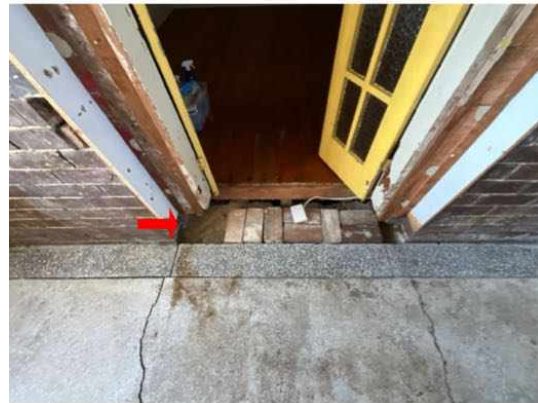
Finding 1.02

Building:	Main Building
Location:	Front Porch
Finding:	Incomplete Works to Front Porch – Sill, Beading and Electrical Fixtures
Information:	Unfinished items were noted to the front porch, including incomplete doorway sill installation, missing or unfinished beading, power points not fixed to walls, and electrical wiring without conduit protection.

Incomplete building and electrical works may affect durability, appearance, and safety. Exposed wiring without conduit presents a potential safety hazard.

A builder and licensed electrician should complete the outstanding works, including installation of the doorway sill and beading, secure fixing of power points, and protection of wiring with appropriate conduit.

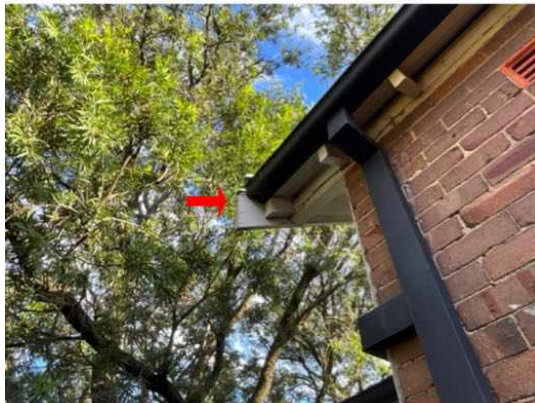
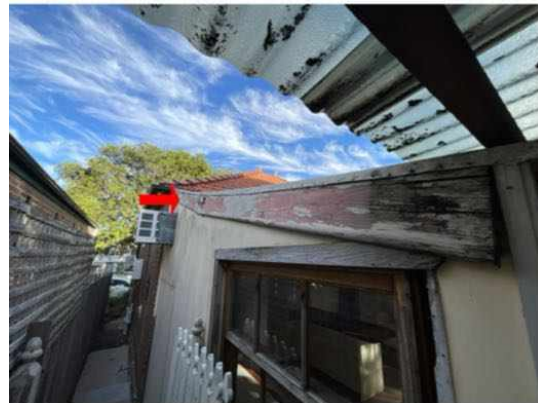
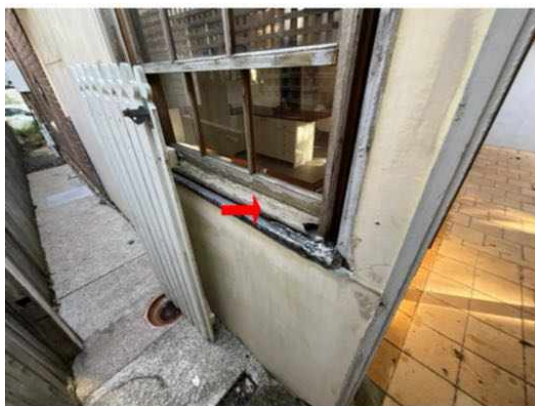
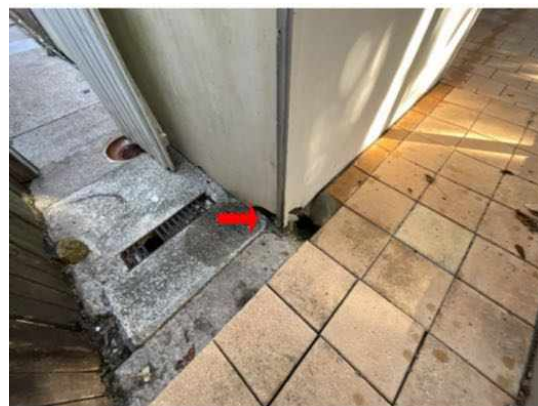
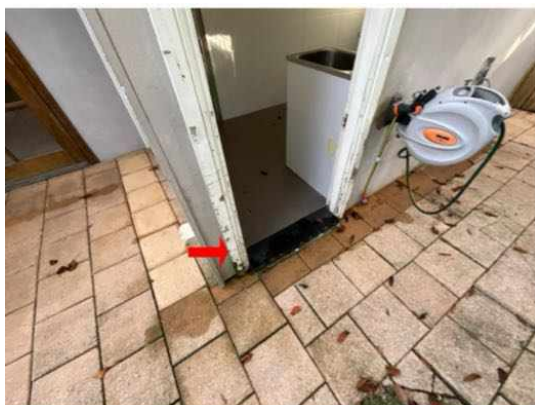
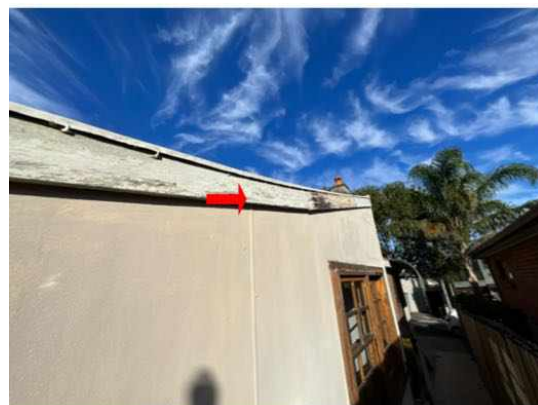
Building:	Main Building
Location:	External Areas
Finding:	Wood rot
Information:	This building element shows evidence of wood rot. Wood rot, also known as Fungal Decay, occurs when timbers and other cellulose building materials are exposed to damp conditions on an ongoing basis. This could be the result of exposure to weathering over a prolonged period of time, or the attraction of excessive moisture from other abutting building materials.

Early intervention and regular maintenance, particularly of exterior timbers, will prolong the useful life of these building elements. Prior to any works being performed, the cause of the moisture that has created the visible wood rot should be identified and addressed in a suitable manner. Replacement of affected timbers may then be a necessary step in protecting surrounding building elements from such deterioration.

A qualified carpenter or registered builder may also be required to replace affected building materials.

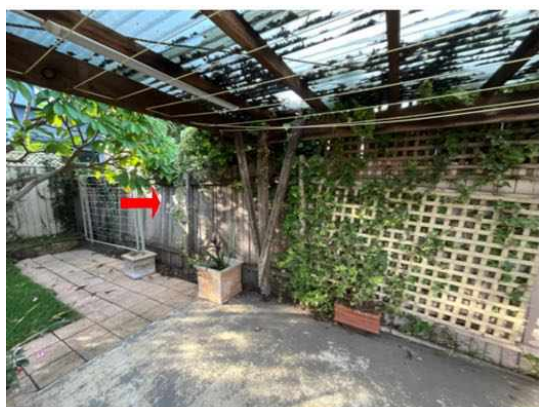
Finding 3.02

Building:	Yard
Location:	Fencing
Finding:	Fencing - Deteriorated
Information:	It was noted at the time of inspection that sections of the fencing throughout the property have deteriorated. Typically fencing deteriorates due to age and or wear, rot and or rust which is generally expected for a structure of this age, due to prolonged exposure to weather conditions. Sometimes inadequate installation or maintenance

If left unattended, it is likely that further damage will occur. It is suspected that repair of several elements of the fencing may be required however replacement may be a consideration of the client also.

A licensed fencing contractor should be appointed to provide further advice and perform rectification works as necessary.

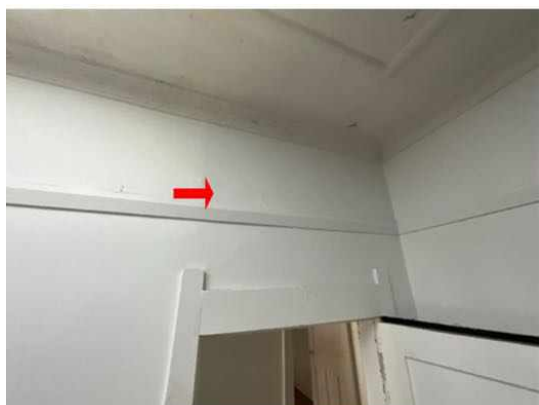
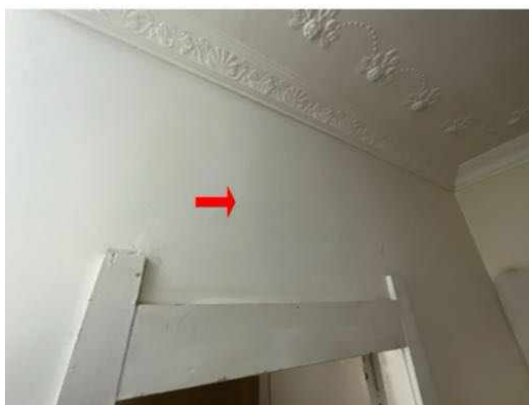
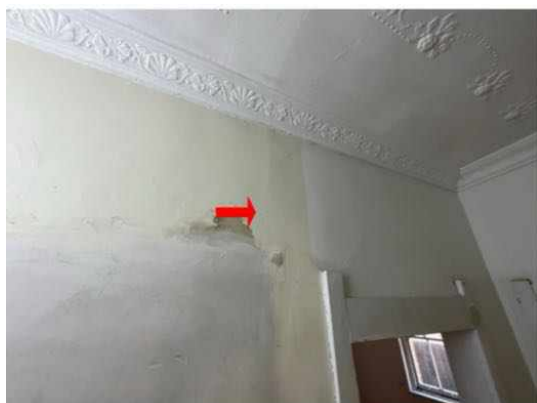
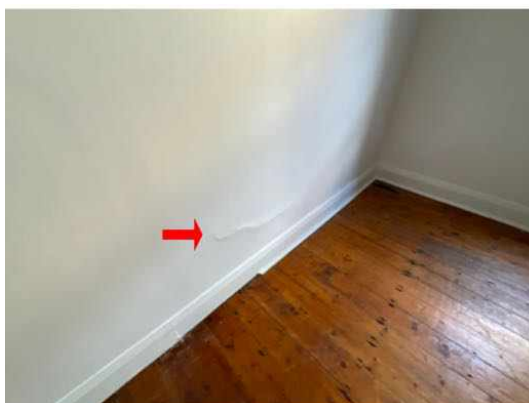
Finding 3.03

Finding: Cracking - Damage Category 2 - Noticeable (up to 5mm)

Information: Noticeable cracks are a common occurrence as a result of many primary defects. Such causes may include age, general wear and tear, expected building movement, general expansion/contraction of building materials in different weather conditions, and/or minor failings in the installation or application of building materials.

I recommend monitoring and if further cracking is evident appoint a bricklayer to see what works are required.

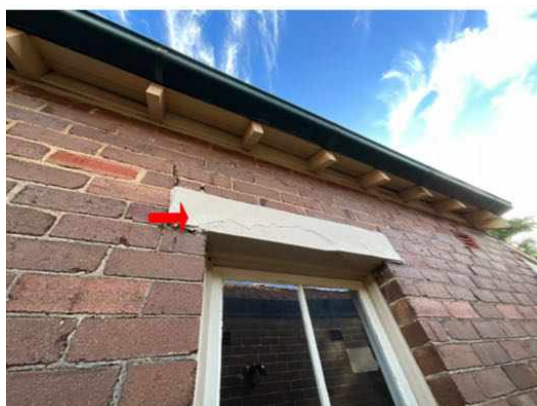
Finding 3.04

Building:	Main Building
Location:	Exterior walls
Finding:	Lintel - Deteriorated
Information:	The lintel in this area is showing signs of deterioration.

I recommend appointing a bricklayer to see what necessary works are required.

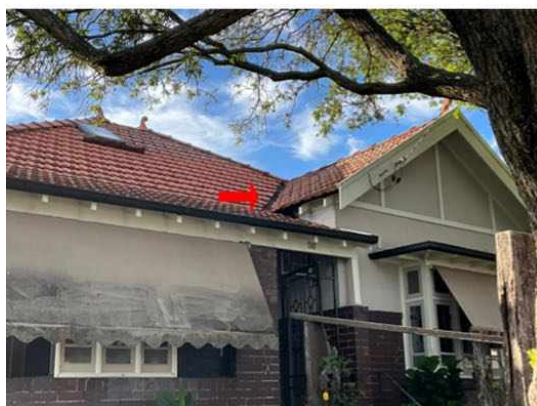
Finding 3.05

Building:	Main Building
Location:	Roof Exterior
Finding:	Building element - Rusted or corroded
Information:	This building element shows evidence of rusting and corrosion, which is likely to have developed as a result of excessive exposure to moisture and or inadequate coatings.

As surface rust provides no protection to the underlying iron, the deteriorating condition is likely to worsen if not addressed in the short-term future.

Rusting and corrosion should be managed by ideally removing or limiting the affected surface from exposure to moisture.

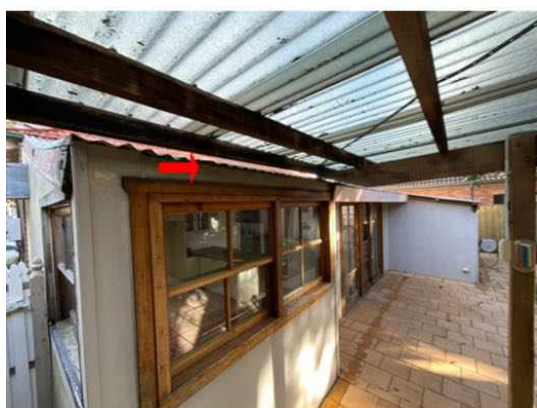
Finding 3.06

Building:	Main Building
Location:	Roof Exterior
Finding:	Roof plumbing - Missing
Information:	Some sections of the roof are not adequately drained via gutters and downpipes. Gutters and downpipes that are not installed adequately are likely to result in excessively damp conditions against the exterior surfaces and around the base perimeter of the building.

A roofing plumber should be appointed to install relevant roof plumbing materials.

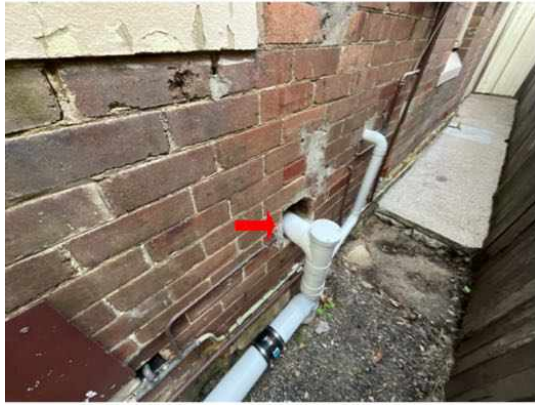
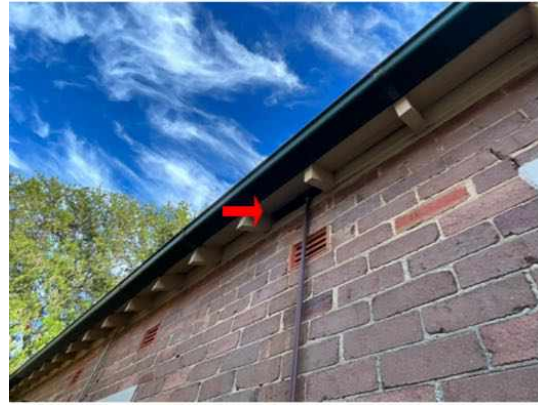
Finding 3.07

Building:	Main Building
Location:	Exterior walls
Finding:	Pest ingress
Information:	An external hole was located at the time of inspection. This hole appears to be large

enough to allow bird rodent or other pest ingress creating the potential for nesting or infestation of live animals.

To ensure no such infestation occurs this hole should be adequately covered. Holes such as these are also likely to attract rain penetration which may lead to subsequent water damage to associated structures if left unmanaged.

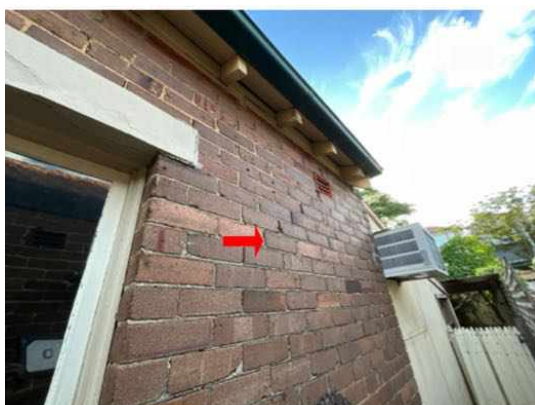
Finding 3.08

Building:	Main Building
Location:	Exterior walls - right side
Finding:	Brickwork - Cracking noticeable
Information:	There were several cracks and or crack repairs evident to external brickwork.

Noticeable cracks are a common occurrence in external brickwork and are a likely result of age expected building movement, general expansion, and/or contraction of building materials in different weather conditions. Noticeable cracks in brickwork may develop if left unattended, with potential for necessitating major remedial works or replacement of the brickwork.

Although the wall does appear to be stable It is advised that a structural engineer be appointed to provide further advice.

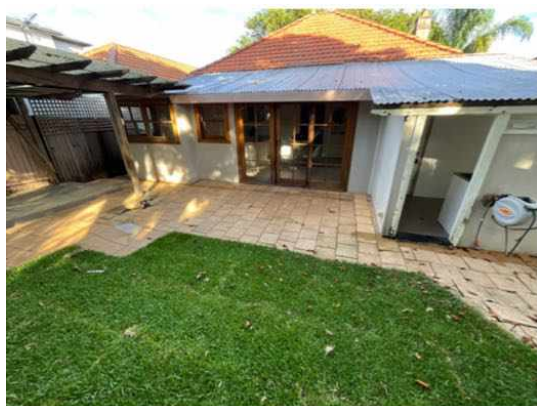
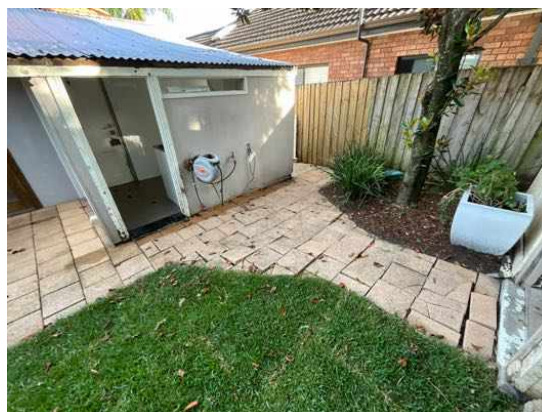
Finding 3.09

Building:	Yard
Location:	The Site
Finding:	Site drainage - Inadequate
Information:	The site drainage in this area was found to be inadequate at the time of inspection, creating potential for subsequent water damage to associated building elements.

Where site drainage is inadequate, installation of drains may be required. A qualified plumber should be appointed to further inspect the property and perform any remedial works as necessary. Water damage and secondary defects are likely to occur if left unmanaged.

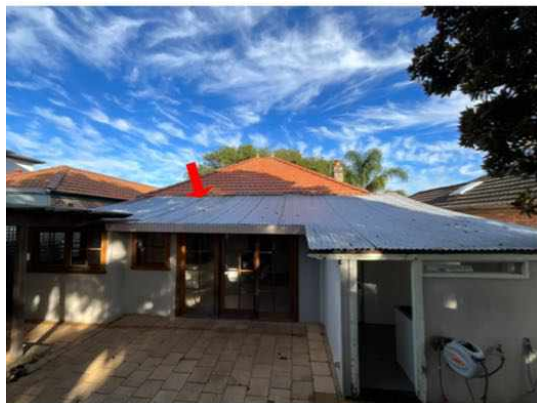
Finding 3.10

Building:	Main Building
Location:	Roof Exterior
Finding:	Roof sheets - Rusted
Information:	Metal roofs generally comprise numerous individual sheets, which join and overlap. These intersections are particularly prone to lift at the edge and consequently rust at these points.

Upon inspection of the exterior roofing structure, evidence of rust to these sections was identified.

A roofing contractor should be appointed to assess the damage to the roofing sheets and to perform remedial works as necessary.

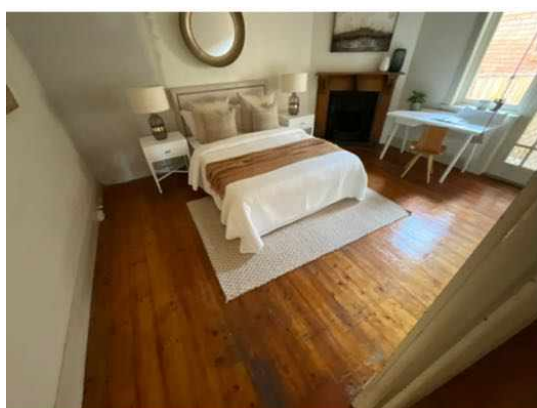
Finding 3.11

Building:	Building 2
Location:	Bedroom
Finding:	Floors - bouncy
Information:	The internal flooring in this area was identified as being bouncy at the time of inspection. A bouncy floor surface generally presents as a discernible change in level as they are walked across, in noisy or creaking flooring, or in consequent movement of surrounding furniture and fixtures.

Bouncy floors generally indicate that the floorboards or the subfloor structures are coming loose from the joists that they are installed on. Bouncy flooring may also be the result of gaps between flooring and stumps or joist structures, which require packing.

The client is advised to seek quotations for required repairs from a Registered Builder specialising in re-stumping. The potential resolution may range from packing gaps in subfloor structures through to replacement of subfloors stumps and refixing of flooring.

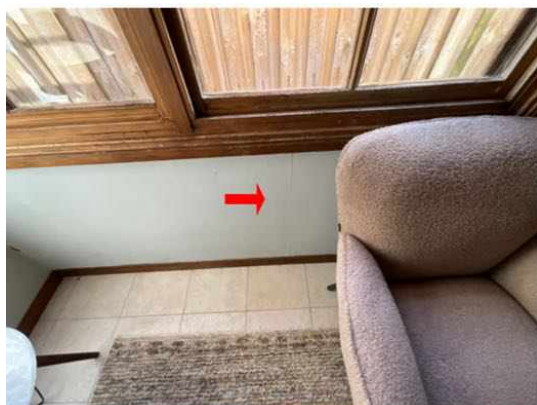
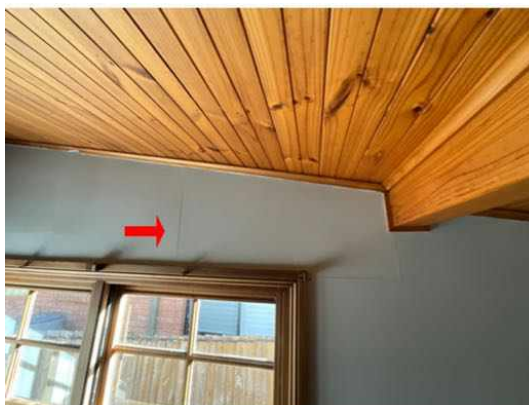
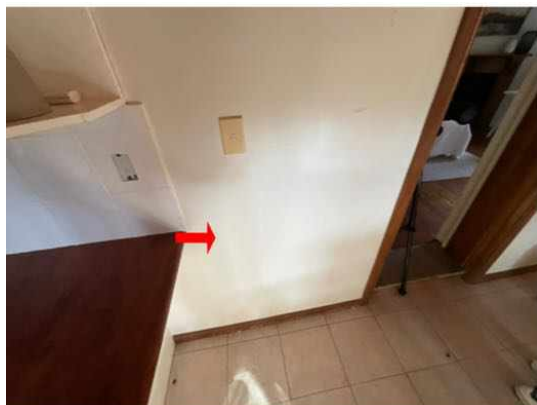
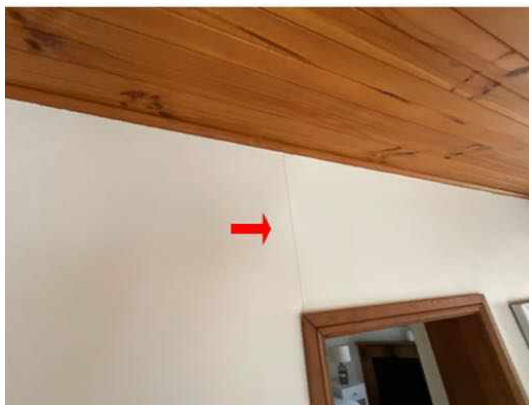
Finding 3.12

Finding: Cracking - Damage Category 1 - Fine (up to 1mm)
Information: Although fine cracks are quite noticeable, they are often only considered to be an appearance defect, and usually do not indicate any structural damage. Generally, the cause of a fine crack is indicative of a separation between building materials and finishes (e.g. paint, plaster, etc.) along joins.

Cracking of this nature can generally be repaired with minor sanding, filling and/or repainting. Such works should be performed by a qualified painter or a general handyman.

Monitoring of all cracking should be conducted frequently. Always contact a building inspector should cracks widen, lengthen, or become more numerous.

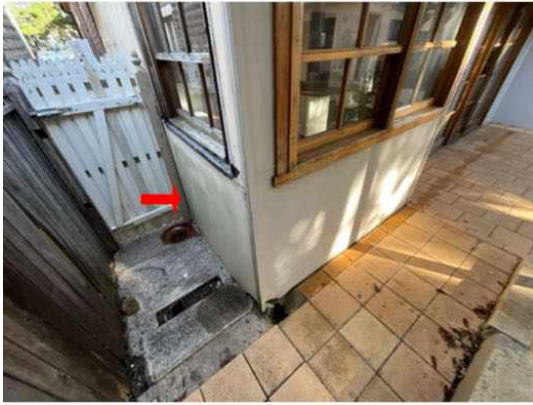
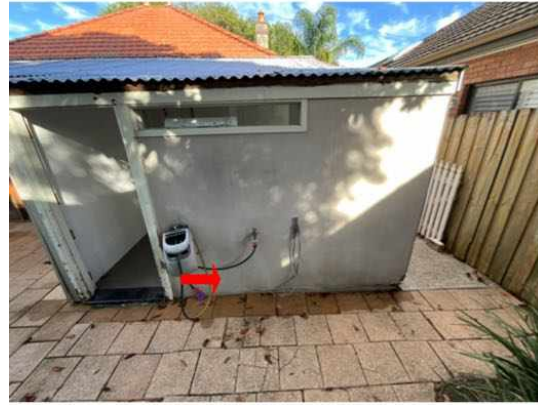
Finding 3.13

Building: Main Building
Location: Exterior walls
Finding: Deteriorated Linings
Information: It was identified that the exterior lining was deteriorated.

I recommend appointing a builder to see what necessary works are required.

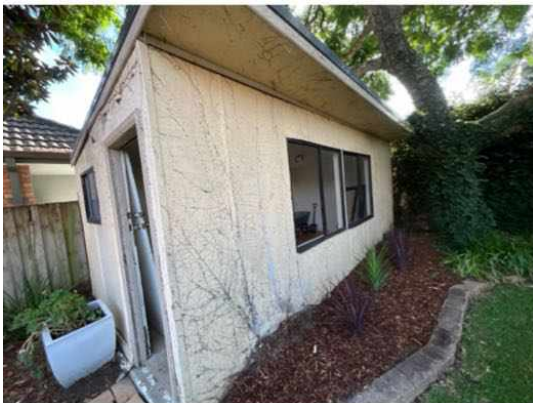
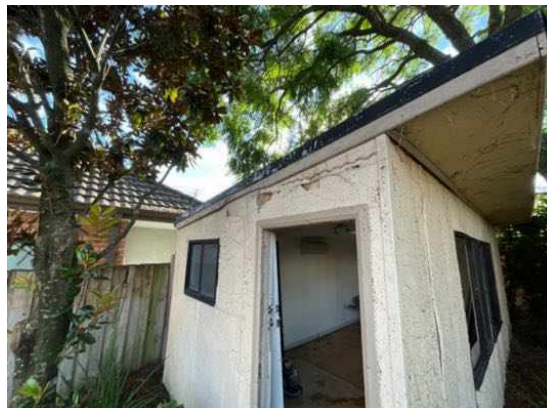
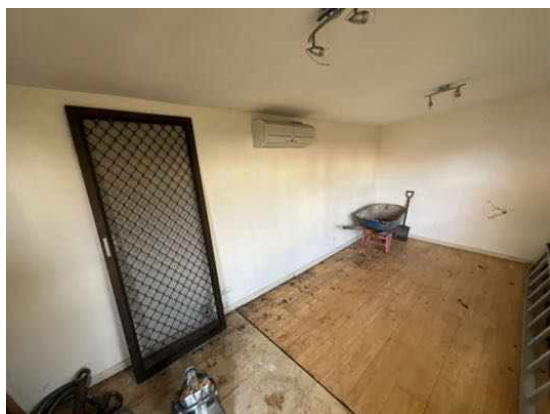
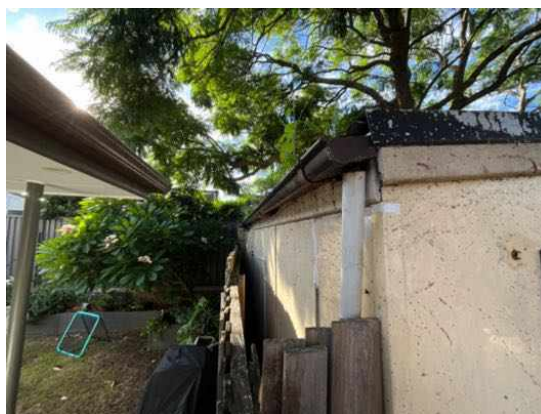
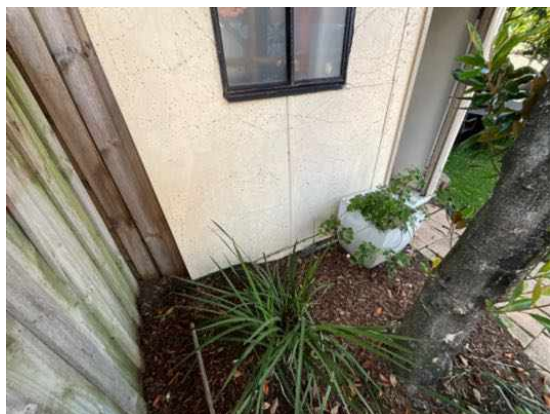
Finding 3.14

Building:	Shed
Location:	Shed
Finding:	Deteriorated Shed Structure with Blocked Gutter and Timber Decay
Information:	The shed structure is deteriorated, with a blocked gutter causing water overflow and penetration. The external lining is deteriorated, and wood rot is evident to timber elements.

Blocked gutters and water ingress are contributing to ongoing deterioration of the structure. Timber decay and degraded linings may compromise the durability and stability of the shed if not addressed.

The gutter should be cleared to restore proper drainage. A builder should assess the shed and carry out repairs, including replacement of rotted timber and reinstatement of external linings as required.

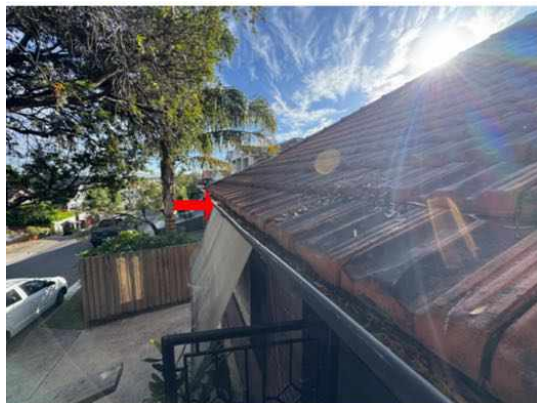
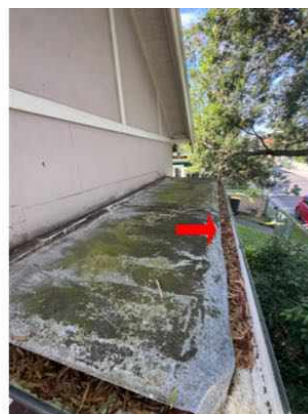
Finding 3.15

Building:	Main Building
Location:	Roof Exterior
Finding:	Gutters - Blocked
Information:	Roof plumbing structures, such as guttering and downpipes, should be free of all debris to prevent blockages. Blockages of the guttering and downpipes will lead to pooling and accumulated water overflows, which is likely to subsequently flood eaves and exterior walls.

Blocked gutters are likely to lead to high levels of moisture in the affected areas. Such moisture will not only cause rust and decay of the associated building materials, but can also provide conditions that are conducive to termite and timber pest activity. Blockages in gutters should therefore be removed to ensure dry conditions are maintained.

Consult a Licensed Plumber for further specific advice on remedial works that may be required. In the interim, it is highly advised that blocked gutters be removed by the homeowner or a general handyperson as a matter of urgency.

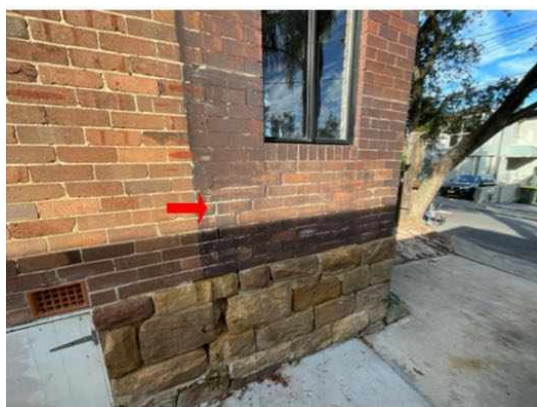
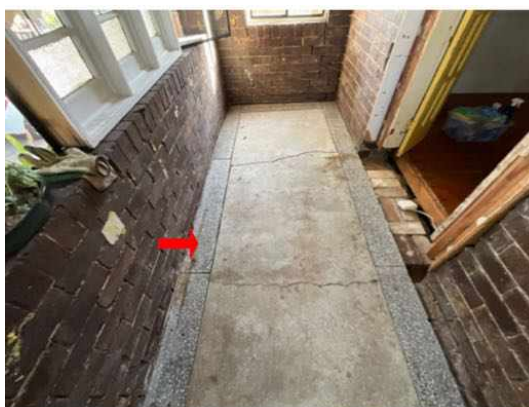
Finding 3.16

Building:	Main Building
Location:	Front Porch
Finding:	Cracking to Front Porch Brickwork and Concrete Floor
Information:	Cracking was observed to the brickwork and concrete floor of the front porch.

Cracking may indicate movement, settlement, or general deterioration. If ongoing, it may lead to further structural or cosmetic damage.

The area should be assessed to determine the cause of cracking, and repairs carried out as required to prevent further deterioration.

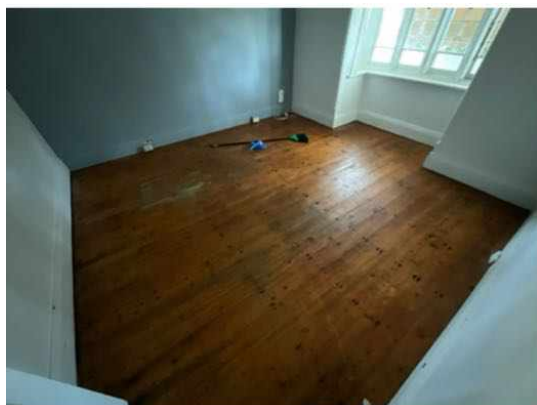
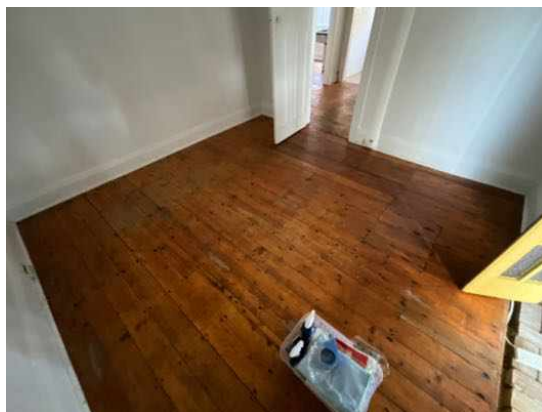
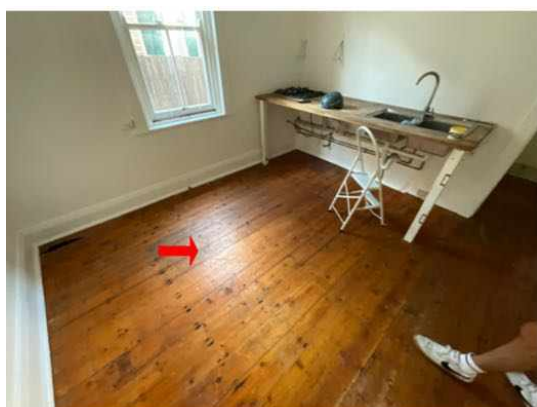
Finding 3.17

Building:	Main Building
Location:	Floors Throughout
Finding:	Floors - bouncy
Information:	The internal flooring in this area was identified as being bouncy at the time of inspection. A bouncy floor surface generally presents as a discernible change in level as they are walked across, in noisy or creaking flooring, or in consequent movement of surrounding furniture and fixtures.

coming loose from the joists that they are installed on. Bouncy flooring may also be the result of gaps between flooring and joist structures, which require packing.

On further inspection it was noted that there was termite damage evident to the subfloor structure.

The client is advised to seek quotations for required repairs from a Registered Builder.

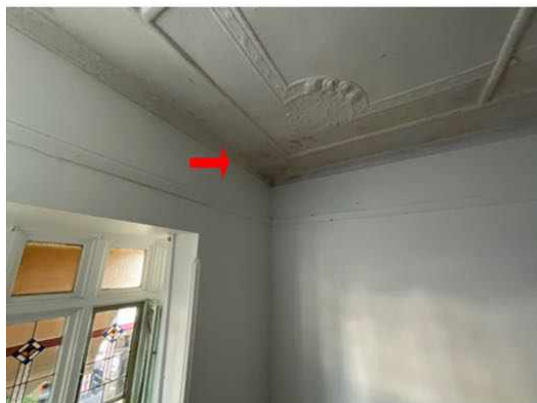
Finding 3.18

Building:	Main Building
Location:	Bedroom
Finding:	Ceiling - Water stained
Information:	Water staining to ceiling linings in this area was evident at the time of inspection. Water staining indicates that surfaces have been exposed to excessive moisture over time. The minerals and other elements in the water lead to staining, which may graduate to corrosion and deterioration if left unmanaged.

Although there was no moisture detected in the ceiling I would recommend monitoring and acting on one of the following.

Where water staining is active, a licensed plumber must be consulted to identify the cause of the staining and to provide advice on any reparation works that may be required. Replacement of any damaged structures is advised.

Conversely, where water staining is old and inactive, affected building materials may be repaired or replaced at client discretion.

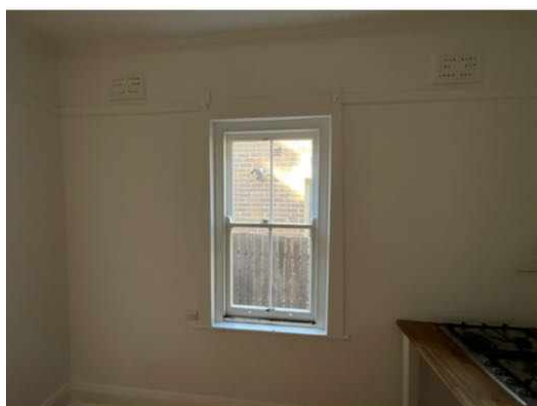
Finding 3.19

Building:	Main Building
Location:	Window
Finding:	Windows - Sash cords missing
Information:	Sashes are the moveable panes of windows that primarily slide vertically over each other to expose one half of the window area. Each sash is provided with springs balances and/or compression weather-stripping, which act to hold the window in place in one position.

To facilitate this operation the weight of the glazed panel is usually balanced by steel weights or counterbalances. The sash weight is connected by a cord or chain that runs over a pulley at the top of the frame. These cords are prone to degradation over time and replacement is required.

Repairing or replacing sash cords involves some work and is often best completed by an experienced carpenter or specialist window restorer. It is advised that such works be completed to improve the operational state of the affected window.

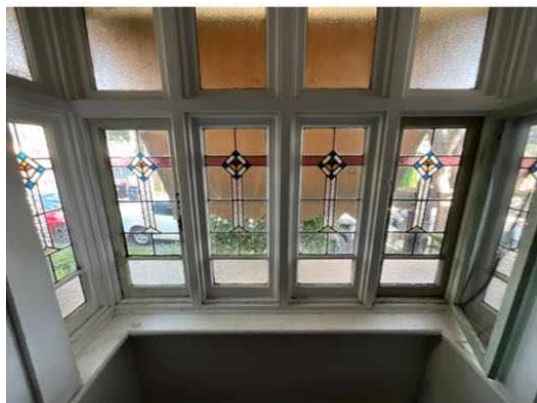
Finding 3.20

Building: Main Building
Location: Window
Finding: Glass - Cracked
Information: Cracks were identified in the glass in this area. Cracking in glass is generally the result of impact damage, and is likely to develop further when left unmanaged.

A qualified glazier is required to repair the glass.

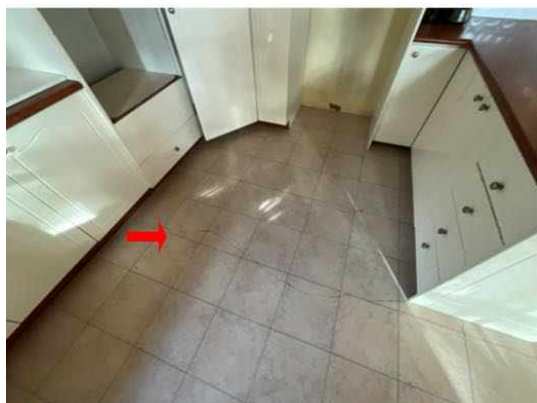
Finding 3.21

Building: Building 2
Location: Kitchen
Finding: Tile - Cracked or damaged
Information: Cracking was evident to the tiling in this area at the time of inspection.

I recommend appointing a tiling contractor to see what necessary works are required to replace any damaged tiles.

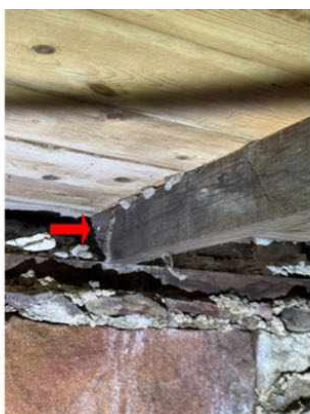
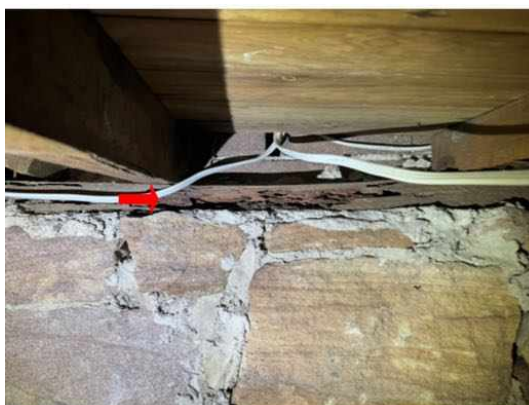
Building:	Main Building
Location:	Subfloor
Finding:	Termite - damage identified
Information:	Despite no live termite or timbered pest activity being indicated, termite damage was found to have affected this area.

A building contractor should be appointed to provide a further invasive inspection and to see what necessary works are required.

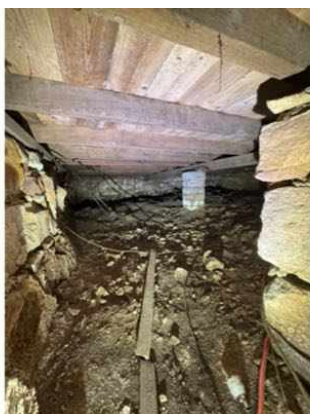
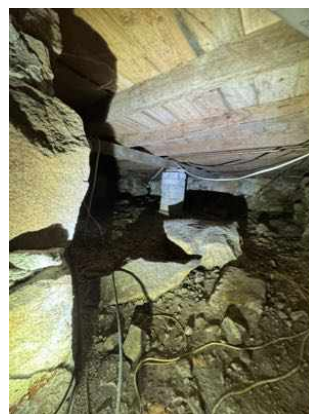
Information: An array of debris was found in the subfloor area at the time of inspection. Debris in this area restricts subfloor ventilation and creates potential for concealed pest entry. Stored timbers and other materials may also make the area susceptible to termite activity and wood rot.

Information: It was noted at the time of inspection that the subfloor area lacks adequate ventilation. Ventilation can be restricted by a variety of minor defects, including obstructions in the subfloor space, a lack of vents or a low clearance.

A clear and empty subfloor will be better ventilated and easier to maintain in a dry condition. The removal of any timber debris is vital in minimising the risk of termite or wood borer activity.

The client may also consider mechanical ventilation (powered fans) to improve subfloor airflow.

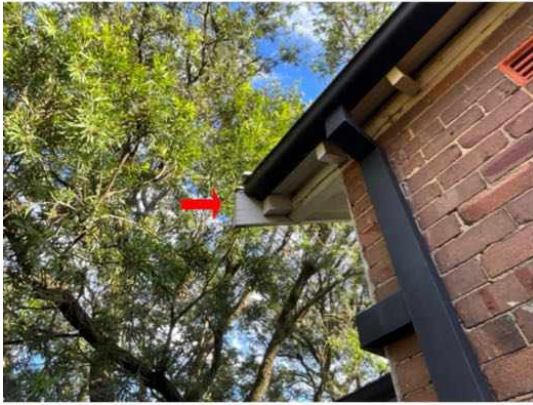
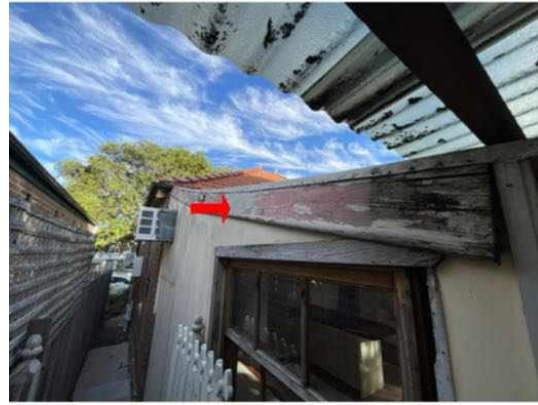
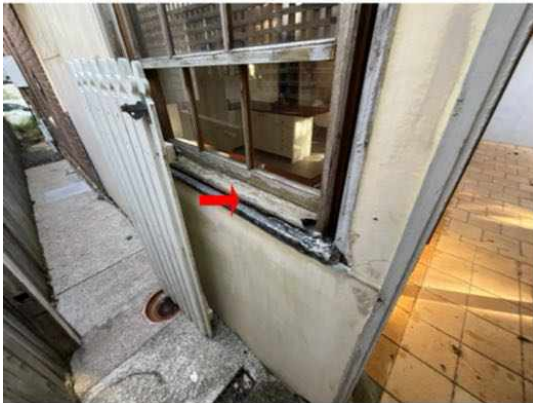
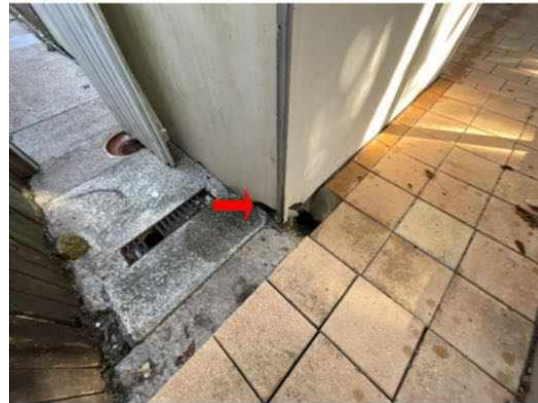
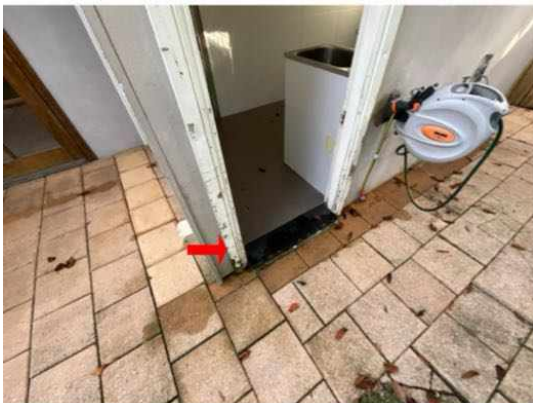
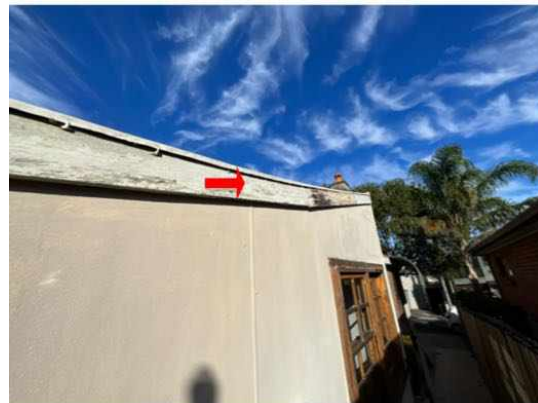
Finding 7.01

Building:	Main Building
Location:	External Areas
Finding:	Fungal decay - present (localised)
Information:	Fungal decay also known as wood decay or wood rot generally refers to the deterioration of timber elements when in contact with excessive levels of moisture for a prolonged period of time.

In this case although the affected timber element is in a decaying state the extent of any visible damage appears to be localised to a specific area and is yet to spread to other parts of the building element or affect adjoining structures. The fungal decay is therefore likely to be of a relatively superficial nature with minimal impact on the structural integrity or tensile strength of the timber element.

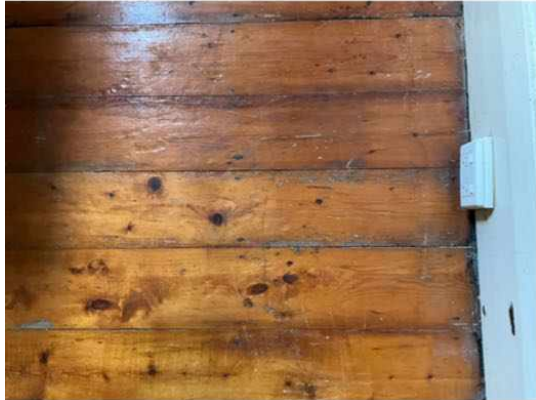
Finding 8.01

As no live wood borer activity was identified treatment is not required at this time.
