# Building and Timber Pest Inspection Report

Inspection Date: Tue, 3 Mar 2026

Property Address: 1/945 High St, Reservoir VIC 3073, Australia

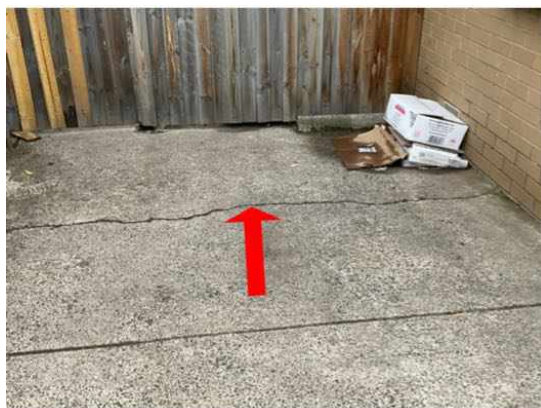
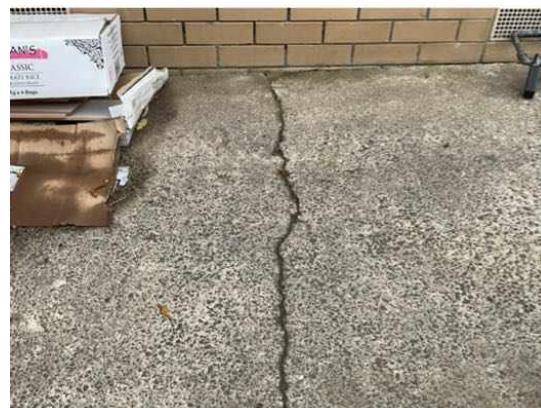
Building:	Main Building
Location:	All External Areas
Finding:	Cracking - External Concrete Paving Damage Category 4 - Gaps in Slab (4mm - 10mm +)
Information:	Gaps in the slab were identified in external concrete paving. Gaps in the slab are significant and are likely to lead to the development of safety hazards and secondary defects if left unmanaged, such as the creation of a trip hazard.

General age and expected deterioration of the paved areas is a common cause of this type of cracking. However, expansion and contraction of the slab may also have occurred due to environmental factors. Such factors include variable moisture and weather conditions, the presence of trees and their roots having a settling or lifting affect on the soil, or the effect of load bearing, e.g. heavy vehicles over a sustained period of time.

Cracking to this degree may also be due to poor original installation of the concrete. Factors such as poor compaction of the sub surface and/or inadequate reinforcing of the slab may create cracking and other secondary defects. Gaps in the concrete paving may also have a more significant structural cause, such as subsidence of soils.

Where gaps in the concrete paving are adjacent to structural elements of the building, the advice of a Structural Engineer is advisable before undertaking repairs. Significant repair and likely replacement of the concrete paving is probable.

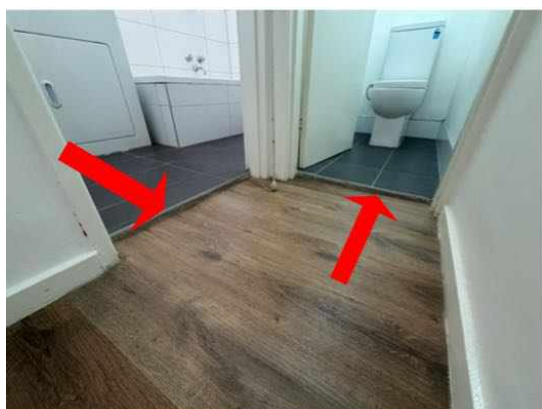
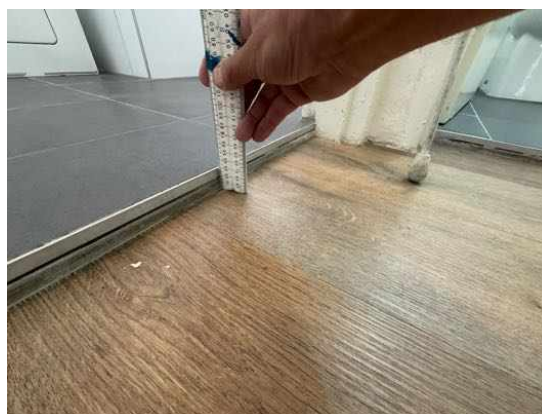
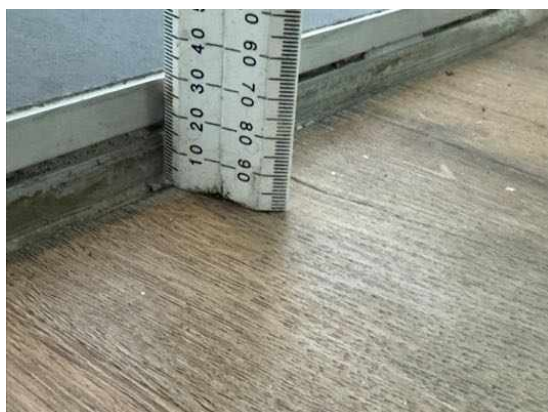
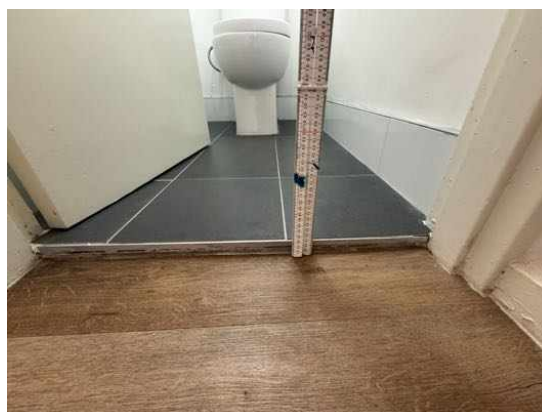
Finding 1.02

Building: Main Building  
 Location: Bathroom  
 Finding: Flooring - Uneven transition - trip hazard  
 Information: The flooring in this area presents a significant tripping hazard due to an uneven transition between the tiled surface and the adjacent timber flooring, with a noticeable height discrepancy. This condition poses a safety risk to occupants and visitors.

The installation of a sloped transition strip would assist in reducing the risk of trips and falls. A suitably qualified carpenter or general handyperson should be engaged to carry out the necessary rectification works as soon as possible

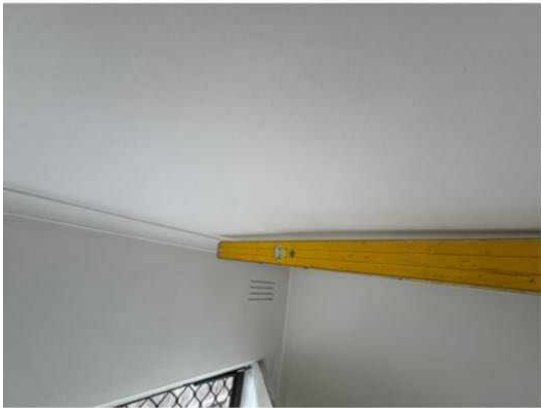
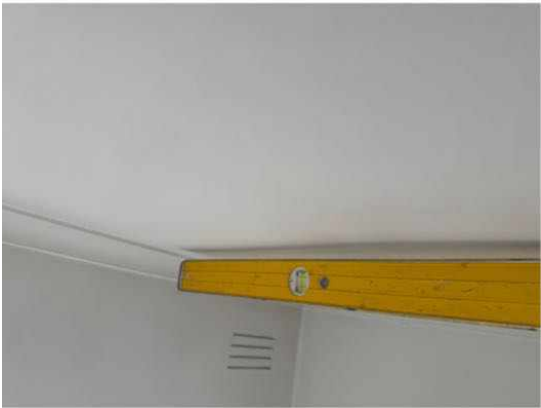
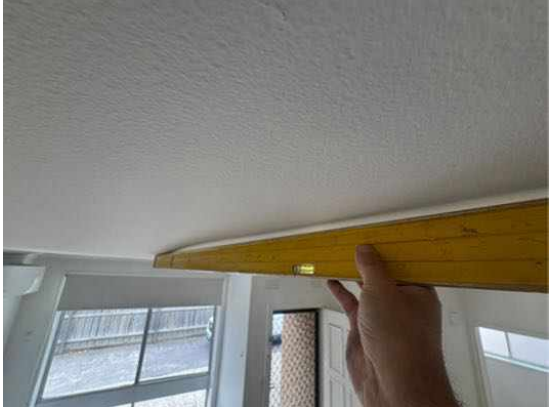
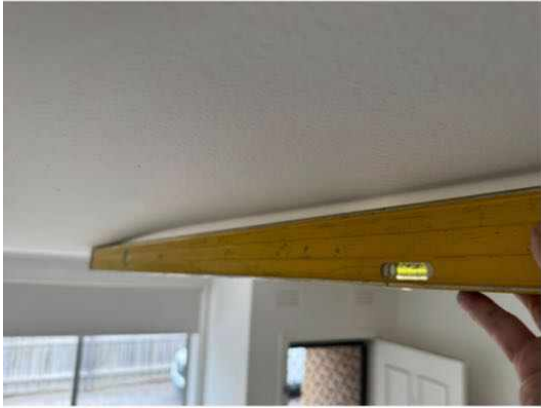
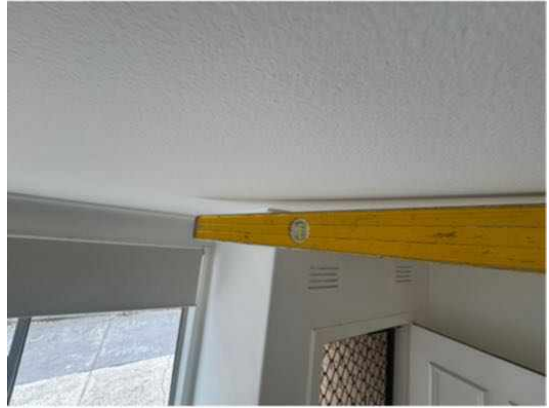
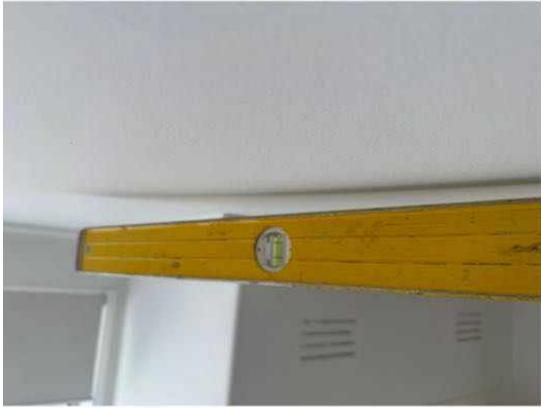
### Finding 2.01

Building: Main Building  
 Location: All Internal Areas  
 Finding: Sagging ceiling - Lack of support  
 Information: The roofing structure was found to be sagging in sections at the time of inspection. This sagging is likely due to the lack of support to the ceiling members (joists). These support members are referred to as hanging beams. While this type of construction is common for the era of building, additional support may be required.

Sagging roof structures are likely to create strain on associated building elements, creating potential for secondary damage including the deterioration of roof coverings. The roof is also unlikely to have sufficient support, which may lead to further sagging if left unmanaged.

The roofing structure was found to be sagging in sections at the time of inspection. This sagging is likely due to the lack of support to the ceiling members (joists). These support members are referred to as hanging beams. While this type of construction is common for the era of building, additional support may be required.

It is advised that a Structural engineer be appointed to provide remedial advice which could then be carried out by a licensed builder.

While it would appear that this defect has been present for a long period of time repair is recommended in the short term to ensure the longevity and structural integrity of the dwelling.

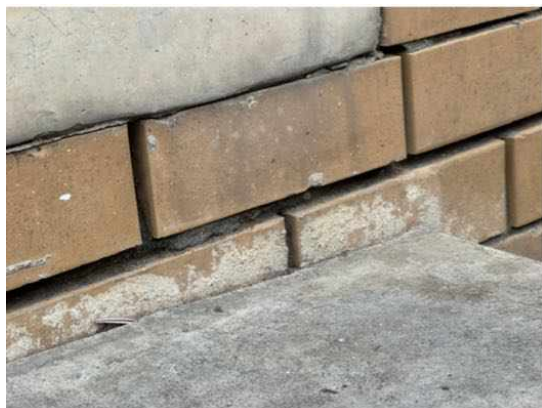
### Finding 3.01

Building:	Main Building
Location:	All External Areas
Finding:	Brickwork - Deteriorated mortar
Information:	Mortar, or 'bedding', is the material which fills joints and intersections between bricks in masonry walls and structures. Sections of mortar in this brickwork were identified as having deteriorated, which is generally expected for a property of this age and condition.

Mortar may deteriorate as a result of age of building materials, minor movement of bricks, or frequent exposure to weathering. Mortar should be replaced to ensure that bricks remain in their intended location and to prevent gaps, which would allow water or moisture ingress and secondary damage as a result.

Mortar deterioration can be addressed by a bricklayer where areas of deterioration are localised and easily accessible. Alternatively, appointment of a registered builder is advised, to repoint large areas of decaying mortar. Where secondary structural defects have become evident, consultation with a structural engineer may be required.

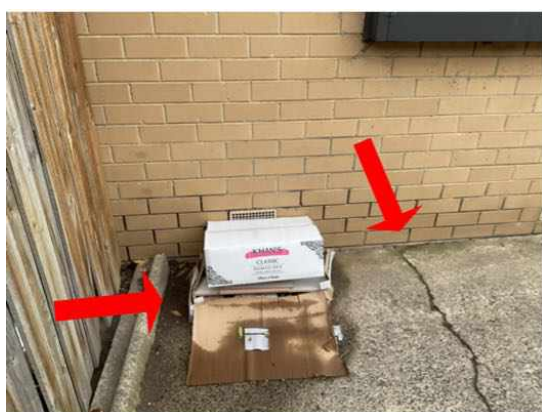
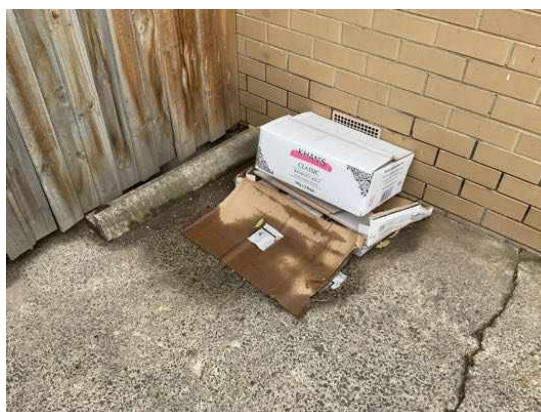
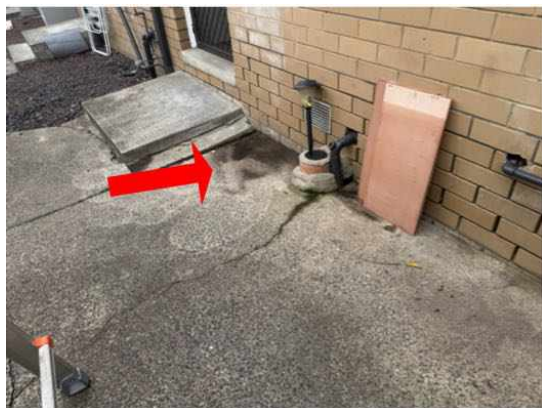
### Finding 3.02

Building:	Main Building
Location:	Exterior walls - left side >
Finding:	Site drainage - Inadequate
Information:	The site drainage in this area was found to be inadequate at the time of inspection, creating potential for subsequent water damage to associated building elements.

It is important that water does not lie against the base of walls; surrounding paths and ground levels should be sloped to drain water away from walls. Downpipes should not discharge stormwater onto lower walls or plinths. Stormwater should be carried away by large, regularly cleaned drains. Ground levels may need to be lowered to expose a buried DPC.

Where site drainage is inadequate, installation of an Agricultural (Aggie) Drain may be required. A qualified plumber should be appointed to further inspect the property and perform any remedial works as necessary. Water damage and secondary defects are likely to occur if left unmanaged.

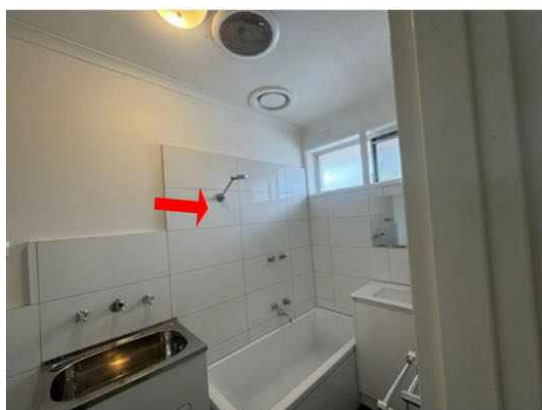
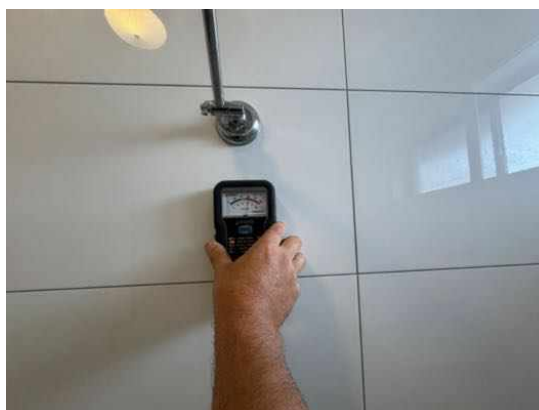
### Finding 3.03

Finding: Water leak - Active

Information: Generally, water leaks occur when a particular area of the property is not weather or water tight. As the surrounding area was found to be damp at the time of inspection, the leak is considered ongoing and hence requires urgent action.

Regardless of the location, even minor leaks that are left unmanaged can lead to serious damage of associated building elements and result in the need for replacement of building materials. Mould and other hazards such as electrical hazards may also arise if the leak is left to develop.

It is highly advised that the cause of the leak be identified and resolved immediately by a licensed plumber to prevent any further damage. Depending on the extent of the damage previously sustained, repair and/or replacement of any affected building materials may be required.

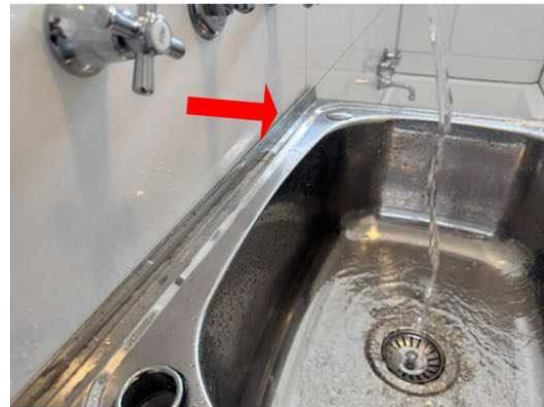
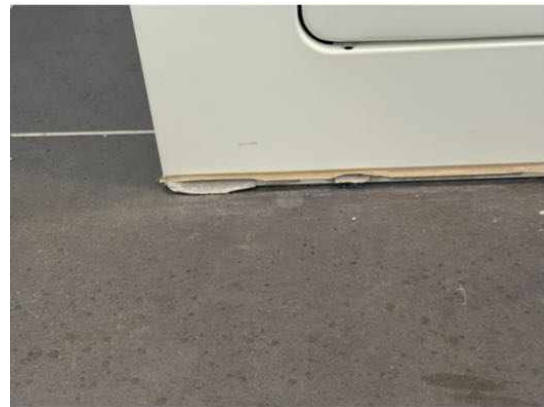
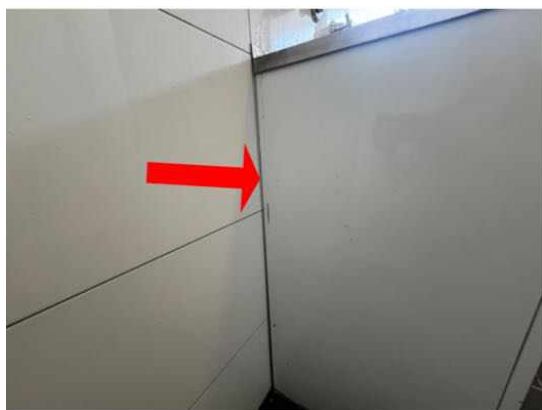
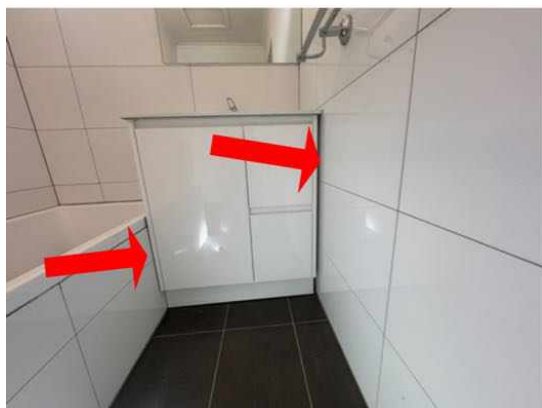
Finding: Sealant - Missing

Information: On inspection it was noted that the sealant is missing to areas of the bathroom.

Flexible and mould-resistant sealant should be applied to the affected areas to reduce the risk of water ingress and subsequent damage that is likely to occur.

Regular maintenance and replacement of damaged sealant is highly recommended for wet areas, as this is a regular wear and tear defect. Sealant and grouting in areas that come into regular contact with water should be maintained for the long-term care of your property.

A sealant specialist or general handy person should be appointed to complete these works as soon as possible

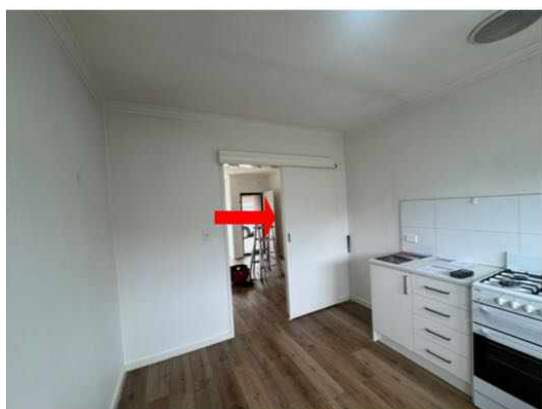
Building: Main Building  
 Location: Kitchen  
 Finding: Door - Binding/jamming  
 Information: Binding and/or jamming of this door is evident during standard operation. This defect inhibits the functionality of the affected door as well as creating potential for secondary defects to associated building elements.

A qualified carpenter or general handyperson should be appointed to perform minor rectification works to improve the operational state of the associated door as soon as possible.

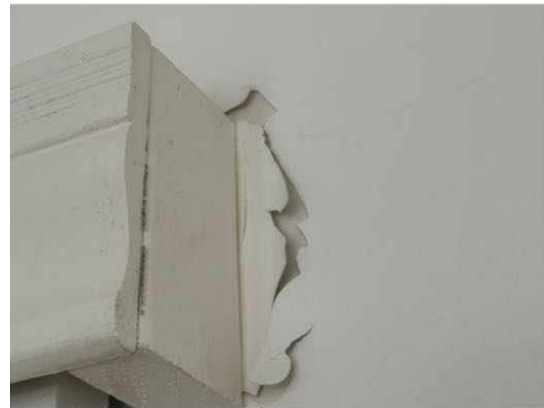
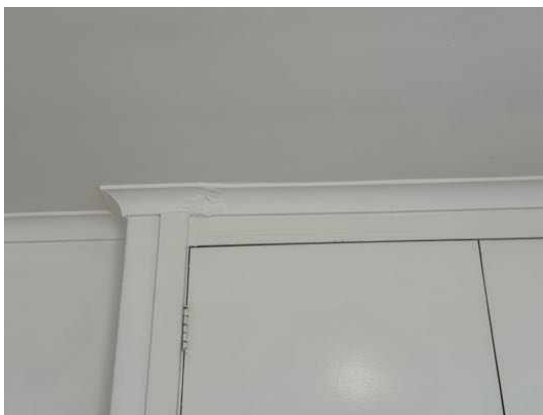
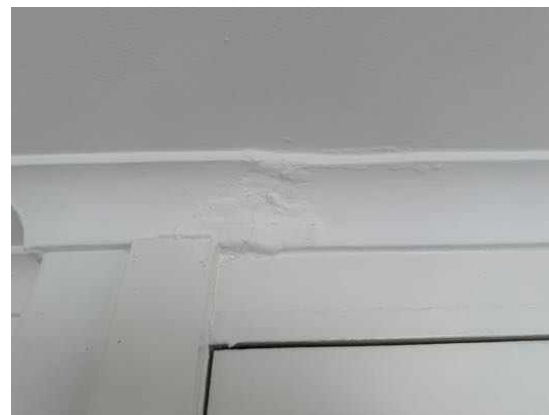
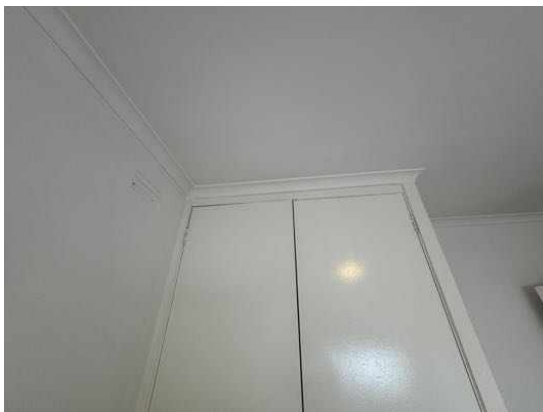
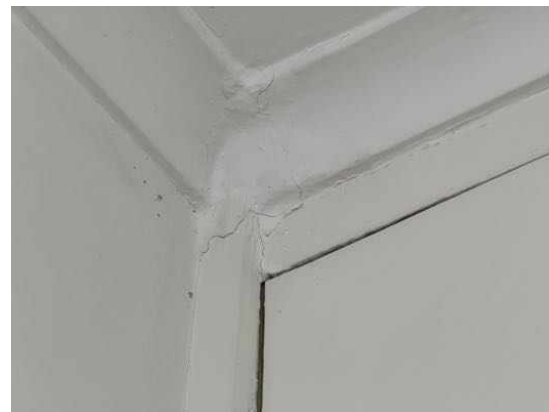
### Finding 3.08

Building: Main Building  
 Location: Lounge Room  
 Finding: Paint finish - Substandard  
 Information: The paint finish in this area was found to have been completed to a substandard level. Substandard painting is generally classified as an appearance defect. However, the substandard appearance may also be indicative of poor surface preparation and substandard workmanship.

If this applies, further areas of poor and incomplete finishes could develop over time. Furthermore, substandard paint finishes in areas exposed to moisture, e.g. external

areas or wet areas, could lead to deterioration of underlying building materials.

Substandard paint finishes should be sanded back, filled, leveled and repainted, as applicable. Where inadequate paint protection has led to the deterioration of the associated building element, repair and/or replacement of this building element may be required.

A painting contractor should be appointed as soon as possible to perform necessary works to aid the appearance of the affected area and to ensure that the area is protected against further deterioration. Alternatively, the homeowner following manufacturer instructions may be able to provide this service.

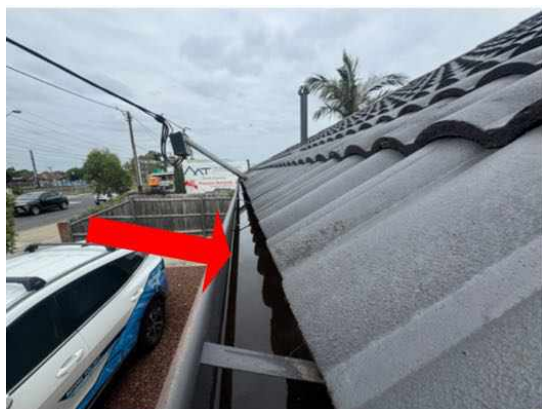
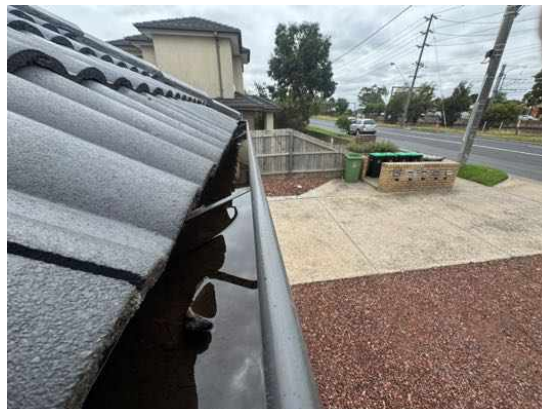
### Finding 3.09

Building:	Main Building
Location:	Front Elevation
Finding:	Gutters - Water pooling
Information:	Water was found to be pooling in sections of the roof guttering. This is generally a secondary defect caused by blocked or partially blocked gutters. Such blockages and subsequent water pooling are likely to lead to rust and water damage to associated structures if left unattended.

Any areas of guttering that shows evidence of water pooling should be checked for partial or full blockages and any secondary damage that may have occurred as a result. Depending on the extent of the damage, building elements may require repair and/or replacement to ensure adequate roof drainage and function of exterior plumbing system.

A roofing plumber should be appointed as soon as possible to rectify this issue. It is highly advised that all gutters be maintained on a frequent basis to ensure the condition of roof plumbing.

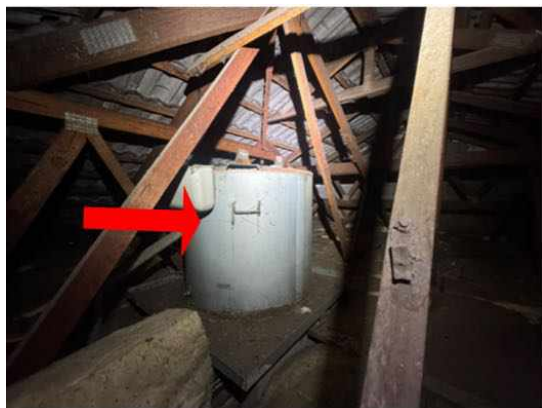
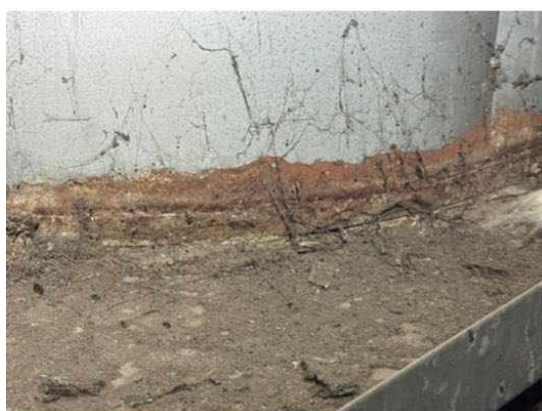
### Finding 3.10

Building:	Main Building
Location:	Roof Void
Finding:	Gravity-Fed HWS - Disconnected
Information:	It was noted at the time of inspection that a disconnected gravity-fed hot water system (HWS) remains in this area.

Despite this plumbing structure being unused, it is likely to be storing residual water, and is therefore susceptible to rust and corrosion. If allowed to continue, rust and corrosion is likely to lead to damage to adjoining building elements, and may also make the area susceptible to termite or timber pest activity.

While it is a costly exercise to remove the disused gravity-fed HWS, it is advisable in

the short-term future to prevent any further damage to the area. Further consultation with a licensed plumber is required to gain further advice on removal of the structure.

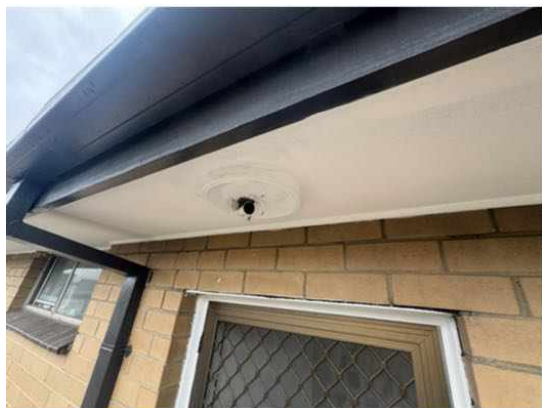
### Finding 3.11

Building:	Main Building
Location:	Rear Elevation
Finding:	Light fitting - Damaged
Information:	The light fitting in this area was found to be damaged at the time of inspection. Damage occurs generally when the building materials have aged and decayed, but may also be indicative of impact damage to the building element (accidental or deliberate).

Left unmanaged, the fitting is unlikely to cause further damage to surrounding building elements. However, the broken light fitting may expose electrical works, and may create a minor safety hazard if there is potential contact with persons in the area.

Repair and/or replacement of the damaged fitting is advised. A Licensed electrician should be appointed to repair/replace the light fitting at the client's discretion.

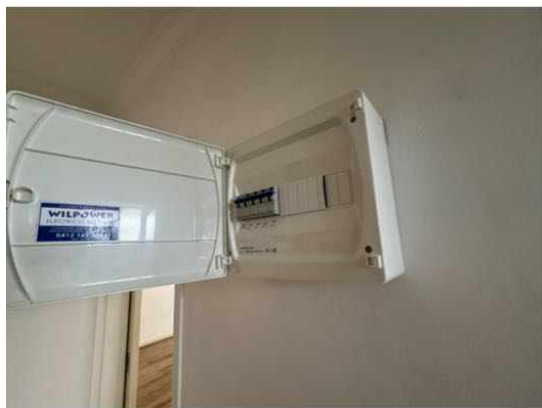
Building: Main Building  
 Location: Meter Box  
 Finding: Termite Management System - no evidence of a chemical installation  
 Information: The application of a post-construction chemical termite barrier is highly recommended for all properties, particularly if live termite activity has been found on the site previously. Such barriers are highly effective in preventing termite attack on any timber building elements throughout the property.

A durable notice should be placed in the switchboard unit to indicate current termite barriers. At the time of inspection, it appeared as though no termite management system has been installed, with no evidence to suggest preventative works taking place.

The client may consider gaining further advice from a pest controller as to the costs and procedures involved with this application. It is recommended that obtaining such advice be a short-term priority.

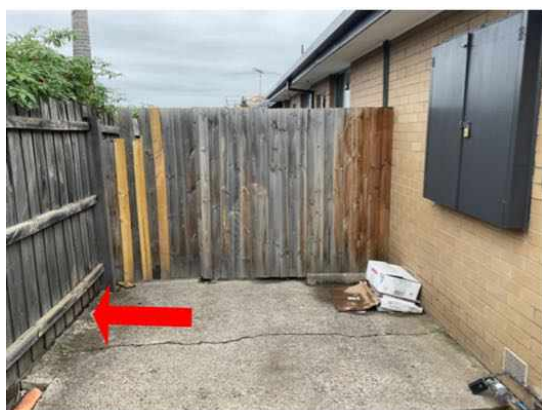
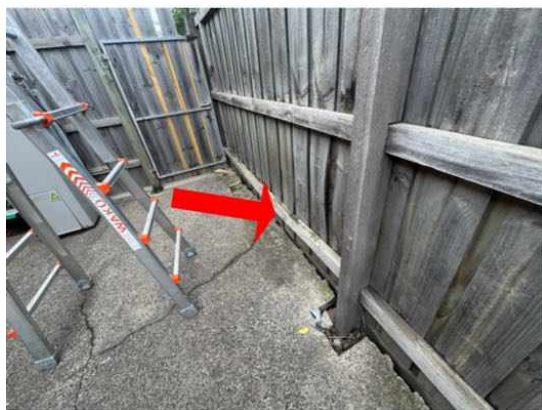
### Finding 6.02

Building: Main Building  
Location: All External Areas  
Finding: Building materials in direct ground contact - conducive to termites  
Information: Where timber elements are in direct contact with the ground and consequently moisture or dampness they become conducive to termite activity. Whether timber is used as a building element part of a fencing structure or stored as an unused item they can provide an environment that is attractive to termite infestation.

When met with excessive moisture timber begins to decay and develop wood rot. Any timbers that are in direct contact with external grounds especially if left untreated or non-durable also provide ingress for subterranean termites into that particular element. Consider replacement with more durable materials i.e. treated timber or non timber elements.

The removal of any such materials that may be conducive to termite activity should be removed as soon as possible to minimise the risk of termite attack. Where it is not possible frequent inspections of these areas shall be undertaken to provide early detection of infestation

It is highly recommended that termite or timber pest inspections be carried out every 6-12 months to aid protection of the property against infestation.

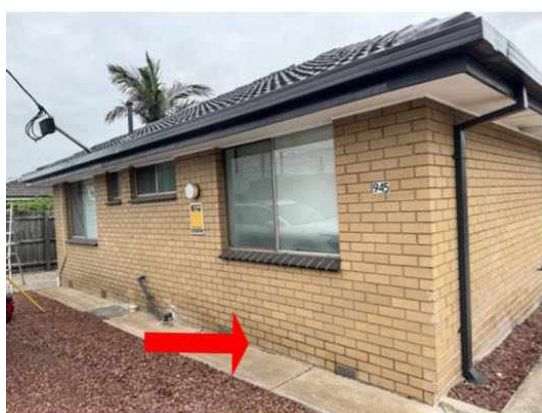
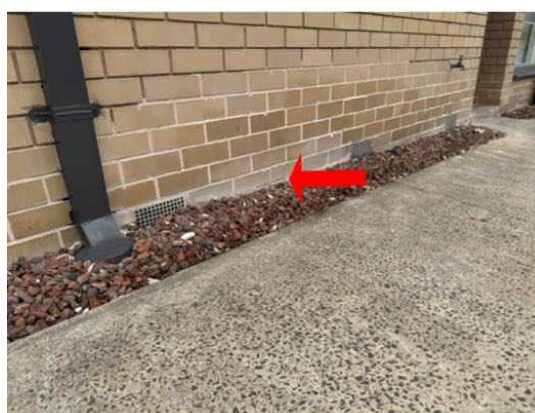
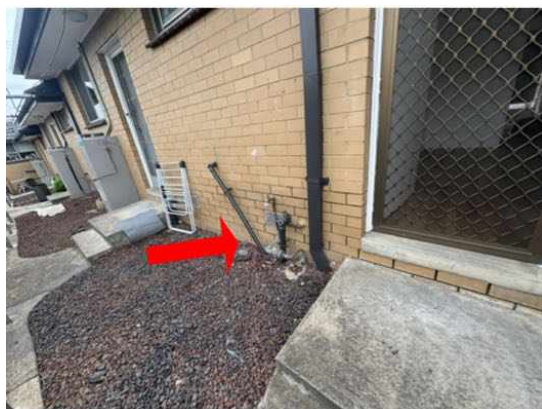
If the slab edge is not properly exposed there is a high risk of termite attack. Sometimes, in order to determine the type of slab, a suitably qualified person such as an architect or builder may be required to consult the construction plans.

Where the slab edge cannot be properly inspected, it is highly recommended that termite or timber pest inspections be carried out every 6-12 months to aid protection of the property against infestation.

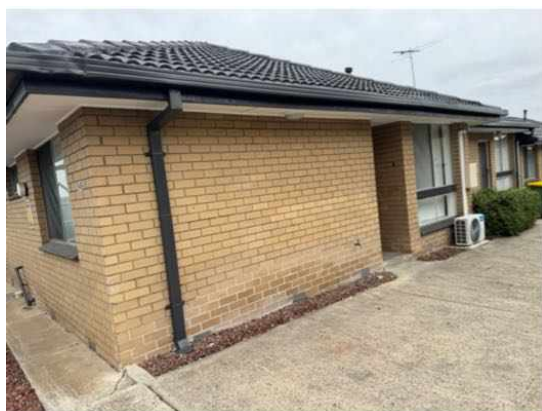
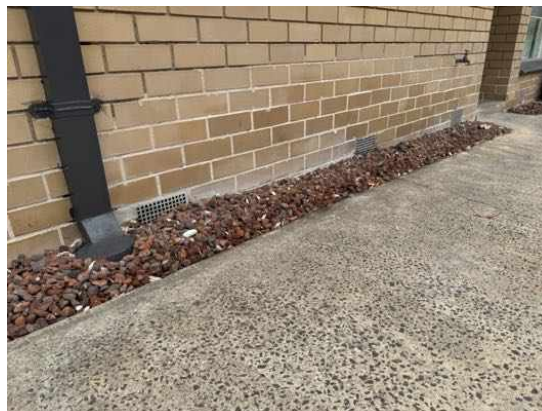
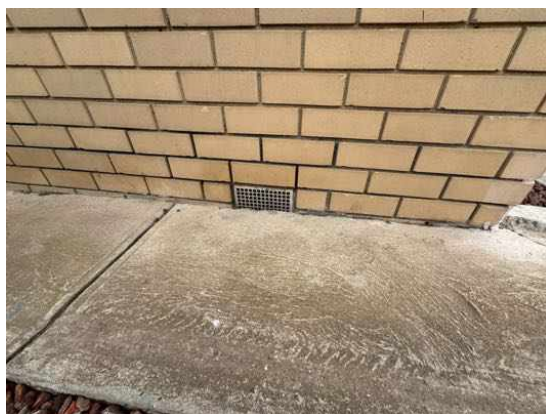
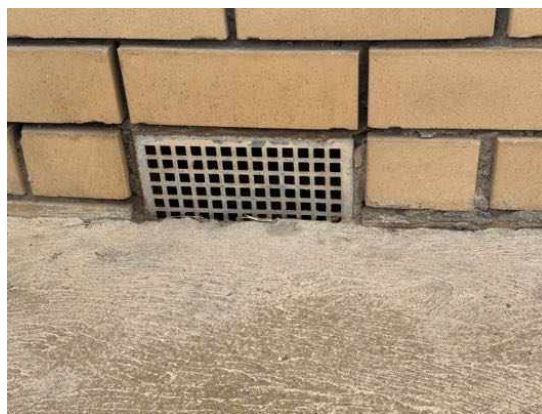
### Finding 6.05

Building:	Main Building
Location:	Walls
Finding:	Bridging or breaching of termite barriers - weep holes
Information:	Bridging is the spanning of a termite barrier or inspection zone so that subterranean termites are provided with passage over or around that barrier.

Weep holes in the exterior brickwork of the property are designed to allow condensation that may build up between the brickwork and subsequent timber framework to drain from within the wall hence preventing any deterioration of the timber building elements.

Additionally build-up of moisture is likely to occur if weep holes are covered further attracting termite activity to these areas.

It is highly recommended that weep holes are left exposed in all areas throughout the external property. Therefore if any termite activity leading into weep holes becomes easily detectable during frequent pest inspections.

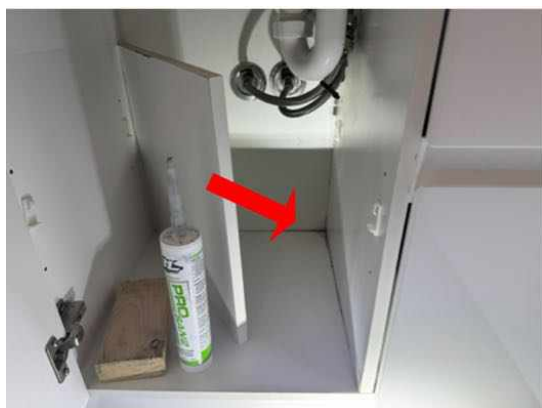
Repair and / or replacement of previously affected building elements is at client discretion. Consider a further invasive inspection: removal of obstructions around the damaged area may reveal further damage which has been concealed. A more significant or major defect may be identified at this time.

Where recurrence of an active water leak is identified, a qualified plumber should be appointed immediately to rectify the leak and advise on any further preventative works as necessary.

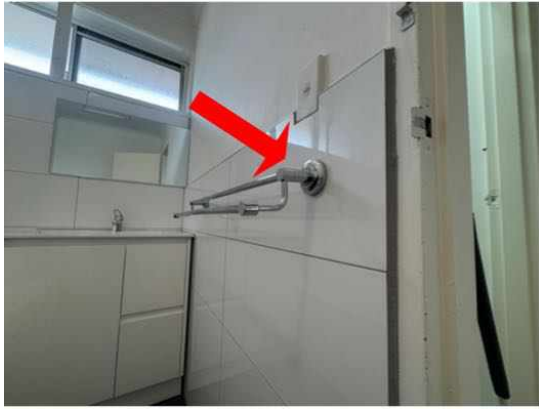
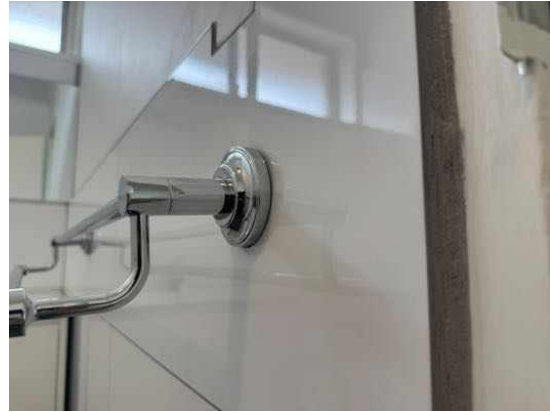
Building: Main Building  
 Location: Bathroom  
 Finding: Towel rail - Loose  
 Information: The towel rail was found to be loose at the time of inspection. While not a major operational defect, function can deteriorate if the problem is left unmanaged.

It is advised that remedial works to re-attach the towel rail be carried out. A qualified carpenter or general handyperson may be required to perform these works.
