Building and Timber Pest Inspection Report

Inspection Date: Sat, 7 Feb 2026

Property Address: 18 Regent St, Paddington NSW 2021, Australia

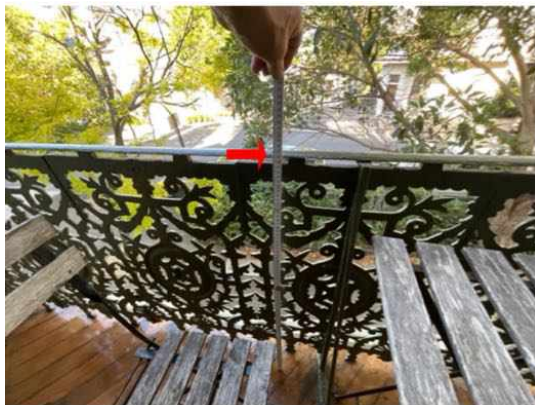
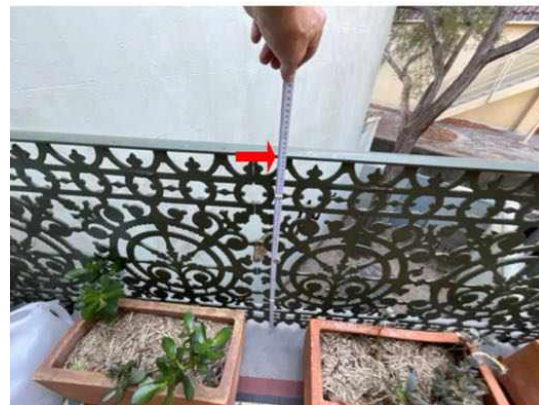
Building:	Main Building
Location:	Balcony
Finding:	Balustrade - Suspected Non-Compliance
Information:	The balustrade was measured and found to be less than the present building regulation requirement of 1000mm high. Additionally the gaps between the balustrade cladding were found to be greater than the present building regulation requirement of 125mm.

This defect creates a potential safety hazard and should be rectified as soon as possible to ensure the safety of the area and to meet present building standards and regulations.

A registered builder should be contacted to discuss possible rectification solutions.

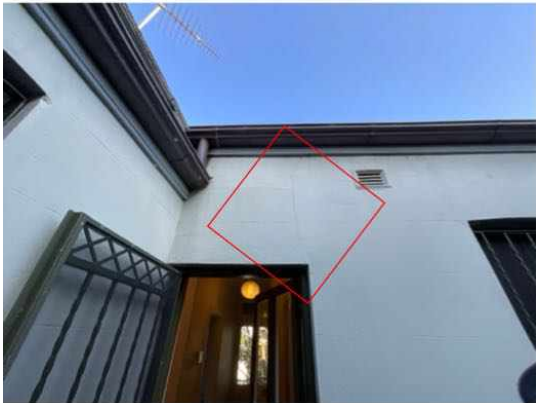
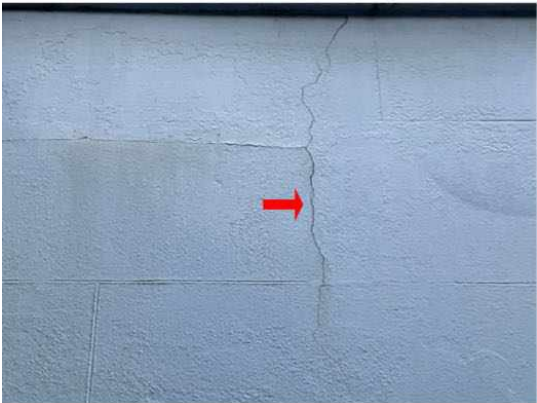
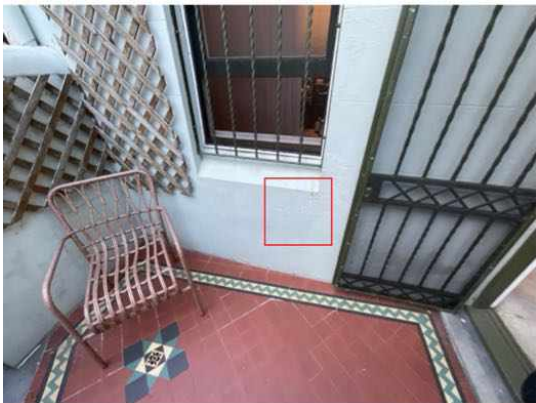
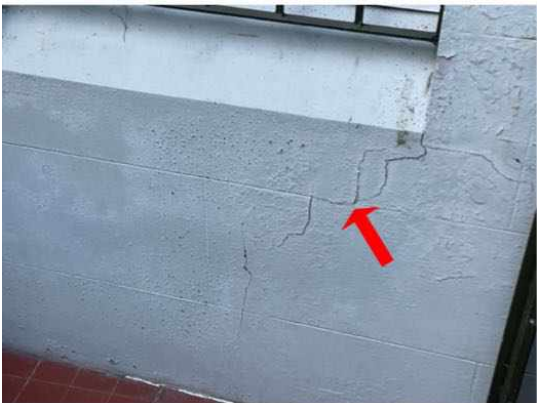
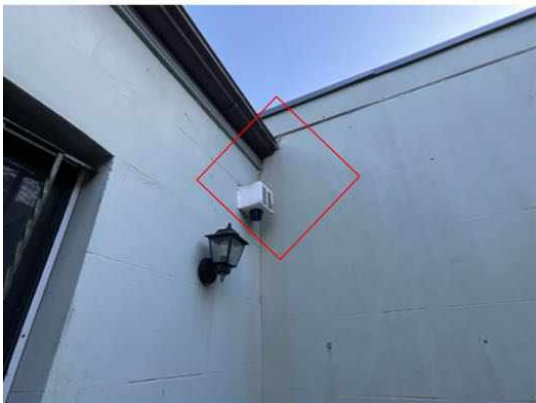
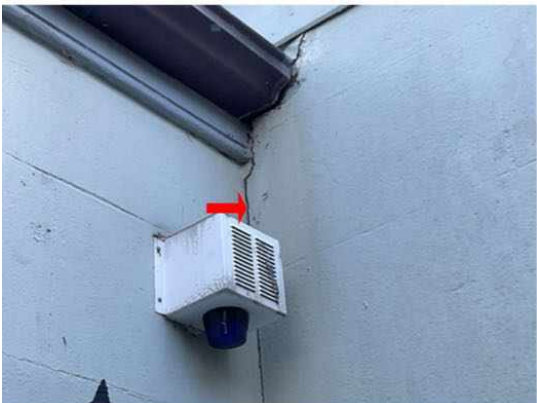
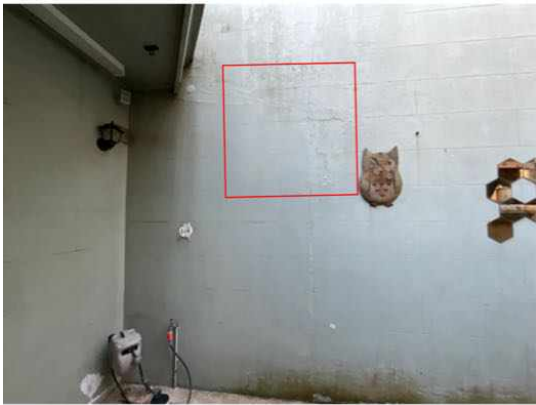
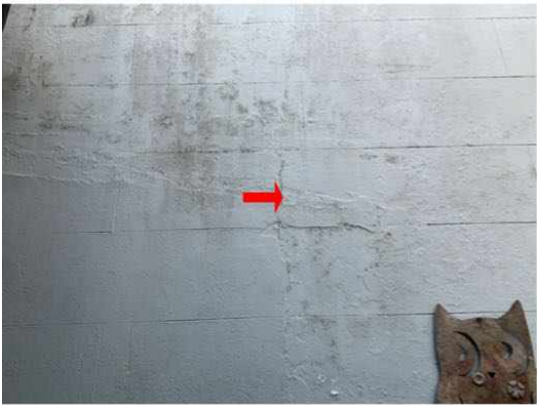
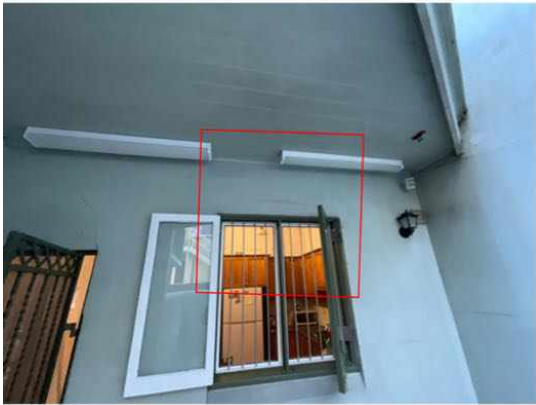
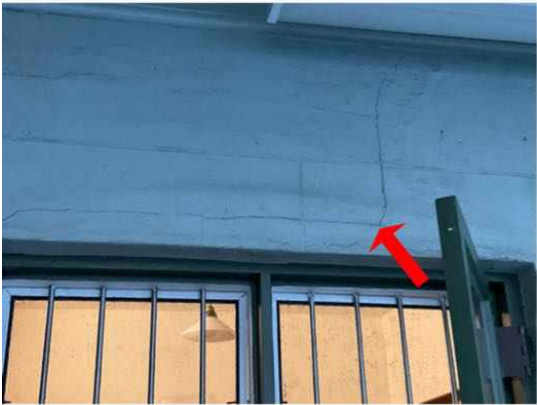
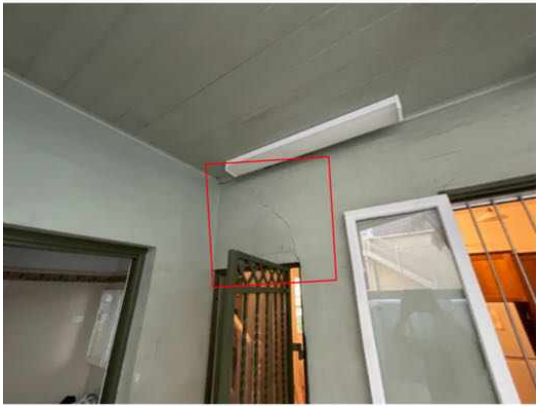
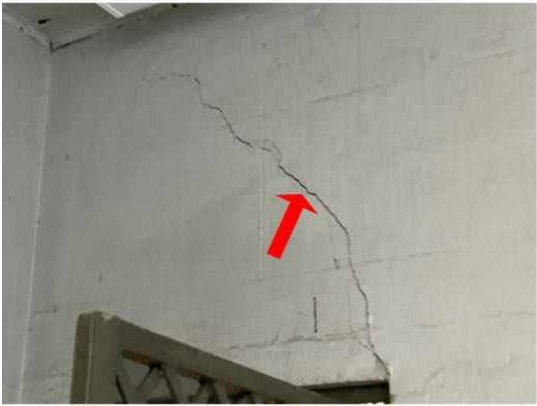
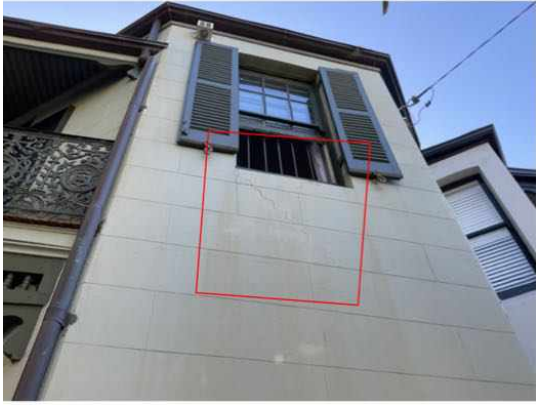
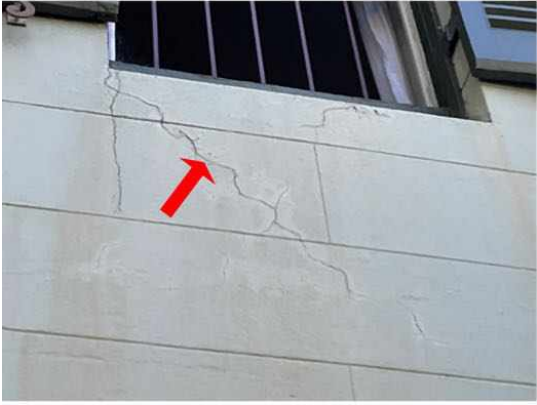
Building: Main Building
Location: Balcony rear
Finding: Damage to Masonry Walls (Cracks) - Category 1
Information: It has been observed that damage to masonry walls caused by movement of slabs, footings, or other causes, has occurred. The degree of damage falls within Category 1, described as fine cracks, which are less than 1.0mm in width limit, and that do not need repair.

Damage of this category is not considered a defect for rectification. Always contact your building inspector should cracks widen, lengthen, or become more numerous.

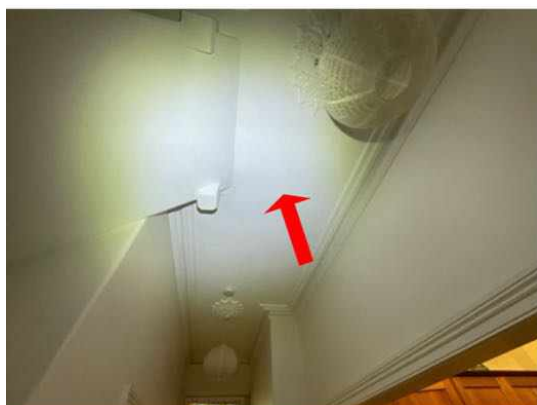
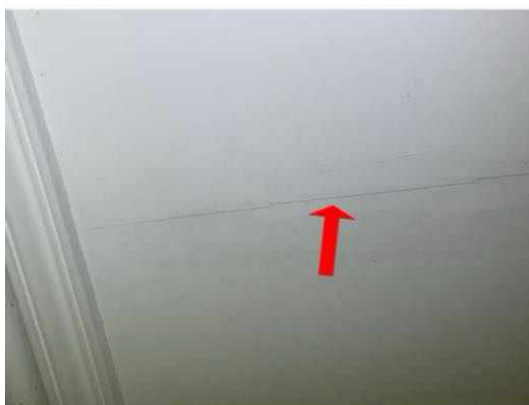
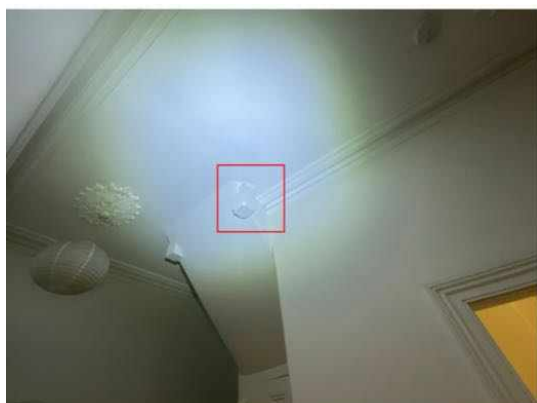
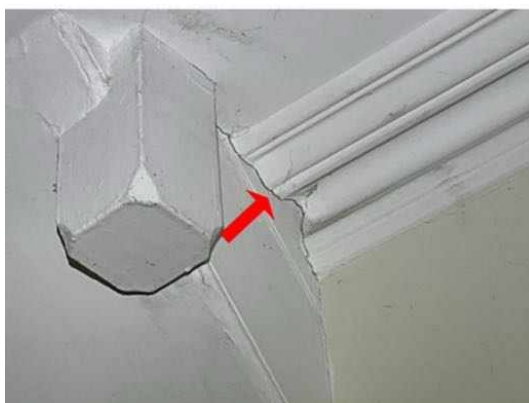
Finding 3.02

Building: Main Building
 Location: Hallway
 Finding: Cracking to Walls and ceilings (Bv1)
 Information: At time of inspection, cracking to walls and ceilings was identified in this area of the property.

While such cracking may be noticeable in some cases, it is quite common and does not necessarily indicate any structural damage. Cracking of this nature can generally be repaired with minor sanding, filling and/or repainting.

A qualified painter or a competent general handyman may be engaged to rectify at clients discretion. Monitoring of all cracking should be conducted frequently.

Always contact a licensed builder or structural engineer should cracks widen, lengthen or become more numerous.

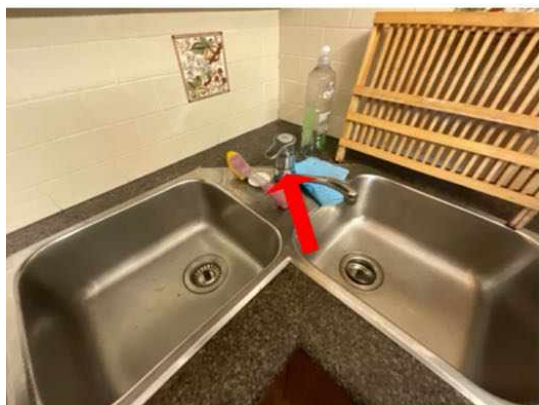
Finding 3.03

Building: Main Building
 Location: Kitchen
 Finding: Water hammer identified (Bv1)
 Information: This tap shows evidence of water hammer being present.

Water hammer, a pressure surge resulting when a fluid is forced to suddenly change direction, is a common defect in plumbing fittings, particularly those that are aged and not frequently maintained. Water hammer is generally caused by factors that create high water pressure in the affected plumbing fixture, usually evidenced by a faint banging noise during operation of the affected tap.

Although water hammer is generally considered to be a minor defect, subsequent damage such as erosion of tap hardware and/or water damage to associated building elements is likely to occur if left unmanaged.

A licensed plumber can be appointed to inspect any affected tap hardware and perform any remedial works as necessary.

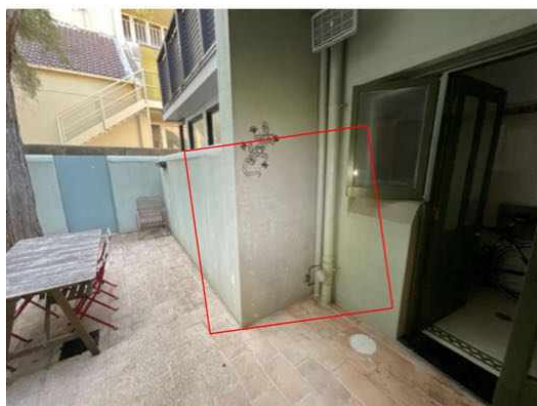
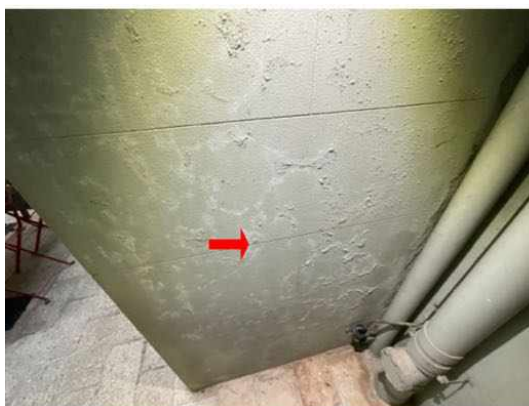
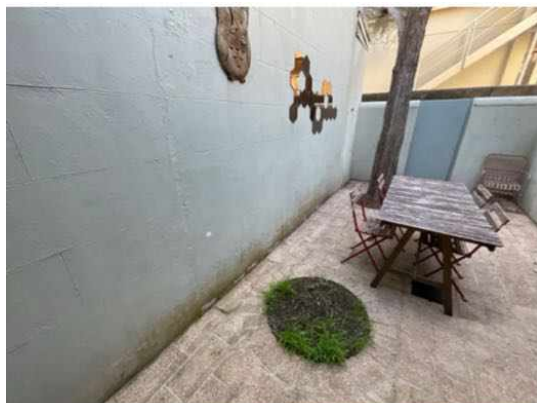
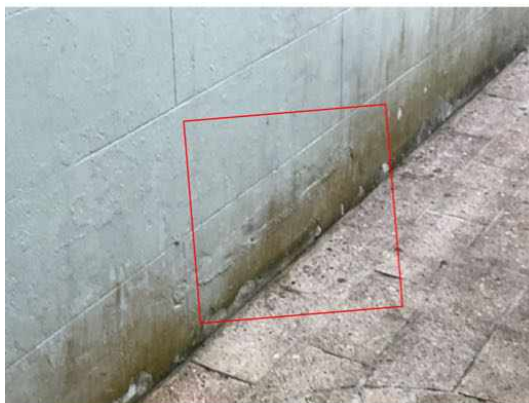
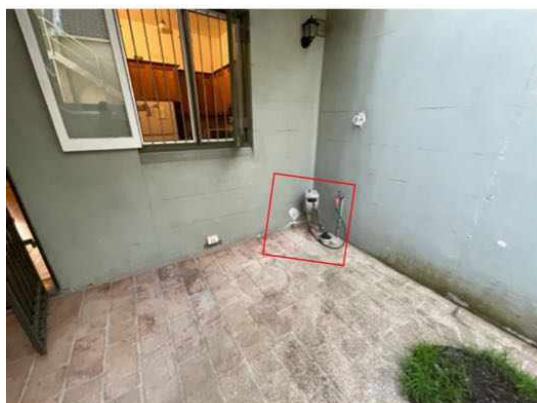
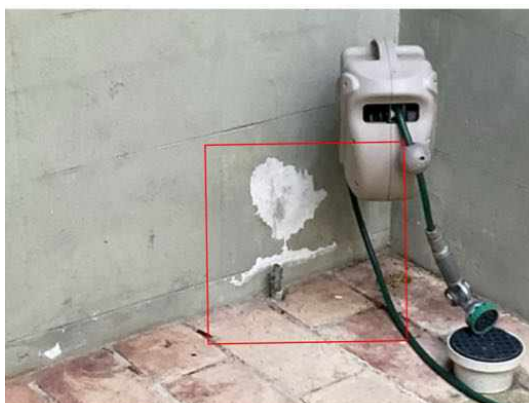
Finding 3.04

Building:	Main Building
Location:	Court yard
Finding:	External painting deteriorated
Information:	Some of the external paintwork have been neglected and require attention to prepare and re-paint.

Whilst incomplete or missing paint finish is generally an appearance defect, it can also lead to the development of secondary building defects over time. Incomplete areas of paint finish expose the area to moisture, potentially accelerating the deterioration of underlying building materials.

Degraded paint finishes should be sanded back, filled, leveled and painted, as applicable. A painting contractor should be appointed in the near future to perform necessary works to aid the appearance of the affected area and to ensure the area is protected against further deterioration. Alternatively, the homeowner following manufacturer instructions may perform these works.

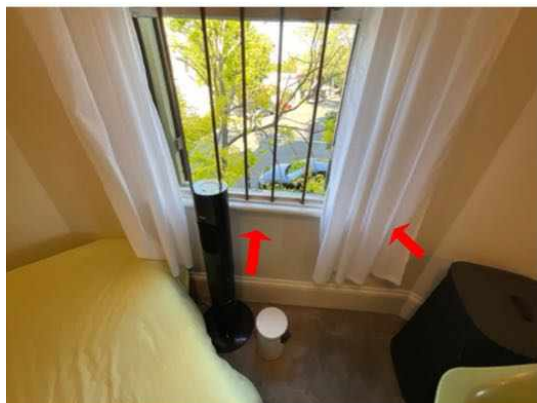
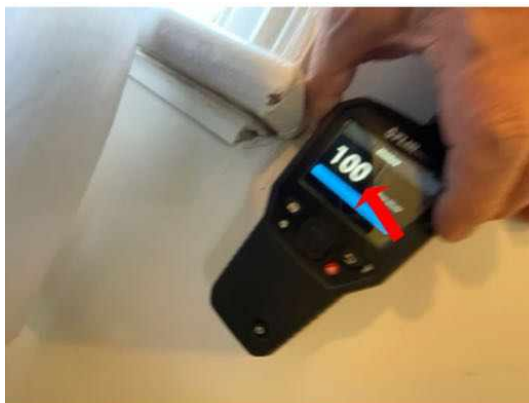
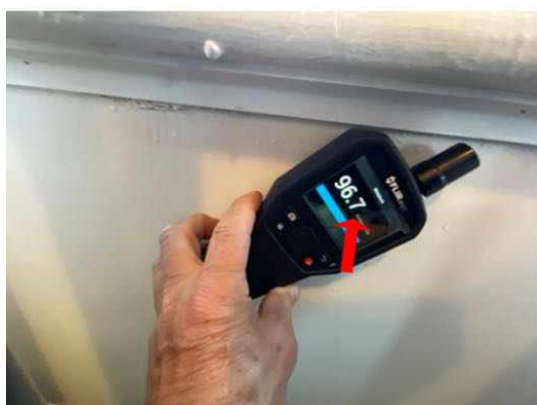
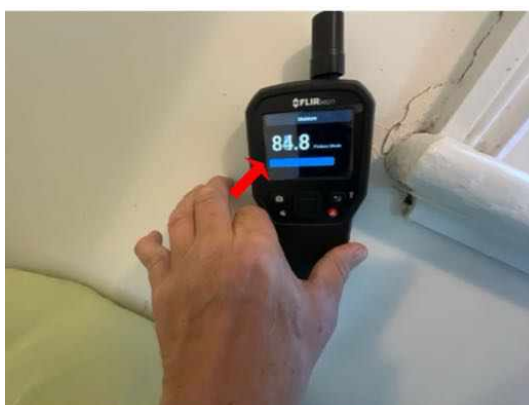
Finding 3.05

Building:	Main Building
Location:	Bedroom 1
Finding:	Damp - Rain penetration (Bv1)
Information:	Rain penetration was observed in this area of the property at time of inspection.

Common causes include faulty or missing flashing, cracked tiles, degraded pointing, lack of sealant and blocked weep holes. Rain penetration can also occur when water tracks horizontally under the lip of eaves and roof linings with insufficient angles, or by

The cause of the water leak should be addressed immediately to prevent further damage. It is recommended that the water leak be resolved prior to any repairs of the damaged area, which may require localised replacement of building materials and refinishing.

Trades responsible for such works may include roofing restoration specialists, roofing plumbers, concrete repair specialist or licensed builder.

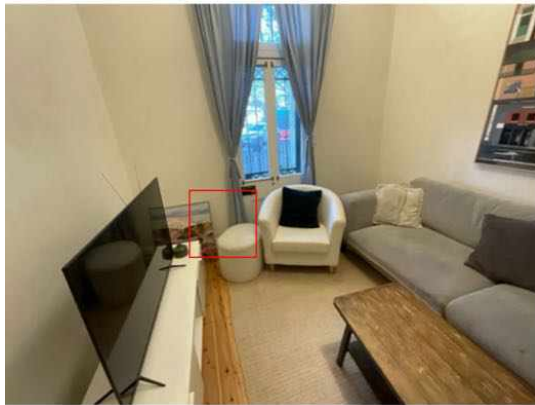
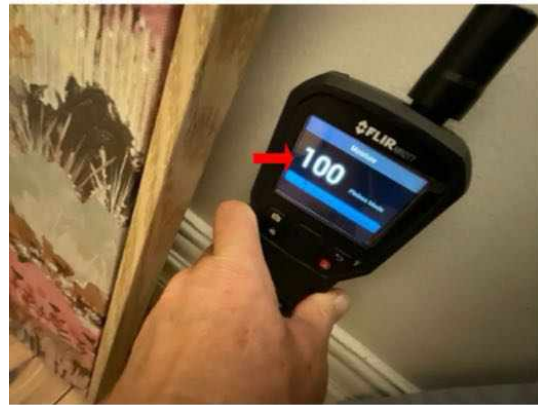
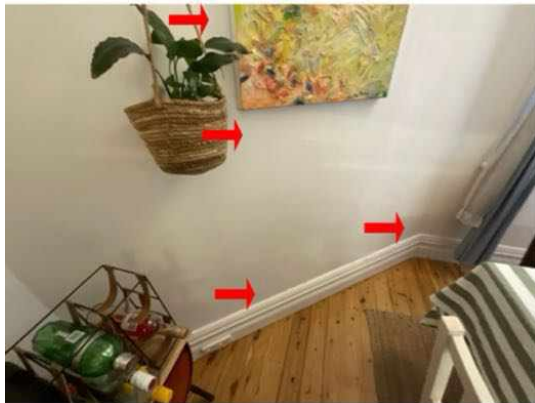
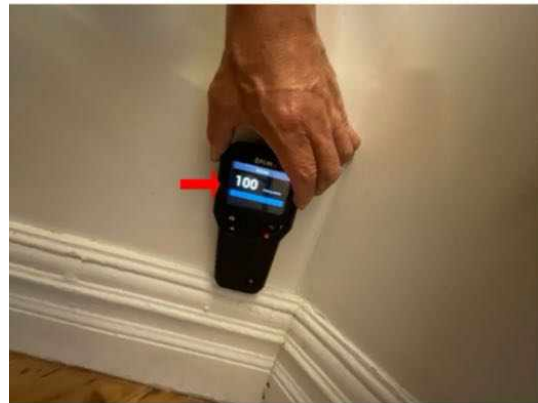
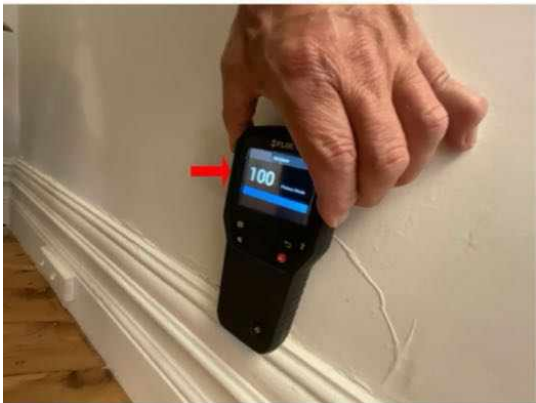
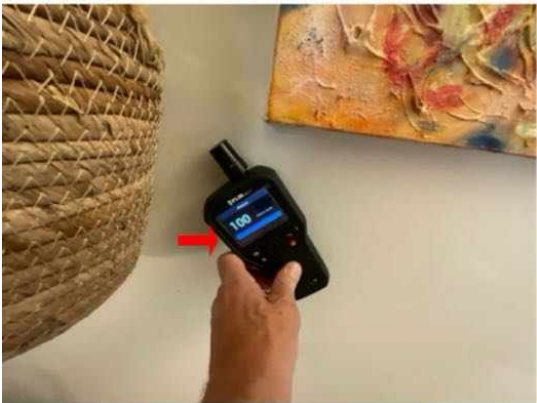
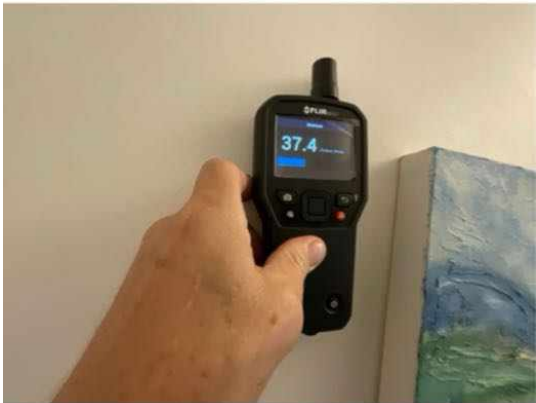
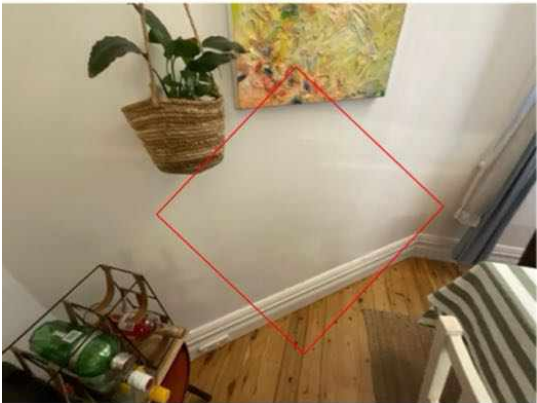
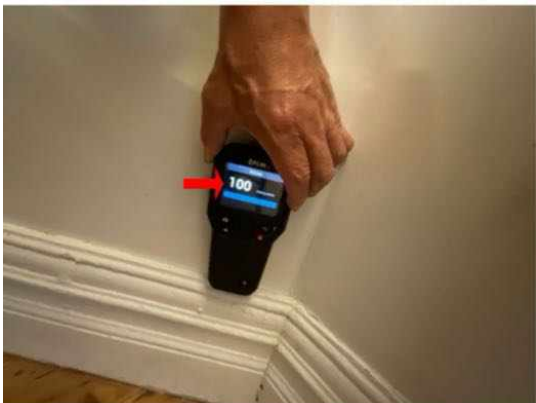
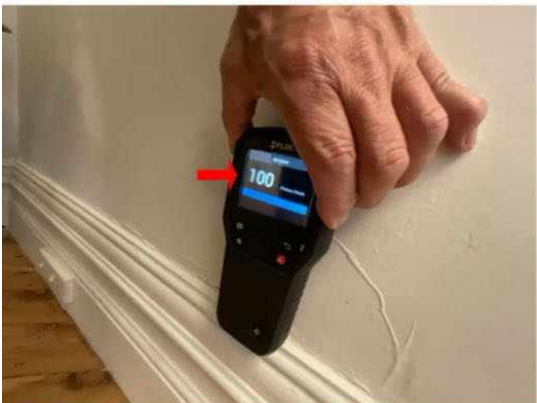
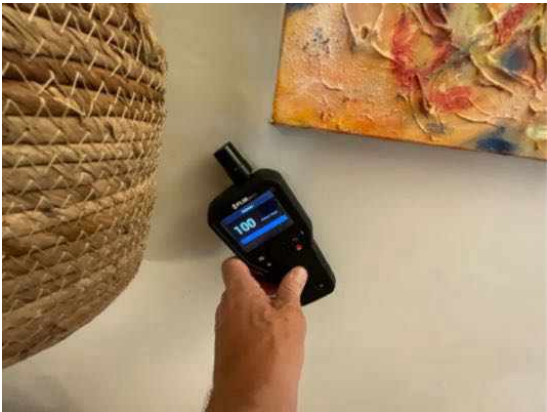
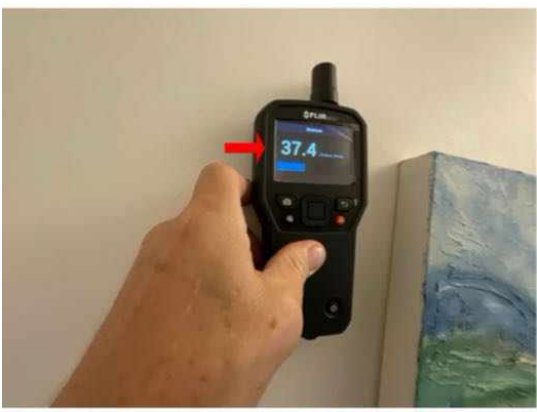
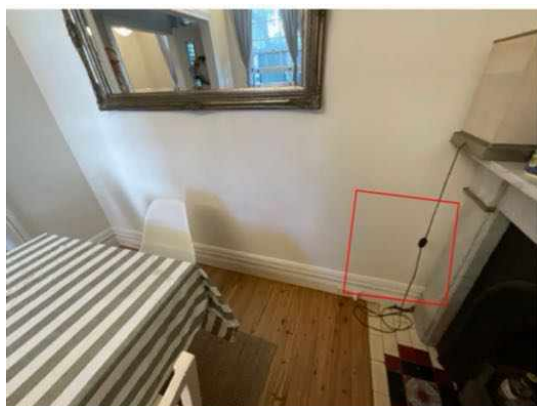
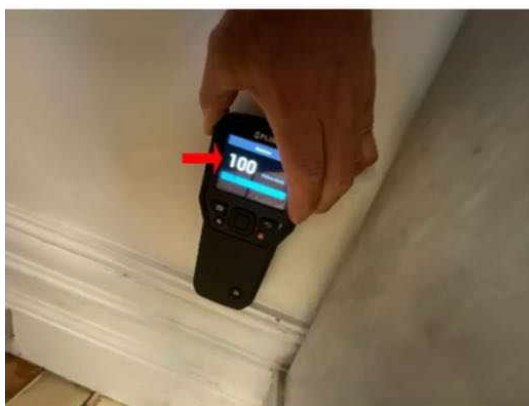
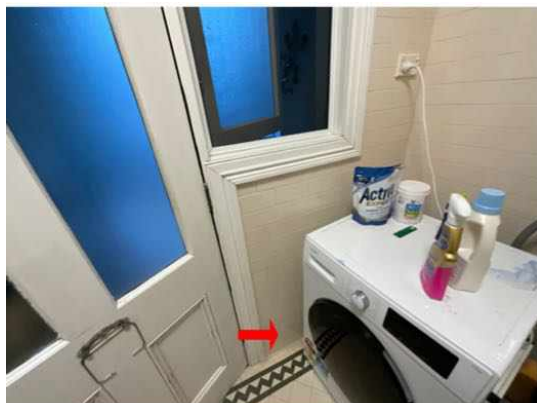
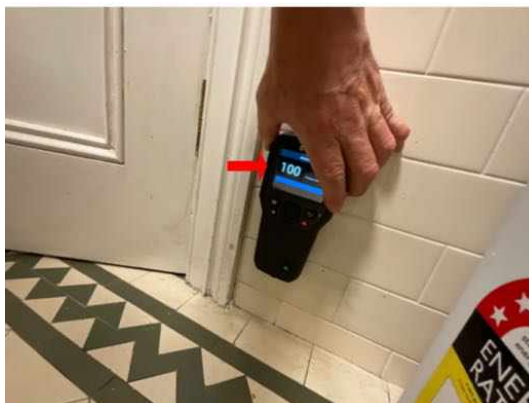
Finding 3.06

Building:	Main Building
Location:	Ground floor
Finding:	Damp - Rising (Bv1)
Information:	Rising damp was observed in this area of the property at time of inspection.

installed, or the materials have failed. The DPC may have been omitted as a consequence of poor workmanship, or it may have been bridged where materials built up against the side of the house allow moisture ingress above the DPC level.

Building:	Main Building
Location:	Ground floor
Finding:	Damp - Rising (Bv1) (Photos shown in previous defect section)
Information:	Rising damp was observed in this area of the property at time of inspection.

Rising damp is generally managed by the installation of a damp proof course during construction. A Damp Proof Course (DPC) is an impermeable barrier at the base of the wall above ground level. However, many 19th Century buildings have no damp course installed, or the materials have failed. The DPC may have been omitted as a consequence of poor workmanship, or it may have been bridged where materials built up against the side of the house allow moisture ingress above the DPC level.

The first step in addressing rising damp is to diagnose the cause. The identified cause should be addressed first before addressing the appearance and other defects which have resulted from the rising damp. If the original cause is not resolved, further cases of damp are likely to ensue, resulting in secondary defects.

Consultation with a qualified rising damp specialist is advised as soon as possible to identify the cause of the damp and perform remedial works as required.

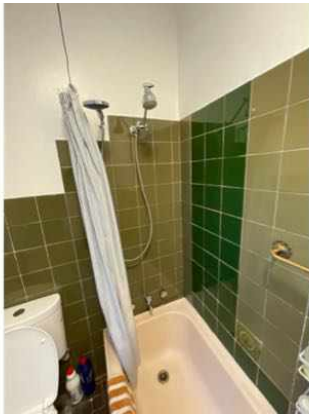
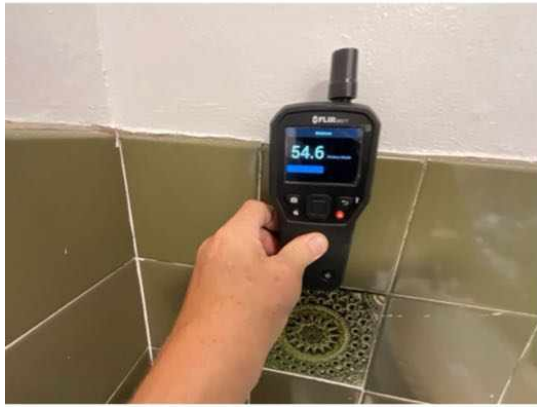
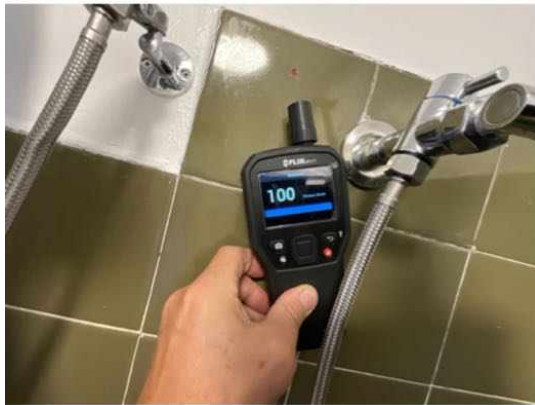
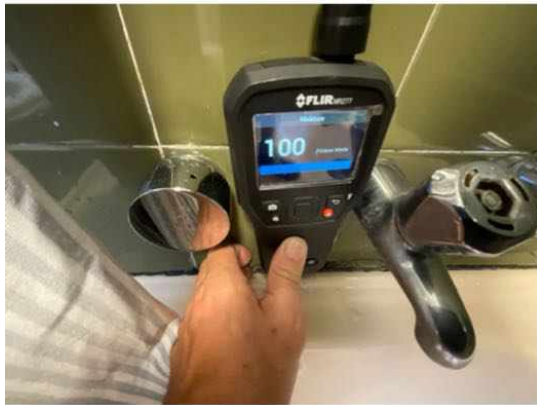
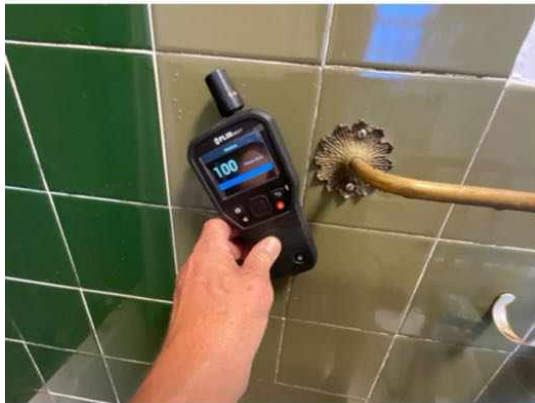
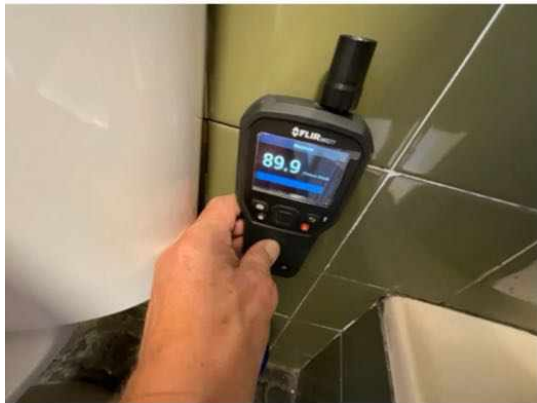
Finding 3.07

Building:	Main Building
Location:	Bathroom
Finding:	Moisture in shower (Bv2)
Information:	Moisture is evident behind the tiles to the shower alcove. This defect is quite common, and is suspected to have been caused by moisture permeating through the grouting in this area. Leaking pipes within the adjoining wall is also a possible cause.

Damp (or structural damp) refers to the presence of unwanted moisture in the structure of a building, either as the result of intrusion from outside, or condensation from within the structure. In the shower area, internal water leaks or other sources of excessive moisture are generally the cause of damp. Always ensure that sealant and grout is in good condition to prevent any moisture issues occurring in the future.

Building:	Main Building
Location:	Bathroom
Finding:	Moisture in shower (Bv2) (Photos shown in previous defect section)
Information:	Moisture is evident behind the tiles to the shower alcove. This defect is quite common, and is suspected to have been caused by moisture permeating through the grouting in this area. Leaking pipes within the adjoining wall is also a possible cause.

Consultation with a qualified plumber or bathroom specialist is advised to identify the cause of damp and to perform remedial works as required.

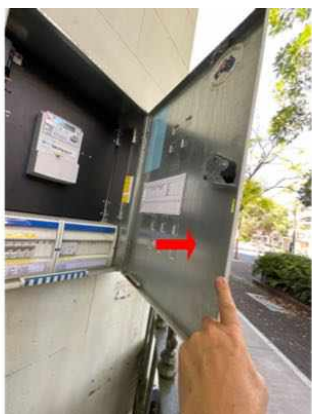
Building:	Main Building
Location:	Meter Box
Finding:	Termite Management System - no evidence of installation (Bv1)
Information:	The application of a post-construction chemical termite barrier is highly recommended for all properties, particularly if live termite activity has been found on the site previously. Such barriers are highly effective in preventing termite attack on any timber building elements throughout the property. A durable notice should be placed in the switchboard unit to indicate current termite barriers.

The client may consider gaining further advice from a pest controller as to the costs and procedures involved with this application. It is recommended that obtaining such advice be a short-term priority.

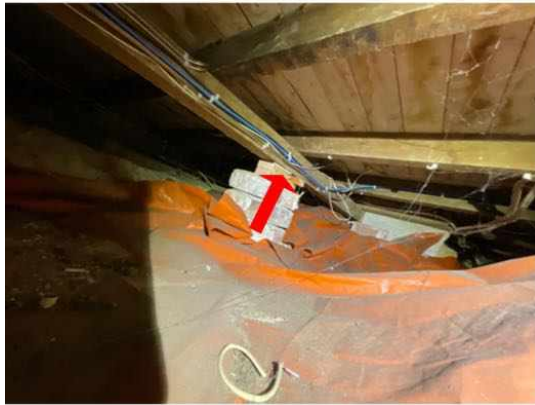
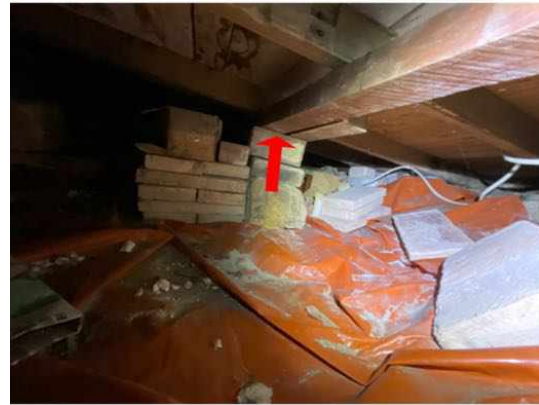
Finding 6.04

Building:	Main Building
Location:	Subfloor
Finding:	Ant caps - Not installed
Information:	Ant caps have not been installed to the subfloor structure at the time of inspection. Generally, ant caps are installed to the intersection between the top of the stumps (or

Installed during the construction process, ant caps are designed to easily identify termite or pest ingress from stumps to the adjoining bearers.

Where ant caps have not been installed, frequent monitoring of these areas should be carried out in order to identify any signs of termite or timber pest workings.
