Building and Timber Pest Inspection Report

Inspection Date: Tue, 31 Mar 2026

Property Address: 4A Barton St, Ermington NSW 2115,
Australia

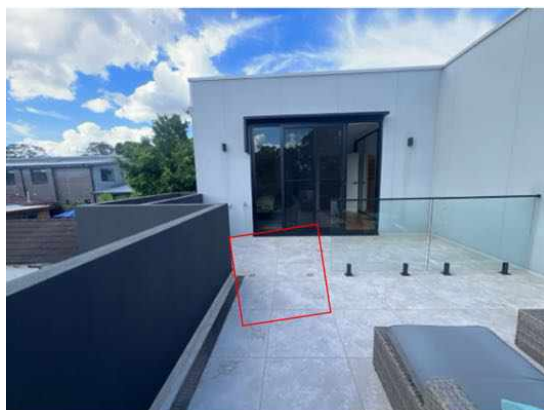
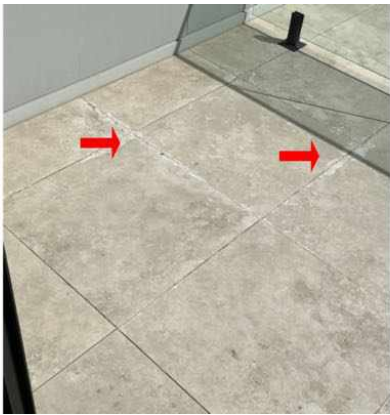
Finding 2.01

Building: Main Building
Location: Balcony
Finding: Balcony – Efflorescence and deterioration (Possible waterproofing defect)
Information: Tiled balcony floor with visible efflorescence and discolouration to grout lines indicating prolonged or recurring moisture presence beneath the tile finish. This condition is commonly associated with failed grout or sealant joints, insufficient surface drainage and/or inadequate waterproofing allowing moisture to become trapped within the balcony substrate. Some tiles also appear to have been damaged or removed leaving behind poor detailing which can cause moisture ingress. The external parapet and front elevation also appears to have deteriorated waterproofing and poor detailing along with flanges. While no internal water ingress was evident at the time of inspection with the potential to escalate if moisture migration continues, and further assessment by a suitably qualified waterproofing specialist is highly recommended.

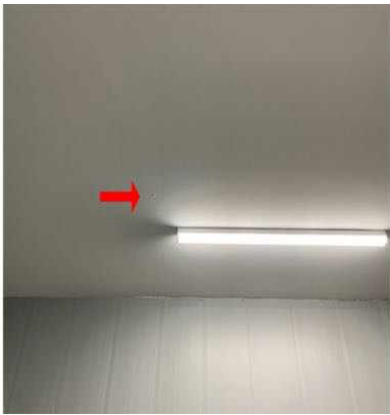
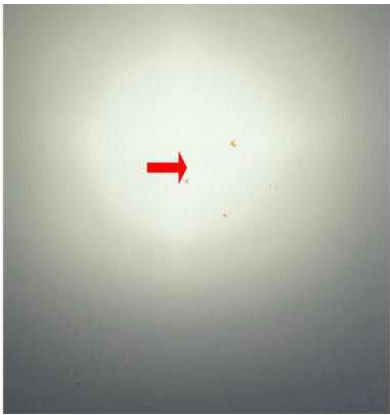
Building:	Main Building
Location:	Garage
Finding:	Painted surface - Bubbling & rust staining
Information:	Sections of paint in this area was found to have bubbled and deteriorated. Paint bubbling is generally an indication of excessive moisture in the area, that is currently hidden by the painted surface.

The presence of excessive moisture can have major implications on associated building elements if left unattended. While only seemingly minor at this stage, the damage cannot be determined due to the paint obstructing any further inspection of the damage.

It is highly advised that the affected paint be cleaned to allow a further, more invasive inspection by a licensed plumber. Failure to act on this defect may necessitate major works in the future.

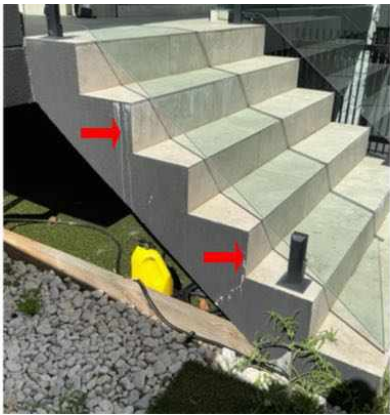
Finding 3.02

Building: Main Building
Location: All External Areas
Finding: Efflorescence and grout deterioration
Information: Efflorescence was observed to tiles together with localised grout and sealant deterioration, indicating intermittent moisture movement through the tiled system. the condition suggests past or periodic moisture presence, potentially associated with drainage or waterproofing detailing. Repairs to grout and sealant and review of drainage are recommended, with ongoing monitoring and further assessment by a licensed plumber for any progression.

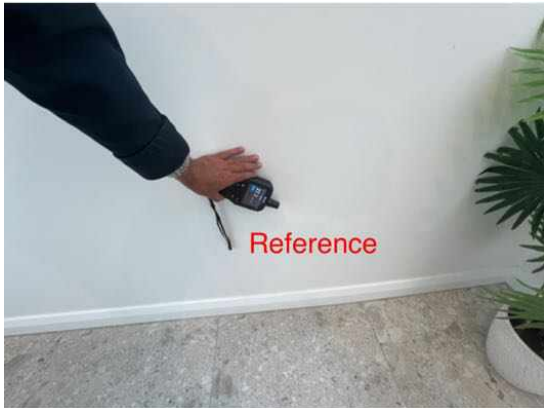
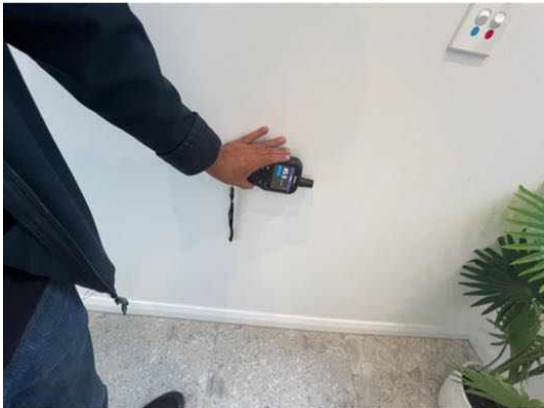
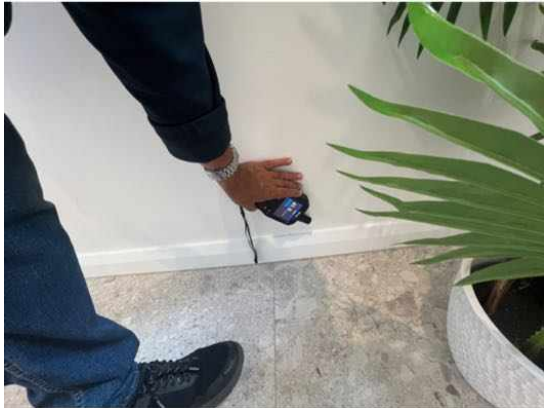
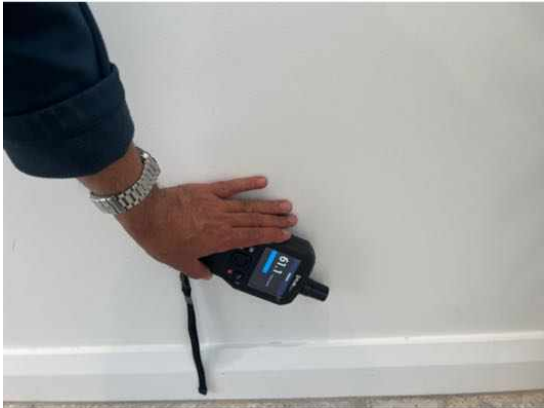
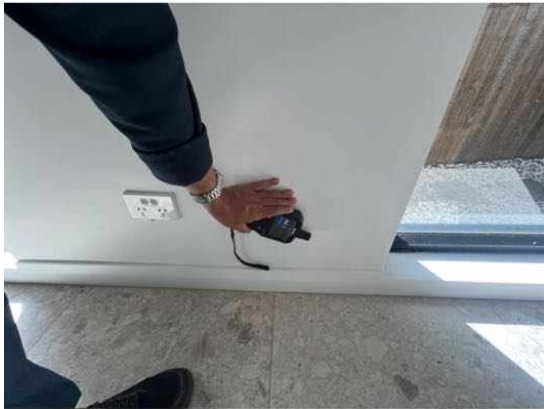
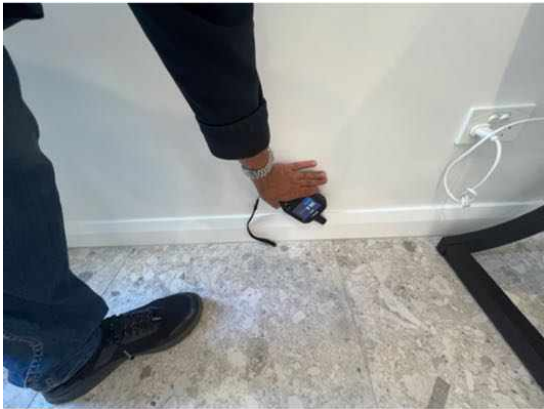
Finding 3.03

Building: Main Building
Location: All Internal Areas - Left parameter wall and rear
Finding: Elevated Moisture – Further Investigation Recommended
Information: Elevated moisture readings were detected in several locations with no visible surface issues, although no significant structural damage was evident at the time of inspection, dampness can contribute to deterioration if left unaddressed. Inspector was not able to inspect the external wall due to space constraints. A further investigation by a licensed plumber or waterproofing specialist is recommended to confirm the source and ensure no concealed issues are developing.

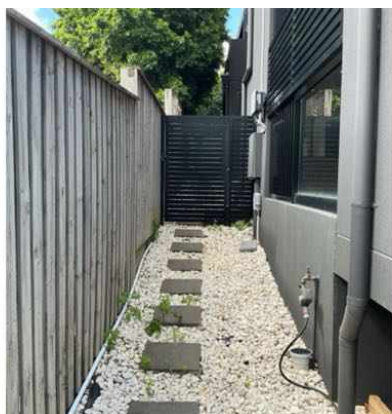
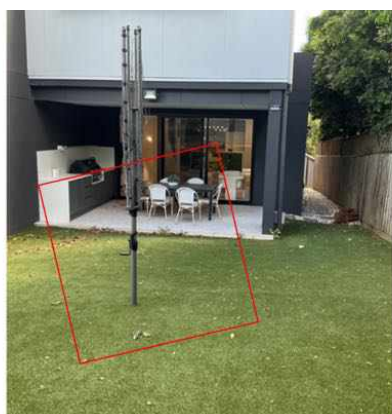
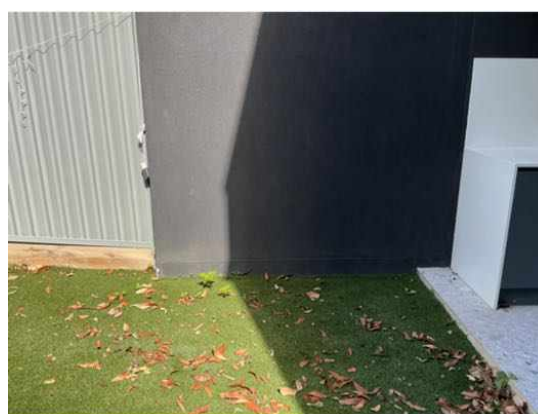
Finding 3.04

Building:	Main Building
Location:	All External Areas
Finding:	Surface Drainage - Gravel
Information:	The setback is finished with loose aggregate. While gravel can assist with surface dispersion of water, it is not a controlled drainage system. The adequacy of falls and stormwater connection could not be confirmed at the time of inspection. Monitoring during rainfall is recommended to ensure no ponding or water discharge occurs toward the slab edge around the property. Further inspection by a licensed plumber is recommended.

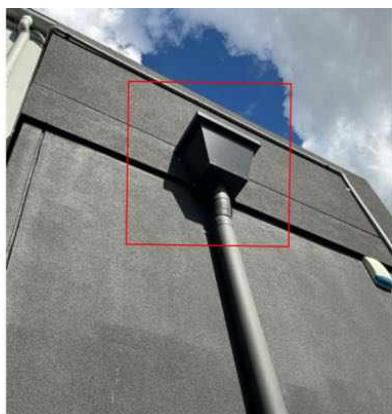
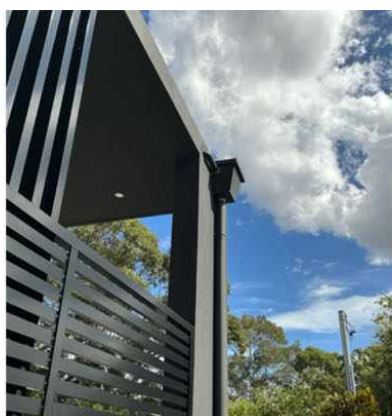
however, an overflow provision was not visible and may be concealed. The system's overall performance could not be confirmed without further inspection or testing during rainfall. Regular cleaning and maintenance of rainheads and downpipes are recommended to ensure effective roof drainage. Use of excessive sealant was also observed to the second rainhead.

It is recommended to consult with a qualified plumber to ensure it meets NCC requirements.

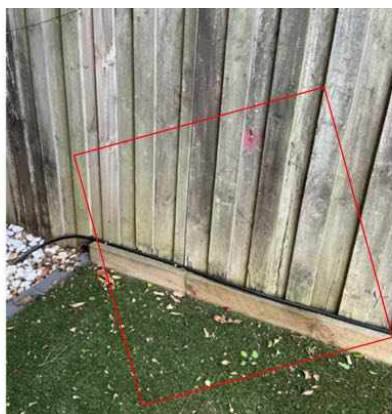
Location: All External Areas - Fence
 Finding: Wood rot to some areas
 Information: This building element shows evidence of wood rot. Wood rot, also known as Fungal Decay, occurs when timbers and other cellulose building materials are exposed to damp conditions on an ongoing basis. This could be the result of exposure to weathering over a prolonged period of time, or the attraction of excessive moisture from other abutting building materials. Contributing factors also include poor air ventilation in the area.

Wood rot is often associated with general damp problems and is evidenced by a 'musty' smell or mould and mildew occurring on surfaces. If left unmanaged, damp conditions can lead to further health problems and the decay of timbers will continue.

Even though Liverpool termite activity was not visible. A further invasive inspection by a licensed termite technician its also highly recommended to eliminate possibility of potential termite activity.

Early intervention and regular maintenance, particularly of exterior timbers, will prolong the useful life of these building elements. Prior to any works being performed, the cause of the moisture that has created the visible wood rot should be identified and addressed in a suitable manner. Replacement of affected timbers may then be a necessary step in protecting surrounding building elements from such deterioration.

A qualified plumber may be appointed to assess the cause of excessive moisture and to provide advice on any remedial works as required. A qualified carpenter or registered builder may also be required to replace affected building materials.

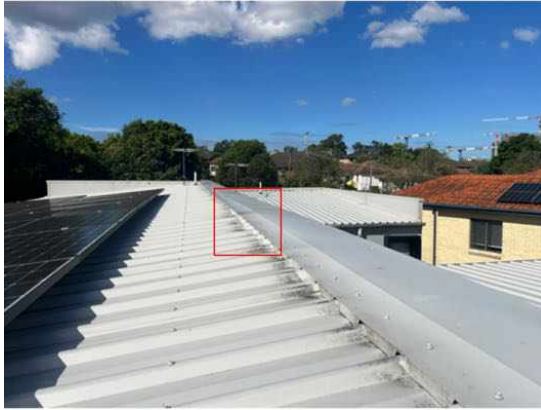
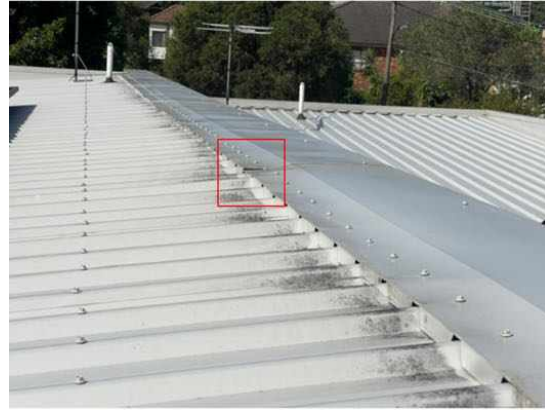
Finding 3.11

Building: Main Building
 Location: Roof Exterior
 Finding: Flashing defective
 Information: The metal flashing at the wall junction appears inadequately installed, with visible gaps and lifting and reliance on surface sealant rather than a properly chased and continuous detail. The junction does not appear fully weather-tight, increasing the risk

of moisture ingress into the wall cavity or roof structure over time. Defective flashing installation can lead to concealed deterioration if not addressed. Recommend assessment and rectification by a qualified roofing contractor to ensure compliant and effective weatherproofing.

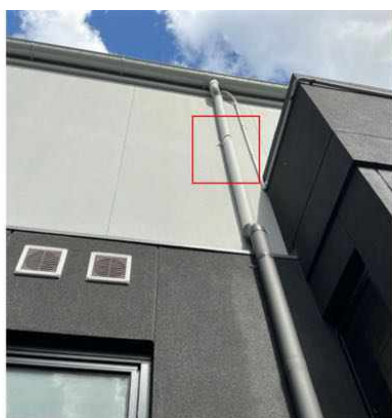
Building:	Main Building
Location:	All External Areas
Finding:	Building element - Damaged - Loose fixing
Information:	Breakage occurs generally when the building materials have either aged and decayed, or as a result of damage (accidental or deliberate).

Repair and/or replacement of broken elements is advised to ensure that additional secondary defects do not arise as a consequence. Such works are necessary, as all building elements play a key role in the operation and function of the overall structure and its performance.

A relevant tradesperson should be appointed to repair or replace the affected building element prior to any subsequent damage being caused.

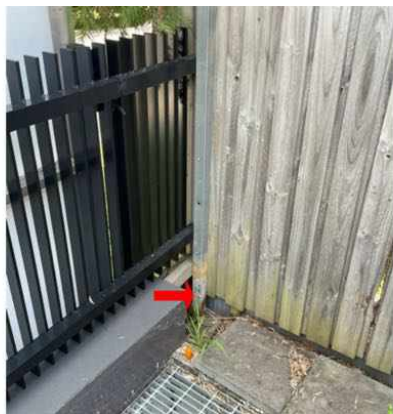
Finding 3.14

Building:	Main Building
Location:	All External Areas
Finding:	Building element - Rusted or corroded - Fence post corroded
Information:	This building element shows evidence of rusting and corrosion, which is likely to have developed as a result of excessive exposure to moisture and or inadequate coatings.

As surface rust provides no protection to the underlying iron, the deteriorating condition is likely to worsen if not addressed in the short-term future.

Where possible, the use of galvanized (treated) metals or aluminium coated metals aid in rust prevention, as does regular general maintenance. Rust formation can be controlled with coatings, such as paint, that isolate the iron from the environment.

Rusting and corrosion should be managed by ideally removing or limiting the affected surface from exposure to moisture. A registered builder may be appointed to replace any building elements that have been severely affected by rust or water damage.

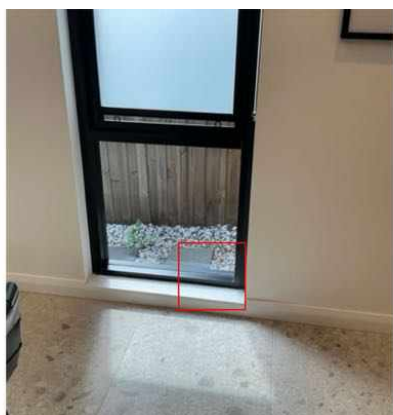
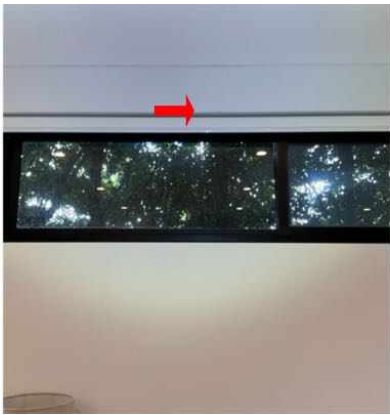
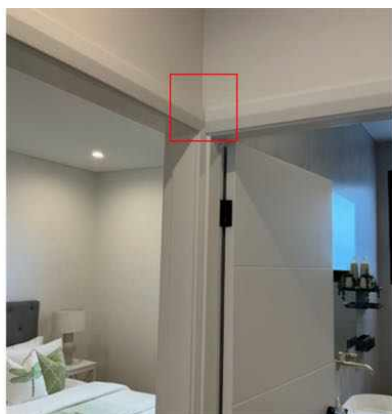
Finding 3.15

Building:	Main Building
Location:	All Internal Areas
Finding:	Paint Finish & Hairline Cracking - To some areas
Information:	The paint finish in this area was identified as being incomplete at the time of inspection including some hairline minor cracking.

Whilst incomplete or missing paint and minor cracking and imperfections in finish is generally an appearance defect, it can also lead to the development of secondary building defects over time. Incomplete areas of paint finish expose the area to moisture, potentially accelerating the deterioration of underlying building materials.

Incomplete paint finishes should be sanded back, filled, leveled and painted, as applicable. Where inadequate or missing paint protection has led to the deterioration of the associated building element, repair and/or replacement of this building element may be required.

A painting contractor should be appointed as soon as possible to perform necessary works to aid the appearance of the affected area and to ensure the area is protected against further deterioration. Alternatively, the homeowner following manufacturer instructions may perform these works.

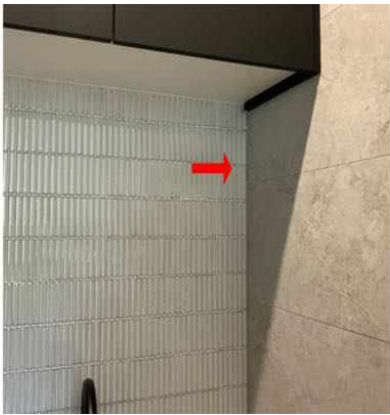
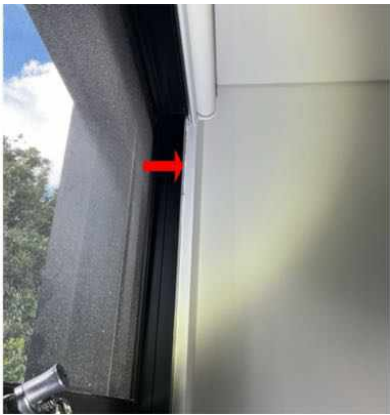
Finding 3.16

Building:	Main Building
Location:	All Internal Areas
Finding:	Sealant and grouting - Missing or degraded to some areas
Information:	It was noted on inspection that sealant or grout is degraded. There is also evidence of poor workmanship and excessive use of sealant. Silicone should never be used as a first line of defence against waterproofing. Further inspection by a licensed waterproofing contractor is highly recommended.

Different materials and floor areas move at different rates, generally causing cracking to grout or sealant at this point. A flexible sealant is required to allow for expected expansion and contraction, while keeping the joint water tight and protective of all associated building materials.

There appears to be excessive mould to the sealant and grout which will likely require scraping out and replacement.

Flexible and mould resistant materials should be applied to affected areas to prevent any subsequent water damage that is likely to occur. Regular maintenance and replacement of damage or missing or damaged sealant and grout is highly recommended to the wet areas, as this is a regular wear and tear defect. Sealant and grouting in areas that come into regular contact with water should be maintained for the long term care of your property.

A sealant specialist or tiling contractor should be appointed to complete these works as soon as possible.

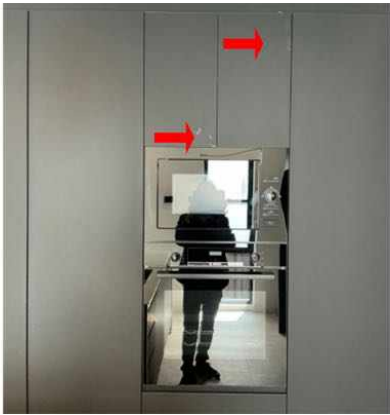
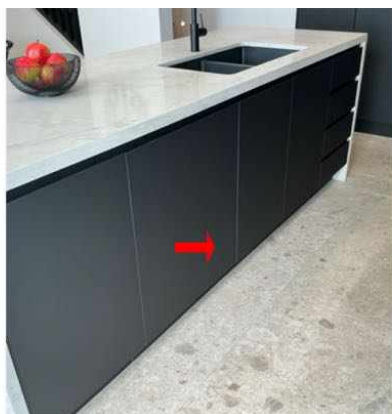
Finding 3.17

Building: Main Building
Location: All Internal Areas
Finding: Building element - Damaged - Kitchen cabinetry paint fading
Information: Breakage occurs generally when the building materials have either aged and decayed, or as a result of damage (accidental or deliberate).

Repair and/or replacement of broken elements is advised to ensure that additional secondary defects do not arise as a consequence. Such works are necessary, as all building elements play a key role in the operation and function of the overall structure and its performance.

A relevant tradesperson should be appointed to repair or replace the affected building element prior to any subsequent damage being caused.

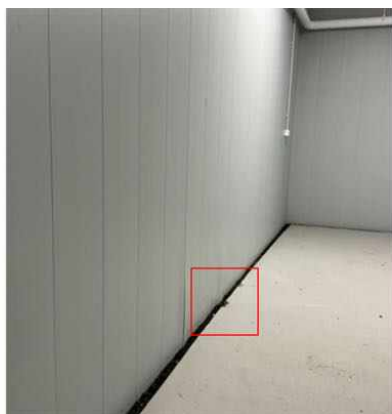
Finding 3.18

Building:	Main Building
Location:	Garage
Finding:	Building element - Damaged - paving and concrete lining bulging
Information:	Breakage occurs generally when the building materials have either aged and decayed, or as a result of damage (accidental or deliberate).

Repair and/or replacement of broken elements is advised to ensure that additional secondary defects do not arise as a consequence. Such works are necessary, as all building elements play a key role in the operation and function of the overall structure and its performance.

A relevant tradesperson (Licensed builder) should be appointed to repair or replace the affected building element prior to any subsequent damage being caused.

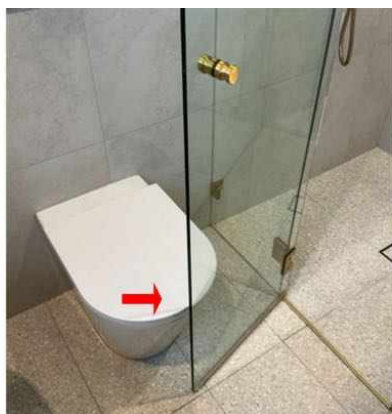
Finding 3.19

Building:	Main Building
Location:	Bathroom
Finding:	Installation - substandard or incomplete - Shower
Information:	The shower screen door appears to be installed in close proximity to the vanity unit/toilet or adjacent walls, resulting in limited or no clearance between the glass panel and adjacent cabinetry. The current installation may restrict full door operation and compromise effective water containment within the shower area. Substandard installation can increase the risk of water escaping beyond the wet area, damage to door or cabinets/walls potentially affecting surrounding finishes over time. Adjustment or rectification by a qualified installer is recommended to ensure proper alignment and adequate clearance.

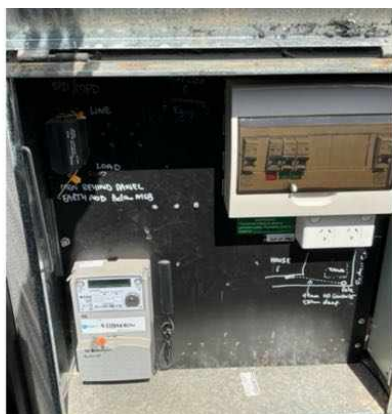
A durable notice should be placed in the switchboard unit to indicate current termite barriers. At the time of inspection, it appeared as though no termite management system has been installed, with no evidence to suggest preventative works taking place.

The client may consider gaining further advice from a pest controller as to the costs and procedures involved with this application. It is recommended that obtaining such advice be a short-term priority.

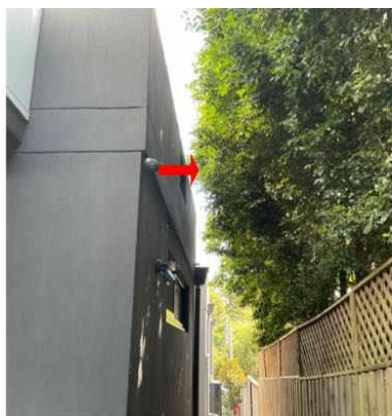
The removal and replanting of species that do not provide "cover" or cutting back of existing vegetation will assist greatly in preventing Bridging from occurring.

The removal of any such materials that may be conducive to termite activity should be carried out as soon as possible and arrange re inspection to minimize the risk of termite attack.

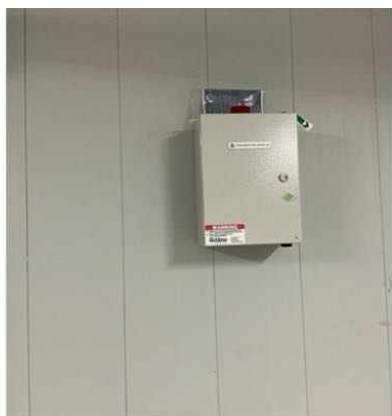
Noted Item

Building:	Main Building
Location:	All Internal Areas
Finding:	Stormwater Pump
Information:	A stormwater pump system is installed and was indicating a red light. These systems rely on mechanical operation and power supply, and may be prone to failure if not properly maintained. In the event of malfunction, water back-up or flooding may occur. Buyers should make their own enquiries regarding maintenance history and ongoing servicing requirements. Further inspection by a licensed plumber is recommended to ensure adequacy and operating as intended.

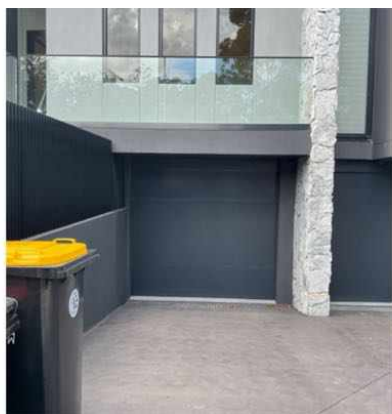
Noted Item

Building:	Main Building
Location:	All External Areas
Finding:	Drainage Performance Risk
Information:	The driveway is fitted with drainage provisions, however, there remains a potential risk of water sheeting towards the garage during periods of heavy rainfall. While the area was dry at the time of inspection and no pooling was evident, it is recommended that drainage performance be monitored during large rain events to confirm effective surface runoff capture. This condition does not currently present as a defect, but proactive maintenance of drainage inlets and consideration of fall adequacy is advised to ensure long-term compliance with NCC FP1.4 and AS/NZS 3500.3 stormwater drainage provisions.

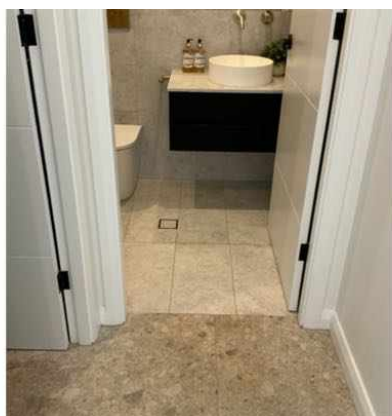
Noted Item

Building: Main Building
 Location: All Internal Areas - First floor bathroom
 Finding: Bathroom & external floor threshold
 Information: The bathroom floor is at the same level as the adjoining timber flooring. This configuration is typical in modern apartments and is permitted where compliant waterproofing and floor falls are provided. No evidence of moisture damage was observed at the time of inspection; however, waterproofing performance cannot be confirmed without invasive inspection.

Care should be taken to avoid excessive water migration beyond the bathroom during use.
