Building and Timber Pest Inspection Report

Inspection Date: Thu, 26 Feb 2026

Property Address: 78 Wellington St, Bondi Beach NSW 2026,
Australia

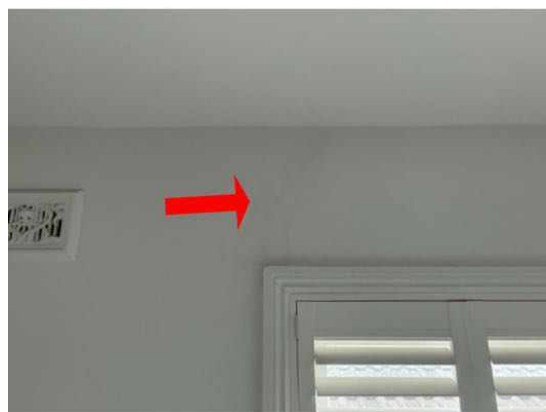
Building: Main Building
 Location: Bedroom 2
 Finding: Cracking - Damage Category 0 - Hairline (less than 1mm)
 Information: Hairline cracks are very minor in nature and generally are only ever an appearance defect. While such cracking may be noticeable in some cases, it is quite common and does not indicate any structural damage.

Cracking of this nature can generally be repaired with minor sanding, filling and/or repainting. Such works should be performed by a qualified painter or a general handyman.

Monitoring of all cracking should be conducted frequently. Always contact a building inspector should cracks widen, lengthen, or become more numerous.

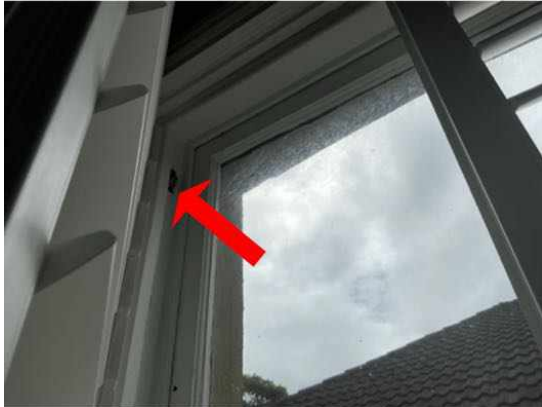
Finding 3.02

Building: Main Building
 Location: Bedroom 2
 Finding: Sash Cords Broken or Missing
 Information: Sashes are the moveable panes of windows that primarily slide vertically over each

These cords are prone to degradation over time and replacement is required.

Repairing or replacing sash cords should be conducted by a carpenter or handyman. It is advised that such works be completed to improves the operational state of the affected window.

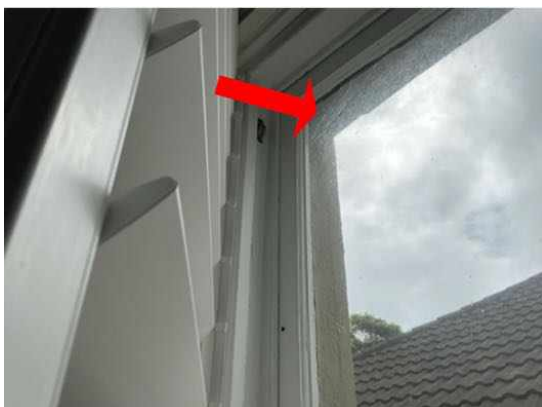
Finding 3.03

Building: Main Building
Location: Bedroom 2
Finding: Window - Cracked
Information: Cracks were identified in the window in this area. Cracking in windows is generally the result of impact damage, and is likely to develop further when left unmanaged.

A qualified glazier is required to repair the window as soon as possible.

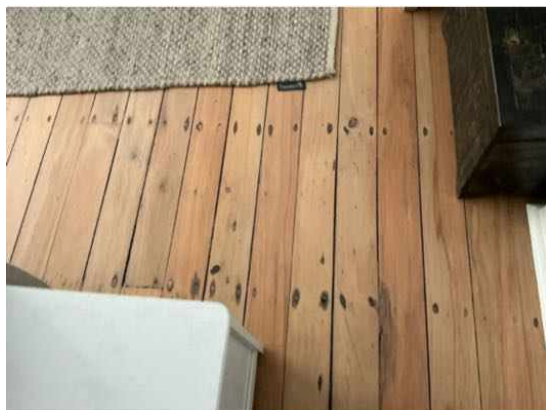
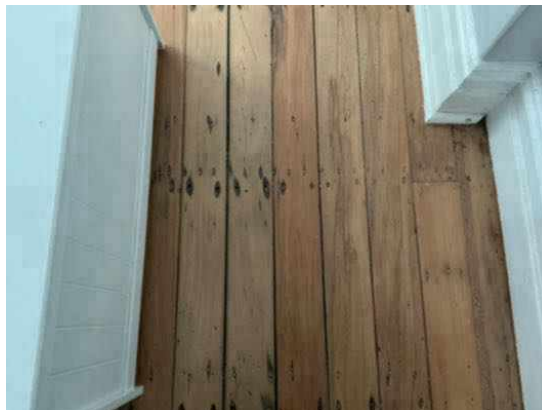
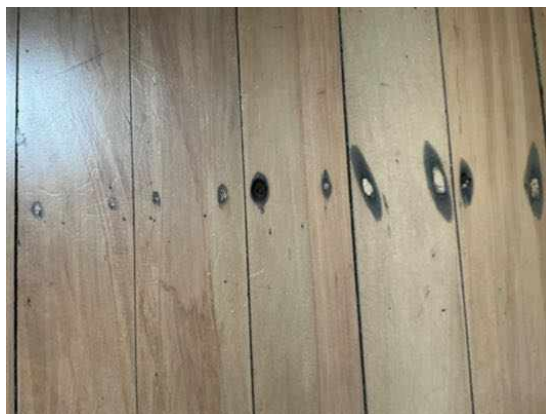
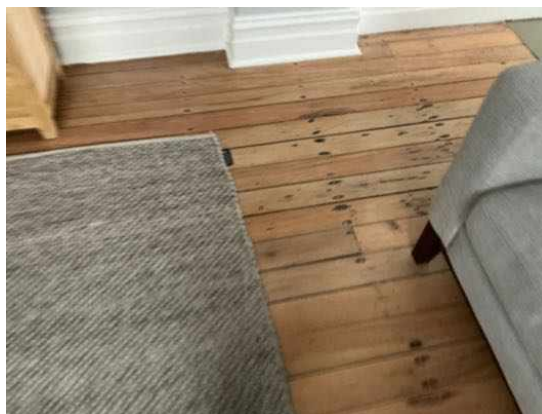
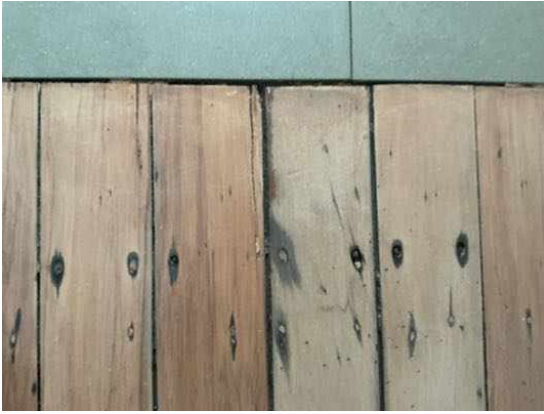
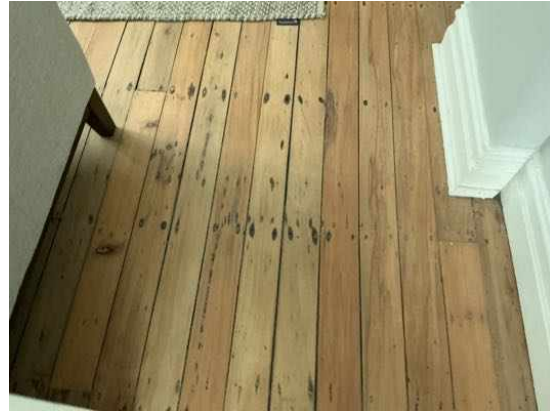
Finding 3.04

Finding: Deterioration to Timber Flooring and Fixings

Information: The timber flooring throughout the lounge room shows staining around nail and fixing points. This is likely due to age-related deterioration and possible corrosion of the original fixings, which has caused discolouration to the surrounding timber.

In some areas, the affected fixings appear to have loosened over time, resulting in slight movement and looseness of individual floorboards. Continued deterioration of the fixings may lead to increased movement, squeaking, or further loosening of the boards.

Repairs are recommended. A carpenter or flooring specialist should be engaged to assess the condition of the fixings and floorboards, re-secure loose boards, and replace deteriorated fixings where required.

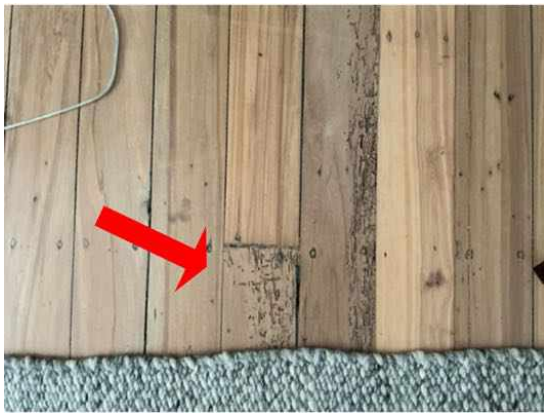
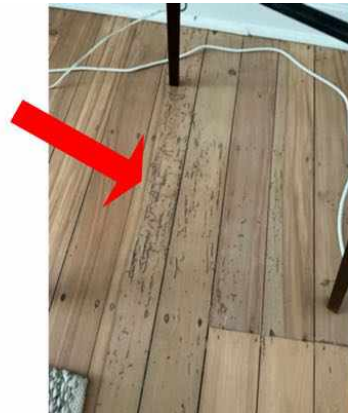
Finding 3.05

Building:	Main Building
Location:	Lounge Room
Finding:	Signs of Wood borer activity identified
Information:	Wood borers small beetles that colonise in exposed timber elements are a common timber pest that are regularly mistaken for termites. Although wood borer activity is generally not detrimental to the affected timber they may lead to serious damage and necessitate replacement of certain building elements if left unattended. As no live wood borer activity was identified treatment is not required at this time. Replacement of affected timbers may be considered by the client for aesthetic reasons.

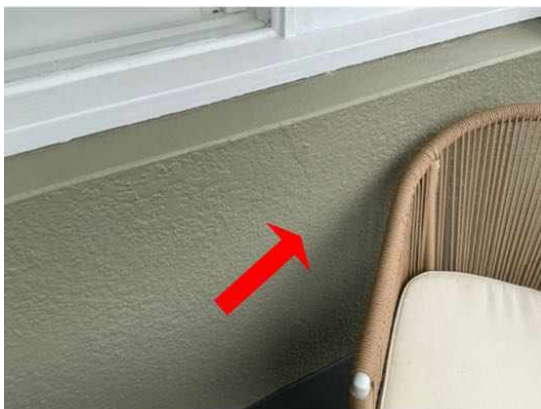
Finding 3.07

Building:	Main Building
Location:	Front Elevation
Finding:	Render - cracking (Fine)
Information:	Although fine cracks are quite noticeable, they are often only considered to be an appearance defect and usually do not indicate any structural damage. Generally, the cause of a fine crack is indicative of slight movement of the property and is common for houses of this age.

Cracking of this nature can generally be repaired with minor filling and should be conducted by a qualified painter.

Always contact a building inspector should cracks widen lengthen or become more numerous.

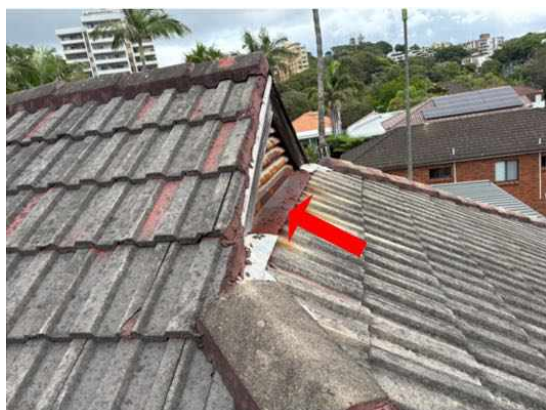
Finding 3.08

Building:	Main Building
Location:	Roof Exterior
Finding:	Roof Flashings - Rusted
Information:	Upon inspection of the exterior roofing structure, evidence of rust was identified to the flashing.

If left unmanaged, these degrading can allow water ingress to the internal roofing structures, potentially leading to secondary damage of building elements. Accelerated deterioration of any associated building elements is also likely to occur.

A roofing contractor should be appointed immediately to assess the damage to the flashings and to perform remedial works as necessary. Works may include replacement of severely affected flashings or minor works such as the application of rust-retardant surface protectors.

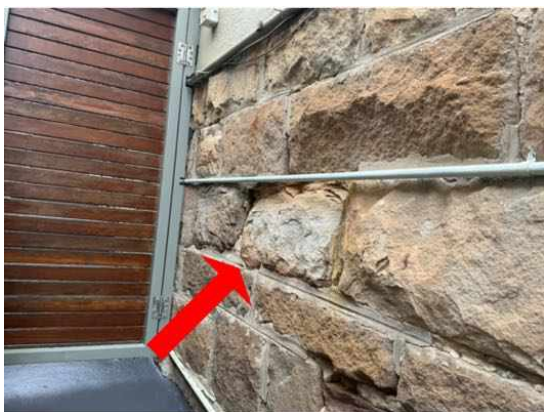
Finding 3.09

Building:	Main Building
Location:	Exterior walls - right side
Finding:	Sandstone deterioration
Information:	Deterioration was evident to sections of the sandstone in this area at the time of inspection. Commonly referred to as stone corrosion or erosion, the blocks are aged and likely to have been affected by a variety of factors, including weather exposure, damage, salt-based deterioration, and more. Overtime, these factors can affect the blocks, causing them to become brittle and appear corroded or eroded. If left unmanaged, potential implications include further deterioration of the building materials, the development of secondary defects, and potential development of structural instability of the wall. Consultation with a stone mason is recommended and repairs should be carried out at their advise.

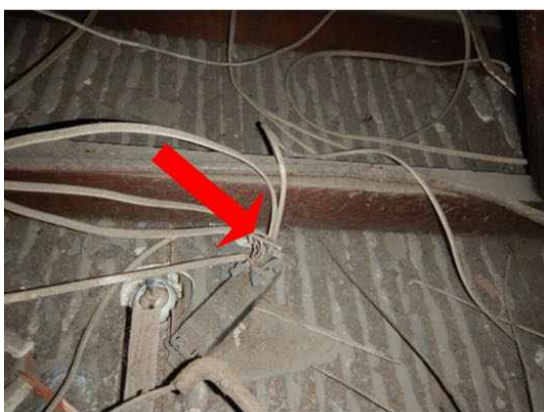
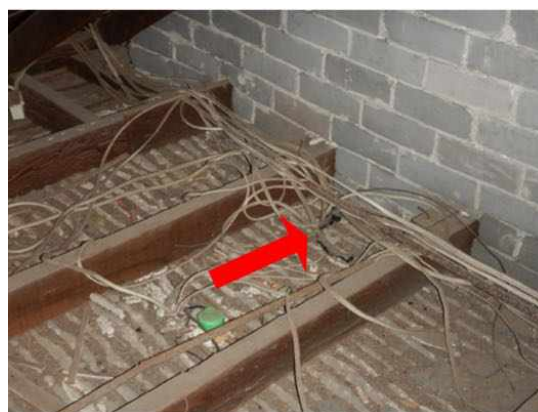
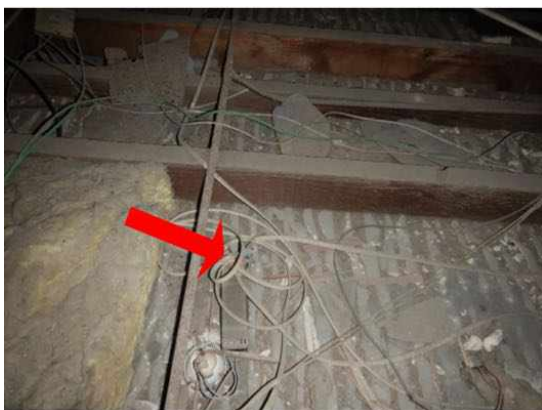
Finding 3.10

Building:	Main Building
Location:	Roof Void
Finding:	Electrical junction box missing
Information:	These wiring joins are not adequately protected by junction boxes. Junction boxes provide a second insulation barrier to adequately seal off and protect the wires, increasing the safety of the immediate environment and ensuring that the wiring is not damaged.

The absence of junction boxes poses as an electrical safety hazard, providing risk of electrocution.

Appointment of a licensed electrician is highly advised to provide additional information on the risks of unprotected wiring and to install junction boxes and any other elements as required.

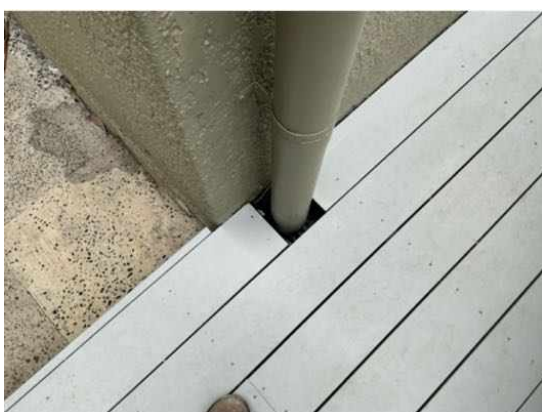
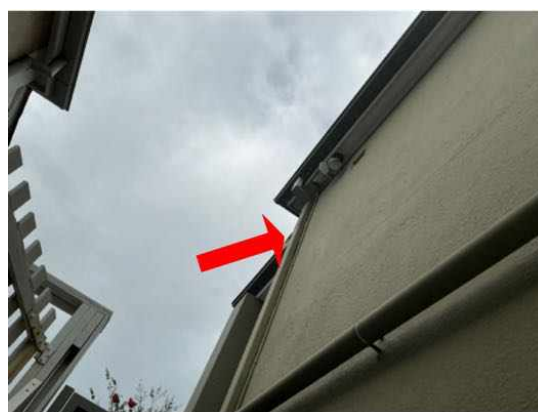
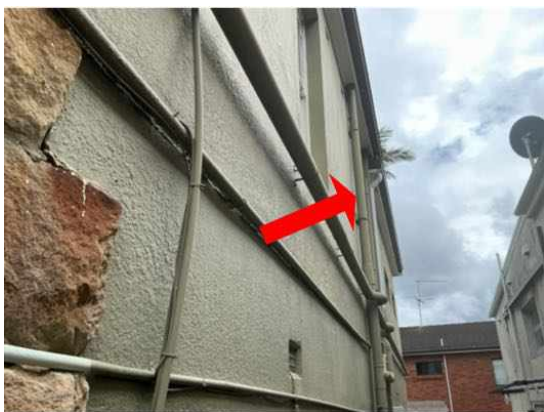
Finding 3.11

Building:	Main Building
Location:	Roof Exterior
Finding:	Suspected Inadequate Downpipe Provision – Roof Plumbing
Information:	The roof plumbing appears to discharge to a single downpipe located at the rear of the property. Based on the roof area being serviced, there is concern that the number of downpipes may be insufficient for effective stormwater discharge.

Although the system may be functioning under normal rainfall conditions, heavy downpours could result in overloading of the single downpipe, leading to gutter overflow or surcharge at the connection point to the stormwater system near the rear deck.

It is recommended that the system be monitored during periods of heavy rainfall to confirm adequate performance. If overflow or back-up is observed, consultation with a licensed roof plumber is advised to assess whether additional downpipes or drainage upgrades are required.

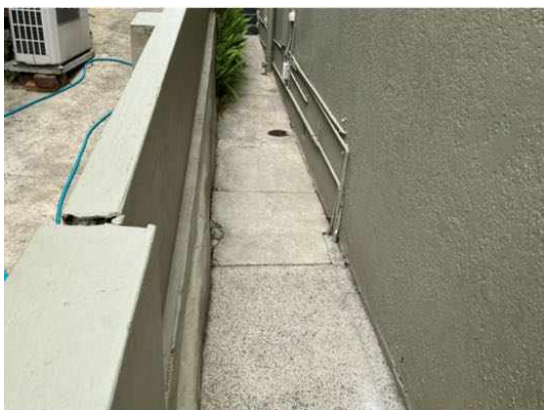
Finding 3.12

Building:	Main Building
Location:	Exterior walls - right side
Finding:	Site drainage - Inadequate
Information:	The site drainage in side and rear of the house was found to be inadequate at the time of inspection, creating potential for subsequent water damage to associated building elements.

It is important that water does not lie against the base of walls; surrounding paths and ground levels should be sloped to drain water away from walls. Stormwater should be carried away by large, regularly cleaned drains.

Where site drainage is inadequate, installation of additional drainage may be required. A qualified plumber should be appointed to further inspect the property and perform any remedial works as necessary. Water damage and secondary defects are likely to occur if left unmanaged.

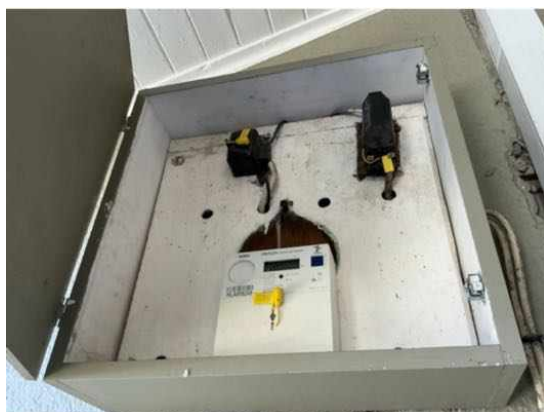
Building:	Main Building
Location:	Front Elevation
Finding:	Termite Management System No Evidence of Installation
Information:	The application of a post-construction termite barrier is highly recommended for all properties. Such barriers are highly effective in preventing termite attack on any timber building elements throughout the property.

A durable notice should be placed in the switchboard unit to indicate current termite barriers. At the time of inspection, it appeared as though no termite management system has been installed, with no evidence to suggest preventative works taking place.

The client may consider gaining further advice from a pest controller as to the costs and procedures involved with this application. It is recommended that obtaining such advice be a short-term priority.
