Building and Timber Pest Inspection Report

Inspection Date: Thu, 26 Mar 2026

Property Address: 4/168 Narracan Dr, Newborough VIC 3825, Australia

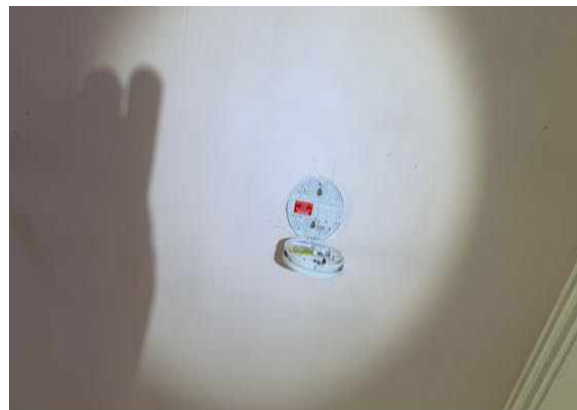
Please note that this defect is highlighted as a caution only. We suspect, based on our experience in the building industry, that the absence of smoke detectors, or their poor condition, should be addressed as a matter of urgency to improve occupant safety.

Always ensure sufficient working and suitable smoke detectors are installed prior to occupying any building. Additionally, it is advised that all smoke detectors be tested by the homeowner on a monthly basis.

Please refer to AS3786 and state based legislation, which may also apply.

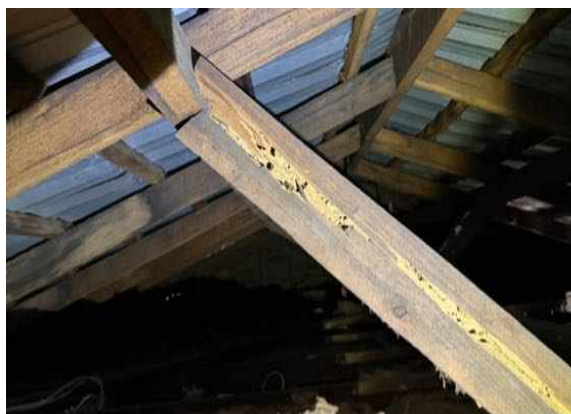
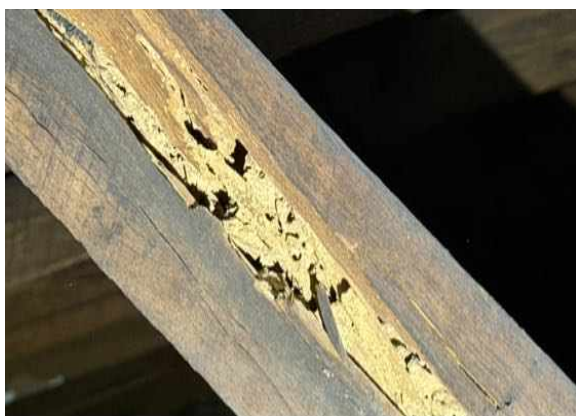
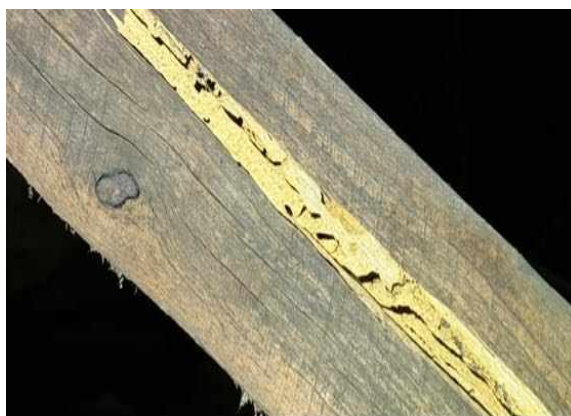
Finding 2.01

Finding: Termite Damage to Roof Structural Timber

Information: Evidence of termite damage was identified to structural timber elements within the roof space during the inspection. The observed damage is consistent with timber pest activity; however, this assessment is based on a visual, non-invasive inspection only. Access limitations and concealed building elements restricted a full assessment, and therefore the extent of damage and whether the activity is current or historical could not be determined.

Termite damage to structural timbers is considered a major defect, as it may significantly compromise the structural integrity and load-bearing capacity of the building. The damage observed may extend beyond visible areas and could be present within concealed elements such as framing members, wall cavities, and other inaccessible sections of the structure. If active infestation is present, further deterioration may occur, potentially leading to extensive structural damage.

An urgent invasive inspection by a licensed timber pest technician is strongly recommended to confirm the presence of active termites and determine the full extent of damage. A registered builder should also be engaged to assess the structural adequacy of affected elements and carry out necessary repairs or replacement. Immediate attention is required to mitigate further risk and potential escalation of damage

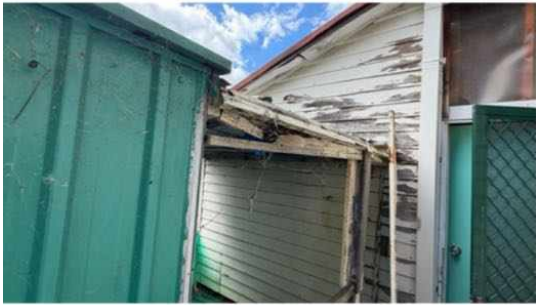
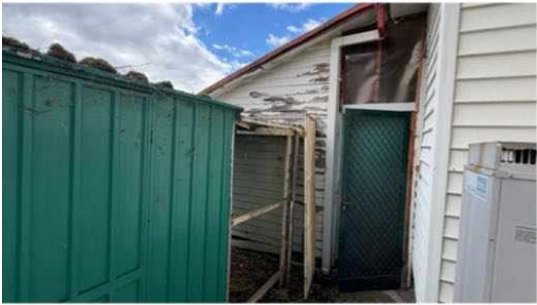
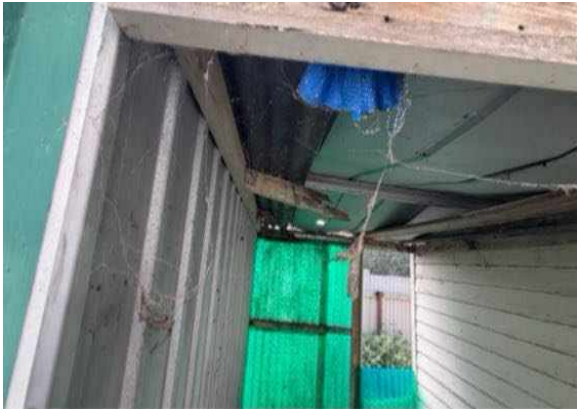
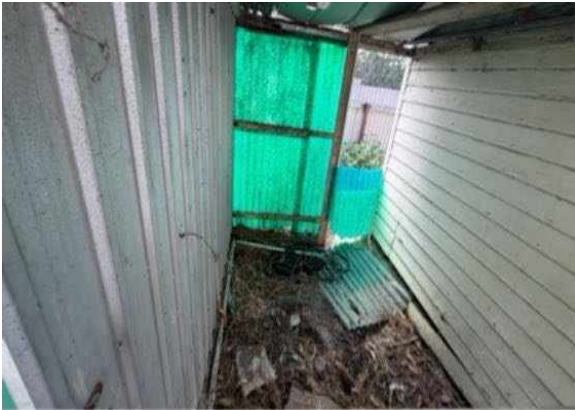
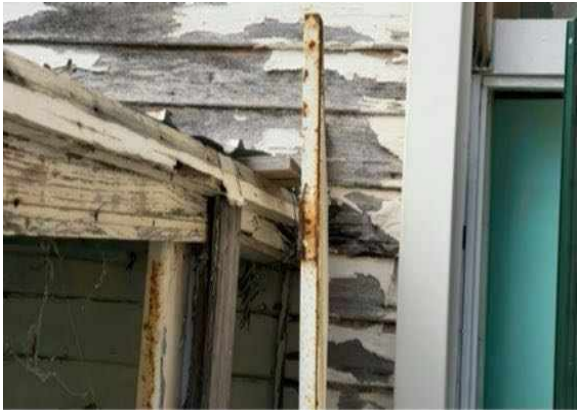
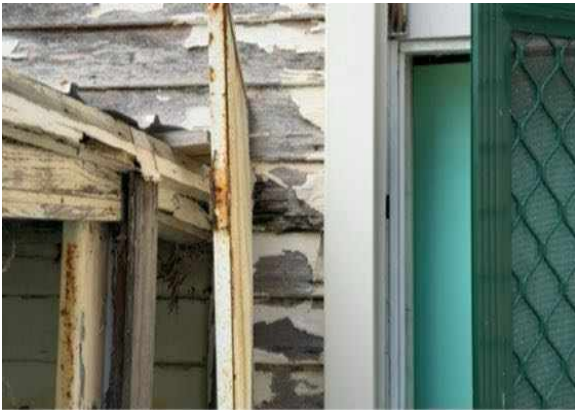
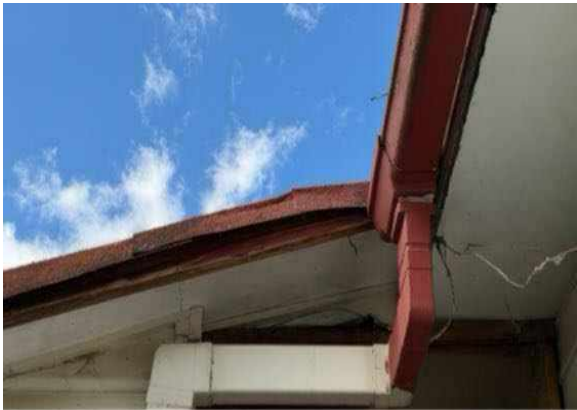
Finding 2.02

Building: Main Building
Location: Exterior walls - rear
Finding: Severely Deteriorated Rear Section
Information: The rear section of the property was observed to be in a severely deteriorated condition during the inspection. Extensive weathering of timber elements was noted, with multiple areas affected by wood rot. Damaged eaves and deteriorated roof flashings were also identified, indicating prolonged exposure to moisture and lack of maintenance.

This condition poses a risk of further structural deterioration if left unaddressed. Timber decay can compromise the integrity of affected building elements, and damaged eaves and flashings increase the likelihood of water ingress, which may lead to additional concealed damage over time.

It is strongly recommended that a registered builder and licensed roofing contractor be engaged to carry out a comprehensive assessment and undertake necessary repairs or replacement of the affected elements. Further investigation may be required to determine the full extent of damage.

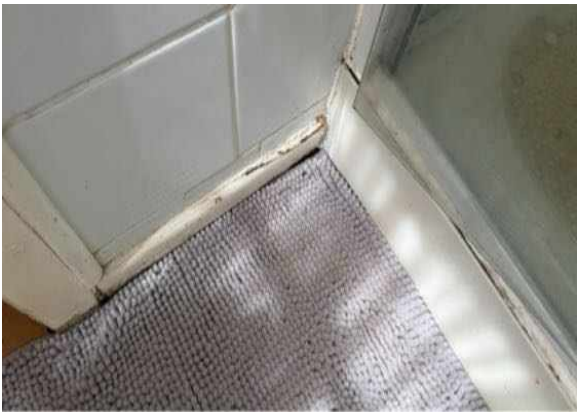
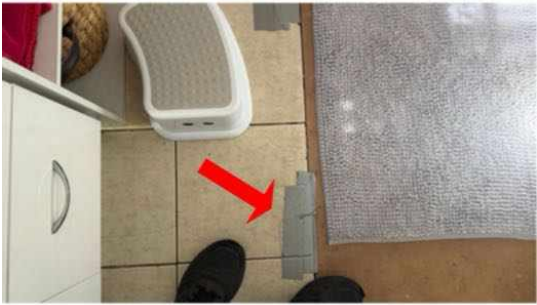
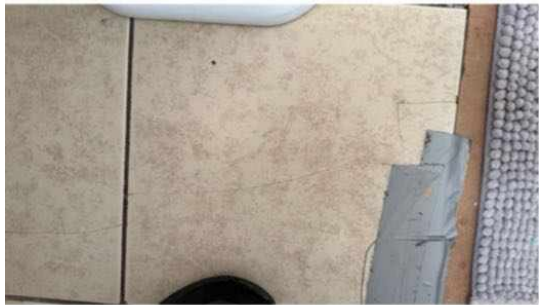
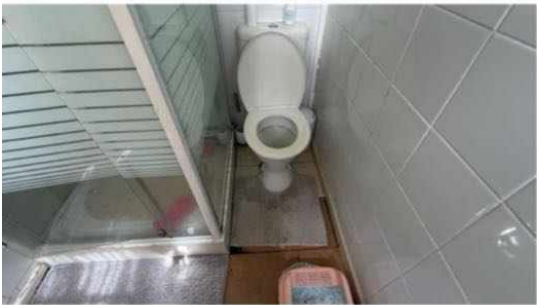
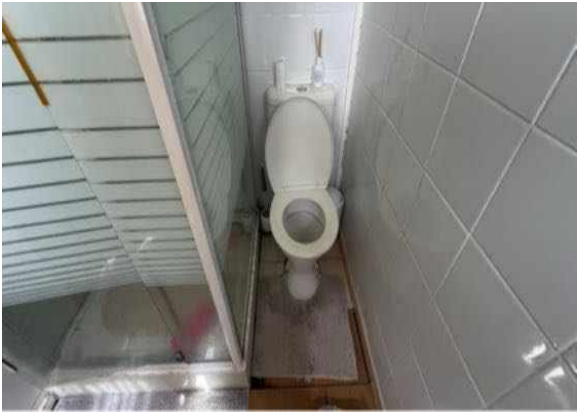
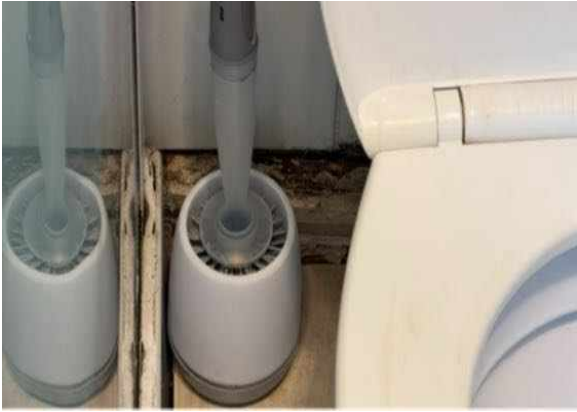
Finding 2.03

Building:	Main Building
Location:	Bathroom
Finding:	Major Bathroom Defects and Suspected Shower Leak
Information:	Significant defects were observed in the bathroom area during the inspection. Several floor tiles were missing and multiple floor tiles were cracked. Deteriorated grouts were also noted to tiled areas. The basin was found to be deteriorated, and the shower base was damaged. Shower door hardware was also faulty. Elevated moisture levels were recorded in multiple sections around the shower area, and severe wood rot was observed to timber elements near the shower and WC. These findings are consistent with a likely active and/or prolonged water leak originating from the shower area.

The extent of moisture ingress, deteriorated grouting, cracked and missing tiles, and timber decay indicates ongoing exposure to water, which may have resulted in concealed damage to adjacent structural and subfloor elements that were not visible at the time of inspection. Such conditions can compromise the integrity of affected building components and are conducive to termite infestation, increasing the risk of timber pest activity. Given the limitations of a visual, non-invasive inspection, the full extent of damage and underlying causes could not be determined.

An invasive inspection is considered essential to accurately determine the source and extent of the leak and any associated damage. It is strongly recommended that a licensed plumber be engaged to investigate and rectify the leak, and a registered builder be appointed to assess and carry out all necessary repairs and reinstatement works as soon as possible. Delay in addressing this issue may lead to further deterioration and increased repair costs.

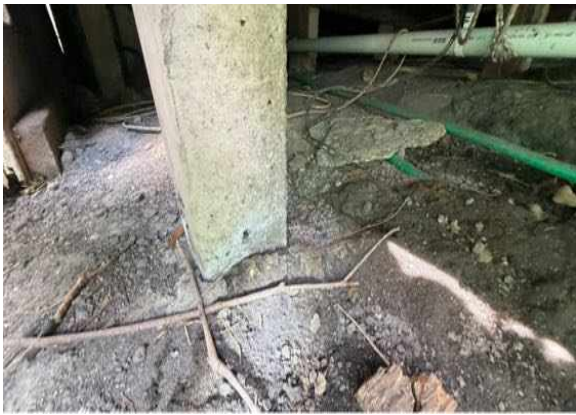
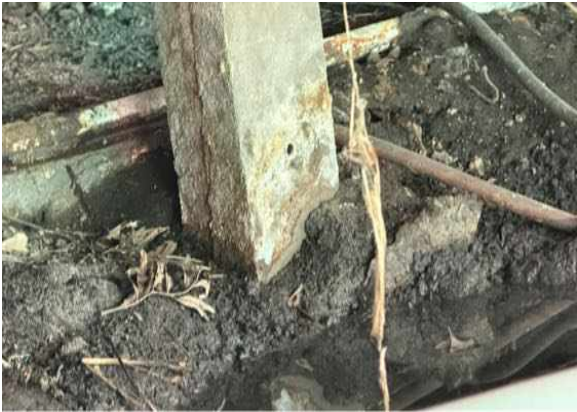
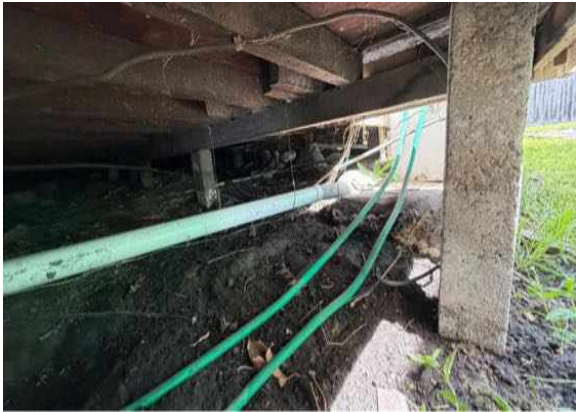
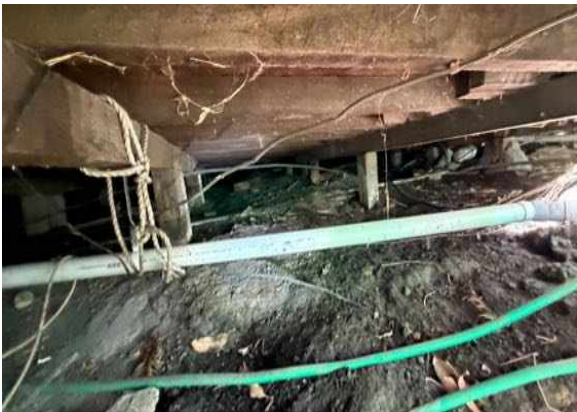
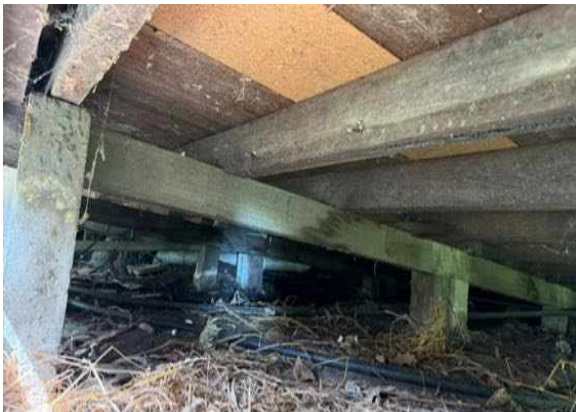
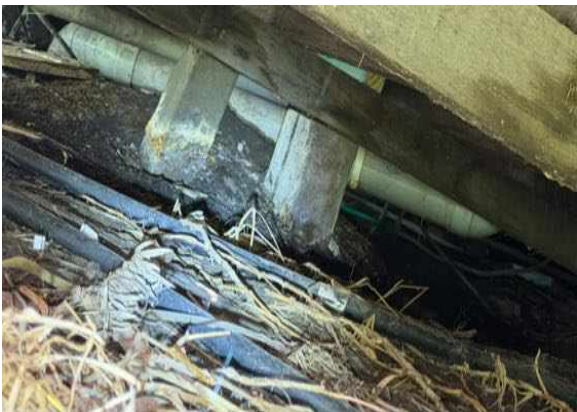
Building:	Main Building
Location:	Subfloor
Finding:	Severe Subfloor Damp Conditions
Information:	Severe damp conditions were identified in multiple sections of the subfloor, predominantly at the rear side of the property. Elevated moisture levels were noted to the subfloor environment, and supporting stumps were found to be damp at the base. This condition may be associated with a potential leak from the adjacent bathroom and/or inadequate site drainage; however, this assessment is based on a visual, non-invasive inspection only, and the exact source of moisture could not be conclusively determined.

Prolonged damp conditions within the subfloor can adversely affect the performance and durability of structural elements, including stumps, bearers, and joists. Continued exposure to moisture may lead to timber decay, weakening of structural components, and creates an environment conducive to termite infestation. It is also possible that concealed damage exists to subfloor elements that were not visible at the time of inspection.

An urgent and thorough investigation is required. It is strongly recommended that a licensed plumber be engaged to identify and rectify any plumbing leaks, and a registered builder be appointed to assess the condition of subfloor structural elements and carry out necessary remedial works. An invasive inspection may be required to determine the full extent of damage. Immediate attention is advised to mitigate further deterioration.

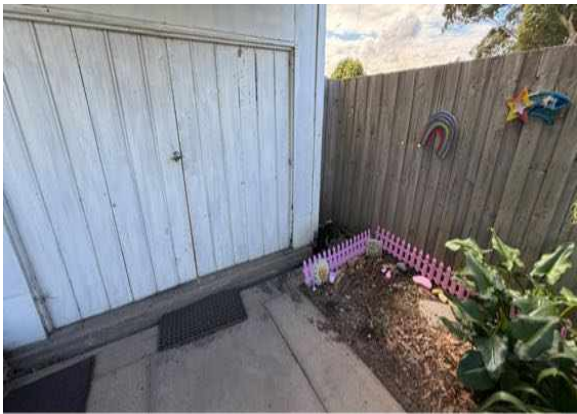
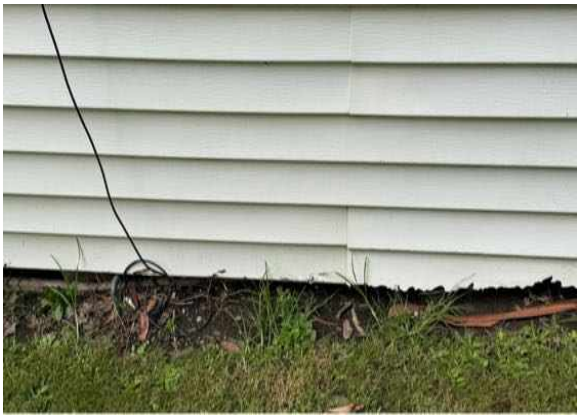
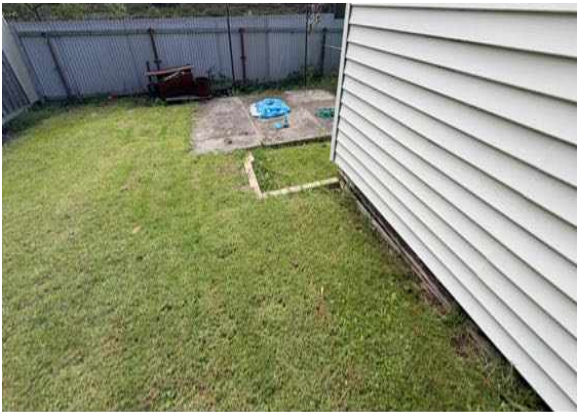
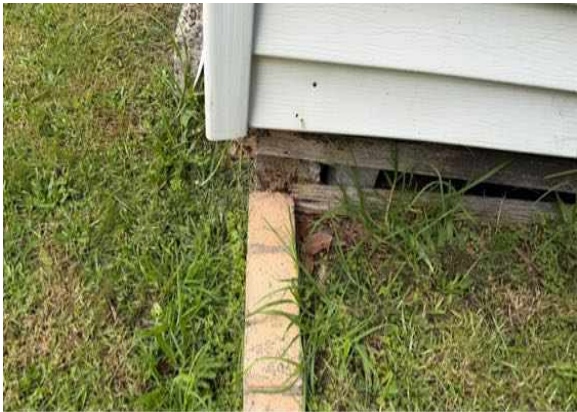
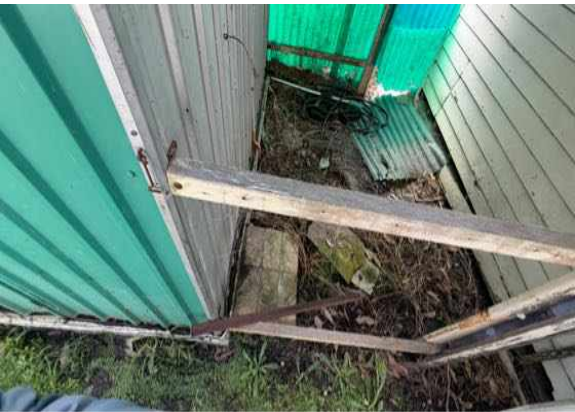
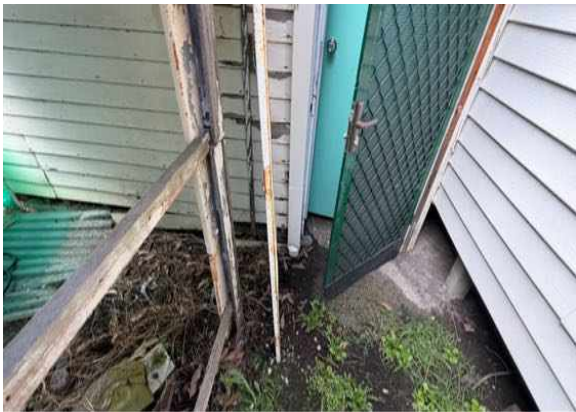
Building:	Main Building
Location:	All Areas
Finding:	Inadequate Site Drainage
Information:	The site drainage around the property was observed to be inadequate, resulting in water accumulating near the building perimeter and creating damp conditions. This may be due to poor grading, insufficient fall away from the structure, or ineffective stormwater management. Timber elements in contact with or close to the ground were also noted to have wood rot, likely as a result of prolonged moisture exposure.

Prolonged damp conditions can contribute to deterioration of building materials,

weakening of structural elements over time, and may lead to moisture ingress into the dwelling. The observed timber decay further indicates ongoing moisture issues. Additionally, such conditions are conducive to termite infestation, increasing the risk of timber pest activity.

It is recommended that a licensed plumber or drainage specialist be engaged to assess and rectify site drainage, including improving surface grading and ensuring proper connection to the stormwater system. Decayed timber elements should be repaired or replaced by a registered builder, and appropriate measures should be implemented to prevent further moisture exposure and maintain a dry perimeter around the structure.

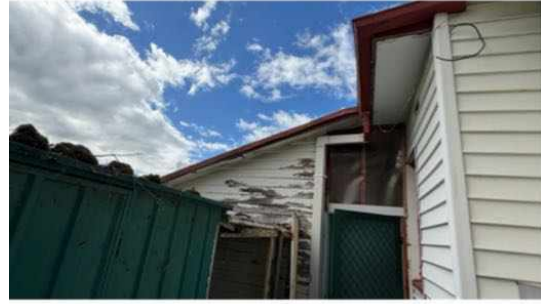
Building: Main Building
Location: Roof Exterior
Finding: Deteriorated Roof Flashings
Information: Roof flashings were observed to be severely deteriorated, with significant rusting evident to the metal components. This condition is likely due to prolonged exposure to weather and lack of maintenance over time.

Deteriorated flashings may compromise the weatherproofing of the roof, increasing the risk of water ingress into the building. If left unaddressed, this may lead to internal water damage, timber decay, and deterioration of surrounding structural elements.

It is recommended that a licensed roofing contractor be engaged to inspect, repair, or replace the affected flashings as required. Further investigation may be necessary to assess any underlying damage caused by potential water ingress.

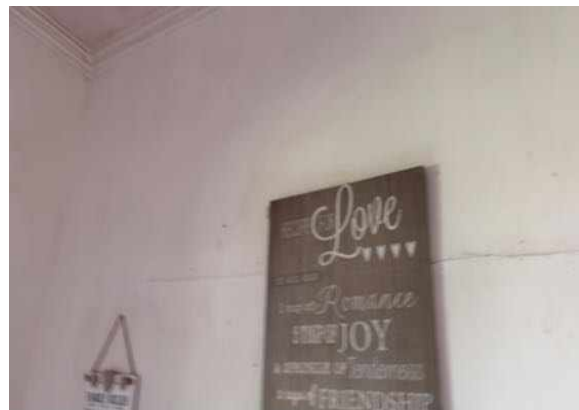
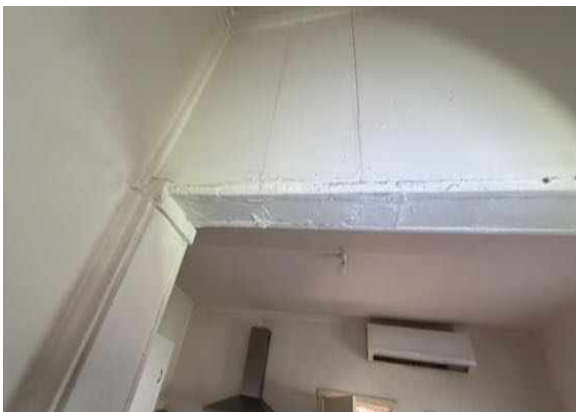
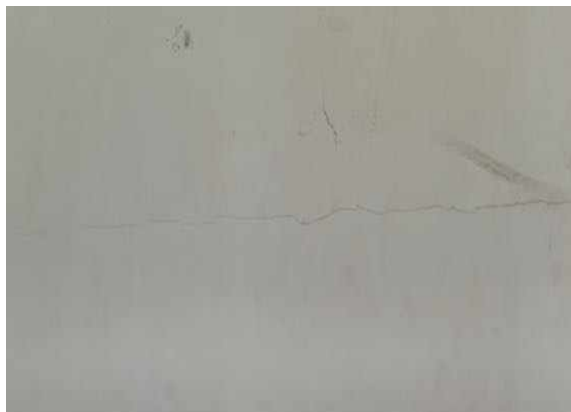
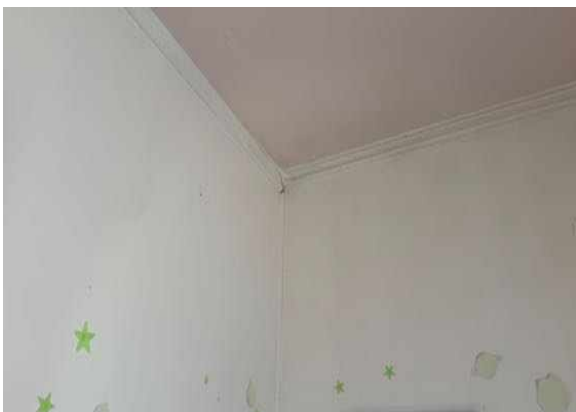
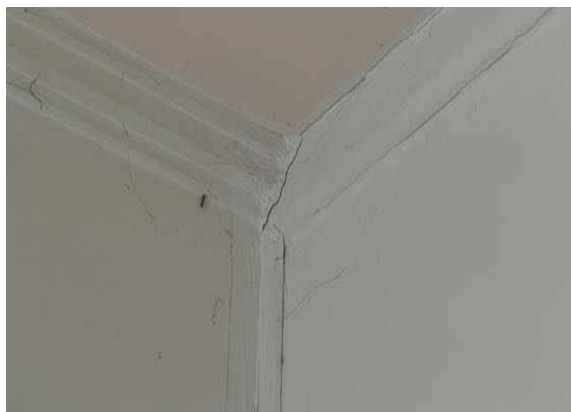
Finding 3.05

Building:	Main Building
Location:	All Areas
Finding:	Cracking to Plasterboard Walls and Ceiling
Information:	Several cracks were observed to plasterboard walls and ceiling areas during the inspection. These are likely attributed to a combination of structural movement and general wear and tear due to poor maintenance over time.

While some cracking may be cosmetic, ongoing structural movement can lead to widening of cracks and potential deterioration of internal finishes. If left unaddressed, this may affect the integrity and appearance of the affected surfaces.

It is recommended that the cracks be monitored for any progression. If movement continues or cracks widen, a registered builder should be engaged to assess the cause and carry out appropriate repairs. Rectification of finishes may also be required once the underlying cause is addressed.

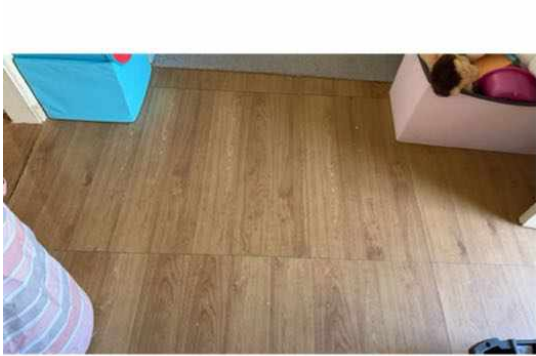
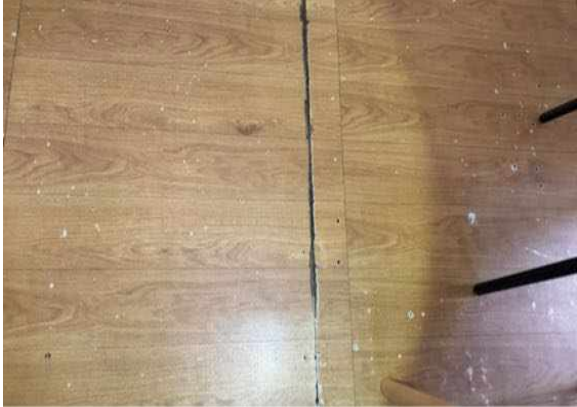
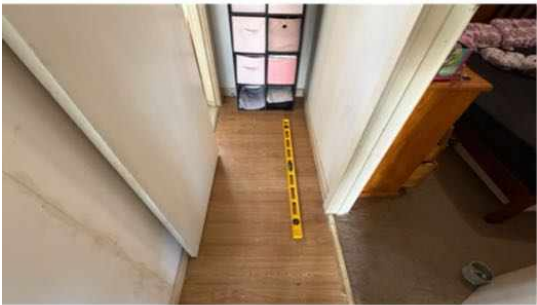
Finding 3.06

Building:	Main Building
Location:	All Areas
Finding:	Deteriorated Floating Floor
Information:	The floating floor was observed to be deteriorated and uneven, with noticeable movement underfoot during the inspection. This condition is likely associated with underlying structural movement or issues with the subfloor, resulting in loss of stability and support.

If left unaddressed, the condition may worsen over time, leading to further deterioration of the flooring system, increased unevenness, and potential safety hazards. It may also indicate underlying structural concerns that require further investigation.

It is highly recommended that a registered builder be engaged to assess the extent of the issue, identify the underlying cause, and carry out appropriate remedial works. Further investigation may be required to determine the condition of the subfloor and supporting elements.

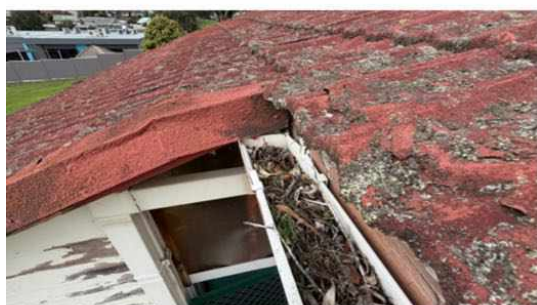
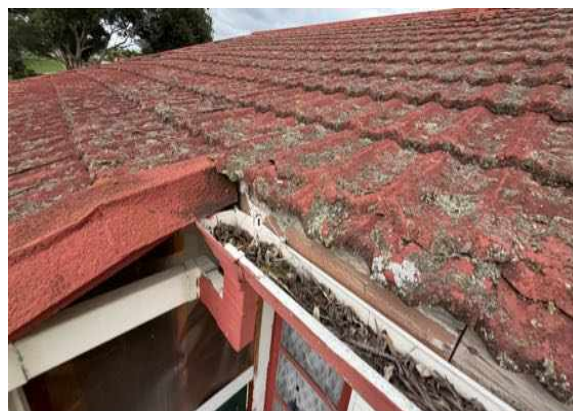
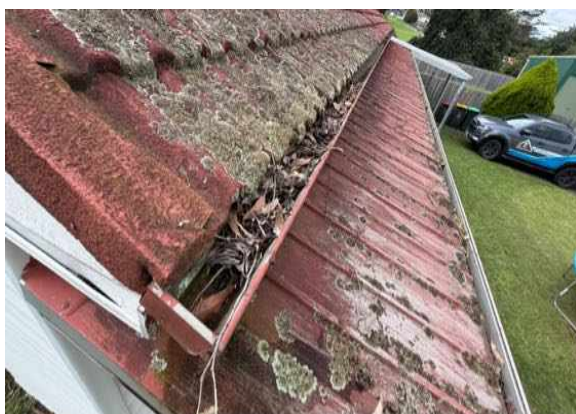
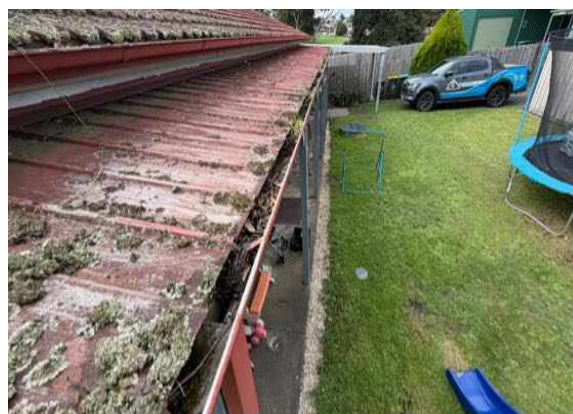
Finding 3.07

Building: Main Building
Location: Roof Exterior
Finding: Gutters - Partially Blocked

Blocked gutters are likely to lead to high levels of moisture in the affected areas. Such moisture will not only cause rust and decay of the associated building materials, but can also provide conditions that are conducive to termite and timber pest activity. Blockages in gutters should therefore be removed immediately to ensure dry conditions are maintained.

Consult a Licensed Plumber for further specific advice on remedial works that may be required. In the interim, it is highly advised that blocked gutters be removed by the homeowner or a general handyperson as a matter of urgency.

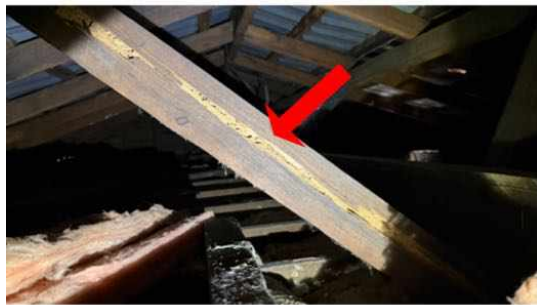
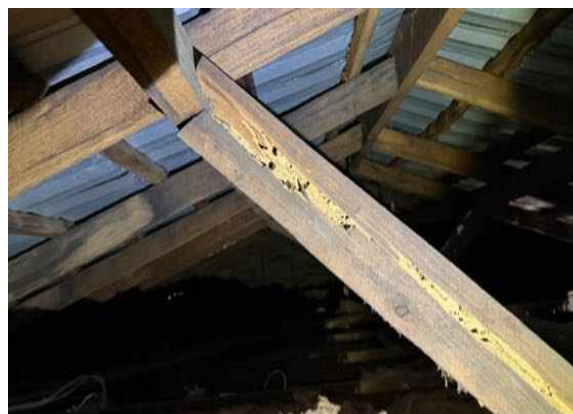
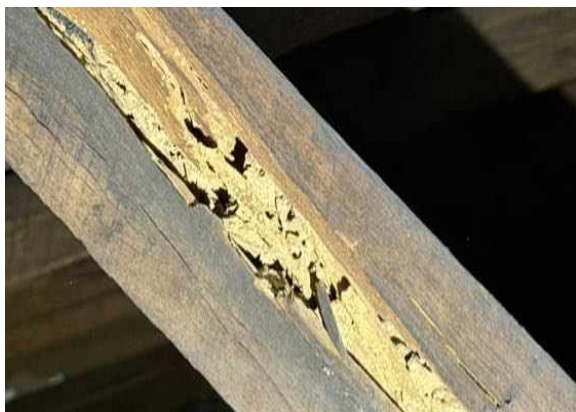
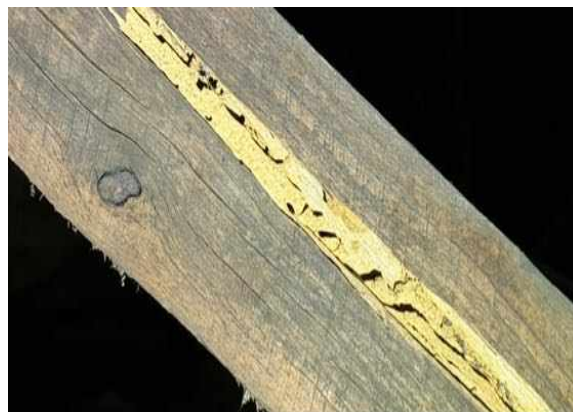
Building:	Main Building
Location:	Roof Void
Finding:	Termite Damage to Roof Structural Timber
Information:	Evidence of termite damage was identified to structural timber elements within the roof space during the inspection. The damage appears consistent with timber pest activity; however, this assessment is based on a visual, non-invasive inspection only. The full extent of damage, including whether the activity is current or historical, could not be determined at the time of inspection.

Termite damage to structural timbers can significantly compromise the integrity and load-bearing capacity of affected elements. It is possible that the damage extends beyond visible areas and may be present within concealed building elements, including framing members, wall cavities, and other inaccessible areas. If active infestation is present, further spread and deterioration may occur, potentially resulting in extensive structural damage.

An urgent invasive inspection by a licensed timber pest technician is strongly recommended to determine the presence of active termites and assess the full extent of damage. A registered builder should also be engaged to evaluate the structural adequacy of affected components and carry out necessary repairs or replacement. Immediate action is advised to mitigate further risk and potential escalation of damage.

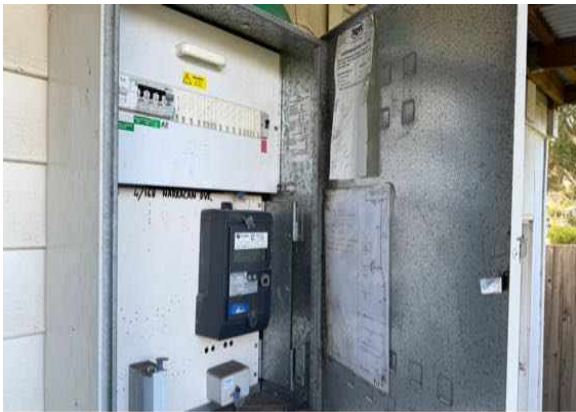
Finding 6.01

Building:	Main Building
Location:	Meter Box
Finding:	Termite Management System - no evidence of a chemical installation
Information:	The application of a post-construction chemical termite barrier is highly recommended for all properties, particularly if live termite activity has been found on the site previously. Such barriers are highly effective in preventing termite attack on any timber building elements throughout the property.

A durable notice should be placed in the switchboard unit to indicate current termite barriers. At the time of inspection, it appeared as though no termite management system has been installed, with no evidence to suggest preventative works taking place.

The client may consider gaining further advice from a pest controller as to the costs and procedures involved with this application. It is recommended that obtaining such advice be a short-term priority.

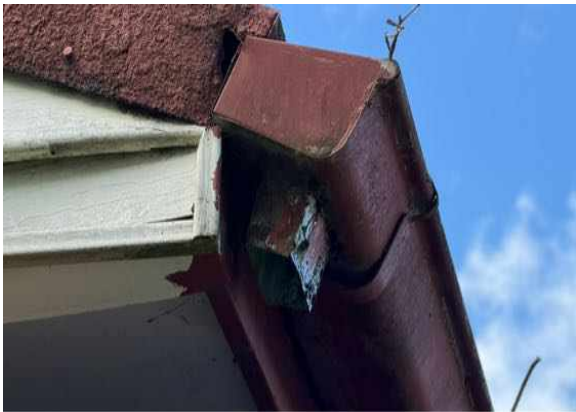
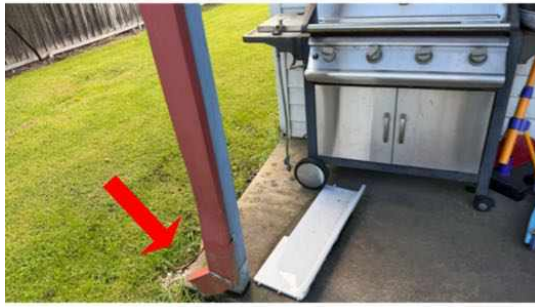
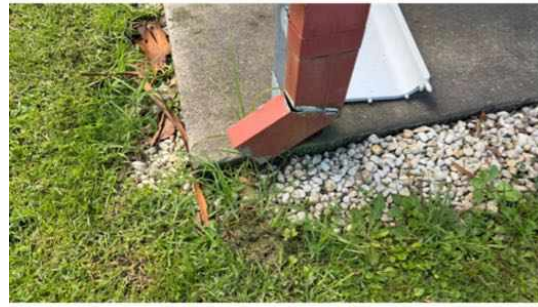
Finding 6.02

Building: Main Building
Location: All Areas
Finding: Downpipes Not Connected to Stormwater System
Information: Several downpipes were observed to be disconnected or not connected to the stormwater drainage system during the inspection. As a result, roof water is likely discharging directly at the base of the structure.

This condition can lead to localised dampness, soil saturation, and potential moisture ingress into the building. Prolonged exposure may contribute to deterioration of footings, external building elements, and create conditions conducive to termite infestation.

It is recommended that a licensed plumber be engaged to connect all downpipes to an appropriate stormwater drainage system to ensure effective discharge of roof water away from the structure.

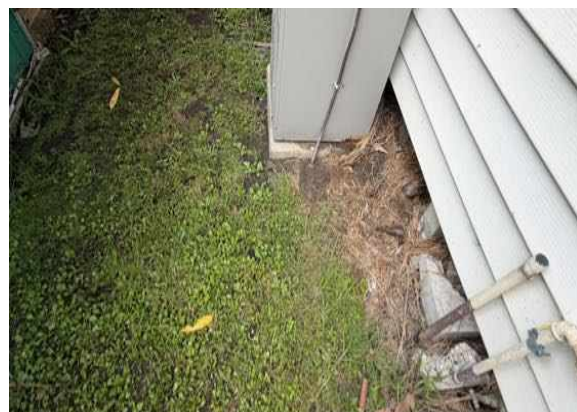
Finding 6.03

Building:	Main Building
Location:	All External Areas
Finding:	HWS Overflow - Not Connected
Information:	The Hot Water System (HWS) overflow was found to be disconnected from storm water drainage and is creating excessive moisture in the surrounding area.

These damp conditions can lead to secondary defects such as rot, rust or corrosion of associated building elements, the formation of fungal decay, or even the creation of potential slip hazards. When coupled with poor site drainage, pooling of water may also attract termite activity to this area.

It is highly recommended that a licensed plumber be appointed to connect the HWS overflow in order to prevent such an environment from being created. These minor works should be carried out as soon as possible.

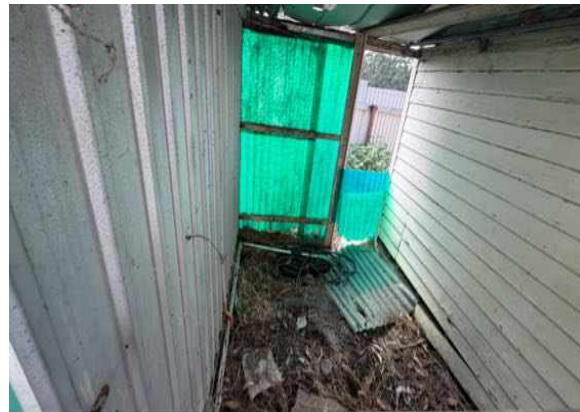
Finding 6.04

Building:	Main Building
Location:	All External Areas
Finding:	Bridging - Attachments to Buildings
Information:	Bridging occurs when items against a building provide a concealed entry point for

Where any part of an attachment to a building is not isolated and is not provided with a clear gap of not less than 25mm from the building, bridging occurs. Attachments to buildings such as hot water services, downpipes, verandahs, decks, steps, fences, service conduits are the like provide the opportunity for concealed entry.

Building attachments of this nature need to be frequently inspected for termite activity by a qualified inspector.

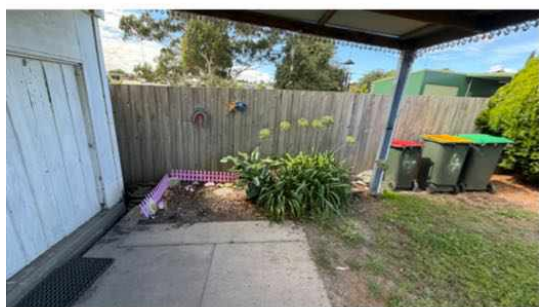
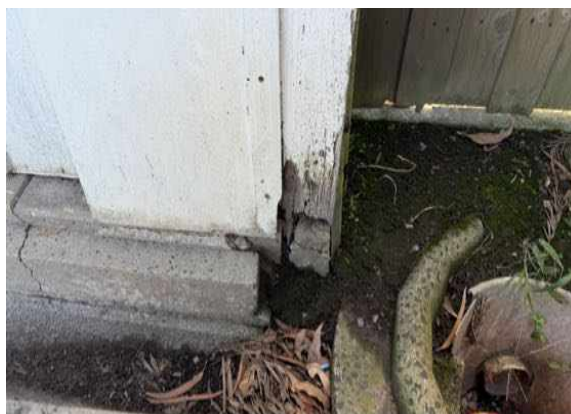
Information: Where timber elements are in direct contact with the ground and consequently moisture or dampness they become conducive to termite activity. Whether timber is used as a building element part of a fencing structure or stored as an unused item they can provide an environment that is attractive to termite infestation.

When met with excessive moisture timber begins to decay and develop wood rot. Any timbers that are in direct contact with external grounds especially if left untreated or non-durable also provide ingress for subterranean termites into that particular element.

The removal of any such materials that may be conducive to termite activity should be removed as soon as possible to minimise the risk of termite attack.

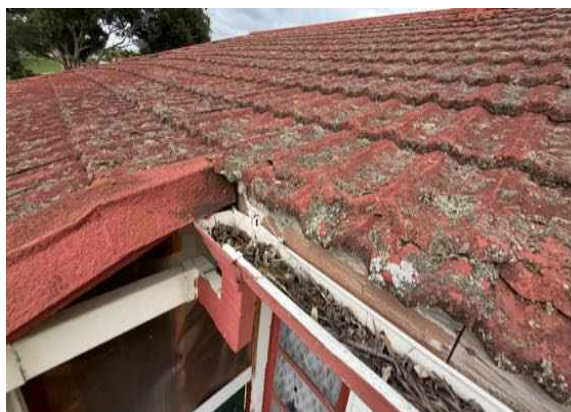
Finding 6.07

Information: During the inspection, debris accumulation was noted in the guttering and downpipes. Blocked gutters can cause water to pool and overflow, leading to excessive moisture around eaves, fascia boards, and exterior walls. Where gutter guards are installed, regular maintenance is essential to remove any debris that may settle on top or filter through. Prolonged exposure to moisture in these areas creates conditions conducive to timber decay and potential termite or timber pest activity.

remedial work. Ongoing gutter maintenance is crucial in preventing future moisture-related timber issues.

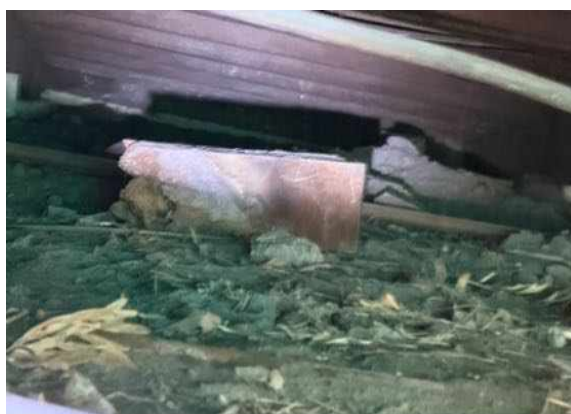
Finding 6.08

Building:	Main Building
Location:	All External Areas
Finding:	Timber debris - exterior areas & subfloor space
Information:	Timber debris were found in the exterior areas & subfloor space at the time of inspection. The storing of timbers in the subfloor space or around the external property increases the risk of termite activity being present. As they are likely to come into contact with weather conditions or excessive moisture wood rot is likely to develop on timbers that are not treated.

It is highly recommended that any stored timbers be immediately removed from areas in which they may attract any termite / timber pest attack. Minimisation of risk / prevention of termite attack is far more adequate than dealing with the presence of termite activity.
