Building and Timber Pest Inspection Report

Inspection Date: Tue, 17 Mar 2026

Property Address: 8 Finlayson St, Wollongong NSW 2500,
Australia

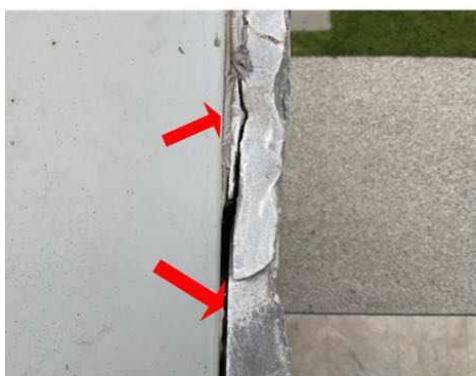
Finding 3.07

Building:	Building 1
Location:	Rear yard tiling
Finding:	Tiles cracked or moved
Information:	A few cracked and minor damaged tiles and sealant were evident in many rear areas at the time of inspection. It is suspected that this cracking has occurred as a result of minor settlement or installation damage. A few at the rear of the pool have moved a few millimetres. Cracked tiles detract from the overall appearance of the affected areas.

Replacement of cracked tiles is recommended as soon as possible. A tiling contractor may be appointed to perform these works. Where cracks become more numerous, contact a licensed building inspector for further investigation.

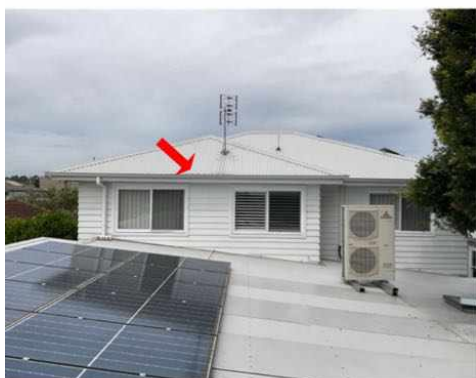
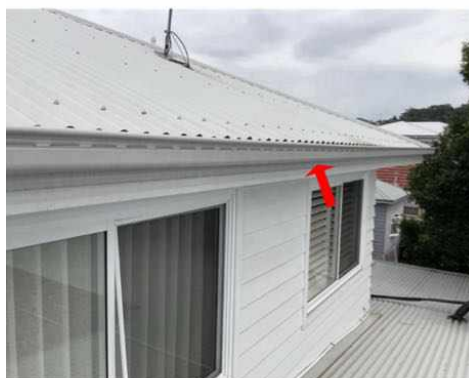
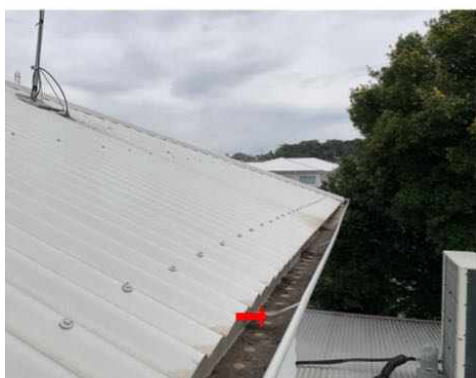
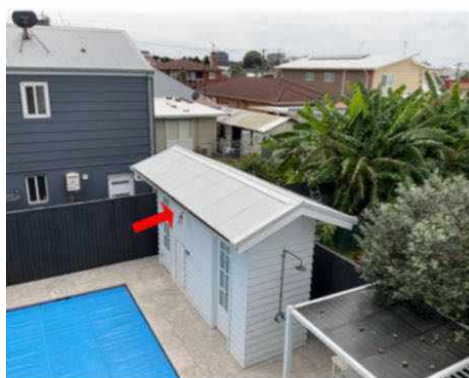
Finding 3.09

Building:	Building 1
Location:	Pictured areas
Finding:	Painting deteriorated
Information:	Some of the external and other paintwork require attention to prepare and re-paint.

Whilst incomplete or missing paint finish is generally an appearance defect, it can also lead to the development of secondary building defects over time. Incomplete areas of paint finish expose the area to moisture, potentially accelerating the deterioration of underlying building materials.

Degraded paint finishes should be sanded back, filled, leveled and painted, as applicable. Where inadequate or missing paint protection has led to the deterioration of the associated building element, repair and/or replacement of this building element may be required.

A painting contractor should be appointed as soon as possible to perform necessary works to aid the appearance of the affected area and to ensure the area is protected against further deterioration. Alternatively, the homeowner following manufacturer instructions may perform these works.

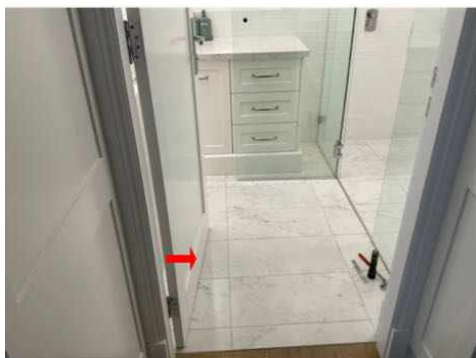
Finding 3.11

Building:	Building 1
Location:	Pictured external areas
Finding:	Building elements damaged or loose.
Information:	Evidence of minor missing or damaged areas was identified at the time of the inspection. These include -

2. The left fence has a hole in it.
3. The front door has minor timber and paint damage.
4. The upper front bedroom window architrave is damaged.
5. The laundry door handle required tightening.
6. The ensuite bathroom has very minor plaster tape damage. A plasterer/ painter can easily rectify.
7. A very small amount of water (up to 2mm) pools near the ensuite shower drain.

A carpenter would be the trade responsible for rectification of these areas when convenient.

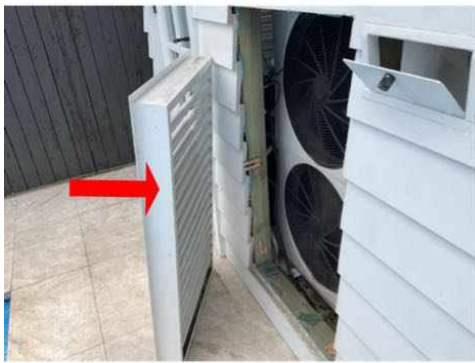
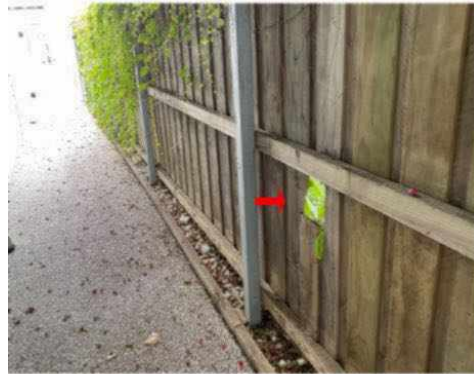
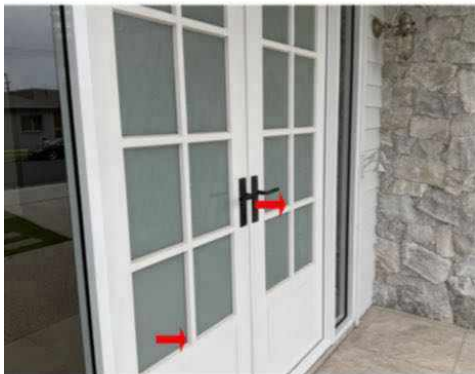
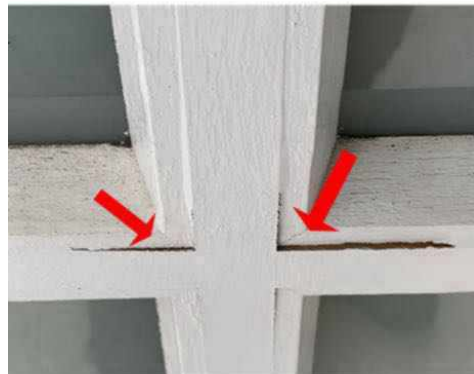
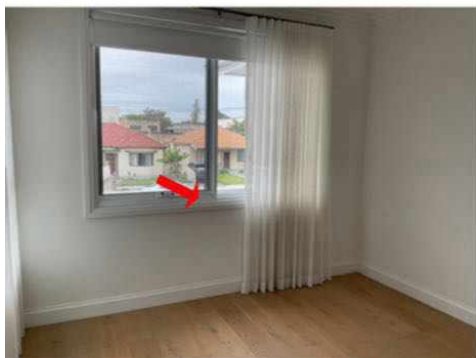
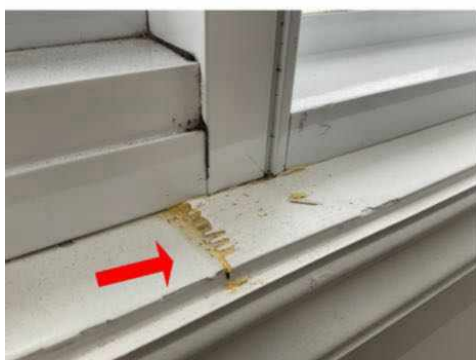
Finding 3.12

Building:	Building 1
Location:	Driveway
Finding:	Crack in concrete slabs - Category 1
Information:	Cracks coded as Category 1 was identified in these pictured slabs. A Category 1 crack is described as a fine but noticeable crack, with the slab at an otherwise reasonable level. To be considered Category 1, the approximate width of the crack is less than 1.0mm, or a less than 10mm change in offset when a 3m straight edge is placed over the defect.

Category 1 cracks should be monitored for a period of 12 months. At the end of the monitoring period, identified cracks that are rated greater than Category 2 are

considered defects, and require rectification.
