Building and Timber Pest Inspection Report

Inspection Date: Fri, 13 Mar 2026

Property Address: 6/22 Hall St, Auburn NSW 2144, Australia

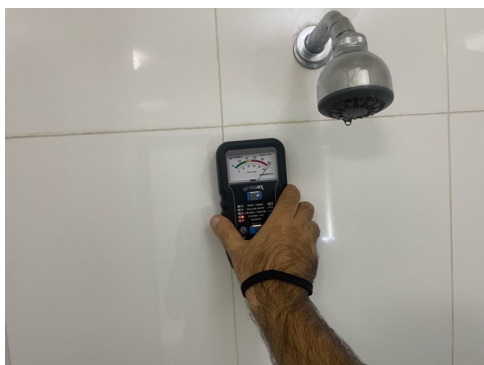
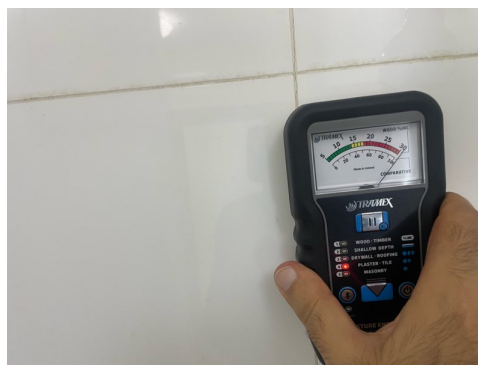
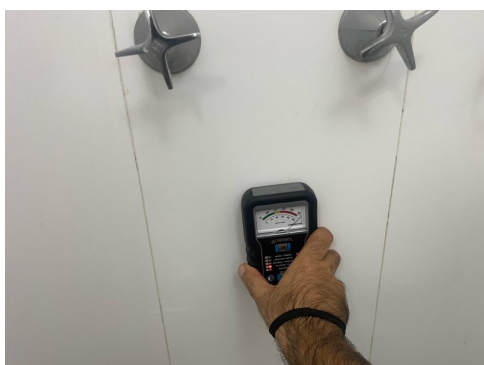
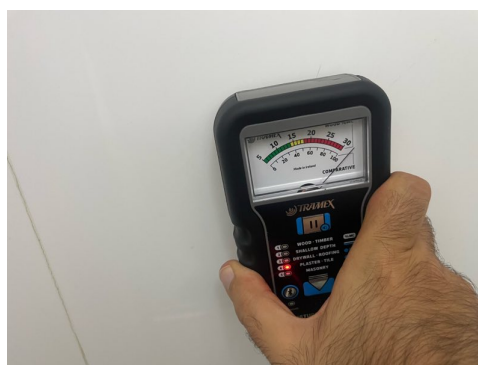
Finding: Damp in Shower Alcove – Elevated Moisture Beneath and Around Tap

Information: During inspection, damp was detected to the lower wall area of the shower alcove, extending up to approximately 1 metre in height. Elevated moisture readings were recorded beneath the shower tap and also around the tap assembly itself. This pattern raises suspicion of a possible plumbing leak within the wall cavity in addition to general moisture ingress.

Such conditions are relatively common and may result from water leaching through grout prior to recent repairs, or from concealed leakage from the tap assembly or associated plumbing. Invasive investigation from the opposite side of the wall may be required to confirm the exact source.

If unmanaged, damp in a shower recess can lead to mould growth, deterioration of tiles and substrates, and potential compromise of the wall structure. Prolonged moisture can also create health risks associated with spores and fungi.

It is recommended that a licensed plumber or bathroom waterproofing specialist investigate the area, including removal of wall linings on the opposite side if necessary, to confirm the source of leakage. Prompt rectification and continued monitoring are advised.

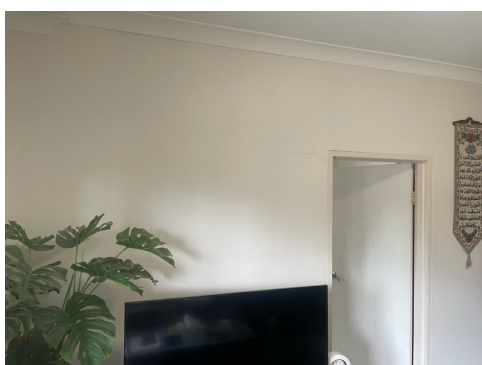
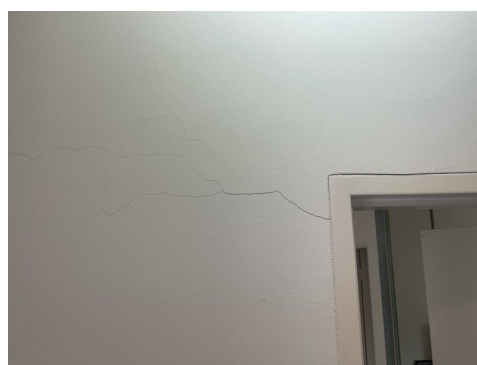
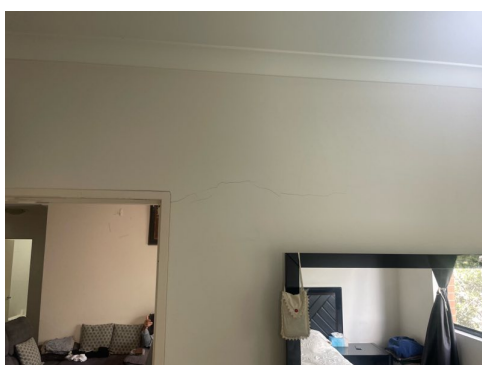
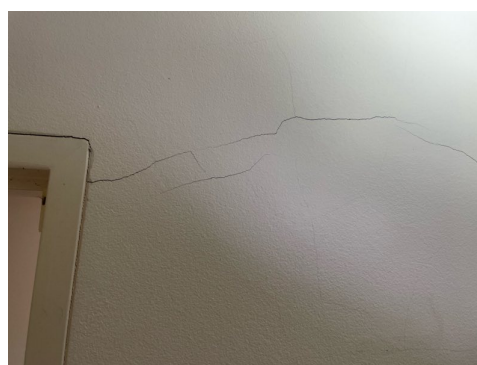
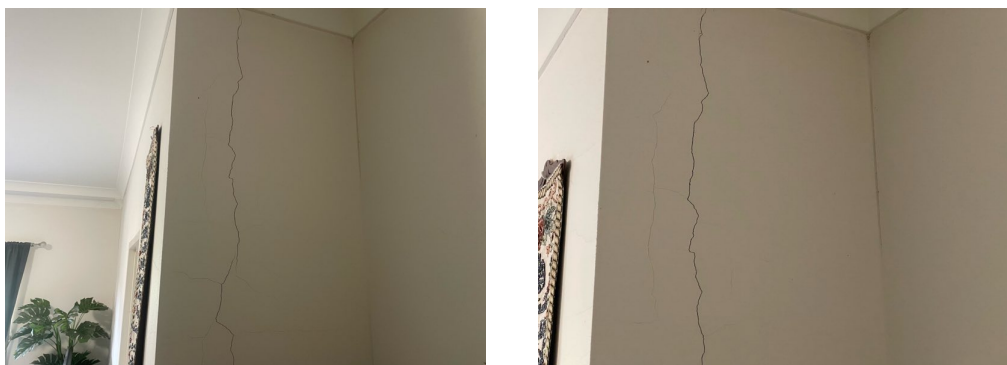
Finding 2.02

Finding: Cracking - Damage Category 2 - Noticeable (up to 5mm)

Noticeable cracks are a common occurrence as a result of many primary defects. Such causes may include age, general wear and tear, expected building movement, general expansion/contraction of building materials in different weather conditions, and/or minor failings in the installation or application of building materials.

Noticeable cracks may result in minor sticking or jamming of associated doors and windows, which require easement. However, noticeable cracks are easily filled and repaired. A plasterer can be consulted to install an expansion joint at this point to allow for this movement during different weather conditions.

Monitoring of all cracking should be conducted frequently. Always contact a building inspector should cracks widen, lengthen, or become more numerous. Additionally, your building inspector should also be contacted if associated building elements such as doors and windows become more difficult to operate over time.

Relevant tradespeople, such as carpenters, painters and plasterers, should be appointed to perform remedial works, as deemed necessary.

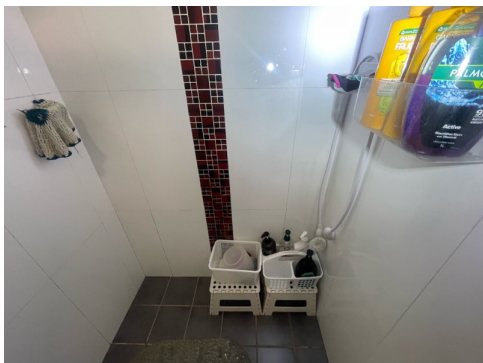
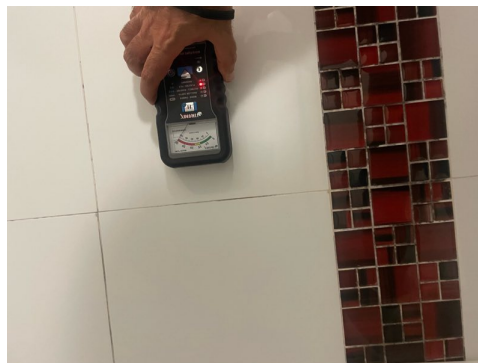
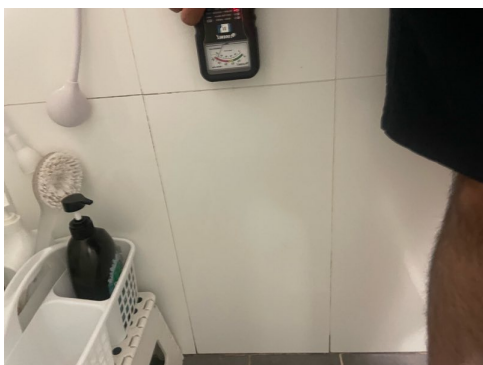
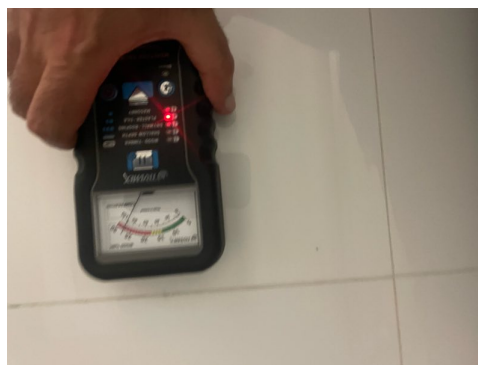
Finding 2.03

Building:	Main Building
Location:	Ensuite - Master
Finding:	Damp in Shower Alcove – Elevated Moisture Beneath and Around Tap
Information:	<p>During inspection, damp was detected to the lower wall area of the shower alcove, extending up to approximately 1 metre in height. Elevated moisture readings were recorded beneath the shower tap and also around the tap assembly itself. This pattern raises suspicion of a possible plumbing leak or waterproofing issue in addition to general moisture ingress.</p> <p>Such conditions are relatively common and may result from water leaching through grout prior to recent repairs, or from concealed leakage from the tap assembly or associated plumbing. Invasive investigation from the opposite side of the wall may be required to confirm the exact source.</p> <p>If unmanaged, damp in a shower recess can lead to mould growth, deterioration of tiles and substrates, and potential compromise of the wall structure. Prolonged moisture can also create health risks associated with spores and fungi.</p> <p>It is recommended that a licensed plumber or bathroom waterproofing specialist investigate the area, including removal of wall linings on the opposite side if necessary, to confirm the source of leakage. Prompt rectification and continued monitoring are advised.</p>

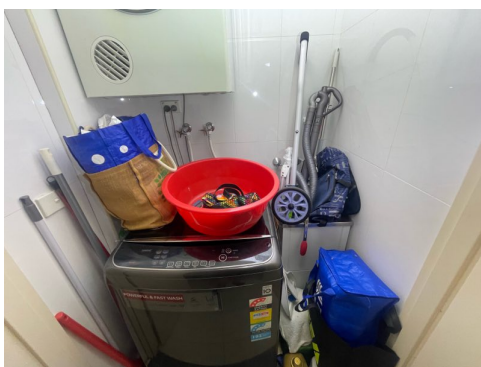
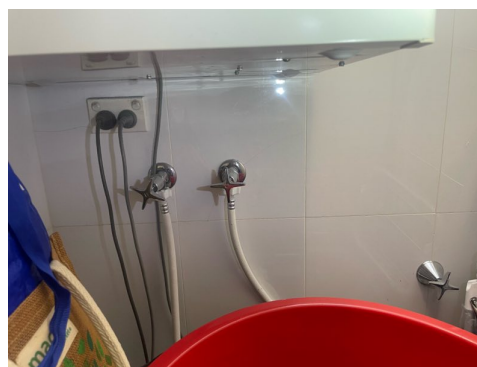
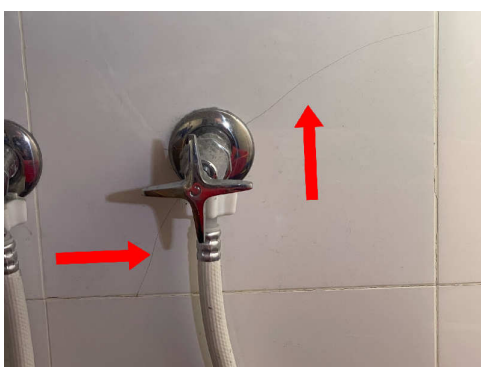
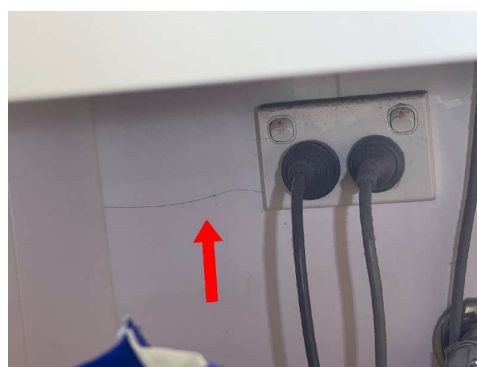
Finding 3.01

Building: Main Building
Location: Laundry
Finding: Tiles - Cracked or damaged

Cracking was evident to the tiling in this area at the time of inspection. While the cracking appears to be minor, this area is frequently exposed to water, allowing potential for water penetration into adjoining sections of walls or flooring.

If left unmanaged, water penetration to these areas may lead to subsequent water damage, which is likely necessitate repair work to affected building elements.

A tiling contractor should be appointed to ensure that no further water damage occurs. The re-application of silicone and grouting throughout remaining tile work is also advised, to further protect the area against water penetration.

Where water penetration has led to water damage, appointment of a relevant tradesperson may be required to repair damaged building elements.

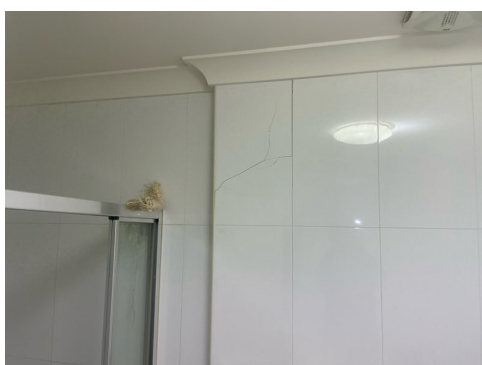
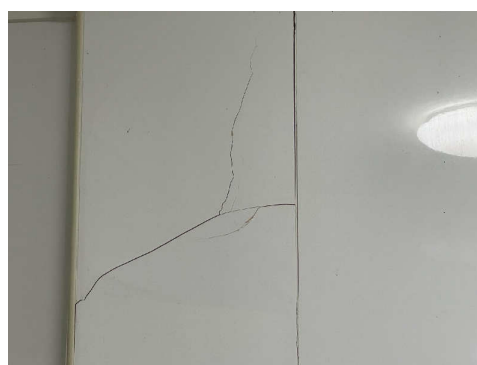
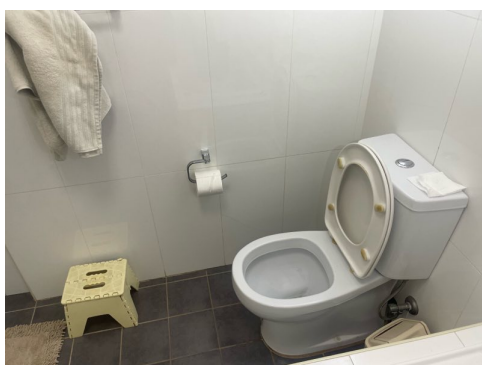
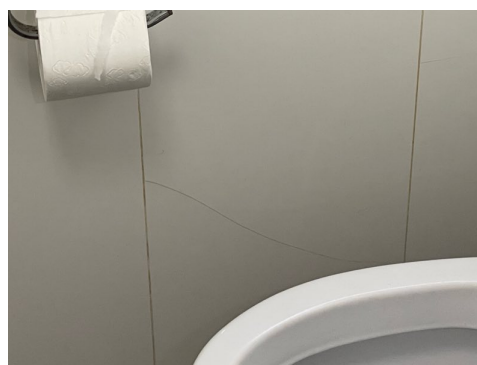
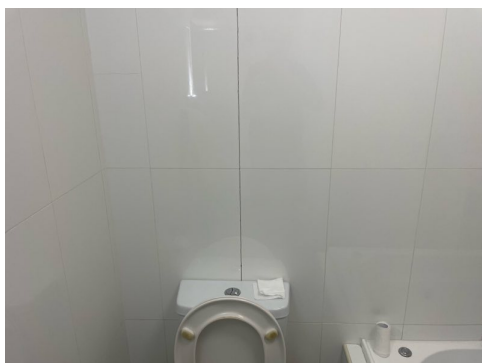
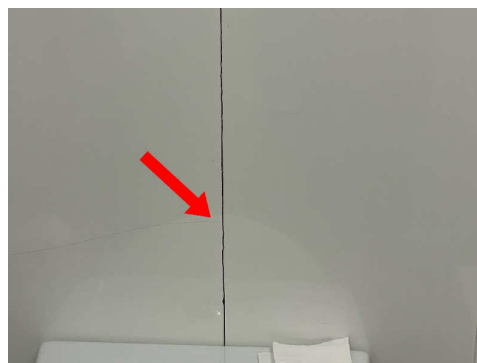
**Finding 3.02**

Finding: Tiles - Cracked or damaged

Information: Cracking was evident to the tiling in this area at the time of inspection. While the cracking appears to be minor, this area is frequently exposed to water, allowing potential for water penetration into adjoining sections of walls or flooring.

If left unmanaged, water penetration to these areas may lead to subsequent water damage, which is likely necessitate repair work to affected building elements.

A tiling contractor should be appointed to ensure that no further water damage occurs. The re-application of silicone and grouting throughout remaining tile work is also advised, to further protect the area against water penetration.

Where water penetration has led to water damage, appointment of a relevant tradesperson may be required to repair damaged building elements.

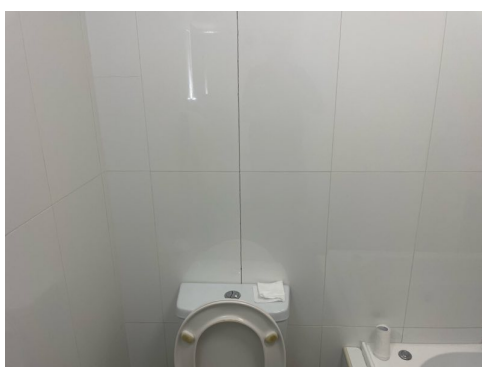
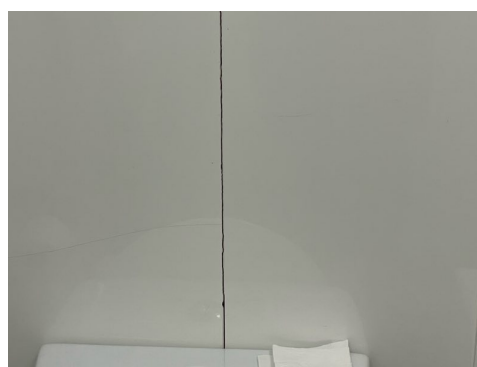
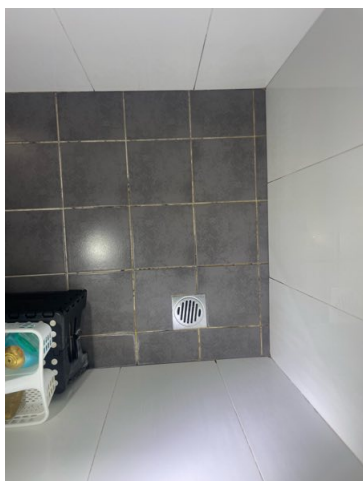
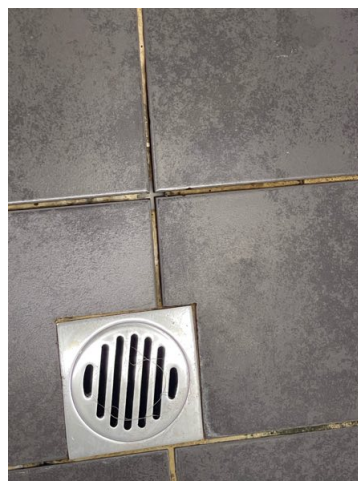
Finding 3.03

Finding: Grout - Missing

Information: Grout is missing in this area. Grout is used to protect gaps and crevices in building materials to ensure that they are water-tight and prevent water penetration to the associated structures.

Where grout is missing, a tiling contractor should be appointed immediately to apply grout and re-apply any silicone where necessary. Failure to do so is likely to lead to water damage to the surrounding area.

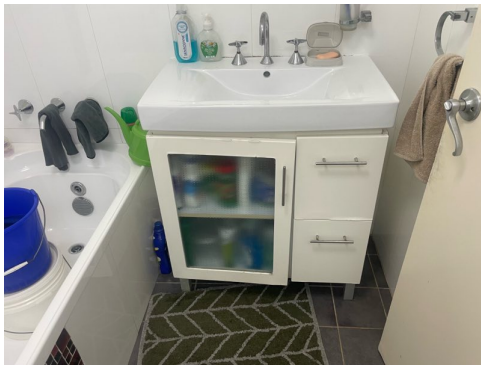
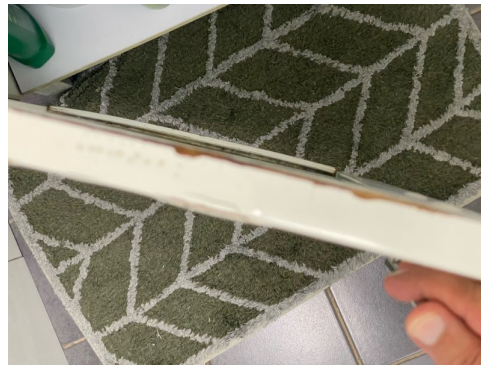
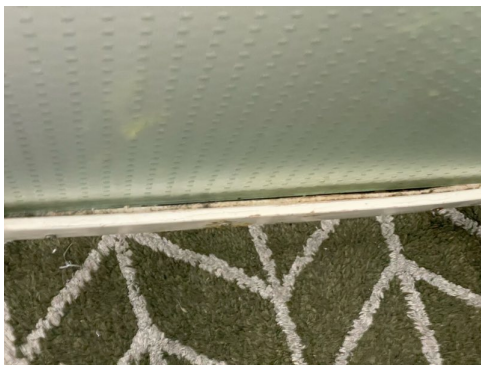
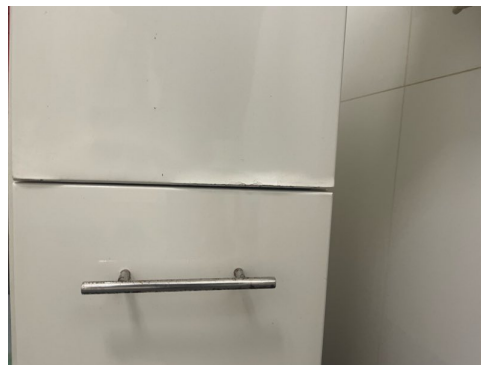
Finding 3.04

Building:	Main Building
Location:	Bathroom
Finding:	Bathroom Vanity – Damaged (Scratches, Water Staining, Wear & Tear, Broken Shelf)

Information: The bathroom vanity was observed to be in a damaged condition at the time of inspection, including visible scratches to the vanity surfaces, water staining, general wear and tear, and a broken internal shelf. This condition affects both presentation and serviceability of the fixture.

The observed staining and deterioration may be consistent with ongoing moisture exposure (splashing, minor leakage, or poor drying/ventilation) combined with normal use over time. Where laminated or painted finishes are scratched, worn, or water stained, the protective coating can be compromised, which may allow moisture absorption and lead to swelling, delamination, and progressive deterioration of the cabinet materials.

It is recommended that the client arrange further assessment and repair or replacement of the affected vanity components as required to restore function and reduce the risk of further deterioration. If water staining is active or worsening, it is also recommended that the plumbing and surrounding junctions (basin waste, taps, silicone seals, and adjacent wall/floor interfaces) be checked to confirm there is no ongoing leak contributing to the damage.

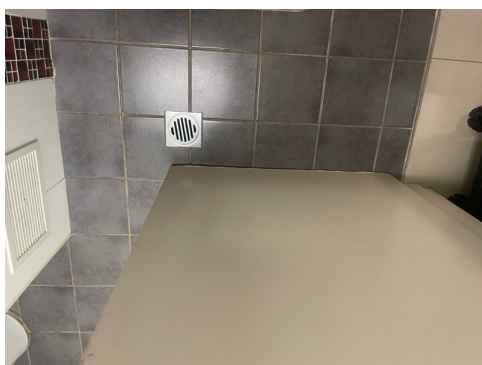
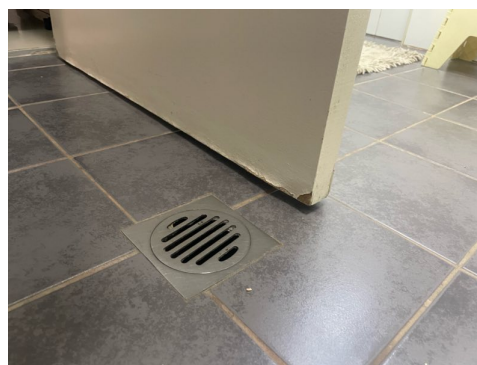
Finding 3.05

Building: Main Building
Location: Bathroom
Finding: Door - Water Damaged

Information: Water damage was observed to the timber door and surrounding door frame. The affected areas showed signs of swelling, discolouration, and surface deterioration, indicating prolonged exposure to moisture.

This type of defect commonly occurs when external moisture enters through unsealed joints, inadequate flashing, or poor paint protection. Continuous exposure can cause decay, warping, and loss of structural strength in the timber components.

The condition should be repaired to prevent further deterioration. Maintenance such as drying, sanding, sealing, or repainting may be required, and moisture sources should be identified and rectified to ensure long-term durability of the door assembly.

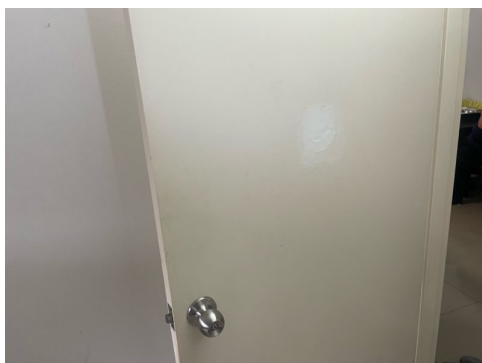
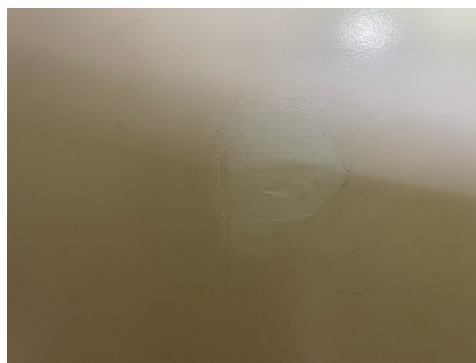
Finding 3.06

Finding: Door – Impact Damage and Rupturing

Information: The door was observed to have sustained significant damage, including impact marks and rupturing of the surface material. The defect was readily visible and has affected both the appearance and integrity of the door.

A damaged and ruptured door may not operate correctly, can compromise security and privacy, and detracts from the overall presentation of the property. If left unmanaged, the damage may worsen with continued use.

This matter is considered a repair defect. It is recommended that a suitably qualified carpenter or builder assess the extent of the damage and carry out repairs or replacement of the affected door to restore full function and appearance.

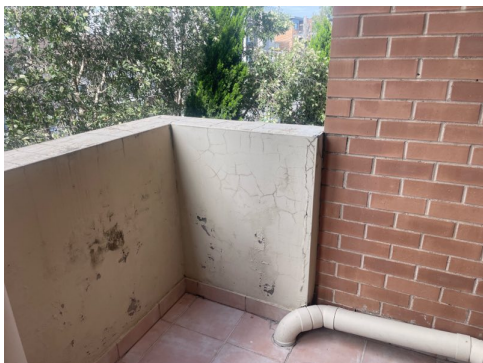
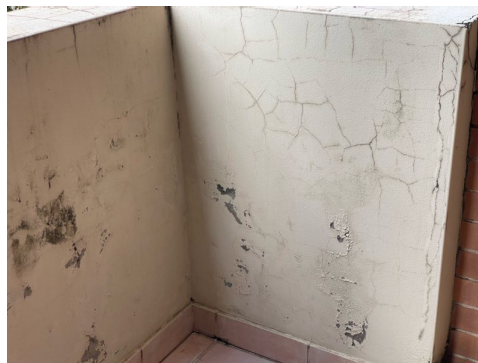
Finding 3.07

Finding: External painting deteriorated

Whilst incomplete or missing paint finish is generally an appearance defect, it can also lead to the development of secondary building defects over time. Incomplete areas of paint finish expose the area to moisture, potentially accelerating the deterioration of underlying building materials.

Degraded paint finishes should be sanded back, filled, leveled and painted, as applicable. Where inadequate or missing paint protection has led to the deterioration of the associated building element, repair and/or replacement of this building element may be required.

A painting contractor should be appointed as soon as possible to perform necessary works to aid the appearance of the affected area and to ensure the area is protected against further deterioration. Alternatively, the homeowner following manufacturer instructions may perform these works.

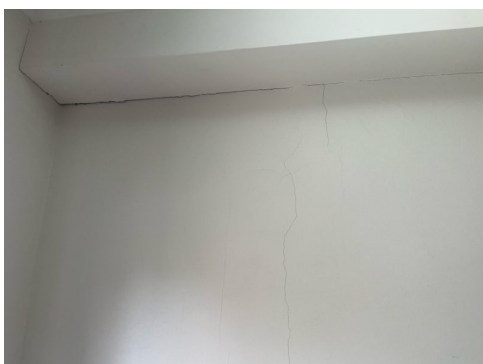
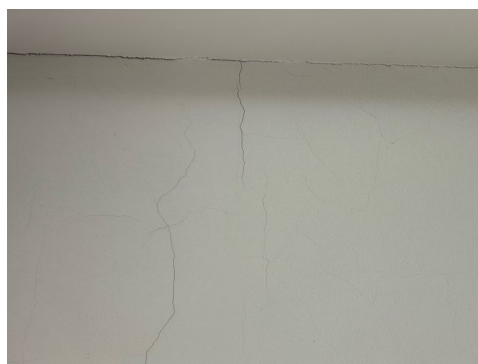
Finding 3.08

Finding: Cracking - Damage Category 1 - Fine (up to 1 mm)

Information: Although fine cracks are quite noticeable, they are often only considered to be an appearance defect, and usually do not indicate any structural damage. Generally, the cause of a fine crack is indicative of a separation between building materials and finishes (e.g. paint, plaster, etc.) along joins.

Cracking of this nature can generally be repaired with minor sanding, filling and/or repainting. Such works should be performed by a qualified painter or a general handyman.

Monitoring of all cracking should be conducted frequently. Always contact a building inspector should cracks widen, lengthen, or become more numerous.

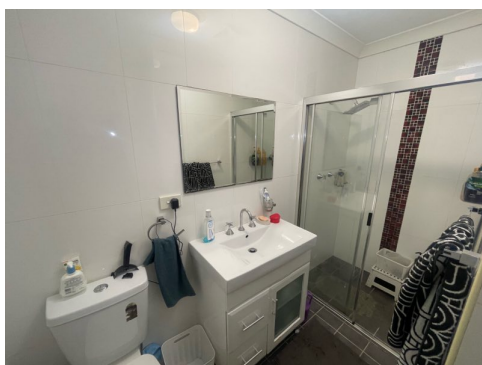
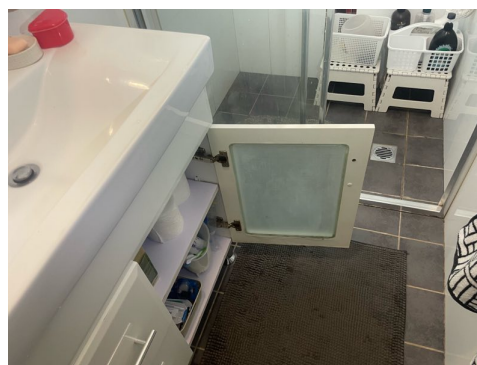
Finding 3.09

Building:	Main Building
Location:	Ensuite - Master
Finding:	Bathroom Vanity – Damaged (Scratches, Water Staining, Wear & Tear, Broken Shelf)
Information:	The bathroom vanity was observed to be in a damaged condition at the time of inspection, including visible scratches to the vanity surfaces, water staining, general wear and tear, and a broken internal shelf. This condition affects both presentation and serviceability of the fixture.

The observed staining and deterioration may be consistent with ongoing moisture exposure (splashing, minor leakage, or poor drying/ventilation) combined with normal use over time. Where laminated or painted finishes are scratched, worn, or water stained, the protective coating can be compromised, which may allow moisture absorption and lead to swelling, delamination, and progressive deterioration of the cabinet materials.

It is recommended that the client arrange further assessment and repair or replacement of the affected vanity components as required to restore function and reduce the risk of further deterioration. If water staining is active or worsening, it is also recommended that the plumbing and surrounding junctions (basin waste, taps, silicone seals, and adjacent wall/floor interfaces) be checked to confirm there is no ongoing leak contributing to the damage.

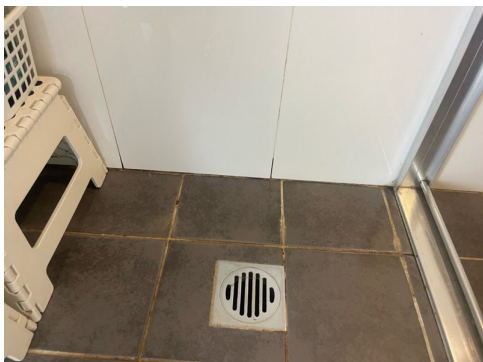
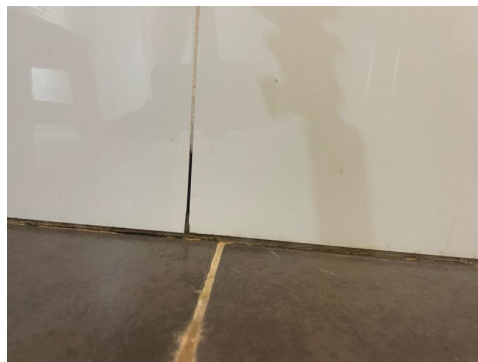
Finding 3.10

Building:	Main Building
Location:	Ensuite - Master
Finding:	Grout - Missing

Grout is missing in this area. Grout is used to protect gaps and crevices in building materials to ensure that they are water-tight and prevent water penetration to the associated structures.

Where grout is missing, a tiling contractor should be appointed immediately to apply grout and re-apply any silicone where necessary. Failure to do so is likely to lead to water damage to the surrounding area.

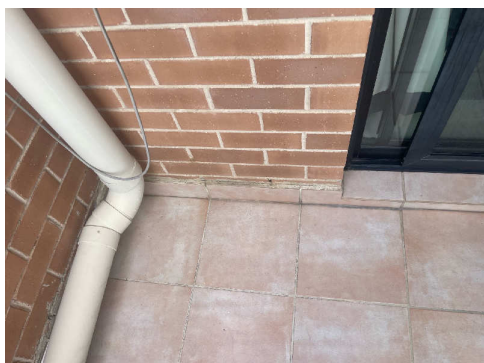
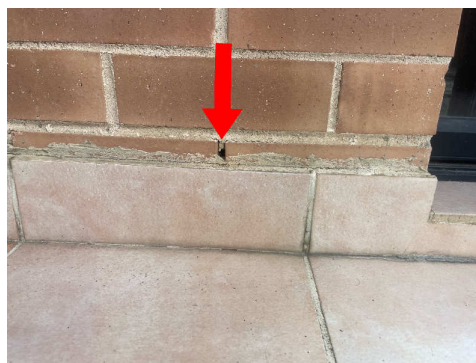
Finding 6.04

Information: It was noted during the time of inspection that some of the weep holes to the brickwork were blocked. Weep holes are designed to allow water from leaks or seepages in brickwork to be directed to the external environment, prior to entering the wall cavity or associated building materials. Weep holes should therefore be kept clean and free of debris or blockages.

Blocked weep holes are likely to result in the presence of excessive moisture within the brickwork and associated structures, creating potential for water damage and moisture problems.

Depending on the nature of the blockage, the homeowner may be able to undertake remedial works to remove blockages. Alternatively, appointment of a registered builder may be required to remove blockages. Preventative works are necessary in ensuring the structural integrity of the affected brickwork and should be performed as soon as possible.

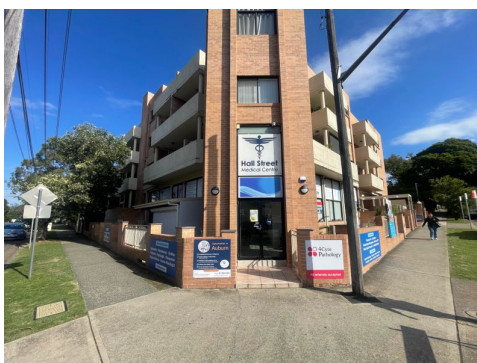
Finding 6.05

Finding: Large trees/stumps within 30m of house

Information: There are a number of large trees/stumps within 30m of the house which may contain natural termite activity. It is important to monitor these areas to ensure no natural activity is allowed to progress into the main house. Regular inspections are recommended. Consider test drilling any large trees. A pest controller can be contacted to carry out such testing at the owners discretion.
