Building and Timber Pest Inspection Report

Inspection Date: Wed, 18 Feb 2026

Property Address: 55 Feathertop Cct, Thurgoona NSW 2640,
Australia

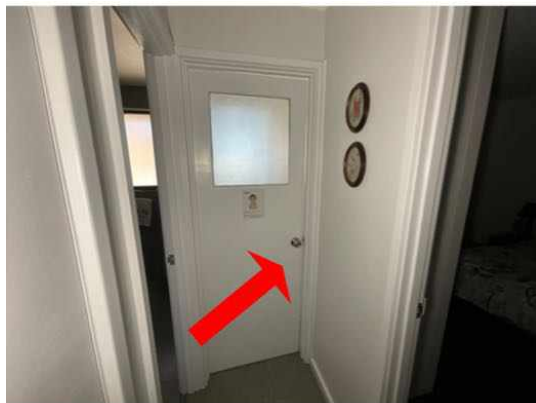
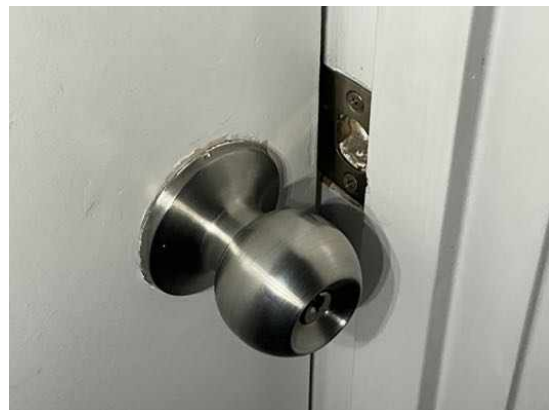
Finding 3.01

This is a common defect and is expected in a property of this age, whether being due to substandard installation or general deterioration of the door hardware.

Readjustment of the striker plate is recommended at client discretion. Works such as these can be completed by a general handyman or qualified carpenter.

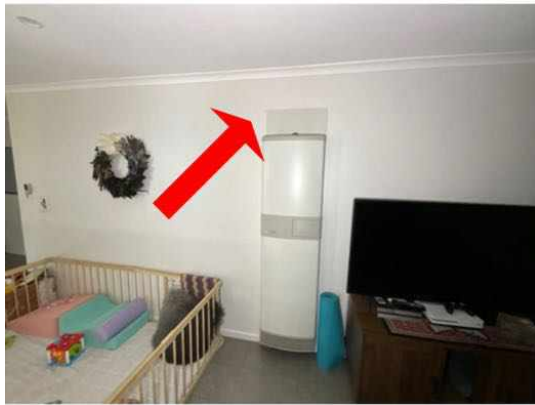
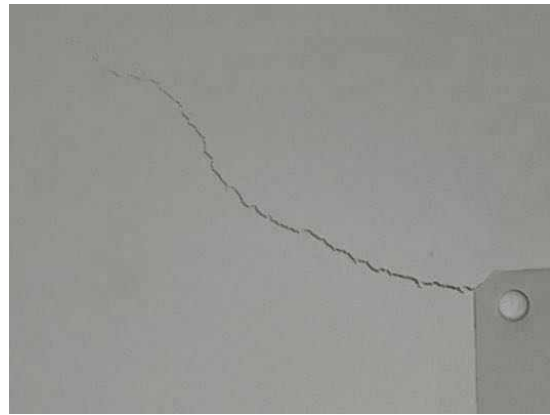
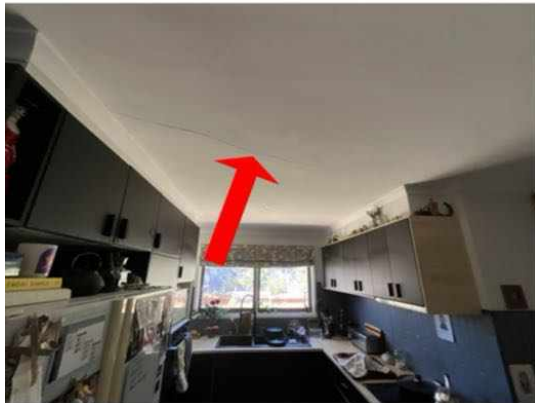
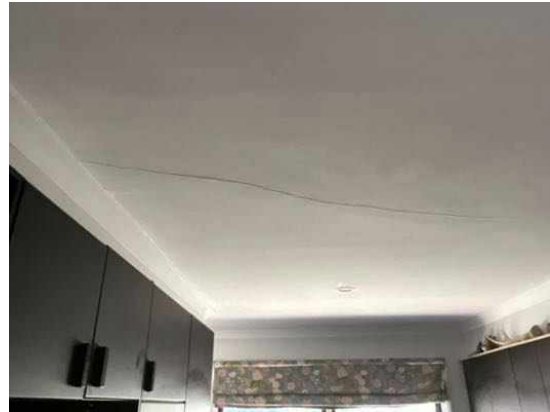
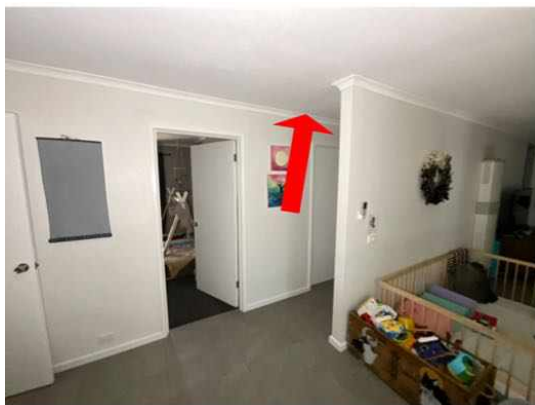
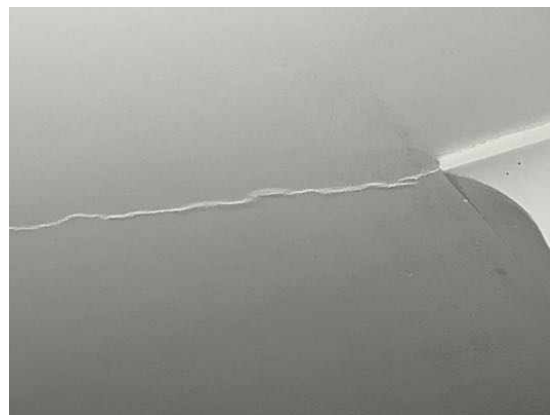
Finding 3.03

| Finding: | Cracking - Damage Category 1 - Fine (up to 1mm) |
| Information: | Although fine cracks are quite noticeable, they are often only considered to be an appearance defect, and usually do not indicate any structural damage. Generally, the cause of a fine crack is indicative of a separation between building materials and finishes (e.g. paint, plaster, etc.) along joins. |

Cracking of this nature can generally be repaired with minor sanding, filling and/or repainting. Such works should be performed by a qualified painter or a general handyman.

Monitoring of all cracking should be conducted frequently. Always contact a building inspector should cracks widen, lengthen, or become more numerous.

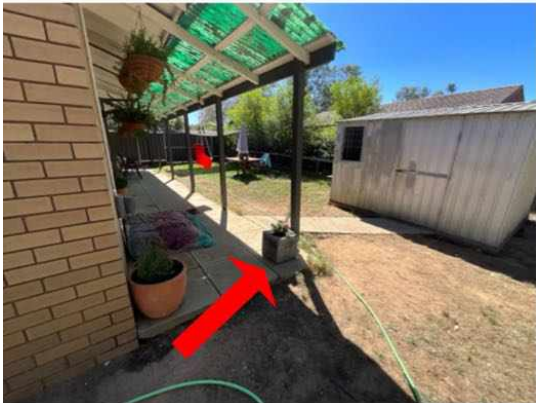
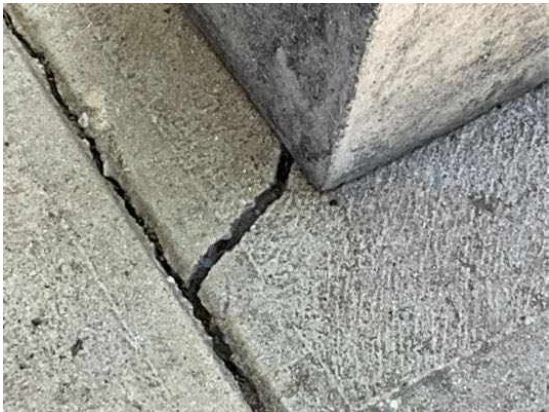
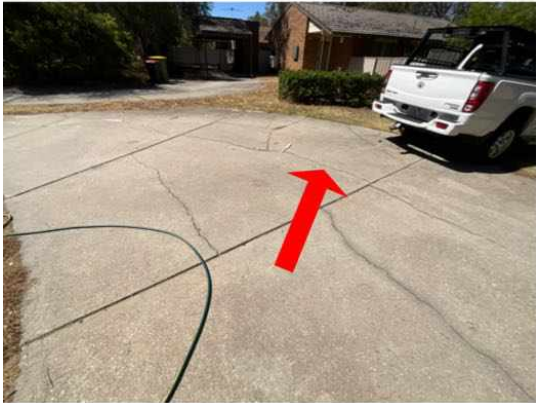
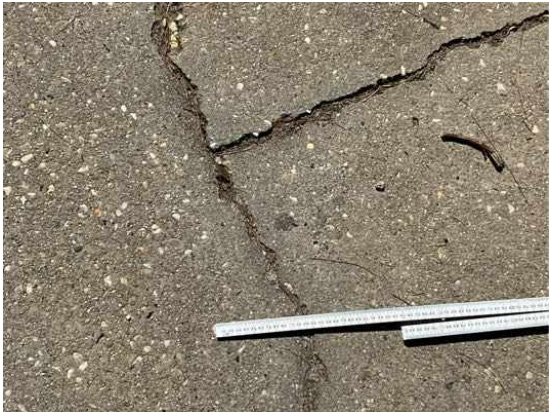
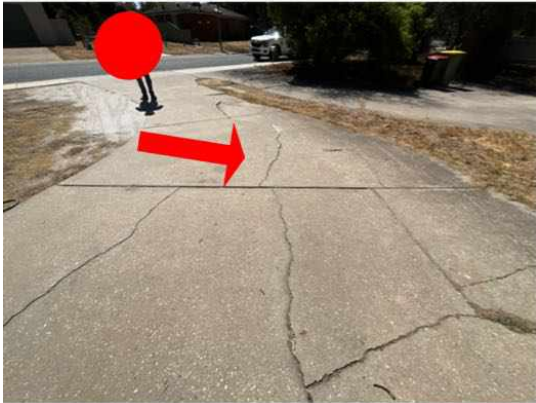
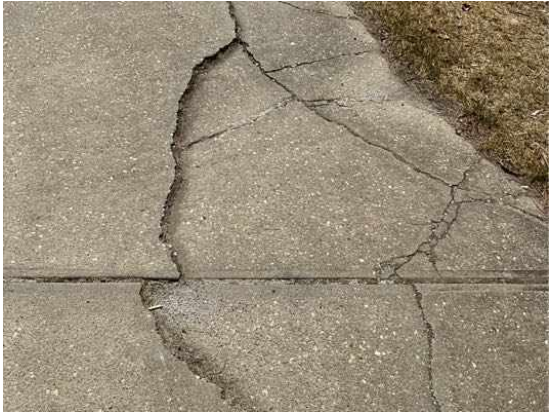
Finding 3.04

| Finding: | Cracking - External Concrete Paving Damage Category 4 - Gaps in Slab (4mm - 10mm +) |
| Information: | Gaps in the slab were identified in external concrete paving. Gaps in the slab are significant and are likely to lead to the development of safety hazards and secondary defects if left unmanaged, such as the creation of a trip hazard. |

General age and expected deterioration of the paved areas is a common cause of this type of cracking. However, expansion and contraction of the slab may also have occurred due to environmental factors. Such factors include variable moisture and

weather conditions, the presence of trees and their roots having a settling or lifting affect on the soil, or the effect of load bearing, e.g. heavy vehicles over a sustained period of time.

Cracking to this degree may also be due to poor original installation of the concrete. Factors such as poor compaction of the sub surface and/or inadequate reinforcing of the slab may create cracking and other secondary defects. Gaps in the concrete paving may also have a more significant structural cause, such as subsidence of soils.

Where gaps in the concrete paving are adjacent to structural elements of the building, the advice of a Structural Engineer is advisable before undertaking repairs. Significant repair and likely replacement of the concrete paving is probable.

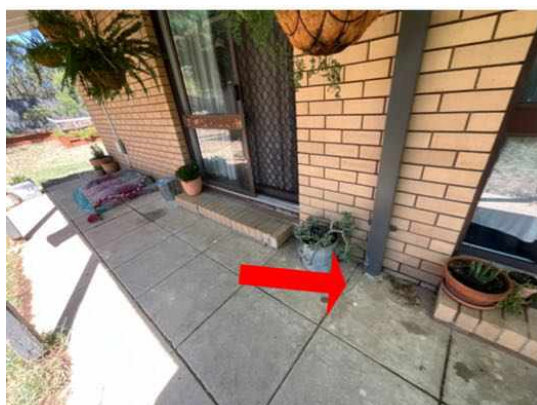
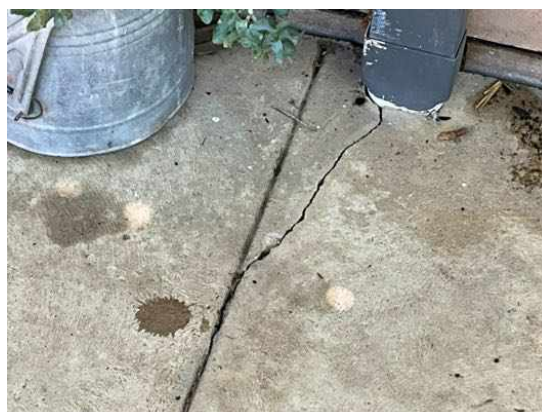
Finding 3.05

| Finding: | Cracking - External Concrete Paving Damage Category 1 - Fine (less than 2mm) |
| Information: | Fine cracks were identified in external concrete paving. Although fine cracks are quite noticeable, they are often only considered to be an appearance defect, and usually do not indicate any structural damage. To be considered a Category 1 or fine crack, the crack is found to be less than 2mm in width. |

Generally the cause of a hairline crack in existing concrete paving such as driveways and pathways is indicative of the expansion and contraction of the concrete. Such causes are generally due to environmental factors, such as moisture levels, weather conditions, root systems of nearby trees or the soil types on which they are laid.

Fine cracks may also be due to poor original installation of the concrete. Factors such as poor compaction of the sub surface and/or inadequate reinforcing of the slab may create cracking and other secondary defects.

Monitoring of all cracking should be conducted frequently. Always contact a building inspector should cracks widen, lengthen, or become more numerous.

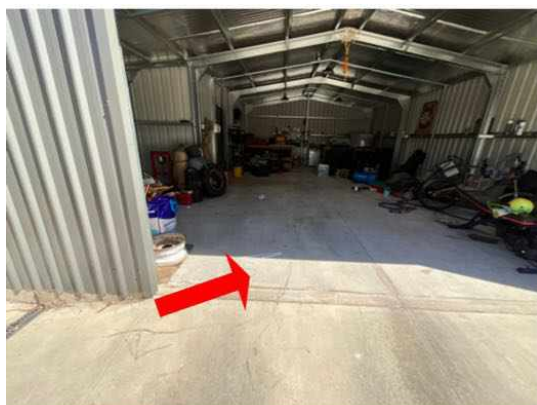
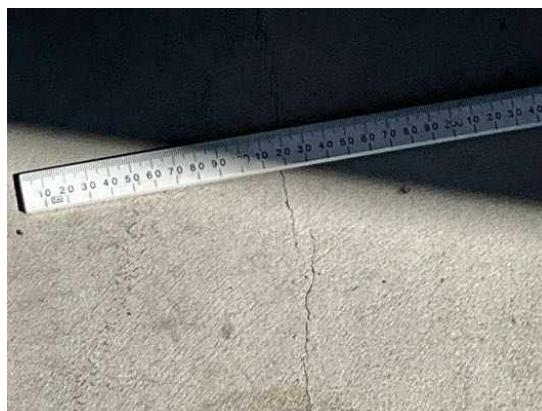
Finding 3.06

| Finding: | Crack in concrete slab - Category 1 |
| Information: | A crack coded as Category 1 was identified in the slab. A Category 1 crack is described as a fine but noticeable crack, with the slab at an otherwise reasonable level. |

To be considered Category 1, the approximate width of the crack is less than 1.0mm, or a less than 10mm change in offset when a 3m straight edge is placed over the defect.

Category 1 cracks should be monitored for a period of 12 months. At the end of the monitoring period, identified cracks that are rated greater than Category 2 are considered defects, and require rectification.

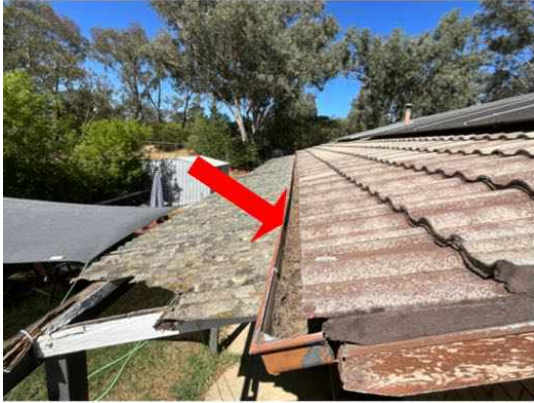
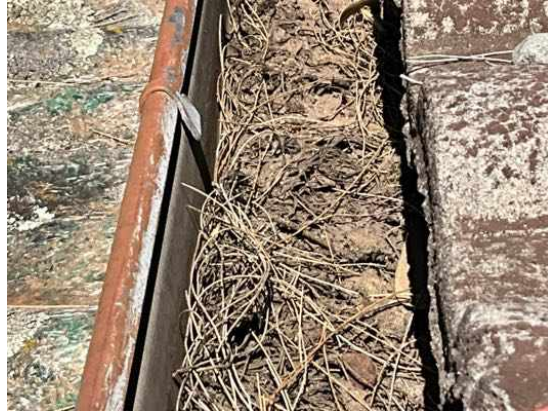
Blocked gutters are likely to lead to high levels of moisture in the affected areas. Such moisture will not only cause rust and decay of the associated building materials, but can also provide conditions that are conducive to termite and timber pest activity. Blockages in gutters should therefore be removed immediately to ensure dry conditions are maintained.

Consult a Licensed Plumber for further specific advice on remedial works that may be required. In the interim, it is highly advised that blocked gutters be removed by the homeowner or a general handyperson as a matter of urgency.

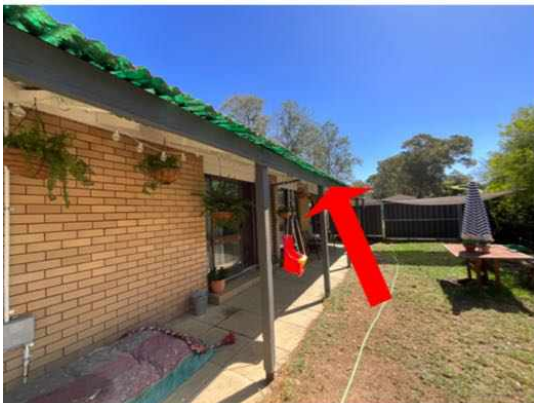
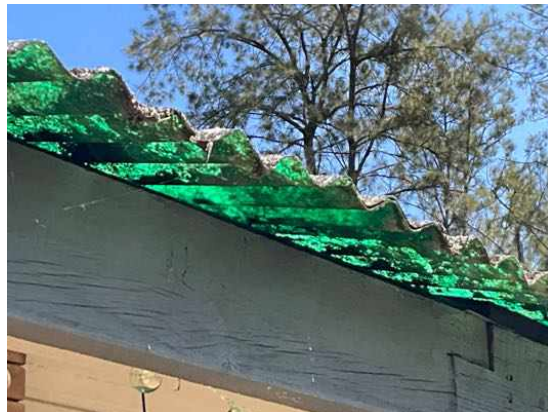
Finding 6.02

| Finding: | Guttering Missing |
| Information: | The Guttering in this area was missing at the time of inspection. Guttering, Downpipes and Stormwater drainage are vital to protect the integrity of the structure and to prevent an environment conducive to Timber Pest attack. |

A Plumber should be contacted as soon as possible to replace and connect to drainage the missing Guttering.

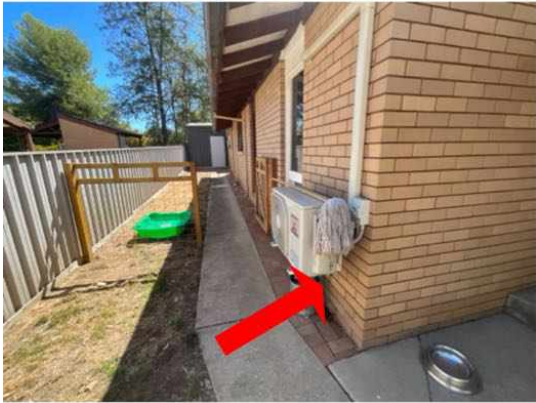
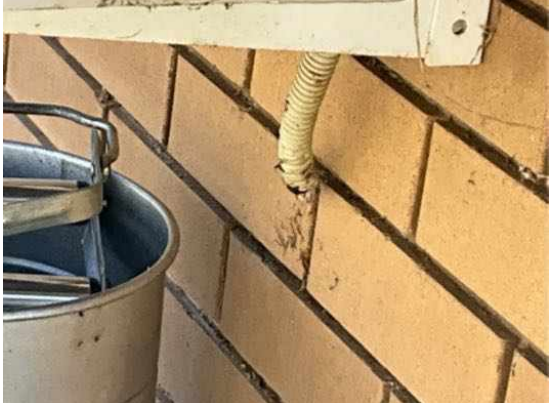
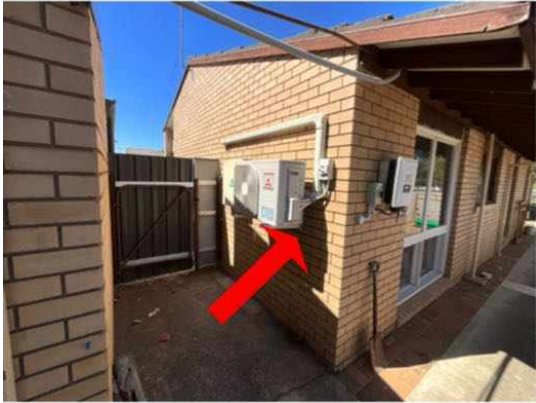
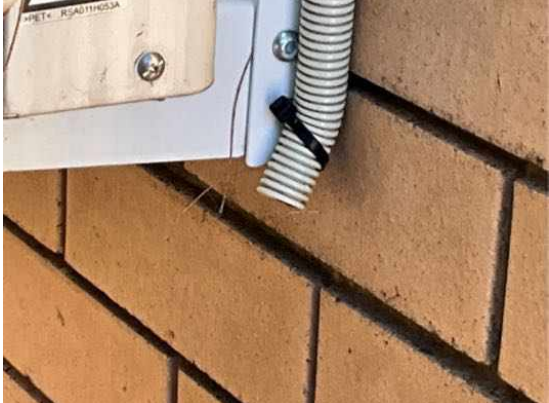
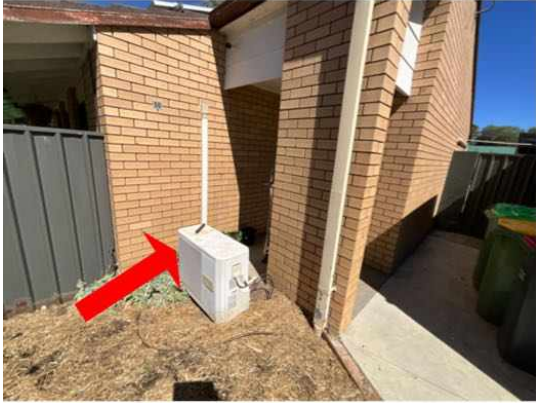
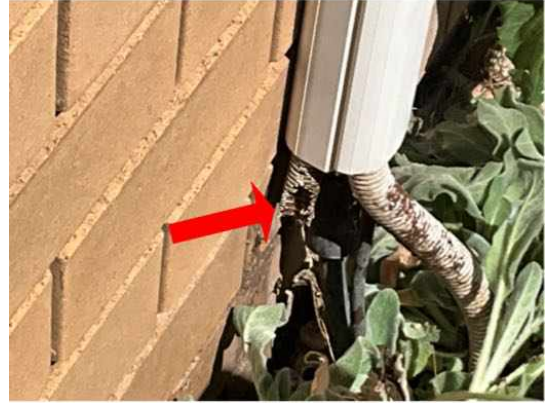
Finding 6.03

| Finding: | Air conditioner - Disconnected overflow |
| Information: | The Air Conditioner (A/C) overflow was found to be disconnected from storm water drainage and is creating excessive moisture in the surrounding area. |

Such leaking creates an environment which is conducive to an array of defects, including water damage to associated building elements and the attraction of termite

or timber pest infestation.

It is highly recommended that a licensed plumber be appointed to connect the A/C overflow in order to prevent such an environment from being created. These minor works should be carried out as soon as possible.

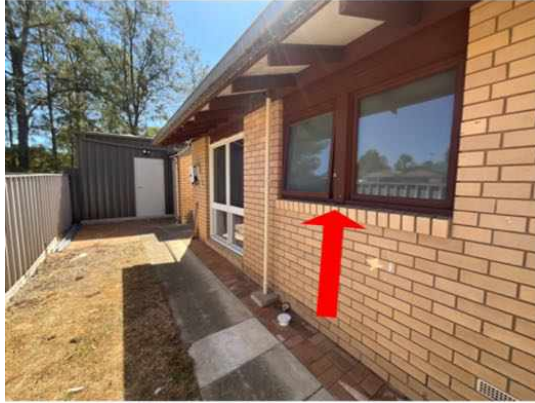
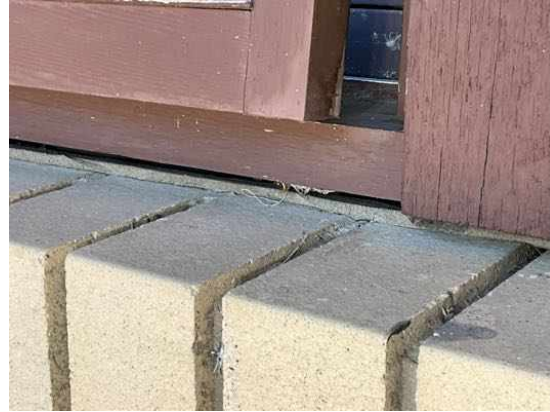
Finding 6.04

| Finding: | Inadequate sealant/caulking |

The presence of water encourages Termite attack, Mould and Fungal Decay.

A Caulker or General Handy person must be contacted soon to effect repairs and prevent possible deterioration.

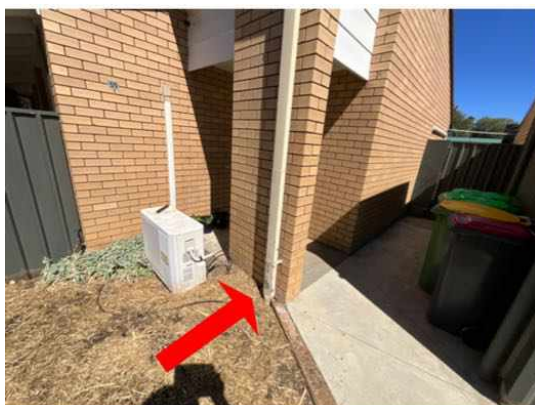
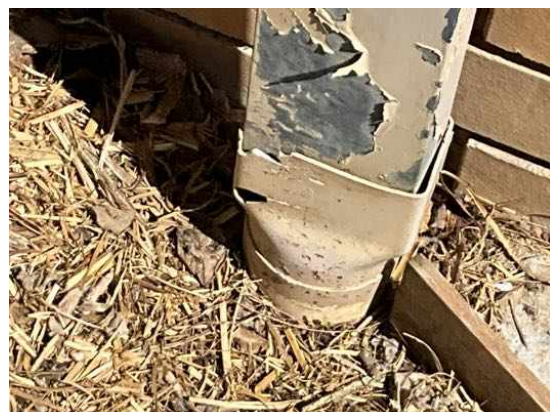
Finding 6.05

Building: Building 1
 Location: Entry
 Finding: Downpipe/ Stormwater pipe Damaged
 Information: The Stormwater element was found to be damaged at the time of inspection.

Downpipes ensure excess water is directed away from the structure to prevent damage. This damage includes Fungal timber decay, Termite attack and sinking of the stumps that support the floor. All of this type of damage may lead to costly repairs.

A Plumber should be contacted to make repairs as soon as possible to prevent deterioration of the Structure.

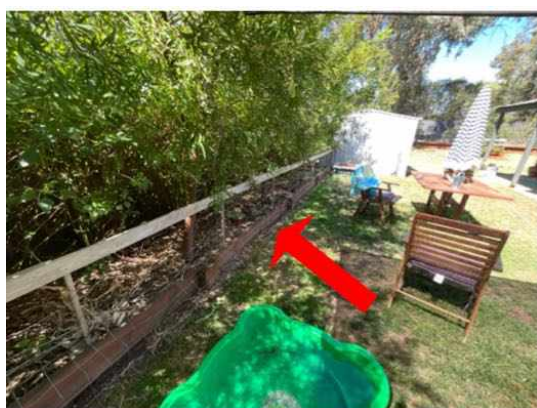
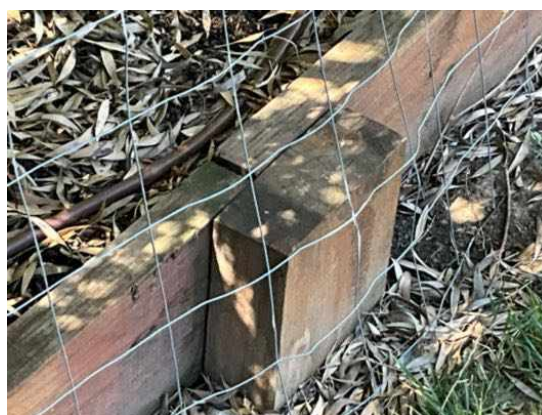
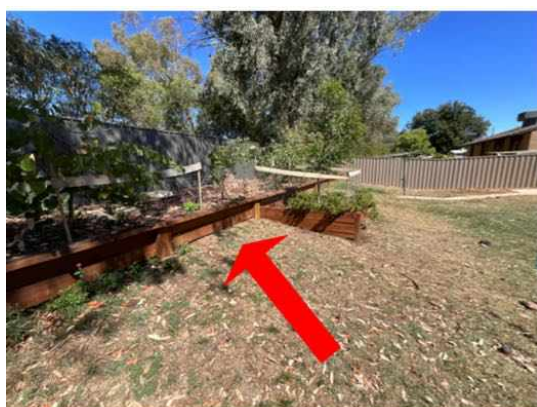
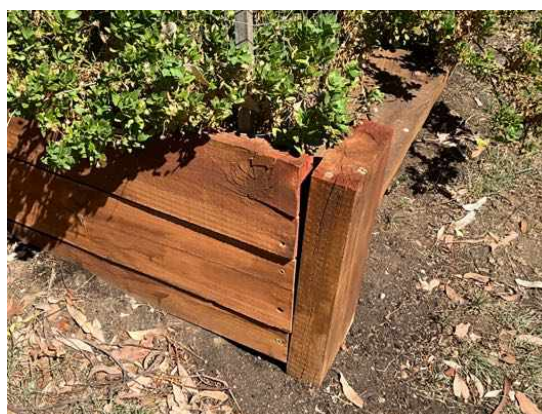
Finding 6.06

Finding: Untreated or non-durable timbers in a hazardous environment

Information: To reduce the risk of timber pest attack it is essential that timber used in a hazardous environment (e.g. in direct contact with the ground or frequently exposed to damp conditions) is of sufficient durability and/or is adequately preservative treated.

Untreated timbers in direct contact with the ground are likely to develop severe wood rot and/or fungal decay if left unattended creating attraction for subterranean termites to infest the timbers from surrounding areas.

If untreated or non-durable timbers are found to be in a hazardous environment it is highly advised that replacement of these building elements be performed as soon as possible to aid the protection of the property against termite / timber pest attack.

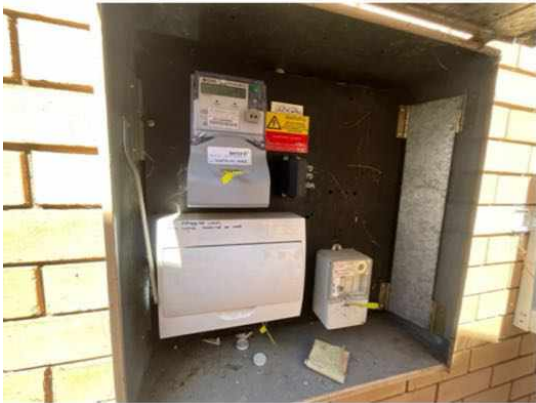
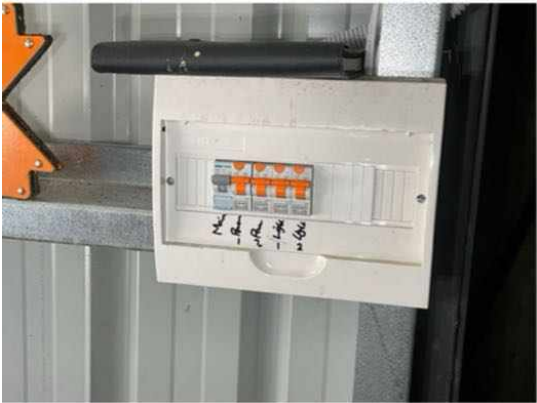
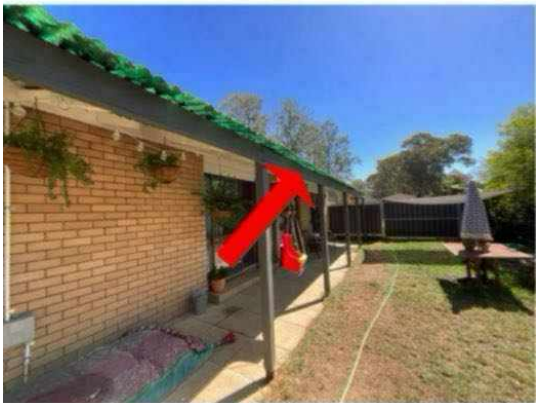
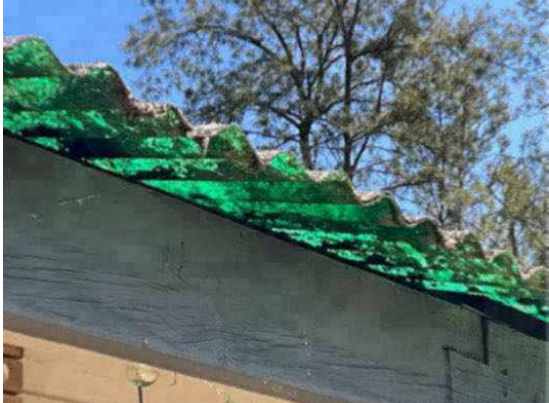
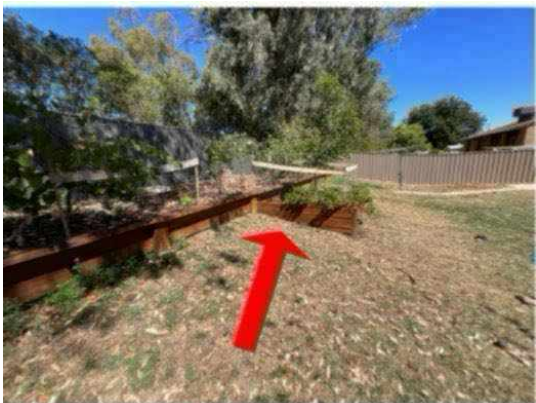
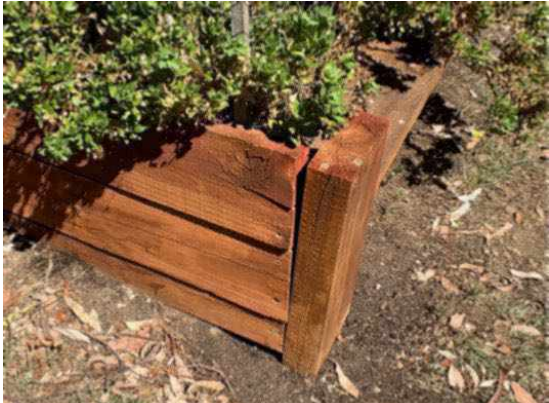
Finding 6.07

Information: The application of a post-construction chemical termite barrier is highly recommended for all properties, particularly if live termite activity has been found on the site previously. Such barriers are highly effective in preventing termite attack on any timber building elements throughout the property.

A durable notice should be placed in the switchboard unit to indicate current termite barriers. At the time of inspection, it appeared as though no termite management system has been installed, with no evidence to suggest preventative works taking place.

The client may consider gaining further advice from a pest controller as to the costs and procedures involved with this application. It is recommended that obtaining such advice be a short-term priority.

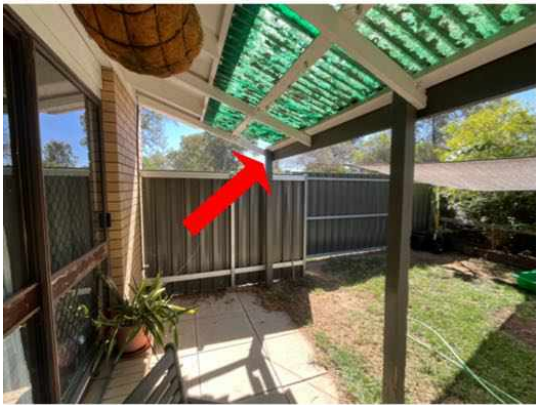
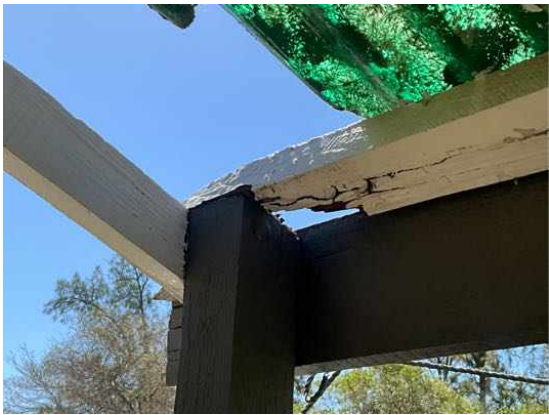
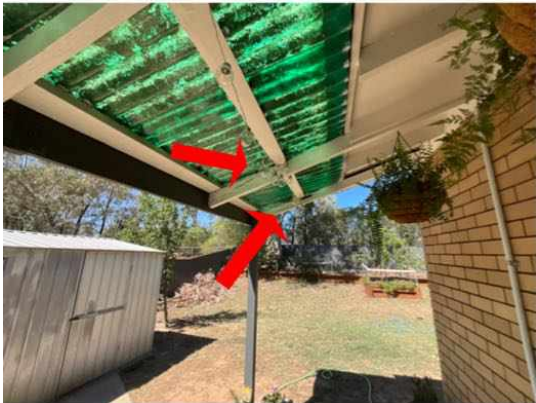
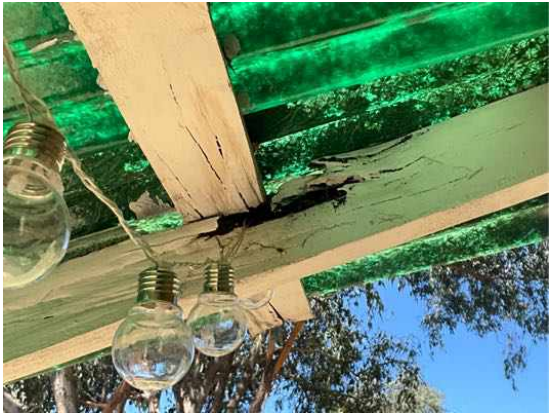
Finding 7.01

| Finding: | Fungal decay - present (localised) |
| Information: | Fungal decay also known as wood decay or wood rot generally refers to the deterioration of timber elements when in contact with excessive levels of moisture for a prolonged period of time. |

The development of fungal decay is accelerated by temperatures in the range of 5degreeC to 40degreeC as well as the presence of oxygen. Generally fungal decay develops on timber elements that are in use in an external environment which are exposed to rain penetration.

In this case although the affected timber element is in a decaying state the extent of any visible damage appears to be localised to a specific area and is yet to spread to other parts of the building element or affect adjoining structures. The fungal decay is therefore likely to be of a relatively superficial nature with minimal impact on the structural integrity or tensile strength of the timber element.

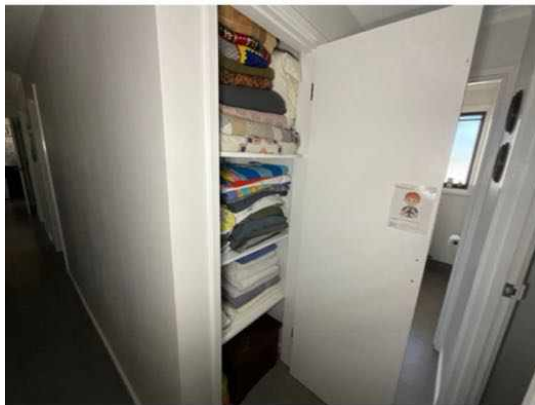
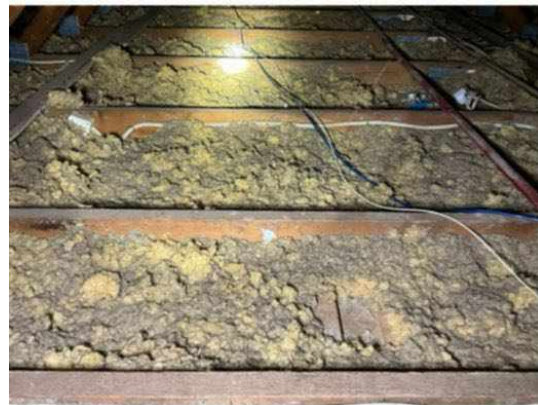
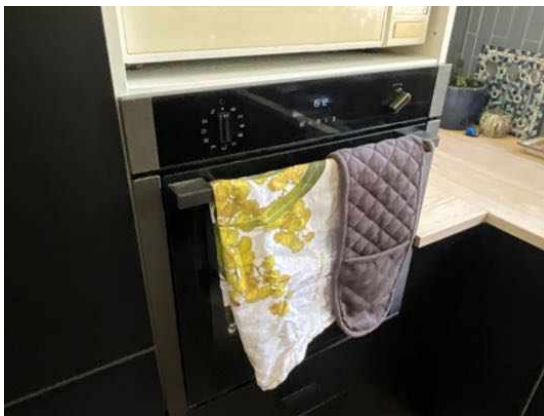
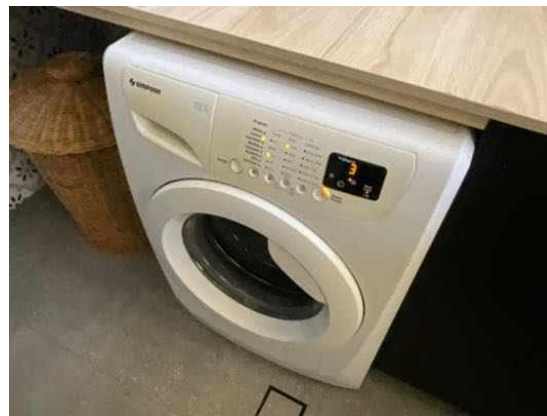
Building: Building 1
Location: All Areas
Finding: Additional Photos - Obstructions and Limitations
Information: These photographs are an indication of the obstructions and limitations which impeded full inspection of the property at the time of inspection. These obstructions can hide an array of defects and should be removed to allow full inspection to be carried out. A re-inspection is recommended once the areas are made accessible.
