Building and Timber Pest Inspection Report

Inspection Date: Mon, 30 Mar 2026

Property Address: 5 Selwyn St, Paddington NSW 2021,
Australia

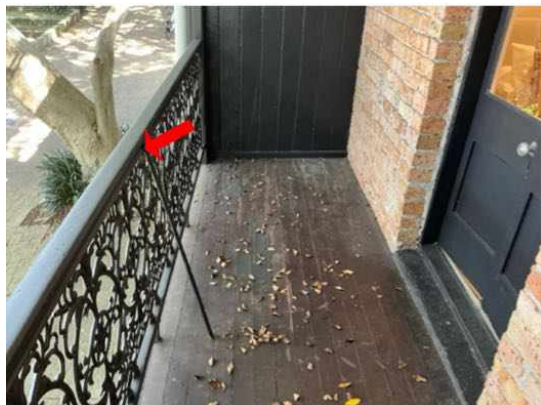
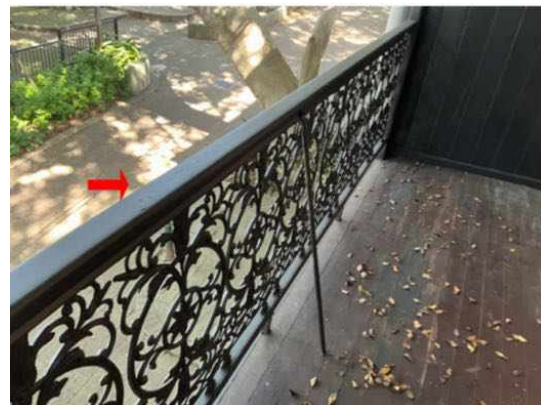
Finding 1.01

Building:	Main Building
Location:	Balcony
Finding:	Balustrade Below Current Height Standard
Information:	During the inspection, it was noted that the balustrade in one area has a height of approximately 900mm, which is below the current NCC requirement of 1,000mm for balustrades in outdoor areas where a fall risk exists.

It is important to note that this property is a heritage building, and the balustrade may have been constructed before the current Australian Standards were introduced. Therefore, it may have complied with regulations at the time of construction.

Although not mandatory for existing heritage structures, for improved safety—especially where there is a risk of falling—upgrading the balustrade height to meet the current standard is recommended. This work can be carried out by a licensed carpenter or metal fabricator, depending on the material and design of the balustrade.

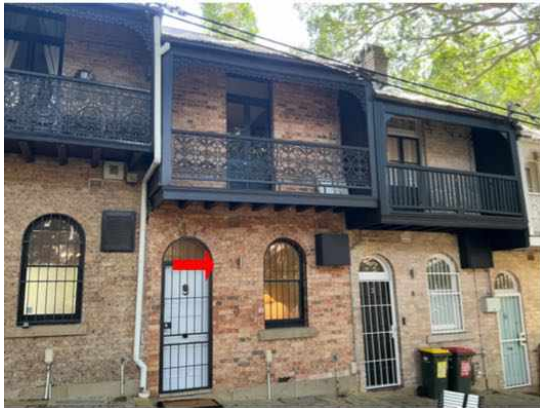
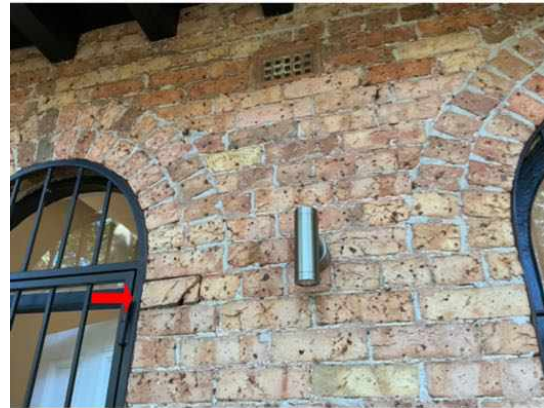
Finding 3.01

Building:	Main Building
Location:	Entry
Finding:	Loose Brick at Entrance

Information: During the inspection, it was noted that one of the bricks at the entrance area is loose. It is recommended that the loose brick be properly re-laid and secured to ensure a stable and safe surface.

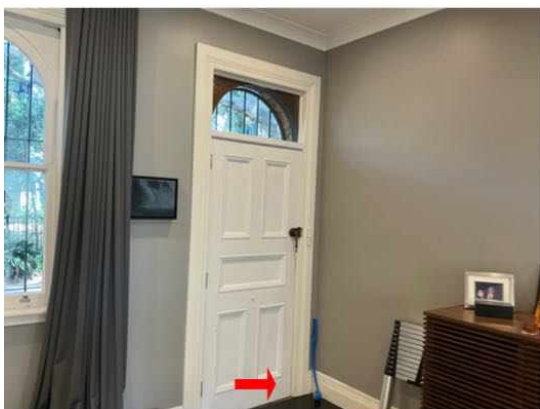
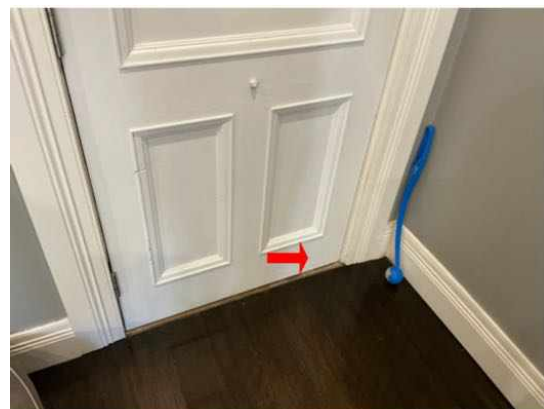
Finding 3.02

Building: Main Building

Location: Entry

Finding: Door stop - Missing

Information: The door stop is missing or is inadequate to stop the door handle from damaging the wall. Although some building elements may seem irrelevant or unnecessary, all building elements play a key role in the operation and function of the overall structure and its performance.

Re-installation or replacement of the door stop is advised as soon as possible to prevent any subsequent damage to the door or associated structures. A general handyman may be appointed to perform these works at client discretion.

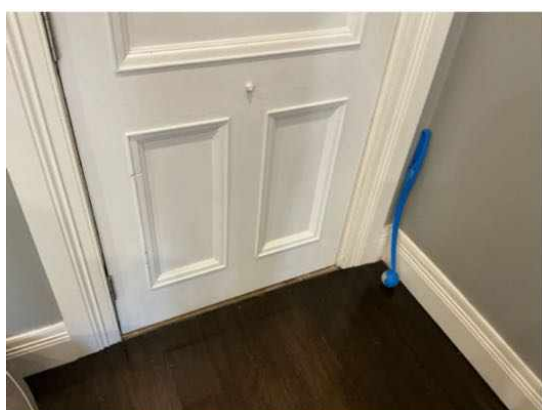
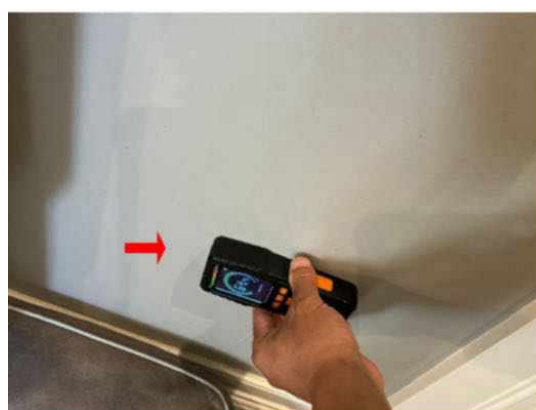
Finding 3.03

Building: Main Building

Location: Living Room

Finding: Damp - Rising

Information: Rising damp describes the upward movement of water in low sections of building elements (e.g. walls) by capillary action - the movement of water through porous materials such as bricks, sandstone or mortar.

Rising damp is generally managed by the installation of a damp proof course during construction. A Damp Proof Course (DPC) is an impermeable barrier at the base of the wall above ground level. However, many 19th Century buildings have no damp course installed, or the materials have failed. The DPC may have been omitted as a consequence of poor workmanship, or it may have been bridged where materials built up against the side of the house allow moisture ingress above the DPC level.

The first step in addressing rising damp is to diagnose the cause. The identified cause should be addressed first before addressing the appearance and other defects which have resulted from the rising damp. If the original cause is not resolved, further cases of damp are likely to ensue, resulting in secondary defects.

Consultation with a qualified plumber is advised immediately to identify the cause of the damp and perform remedial works as required.

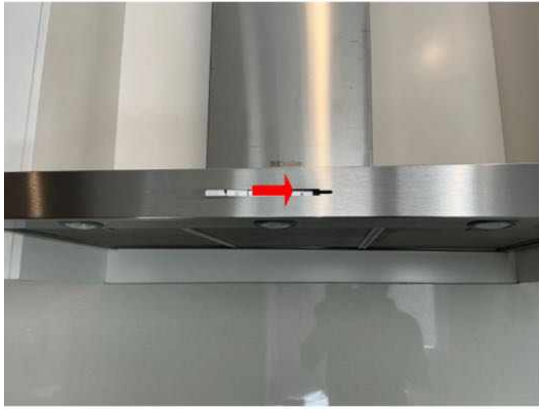
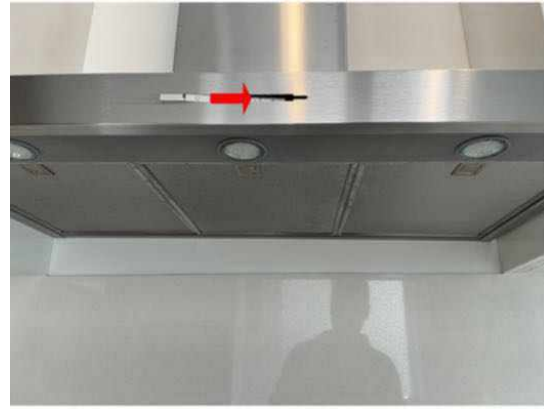
Finding 3.04

Building: Main Building
Location: Kitchen
Finding: Faulty Rangehood Control Button
Information: During the inspection, it was noted that one of the control buttons on the rangehood is damaged and not functioning as intended. This may affect the normal operation of the appliance. It is recommended that the rangehood be assessed and repaired or replaced by a qualified technician to ensure it operates properly.

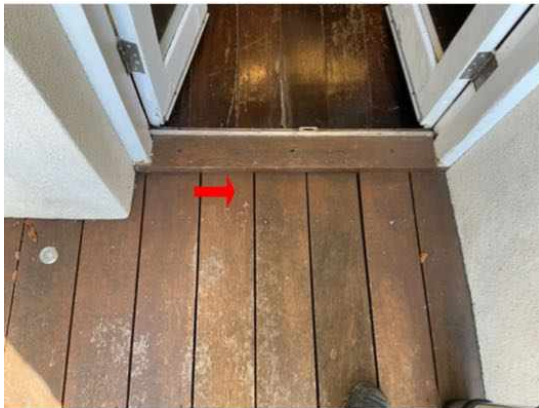
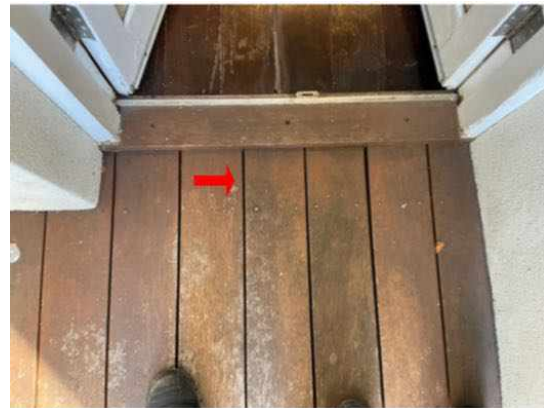
Finding 3.05

Building:	Main Building
Location:	Yard - Side
Finding:	Possible Timber Deterioration to External Deck
Information:	During the inspection, it was noted that a section of the external deck felt spongy and exhibited noticeable deflection underfoot when stepped on. This condition is likely indicative of deterioration or decay of the underlying timber structure. Although no invasive inspection was carried out to confirm the extent of the damage, the current condition may pose a safety risk if left unaddressed. It is recommended that this area be further assessed and repaired by a qualified carpenter as soon as possible to prevent potential failure or injury.

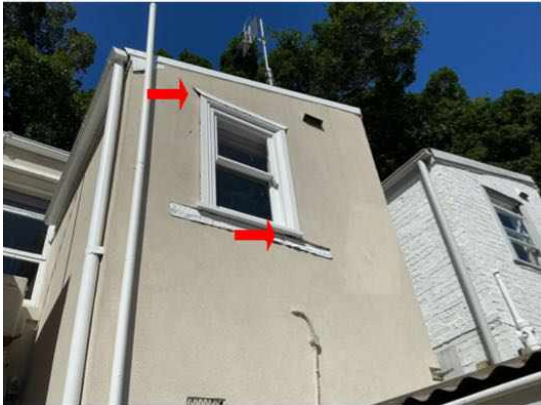
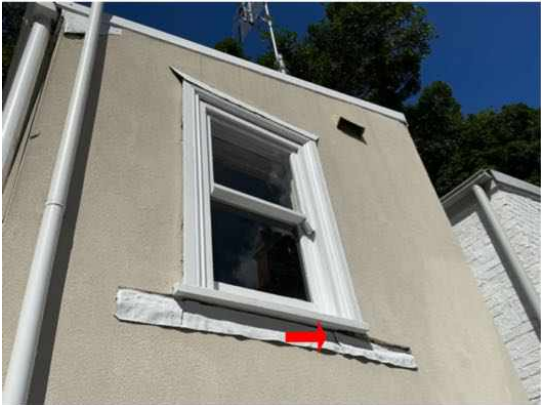
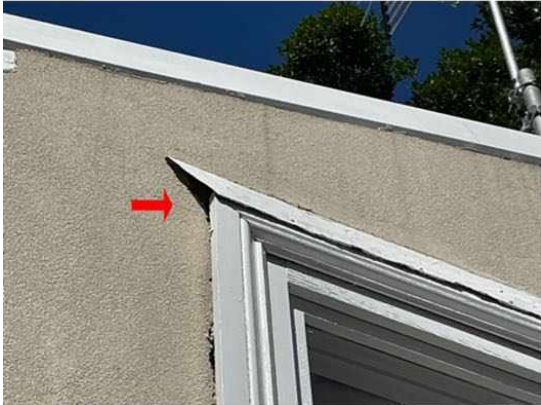
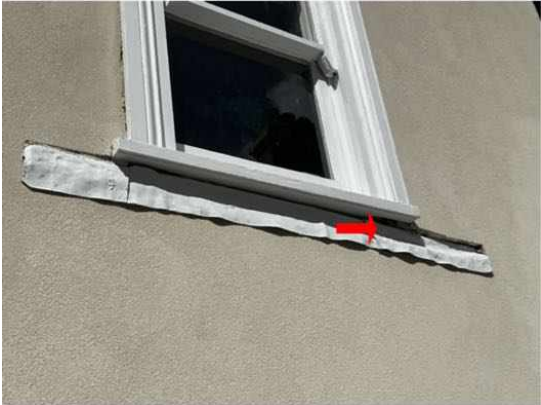
Finding 3.06

Building:	Main Building
Location:	Rear Elevation
Finding:	Gap
Information:	Sealing these areas properly will help protect the home from unwanted water and pest issues.

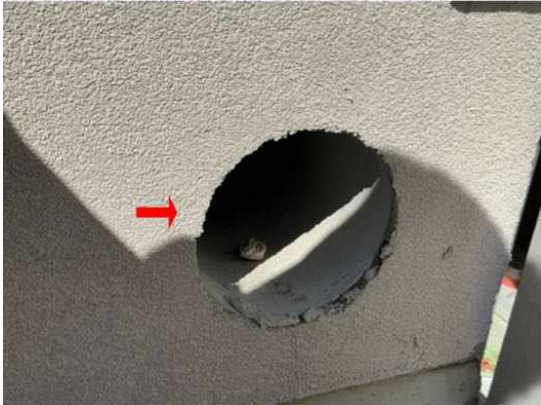
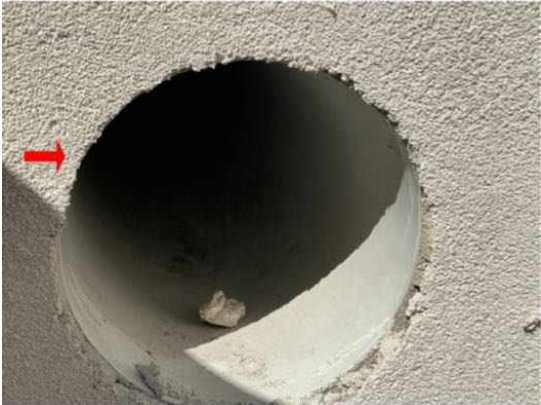
Finding 3.07

Building: Main Building
Location: Exterior walls - rear
Finding: Missing External Vent Cover
Information: During the inspection, it was noted that the exhaust outlet to the external wall (likely serving the rangehood or another mechanical ventilation system) is not fitted with a protective cover. The absence of a proper vent cover may allow the ingress of rainwater, pests, and debris into the ducting system, which can lead to potential damage or hygiene concerns over time. It is recommended that a suitable external vent cover be installed to protect the opening and ensure proper functioning of the exhaust system.

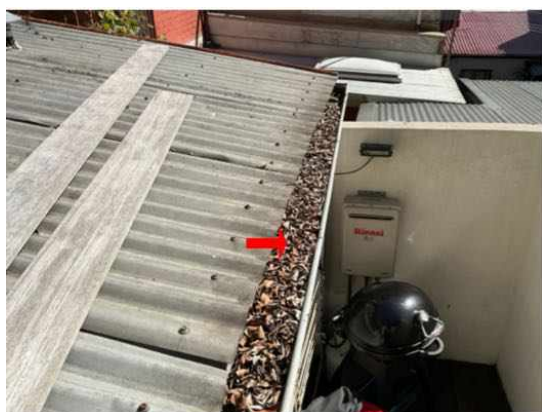
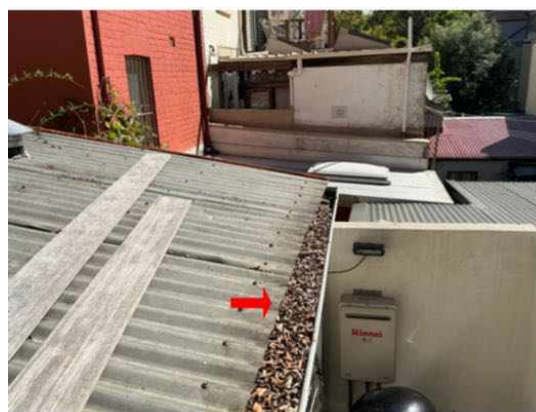
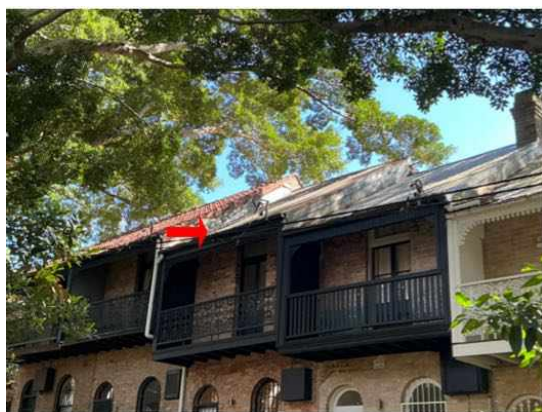
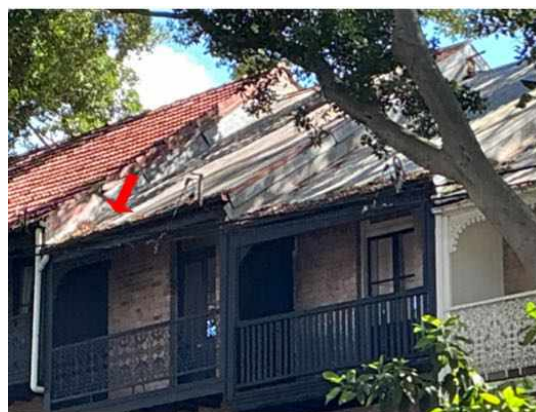
Finding 3.08

Building:	Main Building
Location:	All External Areas
Finding:	Gutters - excessive debris
Information:	During the house inspection, excessive debris was found in the gutters, which have become overgrown with vegetation. This can have a negative impact on the property by potentially causing water damage, clogged drainage, and potential structural issues if not addressed promptly.

It is recommended to hire a specialized Gutter Cleaner to perform gutter cleaning. This will ensure thorough removal of debris and blockages, preventing further damage to the property and maintaining the proper functioning of the gutter system.

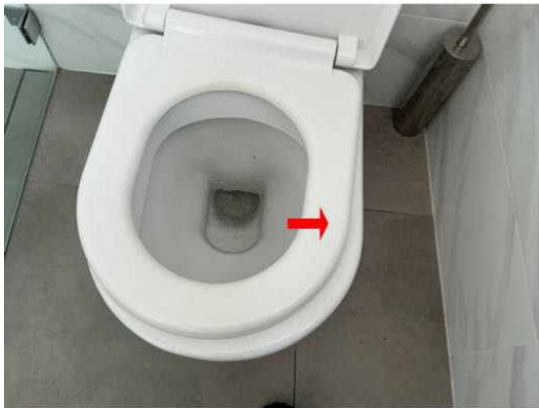
Finding 3.09

Building:	Main Building
Location:	Bathroom
Finding:	Toilet seat- Loose
Information:	During the home inspection, it was observed that the toilet seat is installed with some looseness. This can lead to discomfort during use and potential damage to the toilet. A plumber or a handyman can effectively tighten and secure the toilet seat to address

this issue.

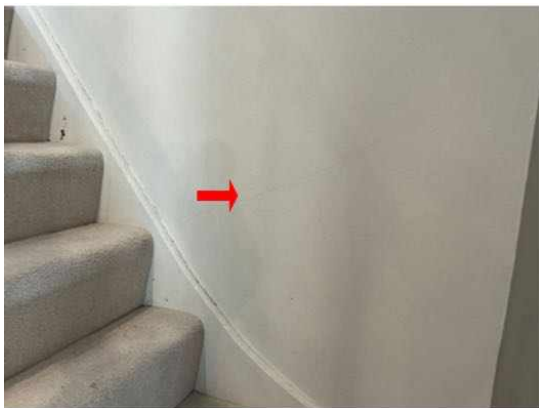
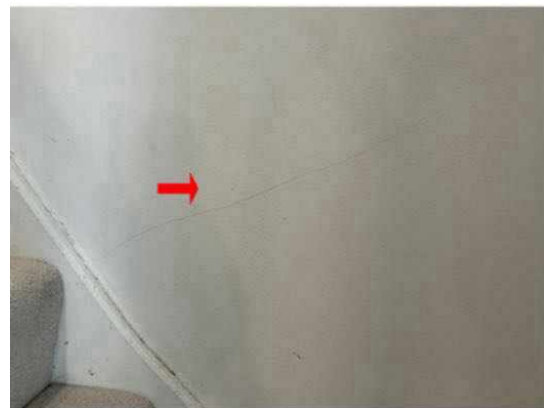
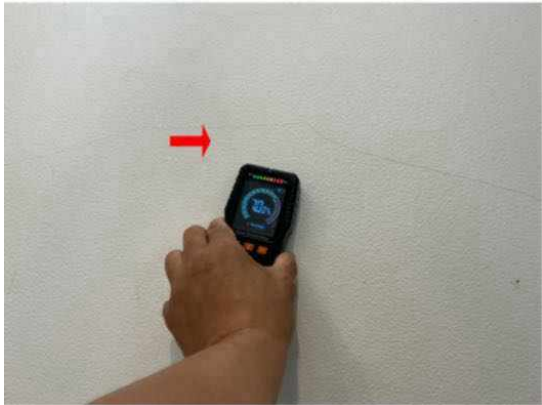
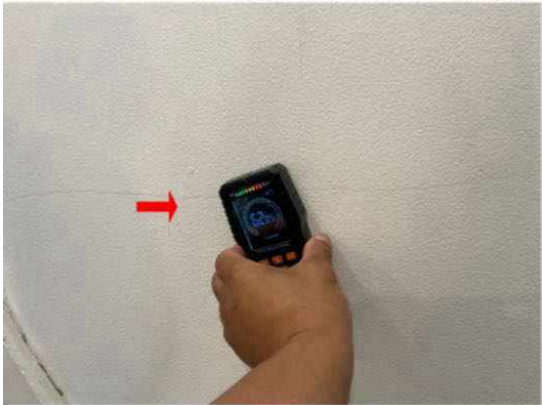
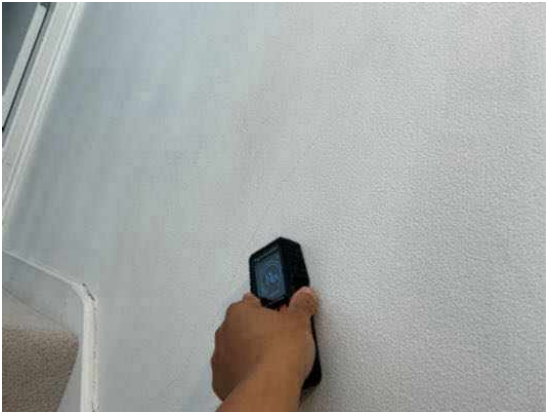
Finding 3.10

Building:	Main Building
Location:	Stairs - Internal
Finding:	Minor Cracking and Elevated Moisture to Staircase Wall
Information:	During the inspection, it was noted that the wall adjacent to the staircase exhibits minor cracking to the rendered surface. Moisture readings taken at the time of inspection indicated elevated levels; however, no evidence of active water ingress was observed. This condition is considered a minor defect. It is recommended that the area be monitored for any changes and, if necessary, further investigation or maintenance be carried out to prevent potential deterioration.

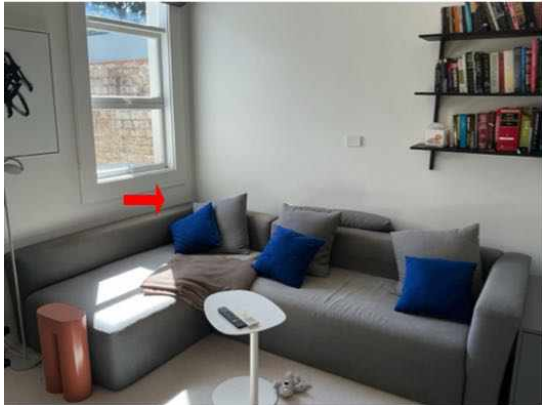
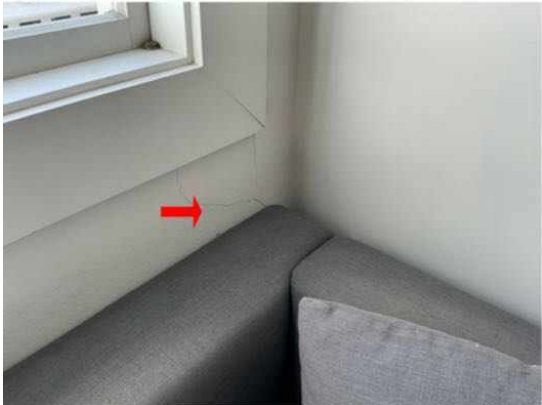
Finding 3.11

Building: Main Building
Location: Rumpus
Finding: Cracks to internal render - Category 3
Information: It has been observed that cracking to internal rendered surfaces has occurred. The degree of damage falls within Category 3, described as cracks which can be repaired with consideration that a section of wall may need to re-rendered.

The cracks are generally 5-15mm in width, or may present as a number of cracks 3mm or more in a group. Damage of this category is a defect that requires rectification work, which may be more extensive.

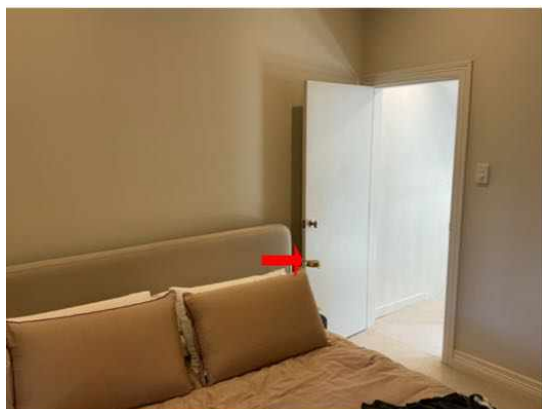
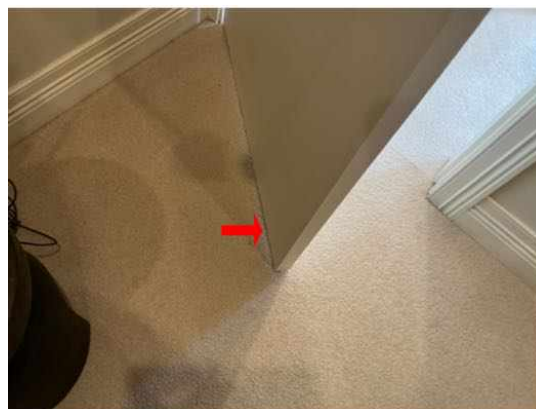
Finding 3.12

Building:	Main Building
Location:	Bedroom
Finding:	Door stop - Missing
Information:	The door stop is missing or is inadequate to stop the door handle from damaging the wall. Although some building elements may seem irrelevant or unnecessary, all building elements play a key role in the operation and function of the overall structure and its performance.

Re-installation or replacement of the door stop is advised as soon as possible to prevent any subsequent damage to the door or associated structures. A general handyman may be appointed to perform these works at client discretion.

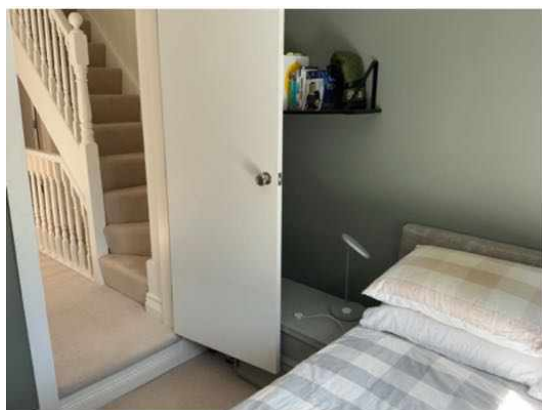
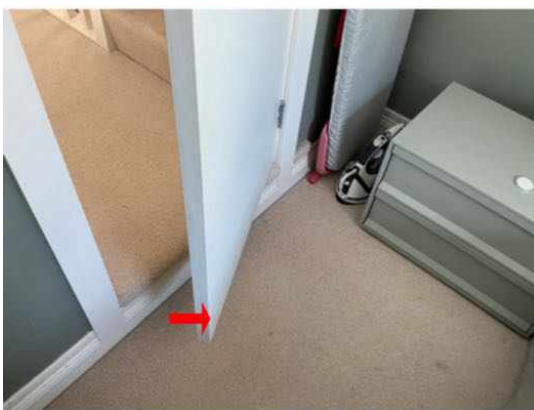
Finding 3.13

Building:	Main Building
Location:	Bedroom 2
Finding:	Door stop - Missing
Information:	The door stop is missing or is inadequate to stop the door handle from damaging the wall. Although some building elements may seem irrelevant or unnecessary, all building elements play a key role in the operation and function of the overall structure and its performance.

Re-installation or replacement of the door stop is advised as soon as possible to prevent any subsequent damage to the door or associated structures. A general handyman may be appointed to perform these works at client discretion.

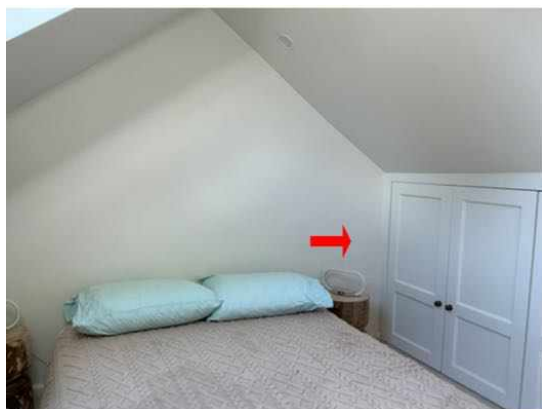
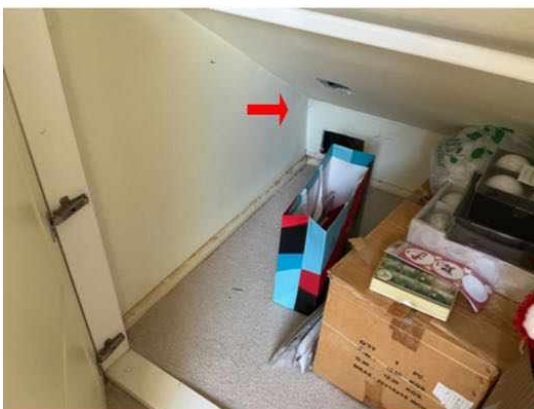
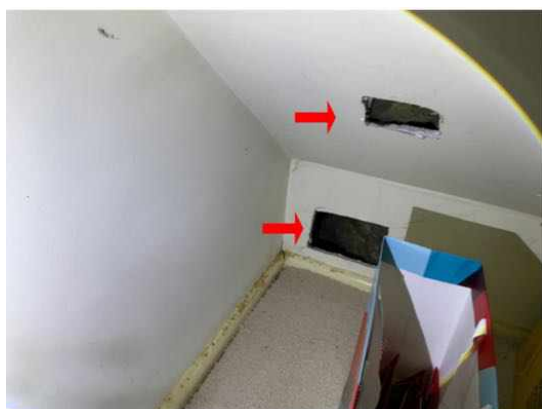
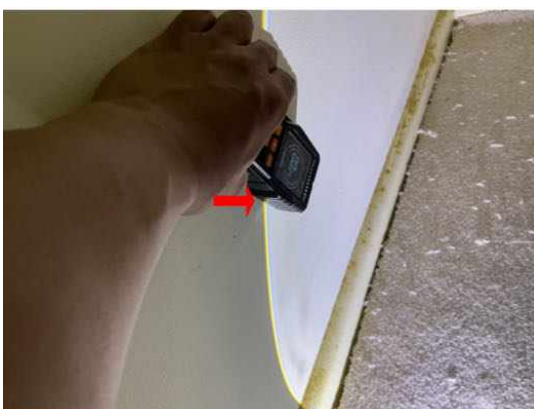
Finding 3.14

Building: Main Building
 Location: Bedroom 3/ Attic
 Finding: Damaged Plasterboard to Wall Cavity
 Information: During the inspection, it was noted that there are two cut openings to the plasterboard within the wall cavity area, along with some adjacent staining. Moisture testing was carried out at the time of inspection and no elevated moisture readings were detected, indicating no evidence of active moisture ingress. While this issue does not currently appear to be associated with damp or water penetration, it is recommended that the openings be properly repaired and sealed to restore the integrity and finish of the wall surface.

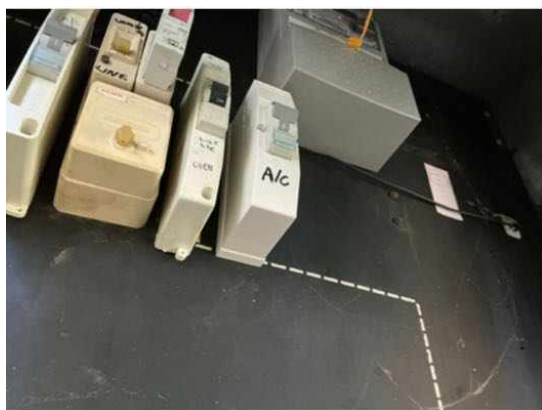
Building: Main Building
 Location: Meter Box
 Finding: Termite Management System - no evidence of a chemical installation
 Information: The application of a post-construction chemical termite barrier is highly recommended for all properties, particularly if live termite activity has been found on the site previously. Such barriers are highly effective in preventing termite attack on any timber building elements throughout the property.

A durable notice should be placed in the switchboard unit to indicate current termite barriers. At the time of inspection, it appeared as though no termite management system has been installed, with no evidence to suggest preventative works taking place.

The client may consider gaining further advice from a pest controller as to the costs and procedures involved with this application. It is recommended that obtaining such advice be a short-term priority.

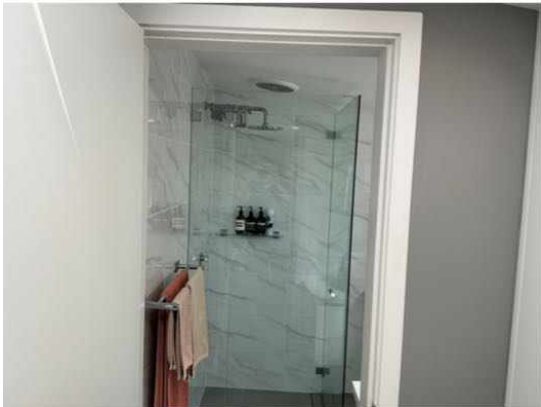
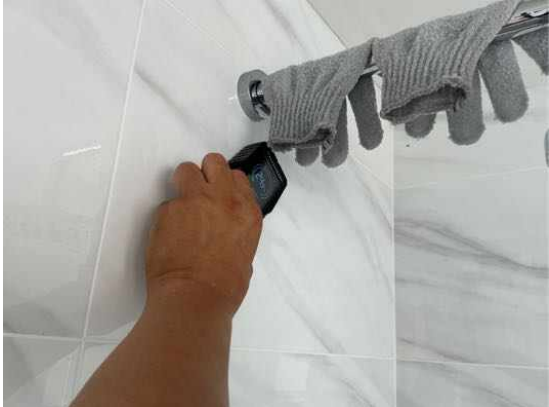
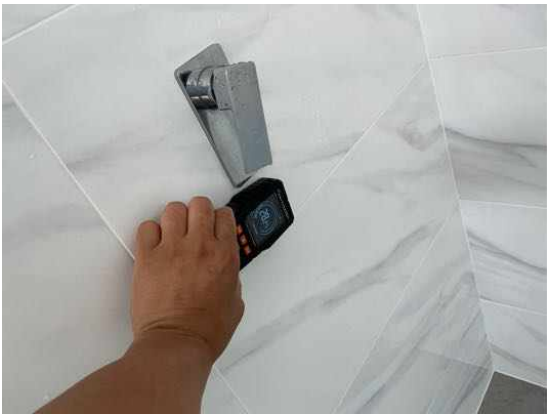
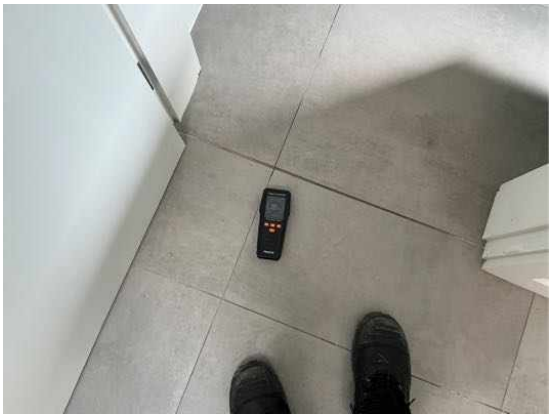
Building: Main Building
Location: Bathroom
Finding: No high moisture reading found
Information: During the home inspection, These areas were checked using a moisture meter, and no high moisture readings were detected.
