Building Inspection Report

Inspection Date: Thu, 12 Mar 2026

Property Address: 2602/311 Hume Hwy, Liverpool NSW 2170,
Australia

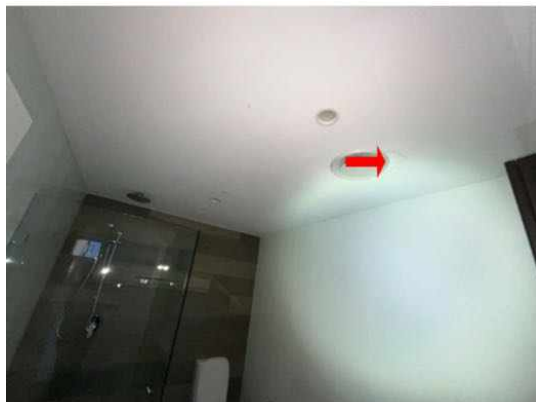
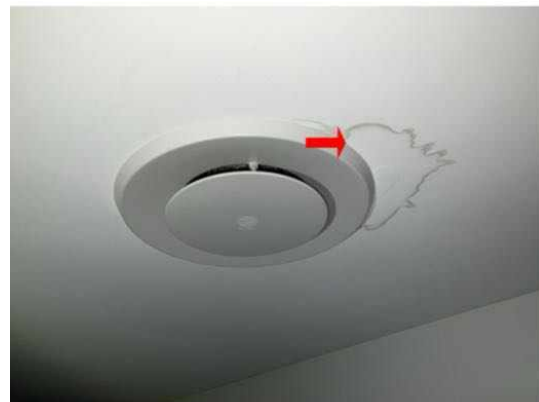
Defects 3.01

Building: Main Building

Location: Bathroom

Finding: Water staining

Information: Water staining was evident in this area at the time of inspection. Water staining indicates that surfaces have been exposed to excessive moisture over time. The minerals and other elements in the water lead to staining, which may graduate to corrosion and deterioration if left unmanaged.

While mostly an appearance defect, water staining can be indicative of more serious defects, which may be currently concealed by other building elements.

Although excess moisture was not measured at the time of inspection, a licensed plumber must be consulted to identify the cause of the staining and to provide advice on any reparation works that may be required. Replacement of any broken or damaged structures is advised.

Conversely, where water staining is old and inactive, affected building materials may be repaired or replaced at client discretion.

- Ensure the balcony balustrade is repaired with the rubber holding the glass tightly
- Investigate and address water staining to the bathroom ceiling

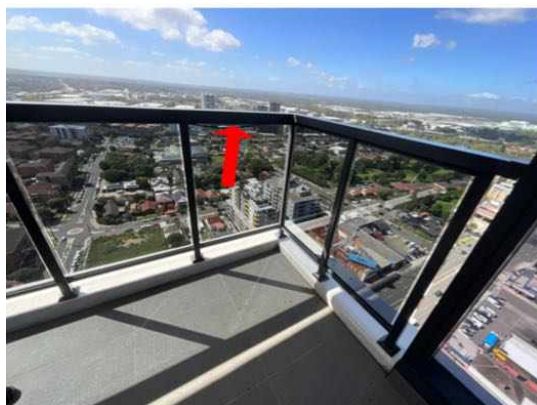
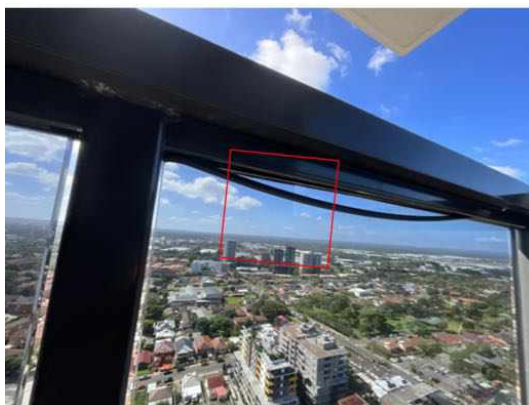
Defects 3.02

Building:	Main Building
Location:	Balcony
Finding:	Fitting or fixture - Loose
Information:	The fitting in this area is loose and requires adjustment to tighten.

If left unmanaged, the fitting may further deteriorate, causing potential for the development of other minor secondary defects.

A relevant tradesperson should be appointed to perform these rectification works at discretion of the client.

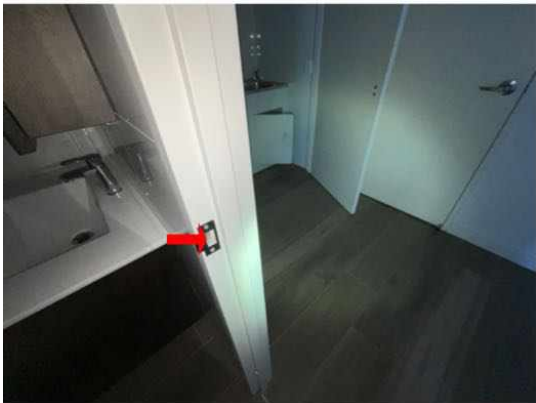
Defects 3.03

Building:	Main Building
Location:	Bathroom
Finding:	Door - Striker plate misaligned
Information:	The striker plate to this door appears to have become misaligned and has consequently resulted in the door's operation being compromised.

This is a common defect and is expected in a property of this age, whether being due to substandard installation or general deterioration of the door hardware.

Readjustment of the striker plate is recommended at client discretion. Works such as these can be completed by a general handyman or qualified carpenter.

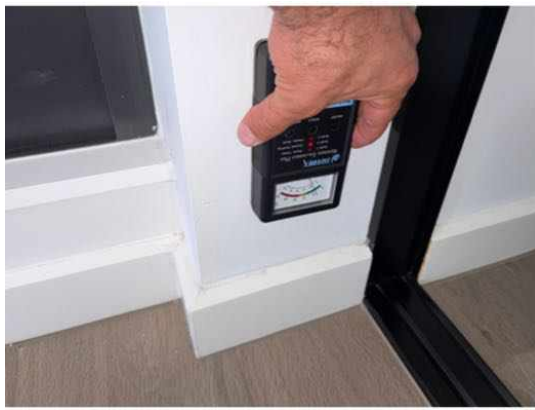
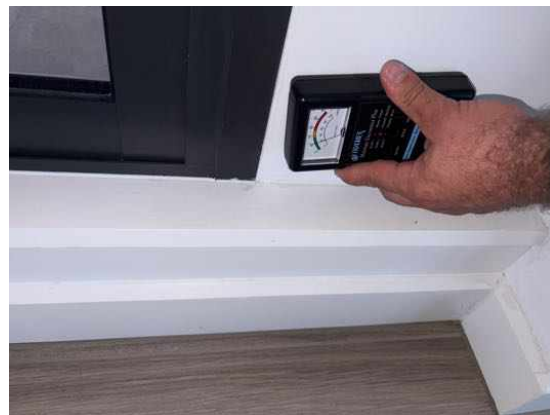
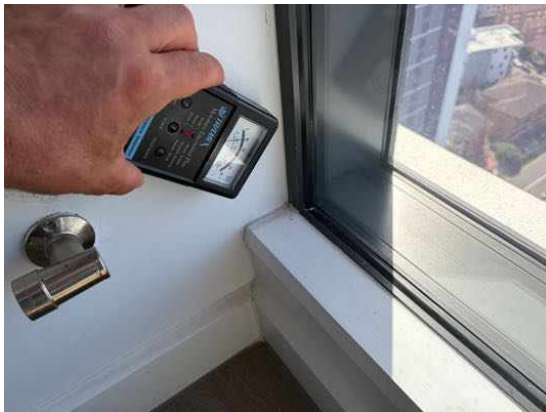
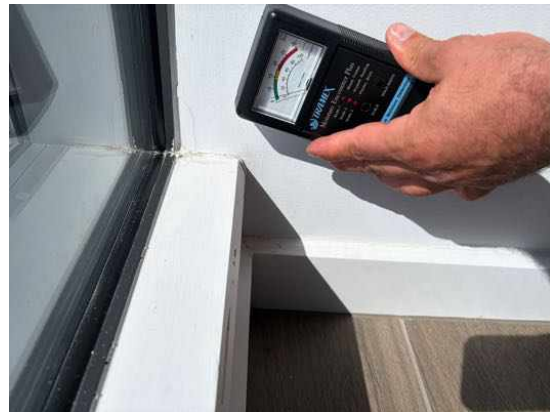
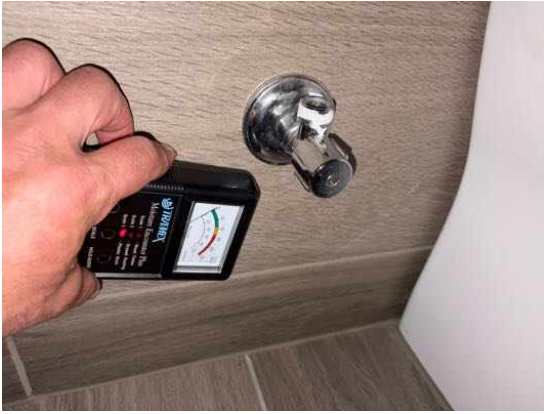
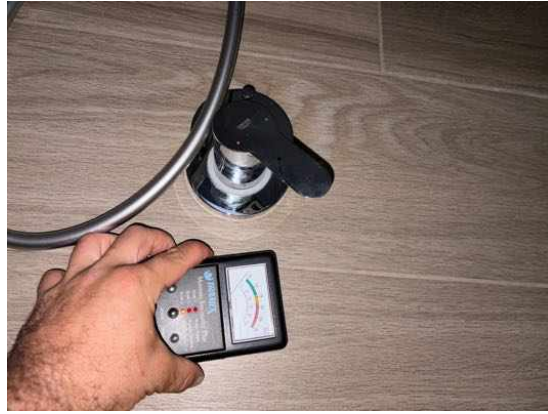
Building: Main Building
Location: All Areas
Finding: Moisture metre
Information: During the inspection the property was checked for moisture using a moisture metre.

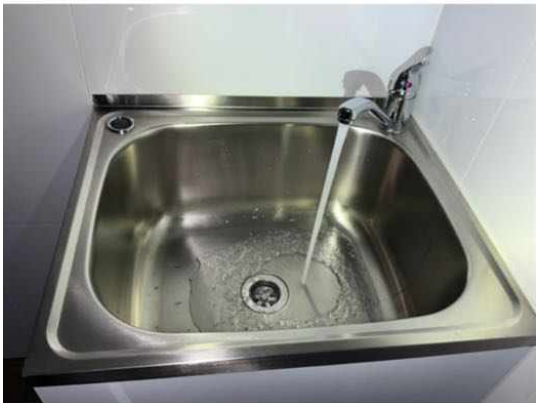
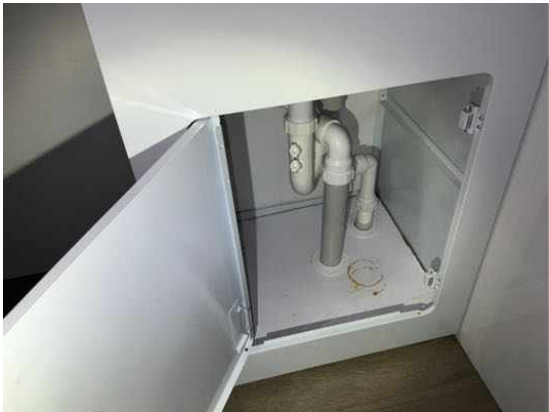
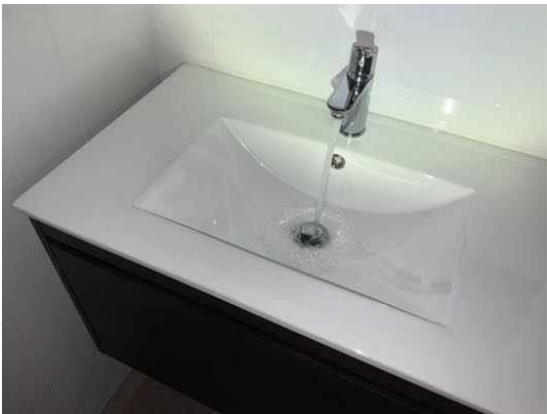
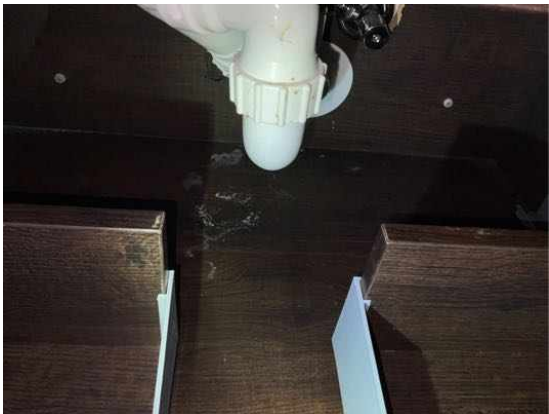
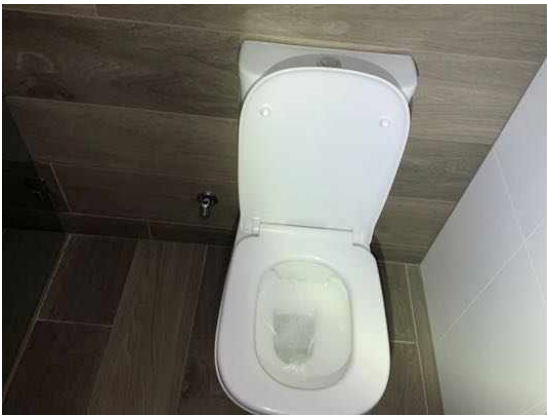
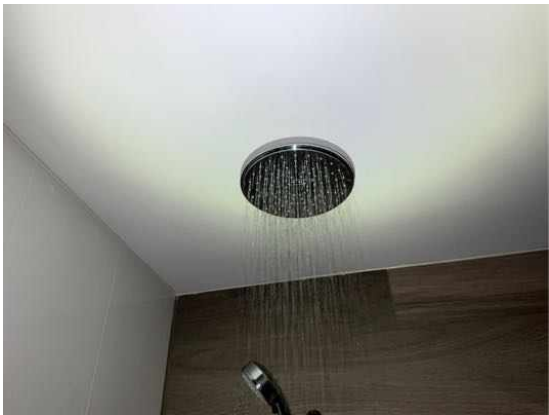
Building: Main Building
 Location: All Wet Areas
 Finding: Waterproofing
 Information:

All taps, mixers and toilets were tested for operation, except for those obstructed. The waterproofing to the shower recess was assessed by checking the walls in and around the shower recess for varying moisture content. There were no significant variations across the tested areas. No sign of recent water damage was evident upon a visual inspection of the surrounding walls, where the visual nature of the inspection was possible.

Consequently, there is no conclusive evidence of any current shower recess leakage other than those which may have already been mentioned earlier in this report. It is reasonable to assume the shower waterproofing is sound. Note that if the shower is not used, or has not been used for some time, moisture readings would not vary significantly and this can lead to erroneous results. It is not possible under the visual inspection criteria (under which a prepurchase inspection is carried out) to categorically determine if there are leaks. If a more accurate assessment is required, a special purpose inspection should be requested. Alternatively, the assumption should be made that the shower may leak.

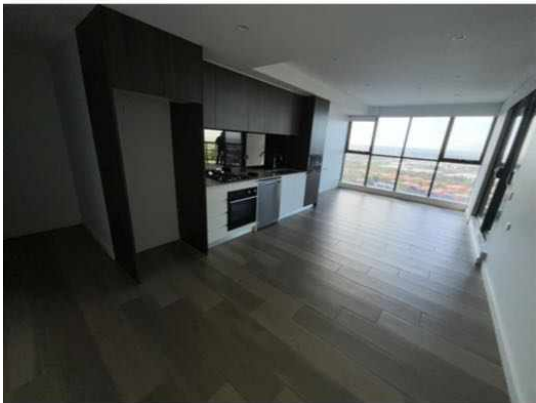
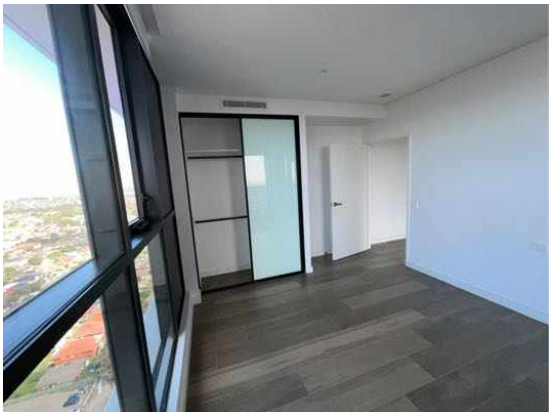
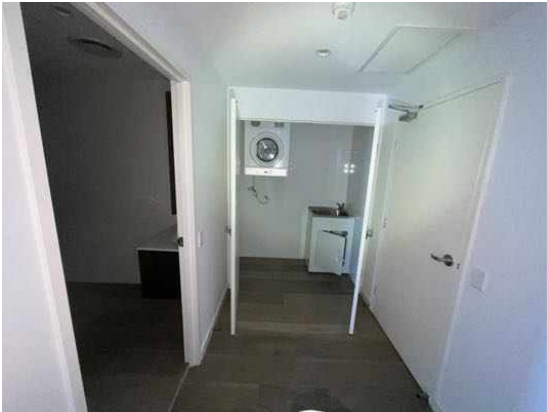
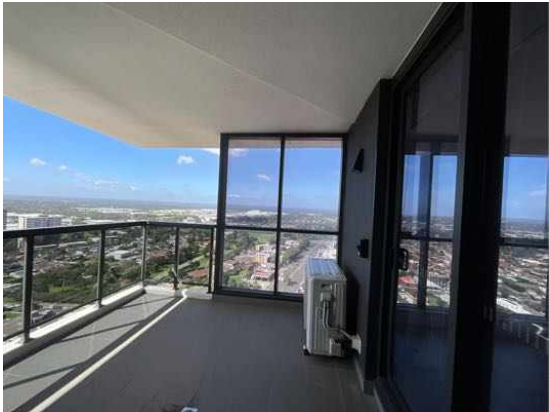
Building: Main Building
 Location: All Areas
 Finding: Additional Photos - Obstructions and Limitations
 Information:

These photographs are an indication of the obstructions and limitations which impeded full inspection of the property at the time of inspection. These obstructions can hide an array of defects and should be removed to allow full inspection to be carried out. A re-inspection is recommended once the areas are made accessible.
