Building and Timber Pest Inspection Report

Inspection Date: Mon, 23 Feb 2026

Property Address: 6 Johnboy Pl, Blacktown NSW 2148,
Australia

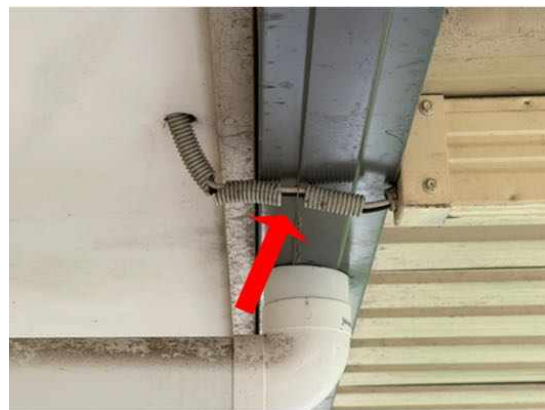
Building:	Main Building
Location:	Rear Patio
Finding:	Electrical wiring exposed
Information:	Sections of electrical wiring have been found exposed and unprotected.

Deteriorated and exposed electrical wiring presents a significant safety hazard, including an increased risk of electrical shock, arcing, fire, and failure of connected electrical systems.

A licensed electrician must be engaged immediately to inspect and make rectifications.

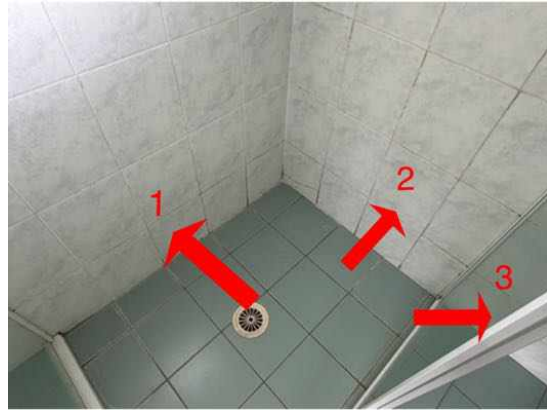
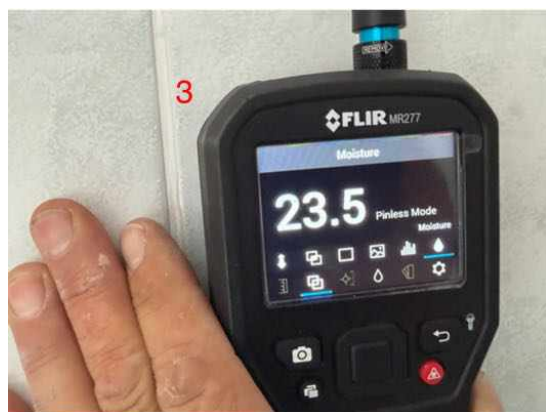
Building:	Main Building
Location:	Bathroom
Finding:	Shower seals recommended
Information:	The waterproofing to the shower recess was assessed by checking the walls in and around the shower recess for varying moisture content. A higher than normal reading was observed to one wall indicating water is penetrating behind the tiles in this area. There were no significant variations across the other tested areas. The bedroom wall

behind the high moisture reading area was tested and showed a normal reading indicating that the water is not penetrating the wall framing therefore suggesting the waterproofing to the wall is sound.

No sign of recent water damage was evident upon a visual inspection of the surrounding walls, where the visual nature of the inspection was possible. Consequently, there is no conclusive evidence of any current shower recess leakage and it is reasonable to assume the shower waterproofing is sound.

It is recommended to re-seal the shower with a new professional epoxy seal to ensure a watertight seal into the future.

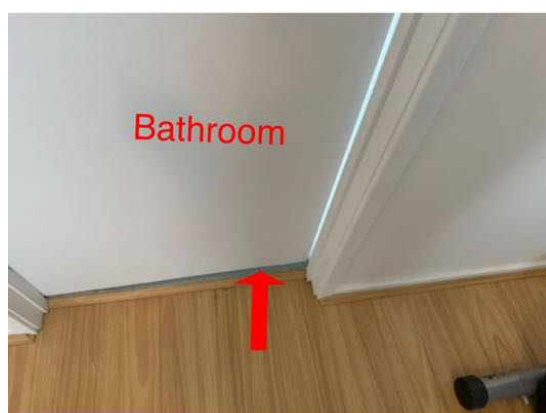
Finding 3.02

Building:	Main Building
Location:	Bathroom/Laundry/Front Entry
Finding:	Doors - Binding/Jamming
Information:	Binding and/or jamming of several doors throughout the property were evident during standard operation. This defect inhibits the functionality of affected doors as well as creating potential for secondary defects to associated building elements, such as damage to the floor covering.

A door that binds to flooring or to the associated door frame may have several causes, ranging from minor defects, such as poor installation of the door or deteriorated hinges, through to major structural issues, such as damage to subfloor structures.

Where door binding/jamming appears to indicate major structural issues, a registered builder specialising in re-stumping should be appointed to provide an estimate on the cost of rectification.

For minor causes, a qualified carpenter or general handyperson should be appointed to perform minor rectification works at client discretion.

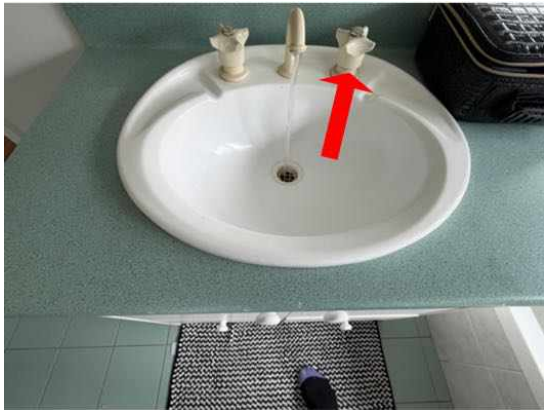
Finding 3.03

Finding: Tap - Loose

Information: The tap in this area has not been installed correctly, or has deteriorated with age, and is consequently loose. This tap being loose creates potential for water leaks and subsequent water damage to the surrounding area.

Where taps or spouts are loose, a qualified plumber should be appointed to re-fix the plumbing fitting.

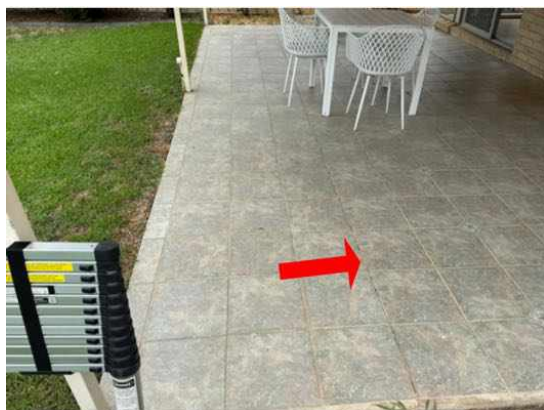
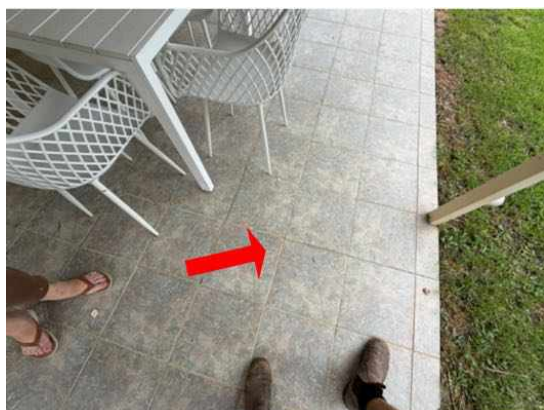
Building:	Main Building
Location:	Rear Patio
Finding:	Tiles - Cracked or damaged
Information:	Cracking was evident to the tiling in this area at the time of inspection. While the cracking appears to be minor, this area is frequently exposed to water, allowing potential for water penetration.

If left unmanaged, water penetration to these areas may lead to subsequent water damage, which is likely necessitate repair work to affected building elements.

A tiling contractor should be appointed to ensure that no further water damage occurs. The re-application of silicone and grouting throughout remaining tile work is also advised, to further protect the area against water penetration.

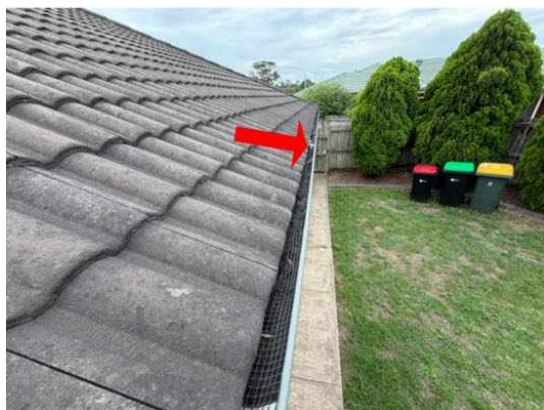
Finding 3.06

Building:	Main Building
Location:	Gutters
Finding:	Gutters - Water pooling
Information:	Water was found to be pooling in sections of the roof guttering. This is generally a secondary defect caused by blocked or partially blocked gutters. Such blockages and subsequent water pooling are likely to lead to rust and water damage to associated structures if left unattended.

Any areas of guttering that shows evidence of water pooling should be checked for partial or full blockages and any secondary damage that may have occurred as a result. Depending on the extent of the damage, building elements may require repair and/or replacement to ensure adequate roof drainage and function of exterior plumbing system.

A roofing plumber should be appointed as soon as possible to rectify this issue. It is highly advised that all gutters be maintained on a frequent basis to ensure the condition of roof plumbing.

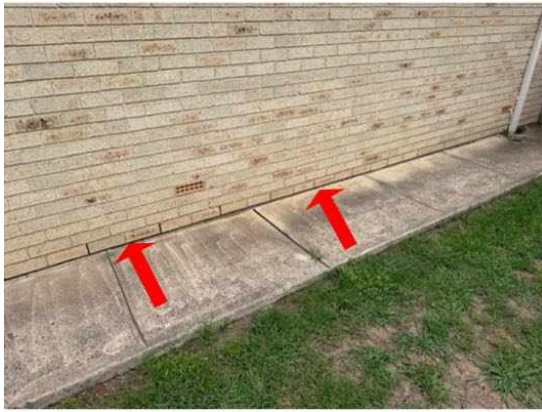
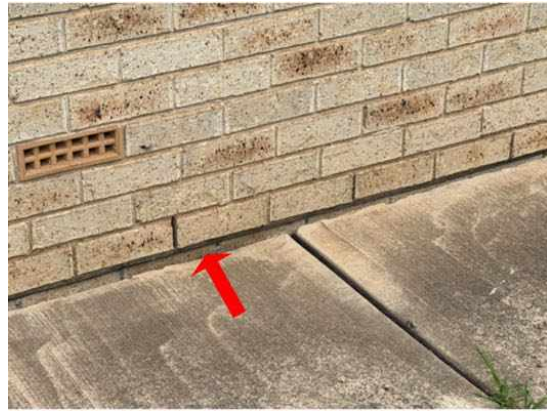
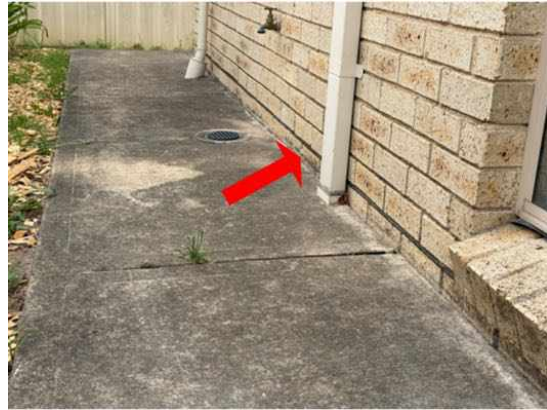
If the slab edge is not properly exposed there is a high risk of termite attack. Sometimes, in order to determine the type of slab, a suitably qualified person such as an architect or builder may be required to consult the construction plans.

Where the slab edge cannot be properly inspected, it is highly recommended that termite or timber pest inspections be carried out every 6-12 months to aid protection of the property against infestation.

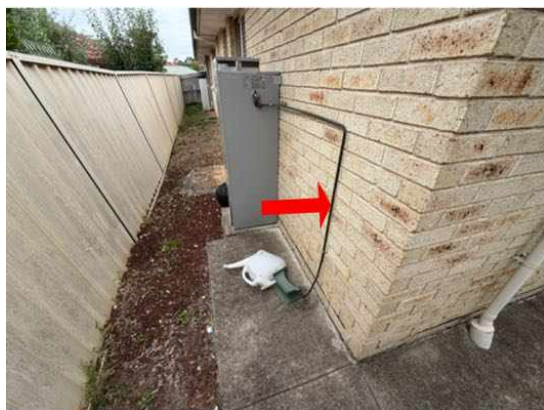
These damp conditions can lead to secondary defects such as rot, rust or corrosion of associated building elements, the formation of fungal decay, or even the creation of potential slip hazards. When coupled with poor site drainage, pooling of water may also attract termite activity to this area.

It is highly recommended that a qualified plumber be appointed to install adequate drainage to the overflow. These works will ensure that the area remains dry and free of any secondary defects.

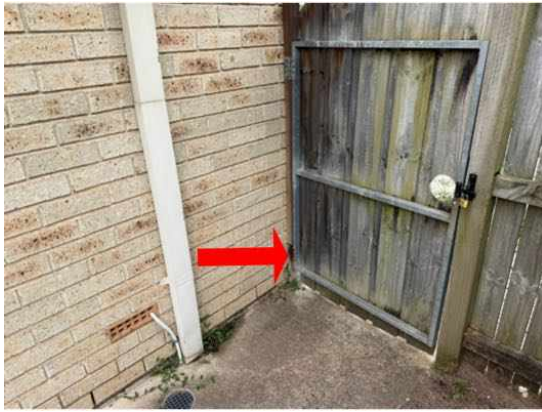
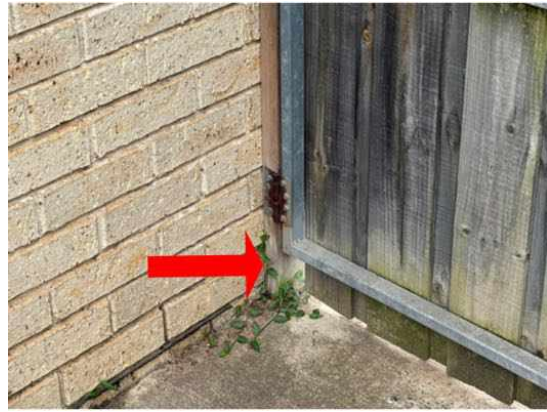
At the time of inspection it was noted that fences abutting the building on both left and right hand sides created a point for concealed access of termites into the building.

The client should consider obtaining further advise from a timber pest technician regarding treatments required in this area. It is recommended that obtaining such advice be a short-term priority.

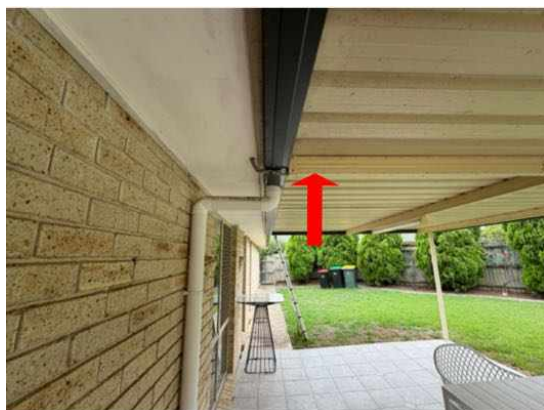
Building:	Main Building
Location:	Rear Patio
Finding:	FYI-Suspected Roof Leak (Rear Patio)
Information:	Visible water staining was noted to the tiled area beneath the rear patio roof, indicating a possible past or intermittent water leak from the roof structure above.

Water staining may result from roof covering defects, flashing issues, blocked drainage components, or previous isolated events. Further monitoring during or immediately after rainfall is recommended to determine if moisture ingress persists.

This item is provided for information only. Should staining worsen or evidence of active leaking be observed, further assessment and repair by a suitably qualified roofing contractor is recommended.

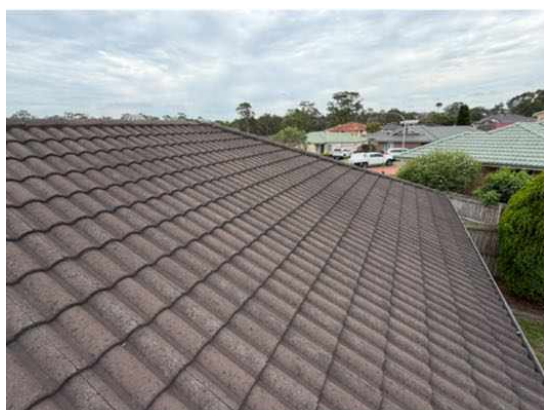
Building: Main Building
 Location: Roof Exterior
 Finding: Roof tiles - Weathered
 Information: Upon inspection of the exterior roofing, the majority of roof tiles were considered to be in a fair condition. While weathering of the tiles is consistent with the age of the property, maintenance works are required.

Where left unmanaged, deteriorating roof tiles are likely to lead to a number of secondary defects, including minor water leaks and weather exposure to internal roofing structures.

Consultation with a roofing contractor is advised to gain advice on cost of remedial works that may be required in the short to medium term. Remedial works are likely to increase the longevity of the exterior roofing structure.
