Building and Timber Pest Inspection Report

Inspection Date: Mon, 2 Mar 2026

Property Address: 73 Alford St, Quakers Hill NSW 2763,
Australia

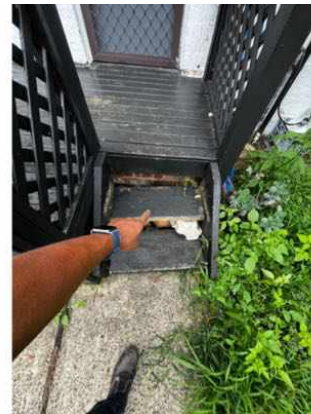
External timber structures are also constantly exposed to weather elements and can deteriorate in an accelerated manner, ongoing assessments are required.

External stairs to the decking was broken during inspection.

It is highly recommended that a Structural Engineer further assess the external timber balcony or deck to inform the client of its load capacity. Regular maintenance inspections by competent practitioners is needed.

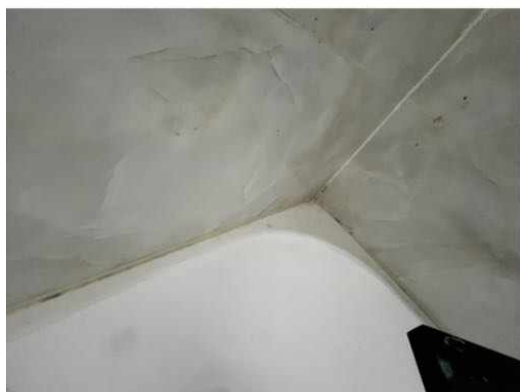
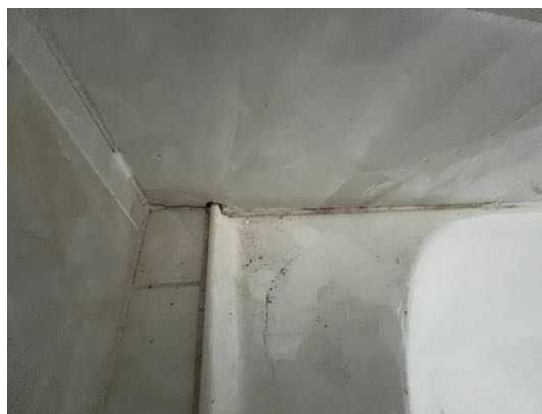
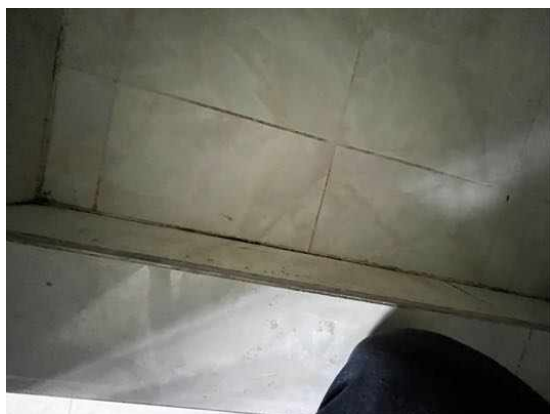
Finding 2.01

Building:	Main Building
Location:	Main Bathroom >
Finding:	Sealant and grouting - Missing or damaged -
Information:	It was noted on inspection that sealant or grout is degraded to the tiled shower alcove and or other areas of the bathroom.

Different materials and floor areas move at different rates, generally causing cracking to grout or sealant at this point. A flexible sealant is required to allow for expected expansion and contraction, while keeping the joint water tight and protective of all associated building materials.

There appears to be excessive mould to the sealant and grout which will likely require scraping out and replacement.

Flexible and mould resistant materials should be applied to affected areas to prevent any subsequent water damage that is likely to occur. Regular maintenance and replacement of damage or missing or damaged sealant and grout is highly recommended to the wet areas, as this is a regular wear and tear defect. Sealant and grouting in areas that come into regular contact with water should be maintained for the long term care of your property.

A sealant specialist or tiling contractor should be appointed to complete these works as soon as possible to prevent water ingress

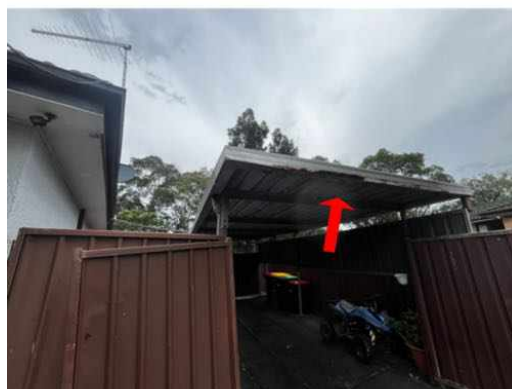
Finding 2.02

Building:	Main Building
Location:	All External Areas
Finding:	Roof plumbing/ downpipes- gutters - Rusted or corroded
Information:	The roof plumbing has areas of rust and corrosion. It is suspected that this has been caused by blockages, resulting in pooling or standing water, that have prematurely rusted elements of the roof plumbing.

Rusted roof plumbing will generally develop holes and leaks that can affect other building elements with poor drainage of storm water. Poorly drained roof areas will also lead to damp conditions surrounding the base perimeter of the building which, if left unmanaged, can lead to a range of secondary building defects.

Repair and/or replacement of rusted roof plumbing is highly required in order to reinstate the roof drainage system to a fully operational level. To further maintain these areas, gutters should be cleaned frequently, allowing the avoidance of any partial blockages.

A licensed plumber or specialist roof restoration company should be appointed to undertake these works. It is advised that such works be completed as soon as possible to prevent any further damage and deterioration.

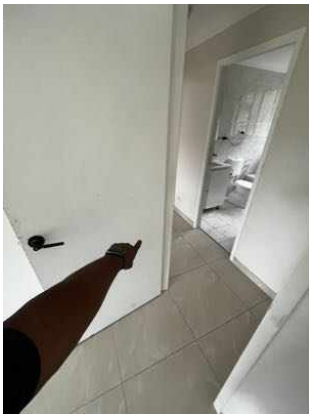
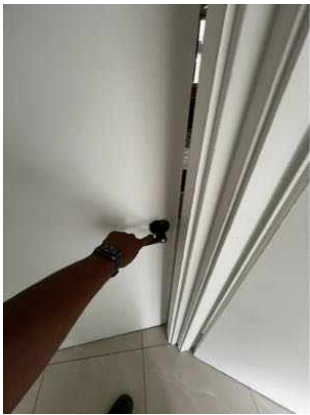
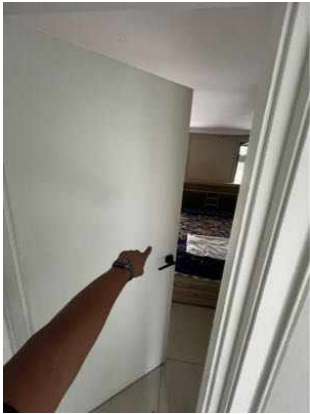
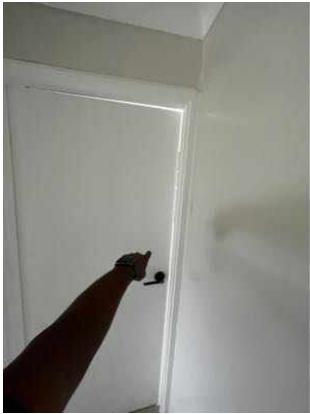
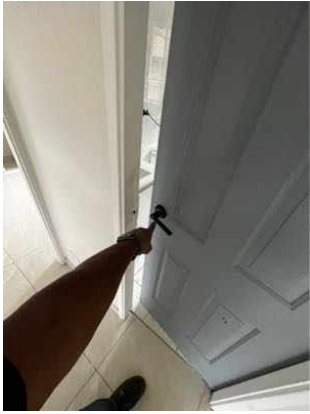
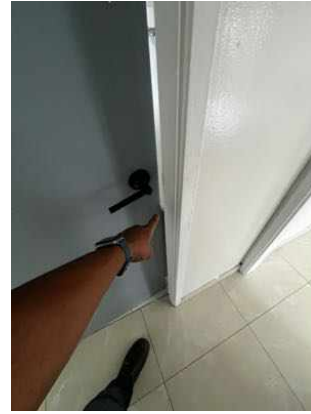
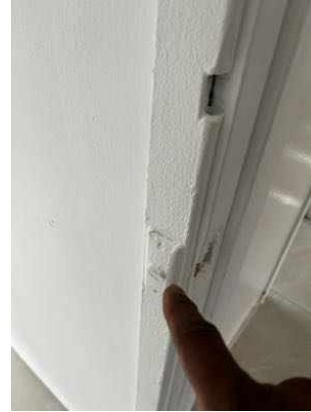
Finding 2.03

Building:	Main Building
Location:	All Internal Areas
Finding:	Door - Binding/jamming
Information:	Binding and/or jamming of this door is evident during standard operation. This defect inhibits the functionality of the affected door as well as creating potential for secondary defects to associated building elements, such as damage to the floor covering.

A door that binds to flooring or to the associated door frame may have several causes, ranging from minor defects, such as poor installation of the door or deteriorated hinges, through to major structural issues, such as damage to subfloor structures.

Upon Inspection it was noted that the Bedroom doors, laundry door and the main doors were all not binding and jamming and were not able to be used for a daily operation.

For minor causes, a qualified carpenter or general handyperson should be appointed to perform minor rectification works at client discretion.

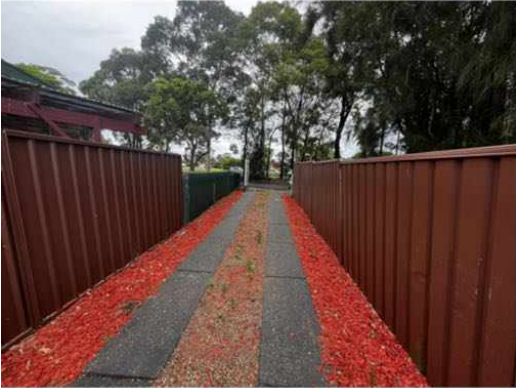
Finding 3.01

Building:	Main Building
Location:	Driveway/ walkway to rear.
Finding:	Crack in concrete slab - Category 2 driveway to the garage.
Information:	A crack coded as Category 2 was identified in the slab. A Category 2 crack is described as a distinct crack, with the slab being noticeably curved or changed in level.

To be considered Category 2, the approximate width of the crack is less than 2.0mm, or a change in offset of less than 15mm when a 3m straight edge is placed over the defect.

Category 2 cracks to slabs should be monitored for a period of 12 months. At the end of the monitoring period, cracks rated greater than Category 2 are considered defects that require rectification.

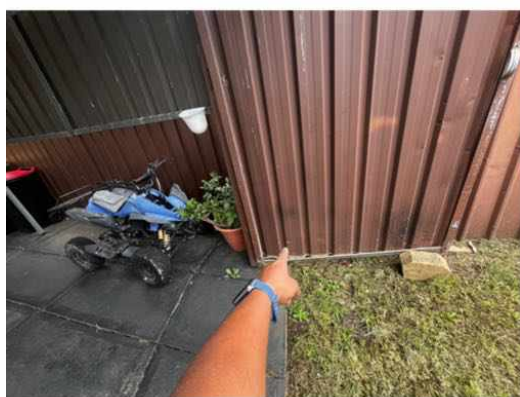
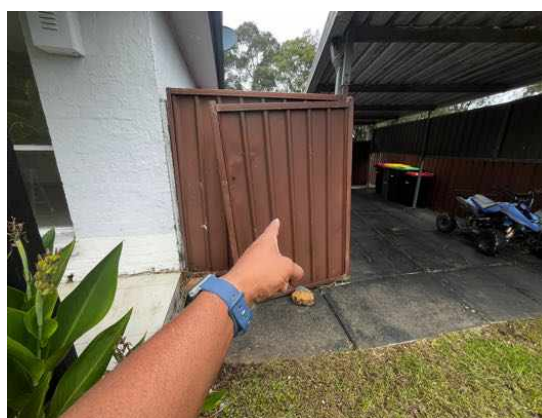
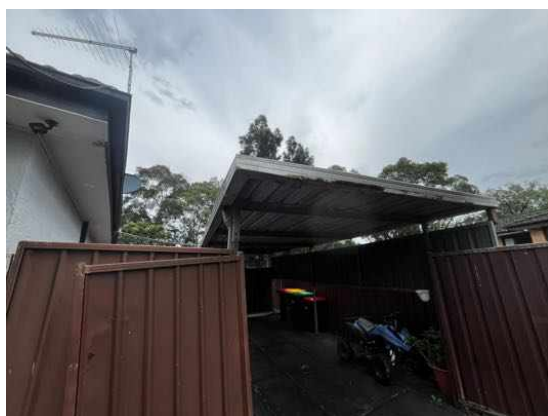
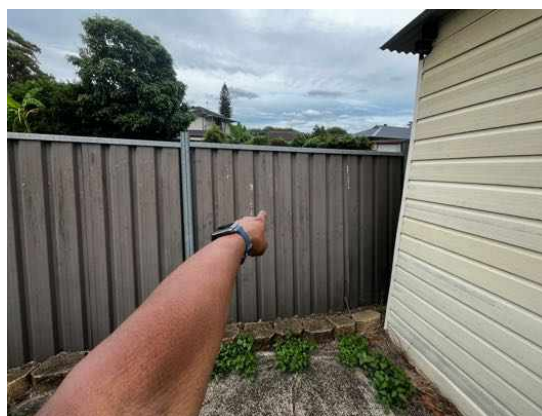
Finding 3.02

Building: Main Building
Location: Yard

Finding: Fencing - Deteriorated

Information: It was noted at the time of inspection that sections of the fencing throughout the property have deteriorated. Typically fencing deteriorates due to age and or wear, rot and or rust which is generally expected for a structure of this age, due to prolonged exposure to weather conditions. Sometimes inadequate installation or maintenance can be to blame.

If left unattended, it is likely that further damage will occur. It is suspected that repair of several elements of the fencing may be required however replacement may be a consideration of the client also.

A licensed fencing contractor should be appointed to provide further advice and perform rectification works as necessary.

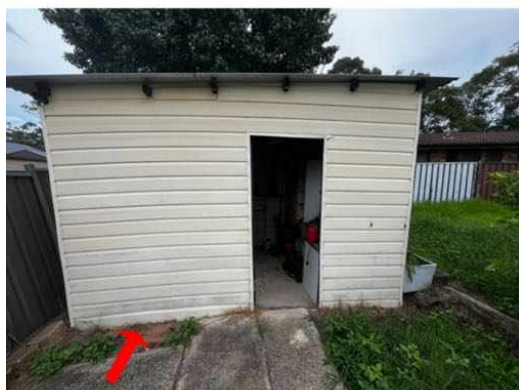
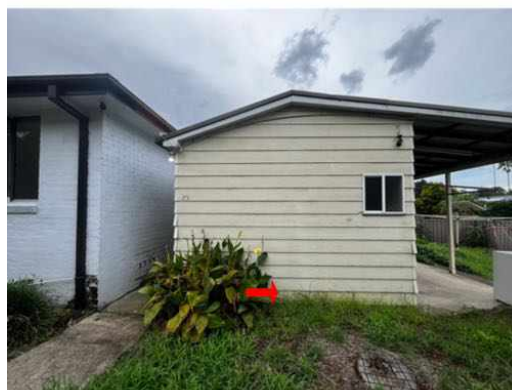
Building:	Main Building
Location:	Main House/Studio
Finding:	Weatherboards - Rotting
Information:	The external weatherboards show signs of fungal decay (wood rot) in several sections. This wood rot is suspected to have developed over a prolonged period of time due to frequent weather exposure, which is expected in a property of this age and condition

Weatherboards are sealed and protected by paint and other sealants. When these sealants deteriorate over time, they allow water penetration to the weatherboards, causing wood rot. If left unmanaged, the wood rot is likely to develop further, possibly necessitating major repair or replacement works in the long-term future.

To maintain the condition of the external wall cladding, any severely affected weatherboards should be substituted as soon as possible with pre-treated replacements. Where weatherboards have rotted due to excessive moisture other than rain penetration, the cause of the moisture should be identified immediately by a licensed plumber. A qualified carpenter should be appointed to repair and replace rotting weatherboards.

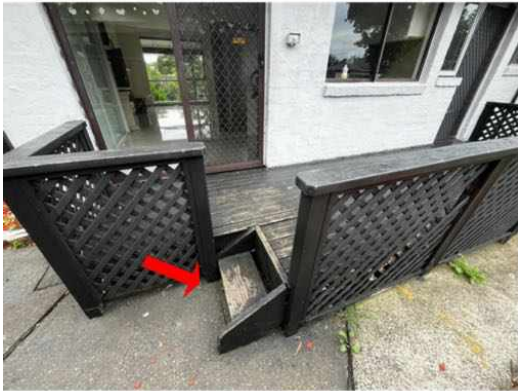
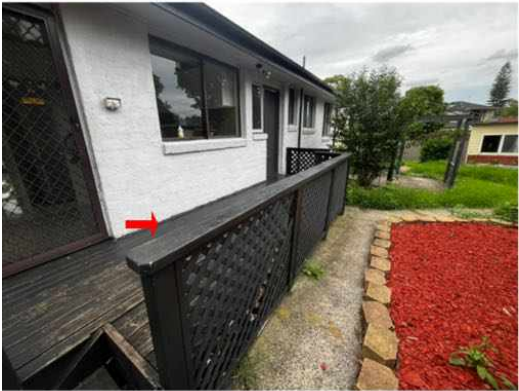
Finding 6.02

Building: Main Building
Location: All Areas
Finding: In ground contact
Information: Any timbers in direct ground contact provide opportunity for concealed termite entry and are likely to be subject to premature rot and decay as the soil retains moisture or damp conditions against the timbers.

Remove untreated timber that is in direct contact with external grounds. Consider replacement with more durable materials i.e. treated timber or non timber elements. Frequent pest inspections are advised to readily identify any termite activity in these areas.

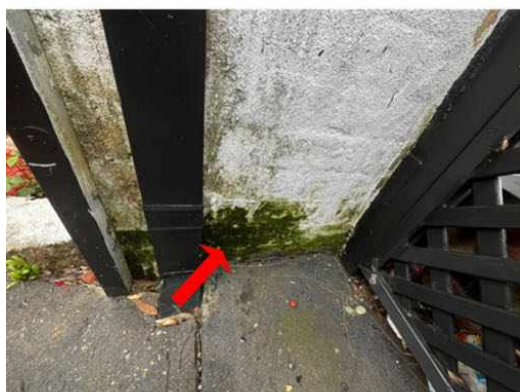
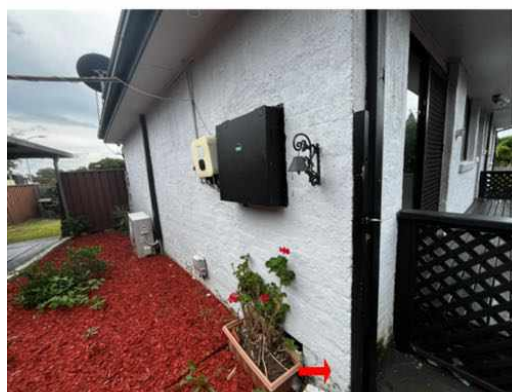
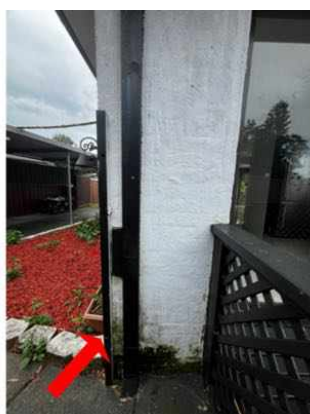
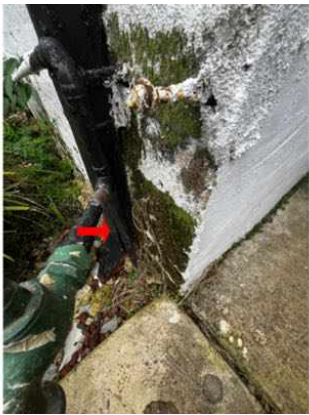
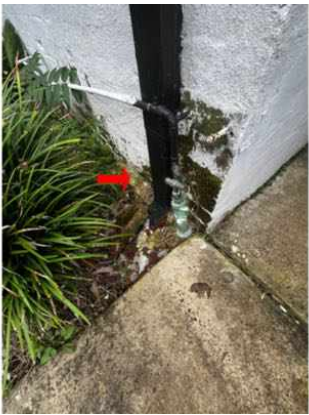
Building:	Main Building
Location:	All External Areas
Finding:	Fungal decay - present (localised)
Information:	Fungal decay also known as wood decay or wood rot generally refers to the deterioration of timber elements when in contact with excessive levels of moisture for a prolonged period of time.

The development of fungal decay is accelerated by temperatures in the range of 5degreeC to 40degreeC as well as the presence of oxygen. Generally fungal decay develops on timber elements that are in use in an external environment which are exposed to rain penetration.

In this case although the affected timber element is in a decaying state the extent of any visible damage appears to be localised to a specific area and is yet to spread to other parts of the building element or affect adjoining structures. The fungal decay is therefore likely to be of a relatively superficial nature with minimal impact on the structural integrity or tensile strength of the timber element.

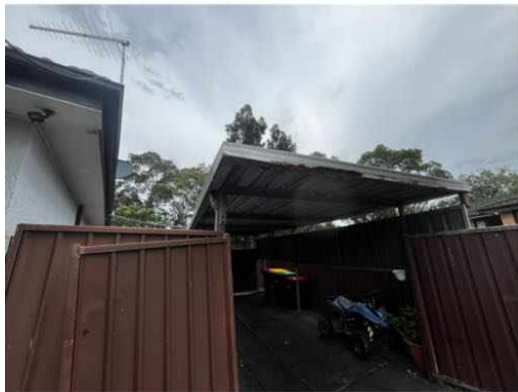
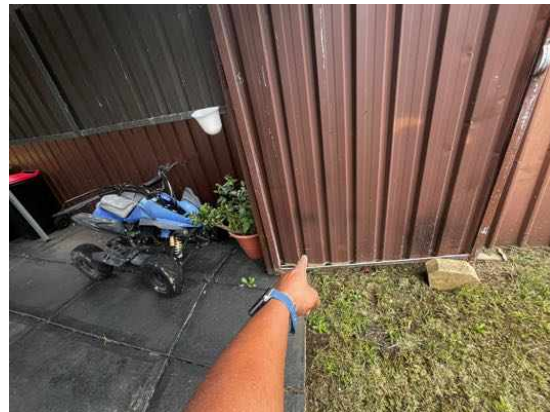
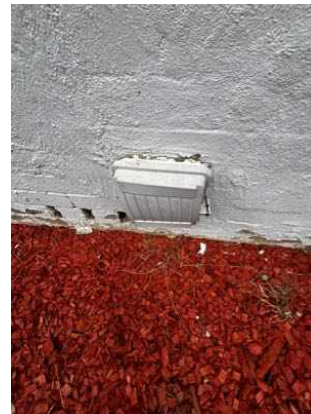
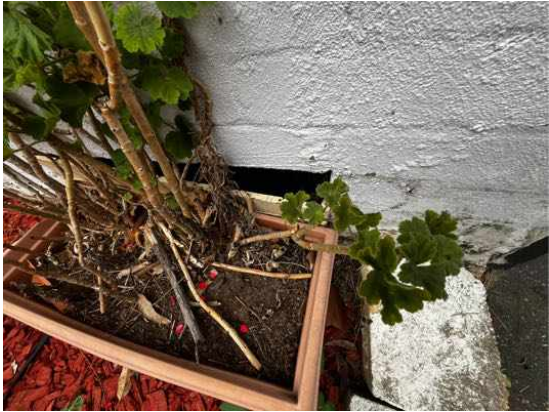
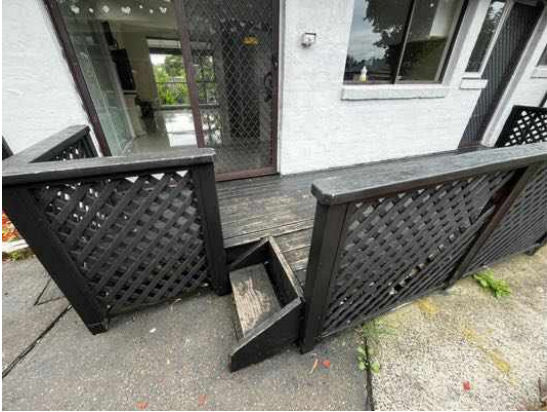
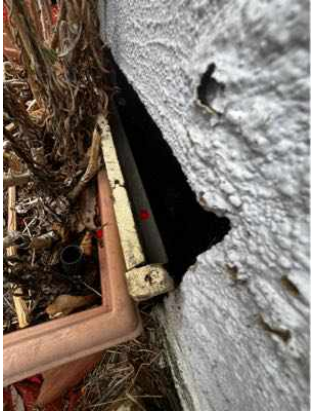
Building: Main Building
Location: All Internal Areas
Finding: Additional Photos - Obstructions and Limitations
Information: These photographs are an indication of the obstructions and limitations which impeded full inspection of the property at the time of inspection. These obstructions can hide an array of defects and should be removed to allow full inspection to be carried out. A re-inspection is recommended once the areas are made accessible.

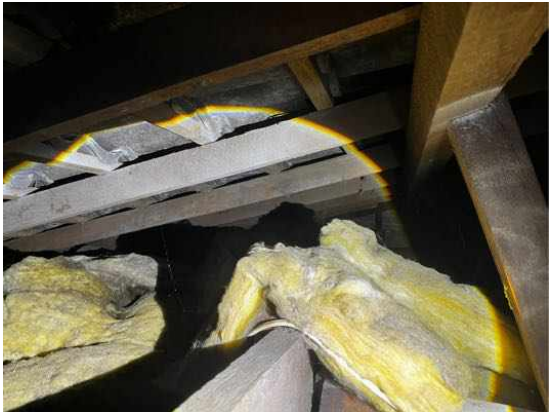
Building: Main Building
Location: Roof Void
Finding: Obstructions and Limitations - Roof space
Information: Roof space no access

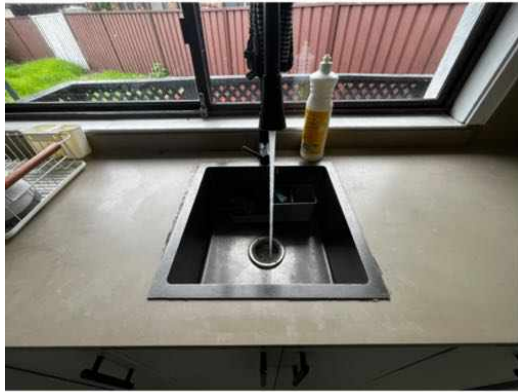
Building: Main Building
 Location: Kitchen/ Bathroom
 Finding: Cabinetry Plumbing - Kitchen/ Bathroom
 Information: All cupboards where sinks and basins with drainage plumbing were inspected and no evidence of leaks were present at the time of inspection.

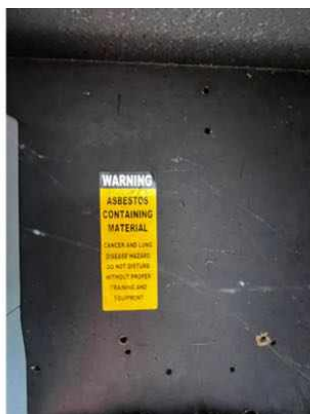
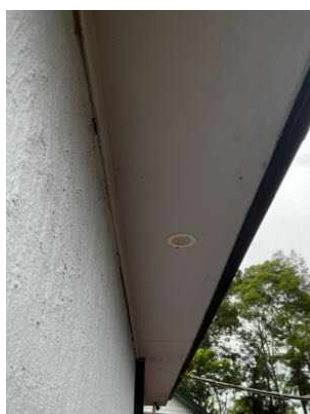
Building:	Main Building
Location:	All Areas
Finding:	Asbestos - Suspected ACM Identified on Site
Information:	Reporting on Asbestos is outside the Scope of this Report. This suspected defect is highlighted as a caution only. We suspect, based on our experience in the building industry, that there is a higher risk of the identified building element containing

As Asbestos Reporting is outside the scope of this report, we advise that you consider a separate Asbestos Inspection and Condition Audit, which can include the taking of samples for definitive confirmation of the presence of Asbestos.

In the interim, the client is advised to act with caution, especially when considering any damage to building materials general wear and tear renovations extensions demolition and general maintenance activities due to the suspected presence of Asbestos.

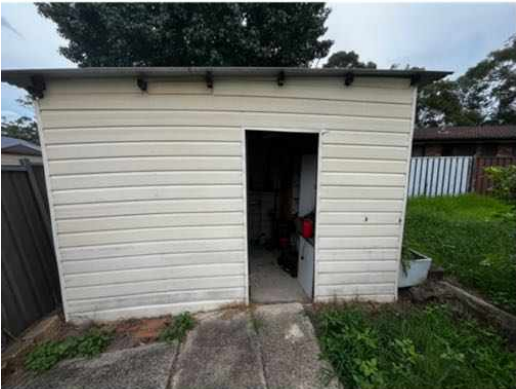
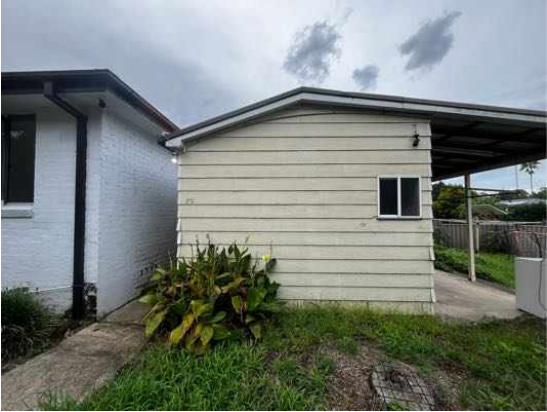
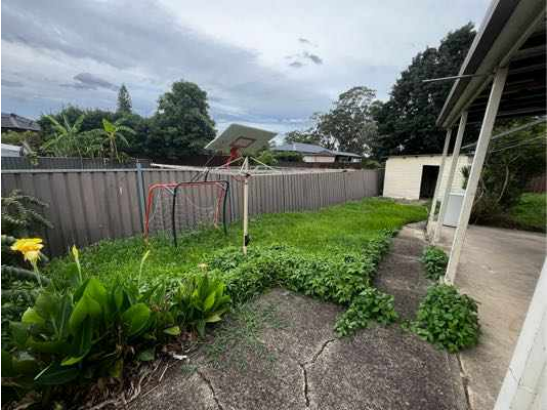
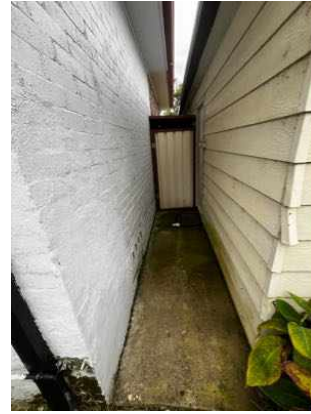
Building:	Main Building
Location:	Seperate Studio
Finding:	Additional structure - Non-compliant
Information:	The additional structure that has been affixed to this area of the dwelling does not appear to comply with contemporary building practices and current Australian Standards. While the structure does not currently appear to be unsafe, compliance with such standards ensures the structural integrity of the main dwelling and abutting addition.

safety issues.

It is highly recommended that any planned repair, remodeling or demolition works be carried out by registered builders. Such works may be necessary in the short-term future to ensure the safety and functionality of the area.

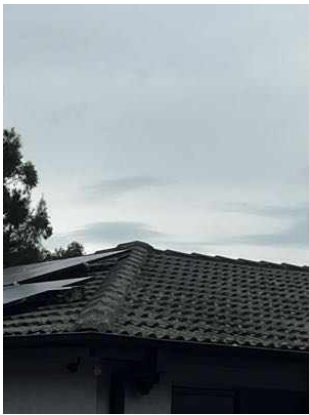
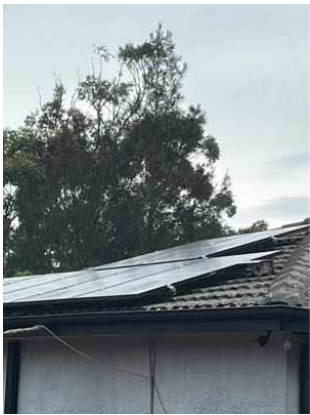
Building:	Main Building
Location:	Roof
Finding:	Roof tiles - Weathered
Information:	Upon inspection of the exterior roofing, the majority of roof tiles were considered to be in a fair condition. While weathering of the tiles is consistent with the age of the property, maintenance works are required.

Consultation with a roofing contractor is highly advised to gain advice on cost of remedial works that may be required in the short to medium term. Remedial works are likely to increase the longevity of the exterior roofing structure.
