Building and Timber Pest Inspection Report

Inspection Date: Fri, 27 Mar 2026

Property Address: 11 Short St, Glen Innes NSW 2370, Australia

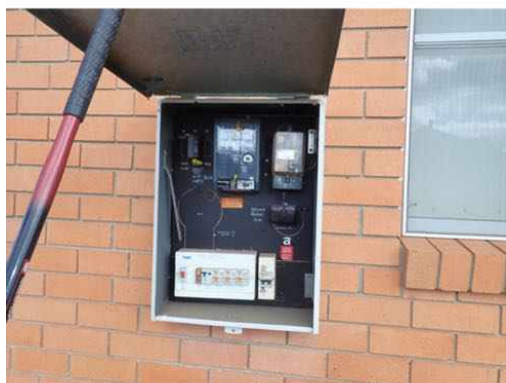
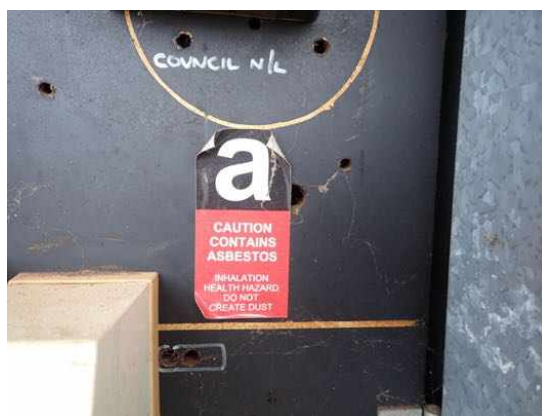
Finding 1.01

Building:	Main Building
Location:	Electrical meter box
Finding:	Asbestos Warning Sticker Identified
Information:	An asbestos warning sticker was identified on site, indicating the possible presence of asbestos-containing materials. No invasive inspection was carried out to confirm the presence or condition of such materials at the time of inspection. If disturbed, asbestos materials can pose a health risk. Further assessment by a licensed asbestos assessor is recommended if works are planned or materials are to be disturbed. No immediate action is required unless disturbance is proposed.

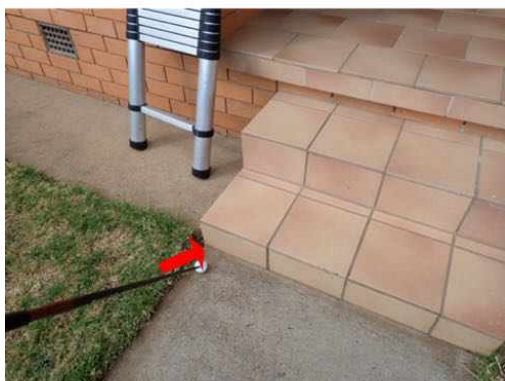
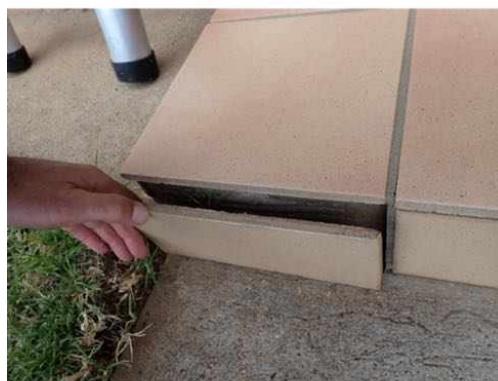
Finding 3.01

Building:	Main Building
Location:	Entry stairs
Finding:	Loose Tile
Information:	A loose tile was identified to the entry stair, likely due to adhesive failure, movement, or age-related deterioration. If left unaddressed, this may present a trip hazard and allow moisture ingress leading to further deterioration. Repairs should be carried out by a tiler, or suitably experienced handyman including re-fixing or replacement of the affected tile and ensuring a secure substrate. Rectification is recommended, at the

owner's discretion.

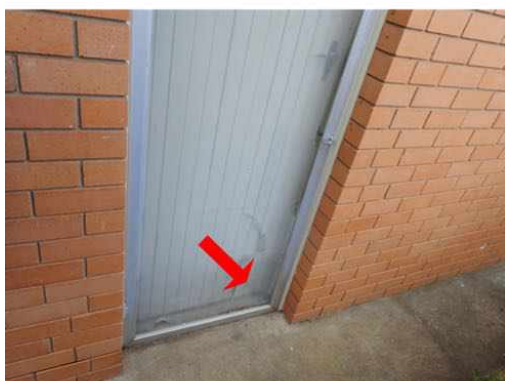
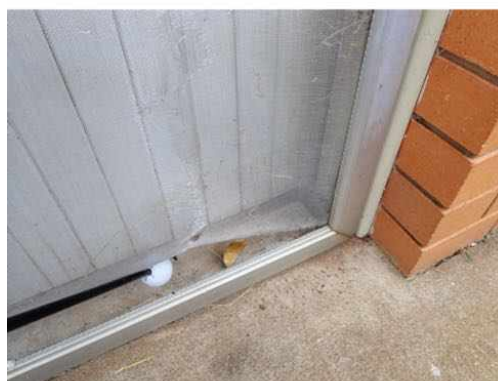
Finding 3.02

Building:	Main Building
Location:	Rear garage screen door
Finding:	Damaged Fly Screen To Rear Garage Door
Information:	Damage was identified to the fly screen on the rear garage door, likely due to wear and tear or impact damage. If left unaddressed, the effectiveness of the screen in preventing pest ingress may be reduced. Repairs should be carried out by a suitably qualified tradesperson or handyman, including repair or replacement of the affected screen as required. Rectification is recommended, at the owner's discretion.

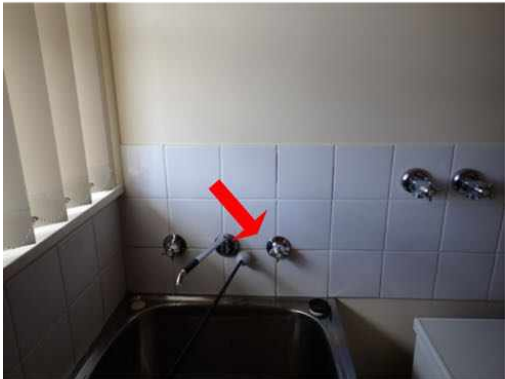
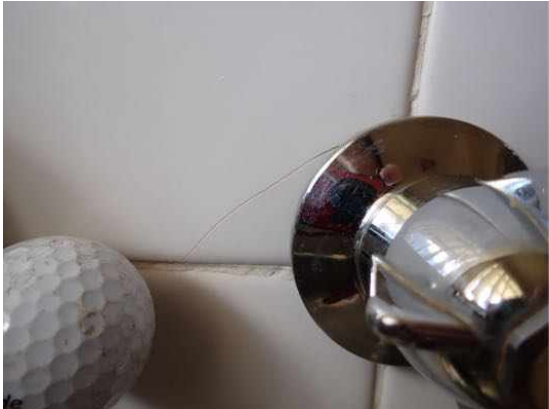
Finding 3.03

Building:	Main Building
Location:	Laundry
Finding:	Small Crack To Laundry Splash Back Tile
Information:	A small crack was identified to the laundry splash back tile, likely due to minor movement, impact, or age-related deterioration. While minor, cracks may allow moisture ingress behind the tile over time. Repairs should be carried out by a tiler if required, including sealing or replacement of the affected tile. Monitoring is recommended and repairs carried out if deterioration continues.

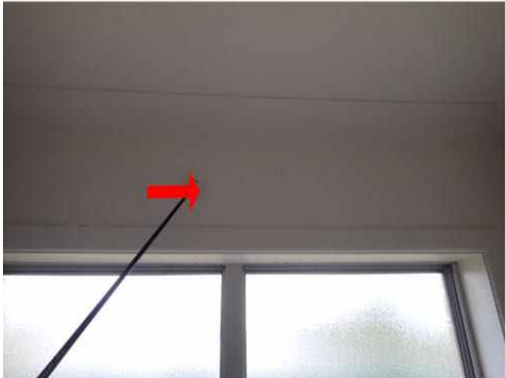
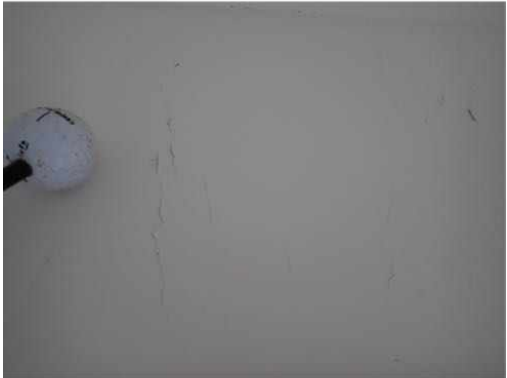
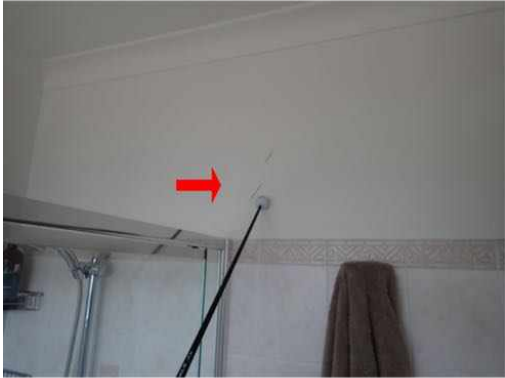
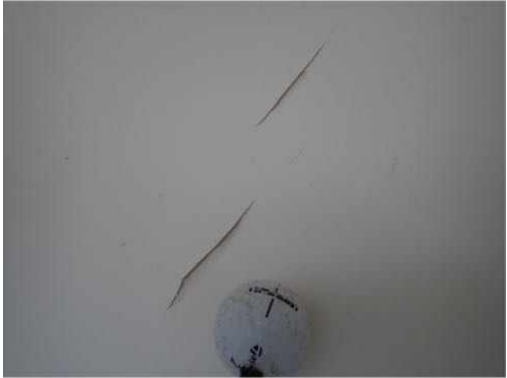
Finding 3.04

Building: Main Building
Location: Bathroom
Finding: Minor Age Related Damage To Bathroom Paint
Information: Minor age-related deterioration was identified to the bathroom paint, consistent with normal wear and tear over time. No significant issues were noted at the time of inspection. Repainting can be carried out by a painter if desired to improve appearance. Maintenance is recommended as part of general upkeep.

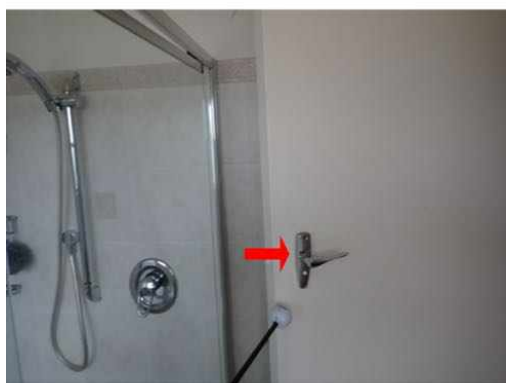
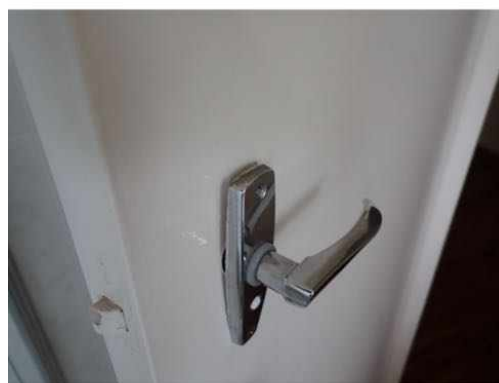
Finding 3.05

Building:	Main Building
Location:	Bathroom
Finding:	Loose Door Handle To Bathroom Door
Information:	A loose door handle was identified to the bathroom door, likely due to wear and tear or loose fixings. If left unaddressed, the handle may become detached or affect operation of the door. Repairs should be carried out by a handyman or carpenter, including tightening or replacement of the handle as required. Repair is recommended to restore proper operation.

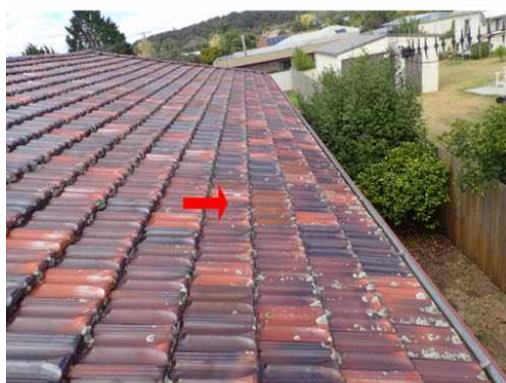
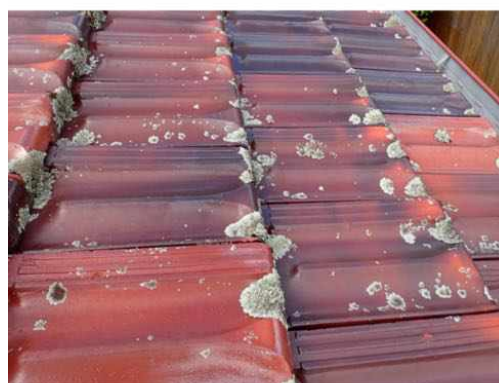
Finding 3.06

Building:	Main Building
Location:	Roof
Finding:	Lichen Growth To Roof Tiles
Information:	Lichen growth was identified to the roof tiles, likely due to prolonged moisture and environmental conditions. While common, this can retain moisture and contribute to gradual deterioration of the tiles over time. Cleaning and treatment should be carried out by a suitably qualified roof contractor. Maintenance is recommended to prevent further build-up and prolong the life of the roofing materials.

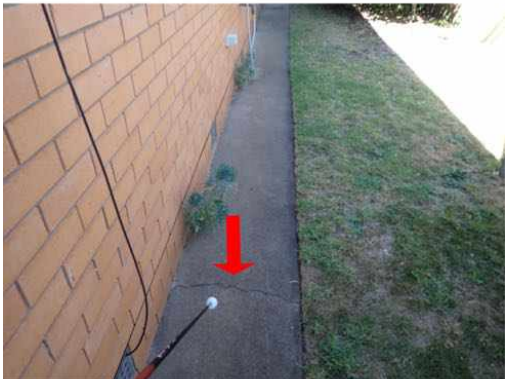
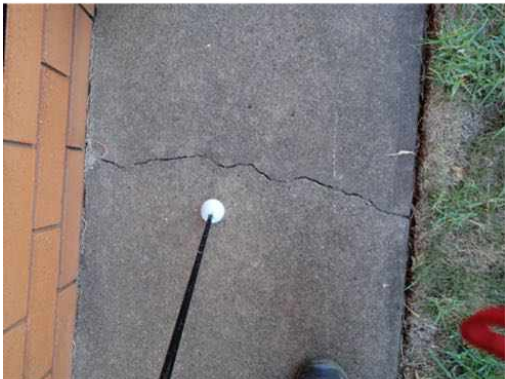
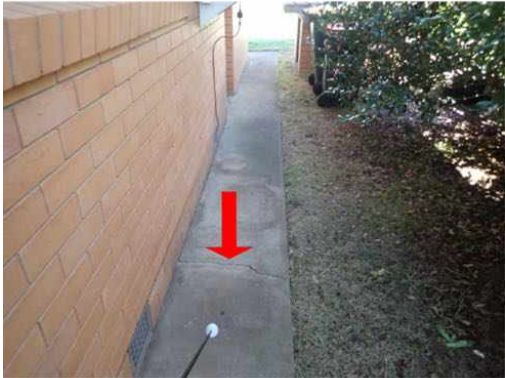
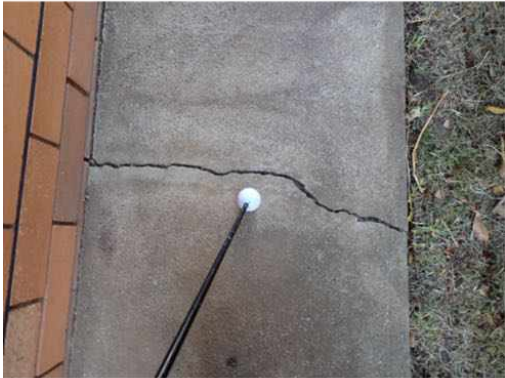
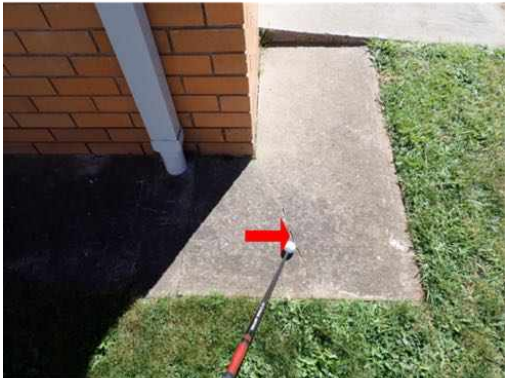
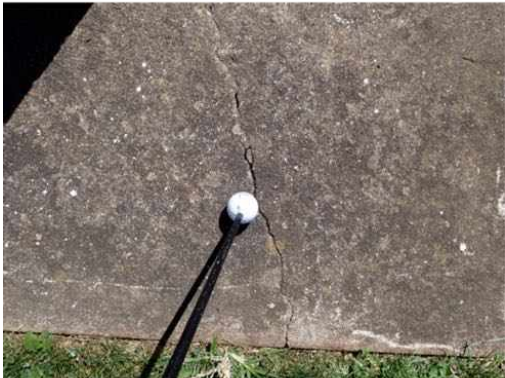
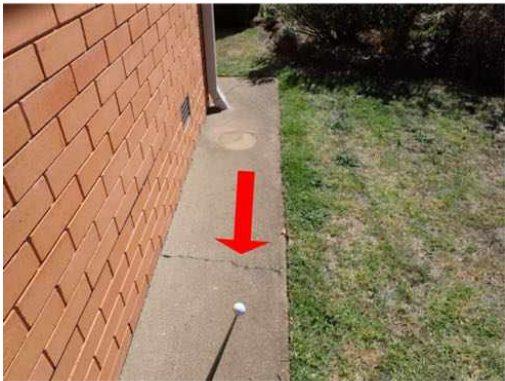
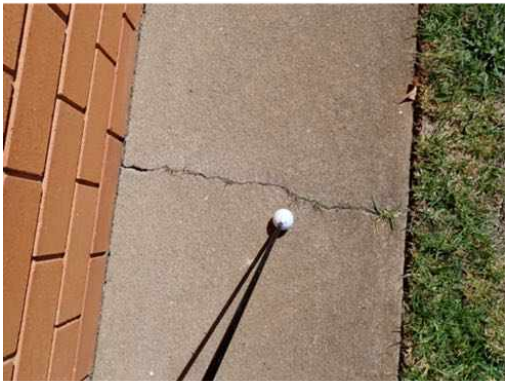
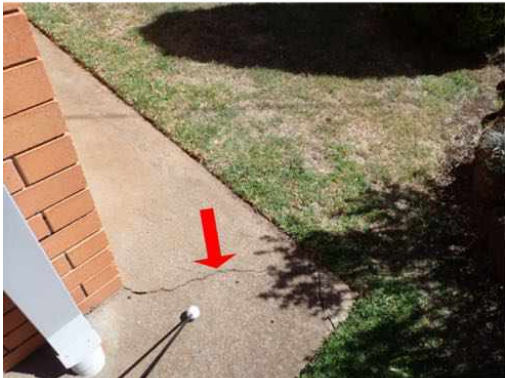
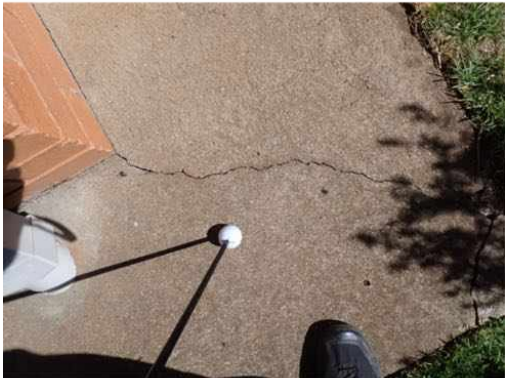
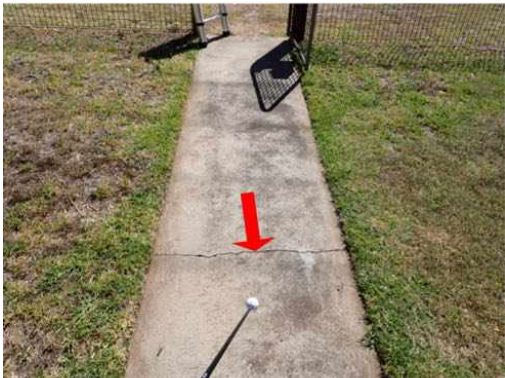
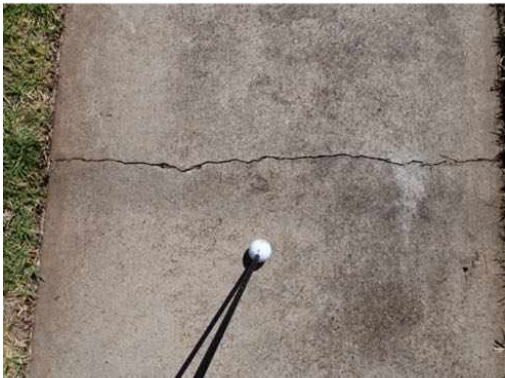
Finding 3.07

Building: Main Building
Location: Path around building
Finding: Age Related Cracks To Concrete Path Around Building
Information: Age-related cracking was identified to the concrete paths around the building, likely due to normal shrinkage, settlement, and long-term wear. This is a common condition; however, continued movement or moisture ingress may lead to further deterioration over time. Repairs should be carried out by a suitably qualified concreter if required, including sealing or repair of affected areas. Monitoring and maintenance are recommended as part of general upkeep.

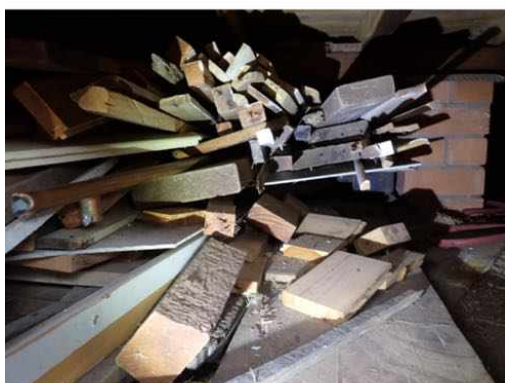
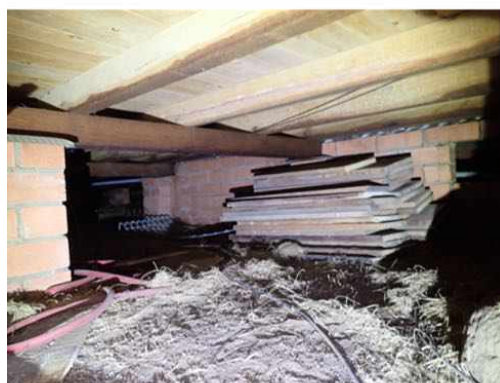
Finding 6.01

Building:	Main Building
Location:	Subfloor
Finding:	Timber Stored In Subfloor Conducive To Termite Attack
Information:	Timber debris and stored materials were identified within the subfloor area, which are conducive to termite activity by providing a potential food source and harbourage. This increases the risk of concealed termite infestation to the structure. Removal of all timber and debris from the subfloor is recommended. A licensed pest controller should be engaged to assess the area and implement appropriate termite management measures if required. Repairs and preventative measures are recommended to reduce the risk of termite attack.

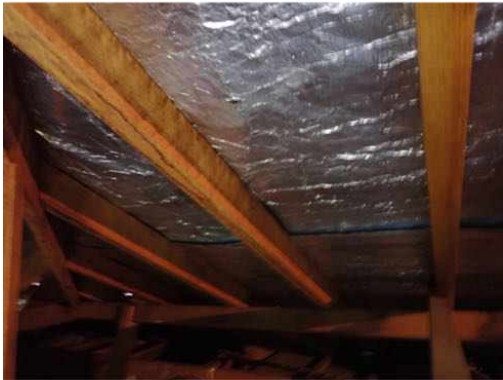
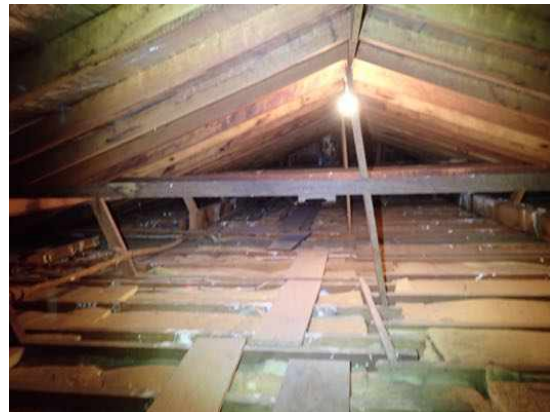
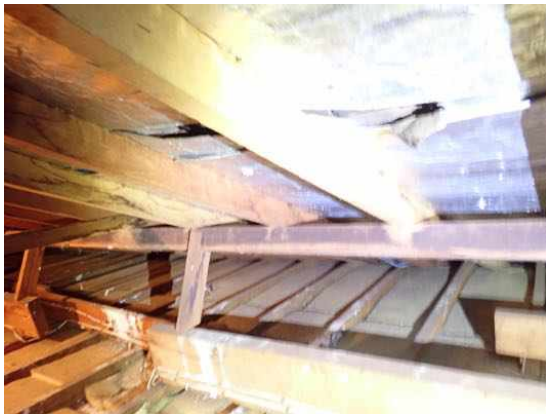
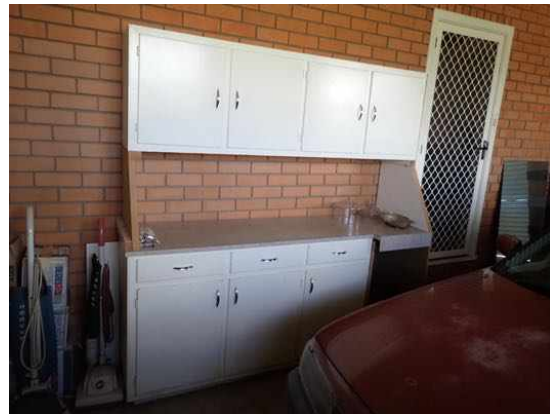
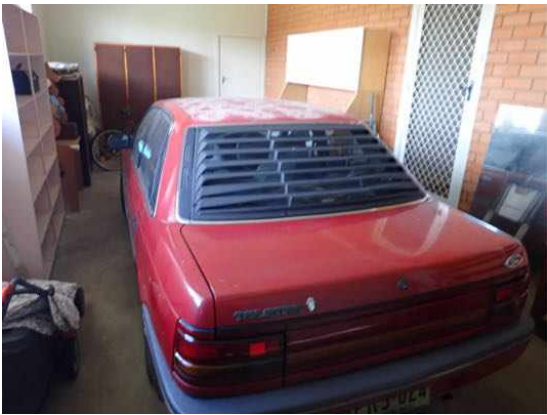
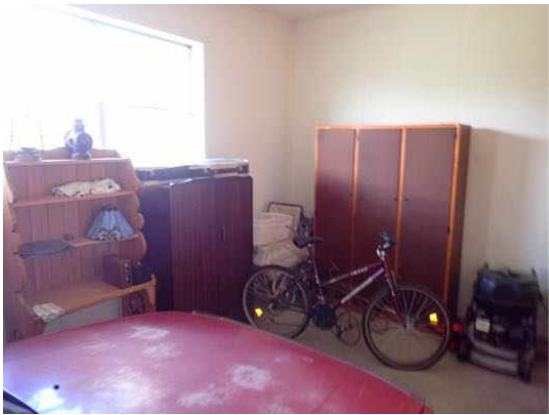
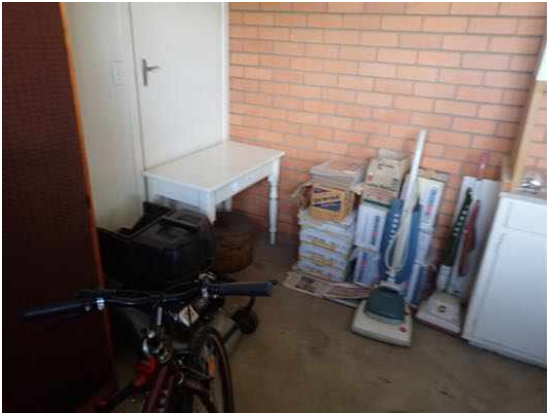
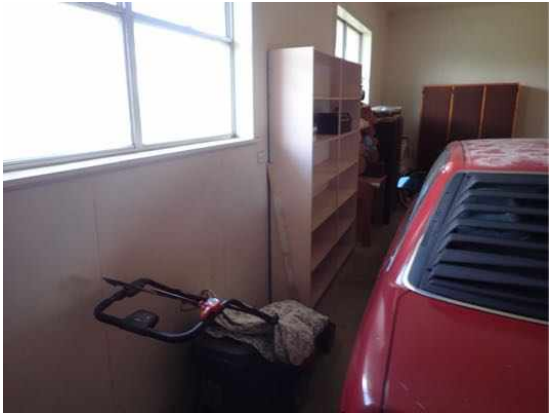
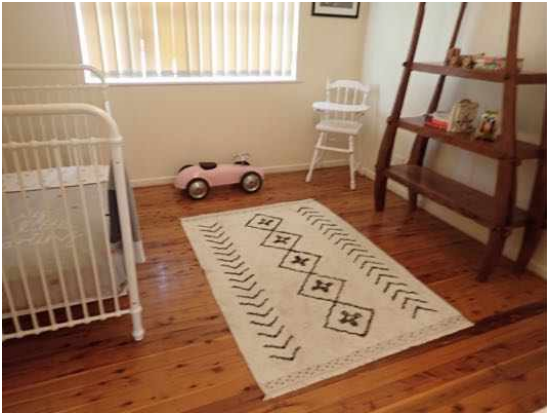
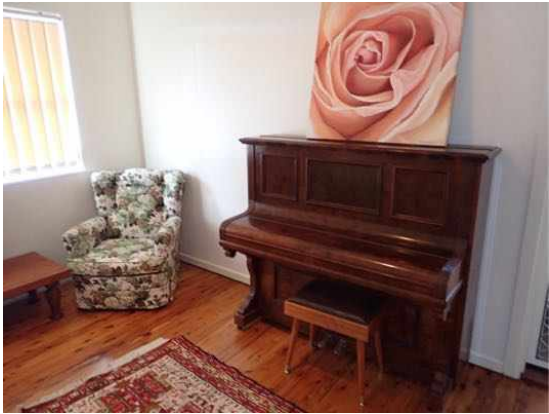
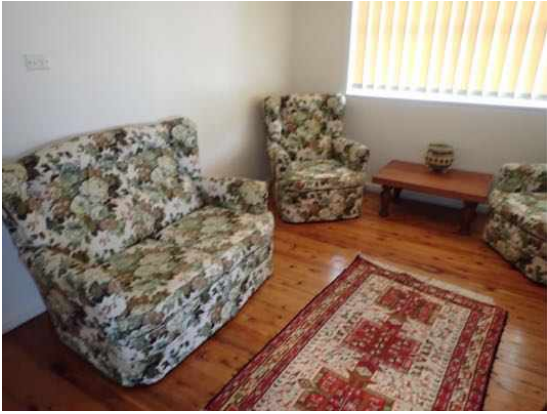
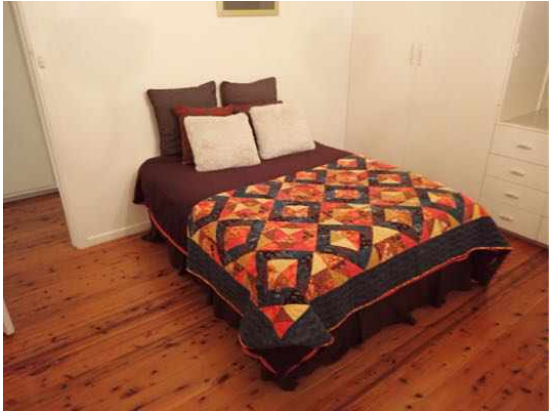
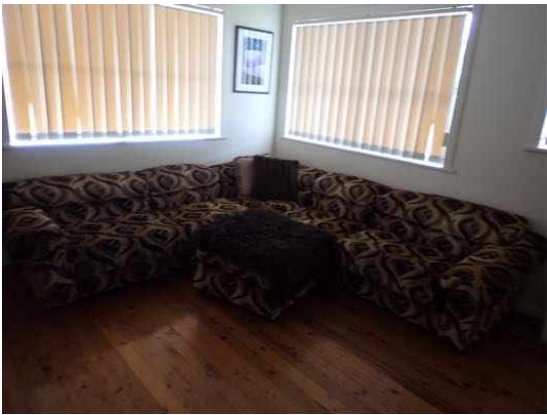
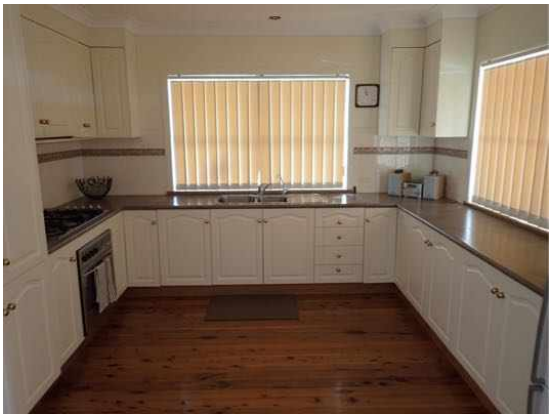
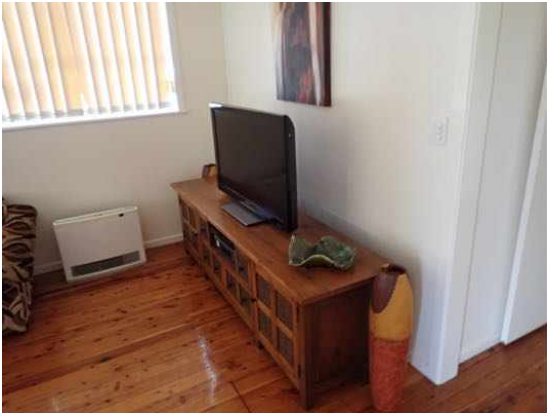
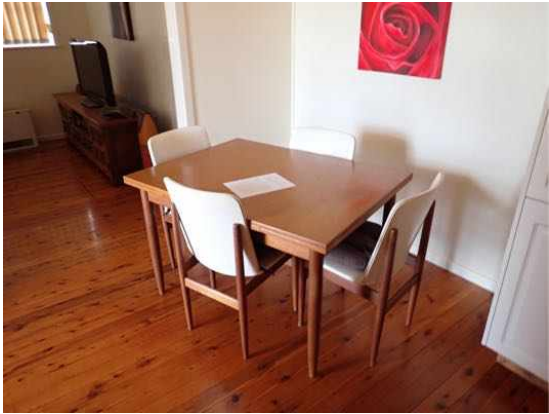
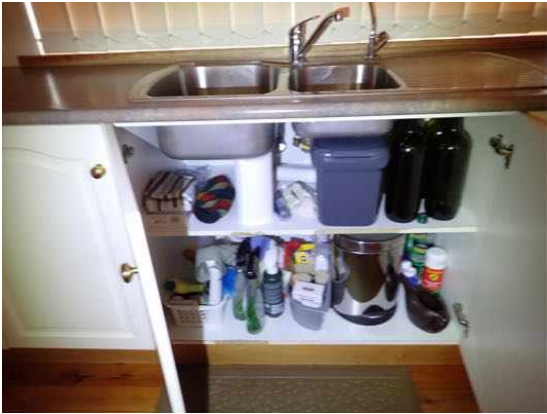
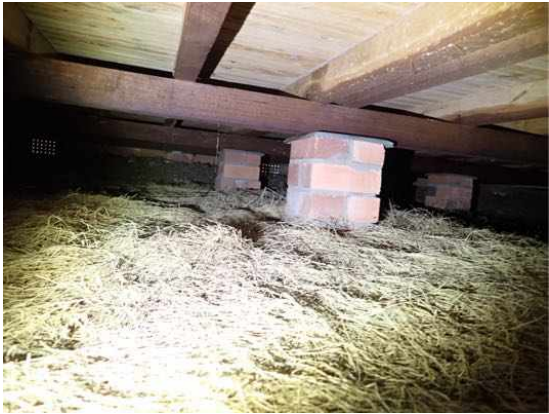
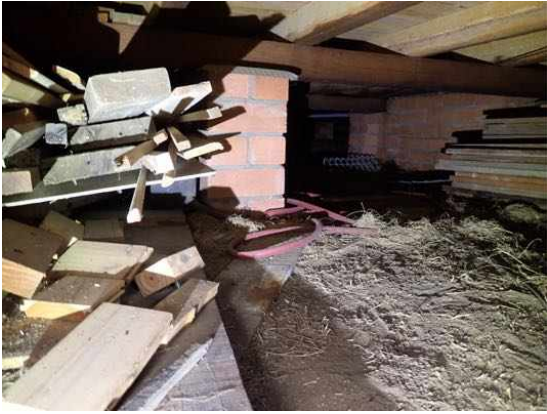
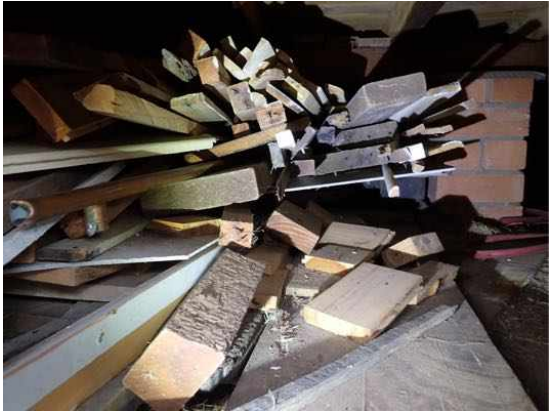
Noted Item

Building: Main Building
Location: All Areas
Finding: Additional Photos - Obstructions and Limitations
Information: These photographs are an indication of the obstructions and limitations which impeded full inspection of the area at the time of inspection. These obstructions can hide an array of defects and should be removed to allow full inspection to be carried out. A re-inspection is recommended once the areas are made accessible.
