Building Inspection Report

Inspection Date: Thu, 5 Feb 2026

Property Address: 1107/35 Tondara Ln, West End QLD 4101,
Australia

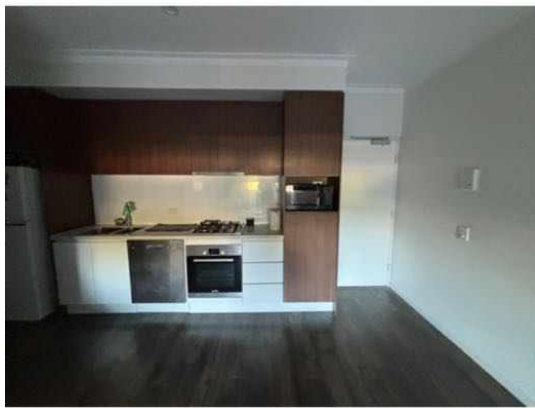
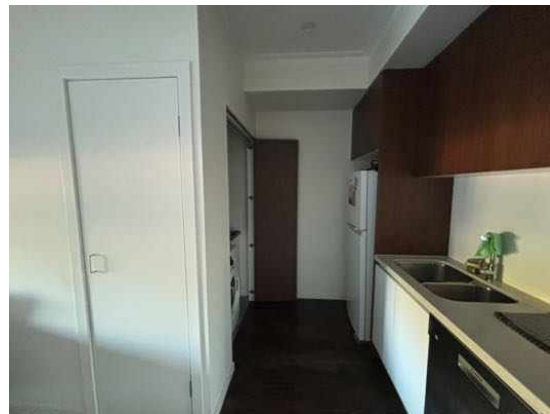
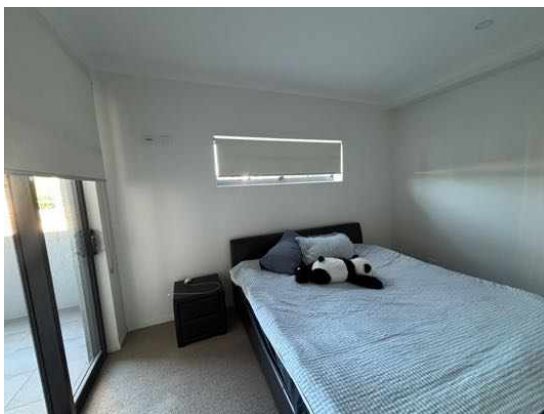
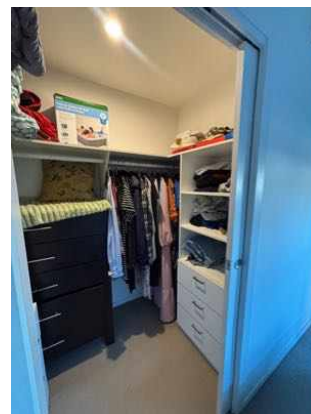
Defects 3.01

Building: Main Building
Location: All Internal Areas
Finding: Obstructions and Limitations - Internal areas
Information: These photographs are an indication of the obstructions and limitations which impeded full inspection of the property of the internal areas at the time of inspection. These obstructions can hide an array of defects and should be removed to allow full inspection to be carried out. A re-inspection is recommended once the areas are made accessible.

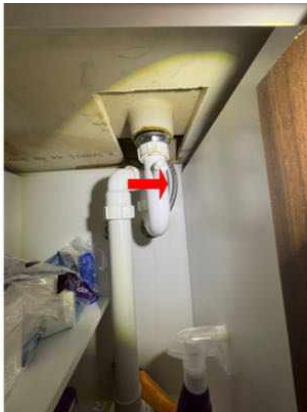
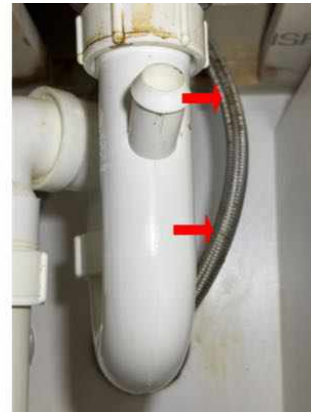
Defects 3.02

Building: Main Building
Location: Bathroom
Finding: Bathroom - flexible hose has signs of rust
Information: At the time of the inspection, it was noted that a flexible hose to the bathroom vanity mixer had signs of rusting. This may be due to the age of the hose. Flexible hoses typically have a 5 - 10 year lifespan.

It is recommended that they be changed if they have signs of bulging, fraying, kinking or rust.

A licensed plumber should be engaged to replace both the flexible hoses to the bathroom vanity mixer. This should be done as a matter of urgency.

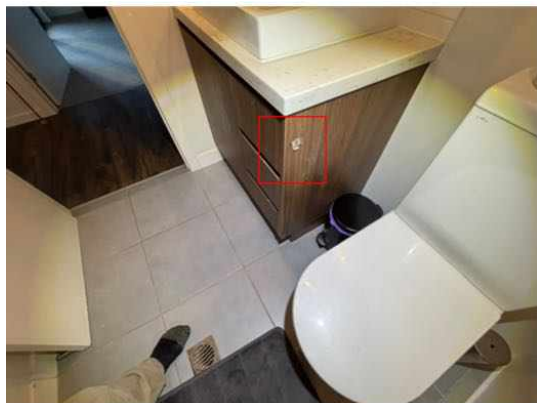
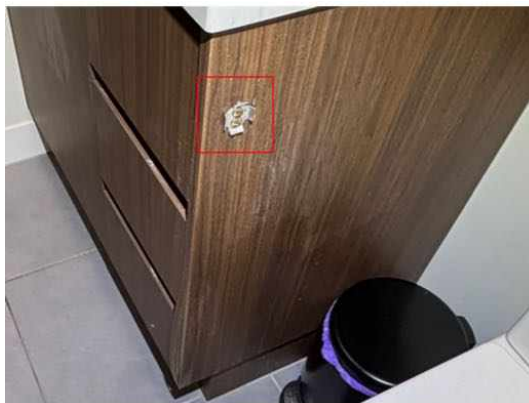
Defects 3.03

Building: Main Building
Location: Bathroom
Finding: Bathroom - toilet roll holder missing
Information: At the time of the inspection, it was noted that the toilet roll holder in the bathroom was missing. This may be due to general wear and tear.

A building maintenance professional could be engaged to install a new toilet roll holder. This can be done at the clients discretion.

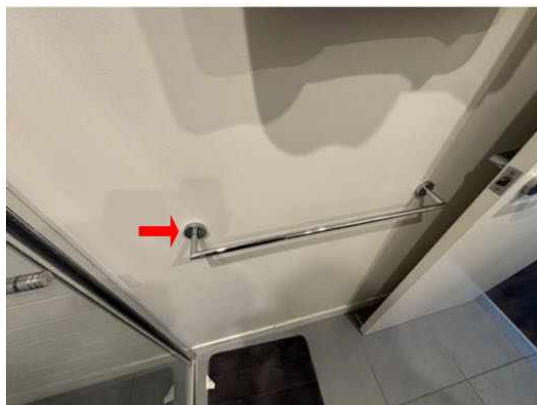
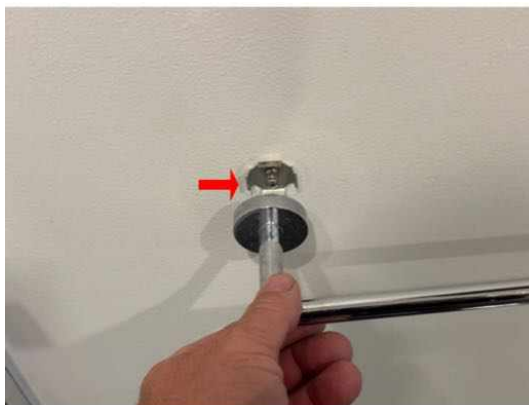
Defects 3.04

Building:	Main Building
Location:	Bathroom
Finding:	Bathroom - towel rail loose
Information:	At the time of the inspection, it was noted that one of the towel rails in the bathroom was loose. This appears to be from general wear and tear. If not addressed, the towel rail may come away from the wall.

This may require simple adjustment of the fasteners attaching the towel rail. A building maintenance professional could be engaged to carry out this minor repair. This can be done at the clients discretion.

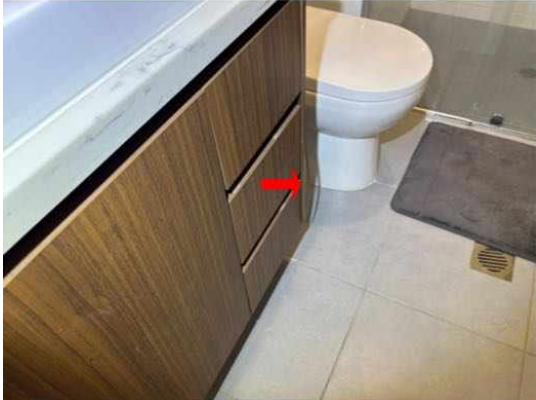
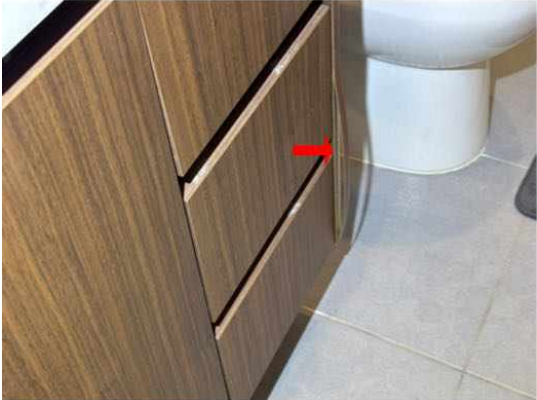
Defects 3.05

Building:	Main Building
Location:	Bathroom
Finding:	Bathroom - vanity minor damage
Information:	At the time of the inspection, it was noted that a veneer strip to the bathroom vanity is pulling away from the carcass. This may be due to general wear and tear.

A building maintenance professional could be engaged to re-attach this strip of veneer. This can be done at the clients discretion.

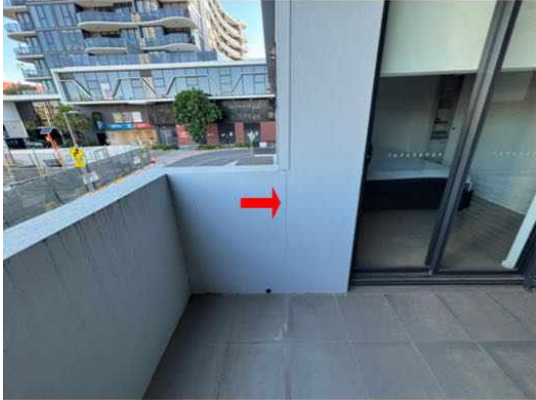
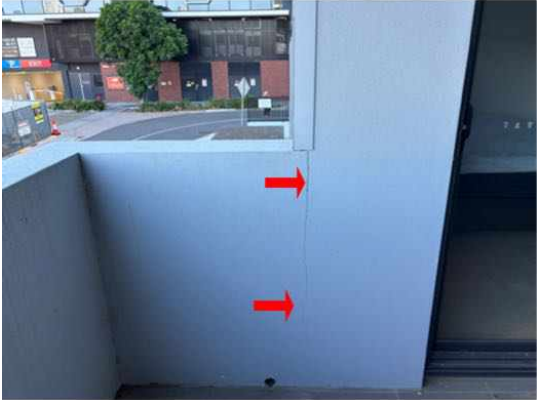
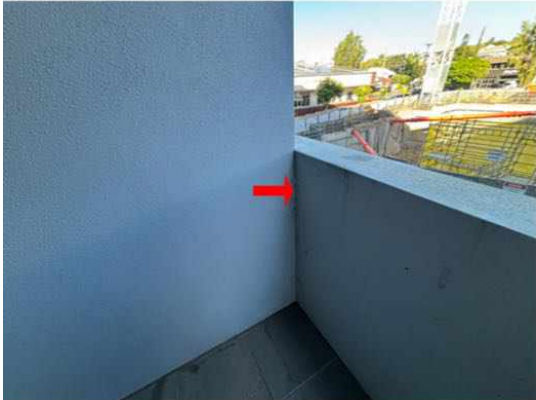
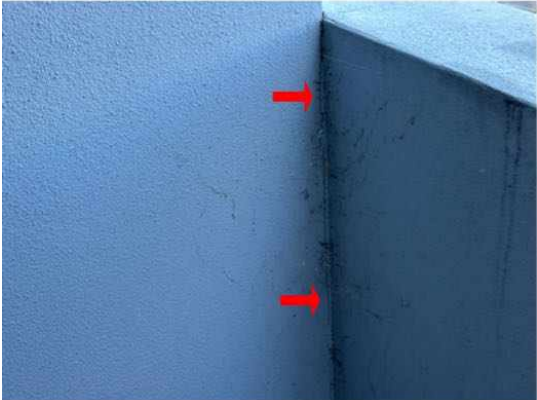
Defects 3.06

Building: Main Building
Location: Balcony
Finding: Balcony - minor cracking
Information: At the time of the inspection, it was noted that there was some minor cracking to the render on the balcony.

The client should inform the body corporate of this minor cracking in order for them to carry out the required maintenance to rectify this issue.
