## Building Inspection Report

Inspection Date: Wed, 8 Apr 2026

Property Address: 2/40 Lomman Ave, Newton SA 5074,  
Australia

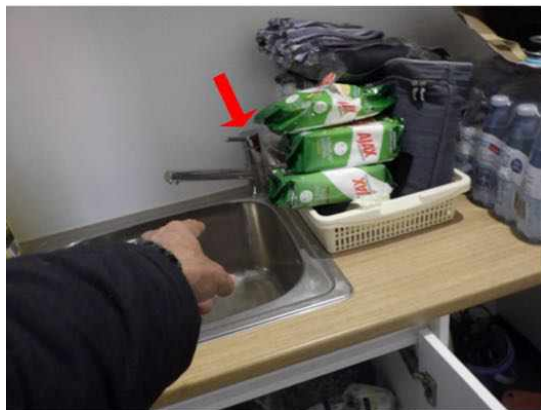
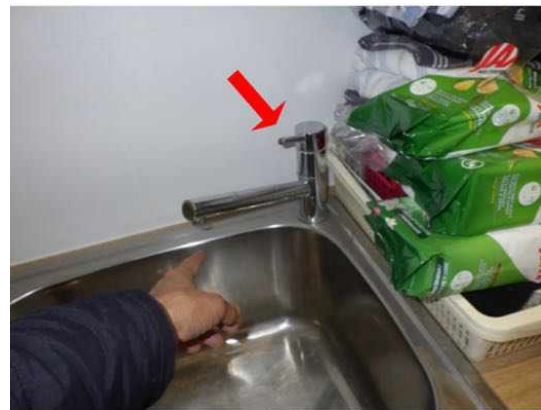
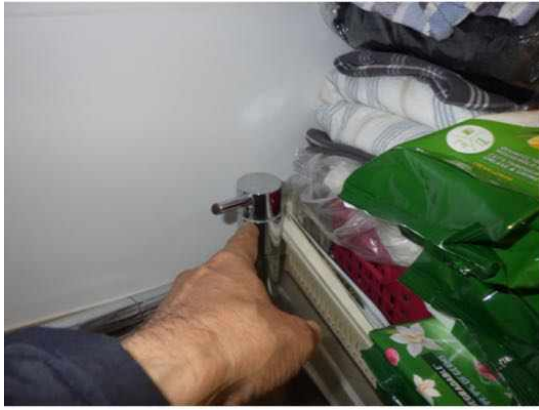
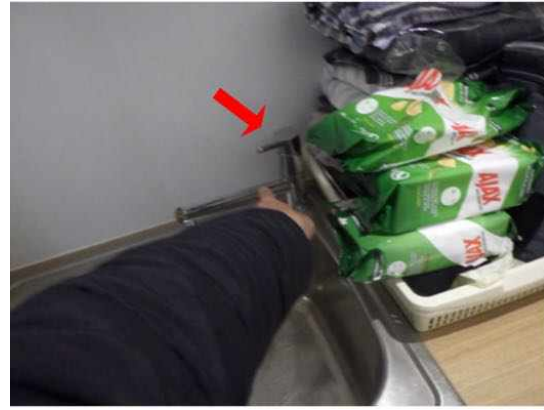
#### Defects 2.01

Building: Building 1  
Location: Laundry  
Finding: Laundry Area - Washbasin - Water not connected  
Information: At the time of inspection it was noticed that water is not connected to the laundry area washbasin.

Non-operational items should be addressed to ensure that the full function of the building structure is available. Where some building elements are not operating as intended, it is possible that secondary building defects could arise due to their non-operation.

Repair and/or replacement of the faulty building element is recommended. It is highly recommended that the relevant tradesperson be engaged as soon possible to perform any necessary works.

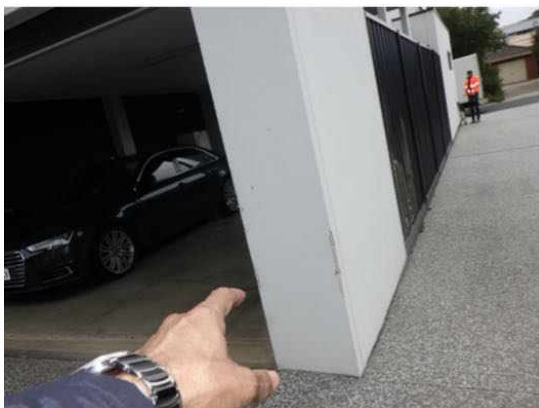
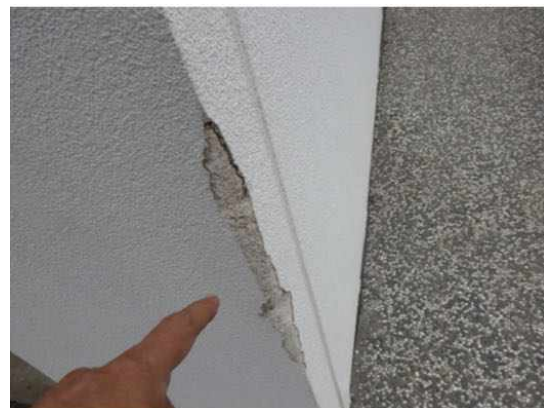
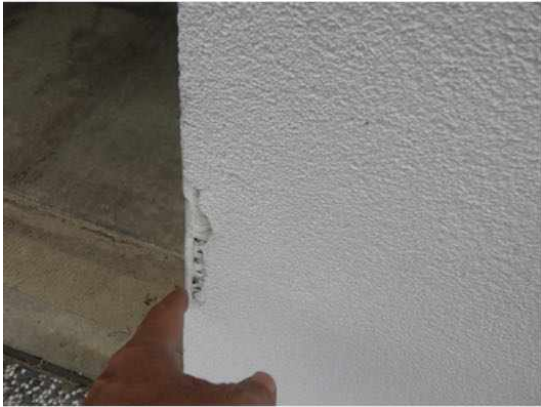
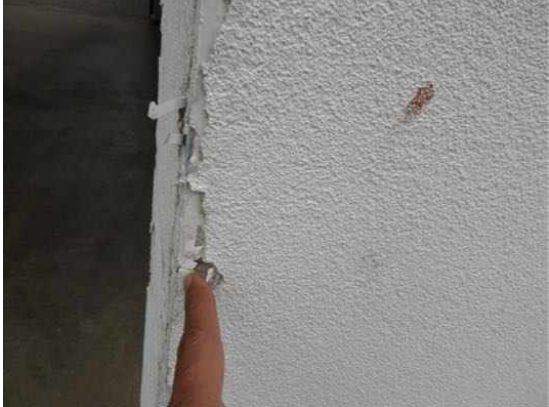
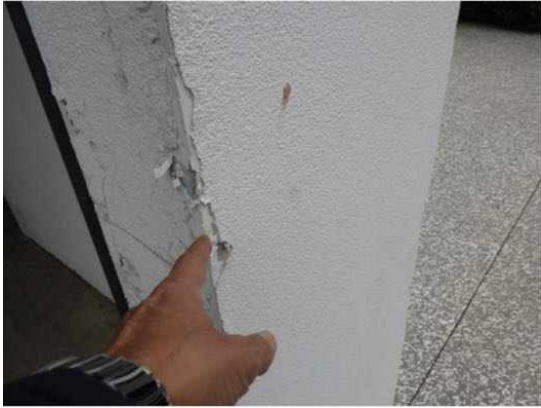
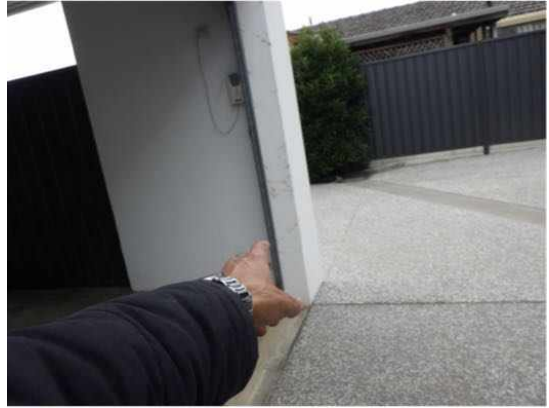
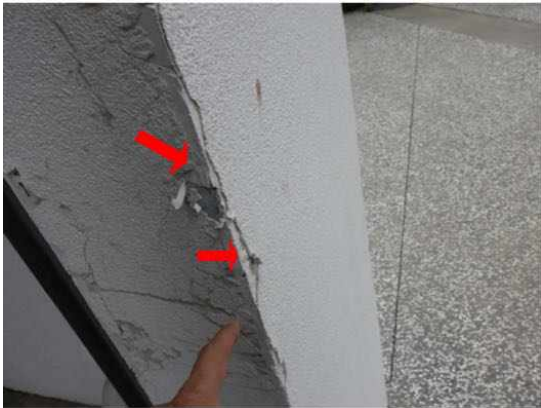
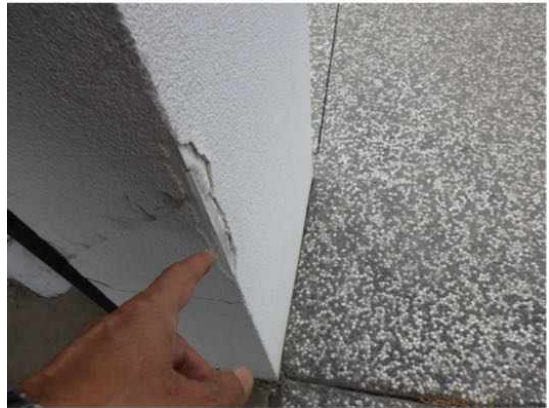
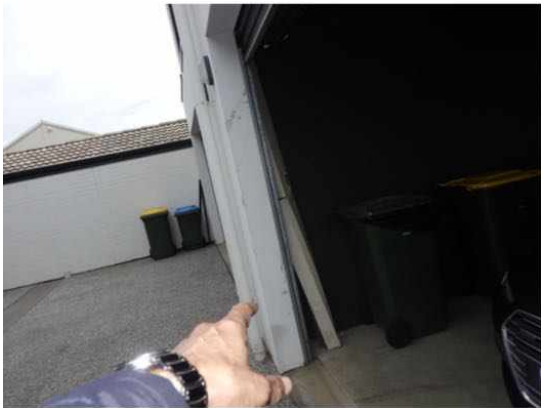
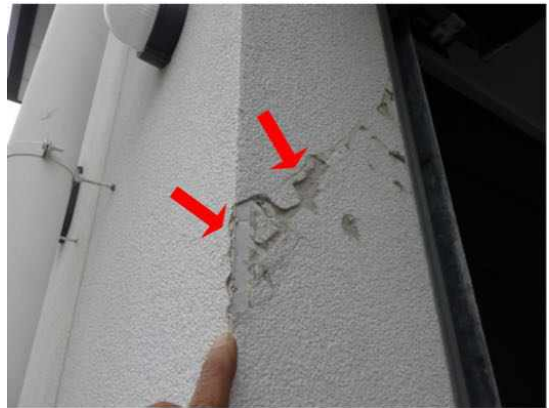
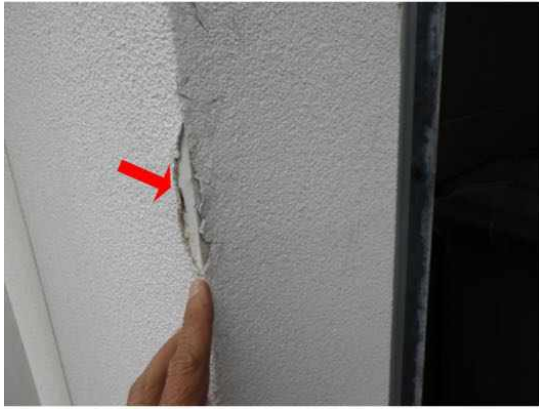
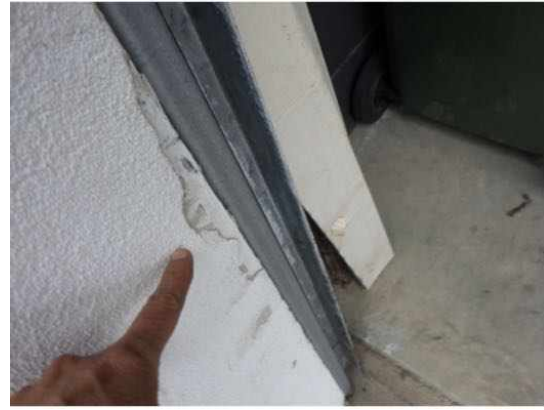
### Defects 3.01

Building:	Building 1
Location:	All External Areas
Finding:	External walls - Damaged
Information:	At the time of inspection it was noticed that few sections of external walls were damaged in this garage area.

Breakage occurs generally when the building materials have either aged and decayed, or as a result of damage (accidental or deliberate).

Repair and/or replacement of broken elements is advised to ensure that additional secondary defects do not arise as a consequence. Such works are necessary, as all building elements play a key role in the operation and function of the overall structure and its performance.

A relevant tradesperson should be appointed to repair or replace the affected building element prior to any subsequent damage being caused.

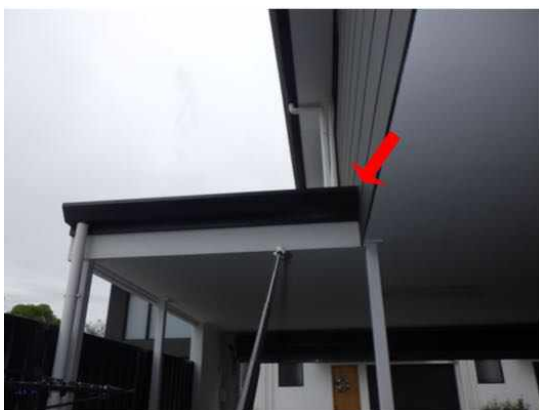
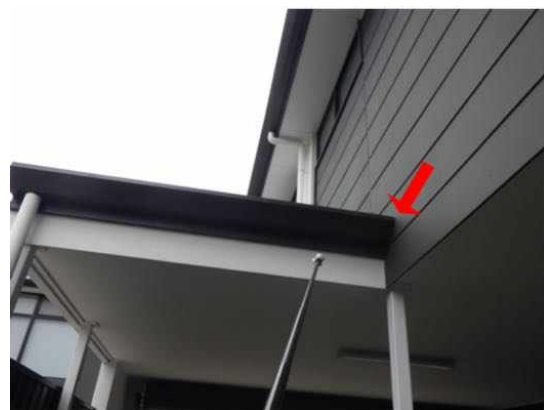
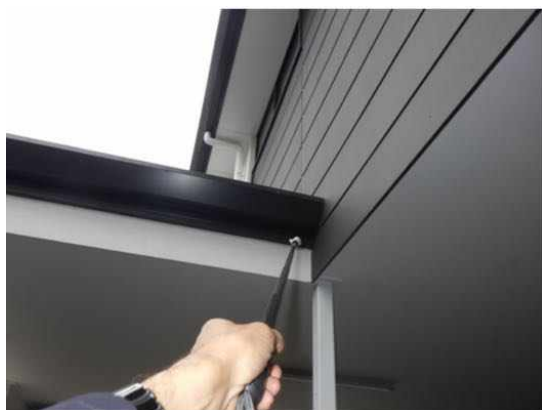
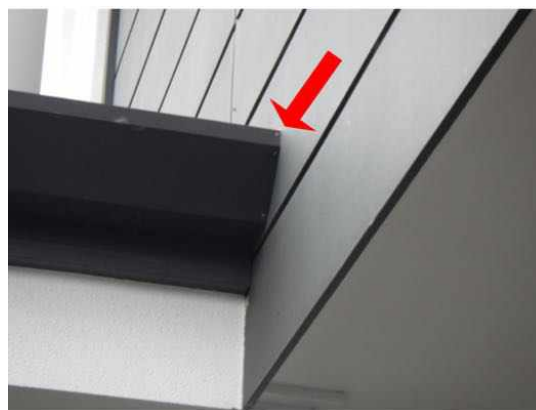
## Defects 3.02

Building:	Building 1
Location:	All External Areas
Finding:	Garage Area- Gutters - Loose from its original fixing
Information:	At the time of inspection, it was observed that the gutters located along the rear garage area are loose and have detached from their original fixings. This condition may result from natural aging and deterioration of building materials or could be due to accidental or external impact damage.

Loose gutters can compromise the effective drainage of rainwater, potentially leading to water ingress, damage to external walls, and accelerated wear of other building elements. If left unattended, this defect may contribute to secondary issues such as water staining, mould growth, or structural deterioration.

It is advised that the affected gutters be repaired or replaced as necessary to restore proper functionality. A qualified and licensed tradesperson should be engaged to assess the extent of the issue and undertake appropriate rectification works. Timely repairs will help maintain the integrity and performance of the building envelope and prevent further damage.

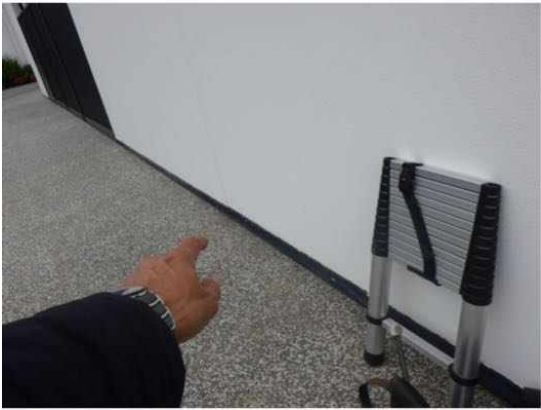
### Defects 3.03

Building:	Building 1
Location:	All External Areas
Finding:	Slab Edge - Exposure compromised
Information:	At the time of inspection it was noticed that damp course member has been popping upwards from the external paving in few sections around property and result of that slab edge exposure has been compromised. It's advised to cut the extra popping upwards damp course.

An inspection zone of at least 75mm in relation to the exposed slab edge, between the bottom brick and the perimeter pavement, is required. This inspection zone should be maintained in order to force termites into the open where they can be detected more readily during regular inspections. The slab edge should not be concealed by anything that may prevent inspection of the area, including render, landscaping, soil, turf, paving, concrete cladding or other structures.

If the slab edge is not properly exposed there is a high risk of termite attack. Sometimes, in order to determine the type of slab, a suitably qualified person such as an architect or builder may be required to consult the construction plans.

Where the slab edge cannot be properly inspected, it is highly recommended that termite or timber pest inspections be carried out every 6-12 months to aid protection of the property against infestation.

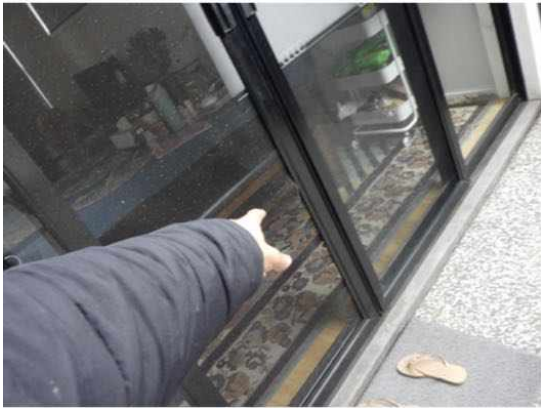
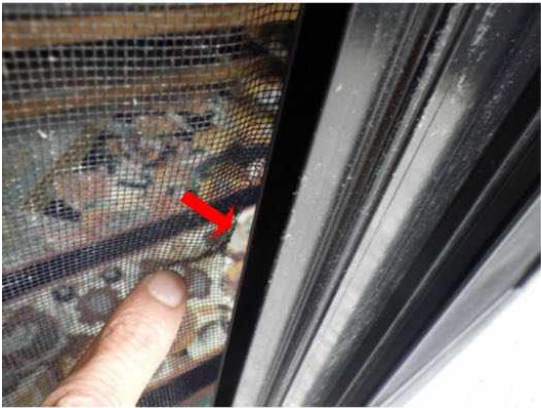
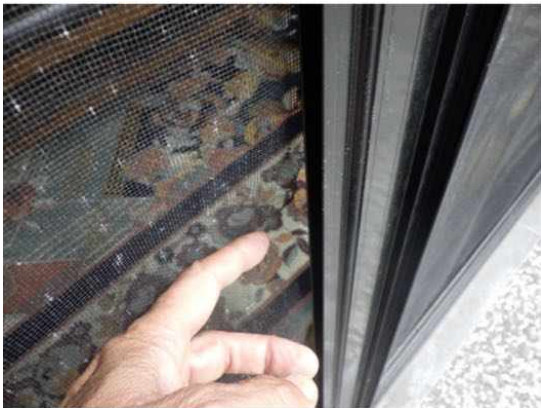
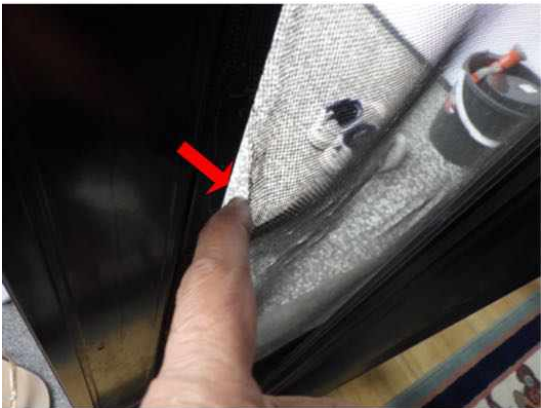
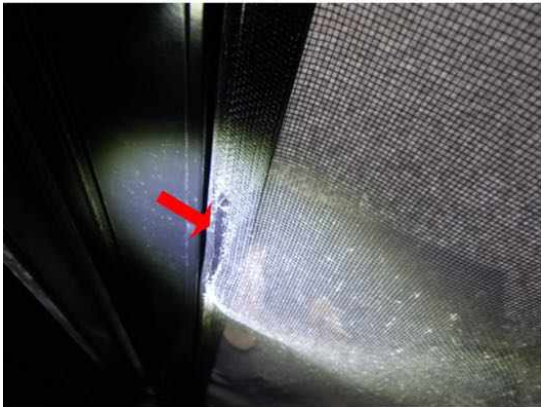
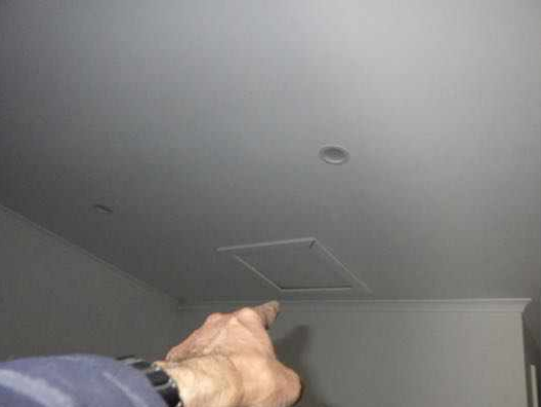
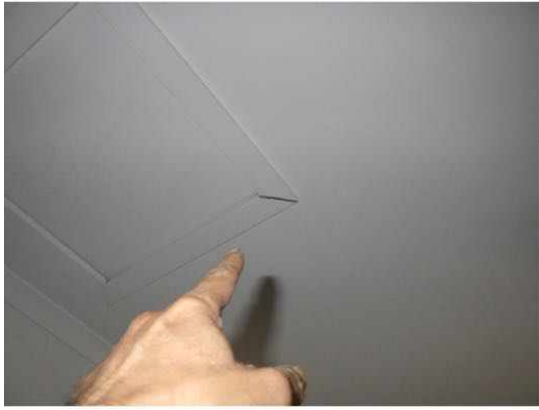
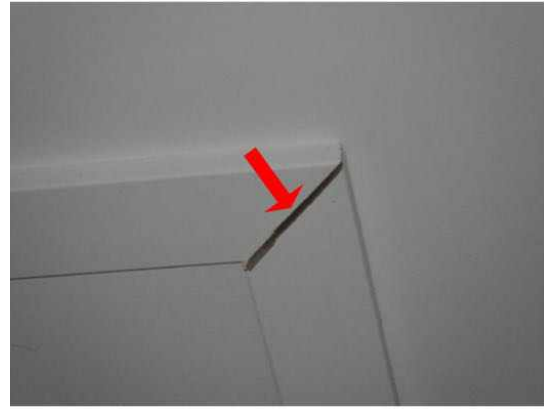
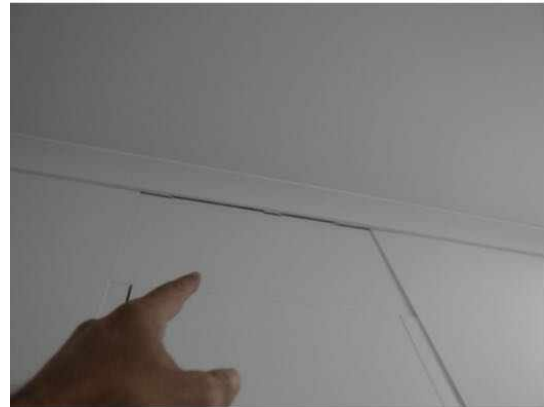
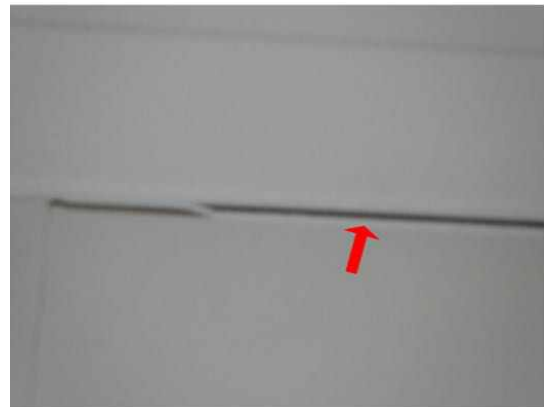
**Defects 3.04**

Building: Building 1  
Location: All Internal Areas  
Finding: Building element - Damaged  
Information: At the time of inspection it was noticed that flyscreen is damaged in this sliding door . Apart from that at the time of inspection it was also noticed that manhole cover & section of internal walls is damaged/ loose from its original fixing.

Breakage occurs generally when the building materials have either aged and decayed, or as a result of damage (accidental or deliberate).

Repair and/or replacement of broken elements is advised to ensure that additional

secondary defects do not arise as a consequence. Such works are necessary, as all building elements play a key role in the operation and function of the overall structure and its performance.

A relevant tradesperson should be appointed to repair or replace the affected building element prior to any subsequent damage being caused.

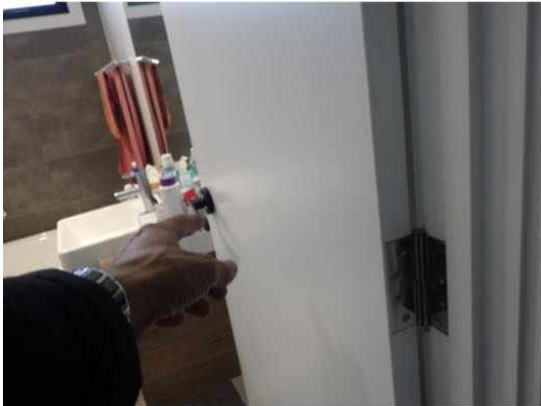
### Defects 3.05

Building: Building 1  
 Location: Bathroom 2  
 Finding: Door - Broken handle  
 Information: The door handle in this bathroom -2 area was found to be broken at the time of inspection. Breakage occurs generally when the building materials have aged and decayed, but may be indicative of impact damage (accidental or deliberate).

Repair and/or replacement of the broken door handle is advised to improve the operational state of the associated door.

A qualified carpenter or general handyman should be appointed to repair/replace the

door handle at the client's discretion.

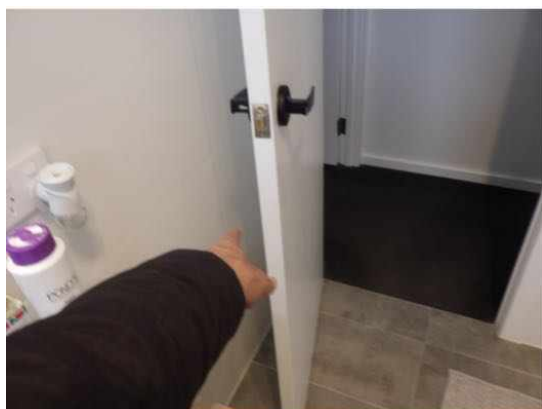
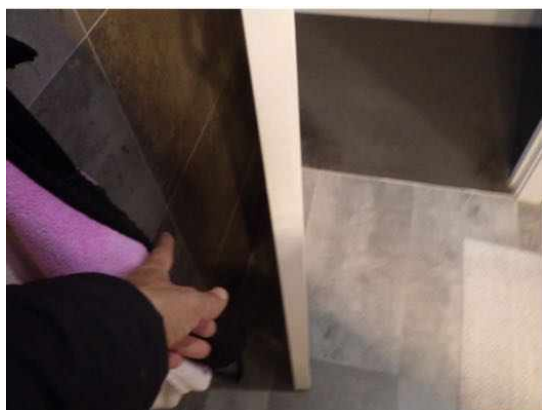
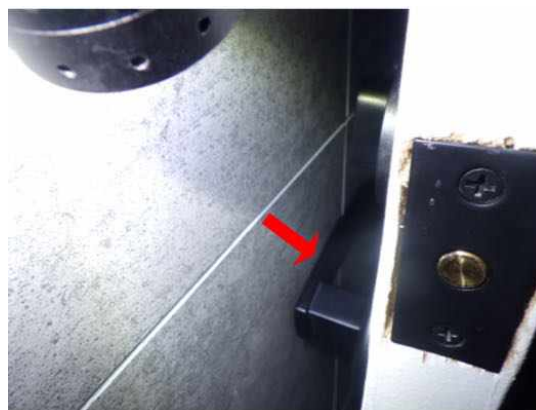
## Defects 3.06

Building:	Building 1
Location:	All Internal Areas
Finding:	Door stop - Missing
Information:	The door stop is missing or is inadequate to stop the door handle from damaging the wall. Although some building elements may seem irrelevant or unnecessary, all building elements play a key role in the operation and function of the overall structure and its performance.

Re-installation or replacement of the door stop is advised as soon as possible to prevent any subsequent damage to the door or associated structures. A general handyman may be appointed to perform these works at client discretion.

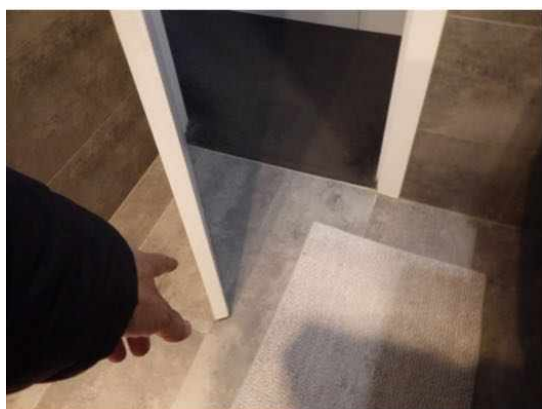
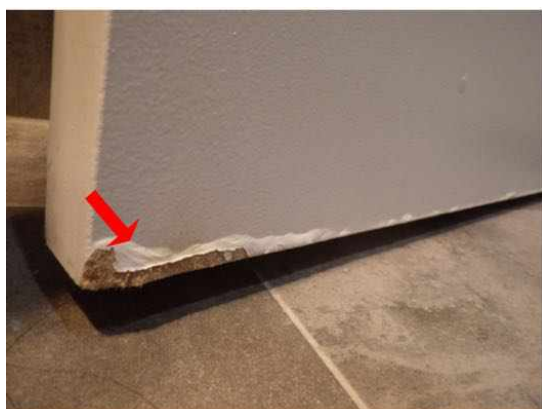
## Defects 3.07

Building:	Building 1
Location:	All Internal Areas
Finding:	Building element - Swollen
Information:	At the time of inspection it was noticed that few sections of building elements were swollen around the property.

Swollen building elements generally indicate that the building materials have been

affected by excessive moisture over a prolonged period of time, and have swollen as a result. The formation and development of mould/fungi or mildew is also a likely consequence of excessive moisture, which may pose major respiratory issues for occupants, particularly the elderly, the very young and those with existing illnesses and could be potential health safety hazards. In these cases an appropriately qualified inspector/tester should also be contacted for advice and/or technical assistance.

The structural integrity of swollen building elements can not be guaranteed, and further damage is likely to develop if left unmanaged. Excessive moisture is likely to lead to the development of secondary damage to any associated building elements, which may necessitate major reparation works if prolonged.

Rectification of the cause of the water leak should be addressed prior to any remedial works to the swollen building elements. A licensed plumber should be appointed immediately to identify the cause of the leak and provide advice on remedial works as necessary. Repair and/or replacement of swollen building elements should be conducted as a matter of urgency by a registered builder or qualified carpenter.

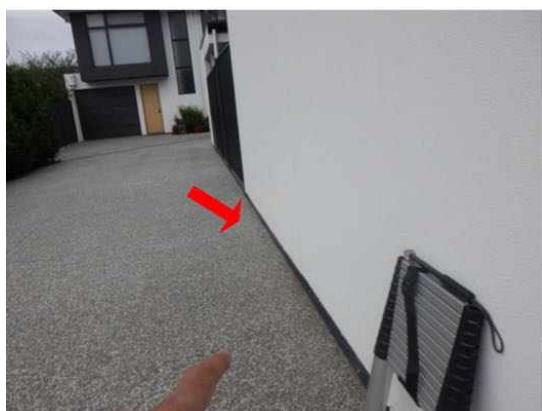
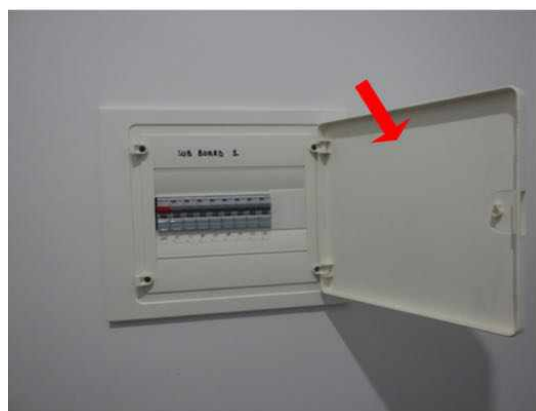
Building: Building 1  
 Location: All External Areas >  
 Finding: Termite Management System - No evidence of a chemical installation  
 Information: The application of a post-construction chemical termite barrier is highly recommended for all properties, particularly if live termite activity has been found on the site previously. Such barriers are highly effective in preventing termite attack on any timber building elements throughout the property.

A durable notice should be placed in the switchboard unit to indicate current termite barriers. At the time of inspection, it appeared as though no termite management system has been installed, with no evidence to suggest preventative works taking place.

The client may consider gaining further advice from a pest controller as to the costs and procedures involved with this application. It is recommended that obtaining such advice be a short-term priority.

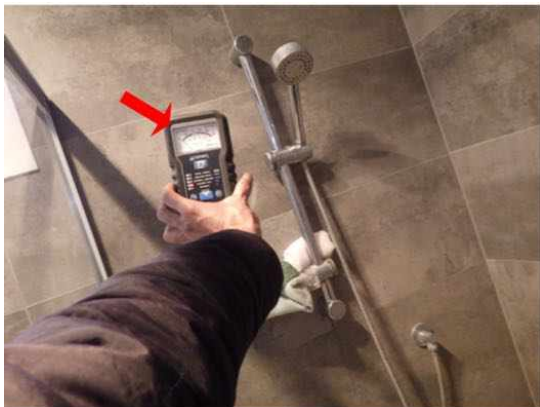
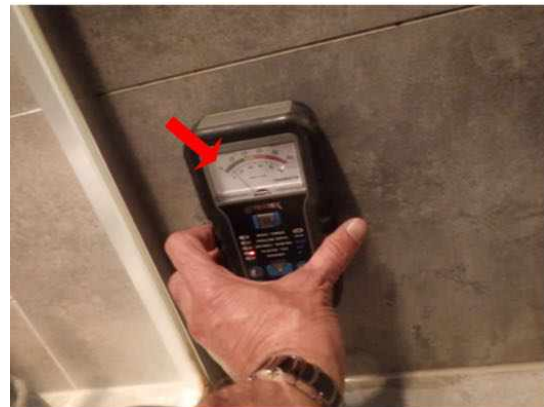
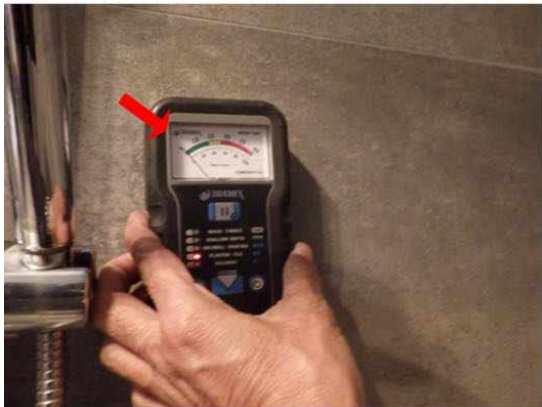
Building: Building 1  
Location: Bathroom-Ensuite  
Finding: Shower Alcove - No Damp  
Information: At the time of inspection it was noticed that damp is not evident to the shower alcove.

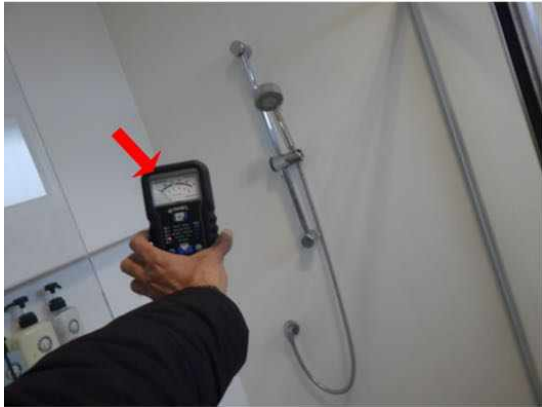
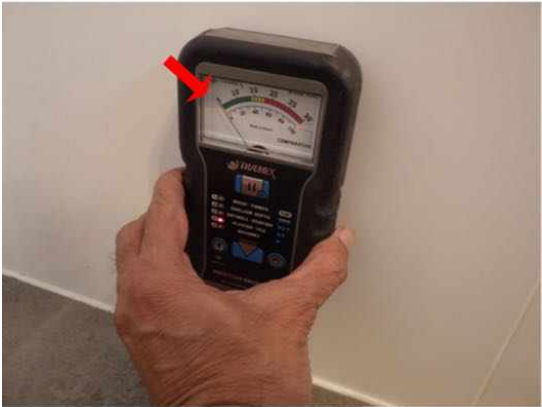
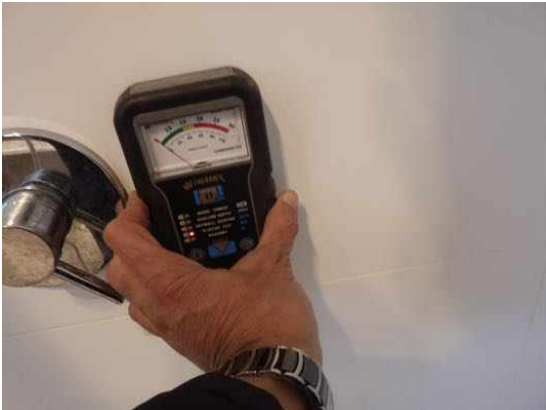
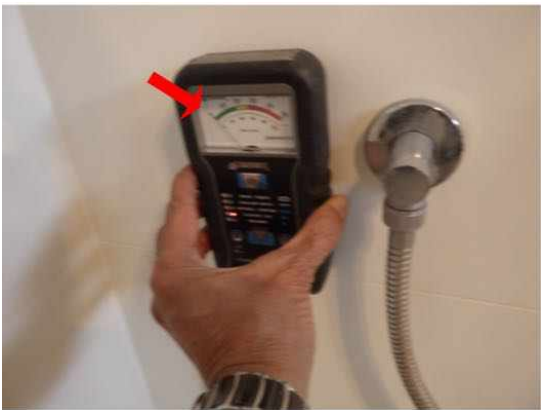
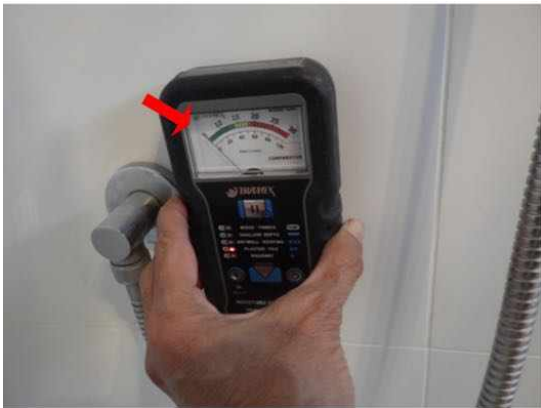
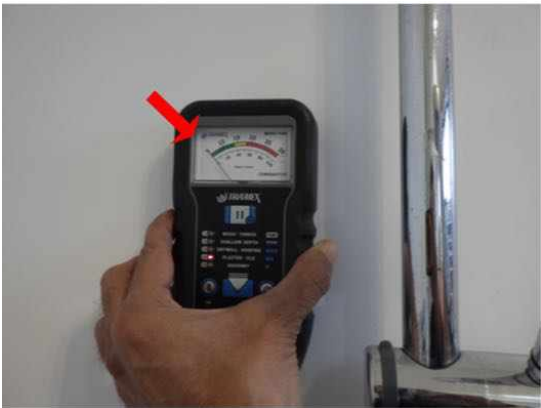
Building: Building 1  
Location: Bathroom 2  
Finding: Shower Alcove - No Damp  
Information: At the time of inspection it was noticed that damp is not evident to the shower alcove.

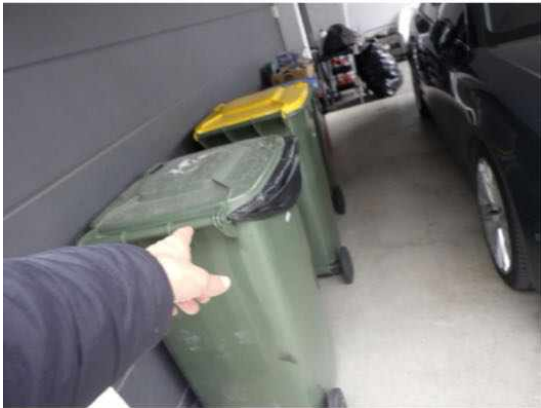
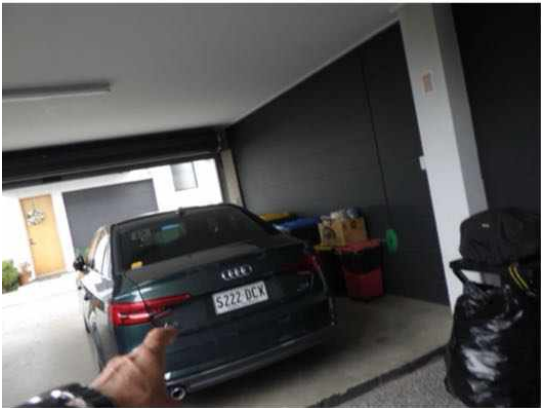
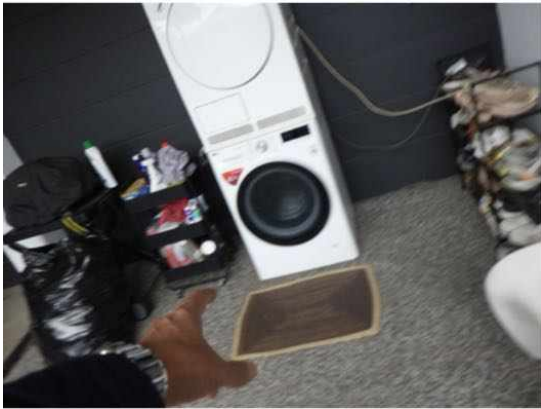
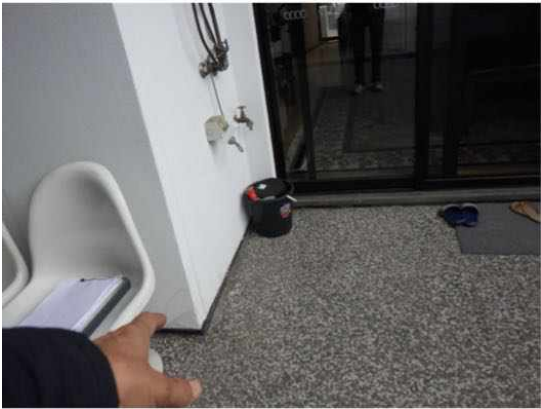
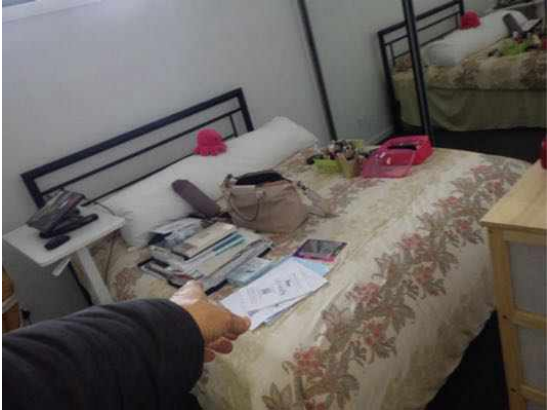
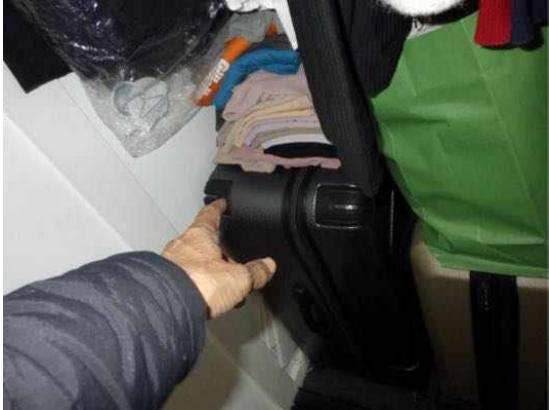
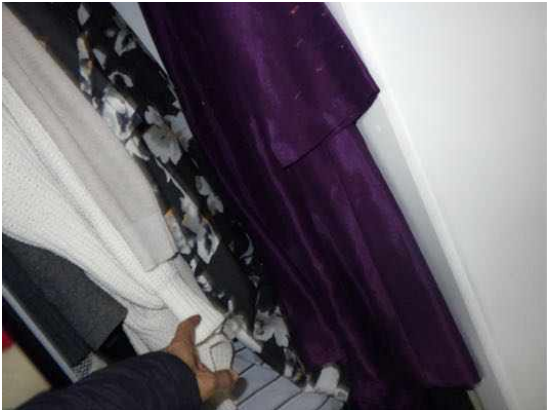
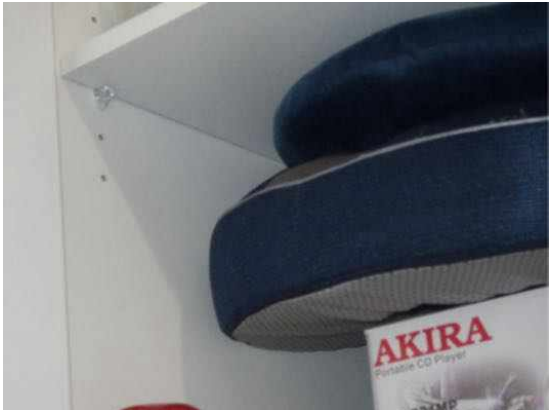
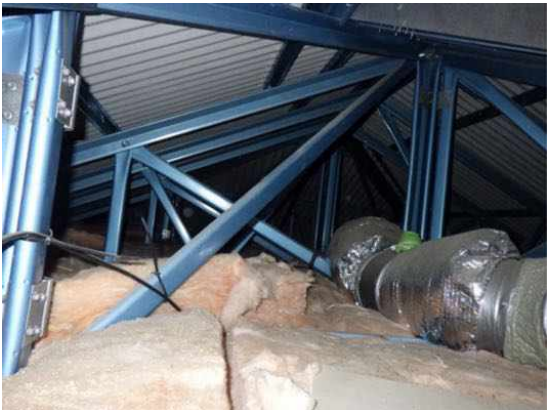
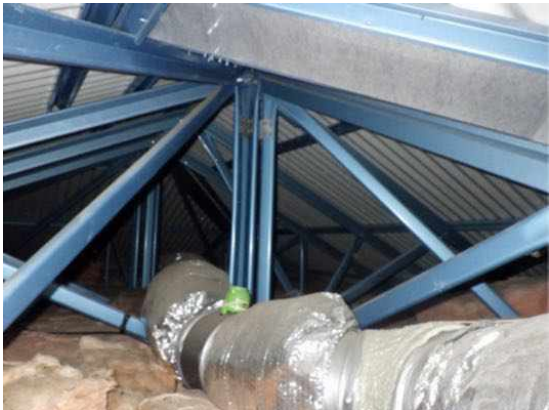
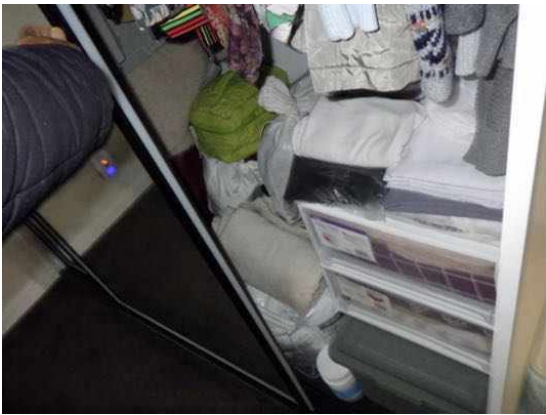
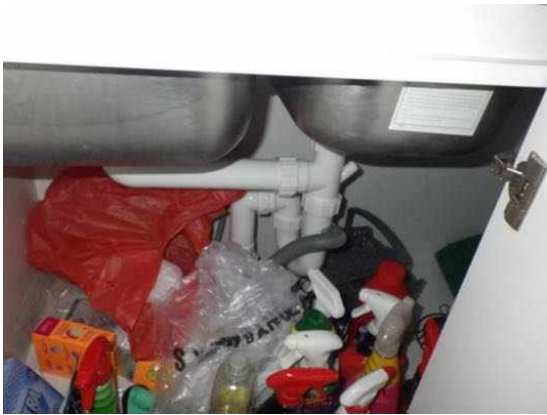
Building: Building 1  
Location: All Areas  
Finding: Additional Photos - Obstructions and Limitations  
Information: These photographs are an indication of the obstructions and limitations which impeded full inspection of the property at the time of inspection. These obstructions can hide an array of defects and should be removed to allow full inspection to be carried out. A re-inspection is recommended once the areas are made accessible.
