Building and Timber Pest Inspection Report

Inspection Date: Thu, 19 Feb 2026

Property Address: 80 Healy Ave, Gregory Hills NSW 2557,
Australia

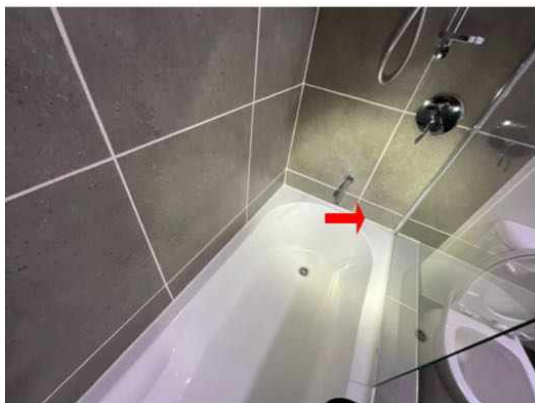
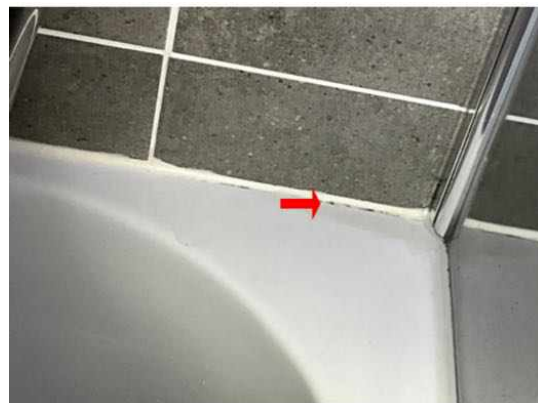
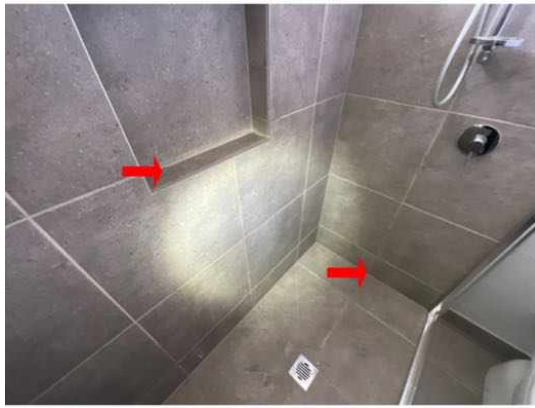
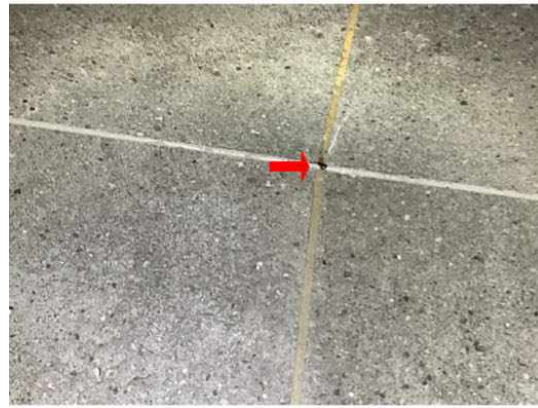
Finding 3.01

Building: Main Building
Location: All Wet Areas
Finding: Sealant and grouting - Missing or damaged
Information:

It was noted on inspection that sealant or grout is degraded to this area.

Different materials and floor areas move at different rates, generally causing cracking to grout or sealant at this point. A flexible sealant is required to allow for expected expansion and contraction, while keeping the joint water tight and protective of all associated building materials.

Flexible and mould resistant materials should be applied to affected areas to prevent any subsequent water damage that is likely to occur. Regular maintenance and replacement of damage or missing or damaged sealant and grout is highly recommended to the wet areas, as this is a regular wear and tear defect. Sealant and grouting in areas that come into regular contact with water should be maintained for the long term care of your property.

A sealant specialist should be appointed to complete these works as soon as possible.

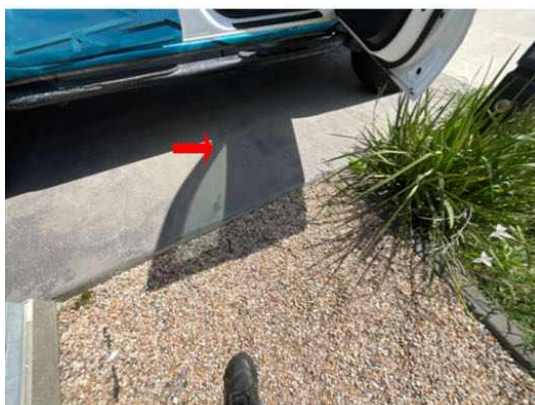
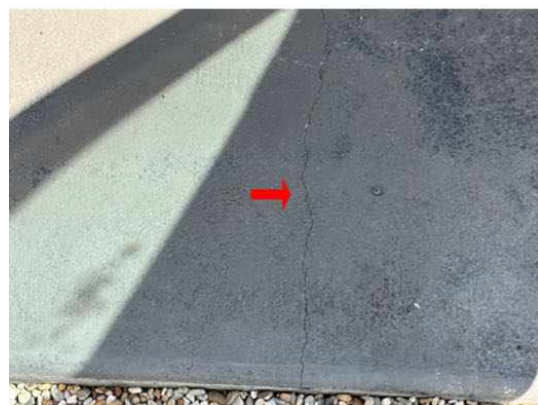
Finding 3.02

Building: Main Building

Location: Driveway

Finding: Cracking - External Concrete Paving Damage Category 0 - Hairline (less than 1mm)

Information: Hairline cracks were identified in external concrete paving. Hairline cracks are very minor in nature and generally are only ever an appearance defect. To be classified as a Category 0 or hairline crack, the crack width would be less than 0.3mm. While such cracking may be noticeable in some cases, it is common and does not indicate any structural damage.

Generally the cause of a hairline crack in existing concrete paving such as driveways and pathways is indicative of the expansion and contraction of the concrete. Such causes are generally due to environmental factors, such as moisture levels, weather conditions, root systems of nearby trees or the soil types on which they are laid.

Hairline cracks may also be due to poor original installation of the concrete. Factors such as poor compaction of the sub surface and/or inadequate reinforcing of the slab may create cracking and other secondary defects.

Monitoring of all cracking should be conducted frequently. Always contact a building inspector should cracks widen, lengthen, or become more numerous.

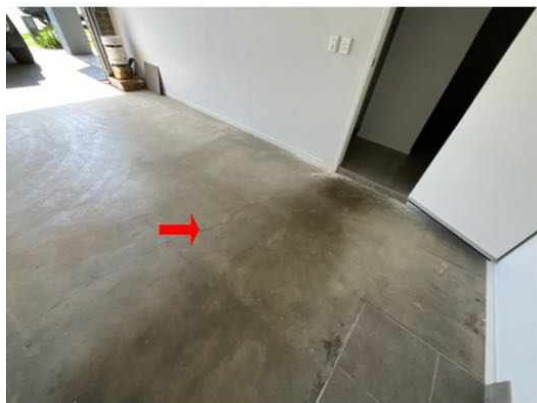
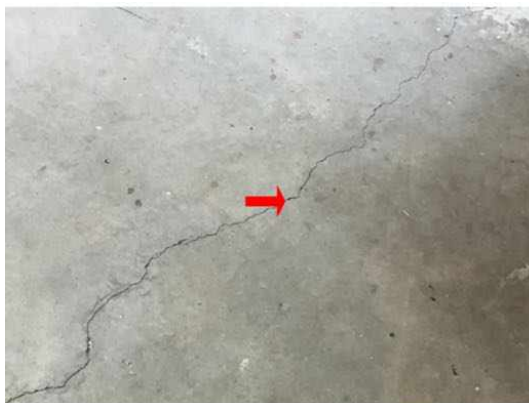
Finding 3.03

Building: Main Building
 Location: Garage
 Finding: Crack in concrete slab - Category 1
 Information: A crack coded as Category 1 was identified in the slab. A Category 1 crack is described as a fine but noticeable crack, with the slab at an otherwise reasonable level.

To be considered Category 1, the approximate width of the crack is less than 1.0mm, or a less than 10mm change in offset when a 3m straight edge is placed over the defect.

Category 1 cracks should be monitored for a period of 12 months. At the end of the monitoring period, identified cracks that are rated greater than Category 2 are considered defects, and require rectification.

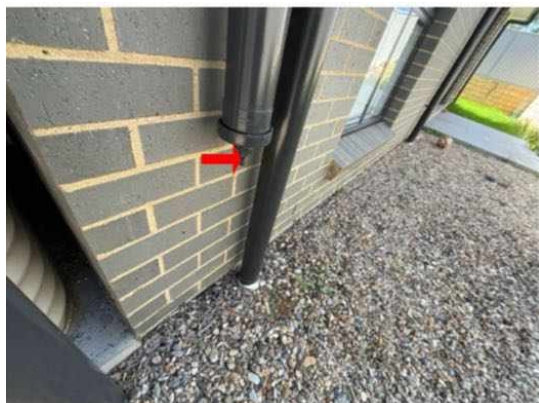
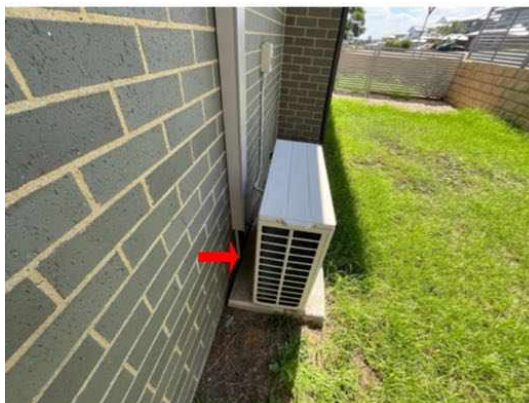
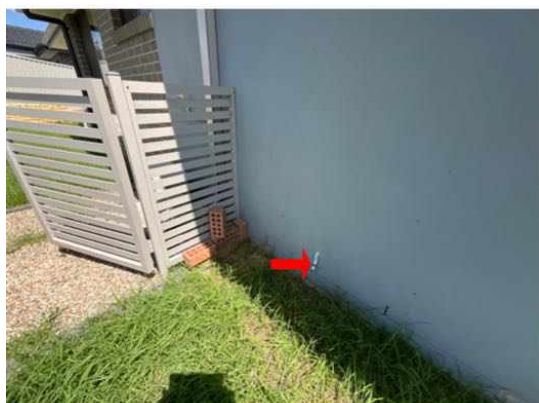
Finding 6.01

Building: Main Building
 Location: Multiple areas
 Finding: Overflow - Not plumbed for drainage
 Information: The overflow is not plumbed or connected to suitable drainage, which can result in the

surrounding area becoming excessively damp.

These damp conditions can lead to secondary defects such as rot, rust or corrosion of associated building elements, the formation of fungal decay, or even the creation of potential slip hazards. When coupled with poor site drainage, pooling of water may also attract termite activity to this area.

It is highly recommended that a licensed plumber be appointed to install adequate drainage to the overflow. These works will ensure that the area remains dry and free of any secondary defects.

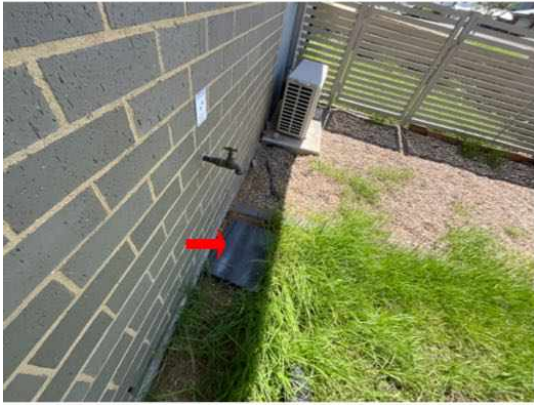
Finding 6.02

Building:	Main Building
Location:	External tap
Finding:	Tap - No drain
Information:	The external tap in this area was noted to have no drain at the time of inspection.

This keeps the surrounding surfaces damp while using the tap, which becomes conducive to termite activity.

A licensed plumber must be appointed to ensure an appropriate drain is installed.

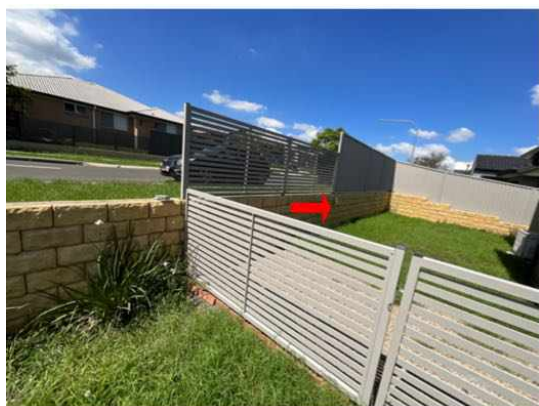
Building: Main Building
 Location: Retaining walls
 Finding: Retaining walls
 Information: At the time of inspection the retaining walls were checked and no defects were observed other than those which May have been mentioned earlier in this report.

AS4349.1-2007 requires all retaining walls in excess of 700mm to be inspected by a licensed and practicing structural engineer.

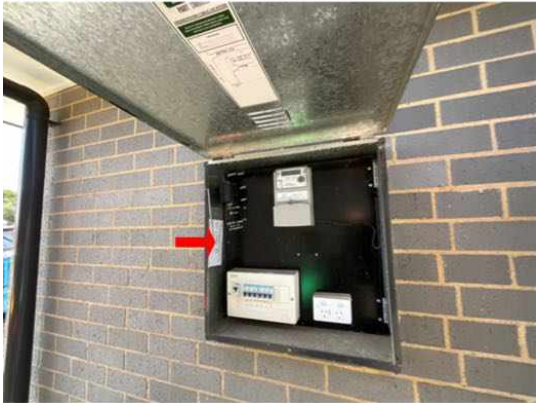
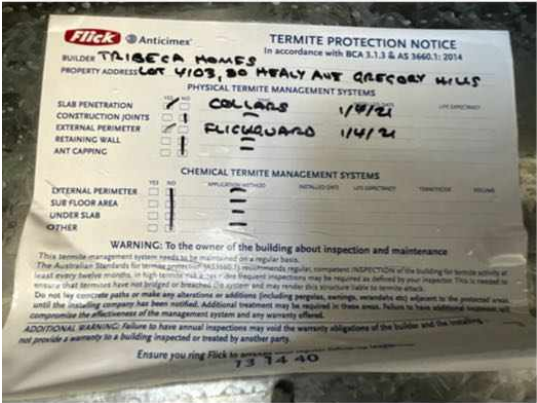
Building:	Main Building
Location:	Meterbox
Finding:	Evidence of a previous termite management system was identified
Information:	There are a number of factors which indicate the presence of a previously installed or applied termite barrier. The most common are a durable notice (to the inside of your meter box) observable physical barriers installed to building perimeter and in ground

reticulation systems.

Where a Termite Management System has been identified you should refer to the type of barrier date of installation warranty conditions and any documentation provided by a builder or past owner. Consult the company who installed the barrier to confirm whether the system is still under warranty.
