Building and Timber Pest Inspection Report

Inspection Date: Thu, 19 Feb 2026

Property Address: 50 Gregson Grove, Lyndhurst VIC 3975, Australia

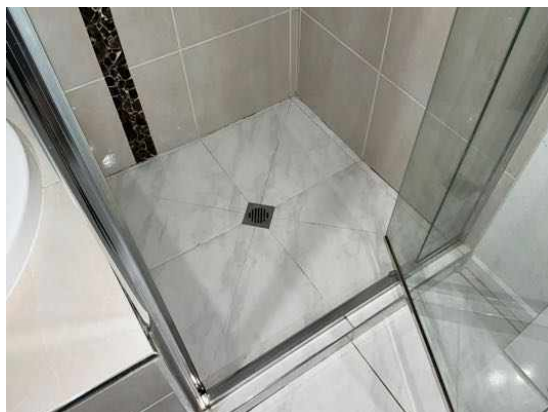
Information: Where evidence of mould growth was noted, there may be environmental, biological or health issues associated with the report. A specialist inspection by a suitably qualified environmental health inspector is warranted, where mould is extensive or where any queries regarding air quality spores or other related issues apply.

Generally, the client is advised to ensure that the general environment is free of moisture and humidity to aid in the prevention of mould formation and development. Any mould found during the inspection should be cleaned immediately by a cleaning contractor or the homeowner as applicable.

Please note that severely affected building elements may require replacement by a registered builder or qualified carpenter.

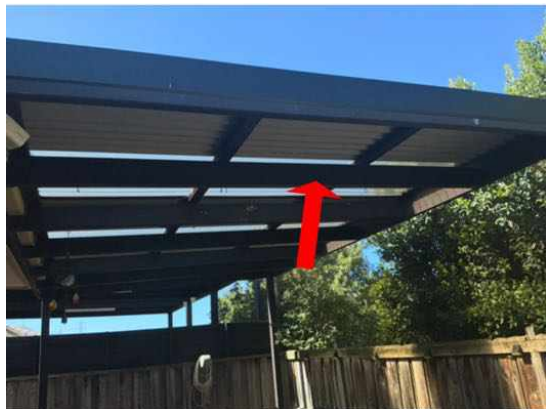
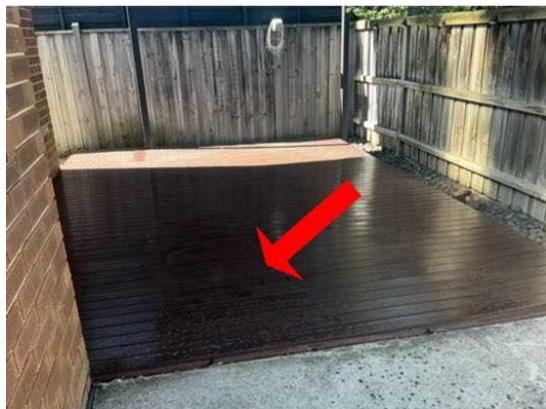
Finding 1.02

Building:	Main Building
Location:	Alfresco
Finding:	Additional structure built without a permit (Suspected)
Information:	The pergola structure on the rear of the house is suspected to have been constructed without a building permit. A building permit would be required for the structure.

It is highly advised to request that the current owner provide a Defect report (Owner Builder/Section 137b) for this structure. This would involve a structural engineer or a licenced building surveyor conducting an inspection of the structure and advising of any defects and/or areas of non-compliance in accordance with the current building codes. The current owner should then attend to any issues on this report prior to settlement.

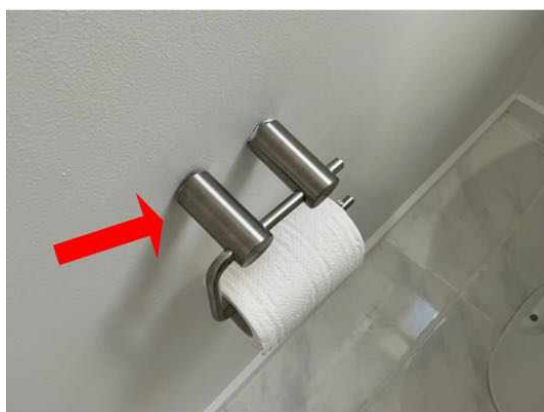
Building: Main Building
 Location: Ensuite
 Finding: Toilet roll holder - Loose
 Information: The toilet roll holder was found to be loose at the time of inspection. While not a major operational defect, function can deteriorate if the problem is left unmanaged.

It is advised that the homeowner performs remedial works to re-attach the toilet roll holder to its original fixing. A general handyperson may be required to perform these works.

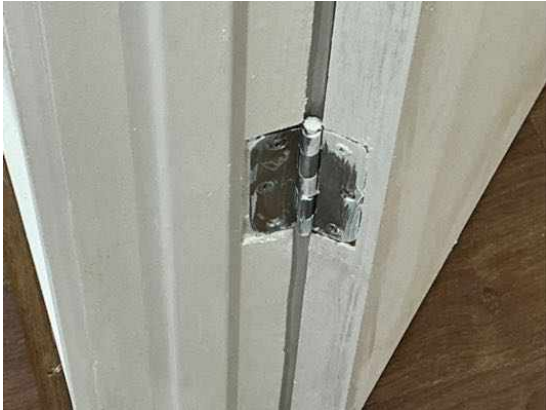
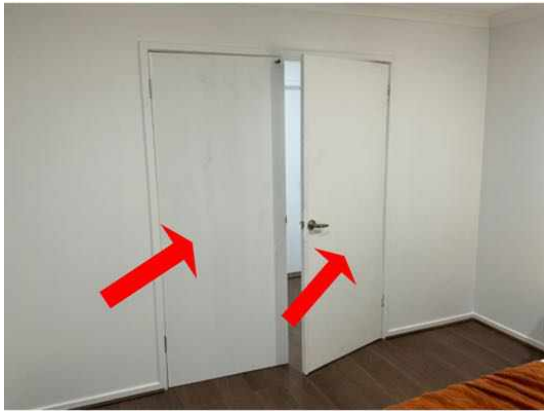
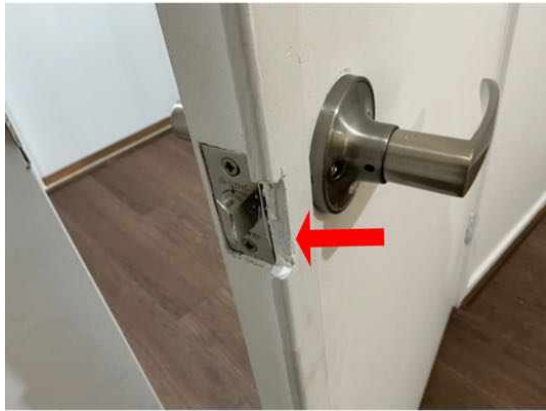
Finding 3.04

Building: Main Building
 Location: Bedroom 2
 Finding: Incomplete or substandard works

Works that have not been completed to a satisfactory level create potential for the development of building defects and may impede on the safety and integrity of the overall structure.

It is highly recommended that a qualified carpenter and painter be appointed to complete these works and ensure the longevity of all associated building elements.

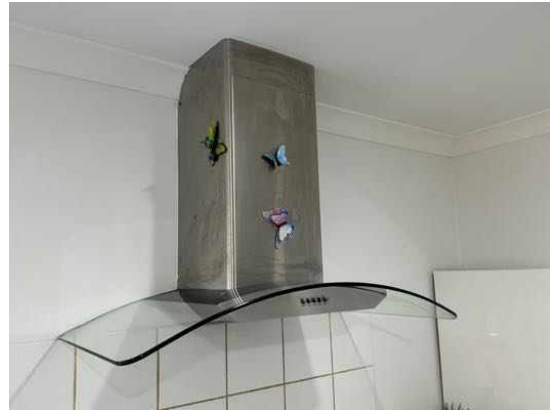
Building: Main Building
 Location: Kitchen
 Finding: Rangehood filters missing
 Information: It was noted at the time of the inspection that the mesh filters to the Rangehood were missing.

The Rangehood filters enable cooking smells and fat deposits to be filtered prior to entering the ventilation ducts of the rangehood. This could cause malfunction or in extreme cases may cause fire.

Licensed electrician should be engaged to review at the owners discretion

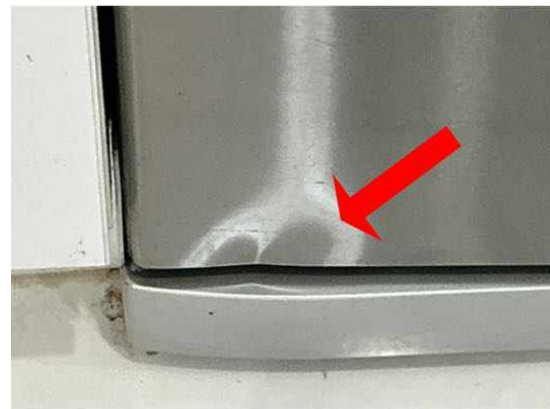
Finding 3.08

Building: Main Building
 Location: Kitchen
 Finding: Dishwasher door damaged
 Information: It was noted that the dishwasher door was damaged and dented

This is an aesthetic defect, however it detracts from the overall appearance of the building.

A licensed plumber should be appointed to review at the owners discretion.

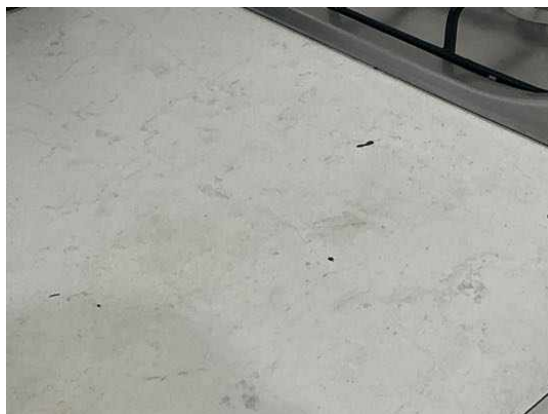
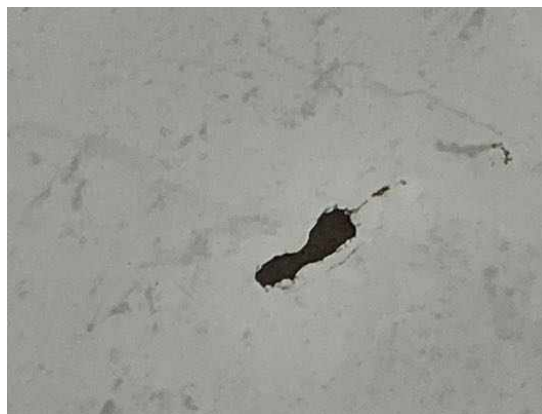
Finding 3.09

Building:	Main Building
Location:	Kitchen
Finding:	Kitchen benchtop damaged
Information:	It was observed at the time of the inspection that the kitchen benchtop was damaged. There was impact damage and there was some excessive heat related damage.
	Damage to the bench to can cause premature deterioration of the building and provide a unhygienic food preparation area
	A qualified cabinet maker should be engaged to review at the owners discretion

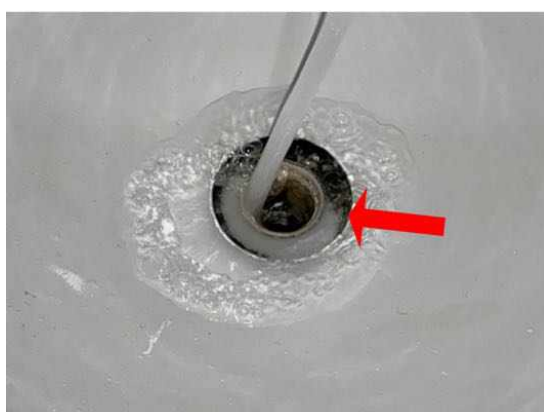
Building:	Main Building
Location:	Bathroom
Finding:	Basin waste damaged
Information:	It was observed at the time of the inspection that the basin waste was damaged.

The damage to the waste could allow for debris such as, hair to enter the draining system which could cause a blockage.

A licensed plumber should be engaged to review at their owners discretion

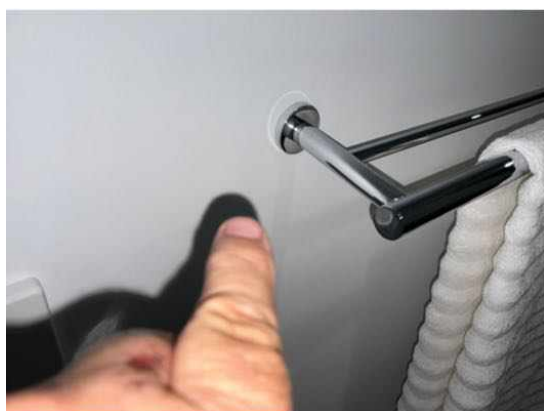
Finding: Towel rail - Loose

Information: The towel rails were found to be loose at the time of inspection. While not a major operational defect, function can deteriorate if the problem is left unmanaged.

It is advised that the homeowner performs remedial works to re-attach the towel rail to its original fixing. A general handyman may be required to perform these works.

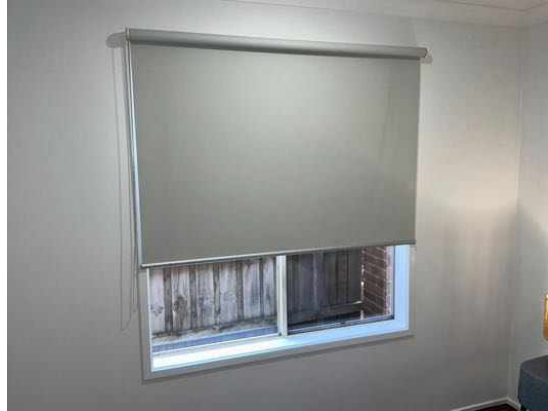
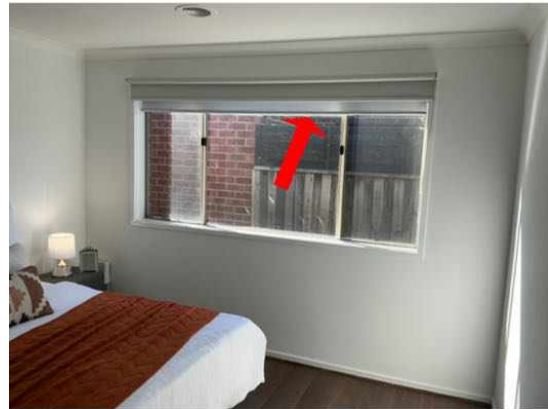
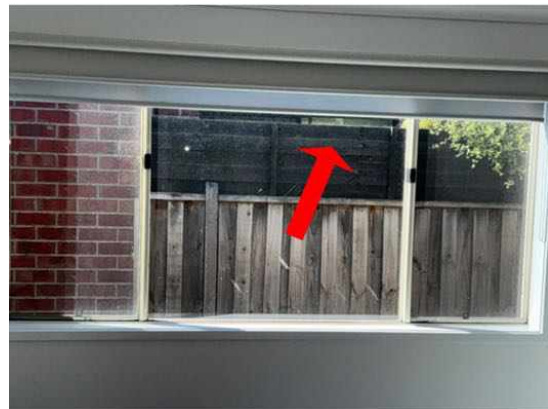
Finding 3.16

Information: It was noted at the time of the inspection that several window blinds throughout the building were stiff to operate and difficult to open and close. It appears that the roller mechanism is worn and may require replacement.

A blind repair contractor should be engaged to review as their owners discretions

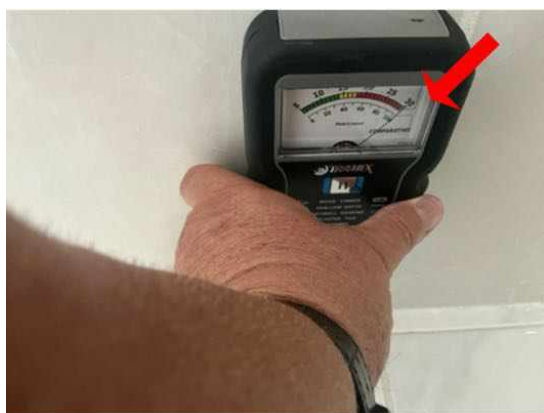
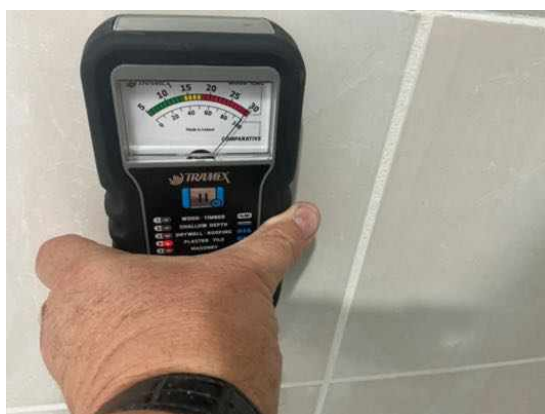
Finding 3.17

Building: Main Building
 Location: Ensuite
 Finding: Shower damp - Monitor
 Information: Damp is evident to the lower 400mm of wall to the shower alcove. There is also a high reading around the taps. There are no high readings transferring to the other side of the wall. Sealant appears to have been repaired recently and both sealant and grout appear in acceptable condition at present.

This defect is quite common, and is suspected to have been caused by moisture permeating or leaching through the grouting and perhaps gaps in the sealant prior to

Unmanaged damp in the shower recess is likely to facilitate the formation and development of mould and fungi growth, decaying associated building materials and compromising their structural integrity. It is important to address damp conditions, as the World Health Organisation notes that excess moisture leads - on almost all indoor materials - to growth of microbes such as moulds, fungi and bacteria, which subsequently emit spores and other matter into the indoor air. Exposure to these contaminants is associated with a wide range of respiratory and other health-related problems.

Monitoring the area is advised and if any visual signs of excessive moisture appear (peeling paint, mould) then consultation with a qualified plumber or bathroom specialist would be advised to identify the cause of damp and to perform remedial works as required.

Always ensure that sealant and grout is in good condition to prevent any moisture issues occurring in the future.

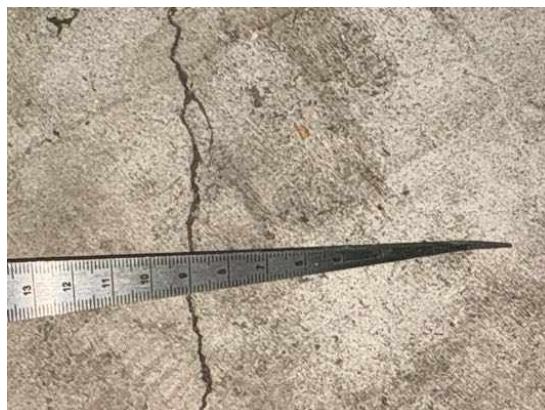
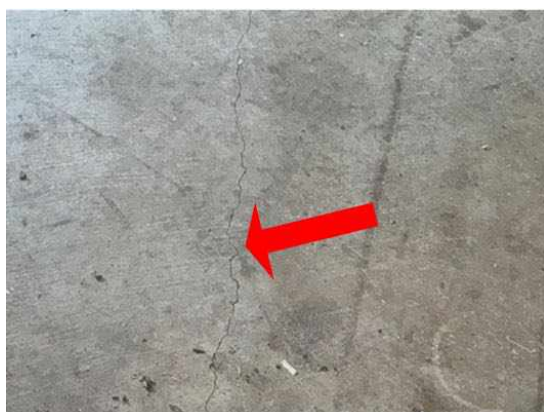
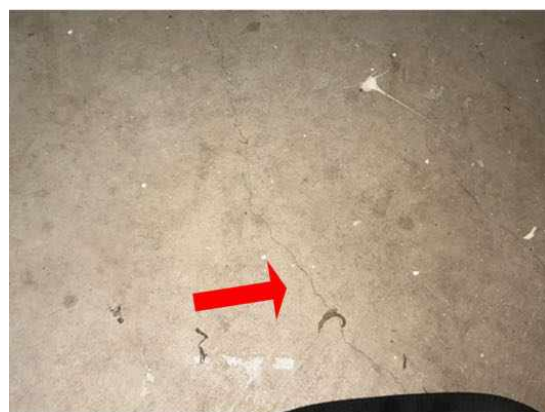
Building: Main Building
Location: Garage and driveway
Finding: Crack in concrete slab - Category 1
Information: A crack coded as Category 1 was identified in the slab. A Category 1 crack is described as a fine but noticeable crack, with the slab at an otherwise reasonable level.

To be considered Category 1, the approximate width of the crack is less than 1.0mm, or a less than 10mm change in offset when a 3m straight edge is placed over the defect.

Category 1 cracks should be monitored for a period of 12 months. At the end of the monitoring period, identified cracks that are rated greater than Category 2 are considered defects, and require rectification.

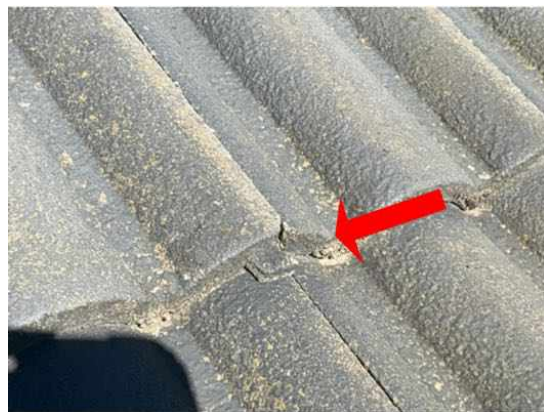
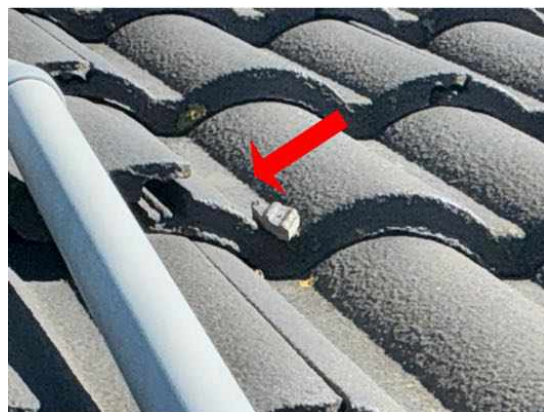
Finding: Roof tiles - Broken

Information: Upon inspection of the exterior roof covering, broken roofing tiles were identified. Broken and friable roof tiles are generally the result of ageing and weathering of what is essentially a porous material.

If left to further deteriorate, broken and brittle roof tiles are likely to lead to water penetration via the roof into the ceiling space, causing secondary damage to ceiling linings, insulation and roof structures. Broken roof tiles are also likely to detract from the effectiveness of the roof drainage system, creating potential for secondary damage to the exterior roof covering and roof plumbing.

Replacement of broken tiles is required and should be performed by a roofing contractor as soon as possible.

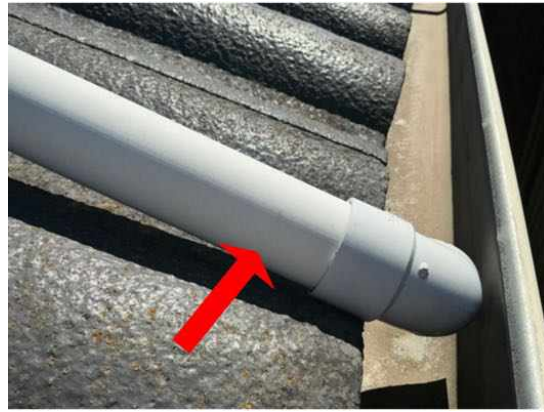
Finding 3.22

Building: Main Building
Location: Roof Exterior
Finding: PVC plumbing pipes not protected from UV
Information: It was observed that there were several PVC plumbing pipes on the roof exterior. These pipes have not been treated or coated to prevent deterioration from UV radiation.

UV radiation causes PVC pipes to go brittle and prematurely deteriorate.

A general handyman should be engaged to provide a UV protective coating to these PVC plumbing pipes at the owners discretion

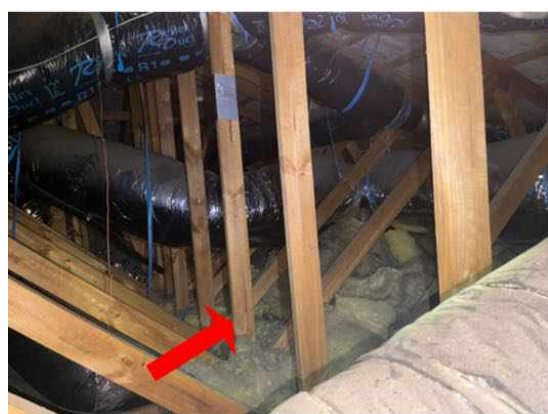
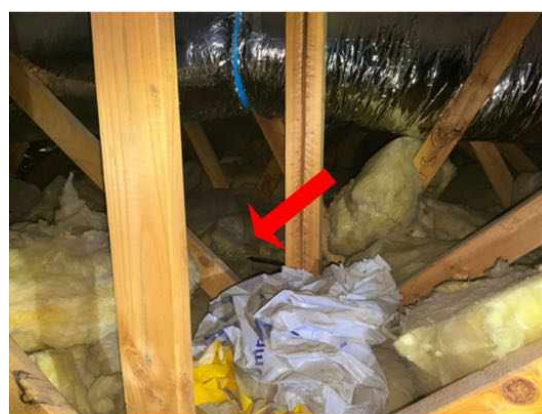
Information: At the time of the inspection, inside the ceiling cavity, it was noted that sections of insulation were blocking the exhaust fans. It is suspected that the inappropriate placement of this insulation is a result of poor installation, or that the insulation has simply been removed from its original position.

Where exhaust fans are blocked, many secondary defects are likely to occur; particularly evaporative water staining to the ceiling in the affected room. The formation and development of mould growth is also a concern, which presents as a respiratory health hazard.

Any misplaced sections of insulation should be removed and returned to its original position. Where insulation is insul-fluff (blown-type), total replacement of insulation may be warranted. An insulation contractor should be consulted prior to any works being performed.

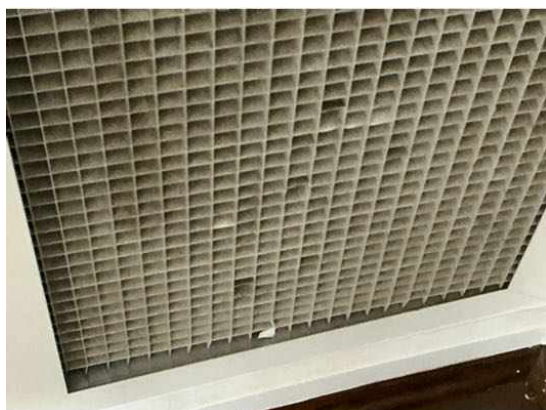
Finding 3.25

Finding: Return air grill dirty and damaged
 Information: It was noted at the time of the inspection that the grill to the heating return air was demonstrating some minor damage.

Although the damage is minor and the defect is mostly cosmetic, however it tracks from the overall appearance of the building.

A licensed plumber or General handyman should review at the clients discretion.

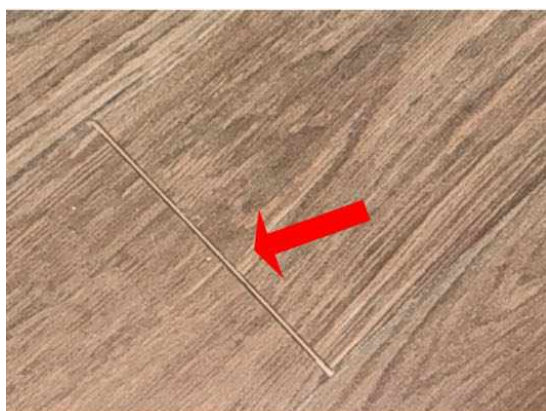
Finding 3.26

Building: Main Building
 Location: All Internal Areas
 Finding: Poor installation/floating floor
 Information: It was observed at the time of the inspection that the floating floor was demonstrating signs of poor and handyman workmanship.

The poor workmanship is mostly an aesthetic defect however this poor workmanship could contribute to the premature deterioration of the floating floor elements.

A specialist flooring contractor should be engaged to review at the owners discretion

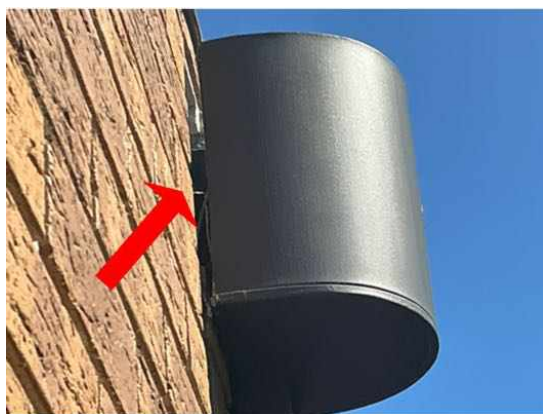
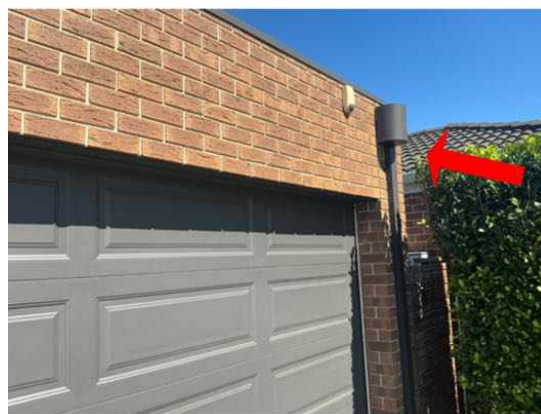
Building: Main Building
 Location: Front Elevation
 Finding: Rain head loose
 Information: It was noted at the time of the inspection that the rain head to the front right hand side of the building appears to be loose and inadequately fixed to the masonry wall.

Unattended to the rain head could move further and start leaking. The leaking water from rainheads can cause ground instability and be conducive to termite activity.

A licensed plumber should review as soon as possible.

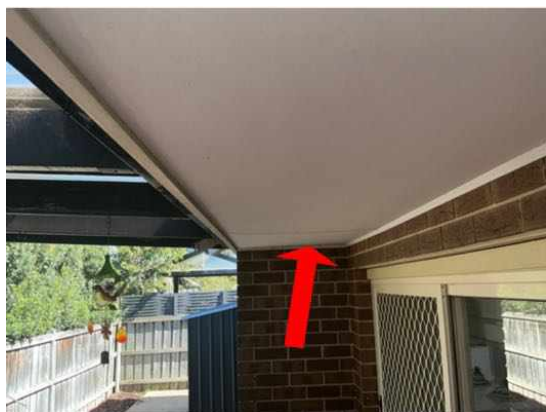
Finding 3.28

Building: Main Building
 Location: Rear Elevation
 Finding: Eaves - Sagging
 Information: Sagging to the eaves was evident in this area at the time of inspection. This type of defect is generally consistent with older properties, where the eave sheeting has worn over time.

Sagging eaves are susceptible to the attraction of excessive moisture, and are therefore considered non-functional. This defect also detracts from the overall appearance and condition of the roofing structure and any associated structures.

A roofing plumber or general handyman is recommended to perform rectification works as soon as possible. Subsequent water damage is likely to result over time if left unattended.

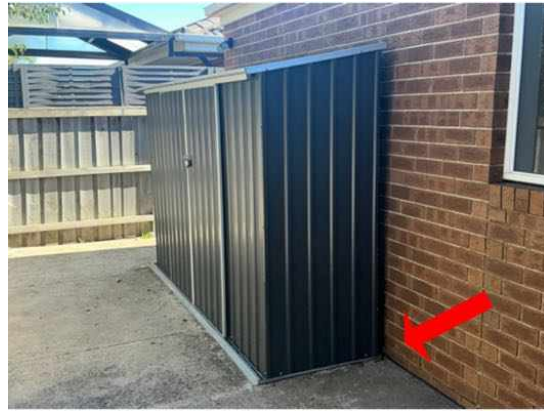
Finding 6.02

Building:	Main Building
Location:	All External Areas
Finding:	Bridging or breaching of termite barriers - adjacent internal flooring
Information:	Bridging is the spanning of a termite barrier or inspection zone so that subterranean termites are provided with passage over or around that barrier.

It is highly advised that a landscaper or paver be appointed to lower external grounds that are raised above adjacent internal flooring. Alternatively if external grounds and internal flooring is level installation of a raised door sill may be appropriate in preventing any water pooling in the area.

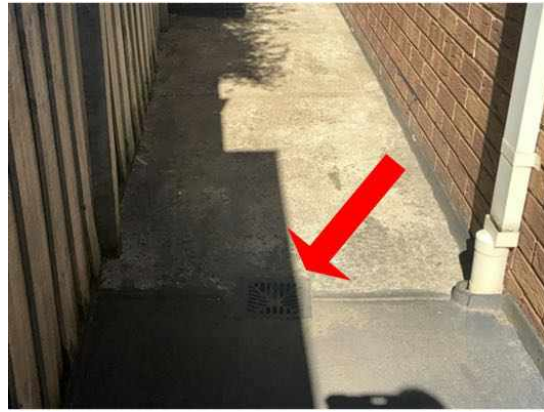
Finding 6.06

Building: Main Building
 Location: All External Areas
 Finding: Surface water drains blocked
 Information: It was observed at the time of the inspection that the surface water drains to the left and right side of the buildings paving was blocked with leaf trash. There was evidence that water hasn't been pooling and staining the concrete pavement. Excessive stormwater run-off and moisture has entered the subfloor which at the time of the inspection was very damp.

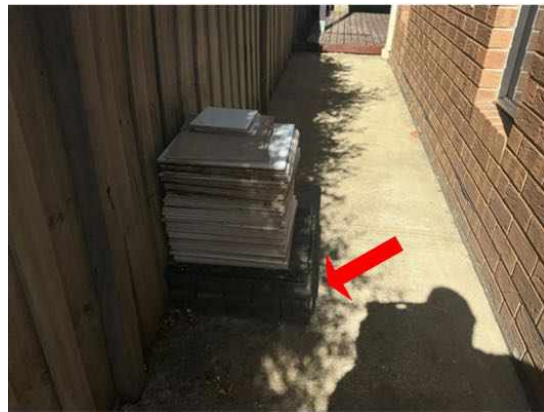
Finding 6.07

Building:	Main Building
Location:	Yard - Side
Finding:	Stored timbers -external area
Information:	The storing of timbers in the subfloor space or around the external property increases the risk of termite activity being present. As they are likely to come into contact with weather conditions or excessive moisture wood rot is likely to develop on timbers that are not treated.

It is highly recommended that any stored timbers be immediately removed from areas in which they may attract any termite / timber pest attack. Minimisation of risk / prevention of termite attack is far more adequate than dealing with the presence of termite activity.
