# Building and Timber Pest Inspection Report

Inspection Date: Fri, 30 Jan 2026

Property Address: 6 Tortola Pl, Parrearra QLD 4575, Australia

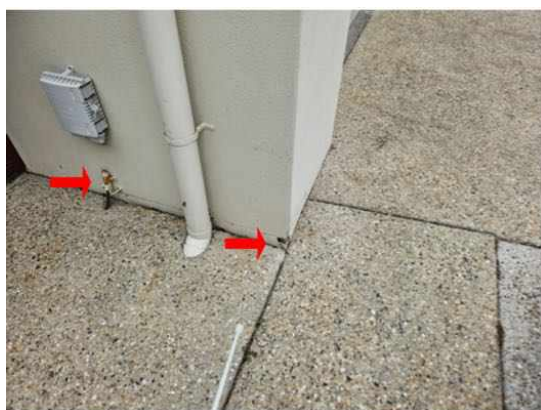
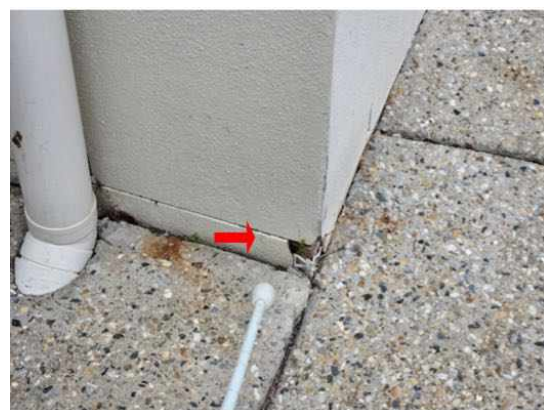
#### Finding 3.01

Building: Main Building  
Location: As shown  
Finding: Miscellaneous minor defects  
Information: Below are listed the miscellaneous minor defects identified on the day of inspection.

1. Chip to render at front left corner.
2. Rust to the earth stake and clip.
3. Minor surface to meter box.
4. Minor surface to fascia and gutter.

These minor defects should be attended to in the short term to prevent further deterioration.

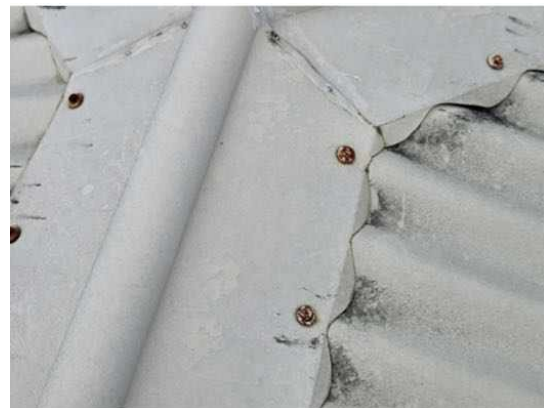
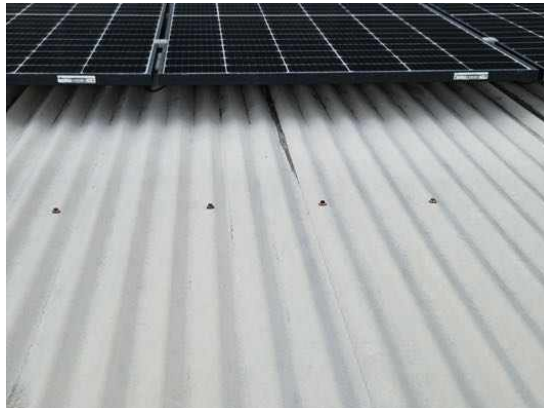
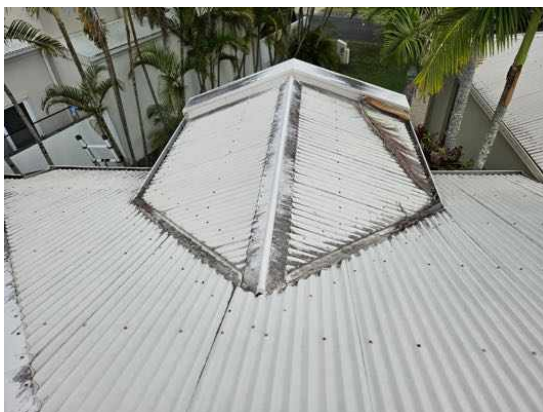
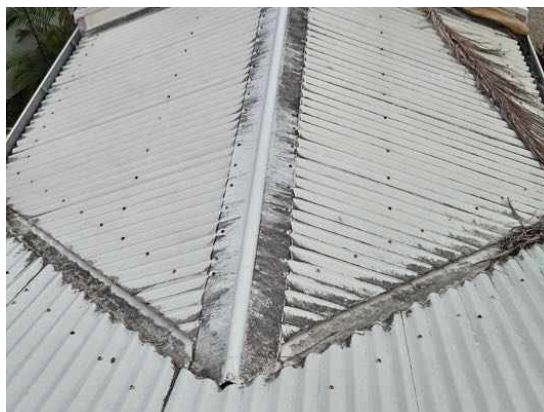
Finding 3.02

Building: Main Building  
Location: All External Areas  
Finding: Roof screws - rusting  
Information: It was noted during inspection, that throughout the roof surface the majority of roof screws are showing signs of rust at varying degrees ranging from minor to moderate.

The roof condition is noted as a minor defect ; however it should be made a priority to maintain the surface condition and prevent possible leaks and further deterioration.

This should be monitored over time, and should the condition worsen, consider replacement of the screws. As roof screws deteriorate they can have an effect on the adjoining roof materials.

A roofing plumber could be appointed at the clients discretion to replace the screws in question.

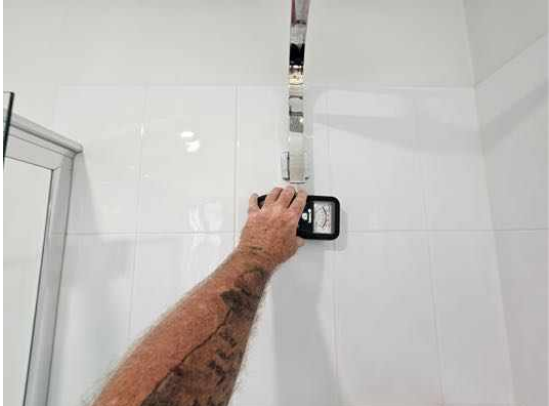
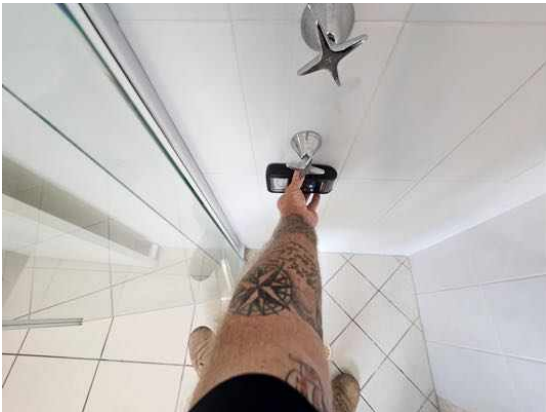
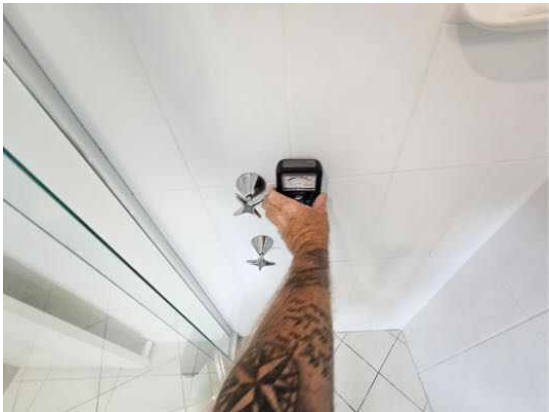
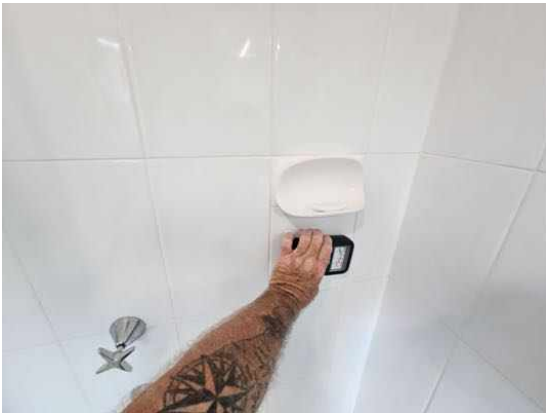
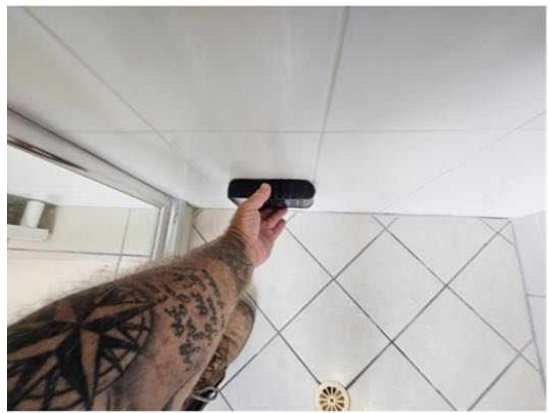
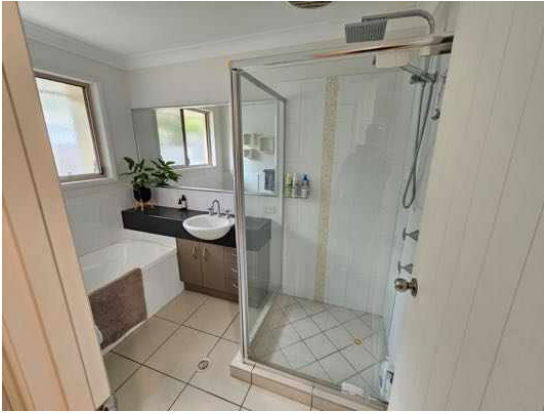
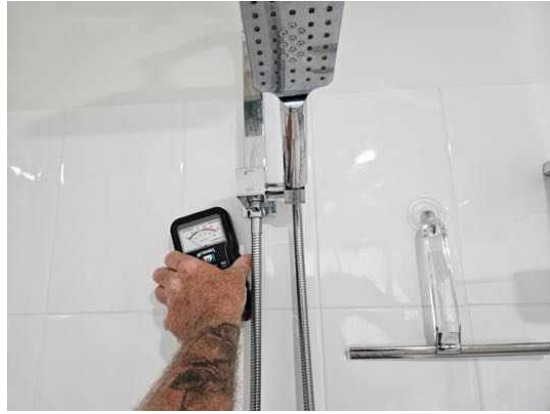
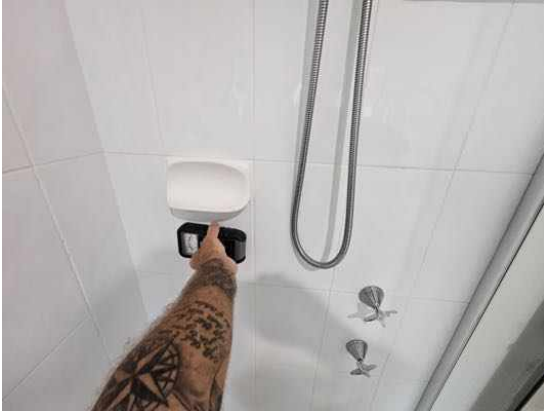
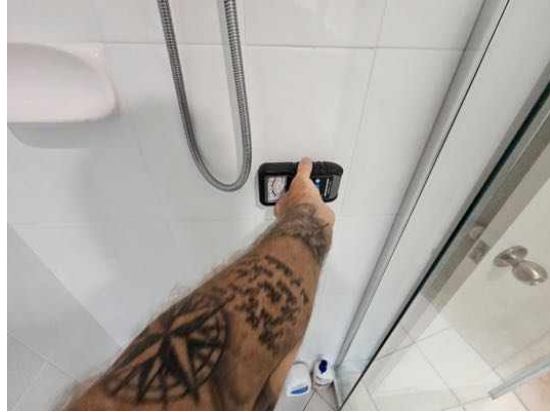
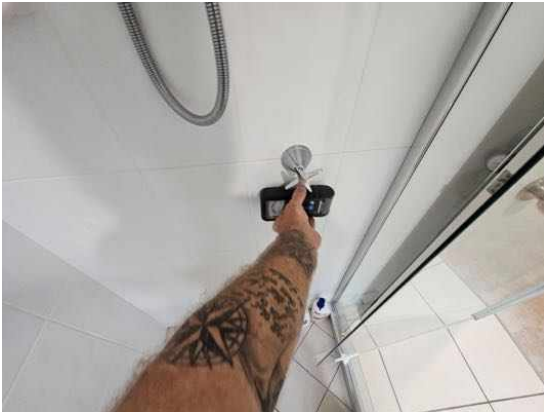
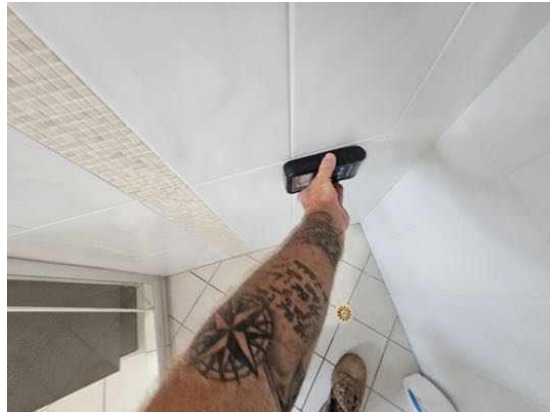
**Finding 3.03**

Building: Main Building  
Location: Bathroom  
Finding: No moisture detected in bathroom / ensuite  
Information: On the day of inspection the showers in the bathroom/s and ensuite are measure for moisture using a "Tramex" moisture meter. During this inspection no moisture was detected in these areas and the tiled / sheeted surfaces appear to be in good order.

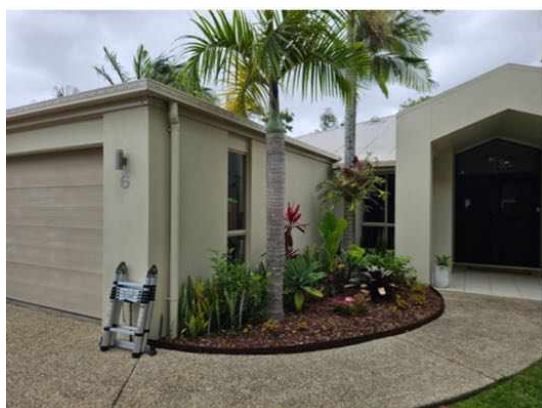
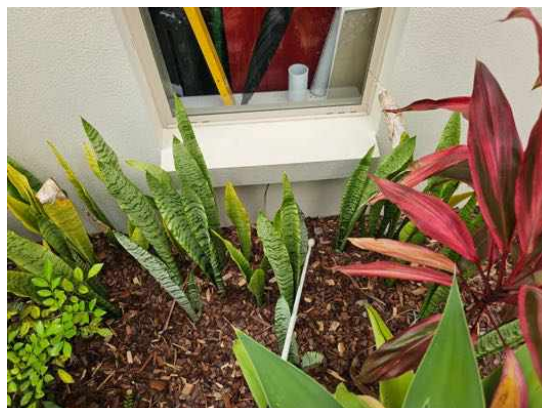
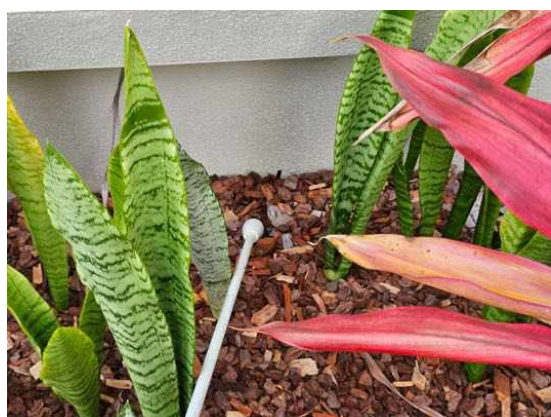
#### **Finding 6.01**

Building:	Main Building
Location:	Front garden
Finding:	Garden / landscaping debris - against building perimeter
Information:	It was noted on the day of inspection that there was garden debris, soil and landscaping litter against the building perimeter and covering the physical barrier. This can be at risk of creating an environment for timber pests and vermin to enter the building.

Allowing the build up of leaf litter and other foliage debris, the area can become a high risk environment by creating conditions such as moisture and cover for timber pests to build concealed mud leads under the cover; therefore, being able to enter the building unnoticed and unhindered.

It is recommended that the garden and debris be raked back to provide a of 75mm clearance below the nearest building elements to the ground. Ideally there would be complete clearance against the building edge.

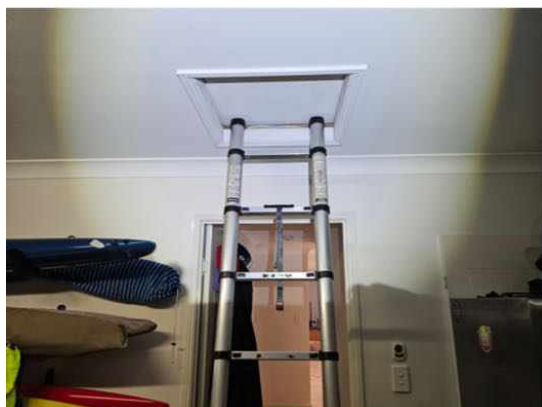
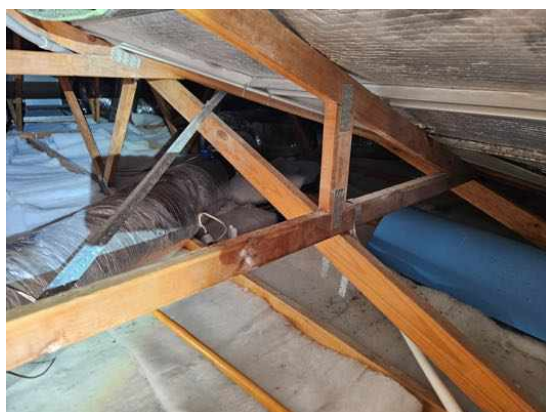
Building: Main Building  
 Location: Garage  
 Finding: Roof cavity / ceiling space - inaccessible  
 Information: On the day of inspection, the ceiling space / roof cavity was considered unsafe to fully inspect due to the congested / restrictive nature of the roof framing. This combined with the congested nature of the entry to the main roof area, made it a WH&S issue and ;therefore not inspected fully.

Should a full inspection be requested, an alternative position for an additional roof access hatch is advised.

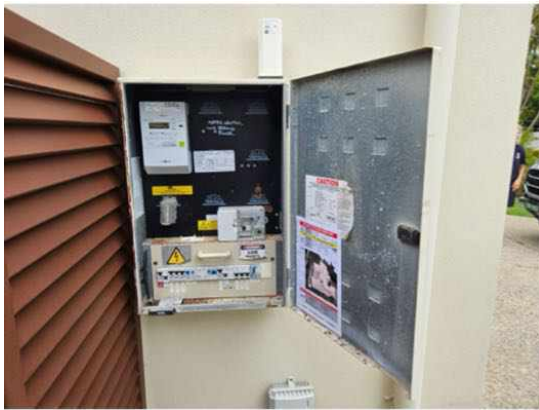
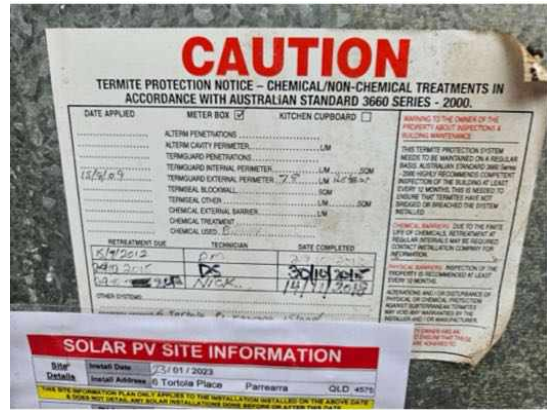
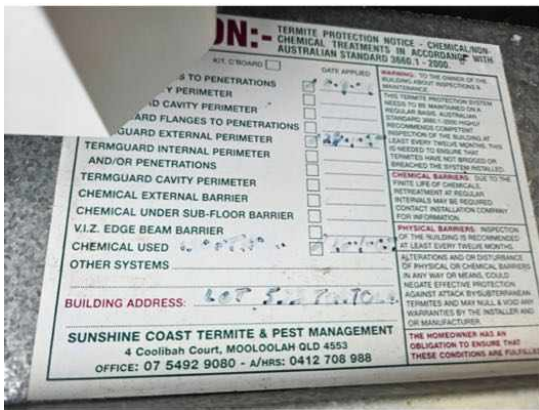
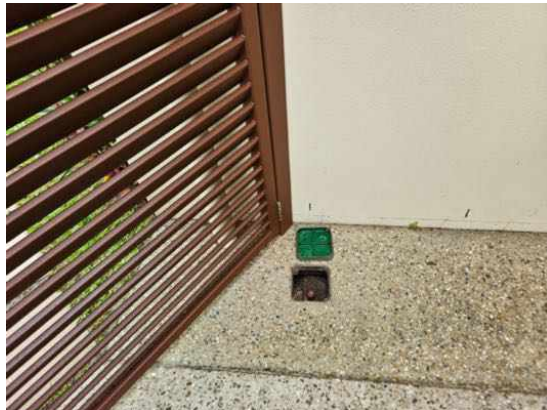
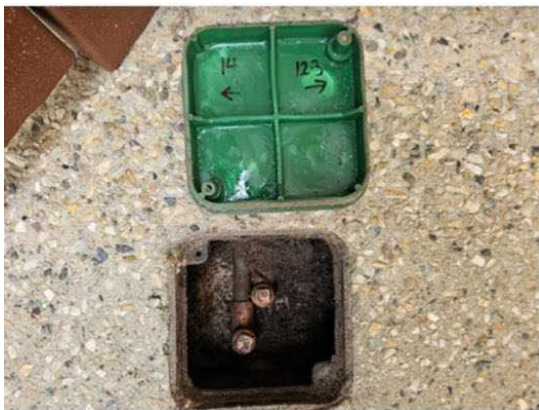
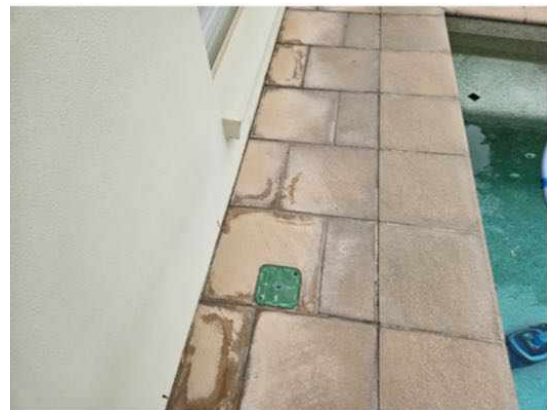
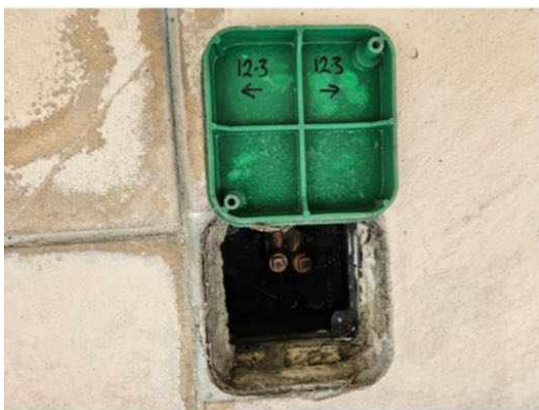
Where a Termite Management System has been identified you should refer to the type of barrier, date of installation, warranty conditions and any documentation provided by a builder or past owner. Consult the company who installed the barrier to confirm whether the system is still under warranty.

In order for a barrier system to be effective, the property must have regular inspections at intervals of not greater than 12 months. Depending on the risk profile attributed to the property, these inspections may be recommended at lesser time
