Building and Timber Pest Inspection Report

Inspection Date: Thu, 5 Mar 2026

Property Address: 579 Homer St, Earlwood NSW 2206,
Australia

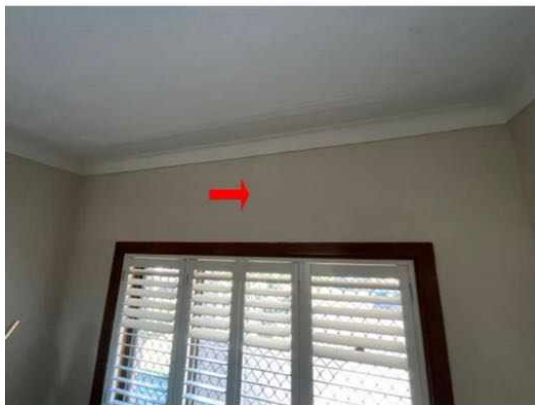
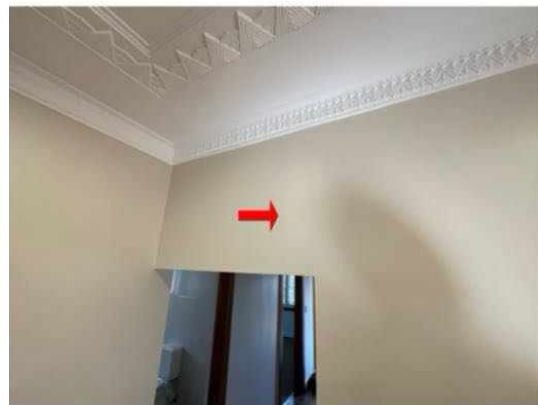
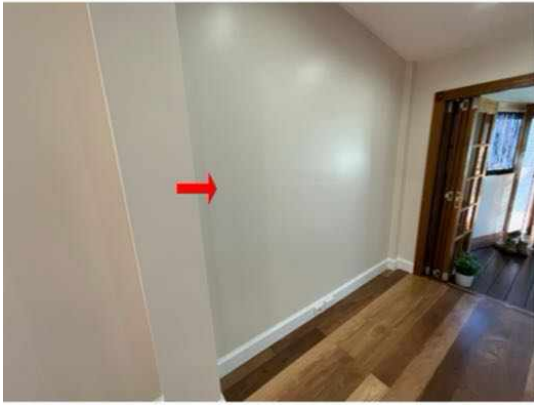
Finding 3.01

Building:	Main Building
Location:	Internal Areas
Finding:	Cracking - Damage Category 2 - Noticeable (up to 5mm)
Information:	Noticeable cracks are a common occurrence as a result of many primary defects. Such causes may include age, general wear and tear, expected building movement, general expansion/contraction of building materials in different weather conditions, and/or minor failings in the installation or application of building materials. I recommend monitoring and if further cracking is evident appoint a bricklayer to see what works are required.

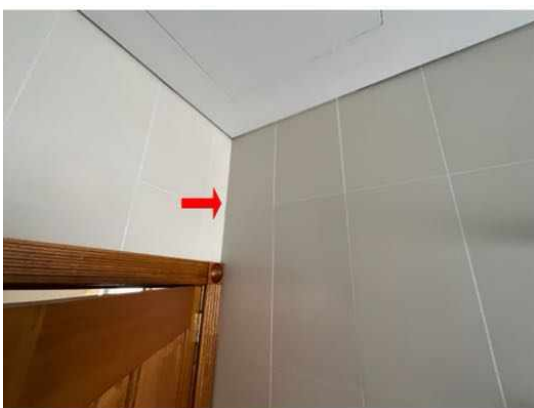
Finding 3.02

Information: Drummy tiled areas were identified at the time of inspection. The term 'drummy' refers to tiles that have become detached from their fixing, despite otherwise being in relatively good condition. Such defects are generally caused by physical or moisture damage to the area. Drummy tiled areas may also be a direct result of poor workmanship during the construction process.

Tiled areas may swell and shrink with changes in air humidity if the area has sustained moisture damage. Any exposure to moisture is capable of causing tiled areas to become drummy and/or cracked over a prolonged period of time. Drummy tiled areas generally require removal and replacement of affected tiles, with adequate sealant and grouting.

I recommend appointing a tiling contractor to see what necessary works are required.

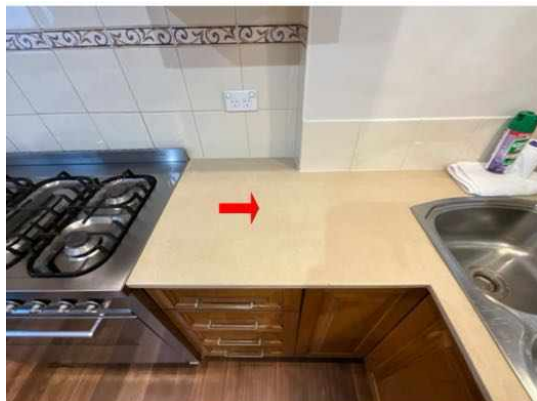
Finding 3.03

Finding: Stone - Cracked or damaged
 Information: Cracking was evident to the stone in this area at the time of inspection.

I recommend appointing a stone mason to see what necessary works are required to replace any damaged areas.

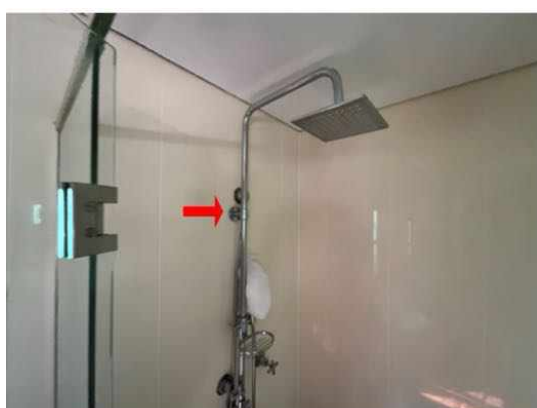
Finding 3.04

Building: Main Building
 Location: Bathroom
 Finding: Fitting or fixture - Loose
 Information: The fitting in this area is loose and requires adjustment to tighten.

If left unmanaged, the fitting may further deteriorate, causing potential for the development of other minor secondary defects.

A relevant tradesperson should be appointed to perform these rectification works at discretion of the client.

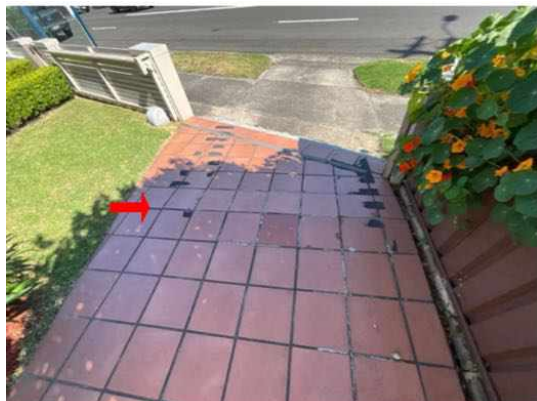
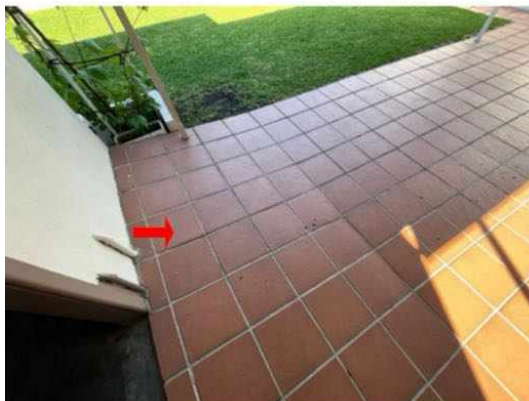
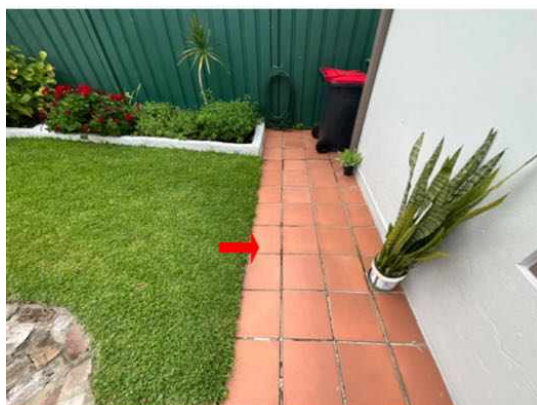
Finding 3.05

Building: Yard
 Location: External Tiled Areas

Finding: Tile - Cracked or damaged
 Information: Cracking was evident to the tiling in this area at the time of inspection.

I recommend appointing a tiling contractor to see what necessary works are required to replace any damaged tiles.

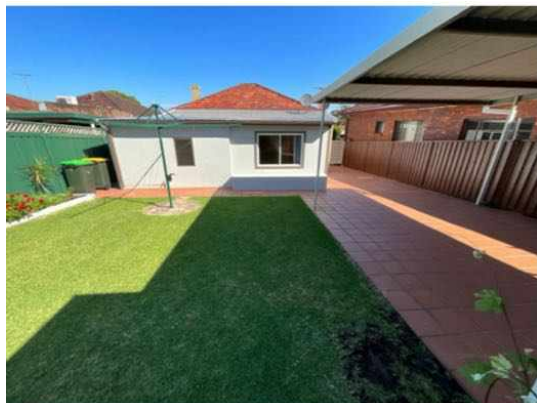
Finding 3.06

Building: Yard
 Location: Yard - Back
 Finding: Site drainage - Inadequate
 Information: The site drainage in this area was found to be inadequate at the time of inspection, creating potential for subsequent water damage to associated building elements.

It is important that water does not lie against the base of walls; surrounding paths and ground levels should be sloped to drain water away from walls.

Where site drainage is inadequate, installation of drains may be required. A qualified plumber should be appointed to further inspect the property and perform any remedial works as necessary. Water damage and secondary defects are likely to occur if left unmanaged.

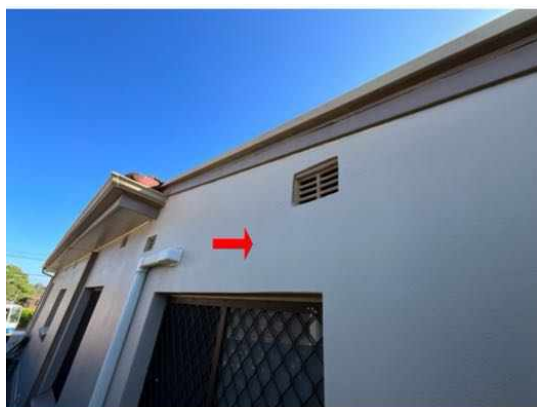
Finding 3.07

Building:	Main Building
Location:	Exterior walls
Finding:	Cracking - Damage Category 2 - Noticeable (up to 5mm)
Information:	Noticeable cracks are a common occurrence as a result of many primary defects. Such causes may include age, general wear and tear, expected building movement, general expansion/contraction of building materials in different weather conditions, and/or minor failings in the installation or application of building materials.

I recommend monitoring and if further cracking is evident appoint a bricklayer to see what works are required.

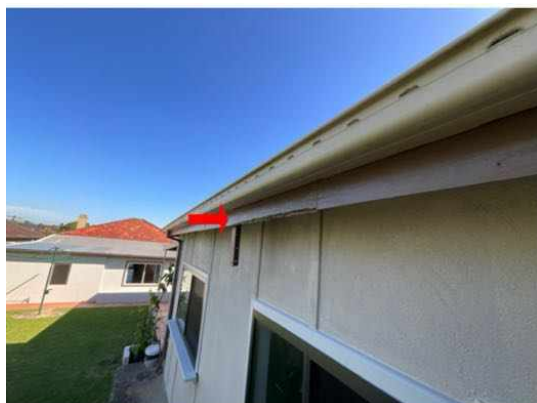
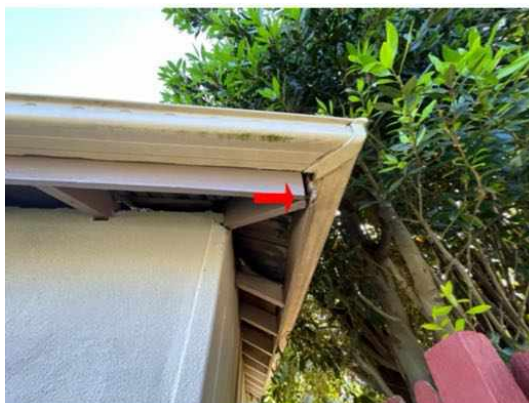
Finding 3.08

Building:	Garage
Location:	External Areas
Finding:	Wood rot
Information:	This building element shows evidence of wood rot. Wood rot, also known as Fungal Decay, occurs when timbers and other cellulose building materials are exposed to damp conditions on an ongoing basis. This could be the result of exposure to weathering over a prolonged period of time, or the attraction of excessive moisture from other abutting building materials.

Early intervention and regular maintenance, particularly of exterior timbers, will prolong the useful life of these building elements. Prior to any works being performed, the cause of the moisture that has created the visible wood rot should be identified and addressed in a suitable manner. Replacement of affected timbers may then be a necessary step in protecting surrounding building elements from such deterioration.

A qualified carpenter or registered builder may also be required to replace affected building materials.

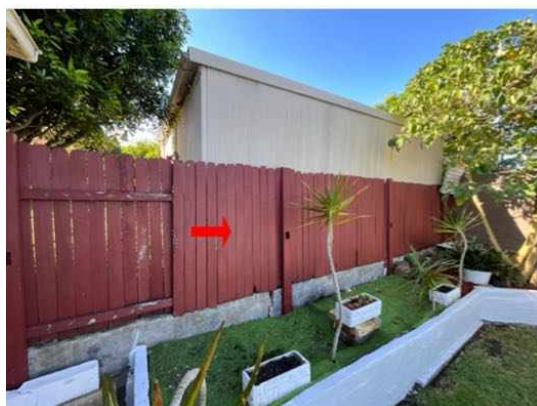
Finding 3.09

Building:	Yard
Location:	Fencing
Finding:	Fencing - Deteriorated
Information:	It was noted at the time of inspection that sections of the fencing throughout the property have deteriorated. Typically fencing deteriorates due to age and or wear, rot and or rust which is generally expected for a structure of this age, due to prolonged exposure to weather conditions. Sometimes inadequate installation or maintenance can be to blame.

If left unattended, it is likely that further damage will occur. It is suspected that repair of several elements of the fencing may be required however replacement may be a consideration of the client also.

A licensed fencing contractor should be appointed to provide further advice and perform rectification works as necessary.

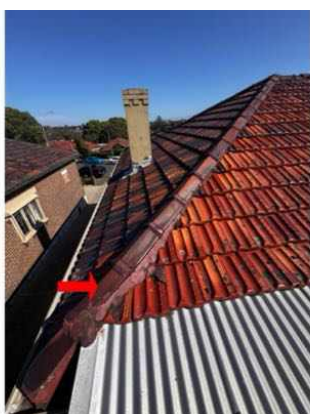
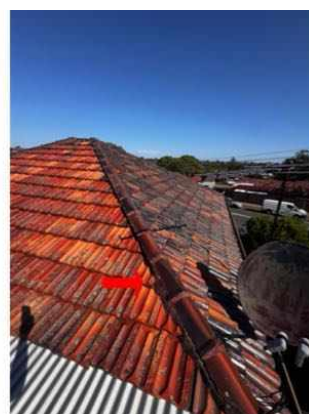
Finding 3.10

Building:	Main Building
Location:	Roof Exterior
Finding:	Mortar - Deterioration
Information:	Mortar, or 'bedding', is the material which fills joints and intersections between tiles and other building elements on the exterior roof covering, such as gable ends, hip capping and valleys. Upon inspection of the exterior roof, it was noted that sections of the mortar show varying levels of deterioration.

Mortar generally deteriorates as a result of frequent exposure to weather conditions over a prolonged period of time. Mortar that is deteriorating may allow water ingress into the roof void, putting associated building elements and roofing structures at risk of water damage. Deteriorated mortar also detracts from the functionality of roof tiles and other roofing elements, potentially decreasing weather tightness and roof drainage.

Mortar deterioration can be attended to by a handyperson where areas of deterioration are localised and easily accessible. Otherwise, consultation with a roofing contractor is advised where greater works are required.

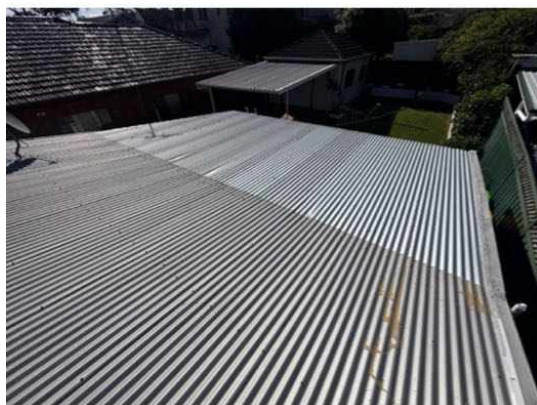
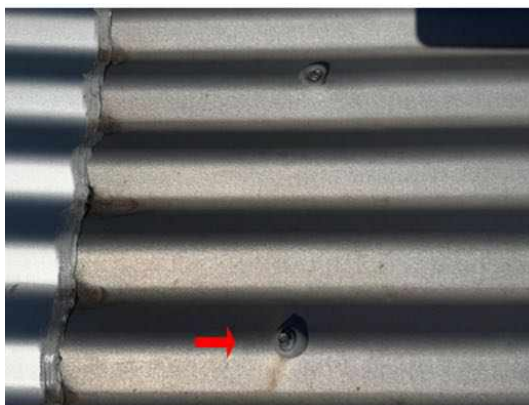
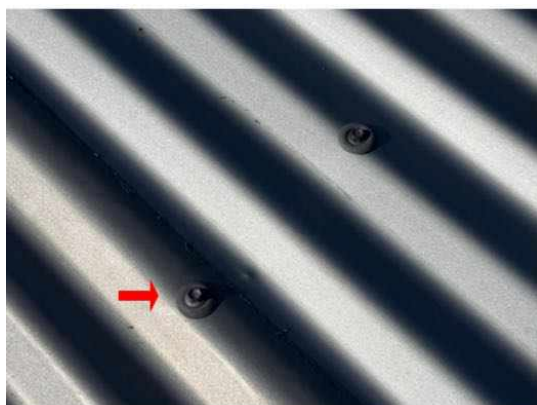
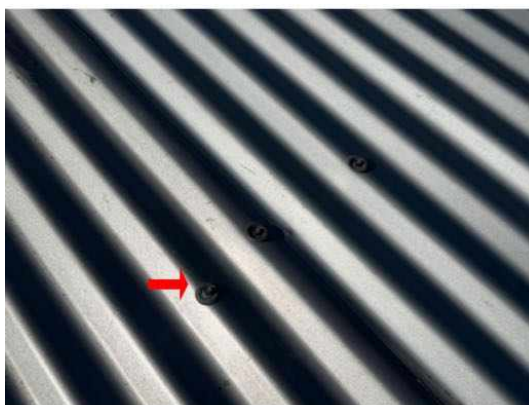
Finding 3.11

These screws may not provide adequate sealing or holding strength for metal sheeting, increasing the risk of leaks, loosening, or corrosion around the fixings.

A licensed roofing plumber should replace the incorrect screws with suitable metal roofing fasteners to ensure a secure and weatherproof installation.

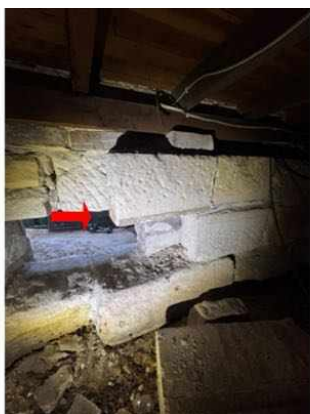
Finding 3.12

Building: Main Building
 Location: Subfloor
 Finding: Missing Lintel
 Information: A lintel has not been installed above the opening, leaving the brickwork unsupported.

Without a proper lintel, the brickwork above the opening may crack or collapse over time due to inadequate structural support.

A builder should be engaged to install a suitable lintel in accordance with building standards to ensure the brickwork is properly supported and structurally sound.

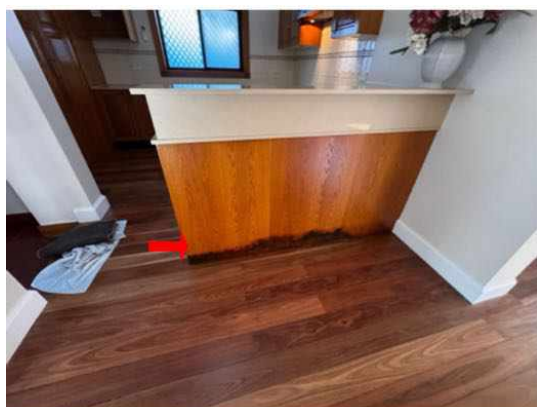
Finding 3.13

Building:	Main Building
Location:	Kitchen
Finding:	Water staining - No Moisture Detected
Information:	Water staining was evident in this area at the time of inspection. Water staining indicates that surfaces have been exposed to excessive moisture over time. The minerals and other elements in the water lead to staining, which may graduate to corrosion and deterioration if left unmanaged.

Where water staining is active, a licensed plumber must be consulted to identify the cause of the staining and to provide advice on any reparation works that may be required. Replacement of any broken or damaged structures is advised.

Conversely, where water staining is old and inactive, affected building materials may be repaired or replaced at client discretion. A qualified carpenter or registered builder may be appointed to perform these works.

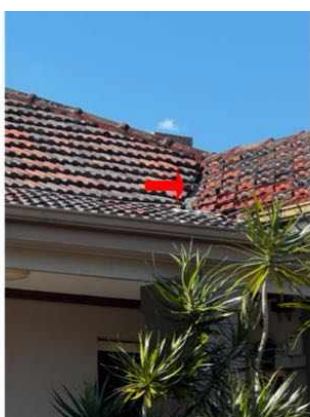
Finding 3.14

Finding: Building element - Rusted or corroded
 Information: This building element shows evidence of rusting and corrosion, which is likely to have developed as a result of excessive exposure to moisture and or inadequate coatings.

As surface rust provides no protection to the underlying iron, the deteriorating condition is likely to worsen if not addressed in the short-term future.

Where possible, the use of galvanized (treated) metals or aluminium coated metals aid in rust prevention, as does regular general maintenance. Rust formation can be controlled with coatings, such as paint, that isolate the iron from the environment.

Rusting and corrosion should be managed by ideally removing or limiting the affected surface from exposure to moisture.

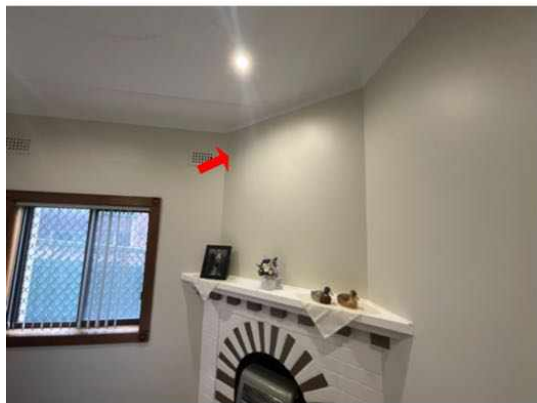
Finding 3.15

Building: Main Building
 Location: Bedroom 3
 Finding: Damp - Rain penetration
 Information: Rain penetration (also known as penetrating damp) is a common form of dampness that can occur through walls, roofs or openings (e.g. windows).

Common causes include faulty or missing flashing, lack of sealant and lateral damp.

The cause of the water leak should be addressed to prevent further damage. It is recommended that the water leak be resolved prior to any repairs of the damaged area, which may require localised replacement of building materials and refinishing.

I recommend appointing a builder to see what necessary works are required.

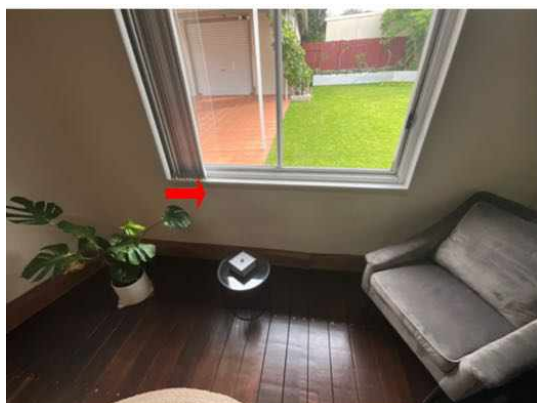
Finding 3.16

Building:	Main Building
Location:	Study
Finding:	Damp - Rain penetration
Information:	Rain penetration (also known as penetrating damp) is a common form of dampness that can occur through walls, roofs or openings (e.g. windows).

Common causes include faulty or missing flashing, lack of sealant and lateral damp.

The cause of the water leak should be addressed to prevent further damage. It is recommended that the water leak be resolved prior to any repairs of the damaged area, which may require localised replacement of building materials and refinishing.

I recommend appointing a builder to see what necessary works are required.

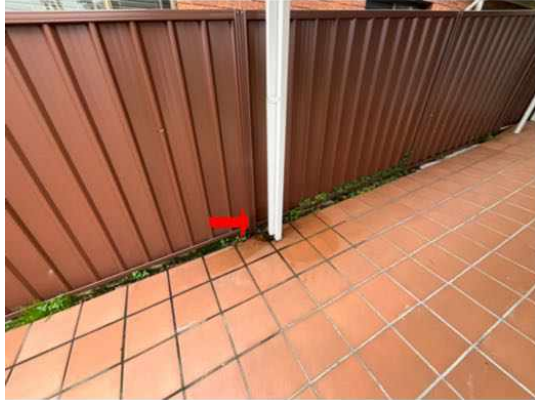
Finding 3.17

Building:	Garage
Location:	External Areas
Finding:	Stormwater drain - Not connected
Information:	The roof plumbing is not adequately connected to stormwater drainage on the site. This disconnection negatively impacts the functional capacity of the roof plumbing.

Where roof plumbing doesn't drain adequately, the area at the base perimeter can become excessively damp, potentially creating an environment that is susceptible to rust and corrosion of surrounding building elements, as well as attracting termites and other pests.

It is highly recommended that a plumber be appointed to further inspect the area and to install adequate drainage equipment where necessary.

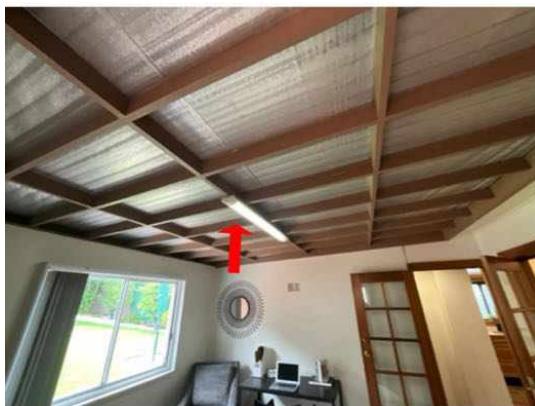
Finding 3.18

Building:	Main Building
Location:	Study
Finding:	Undersized Roof Rafter
Information:	A roof rafter appears to be undersized for its span and loading.

Undersized rafters may lead to excessive deflection or reduced structural performance of the roof over time.

A builder or structural engineer should assess the adequacy of the rafter and determine whether strengthening or additional support is required.

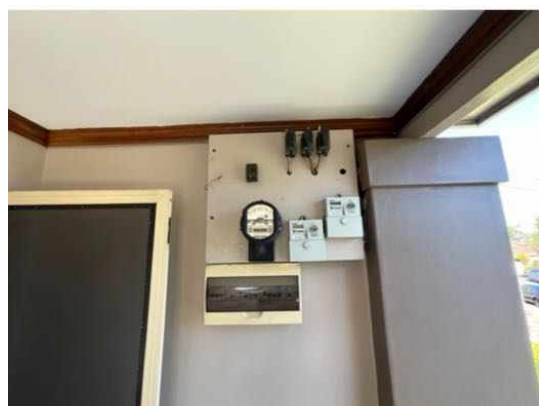
Building: Main Building
 Location: All Areas
 Finding: Termite Management System - no evidence of a chemical installation
 Information: The application of a post-construction chemical termite barrier is highly recommended for all properties, particularly if live termite activity has been found on the site previously. Such barriers are highly effective in preventing termite attack on any timber building elements throughout the property.

A durable notice should be placed in the switchboard unit to indicate current termite barriers. At the time of inspection, it appeared as though no termite management system has been installed, with no evidence to suggest preventative works taking place.

The client may consider gaining further advice from a pest controller as to the costs and procedures involved with this application. It is recommended that obtaining such advice be a short-term priority.

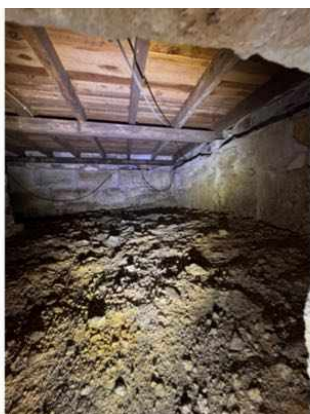
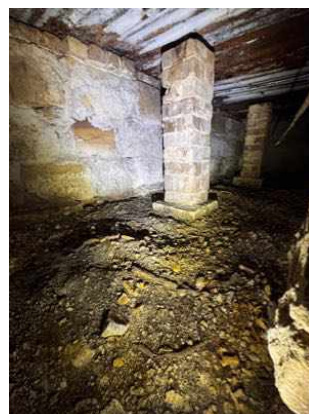
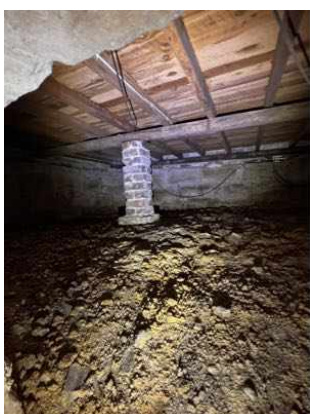
Finding 6.02

Building: Main Building
 Location: Subfloor
 Finding: Subfloor - Lack of ventilation
 Information: It was noted at the time of inspection that the subfloor area lacks adequate ventilation. Ventilation can be restricted by a variety of minor defects, including obstructions in the

A well ventilated subfloor aids in maintaining dry conditions, preventing secondary damage such as wood rot and pest activity, as well as preventing the development of mould and mildew (which can lead to respiratory safety hazards for occupants).

The client may also consider mechanical ventilation (powered fans) to improve subfloor airflow.

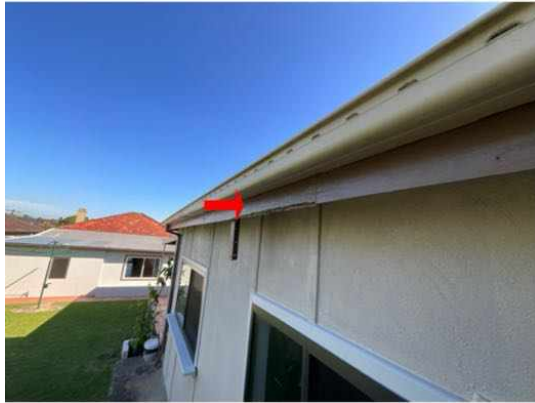
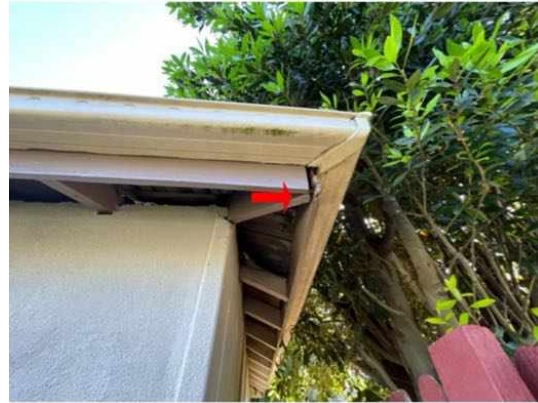
Finding 7.01

Building:	Garage
Location:	External Areas
Finding:	Fungal decay - present (localised)
Information:	Fungal decay also known as wood decay or wood rot generally refers to the deterioration of timber elements when in contact with excessive levels of moisture for a prolonged period of time.

In this case although the affected timber element is in a decaying state the extent of any visible damage appears to be localised to a specific area and is yet to spread to other parts of the building element or affect adjoining structures. The fungal decay is therefore likely to be of a relatively superficial nature with minimal impact on the structural integrity or tensile strength of the timber element.

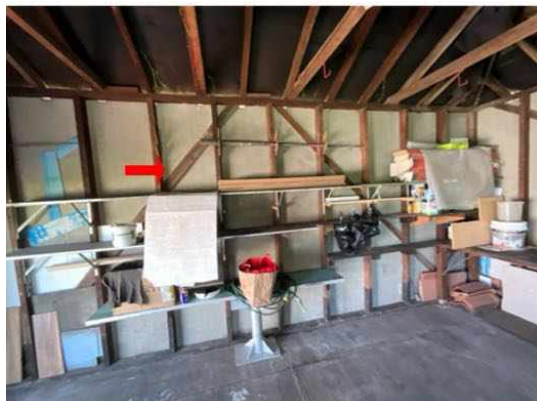
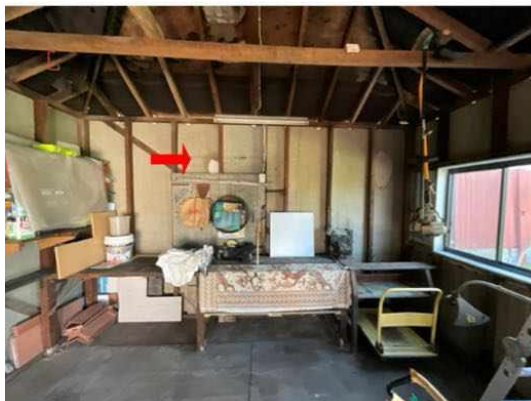
Building:	Garage
Location:	External Areas
Finding:	Asbestos - Suspected ACM Identified on Site
Information:	Reporting on Asbestos is outside the Scope of this Report. This suspected defect is highlighted as a caution only. We suspect, based on our experience in the building industry, that there is a higher risk of the identified building element containing asbestos.

As Asbestos Reporting is outside the scope of this report, we advise that you consider a separate Asbestos Inspection and Condition Audit, which can include the taking of

In the interim, the client is advised to act with caution, especially when considering any damage to building materials general wear and tear renovations extensions demolition and general maintenance activities due to the suspected presence of Asbestos.

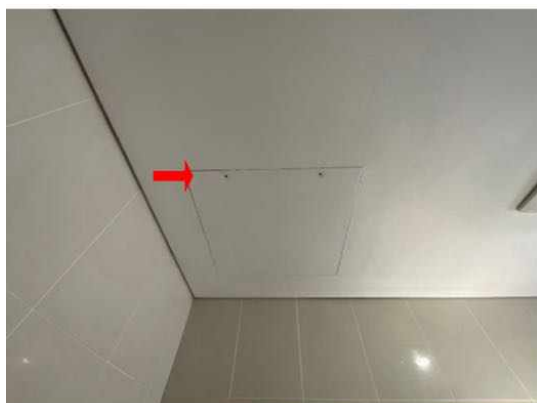
Building: Main Building
 Location: Roof Void
 Finding: Additional Photos - Obstructions and Limitations
 Information: These photographs are an indication of the obstructions and limitations which impeded full inspection of the property at the time of inspection. These obstructions can hide an array of defects and should be removed to allow full inspection to be carried out. A re-inspection is recommended once the areas are made accessible.
