Building and Timber Pest Inspection Report

Inspection Date: Fri, 30 Jan 2026

Property Address: 38 & 38A Glenfern Cres, Bossley Park NSW
2176, Australia

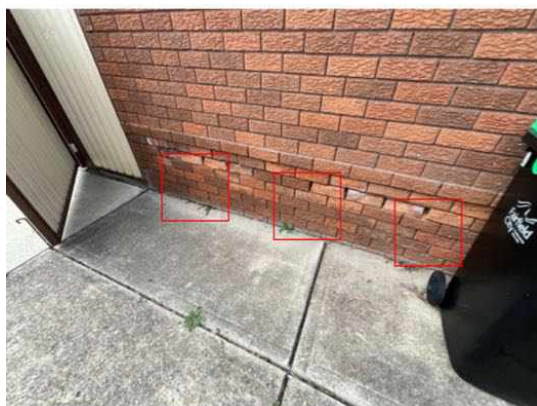
Building:	Main Building
Location:	Multiple areas
Finding:	Brickwork and Mortar - Deteriorated (Erosion)
Information:	This section of walls and piers were found to be deteriorated. Mortar, or `bedding`, is the material which fills joints and intersections between bricks in masonry walls and structures.

Commonly referred to as corrosion or erosion, the bricks and mortar are aged and likely to have been affected by a variety of factors, including moisture, salt-based deterioration, and more.

Mortar and brickwork should be replaced to ensure the structure remains in their intended location and to prevent gaps, which would allow water or moisture ingress and secondary damage as a result.

This can be addressed by a licensed bricklayer where areas of deterioration are localised and easily accessible. Otherwise engagement of a licensed builder is required.

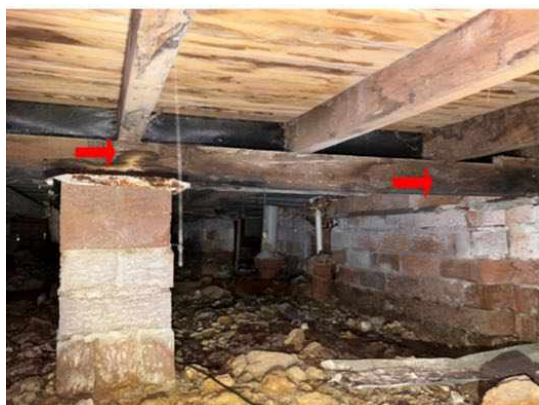
Building: Main Building
 Location: Bathroom
 Finding: Subfloor members — Water staining
 Information: There is evidence of water staining to the subfloor members under the bathroom.

This water staining indicates that surfaces have been exposed to excessive moisture over time, potentially due to water leak. The minerals and other elements in the water lead to staining, which may graduate to corrosion and deterioration if left unmanaged.

A licensed plumber must be appointed immediately for further assessment and to confirm whether any active leaks are affecting the area or not and also that the waterproofing membrane is in serviceable condition.

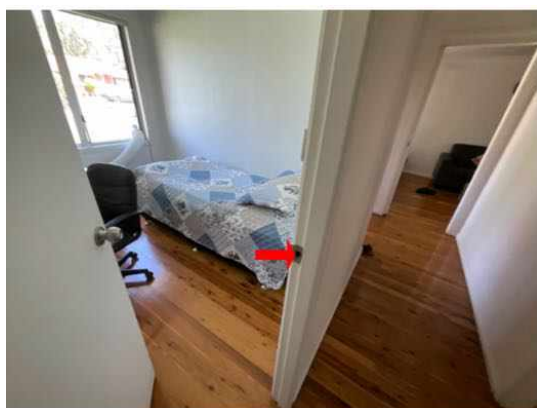
This is a common defect and is expected in a property of this age, whether being due to substandard installation or general deterioration of the door hardware.

Readjustment of the striker plate is recommended at client discretion. Works such as these can be completed by a general handyman or qualified carpenter.

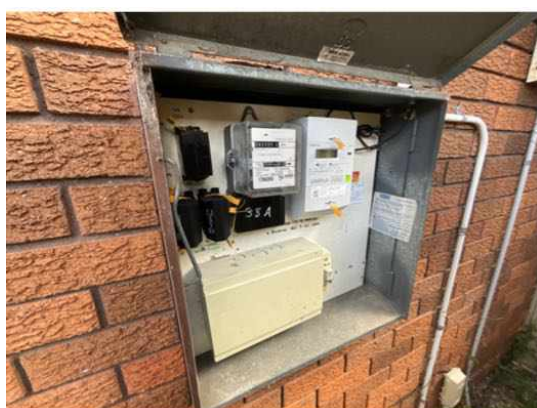
A durable notice should be placed in the switchboard unit to indicate current termite barriers. At the time of inspection, it appeared as though no termite management system has been installed, with no evidence to suggest preventative works taking place.

The client may consider gaining further advice from a pest controller as to the costs and procedures involved with this application. It is recommended that obtaining such advice be a short-term priority.

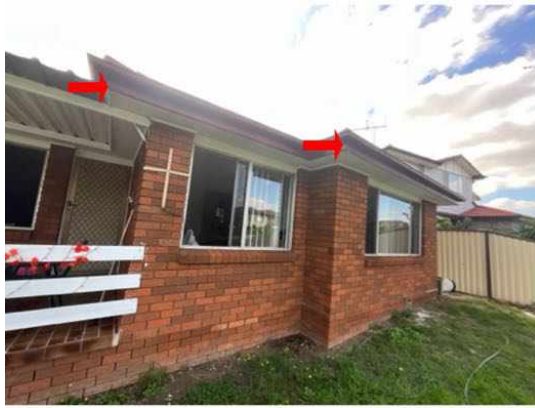
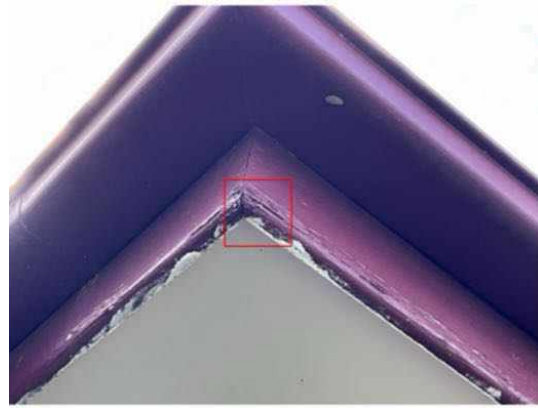
Finding 7.02

Building:	Main Building
Location:	Fascias
Finding:	Fascias - Wood rot/decay
Information:	Wood rot was found to be affecting fascias and barges in this area, evidenced by the presence of mould on the surface in some areas. Wood rot, also known as Fungal Decay, occurs when timbers and other cellulose building materials are exposed to damp conditions on an ongoing basis.

barges may then be a necessary step in protecting surrounding building elements from such deterioration.

A licensed plumber may be appointed to assess the cause of excessive moisture and to provide advice on any remedial works as required. A licensed carpenter may also be required to replace affected building materials.
