Building and Timber Pest Inspection Report

Inspection Date: Wed, 4 Mar 2026

Property Address: 13/13 Churchill Ave, Chadstone VIC 3148,
Australia

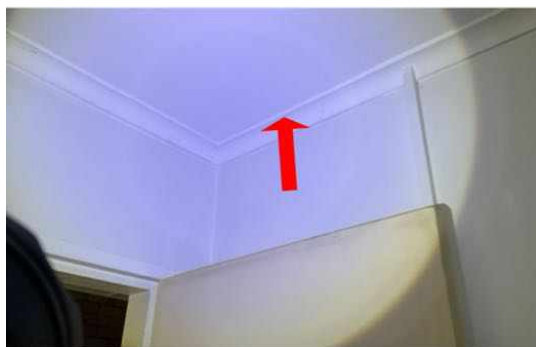
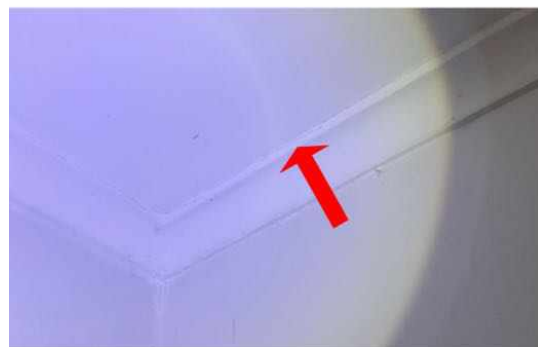
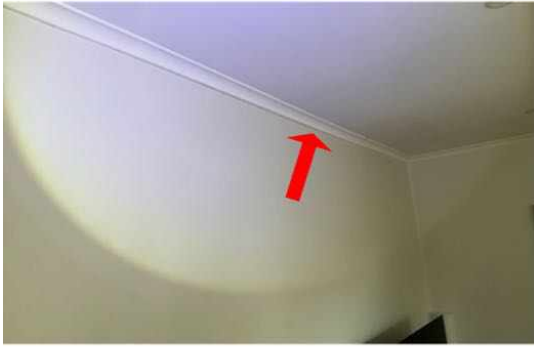
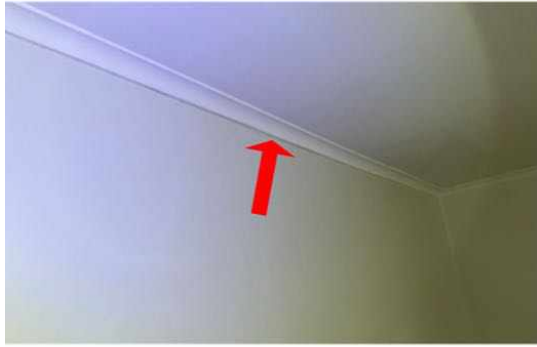
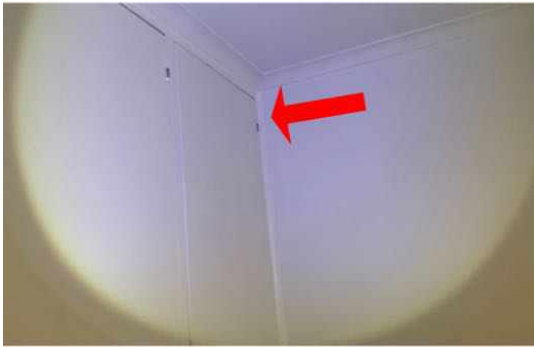
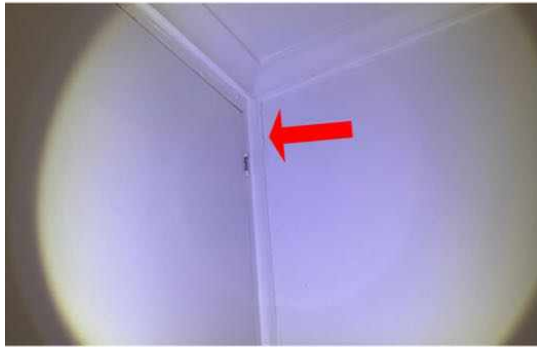
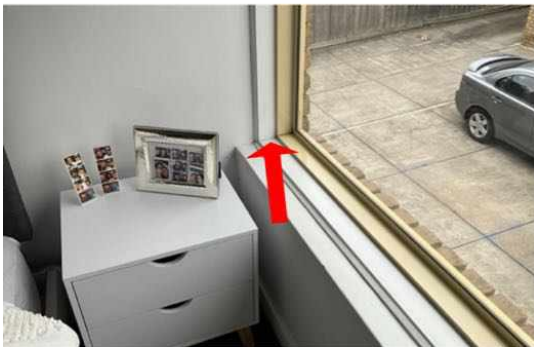
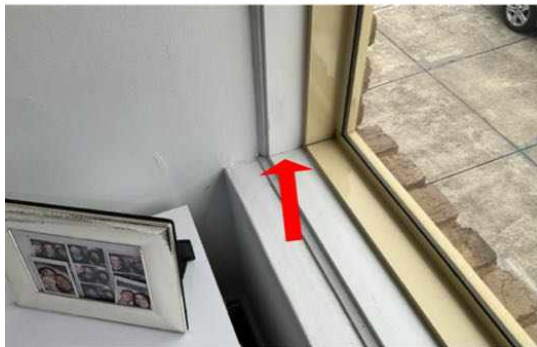
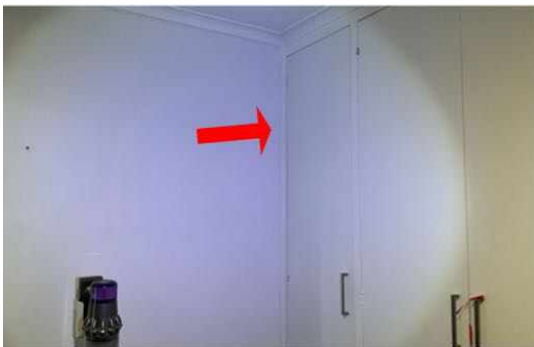
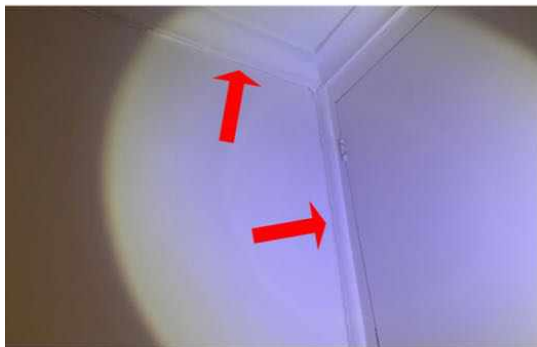
Finding: Cracking - fine

Information: Some fine cracking was noted throughout the property.

Although fine cracks are quite noticeable, they are often only considered to be an appearance defect, and usually do not indicate any structural damage. Generally, the cause of a fine crack is indicative of a separation between building materials and finishes (e.g. paint, plaster, etc.) along joins.

Note: photos included are indicative of fine cracking noted at the the time of inspection. Other fine cracks may be present but not recorded here.

Cracking of this nature can generally be repaired with minor sanding, filling and/or repainting. Such works should be performed by a qualified painter or a general handyman.

Monitoring of all cracking should be conducted frequently. Always contact a building inspector should cracks widen, lengthen, or become more numerous.

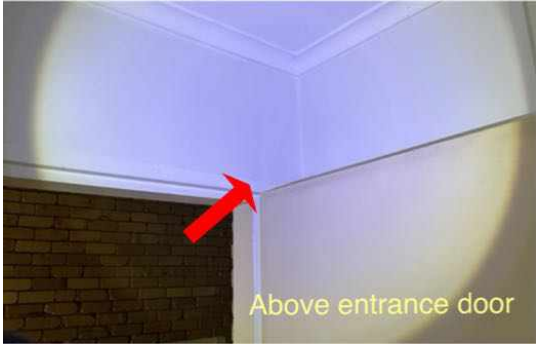
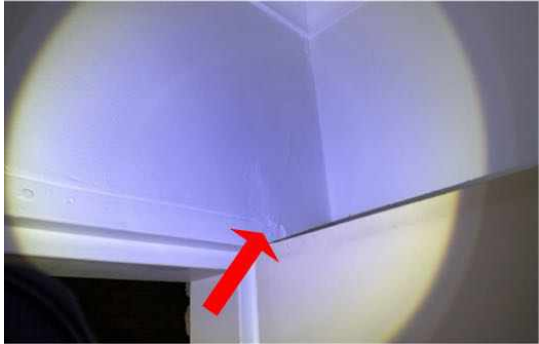
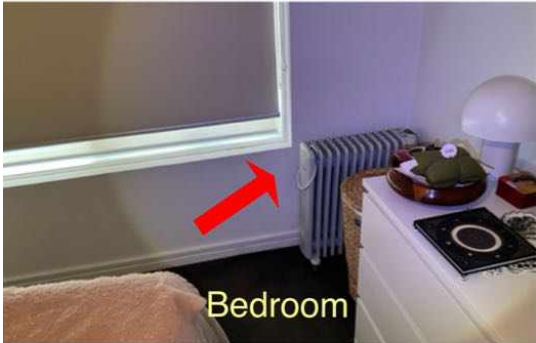
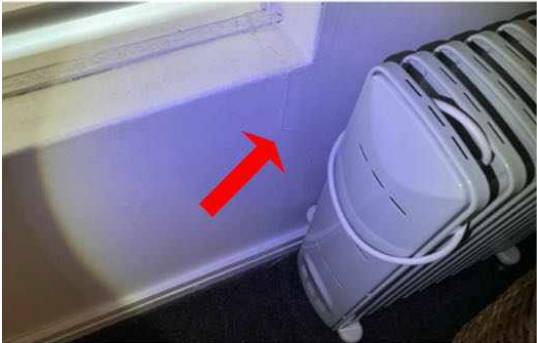
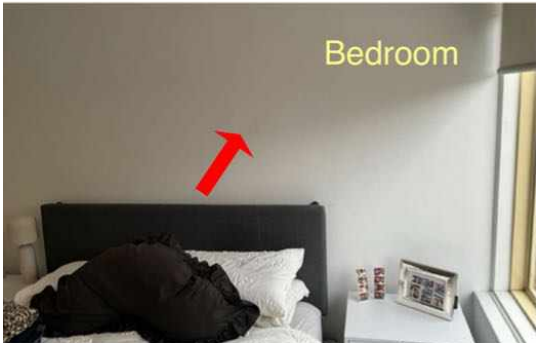
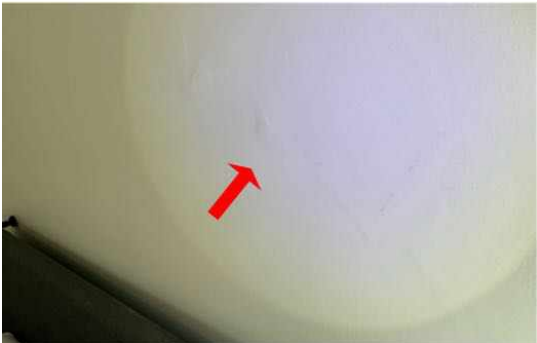
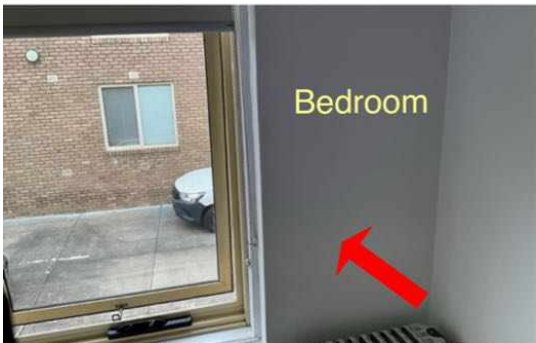
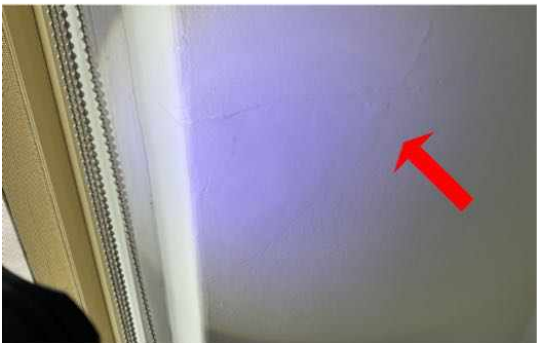
Finding 3.02

Finding: Cracks and crack repairs noted to the internal solid walls

Information: Cracking and previous patching of cracks was noted to the internal solid wall in the bedroom. Generally these cracks are the result of movement in the foundations of the property and occur quite easily.

It is recommended that the cracks be monitored for a period of time to determine any ongoing cracking.

Consultation with a solid plasterer or painting contractor should be sought if the cracking develops further .

Always contact your building inspector should cracks widen, lengthen, or become more numerous.

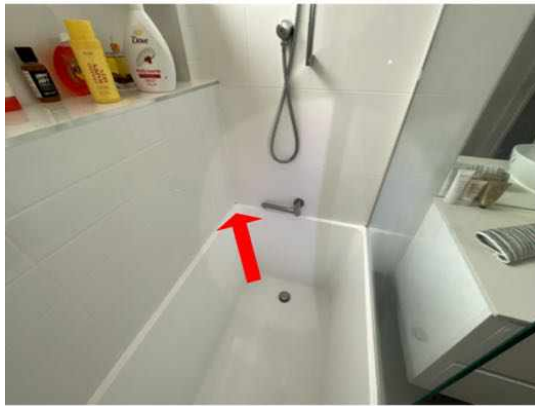
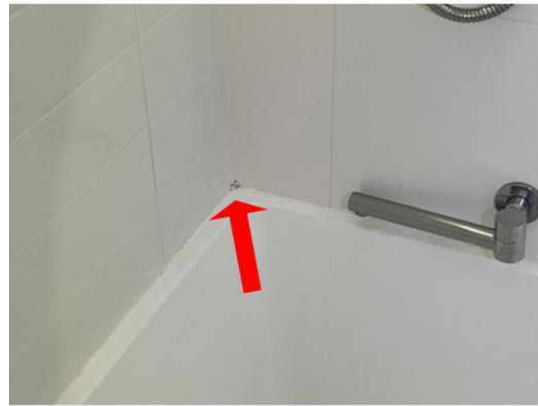
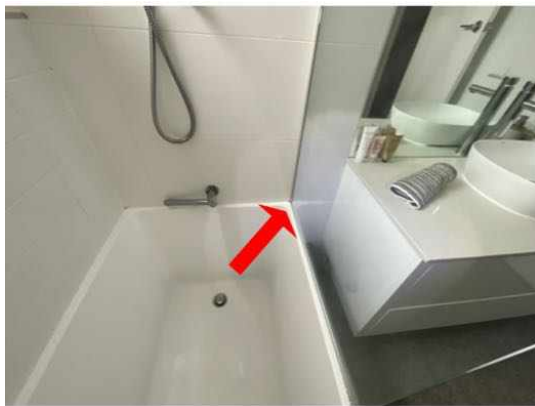
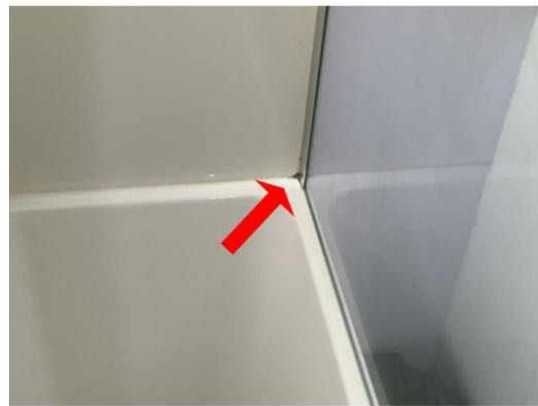
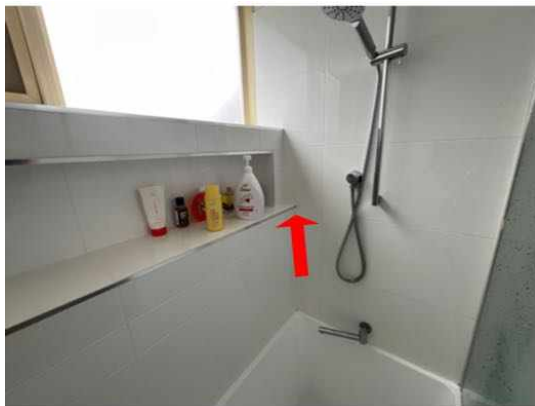
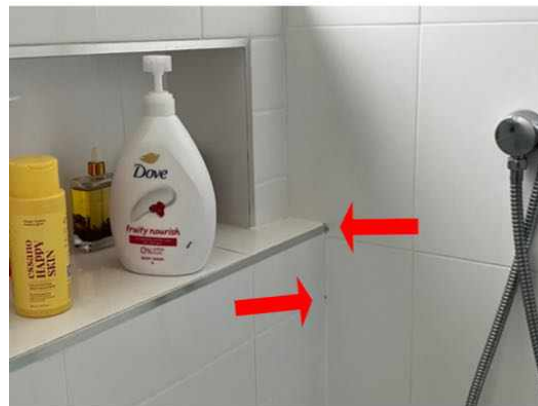
Finding 3.03

Building:
 Location: Bathroom
 Finding: Sealant - Degraded and mouldy within the shower/ bath area
 Information: Sealant is degraded in this area. Sealant is used to protect gaps and crevices in building materials to ensure that they are water-tight and prevent water penetration to the associated structures.

Failure to do so can lead to further deterioration which can then lead to water damage

Where sealant is damaged or mouldy , a tiling contractor should be appointed immediately to re-apply any silicone where necessary.

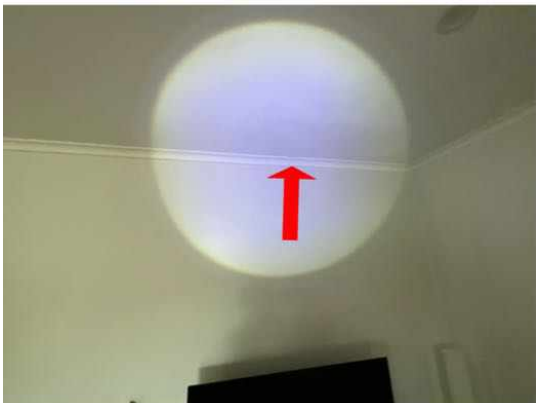
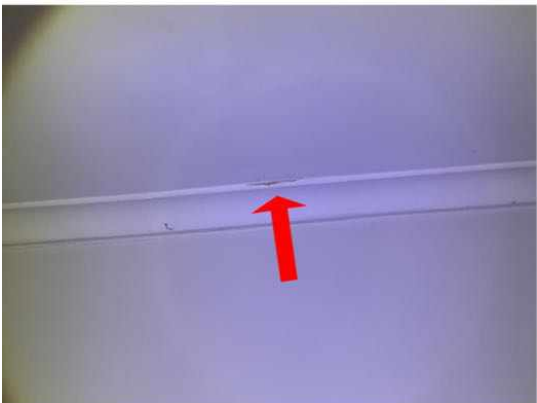
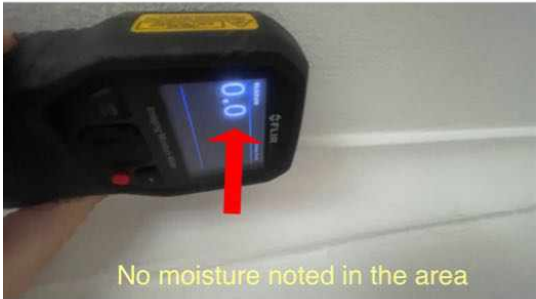
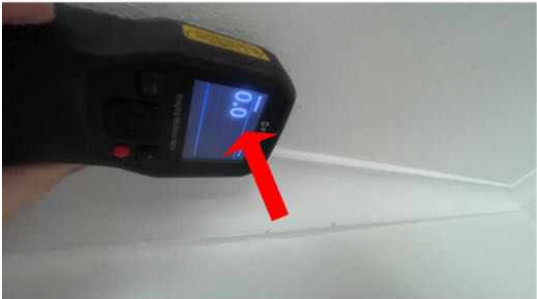
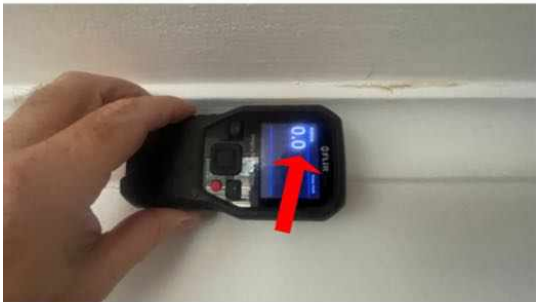
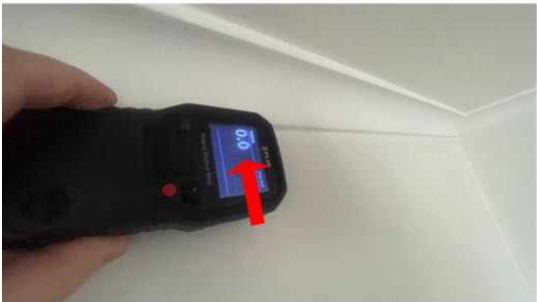
Finding 3.04

Ceiling stained - no current moisture noted

At the time of inspection, there appeared to be some staining to the ceiling in this area. It is unclear how the staining has occurred. Previous leaking from the roof could be a possibility.

At the time of the inspection, there was no moisture within the stained area of the

ceiling when tested with a moisture meter.

Please note: should leaking through the roof occur, it is suspected this would be an OC issue.

It is recommended that the area be monitored for any changes or increase in staining. Should this occur, consultation with a roofing plumber should be undertaken to determine the source of the leak and make necessary repairs.

Should no changes occur, the area may be repainted at the discretion of the homeowner.

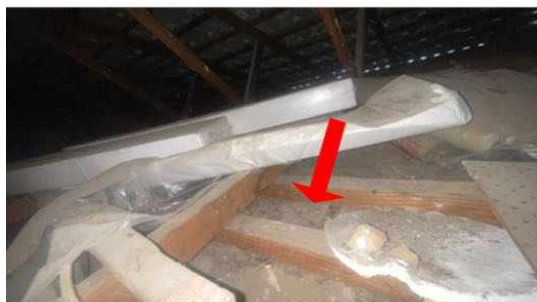
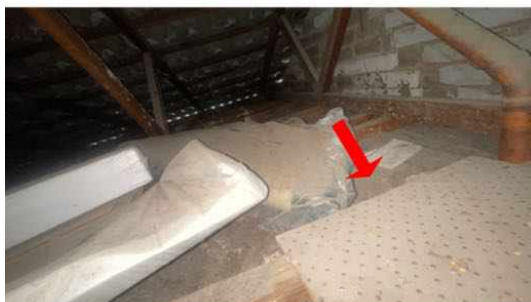
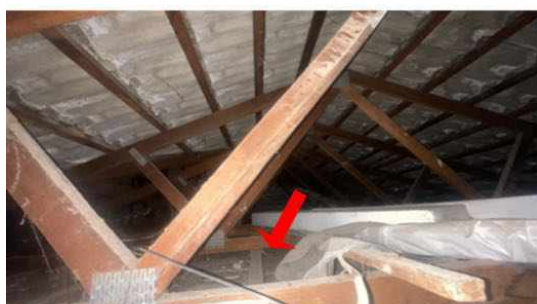
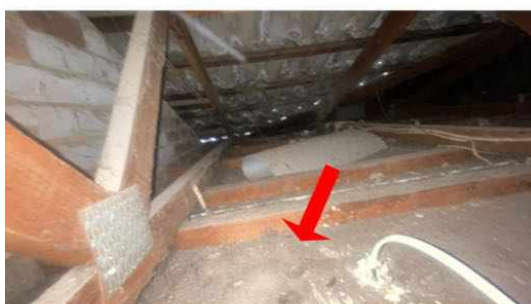
Finding 3.05

Building:
Location: All Areas
Finding: Insulation - Missing or poor coverage
Information: Upon inspection of the roof void it was noted that insulation is not present within the roof space.

Insufficient insulation will result in a comparatively higher cost to heat and cool a property as there is a lack of Insulation (or uneven coverage of insulation) which works as a barrier to heat transfer. This helps to keep out unwanted heat in summer and preserves warmth inside your home in winter. It can also help soundproof your home from unwanted airborne noise transfer.

Where insulation is not present or missing in large areas, this does not meet current Australian Standards. Installation of adequate insulation is required and should be conducted as soon as possible by an insulation specialist.

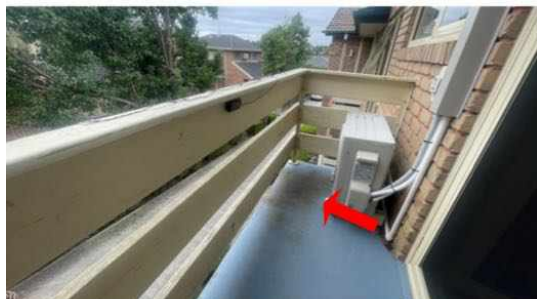
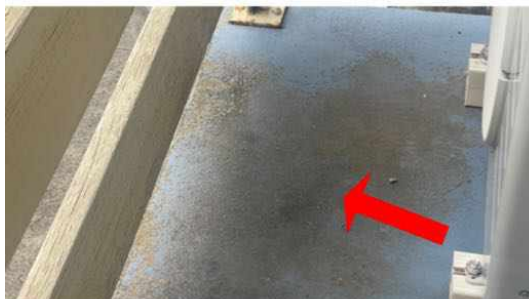
Finding: Additional Photos - minor defects
 Information: Additional photos are provided for your general reference.
 Painted surface deteriorated on balcony.

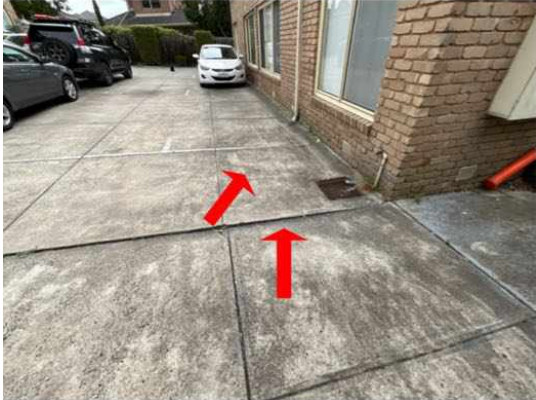
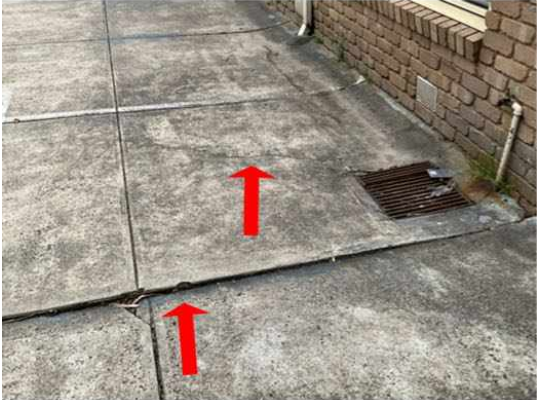
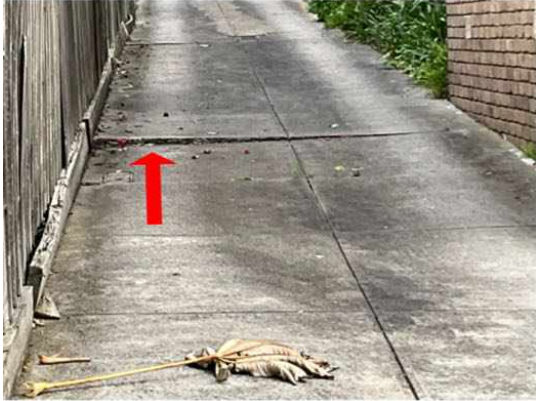
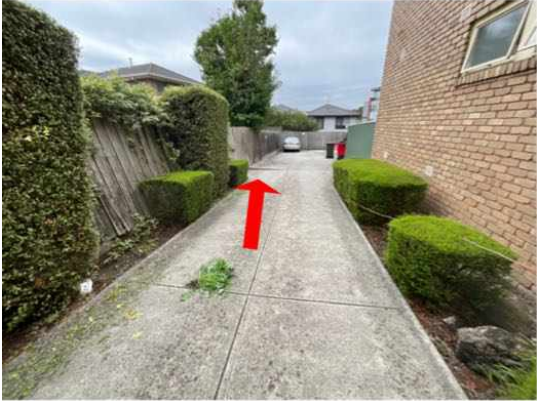
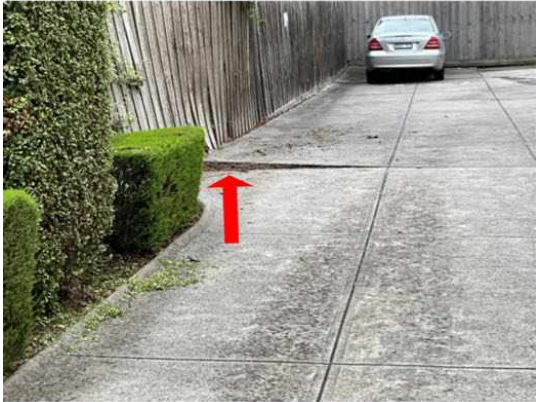
Finding 3.08

Building:
 Location: Driveway
 Finding: Distinct Cracking and subsidence to concrete paving (suspected owners corporation issue)
 Information: Distinct cracking and some subsidence was identified to the concrete paving in this area.

Distinct cracks and subsidence are generally found in older paving, and may also present as a trip hazard as consequence of an uneven or curved surface.

General age and expected deterioration of the paved areas is a common cause of this type of defect. However, damage may also have occurred due to environmental factors. Such factors include variable moisture and weather conditions, the presence of trees and their roots having a settling or lifting affect on the soil, or the effect of load bearing over a sustained period of time.

Damage to this degree may also be due to poor original installation of the pavers . Factors such as poor compaction of the sub surface may create cracking, subsidence and other secondary defects.

Repairs and/or replacement will be to be required to prevent further damage and to reduce hazards associated, such as tripping. A landscaper should be engaged to inspect the pavers and repair / rectify the subsided and cracked pavers.

Monitoring of the area should be conducted frequently.

Always contact a building inspector should cracks widen, lengthen, or become more numerous.

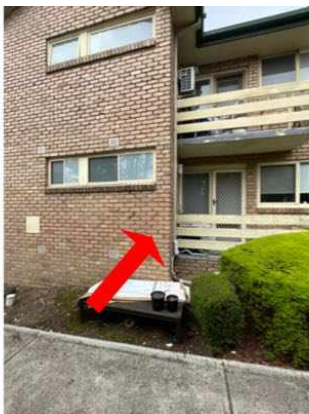
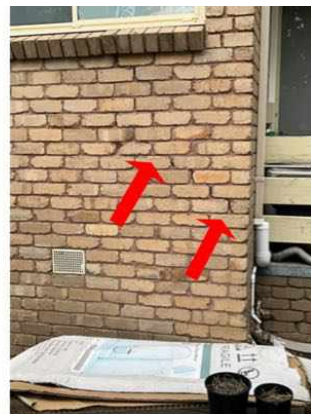
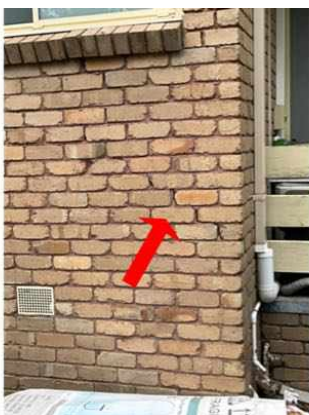
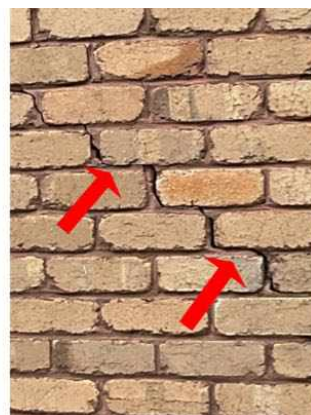
Finding 3.09

Building: Exterior walls - left side
Location: Brickwork - Step cracking (suspected owners corporation issue)
Finding: Step cracking was identified to the brickwork in this area at the time of inspection. Step cracking, which is similar to other forms of cracking, has a variety of possible causes. However, the most common is the subsidence of adjacent footings.
Information: Step cracking is a relatively common defect, and is most likely to occur adjacent to windows, doors and other openings. Mortar failure in the gaps between affected

Minor step cracking can be used as a warning sign to address factors causing stress to the wall, which can include the effect of surrounding trees, water leaks, soil erosion, or even the presence of reactive soils in the surrounding area.

Please note: as this is external brickwork to the building it is suspected it would be covered by the owners corporation. Your own enquiry should be made to determine whether this is the case.

Where step cracking is extensive or severe or is coupled with other forms of cracking to the brickwork, the client is advised to consult a structural engineer.

It is highly recommended that the cracking be monitored for a period of time e.g. six months, to determine if there is any further cracking or active movement within the bricks. Should no further cracking or movement occur, the bricks may be patched by a qualified bricklayer.

Should cracking increase, a structural engineer should be engaged. In that instance, underpinning of the foundations may be required to stabilise the area and reduce the cracking.

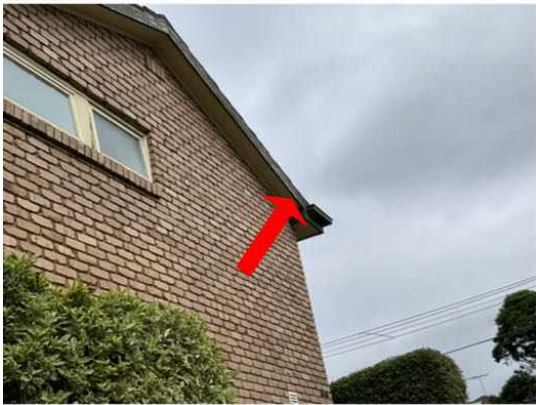
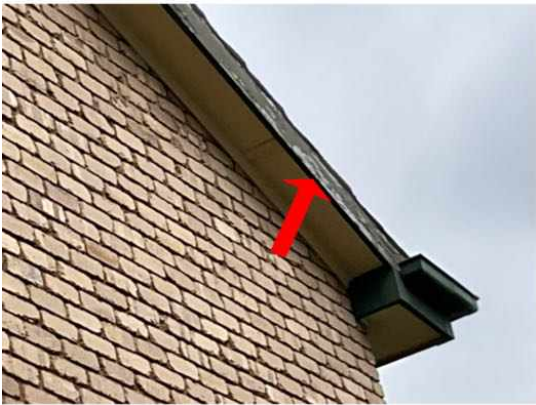
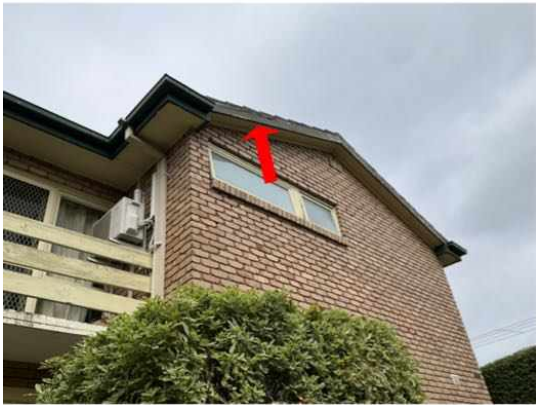
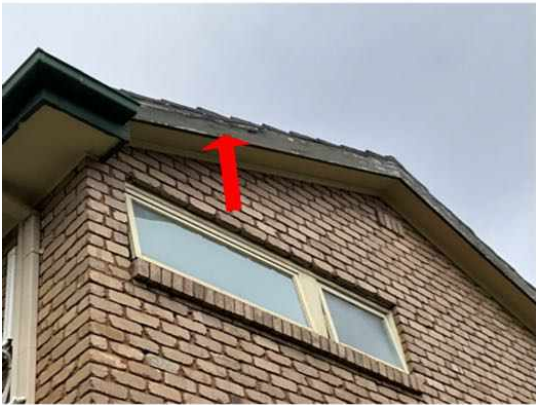
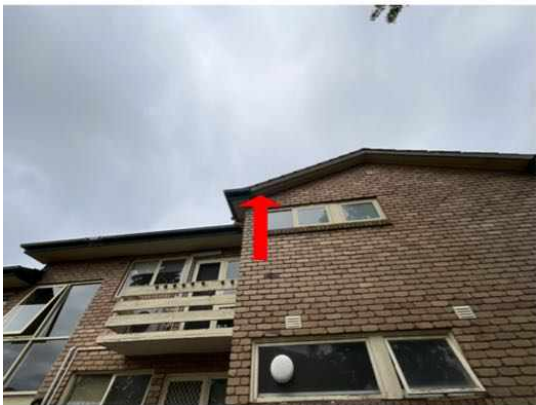
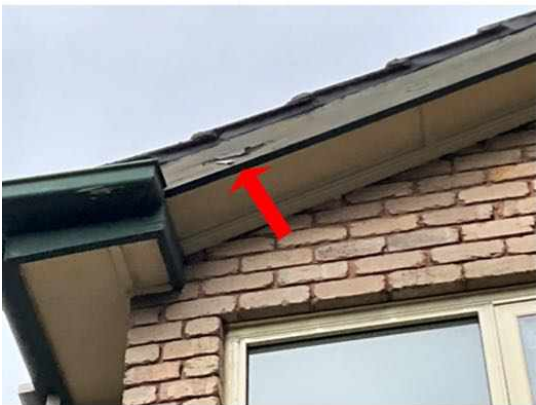
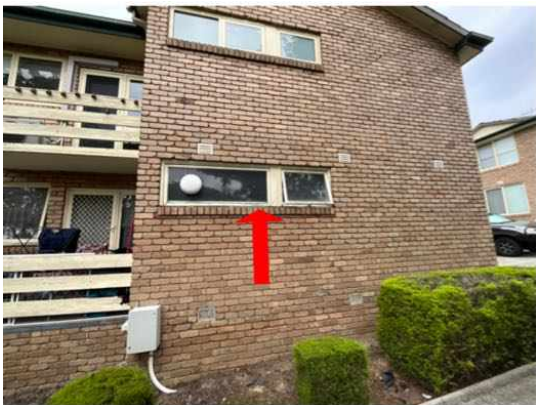
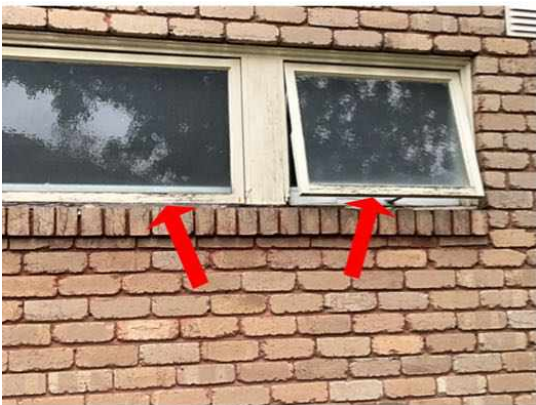
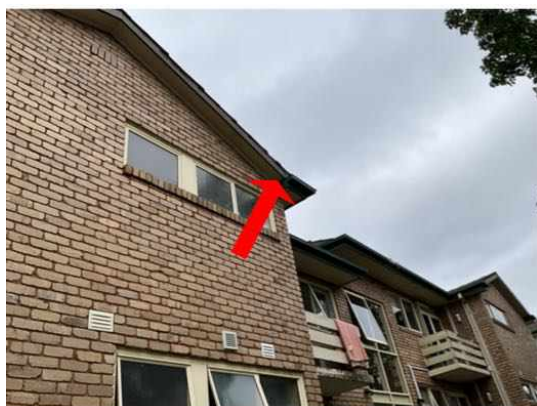
Finding 3.10

Building:
Location: All External Areas
Finding: Timber - exposed to weather (suspected owner corporation issue)
Information: External timbers that are frequently exposed to harsh weather conditions require adequate protection in order to maintain their condition. Where timbers have not been painted or treated adequately, general deterioration is likely to occur at an accelerated rate.

If left unattended, replacement of these timbers is likely to be necessary in the short-term future.

Please note as these are external timbers it is suspected they would be covered by the owners corporation. Your own enquiry should be made to determine whether this is the case.

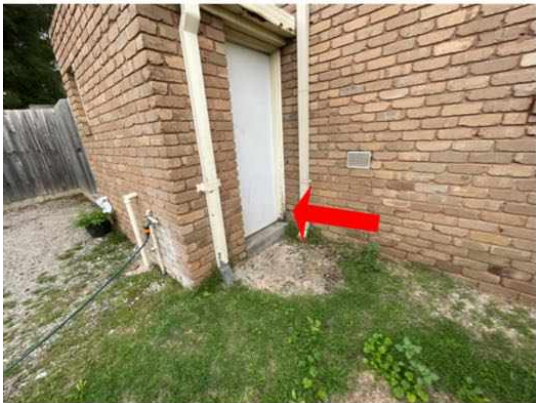
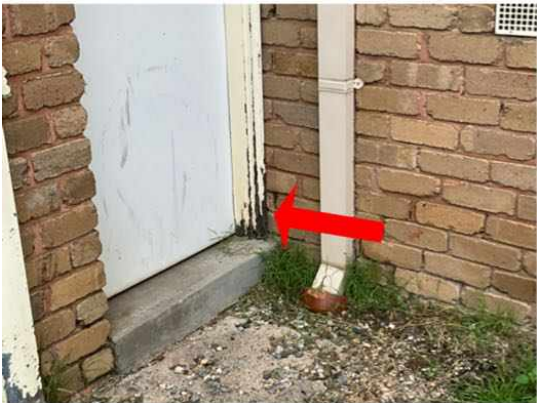
Finding 3.11

Finding: Door frame - Wood rot (suspected owners corporation issue)

Information: Wood rot was found to be affecting external door frames. Wood rot, also known as Fungal Decay, occurs when timbers and other cellulose building materials are exposed to damp conditions on an ongoing basis.

It is likely that this wood rot has developed as a result of frequent exposure to rain and other weather conditions. It is suspected that failure to maintain the door frames over a prolonged period has resulted in them deteriorating at an accelerated rate, increasing their susceptibility to the development of wood rot. Constant exposure to the weather may have also contributed to the formation of the wood rot in this area.

Please note: as this is an exterior element, it is suspected it would be covered by the owners corporation. Your own enquiries should be made to determine whether this is the case.

Repair and/or replacement of affected door frames may be a necessary step in protecting surrounding building elements from such deterioration.

Remedial works should be performed by a qualified carpenter or registered builder as soon as possible to prevent any further damage.

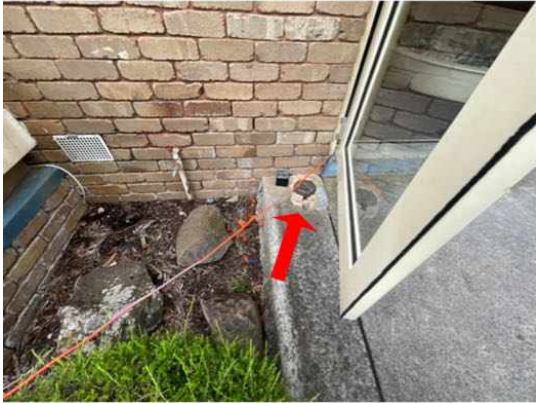
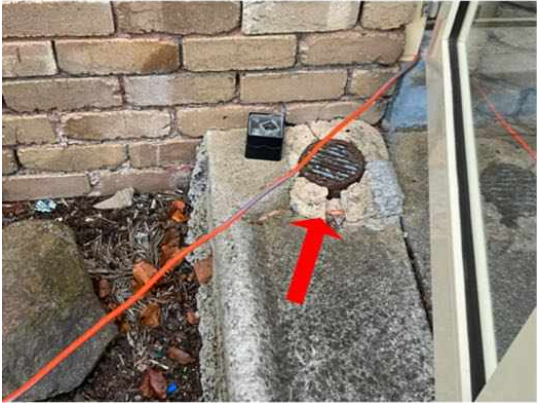
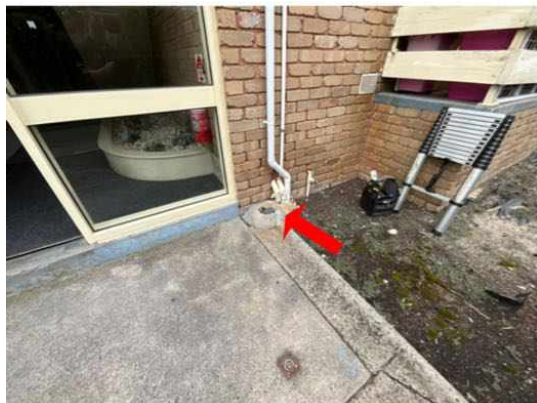
Finding 3.12

Building:
Location: Exterior walls - left side
Finding: Additional Photos - for your information (common areas - suspected owners corporation issue)
Information: Additional photos are provided for your general reference.

It is suspected these items would be covered by the owners corporation. Your own enquiries should be made to determine whether this is the case.

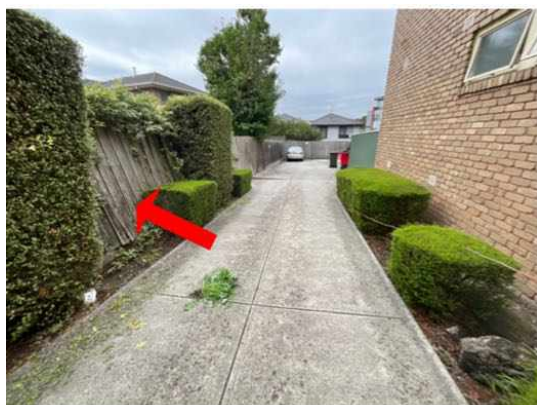
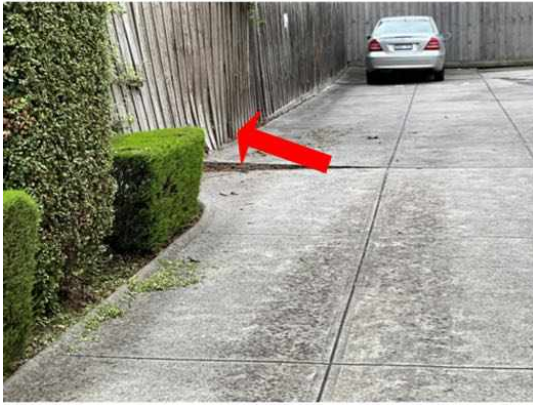
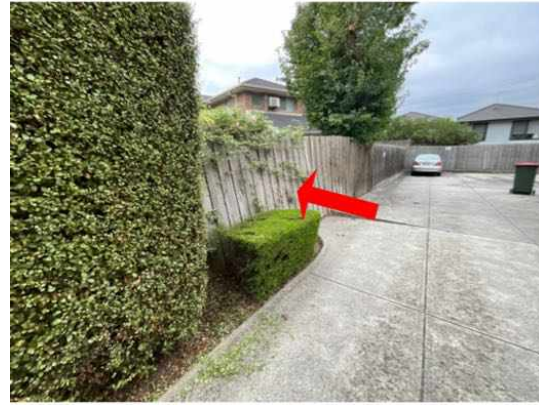
Finding 3.13

Information: It was noted at the time of inspection that a section of the fencing at the side of the property was leaning.

Typically fencing deteriorates due to age and or wear, rot and or rust which is generally expected for a structure of this age, due to prolonged exposure to weather conditions. Sometimes inadequate installation or maintenance can be to blame.

Please note: it is suspected this item would be covered by the owners corporation. Your own enquiry should be made to determine whether this is the case.

Should further damage occur, repair of several elements of the fencing may be required. Replacement may also be a consideration.

A licensed fencing contractor should be appointed to provide further advice and perform rectification works as necessary.

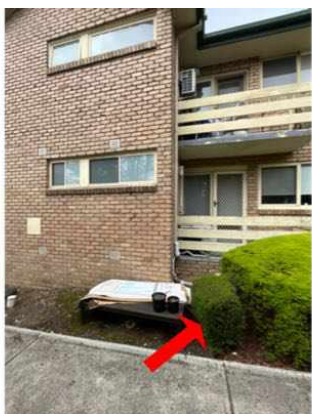
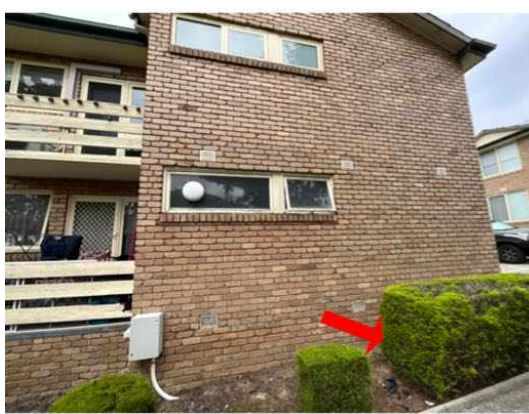
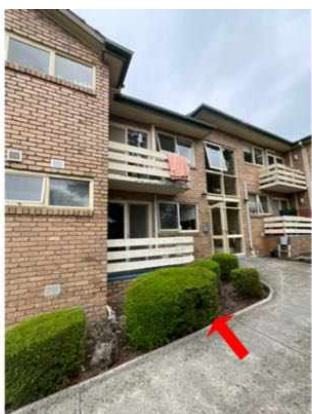
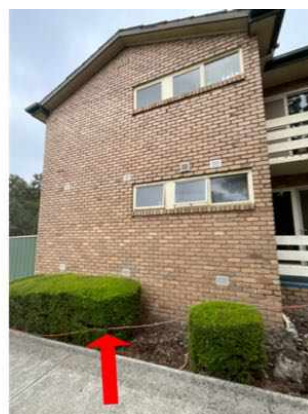
Finding: Garden Beds - Conditions Conducive to Termites

Information: Garden beds were found to be evident around and against the property. These garden beds can include untreated timber, and with a combination of moisture from rainfall and hosing, can make conditions conducive to termite activity and termite ingress.

The removal and replanting of species that do not provide "cover" or cutting back of existing vegetation will assist greatly in preventing this from occurring.

The removal of any such materials that may be conducive to termite activity should be carried out as soon as possible to minimize the risk of potential termite attack.

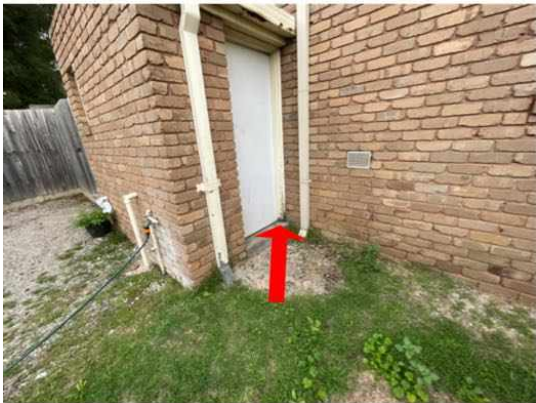
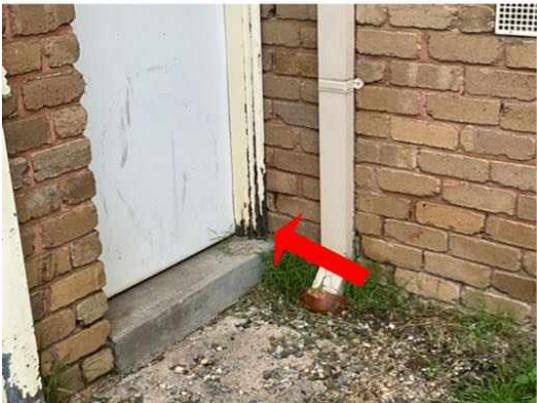
Finding 7.01

Finding: Fungal decay - conditions conducive to timber pest attack

Information: Fungal decay also known as wood decay or wood rot generally refers to the deterioration of timber elements when in contact with excessive levels of moisture for a prolonged period of time.

Generally fungal decay develops on timber elements that are in use in an external environment which are exposed to rain penetration.

Decaying timbers can create an environment conducive to timber pest attack. It is recommended that the decaying timbers be repaired / replaced to lessen the risk of timber pests.
