# Building and Timber Pest Inspection Report

Inspection Date: Fri, 27 Mar 2026

Property Address: 5/54 Shetland St, Morningside QLD 4170,  
Australia

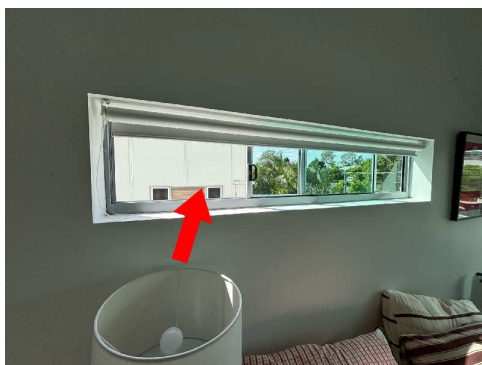
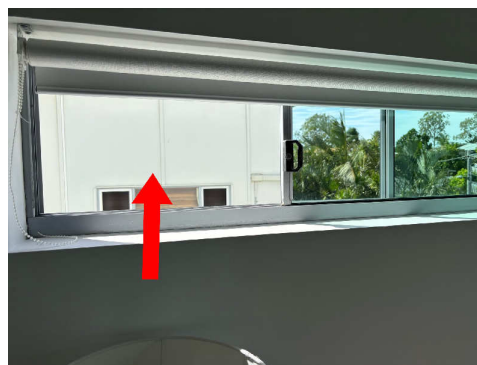
Information: At the time of the inspection, it was noted that the window in the master bedroom was not restricted to prevent it from opening more than 125mm. Both windows could be opened to their full width. Permanent screens were not fitted to either window, only removable fly screen covered the openings.

The client should engage a building maintenance professional to fit a restrictor or permanent screen to the window in the master bedroom. This must be done as a matter of urgency.

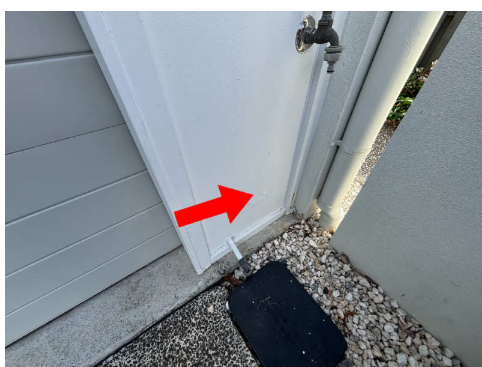
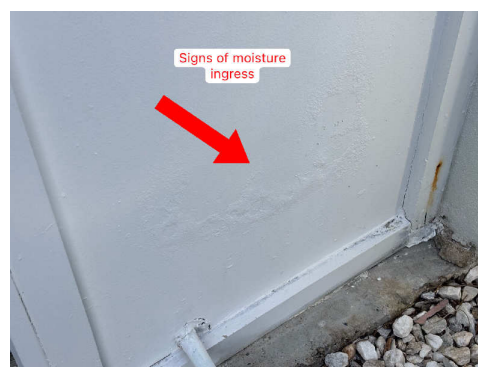
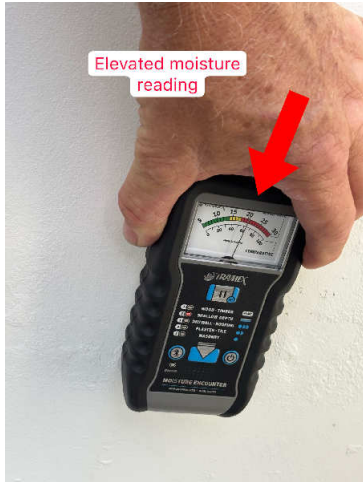
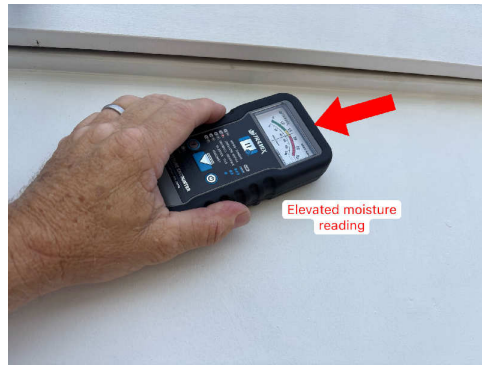
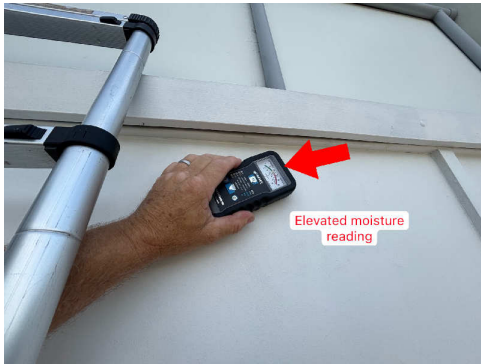
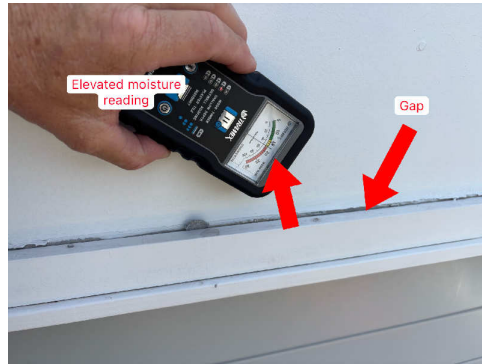
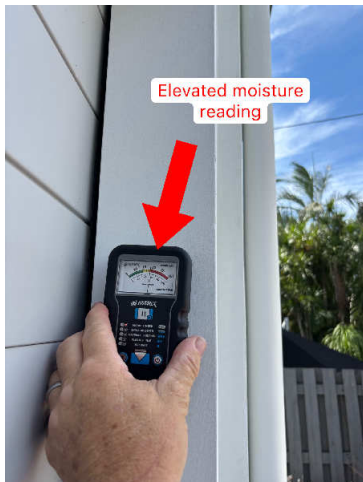
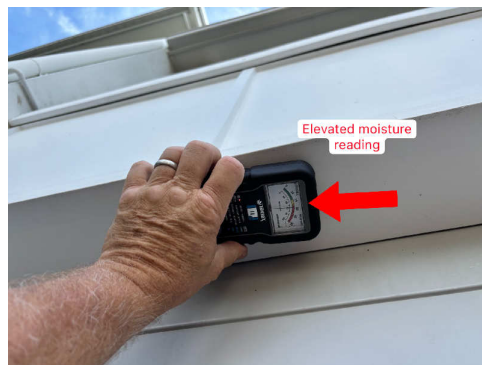
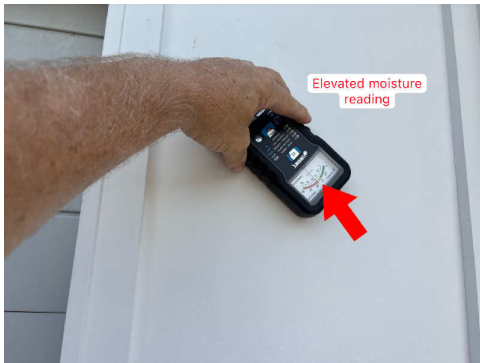
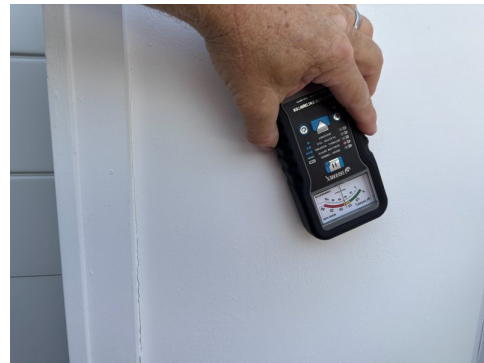
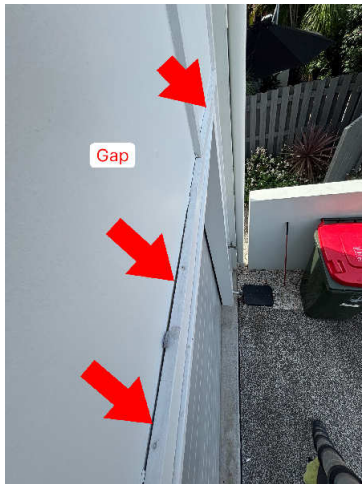
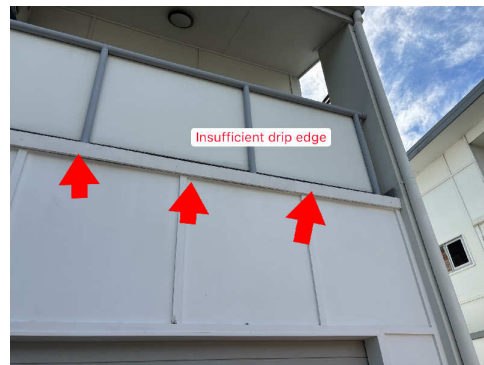
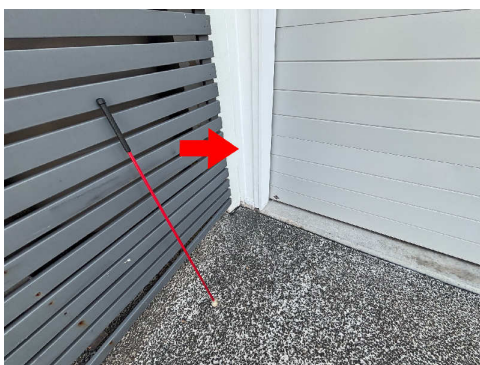
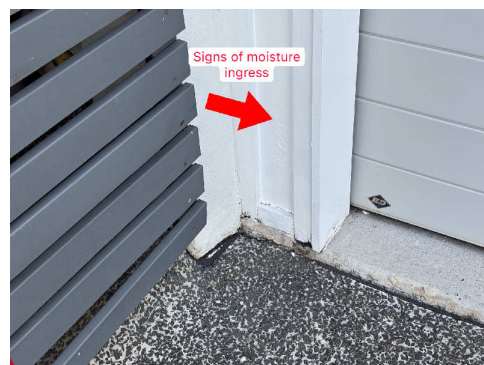
### Finding 2.01

Finding: Front elevation - evidence of moisture ingress

Information: At the time of the inspection, it was noted that there was signs of moisture ingress behind the cladding around the garage door.

It appears that the drip edge for the balcony above these area is not sufficient enough to stop moisture tracking back between the underside of the balcony tiles and the timber moulding below it into the wall cavity. A piece of timber is attached to this area making it difficult to determine the size of the drip edge and whether there is a visible gap between the underside of the tiles and the timber moulding.

There is a visible gap on top of the timber moulding at the top of the garage door frame which could allow moisture to enter the wall cavity in this area. Elevated moisture readings were recorded in this area.

An invasive inspection would be required in order to determine if any damage has been done to the wall framing in this area. The client should enquire of the body corporate as to who is responsible for maintenance and repairs to the exterior of the dwelling.

A licensed builder should be engaged to carry out the necessary remedial work in order to rectify this issue. This chiefs be done as a matter of urgency.

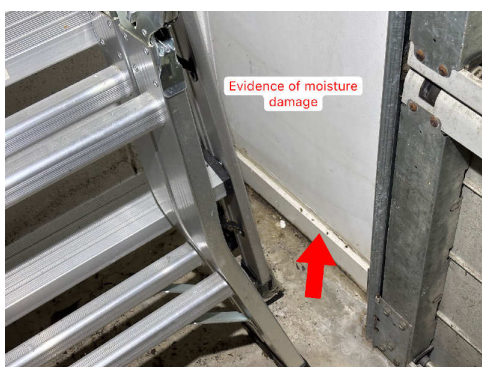
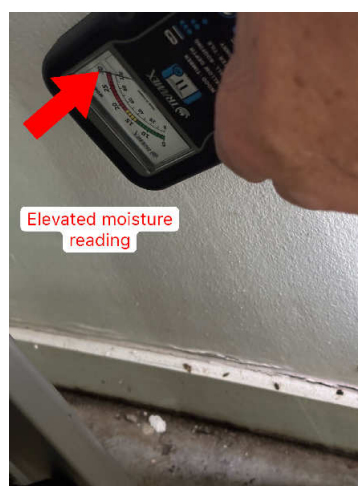
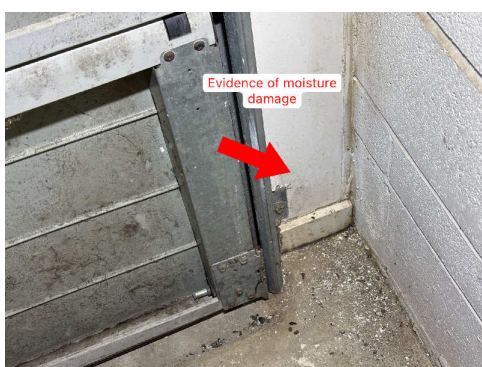
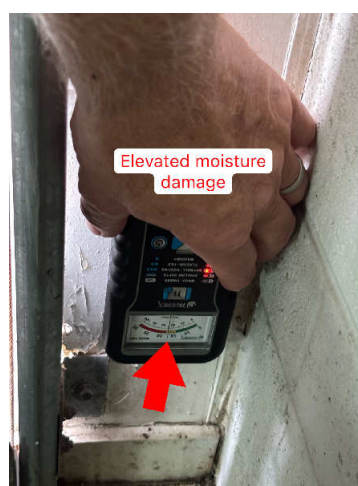
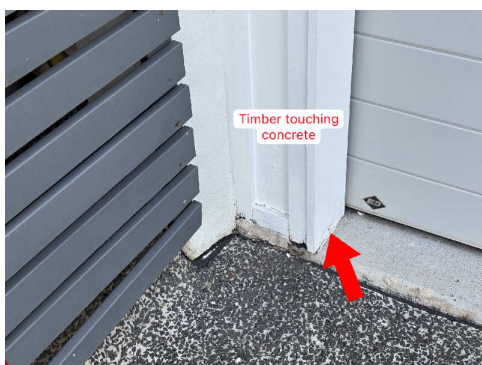
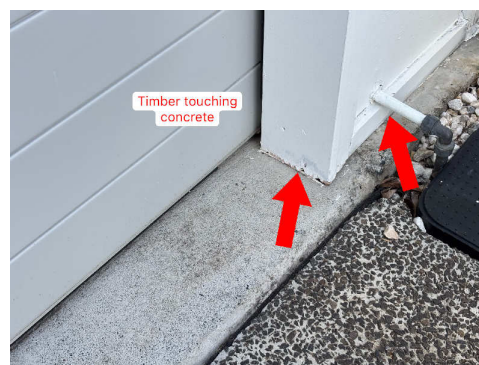
Finding 3.01

Finding: Garage - evidence of moisture damage

Information: At the time of the inspection, it was noted that there was evidence of moisture damage to the bottom section of the wall on either side of the garage door.

This may be caused by the timber mouldings on the exterior touching the concrete. Moisture may be drawn into the other building materials such as the wall linings on the interior of the garage.

A building maintenance professional or licensed carpenter should be engaged to replace the timbers on the exterior ensuring that they are not touching the concrete. This should be done as a short term priority.

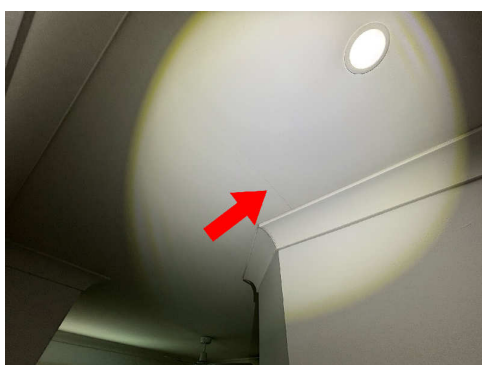
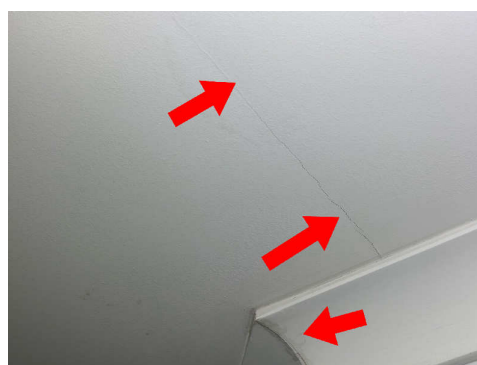
### Finding 3.02

Finding: Bedroom 2 - minor crack to ceiling

Information: At the time of the inspection, it was noted that there was a minor crack to the ceiling in bedroom 2. This may be due to normal building movements.

A building maintenance professional or painting contractor could be engaged to carry out this minor repair. This can be done at the clients discretion.

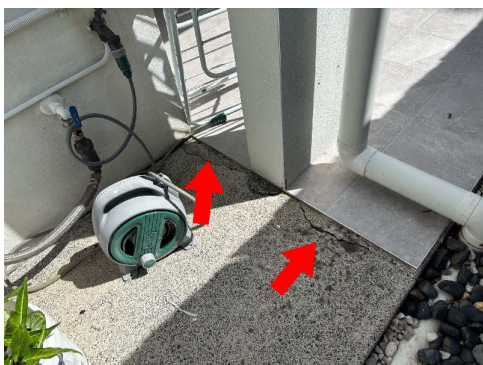
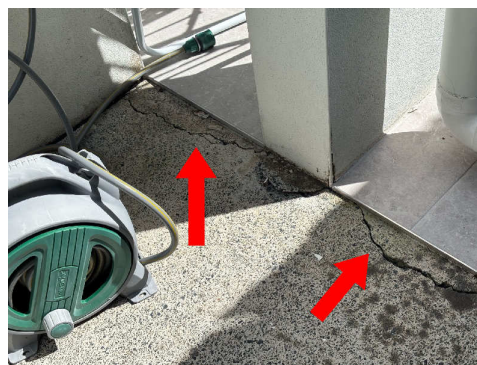
### Finding 3.03

Finding: Concrete path - minor crack

Information: At the time of the inspection, it was noted that there was a minor crack in the concrete path on the side of the dwelling. This crack appears to be historic. The client should monitor the crack for any change in appearance.

A building maintenance professional could be engaged to carry out a repair on this crack. This can be done at the clients discretion.

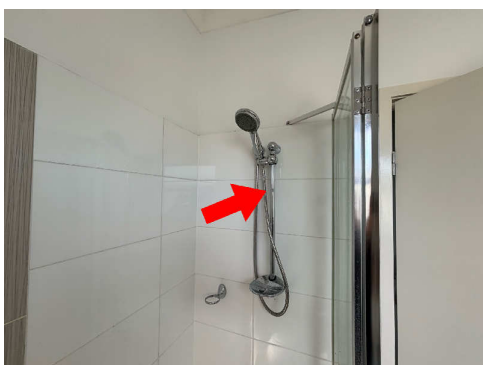
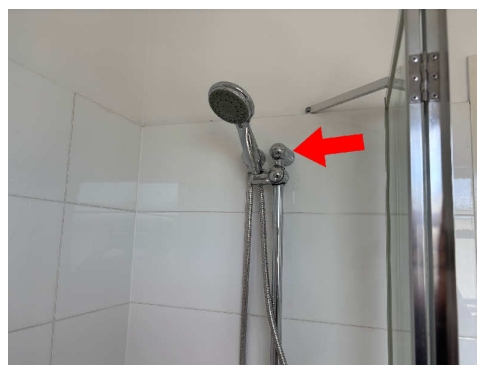
### Finding 3.04

Finding: Family bathroom - loose shower rail

Information: At the time of the inspection, it was noted that the shower rail in the family bathroom was loose. If left unaddressed, the shower rail may come away from the wall.

A building maintenance professional could be engaged to re-secure the shower rail. This can be done at the clients discretion.

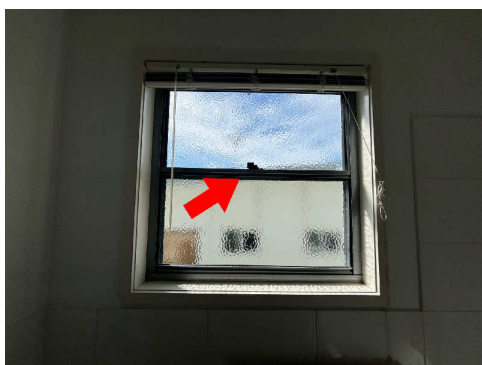
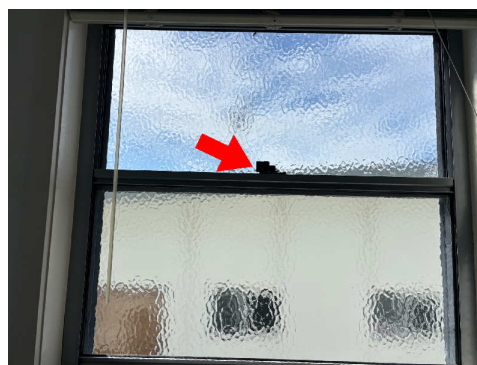
### Finding 3.05

Information: At the time of the inspection, it was noted that the window catch in the family bathroom was not latching. As a result, the window can be opened when the catch is locked.

A building maintenance professional could be engaged to carry out the necessary repairs to the window catch. This can be done at the clients discretion.

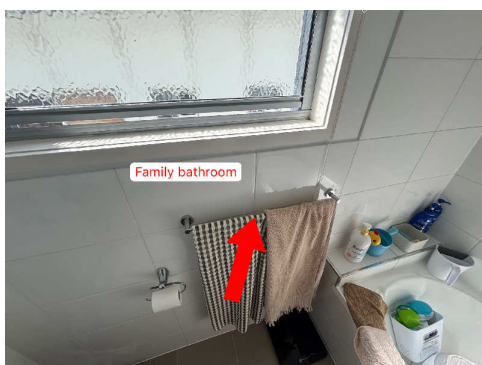
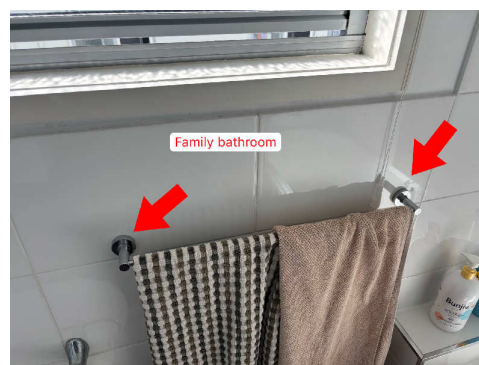
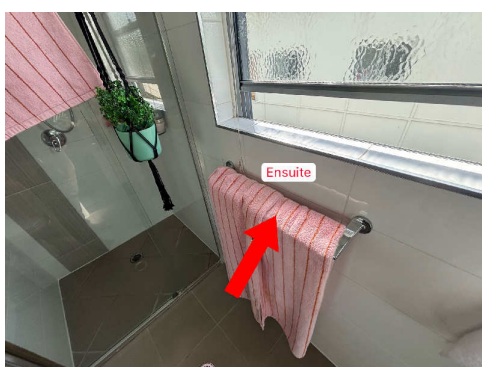
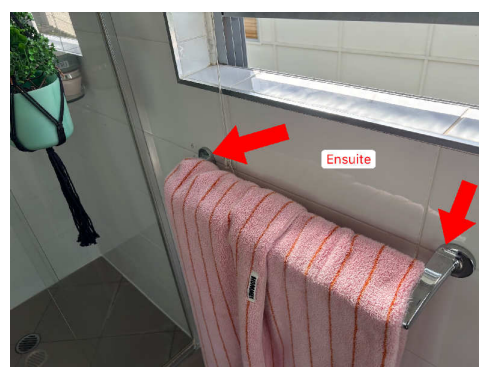
### Finding 3.06

Finding: Towel rails loose

Information: At the time of the inspection, it was noted that the towel rails in the family bathroom and ensuite were loose. This appears to be from general wear and tear. If not addressed, the towel rails may come away from the wall.

This may require simple adjustment of the fasteners attaching the towel rails. A building maintenance professional could be engaged to carry out these minor repair. This can be done at the clients discretion.

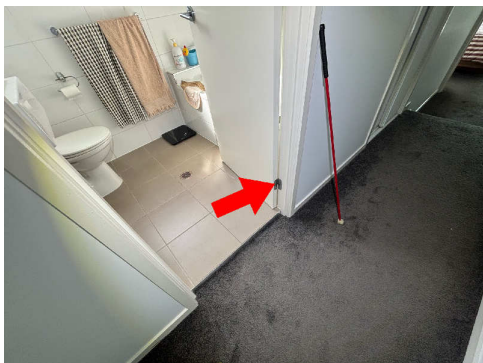
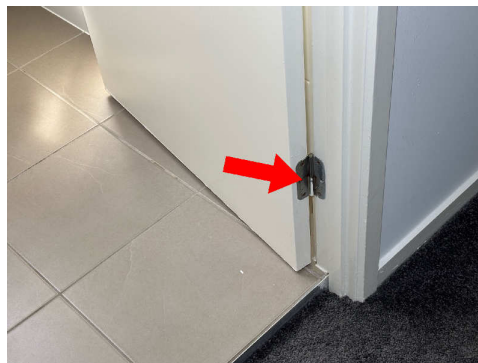
### Finding 3.07

Finding: Family bathroom - loose door hinge

Information: At the time of the inspection, it was noted that the bottom door hinge to the family bathroom was loose. The screws can not be tightened to secure the hinge. If left unaddressed, the functionality of the door may be affected.

A building maintenance professional could be engaged to carry out this minor repair. This can be done at the clients discretion.

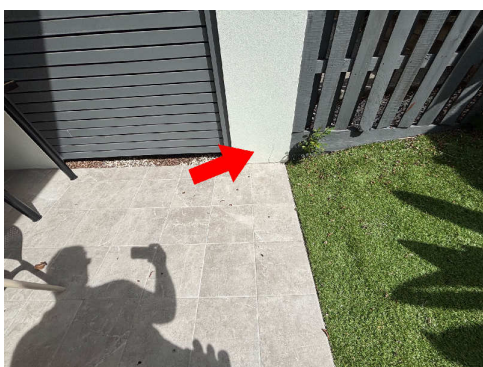
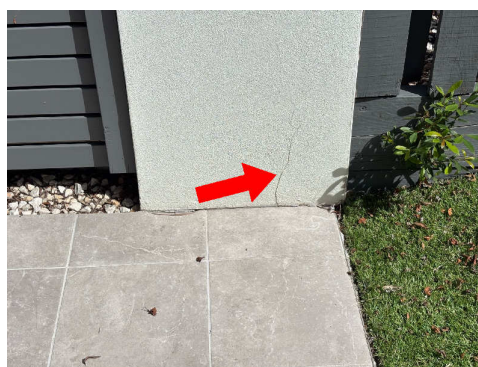
### Finding 3.08

Finding: Render - cracking

Information: At the time of the inspection, it was noted that there was a minor crack to the render at the rear of the dwelling. This may be due to general wear and tear.

As it is on the exterior, the client may wish to confirm with the body corporate as to who is responsible for this repair.

A solid plasterer or painting contractor could be engaged to carry out this repair. This can be done at the clients discretion.

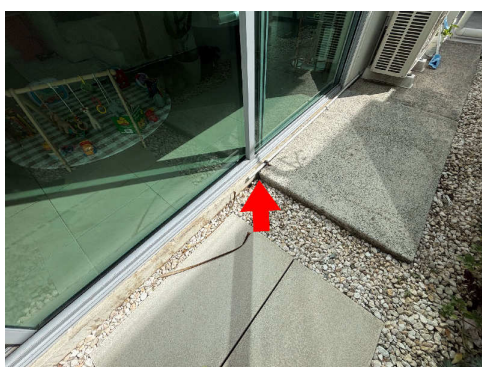
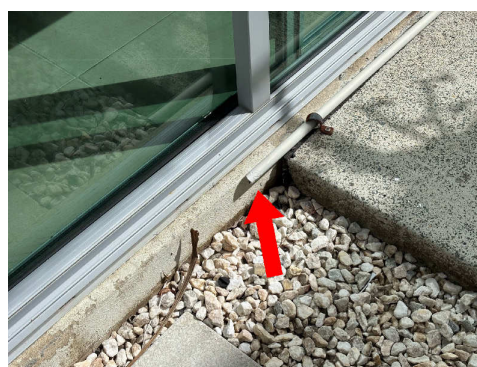
Finding: Air conditioner - Disconnected overflows

Information: At the time of the inspection, it was noted that the air conditioner drain overflow to the unit on the side of the dwelling was not connected to the storm water drainage and as a result are draining next to the foundations of the dwelling.

Air conditioning overflows that are not connected to the storm water drainage and are draining near the foundation can create excessive moisture in the surrounding area.

Such leaking creates an environment which is conducive to an array of defects, including water damage to associated building elements and the attraction of termite or timber pest infestation.

It is highly recommended that a licensed plumber be appointed to connect the A/C overflow in order to prevent such an environment from being created. These minor works should be carried out as soon as possible.

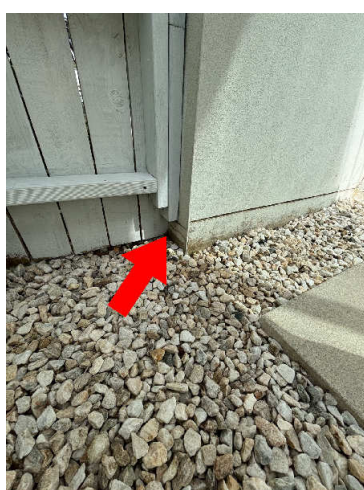
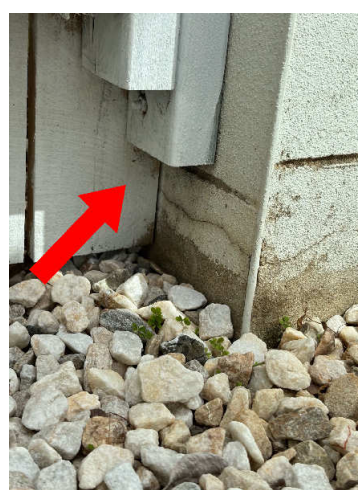
#### Finding 6.02

Information: At the time of the inspection, it was noted that the timber fence paling on the side of the dwelling was bridging the physical termite barrier.

Bridging is the spanning of a termite barrier or inspection zone so that subterranean termites are provided with a passage over or around that barrier. Bridging can provide a concealed entry point for termites to bypass the termite barrier.

A building maintenance professional should be engaged to remove the section of timber that is bridging the physical barrier and allow a clear inspection zone between the bottom of the timber and the termite barrier. This should be done as a matter of urgency.

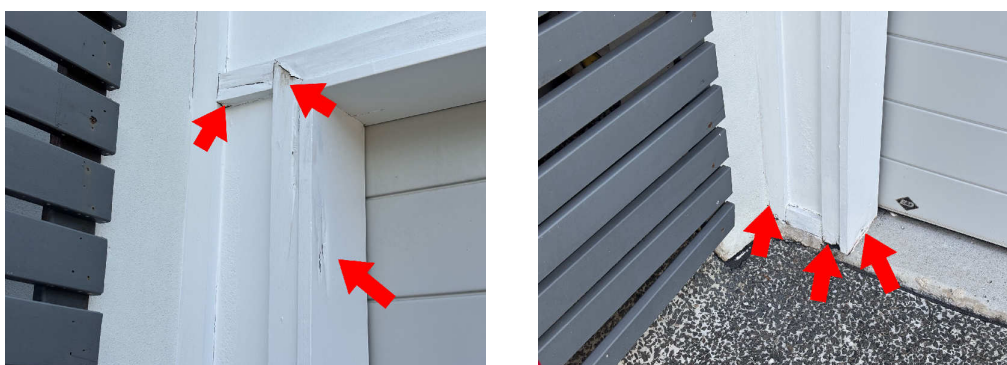
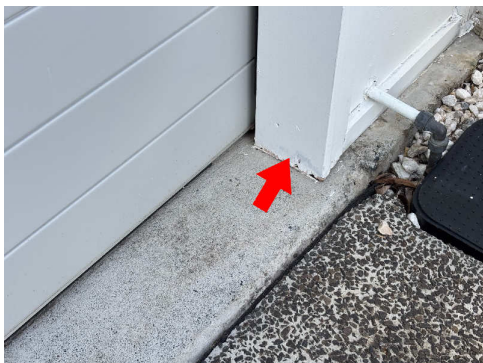
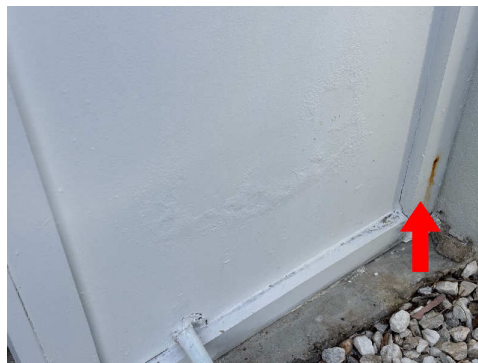
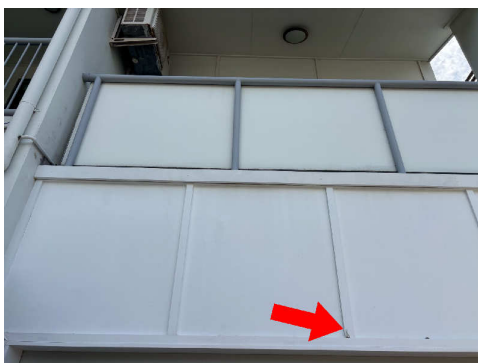
### Finding 7.01

Finding: Wood rot - timber mouldings

At the time of the inspection, it was noted that there was evidence of wood rot to timber mouldings at the front of the dwelling. This may be due to the age of the timber building elements and general weathering.

This building element shows evidence of wood rot. Wood rot, also known as Fungal Decay, occurs when timbers and other cellulose building materials are exposed to damp conditions on an ongoing basis.

Wood rot is often associated with general damp problems and is evidenced by a 'musty' smell or mould and mildew occurring on surfaces. If left unmanaged, damp conditions can lead to further health problems and the decay of timbers will continue.

Early intervention and regular maintenance, particularly of exterior timbers, will prolong the useful life of these building elements. Prior to any works being performed, the cause of the moisture that has created the visible wood rot should be identified and addressed in a suitable manner. Replacement of affected timbers may then be a necessary step in protecting surrounding building elements from such deterioration.

A qualified carpenter or registered builder may also be required to replace affected building materials.

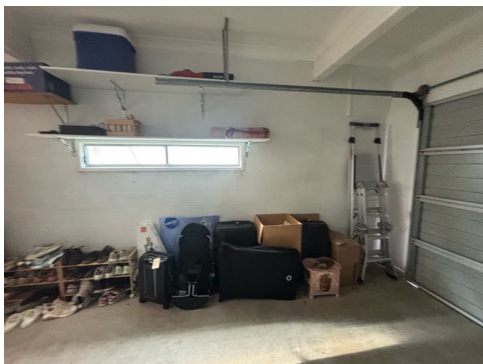
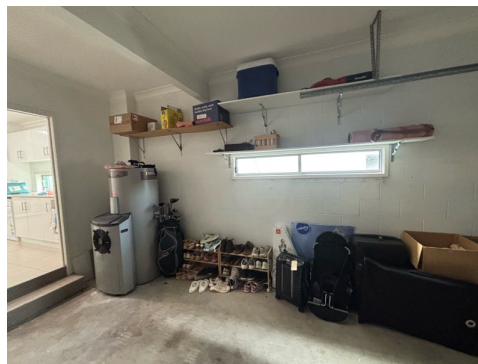
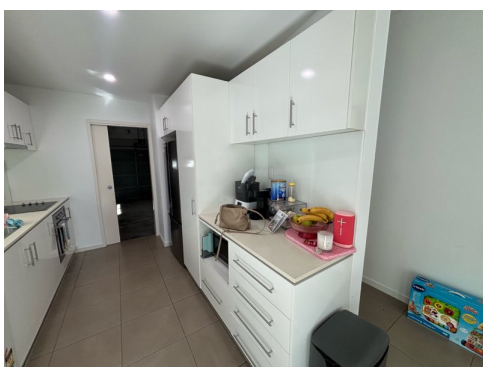
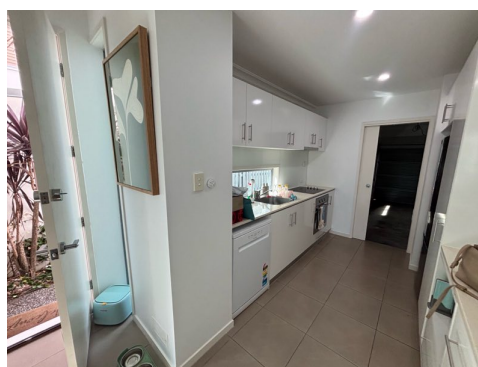
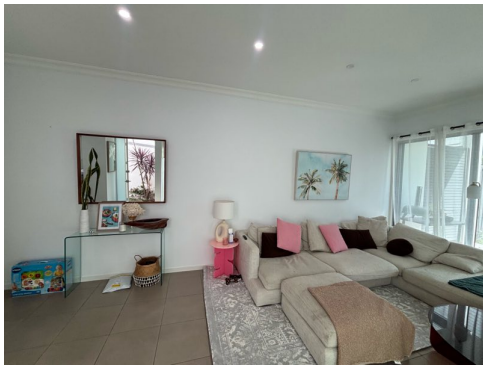
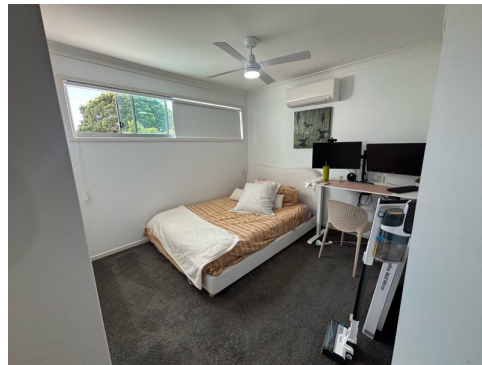
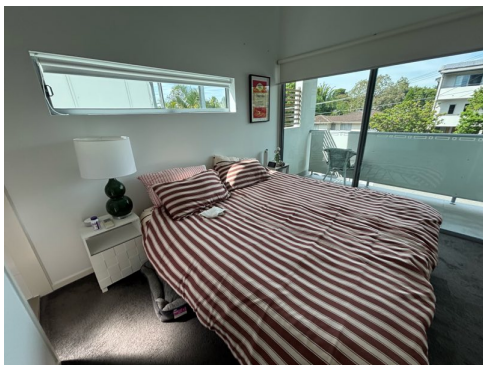
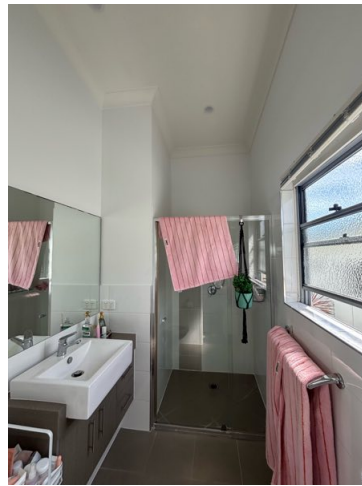
Finding: Obstructions and Limitations - Internal areas

Information: These photographs are an indication of the obstructions and limitations which impeded full inspection of the property of the internal areas at the time of inspection. These obstructions can hide an array of defects and should be removed to allow full inspection to be carried out. A re-inspection is recommended once the areas are made accessible.
