# Building and Timber Pest Inspection Report

Inspection Date: Tue, 30 Dec 2025

Property Address: 4/10 Siracusa Ave, Point Cook VIC 3030,  
Australia

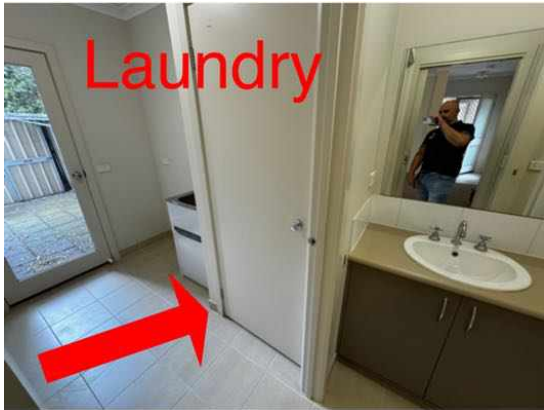
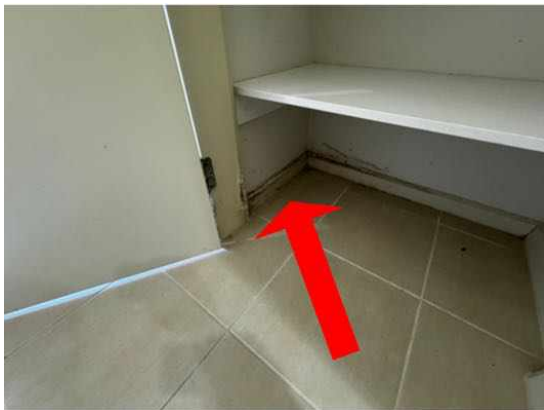
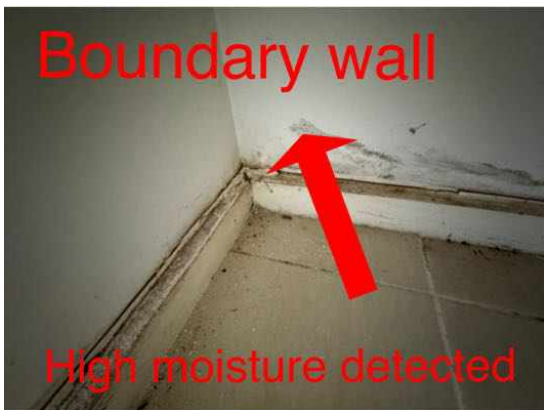
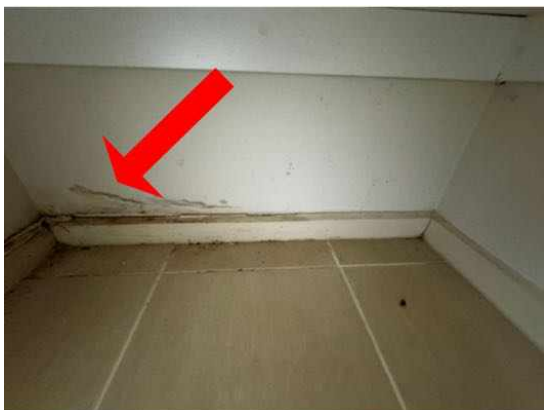
Building:	Main Building
Location:	Laundry > Ground Level
Finding:	Suspected moisture ingress to ground floor laundry and adjoining areas
Information:	<p>Very high moisture readings were detected to the ground floor laundry, particularly within the linen cupboard and beneath the laundry trough. Visible damage was observed to plaster walls, skirting boards, door jambs and tiled skirtings, with sections starting to separate from the wall at floor junctions. Moisture meter testing confirmed very high readings to the floor tiles and lower wall elements in these locations. The affected wall behind the laundry trough and linen cupboard is a boundary wall. A visual inspection of the adjoining property indicates suspected poor site drainage, with external paving sloping toward the boundary wall and no visible drainage provisions, which may be directing surface water toward the foundations and allowing moisture to migrate into the building envelope over time. An internal plumbing leak cannot be ruled out as a contributing factor. Additional moisture testing to surrounding wet areas, including the powder room, recorded medium moisture levels, suggesting suspected moisture migration beneath tiled surfaces. This condition is considered a major defect under AS 4349.1–2007 due to the extent of moisture damage and potential for ongoing deterioration if left unresolved.</p>

High moisture reading

A licensed plumber should be engaged to investigate and rule out any internal plumbing leaks. A qualified building consultant or waterproofing specialist should assess the boundary wall, footings (if accessible), and surrounding wet areas to determine the source and extent of moisture ingress. Rectification may require drainage improvements, damp-proofing or waterproofing works to the boundary wall, and replacement of moisture-damaged internal finishes. Coordination with the neighbouring property owner may be required if external drainage is contributing to the issue.

Immediate. Further investigation and rectification should be undertaken without delay to prevent continued moisture ingress, deterioration of building elements, and potential health or structural impacts.

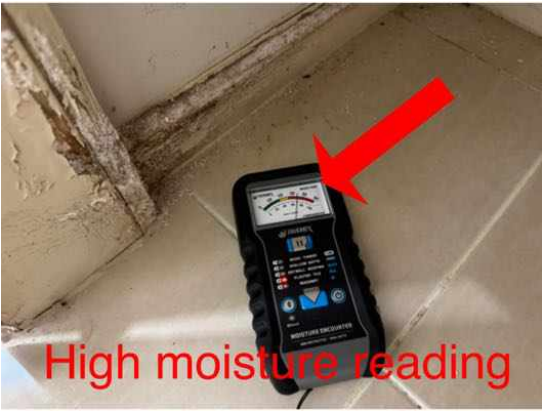
High moisture reading

Moisture damage

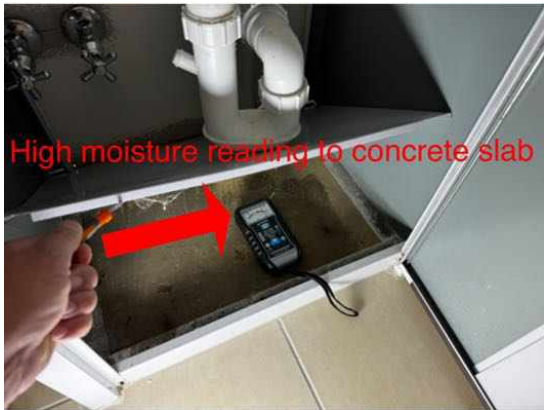
High moisture reading to concrete slab

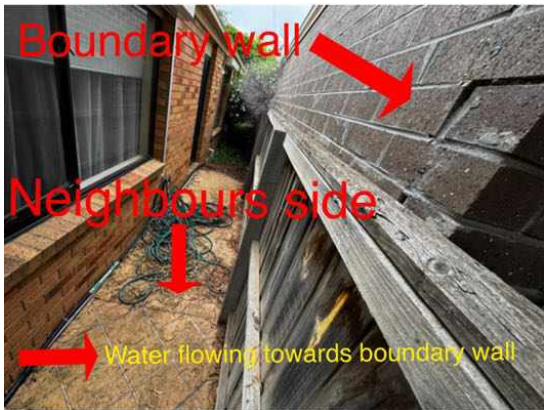
Boundary wall

Neighbours side

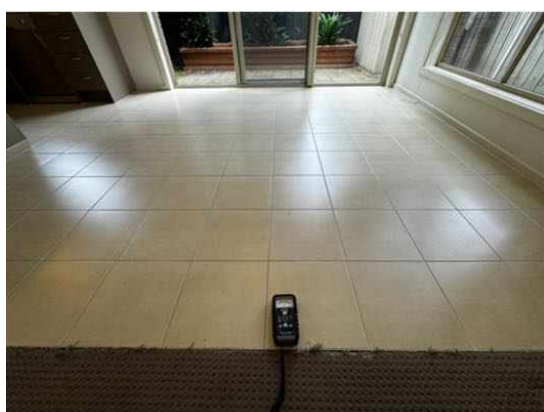
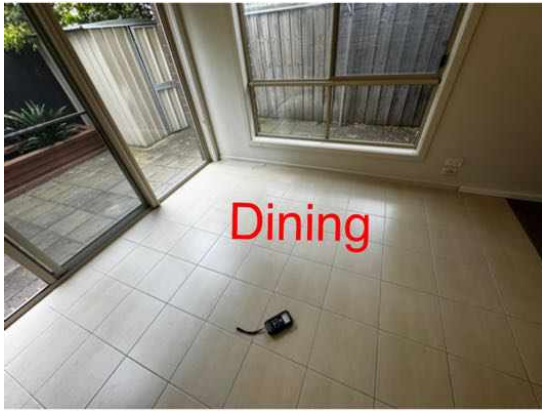
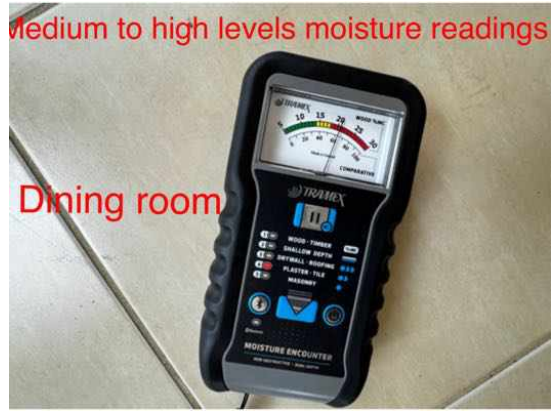
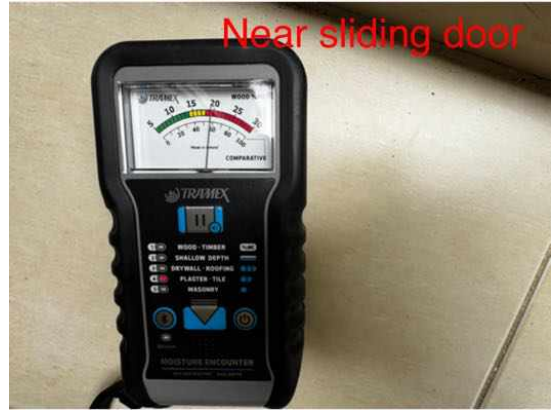
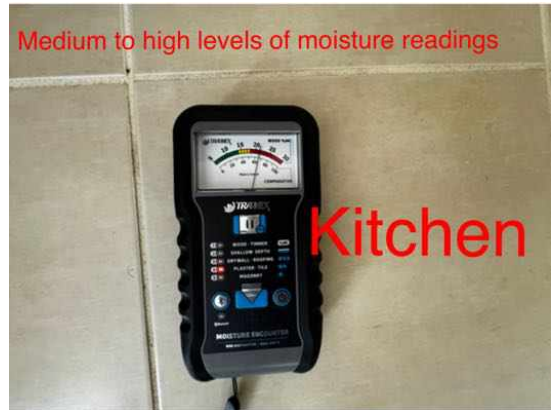
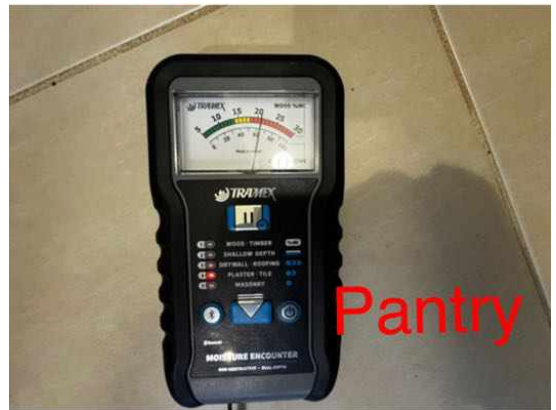
Building: Main Building  
Location: Dining, kitchen, pantry > Ground Level  
Finding: Suspected moisture ingress beneath tiled floors to kitchen, dining and pantry areas  
Information: Medium to high moisture readings were recorded to the tiled floor areas within the kitchen, dining and pantry during moisture meter testing. No visible signs of active plumbing leaks were observed at the time of inspection; however, the elevated readings indicate suspected moisture migration beneath the tiles. It is considered possible that moisture is travelling from the subgrade or footing level, potentially associated with suspected poor site drainage conditions, including surface water being directed toward the building from neighbouring land. Other potential moisture sources, such as concealed plumbing leaks or historic moisture ingress, cannot be ruled out without further investigation. This condition represents a suspected major defect under AS 4349.1–2007 due to the risk of ongoing deterioration to floor finishes, substrates and adjoining building elements if left unresolved.

A suitably qualified building consultant or waterproofing specialist should be engaged to further investigate the source of the moisture, including assessment of site drainage, subfloor or slab conditions, and adjoining external ground levels. Intrusive investigation may be required to confirm whether moisture is originating from the footing, slab edge, or concealed services. Rectification should be undertaken in accordance with specialist findings and may include drainage improvements, waterproofing works, and repair or replacement of affected flooring materials.

Immediate. Further investigation is recommended without delay to identify the moisture source and prevent progressive damage to floor systems and internal finishes.

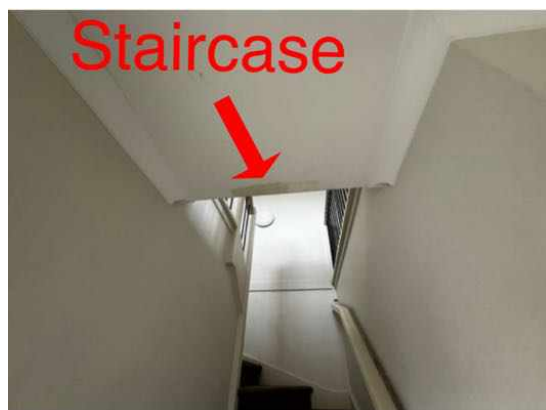
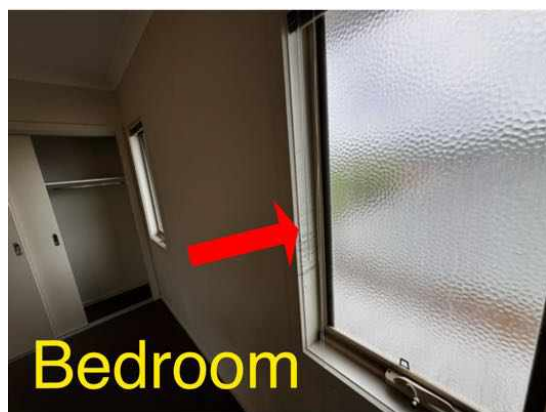
### Finding 3.01

Building: Main Building  
 Location: All Areas > All Areas  
 Finding: Internal finishes defects and minor serviceability issues throughout dwelling  
 Information: Cracked and damaged plaster walls and ceilings were observed in multiple internal areas, along with carpet damage throughout the dwelling. A non-operational window winder and a damaged window blind were noted, affecting functionality and amenity. The main entry door does not latch correctly and the laundry door was observed to bind, indicating suspected installation or alignment issues. Staining was present to the powder room floor tiles, along with a broken toilet seat and a cracked floor tile. In addition, loose low-voltage cabling consistent with TV aerial or data cables was observed running beneath carpeted flooring. While these cables are not electrical, their location beneath floor coverings presents a suspected trip hazard and may lead to damage to the cabling over time. In accordance with AS 4349.1–2007, these matters are generally consistent with minor defects relating to poor finish, wear, or installation quality.

A licensed builder or handyman should repair damaged plaster surfaces, adjust or rehang doors so they latch and operate correctly, and replace damaged carpets, tiles, and sanitary fittings as required. A glazier or window installer should rectify the non-operational window winder and damaged blind. A qualified cabling technician or electrician should reroute or secure the TV aerial/data cabling within wall cavities or conduits to eliminate the trip hazard and protect the cables from damage.

Within the next 3 months, with the loose cabling beneath carpet addressed as a priority to reduce trip risk.

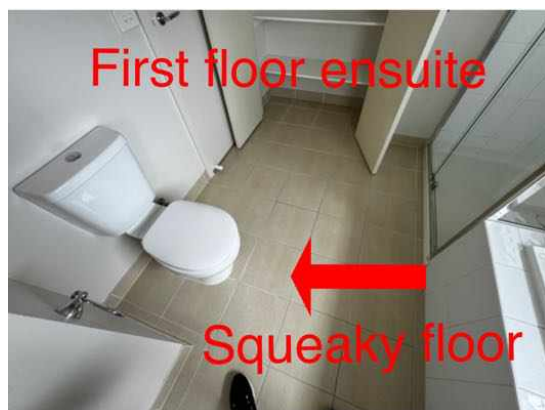
### Finding 3.02

Building:	Main Building
Location:	Ensuite > Level 1
Finding:	Squeaky and loose floor tiles to first floor ensuite
Information:	Squeaky floor tiles with slight movement under body weight were observed directly in front of the toilet within the first-floor ensuite. The movement suggests the tiles or underlying substrate are not adequately bonded or supported. This condition is suspected to be the result of inadequate fixing, deterioration of the adhesive bed, or minor substrate movement beneath the tiled surface. While no visible cracking was noted at the time of inspection, continued movement may lead to tile fracture, grout failure, or moisture ingress into the substrate over time. In accordance with AS 4349.1-2007, this condition is considered a minor defect, as it affects serviceability and finish.

A qualified tiler or builder should investigate the affected area, lift loose tiles as required, assess the condition of the substrate, and reinstate tiles using appropriate adhesive and fixing methods. Any damaged tiles or grout should be replaced to restore a stable and durable floor finish.

Within the next 3-6 months, or sooner if tile movement increases or cracking becomes evident.

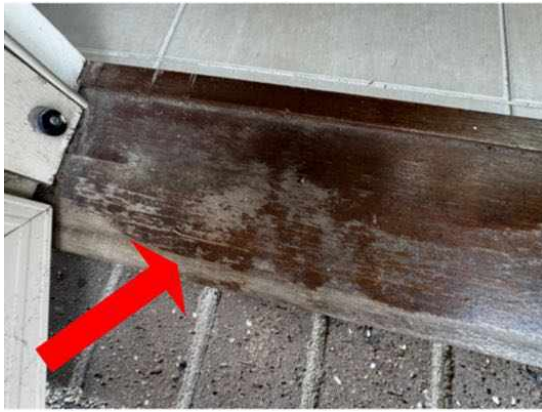
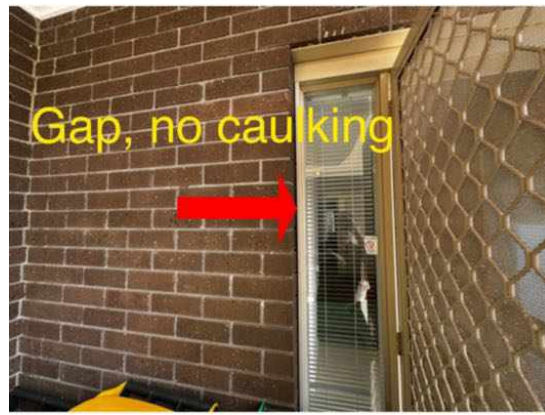
### Finding 3.03

Building:	Main Building
Location:	All Areas > All Areas
Finding:	Multiple minor defects to rear yard shed, external openings, and external finishes
Information:	Several minor issues were observed across the property. The garden shed located in the rear yard has a broken door, reducing security and weather protection. Gaps were noted around the laundry and main entry doors where sealant or caulking has not been applied, which is suspected to allow air, dust, moisture, and pests to enter the building. Minor cracking was observed to the rendered finish on the first-floor external wall, consistent with age-related movement or shrinkage and considered cosmetic in nature. The main entry door sill was found to be weathered, indicating exposure to moisture and wear over time. Minor surface rusting was also observed to the garage steel lintel, suggesting early corrosion likely due to moisture exposure. In accordance with AS 4349.1-2007, these items are considered minor defects, as they do not currently affect structural integrity but may deteriorate further if not maintained.

Repair or replace the broken garden shed door. Apply appropriate external-grade sealant to gaps around the laundry and entry doors. Monitor and repair render cracking as required, including sealing and repainting to prevent moisture ingress. Sand, reseal, or replace the weathered entry door sill. Clean, treat, and protect the garage steel lintel with an appropriate anti-corrosion coating.

Within the next 6–12 months as part of general maintenance, or sooner to prevent progressive deterioration.

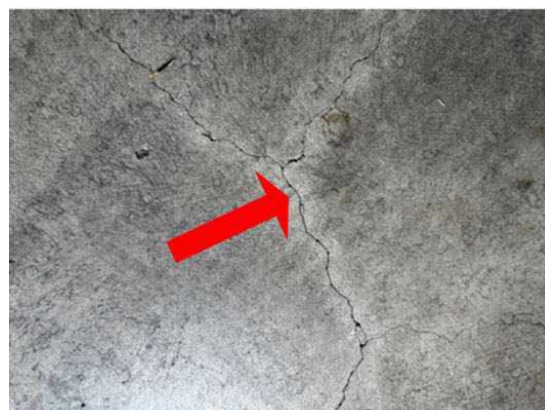
Building:	Main Building
Location:	Garage > Front Right
Finding:	Garage floor cracking, oil staining, and incomplete finishes
Information:	Multiple cracks measuring less than 5 mm in width were observed to the concrete garage floor, which are consistent with minor shrinkage or age-related movement and are suspected to be within acceptable tolerances. A large oil stain was also present on the garage floor, which is cosmetic in nature but detracts from presentation. The garage door motor was observed to be missing its protective cover, leaving electronic components exposed; however, the garage door was tested at the time of inspection and was operational. In addition, incomplete paintwork was noted to the plaster

cornice above the garage door, where a section appears to have been replaced at some stage but not finished. The repair is suspected to relate to a previously cracked roof tile directly above this area, which appears to have been patched using a putty-type material. A moisture meter was used to test the affected ceiling area, and no abnormal moisture readings or active water leaks were detected at the time of inspection. In accordance with AS 4349.1-2007, these items are considered minor defects, as they do not currently affect structural performance but indicate incomplete maintenance and workmanship.

Monitor the garage floor cracks for any change in width or movement. Clean or treat the oil-stained area if improved presentation is desired. Reinstall or replace the missing garage door motor cover to protect electrical components. Complete painting to the repaired plaster cornice to achieve a consistent finish. The roof tile repair above this area should be reviewed by a licensed roof plumber to confirm it is weather-tight and durable.

Within the next 6–12 months as part of general maintenance, or sooner to prevent deterioration of finishes and exposed components.

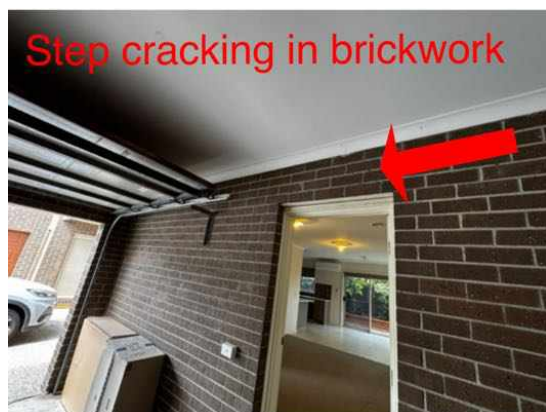
Finding 3.05

Building: Main Building  
 Location: Garage > Front Right  
 Finding: Step cracking to brickwork above garage internal doorway  
 Information: Step cracking was observed to the brickwork within the garage, located above the internal doorway access. The cracking pattern is consistent with suspected movement or stress within the wall, potentially influenced by load transfer from the upper floor structure located above this area. While the cracking is currently localised and does not appear to be causing immediate instability, its position beneath an upper-level structure raises concern that load-related movement or differential settlement may be contributing factors. This condition is considered a minor defect under AS 4349 at the time of inspection, as no significant displacement or loss of structural capacity was evident.

The affected area should be monitored over time for any increase in crack width, length, or displacement. If cracking worsens or additional cracking develops, a structural engineer should be engaged to assess the cause and determine whether rectification or strengthening works are required. Minor crack repair may be considered once the cause is confirmed and movement has stabilised.

Monitor over the next 6–12 months, or sooner if cracking increases or new movement is observed.

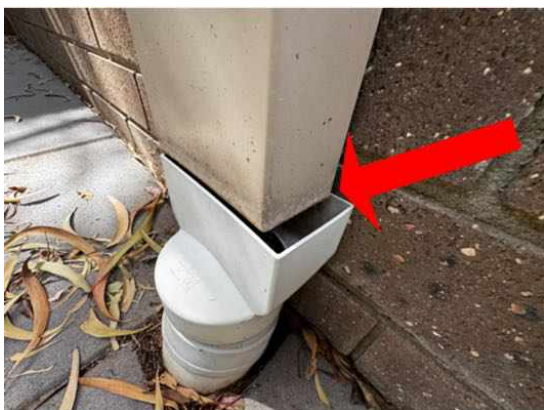
Building:	Main Building
Location:	Roof gutters, downpipe > All Areas
Finding:	Blocked gutters, compromised downpipe, and uncontrolled discharge from air-conditioning overflow
Information:	At the time of inspection, roof gutters located behind the garage and above and behind the boundary wall were observed to be blocked with accumulated organic matter. This condition is suspected to restrict effective roof drainage and may result in water overflow during rainfall events.

In addition, a downpipe located in the rear yard was observed to be slightly separated at its base, leaving a visible gap that may allow water to leak and discharge onto the ground during rainfall. This condition is suspected to contribute to ongoing moisture accumulation adjacent to the building.

It was also noted that the overflow pipe from the air-conditioning condenser unit was not connected to a suitable drainage system and was discharging directly onto the ground. This uncontrolled discharge further contributes to localised damp conditions around the building.

In accordance with AS 3660.2, poor roof drainage and uncontrolled discharge of water are recognised as conditions that increase termite risk, as persistent dampness around building elements and foundations can create environments conducive to termite activity and concealed foraging. Blocked gutters, leaking downpipes, and unconnected overflow pipes may therefore increase moisture exposure and undermine effective termite risk management.

As a result, these drainage-related defects are considered to increase the risk of moisture-related deterioration and termite activity. It is recommended that an appropriately qualified roof plumber and/or air-conditioning technician be engaged to clean and service the gutters, repair or reconnect the downpipe, and connect the air-conditioning overflow to an approved drainage point, ensuring that water is not discharged directly onto the ground, with further advice from a licensed termite management or pest control contractor where elevated termite risk is identified.

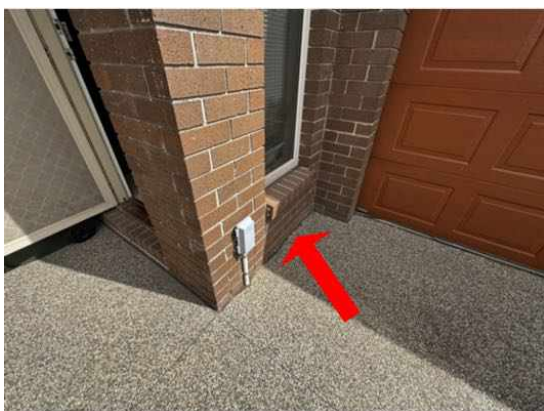
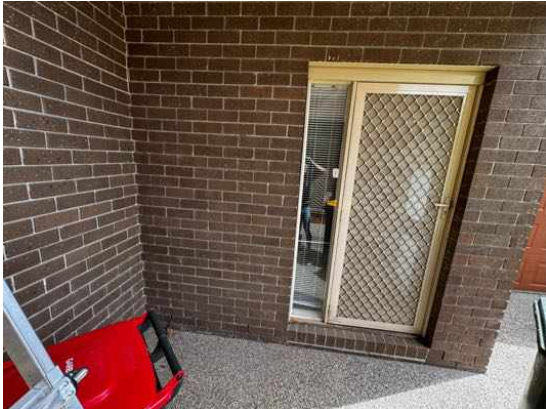
### Finding 6.02

Building: Main Building  
Location: Walls > All Areas  
Finding: Concrete paved porch are hard up against building (TP)  
Information: At the time of inspection, the concrete paved areas was observed to be constructed hard up against the building, concealing the slab edge. This condition restricts visual access to the slab perimeter and limits the ability to inspect critical areas intended for early detection of termite activity.

Effective termite risk management for existing buildings relies on maintaining accessible inspection zones around the structure. Where slab edges are concealed by paving or other hard surfaces, concealed termite entry paths may develop without early warning, increasing the likelihood of undetected termite activity.

As a result, the paved areas are considered to increase the risk of concealed termite entry. It is recommended that a licensed termite management or pest control contractor be engaged to assess this area and provide advice on suitable rectification options, which may include modifying the paving to reinstate inspection access or implementing supplementary termite management measures appropriate to the existing conditions.

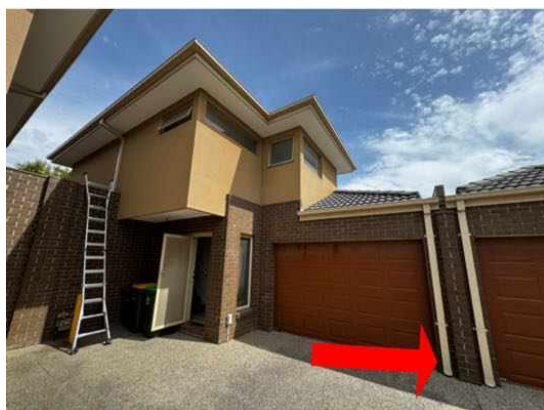
**Finding 6.03**

Building: Main Building  
 Location: Downpipes > Front Right,Rear Left  
 Finding: Downpipes hard against brickwork concealing inspection zones (TP)  
 Information: At the time of inspection, several downpipes were observed to be installed hard against the external brick walls. This configuration restricts visual access to the wall surface and slab edge behind the downpipes, making it difficult to identify early signs of termite activity.

may develop behind these elements without being readily visible, increasing the likelihood of undetected termite ingress.

As a result, the positioning of downpipes hard against the brickwork is considered to increase the risk of concealed termite entry. It is recommended that a licensed termite management or pest control contractor be engaged to assess these locations and provide advice on improving inspection access or implementing supplementary termite management measures to address the increased risk.

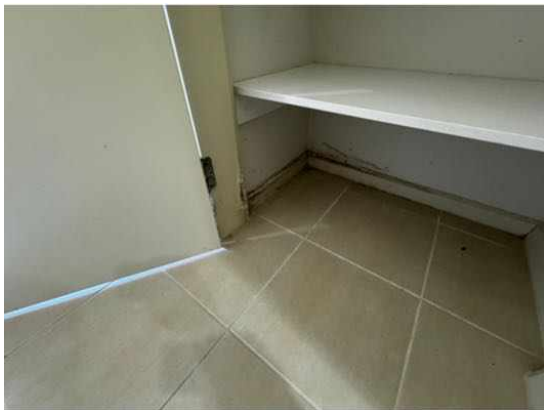
### Finding 6.04

Building:	Main Building
Location:	Tiled and wet areas > Ground Level
Finding:	Elevated moisture levels to ground floor wet and tiled areas (TP)
Information:	At the time of inspection, high moisture readings were detected using a moisture meter in the ground floor tiled and wet areas. In the laundry in particular, very high moisture readings were recorded to the floor tiles and surrounding building elements next to the laundry trough and inside the linen cupboard.

Additional elevated moisture readings were detected in the floor tiles in the dining, kitchen and pantry floors. This condition is suspected to indicate a possible internal plumbing leak within the wall or fitting or external drainage issues, and further investigation is required to confirm the source and extent of moisture ingress.

In accordance with AS 3660.2, wet areas and plumbing-related moisture issues are recognised as increasing termite risk, as persistent dampness within building elements can create conditions conducive to termite activity and concealed access. Ongoing moisture exposure may also lead to deterioration of surrounding materials, further elevating termite susceptibility.

As a result, the moisture issues identified are considered to increase the risk of termite activity and material deterioration. It is recommended that a licensed plumber be engaged to investigate and rectify the suspected leaks, with subsequent assessment by a licensed termite management or pest control contractor where elevated termite risk is identified.

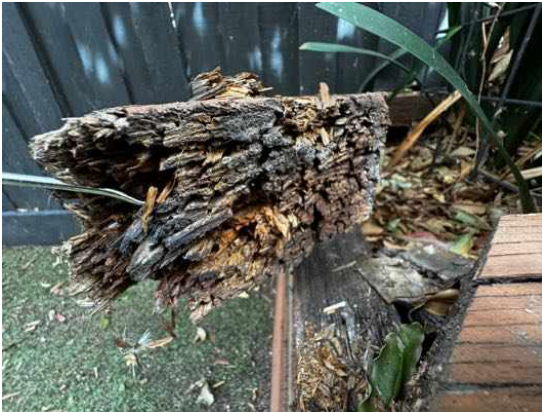
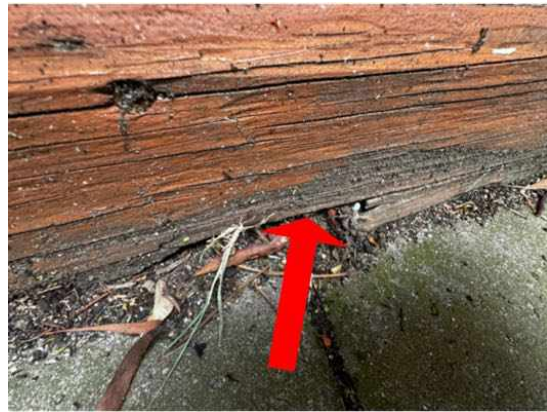
Building:	Main Building
Location:	Yard - Back > Ground Level
Finding:	Timber decay & rot - Conducive conditions (TP)
Information:	At the time of inspection, severe timber decay was observed to the rear garden bed timbers. This condition is suspected to have developed over time due to prolonged moisture exposure and a lack of appropriate timber maintenance, allowing moisture ingress and decay to progress within the timber elements.

In accordance with AS 3660.2, deteriorated and moisture-affected timber is recognised as increasing the risk of termite activity, as decayed timber can attract

termites and may provide concealed access or harbourage.

As a result, the condition of the timber garden bed is considered to present an elevated risk of ongoing deterioration and potential termite susceptibility. It is recommended that an appropriately qualified builder or carpenter be engaged to further assess the extent of timber decay, remove any concealed deteriorated material, and undertake suitable repairs or replacement, with consideration also given to advice from a licensed termite management or pest control contractor where termite risk is identified.
