# Building and Timber Pest Inspection Report

Inspection Date: Tue, 3 Feb 2026

Property Address: 4/223 Princes Hwy, Albion Park Rail NSW  
2527, Australia

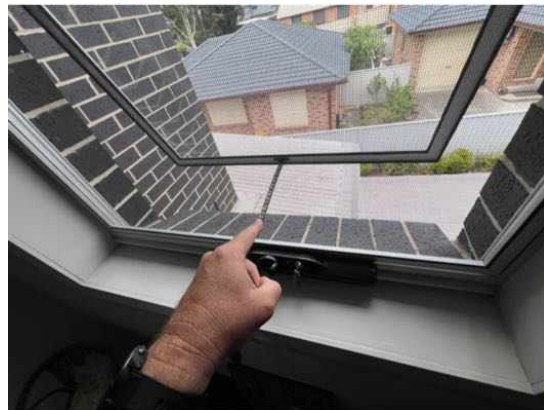
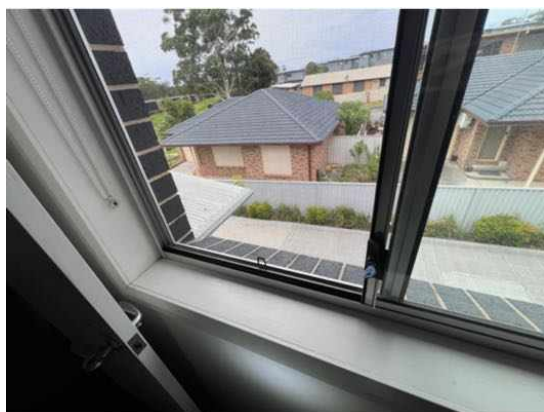
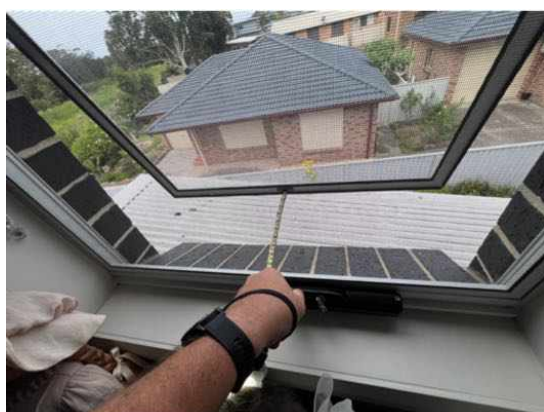
Building:	Main Building
Location:	Upstairs > Level 1
Finding:	Window restrictors recommended
Information:	It was noted that window restrictors were not installed on the upper level windows. This presents a safety hazard as per the Australian Standards AS5203 about fall protection, which requires that all upper-level windows must be fitted with window restrictors to prevent falls.

The lack of restrictors leaves the property vulnerable to potential accidents, particularly for children and other vulnerable individuals. It is recommended that window restrictors be installed on all upper-level windows as soon as possible to ensure the safety of the occupants and to comply with the relevant standards. The restrictors can be bought in a hardware stores or online and they can be installed by the home owner.

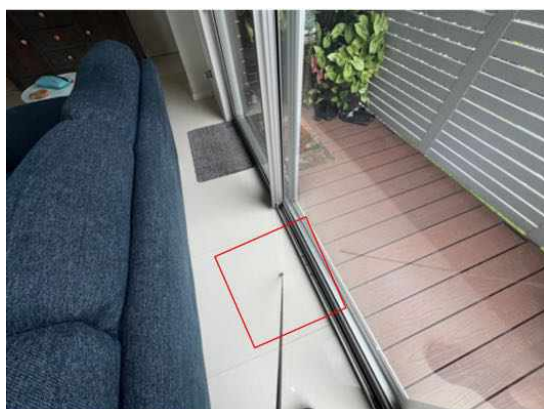
Building:	Main Building
Location:	Entry, Living Room, Garage
Finding:	Tiles - Drummy
Information:	Drummy tiled areas were identified at the time of inspection. The term 'drummy' refers to tiles that have become detached from their fixing, despite otherwise being in relatively good condition. Such defects are generally caused by physical or moisture damage to the area. Drummy tiled areas may also be a direct result of poor workmanship during the construction process.

Tiled areas may swell and shrink with changes in air humidity if the area has sustained moisture damage. Any exposure to moisture is capable of causing tiled areas to become drummy and/or cracked over a prolonged period of time. Drummy tiled areas generally require removal and replacement of affected tiles, with adequate sealant and grouting.

Specialist trades are available for these types of services. A registered builder may be required to undertake works if damage is extensive or if secondary building defects have resulted. Otherwise, it is advised that a tiling contractor be appointed to perform works as necessary. Immediate action is recommended to ensure that no further damage is sustained in the affected area.

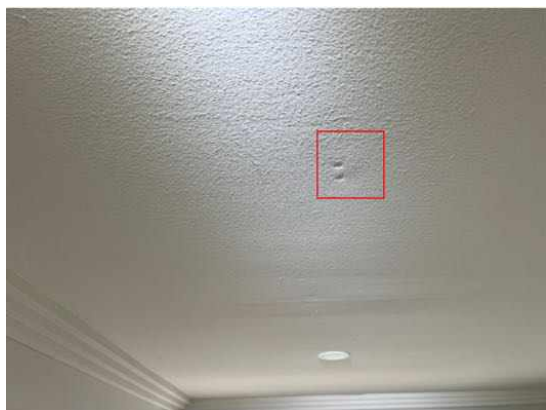
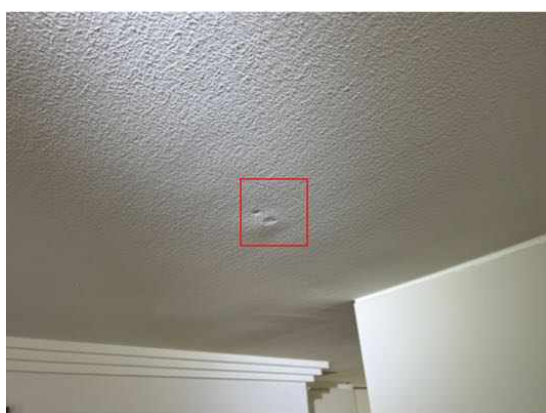
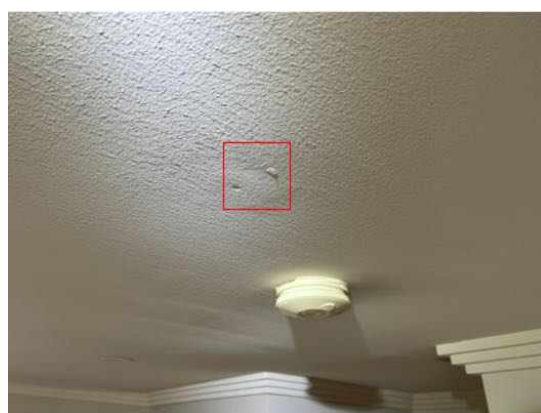
### Finding 3.02

Building:	Main Building
Location:	Living Room
Finding:	Ceiling nails - Popping
Information:	Numerous popped nails were identified in the internal ceiling at the time of inspection. Nails and screws hold simply by the friction between them and the surface they are applied to. Over time, the nails and screws can back out, which is often a result of general ageing and deterioration of the building structure.

If left unmanaged, the ceiling sheets may become loose and unstable, increasing the rate of deterioration of the internal ceiling and creating potential for the development of secondary defects.

onset of ceiling sagging. These works should be performed by a qualified carpenter or plasterer at client discretion.

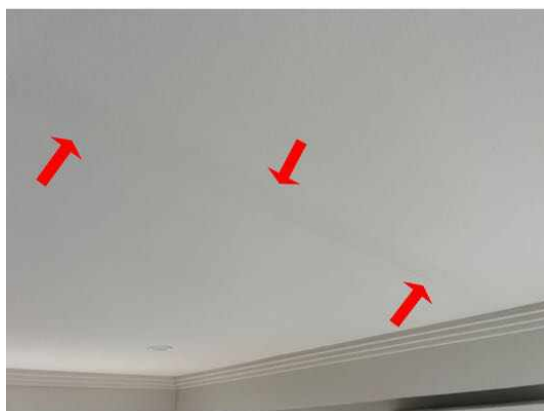
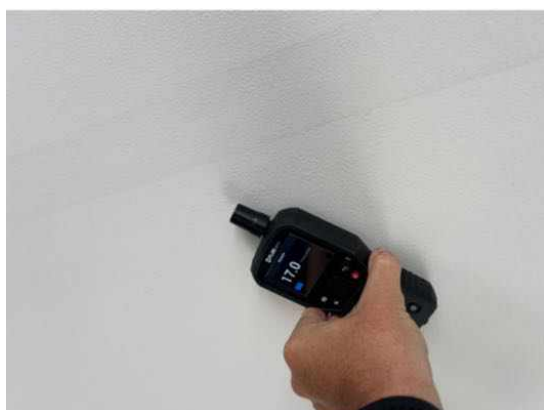
### Finding 3.03

Building:	Main Building
Location:	Living Room
Finding:	Ceiling Sheet Joint Shadowing - Suspected Air-Conditioner Condensation
Information:	A faint linear mark and localised colour variation were observed along a plasterboard ceiling sheet joint, running at right angles to the floor joists. The location and pattern were consistent with joint “shadowing” and suspected intermittent surface condensation, likely influenced by the nearby wall-mounted air-conditioning unit discharging directly across this area.

As part of the inspection process, the hot water was run for an extended period and the accessible underside of the floor structure, including the area adjacent to the shower waste plumbing, was observed. No active leakage was identified during these checks. Moisture meter testing to the ceiling lining did not detect elevated readings, with results consistent across the ceiling surface.

This condition is commonly associated with temperature differentials and humidity, where cooler ceiling zones around sheet joints can promote brief condensation and airborne dust adhesion, creating visible “ghosting” over time. While this appears to be

an aesthetic issue rather than evidence of current leakage, the area should be monitored. If staining worsens, or if the ceiling lining shows softening, bubbling, or deterioration, further investigation should be undertaken to confirm the cause and ensure the air-conditioning condensate management is performing as intended.

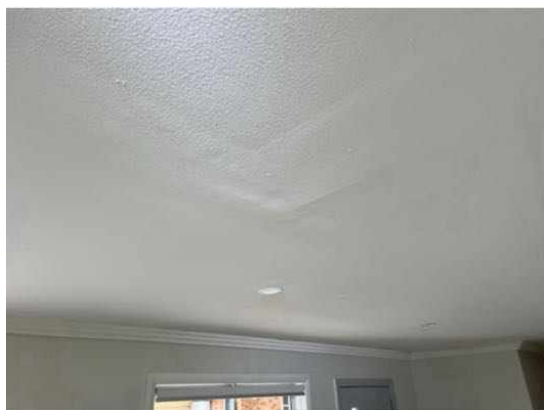
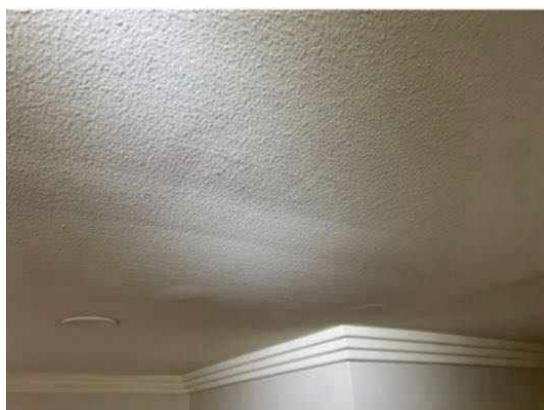
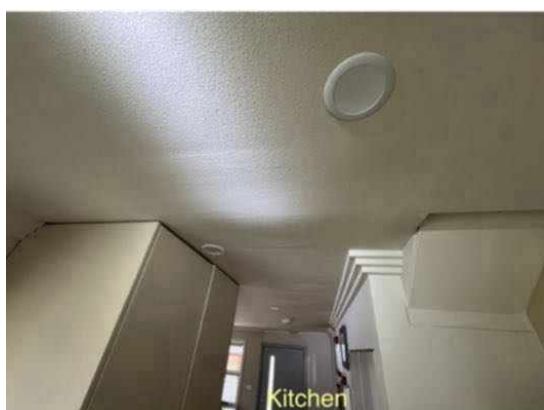
### Finding 3.04

Building:	Main Building
Location:	Living Room, Kitchen
Finding:	Ceiling Defects - Poor Finishing
Information:	Visual inspection revealed inconsistent flushing of joint lines. Minor sagging across some ceiling surfaces suggests that back-blocking may have been omitted or poorly executed during installation.

Poor joint treatment, while generally not structural, can lead to further deterioration of ceiling linings if left unmanaged. These issues detract from the ceiling's appearance and may compromise the long-term durability of the plasterboard fixing.

Rectification by a qualified plasterer is recommended. Works should include securing loose fixings, re-flushing affected joints, and applying back-blocking where necessary to stabilise the ceiling structure and improve the visual condition.

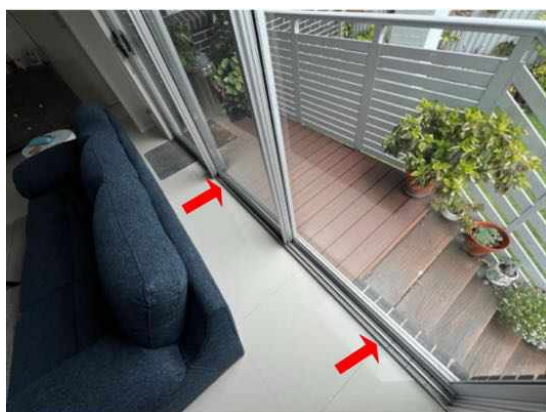
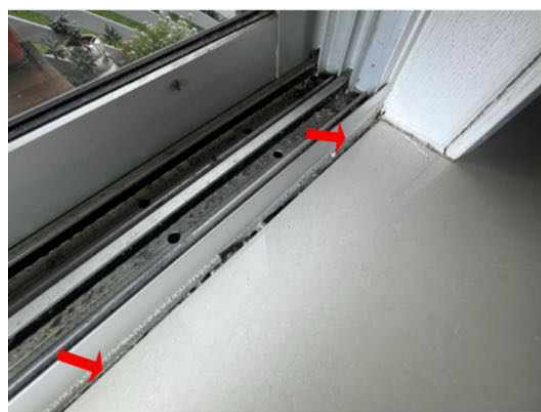
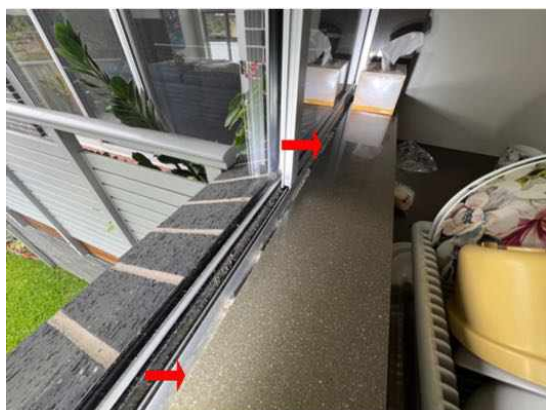
### Finding 3.05

Building:	Main Building
Location:	Living Room, Kitchen
Finding:	Sealant - missing
Information:	It was noted on inspection that sealant or grout is missing to this area.

Different materials move at different rates, generally causing cracking to grout or sealant at this point. A flexible sealant is required to allow for expected expansion and contraction, while keeping the joint water tight and protective of all associated building materials.

any subsequent water damage that is likely to occur. Regular maintenance and replacement of damaged or missing or damaged sealant and grout is highly recommended to the wet areas, as this is a regular wear and tear defect. Sealant and grouting in areas that come into regular contact with water should be maintained for the long term care of your property.

A sealant specialist or tiling contractor should be appointed to complete these works as soon as possible

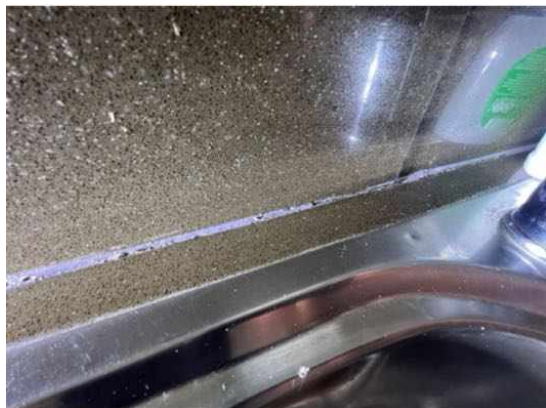
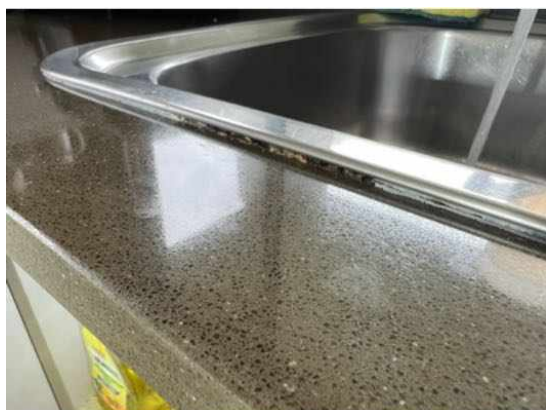
### Finding 3.06

Building:	Main Building
Location:	Kitchen
Finding:	Kitchen Sealant - degraded
Information:	It was noted on inspection that sealant or grout is degraded to the kitchen sink and splash back.

Different materials move at different rates, generally causing cracking to grout or sealant at this point. A flexible sealant is required to allow for expected expansion and contraction, while keeping the joint water tight and protective of all associated building materials.

Flexible and mould resistant materials should be applied to affected areas to prevent any subsequent water damage that is likely to occur. Regular maintenance and

replacement of damage or missing or damaged sealant and grout is highly recommended to the wet areas, as this is a regular wear and tear defect. Sealant and grouting in areas that come into regular contact with water should be maintained for the long term care of your property.

A sealant specialist or tiling contractor should be appointed to complete these works as soon as possible

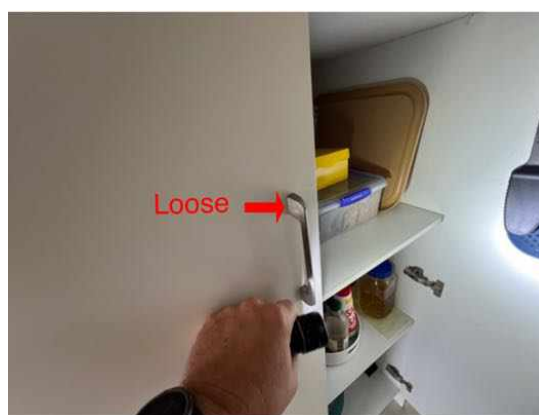
### Finding 3.08

Building:	Main Building
Location:	Kitchen
Finding:	Cabinetry - Loose hinges
Information:	Several cupboard doors are not level and detract from the operational state of the cabinetry. Upon further inspection, it was noted that the hinges to the cupboard doors have deteriorated over time and, as a result, have come loose from their original fixing. To improve operation of the affected cupboard doors, a general handyman may be appointed to replace the faulty hinges. Such works should be completed at discretion of the client.

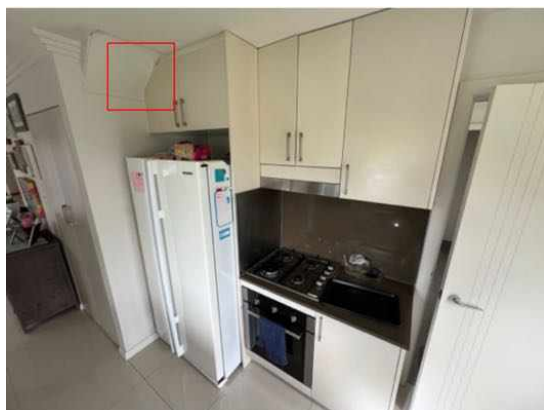
### Finding 3.09

Building:	Main Building
Location:	Kitchen
Finding:	Building element - Not operating
Information:	Non-operational items should be addressed to ensure that the full function of the building structure is available. Where some building elements are not operating as intended, it is possible that secondary building defects could arise due to their non-operation.

Repair and/or replacement of the faulty building element is recommended. It is highly

recommended that the relevant tradesperson be engaged to perform any necessary works.

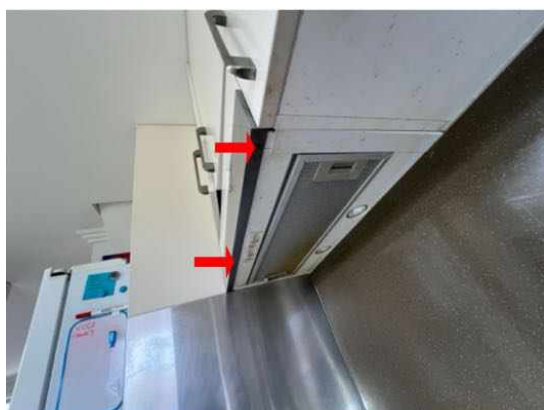
### Finding 3.10

Building:	Main Building
Location:	Kitchen
Finding:	Sliding Rangehood - Restricted Movement
Information:	The sliding rangehood was observed to be difficult to extend and did not slide out as intended. The unit operated when switched on; however, restricted movement indicates a functional issue with the sliding mechanism.

It is recommended that a suitably qualified appliance technician assess the range hood and carry out any necessary adjustment or servicing to restore proper sliding function.

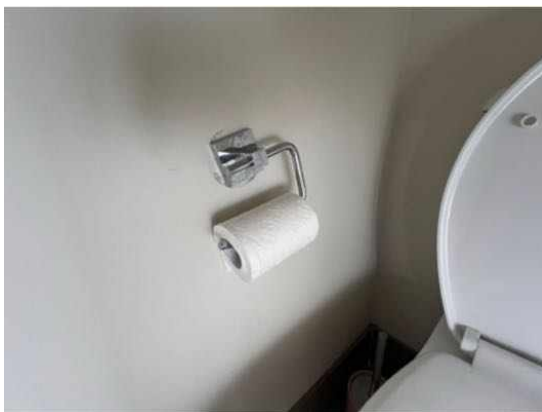
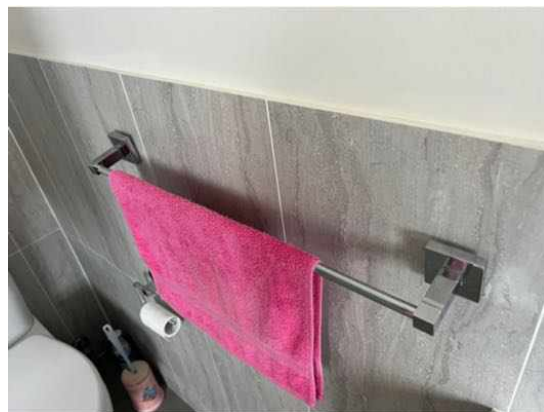
Building:	Main Building
Location:	Toilet (WC), Ensuite, Bathroom
Finding:	Fitting or fixture - Loose
Information:	The fitting in this area is loose and requires adjustment to tighten.

If left unmanaged, the fitting may further deteriorate, causing potential for the development of other minor secondary defects.

A relevant tradesperson should be appointed to perform these rectification works at discretion of the client.

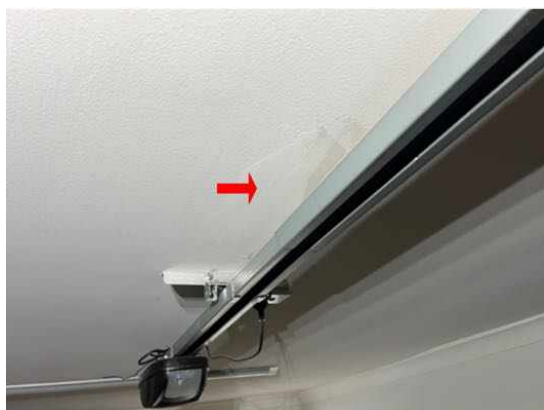
### Finding 3.13

Works that have not been completed to a satisfactory level create potential for the development of building defects and may impede on the safety and integrity of the overall structure.

It is highly recommended that a licensed plasterboard contractor should be appointed to repair the ceiling. To ensure the safety of the area and the longevity of all associated building elements.

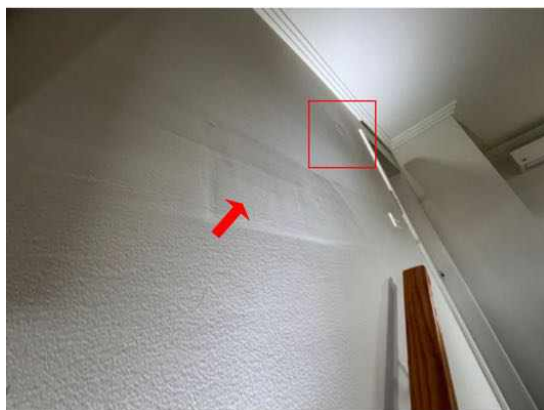
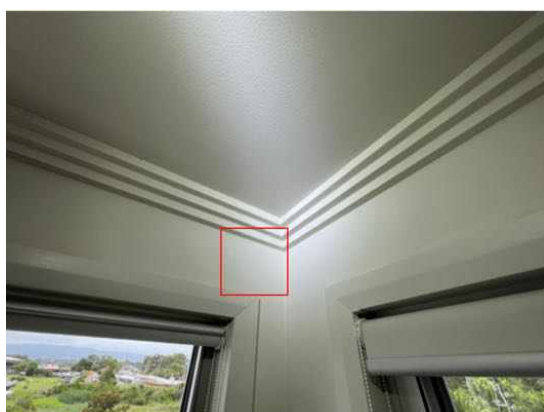
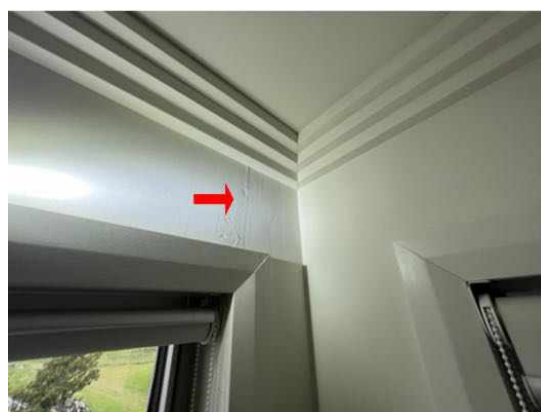
### Finding 3.14

Building:	Main Building
Location:	Stairs - Internal, Lounge Room
Finding:	Wall - Incomplete or substandard works
Information:	The plasterboard finishing to this area appear to be incomplete or have been completed to a substandard level.

Works that have not been completed to a satisfactory level create potential for the development of building defects and may impede on the safety and integrity of the overall structure.

It is highly recommended that a licensed plasterboard contractor or painter should be appointed to finish the wall to an acceptable standard.

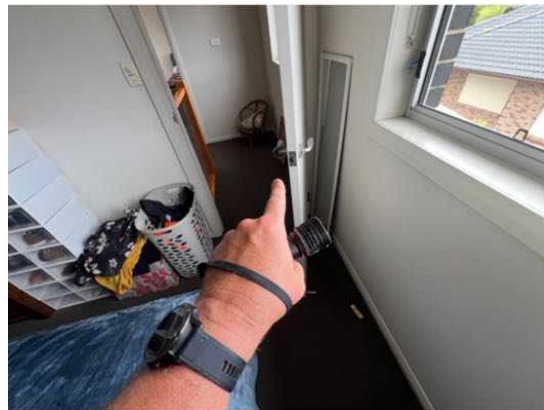
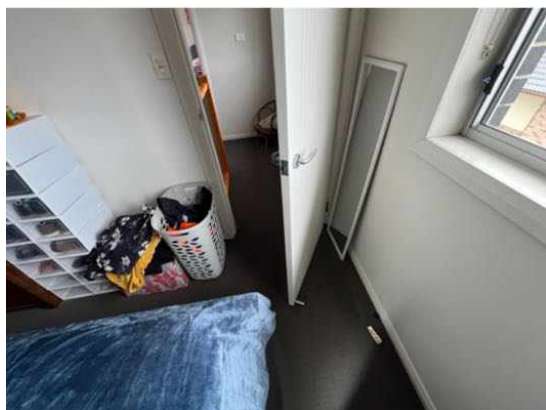
Building:	Main Building
Location:	Bedroom 2
Finding:	Door - swings drifts open not stationary
Information:	The door was observed to swing or drift open and closed on its own, failing to remain stationary when positioned. A properly installed door should stay in place unless intentionally moved, and this condition is typically caused by a substandard door or jamb installation, or slight unevenness in the floor surface.

While not structural, this defect is inconvenient and detracts from normal use. A carpenter or general handyperson should be engaged to inspect the installation and make necessary adjustments to ensure the door remains stable when open or closed.

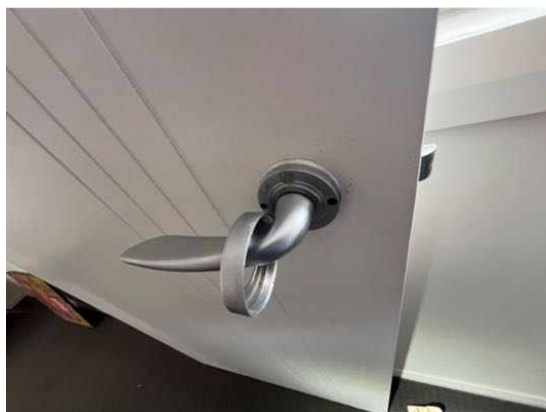
### Finding 3.17

Building: Main Building  
 Location: Bedroom 2  
 Finding: Door - damage handle  
 Information: The door handle in this area was found to be damaged at the time of inspection. Breakage occurs generally when the building materials have aged and decayed, but may be indicative of impact damage (accidental or deliberate).

Repair and/or replacement of the broken door handle is advised to improve the operational state of the associated door.

A qualified carpenter or general handyman should be appointed to repair/replace the door handle at the client's discretion.

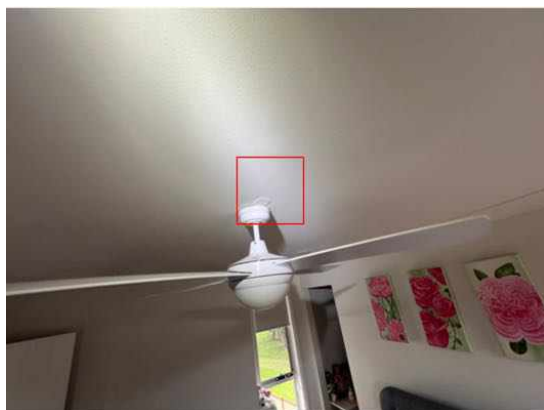
### Finding 3.18

Building: Main Building  
 Location: Bedroom - Master  
 Finding: Ceiling - Damaged  
 Information: Breakage occurs generally when the building materials have either aged and decayed, or as a result of damage (accidental or deliberate).

A plasterer, painter or handyman should be appointed to repair or replace the affected building element prior to any subsequent damage being caused.

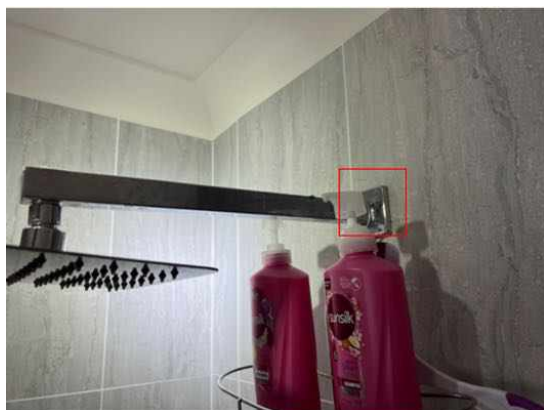
### Finding 3.22

Building:	Main Building
Location:	Ensuite
Finding:	Shower head - Loose
Information:	The shower head at the wall connection in this area has not been installed correctly, or has deteriorated with age, and is consequently loose. This shower head being loose creates potential for water leaks and subsequent water damage to the surrounding area.

Where taps or spouts are loose, a qualified plumber should be appointed to re-fix the plumbing fitting.

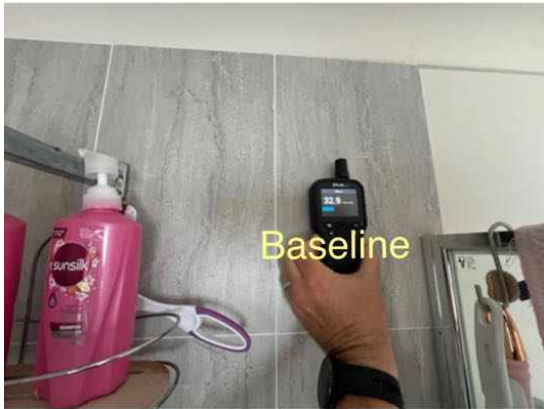
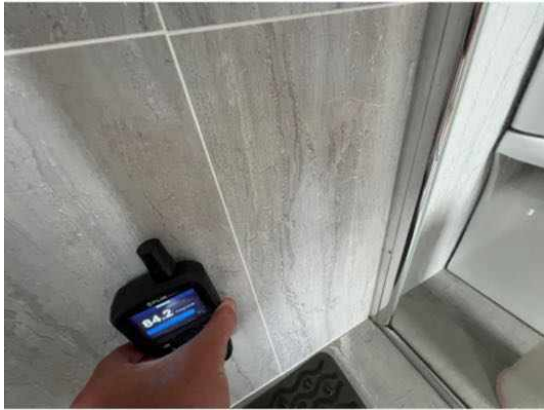
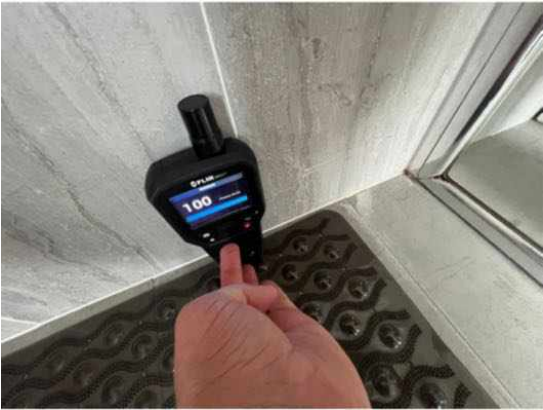
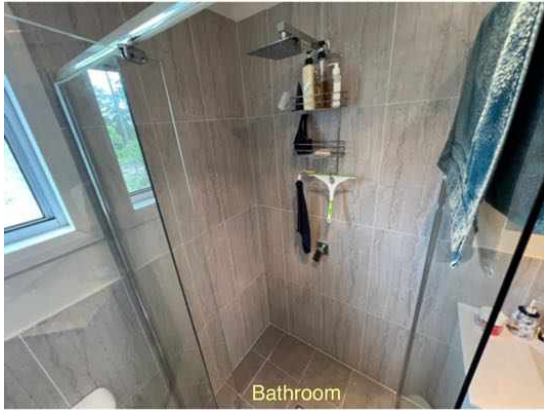
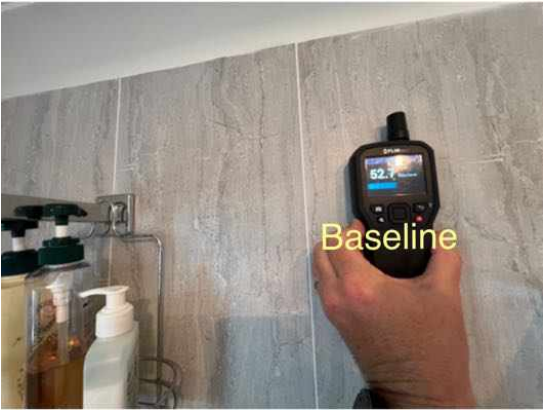
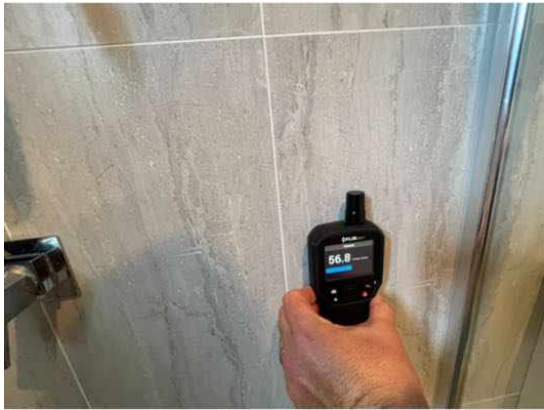
### Finding 3.23

Building:	Main Building
Location:	Ensuite, Bathroom
Finding:	Moisture in Shower
Information:	Moisture is evident behind the tiles to the shower alcove. This defect is quite common, and is suspected to have been caused by moisture permeating through the grouting in this area. Leaking pipes within the adjoining wall is also a possible cause.

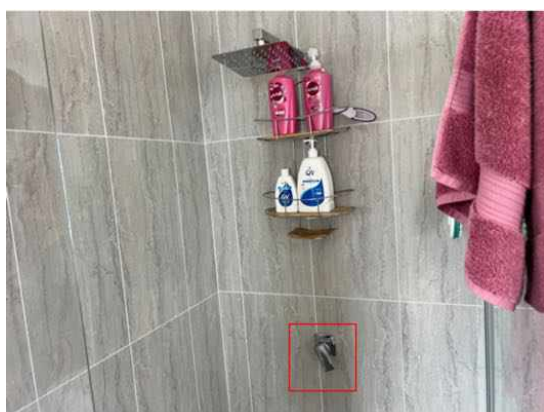
Finding 3.24

Building:	Main Building
Location:	Ensuite, Bathroom
Finding:	Tap - Water hammer
Information:	This tap shows evidence of water hammer being present. Water hammer, a pressure surge resulting when a fluid is forced to suddenly change direction, is a common defect in plumbing fittings, particularly those that are aged and not frequently maintained. Water hammer is generally caused by factors that create high water pressure in the affected plumbing fixture, usually evidenced by a faint banging noise during operation of the affected tap.

A licensed plumber should be appointed as soon as possible to replace any affected tap hardware and perform any remedial works as necessary. Please be advised that the appointment of a cabinet maker or qualified carpenter may be necessary if water damage to associated building elements has occurred.

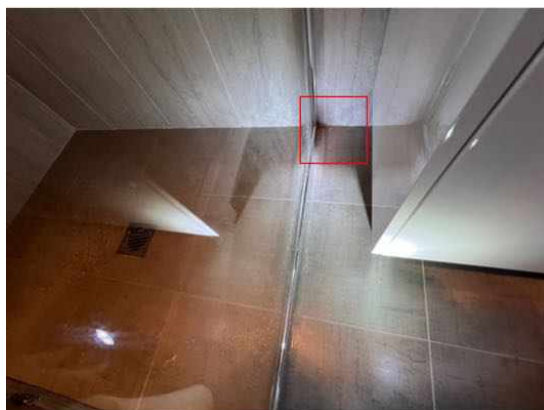
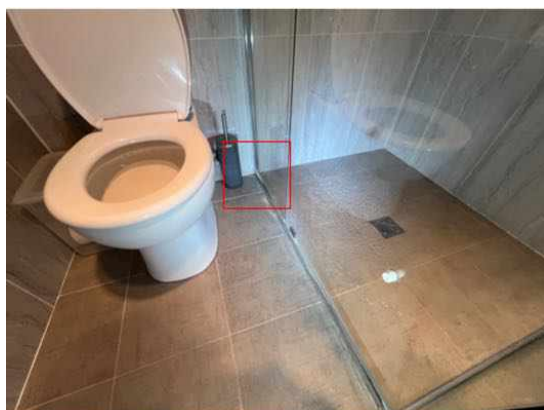
### Finding 3.27

Building:	Main Building
Location:	Bathroom
Finding:	Shower screen - active leak
Information:	A active leak was identified to the shower screen, likely due to deteriorated or inadequate sealant. If left unmanaged, water ingress may lead to damage to adjacent walls and flooring, as well as creating conditions conducive to mould growth.
	Resealing is recommended to restore a watertight seal and prevent further deterioration.

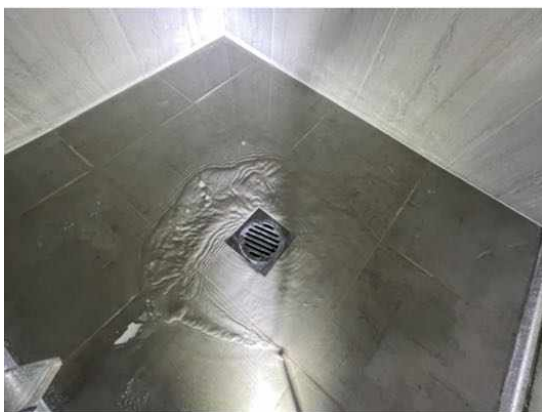
### Finding 3.28

Building:	Main Building
Location:	Bathroom
Finding:	Shower base - Water pooling
Information:	Evidence of water pooling around the floor waste in the shower recess was noticed at the time of inspection. It is suspected that this excessive moisture is attributed to insufficient fall in the shower floor tiles.

Remedial works may involve some sections of tiling and flooring repair and replacement. A tiling contractor or bathroom specialist should be appointed to provide further advice on reparation options and to perform works as necessary.

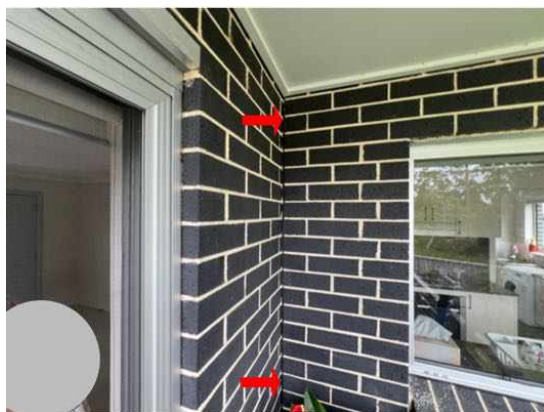
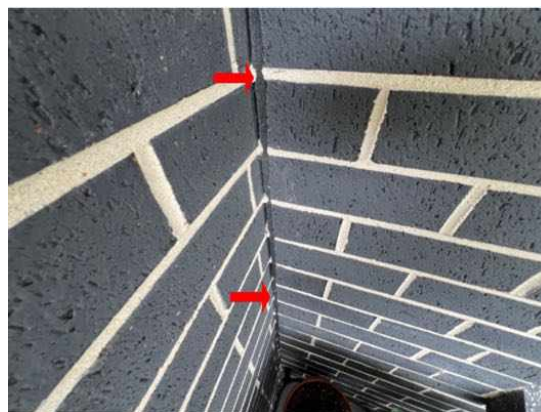
### Finding 3.31

Building: Main Building  
 Location: Decking - Landing  
 Finding: Expansion Joint – Incomplete  
 Information: An expansion joint was identified with foam backing material in place but no evidence of flexible sealant having been applied over the joint. Expansion joints are intended to accommodate movement while preventing moisture ingress, pest entry, and air leakage.

The client should engage a qualified sealant contractor or experienced handyman to assess and complete the sealing of the joint where necessary.

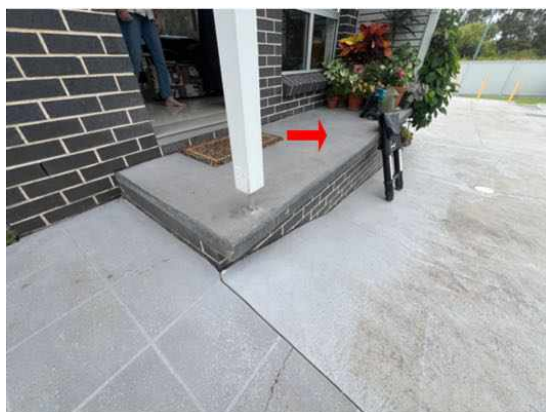
## Finding 6.04

Building:	Main Building
Location:	All External Areas
Finding:	Bridging (decking)- Attachments to Buildings.
Information:	Decking to rear landing about dwelling causing bridging and concealment. Bridging occurs when items against a building provide a concealed entry point for termites into the building or by passing around a termite management system.

The client should consider obtaining further advice from a timber pest technician regarding treatments required in this area. It is recommended that obtaining such advice be a short-term priority.

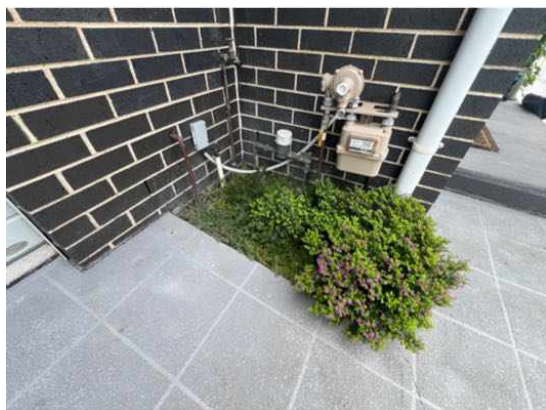
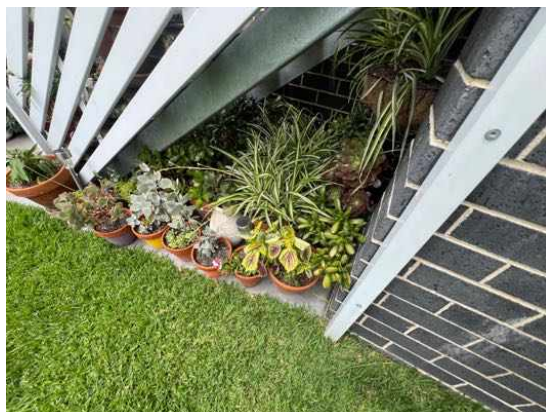
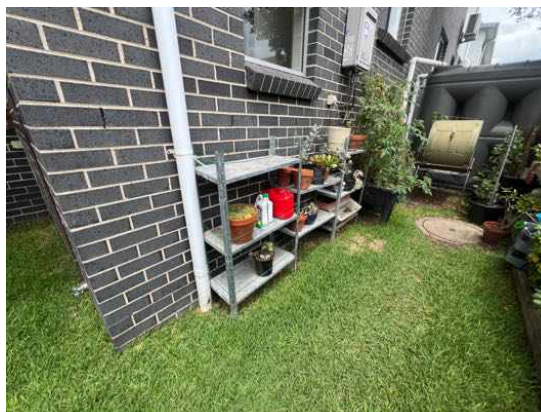
### Finding 6.08

Building:	Main Building
Location:	All External Areas
Finding:	Garden Beds - Conditions Conducive to Termites
Information:	Garden beds were observed around the perimeter of the building, obstructing visual inspection of lower wall areas and providing potential concealed termite entry points.

It is recommended that garden beds be reduced or cleared from the building perimeter, or that regular timber pest inspections be carried out in accordance with AS 4349.3 or AS 3660.2 to monitor risk.
