Building Inspection Report

Inspection Date: Wed, 25 Feb 2026

Property Address: 43 Baseline Way, Clyde VIC 3978, Australia

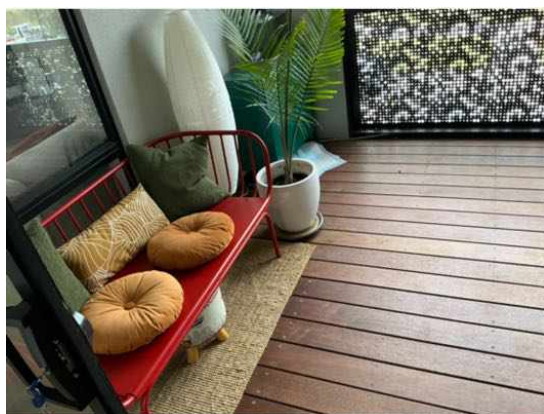
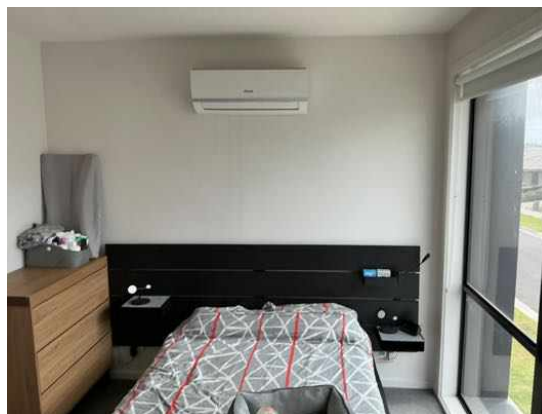
Defects 3.01

Building:	Main Building
Location:	All Internal Areas
Finding:	Obstructions and Limitations - Interior
Information:	These photographs are an indication of the obstructions and limitations which impeded the inspection of the internal areas of the property at the time of inspection. These obstructions can hide an array of defects and should be removed to allow full inspection to be carried out. A re-inspection is recommended once the areas are made accessible.

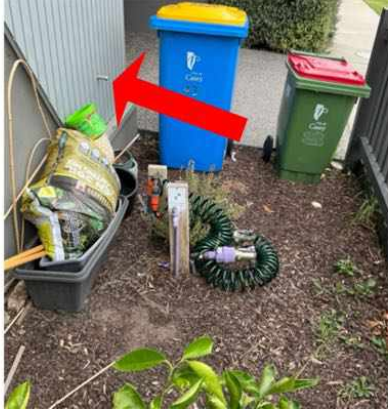
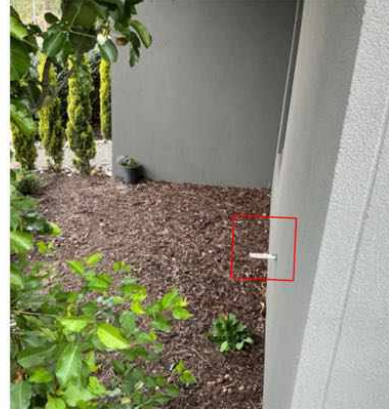
Defects 3.02

Building:	Main Building
Location:	All External Areas
Finding:	AC Overflows - Not plumbed to suitable drainage
Information:	Upon inspection, it was found that the AC overflow is not plumbed or connected to suitable drainage. This could lead to the surrounding area becoming excessively damp, which in turn may cause secondary defects such as rot, rust, corrosion of associated building elements, and the formation of fungal decay. In addition, prolonged damp conditions could create potential slip hazards. Poor site drainage may

exacerbate the issue, potentially attracting termite activity to the area.

We recommend that a licensed plumber be appointed to properly plumb the AC overflow and connect it to suitable drainage. This will help ensure that the area remains dry and free from secondary defects.

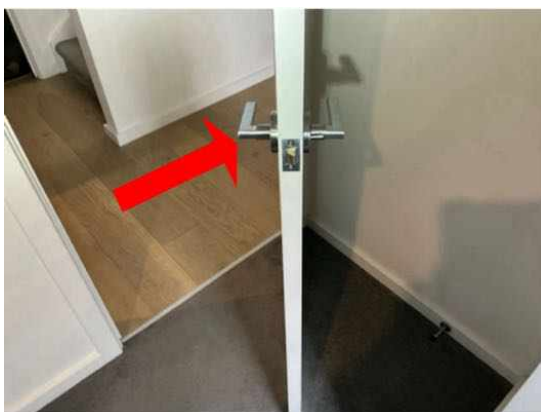
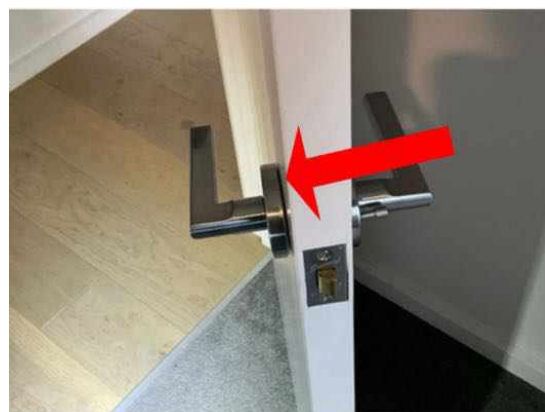
Defects 3.03

Building: Main Building
 Location: Bedroom 2
 Finding: Loose Door Handle to Bedroom 2
 Information:

At the time of inspection, the door handle to Bedroom 2 was observed to be loose and unstable when operated. The handle exhibited movement at the fixing points, indicating that the hardware has loosened over time.

Loose door hardware may worsen with continued use and can result in premature wear or failure of the latch mechanism if not addressed. The condition is considered a minor maintenance issue.

It is recommended that a qualified carpenter or competent handyman tighten the fixings and secure the handle assembly to ensure proper and stable operation.

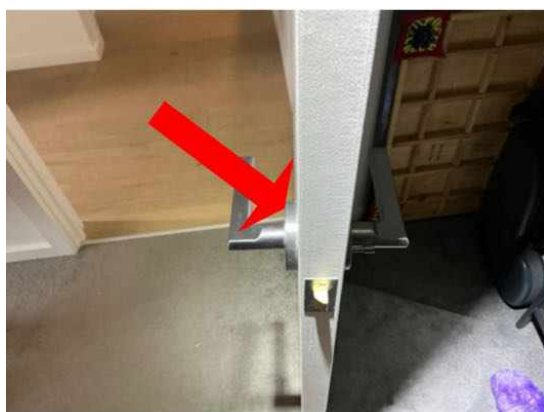
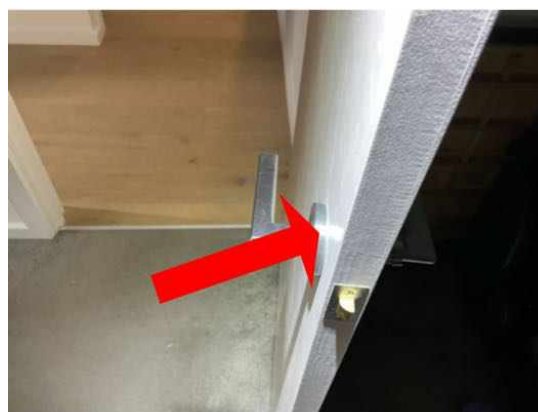
Defects 3.04

Building: Main Building
 Location: Bedroom 3
 Finding: Loose Door Handle to Bedroom 3
 Information:

At the time of inspection, the door handle to Bedroom 3 was observed to be loose and shaky when tested. The hardware appears inadequately secured to the door leaf.

Continued use in this condition may lead to further loosening or damage to the internal latch components. The issue is a minor maintenance item rather than a structural concern.

It is recommended that a qualified carpenter or competent handyman resecure and tighten the door handle assembly to restore proper function.

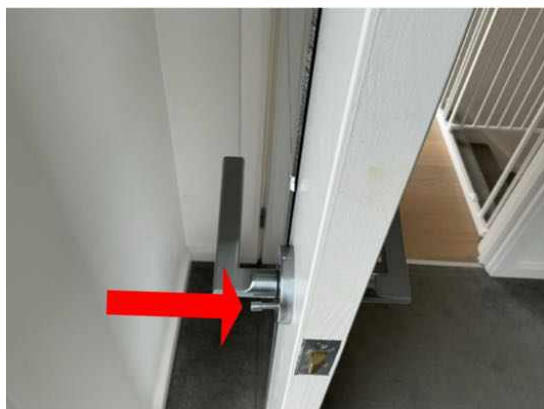
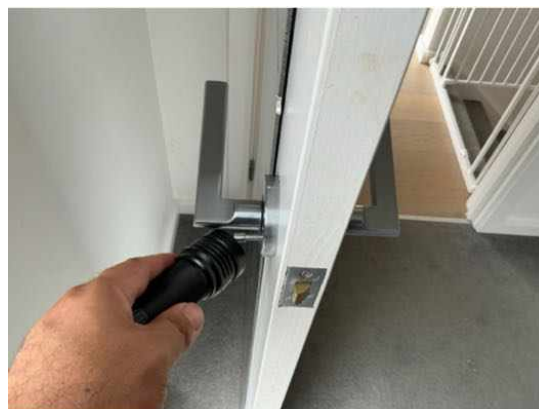
Defects 3.05

Building: Main Building
 Location: Bedroom - Master
 Finding: Defective Door Latch/Lock Mechanism to Master Bedroom (Upper Level)
 Information:

At the time of inspection, the door latch/lock mechanism to the master bedroom located on the upper level was tested and found to be inoperative. The door hardware did not engage or operate as intended when attempting to lock the door. No structural distortion of the door frame was observed; however, minor misalignment or internal mechanism failure cannot be excluded.

A defective lock mechanism affects the functionality, privacy, and security of the room. Such issues are commonly caused by internal wear of the latch assembly, loose hardware, or minor misalignment between the latch tongue and strike plate due to normal building settlement or door movement over time. The condition is considered a maintenance item rather than a structural defect.

It is recommended that a qualified carpenter or competent handyman inspect the door

hardware and undertake necessary repairs, which may include adjustment of hinges, realignment of the strike plate, tightening of fixings, or replacement of the latch/lock assembly as required to ensure proper operation.

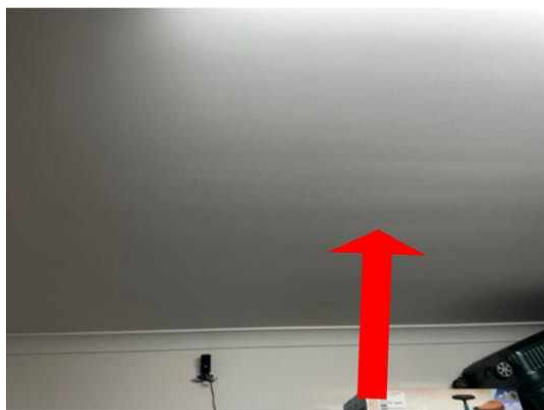
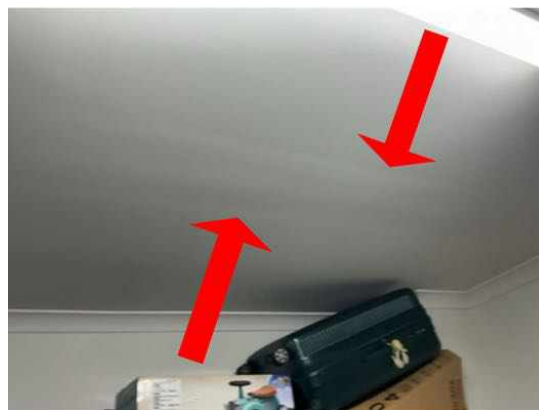
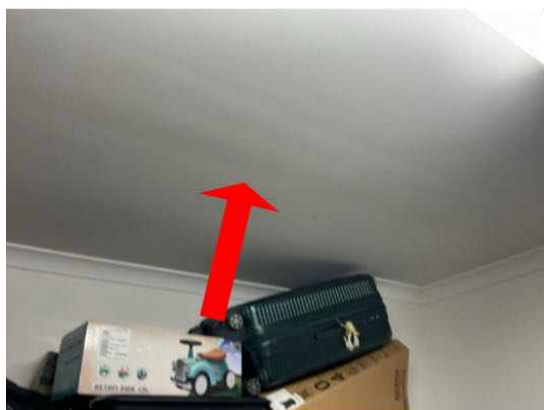
Defects 3.06

Building: Main Building
 Location: Garage
 Finding: Visible Plasterboard Ceiling Joints to Garage
 Information:

At the time of inspection, the plasterboard ceiling lining within the garage was observed to have visible joint lines. The joints between plasterboard sheets were discernible under normal lighting conditions, indicating an inconsistent finish to the setting, sanding, and/or painting of the ceiling surface. No associated sagging, cracking, moisture staining, or structural movement was observed at the time of inspection.

This condition is indicative of workmanship and finishing quality rather than structural inadequacy. Visible plasterboard joints can occur where joint compound has not been adequately feathered, sanded, or sealed prior to painting, or where insufficient coats have been applied. The issue is cosmetic in nature and does not affect the structural performance of the ceiling lining.

If improved appearance is desired, a qualified plasterer should re-set, feather, and sand the affected joints as required, followed by appropriate sealing and repainting by a qualified painter to achieve a more uniform finish. Rectification is discretionary and relates to presentation only.

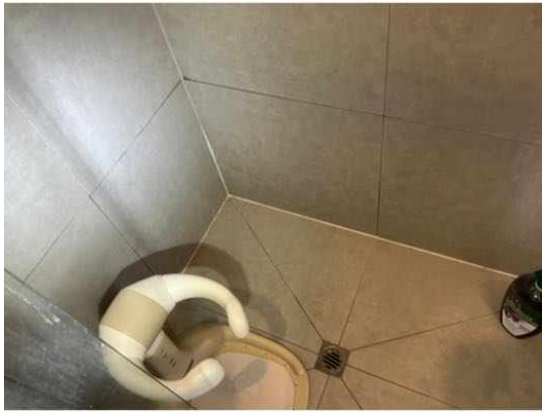
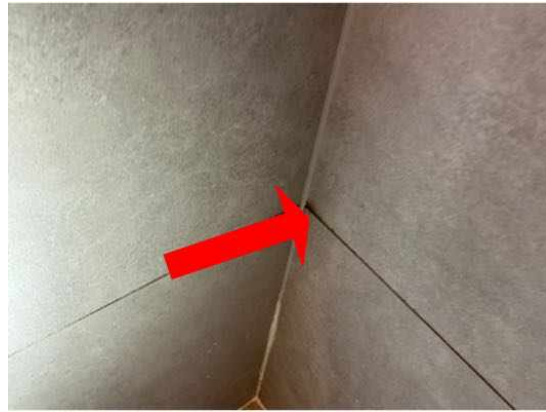
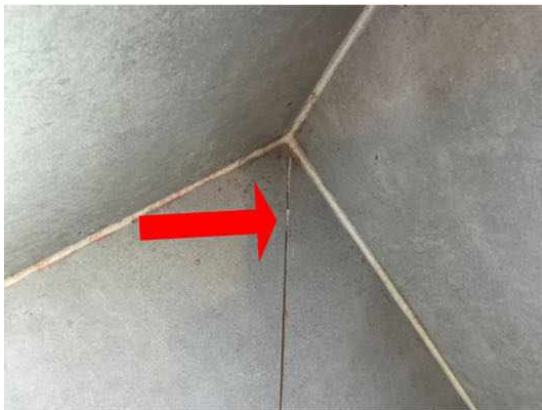
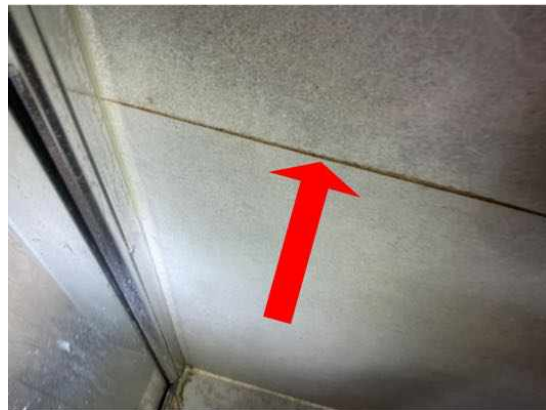
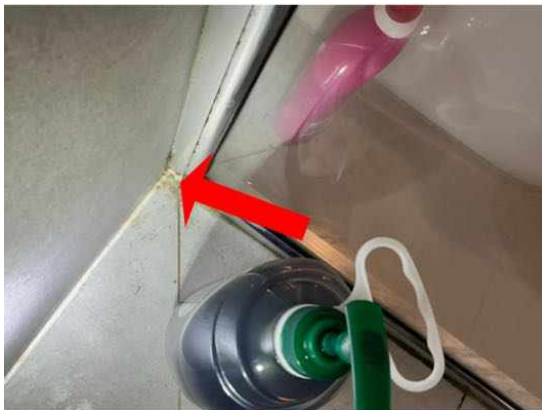
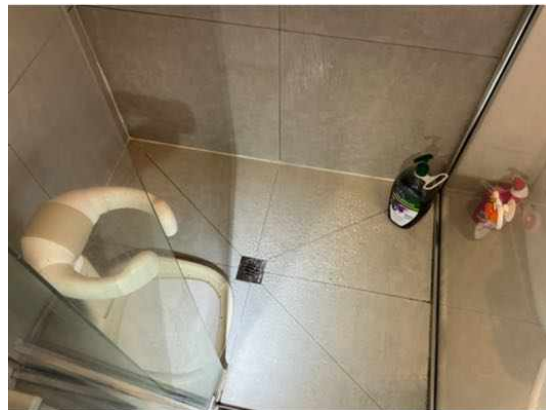
Defects 3.07

Building:	Main Building
Location:	Ensuite - Master
Finding:	Sealant and grouting - Deteriorated
Information:	It was noted on inspection that sealant or grout is degraded to the tiled shower alcove and or other areas of the bathroom.

Different materials and floor areas move at different rates, generally causing cracking to grout or sealant at this point. A flexible sealant is required to allow for expected expansion and contraction, while keeping the joint water tight and protective of all associated building materials.

There appears to be some mould to the sealant and grout which will likely require scraping out and replacement.

Flexible and mould resistant materials should be applied to affected areas to prevent any subsequent water damage that is likely to occur. Regular maintenance and replacement of damage or missing or damaged sealant and grout is highly recommended to the wet areas, as this is a regular wear and tear defect. Sealant and grouting in areas that come into regular contact with water should be maintained for the long term care of your property.

A sealant specialist or tiling contractor should be appointed to complete these works

as soon as possible

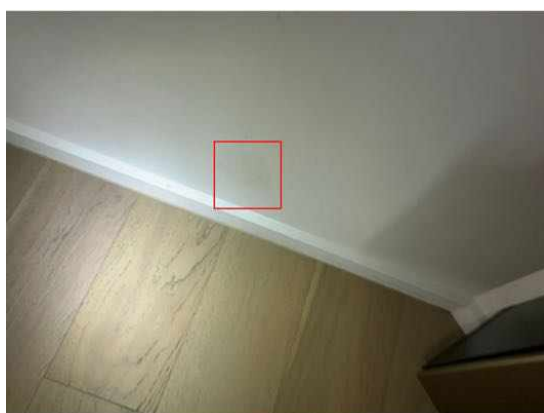
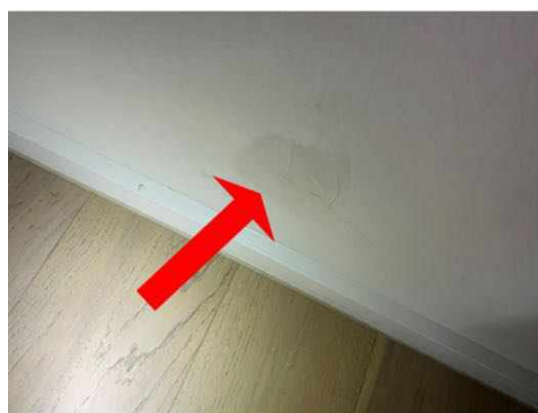
Defects 3.08

Building: Main Building
 Location: Living Room
 Finding: Inadequate Finish to Patched Plasterboard Wall (Upper-Level Living Area)
 Information:

At the time of inspection, the plasterboard wall lining within the upstairs living area was observed to contain a previously repaired section. The patch repair appears to have been completed; however, the surface finish is uneven and does not match the surrounding wall, indicating inadequate sanding, surface preparation, and/or painting.

No associated cracking, movement, or moisture-related defects were identified at the time of inspection.

This condition is cosmetic in nature and relates to workmanship and finish quality rather than structural performance. Poorly blended patch repairs can remain visible under certain lighting conditions and may detract from the overall presentation of the room. There was no evidence at the time of inspection to suggest structural wall movement or ongoing damage associated with this repair.

If improved presentation is desired, a qualified plasterer or painter should prepare the surface appropriately, including sanding, feathering of compound edges, priming, and repainting to achieve a uniform finish consistent with the surrounding wall surface. Rectification is discretionary and for aesthetic purposes only.

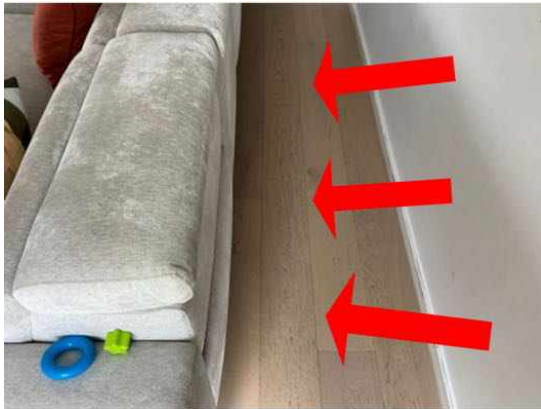
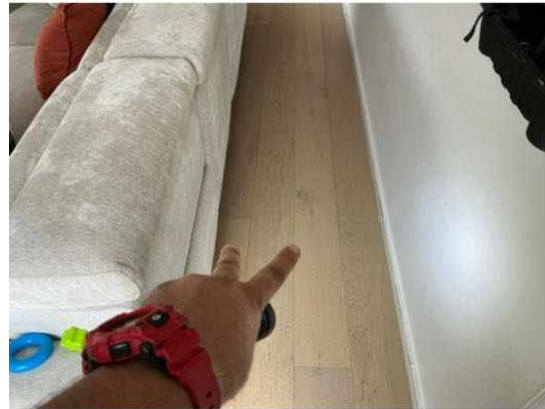
Defects 3.09

Building:	Main Building
Location:	Hallway upstairs
Finding:	Squeaking to Upper-Level Floor Structure
Information:	At the time of inspection, the upper-level floor was observed to produce audible squeaking in the hallway area when walked upon. This condition is commonly associated with double-storey timber-framed construction and is typically caused by minor frictional movement between flooring components such as timber joists, structural subfloor sheeting, fixings, or floor coverings under load. No abnormal deflection, structural movement, or signs of structural inadequacy were observed at the time of inspection.

Floor squeaking in double-storey dwellings is generally a serviceability or convenience issue rather than a structural defect. Such noises can develop over time due to normal building settlement, seasonal expansion and contraction of timber elements, minor loosening of fixings, or differential movement between materials. The condition does not indicate structural instability where no associated movement, sagging, cracking, or failure is evident.

If considered bothersome, further assessment by a qualified carpenter or registered

builder can be undertaken to identify specific friction points and apply remedial measures such as re-fixing flooring, securing loose sheets, or reducing movement between components. From a structural performance perspective, the condition was considered acceptable at the time of inspection.

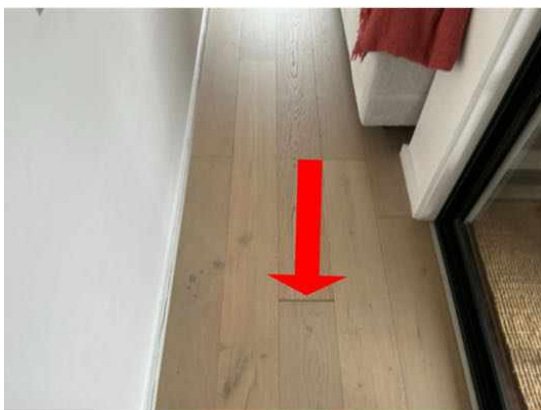
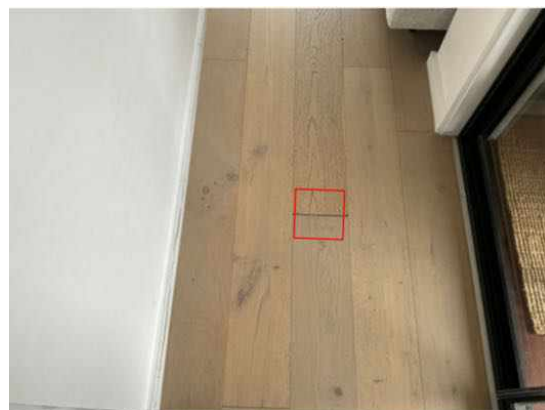
Defects 3.10

Building: Main Building
 Location: Hallway upstairs
 Finding: Minor Gap to Floorboard in Upper-Level Hallway
 Information:

At the time of inspection, one floorboard within the upper-level hallway was observed to have a minor separation gap along its joint line. The gap appears consistent with slight movement or shrinkage of the flooring material and no associated lifting, deflection, or structural concern was noted.

Minor gaps between floorboards can occur due to seasonal expansion and contraction, normal settlement, or localised movement of the flooring system. The condition is cosmetic and does not indicate structural inadequacy.

If rectification is desired for appearance purposes, a qualified flooring specialist should assess and undertake appropriate repairs, which may include re-securing, adjustment, or filling of the affected board.

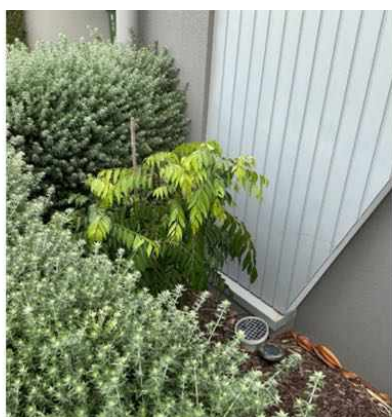
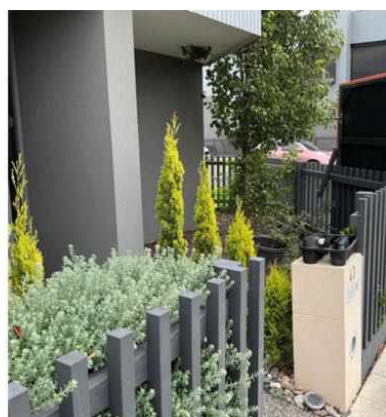
Building: Main Building
 Location: All External Areas
 Finding: Obstructions and Limitations - Exterior
 Information: These photographs are an indication of the obstructions and limitations which impeded the inspection of the external areas of the property at the time of inspection. These obstructions can hide an array of defects and should be removed to allow full inspection to be carried out. A re-inspection is recommended once the areas are made accessible.

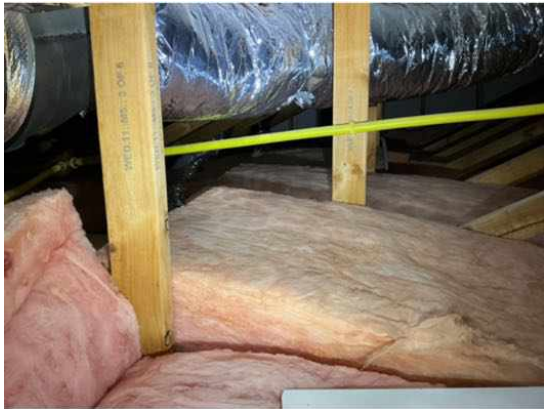
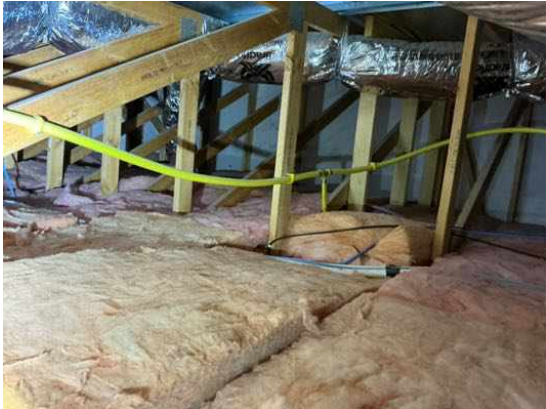
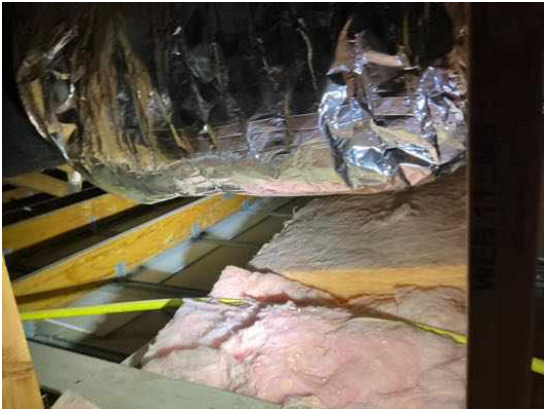
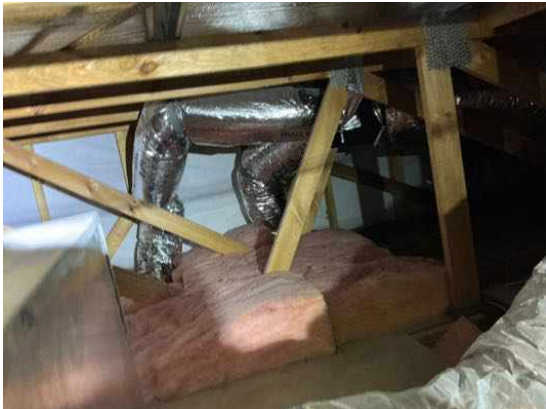
Building: Main Building
 Location: Roof Void
 Finding: Obstructions and Limitations - roof cavity
 Information: These photographs are an indication of the obstructions and limitations which impeded the inspection of the roof cavity area of the property at the time of inspection. These obstructions can hide an array of defects and should be removed to allow full inspection to be carried out. A re-inspection is recommended once the areas are made accessible.
