# Building and Timber Pest Inspection Report

Inspection Date: Thu, 19 Mar 2026

Property Address: 17 Burra Close, Glenmore Park NSW 2745

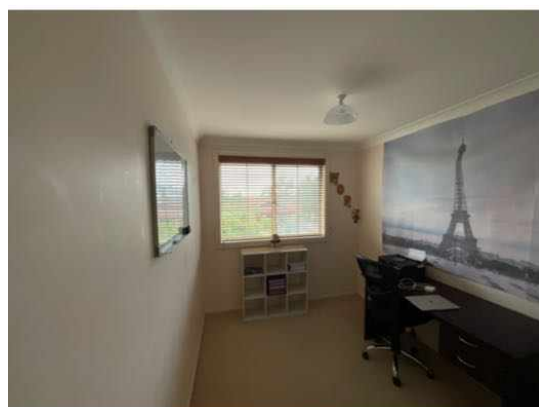
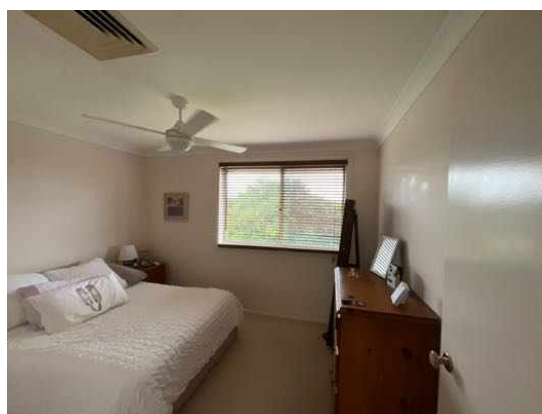
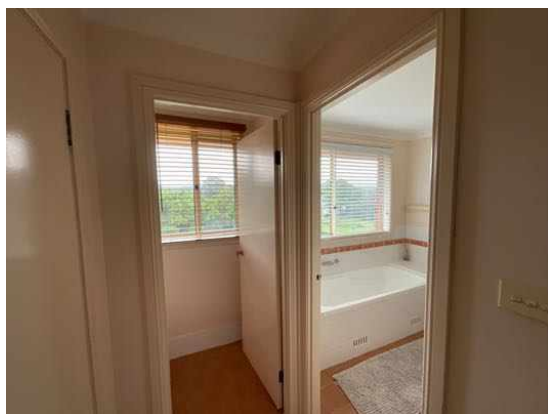
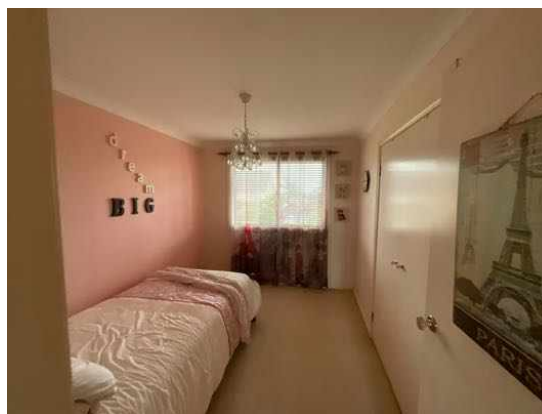
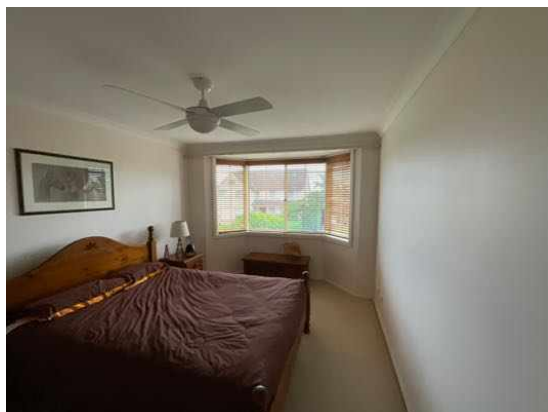
Building: Main Building  
Location: All Areas  
Finding: Window Safety – Restriction Devices Missing.  
Information: Observation Classification:  $\Delta$  Caution

Window restriction devices were found to be missing or not installed on one or more windows, particularly in bedroom areas. According to safety guidelines, where the floor surface below the window is 2 metres or more, windows must be fitted with either permanent screens or restriction devices to reduce the risk of falls.

If left unaddressed, this presents a significant fall hazard, particularly for children, and could result in serious injury in the event of an accidental fall.

It is strongly recommended that window restriction devices be installed in all applicable locations. A qualified window specialist should be engaged to assess and fit appropriate restriction mechanisms to comply with current safety standards. This should be treated as a preventative safety measure and addressed as soon as possible.

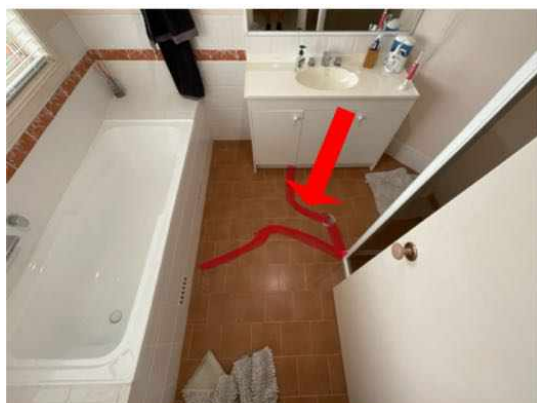
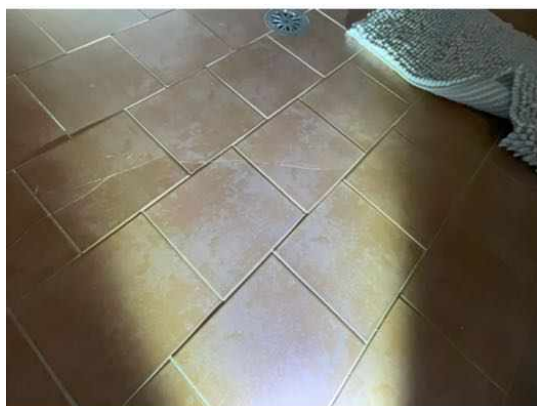
### Finding 2.01

Building:	Main Building
Location:	Bathroom & Ensuite
Finding:	Major Defect – Cracked Floor Tiles to Bathroom and Ensuite
Information:	Observation

At the time of inspection, cracking to multiple floor tiles was observed in the main traffic areas outside the shower zones within both the Bathroom and Ensuite, located on the upper level of the dwelling. These areas are constructed over a suspended timber floor system. The cracking appeared to affect several tiles and was not isolated to a single point, indicating a broader issue rather than incidental damage.

The pattern and location of the cracking suggest the likelihood of substrate movement and/or inadequate rigidity of the underlying floor structure or tile underlay. In suspended timber floor systems, excessive deflection, insufficient sheet flooring thickness, poor installation of tile underlay, or deterioration of supporting structural members can result in tile failure.

This condition is considered a major defect as it may indicate ongoing movement within the floor system. Continued movement can lead to further tile cracking, loosening of tiles, and potential failure of waterproofing membranes. Once compromised, waterproofing may allow moisture ingress into the subfloor structure, which can contribute to timber decay, mould growth, and deterioration of associated building elements.

It is recommended that a suitably qualified and licensed builder be engaged to undertake a comprehensive assessment of the floor structure, including the adequacy of the substrate, framing, and tile underlay system. Further investigation may require removal of sections of the tiled surface to determine the extent of movement and condition of the supporting elements.

Appropriately qualified trades, such as a licensed tiling contractor and/or bathroom renovation specialist, should be engaged to carry out rectification works. These works may involve structural stiffening of the floor, replacement of the substrate and underlay, reinstallation of compliant waterproofing, and retiling of the affected areas.

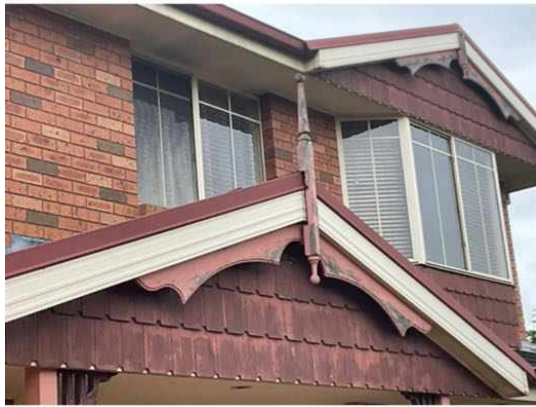
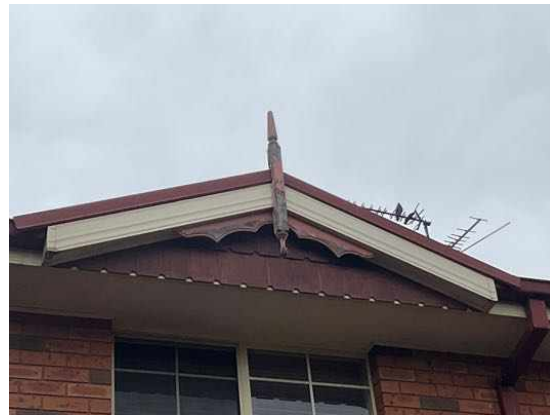
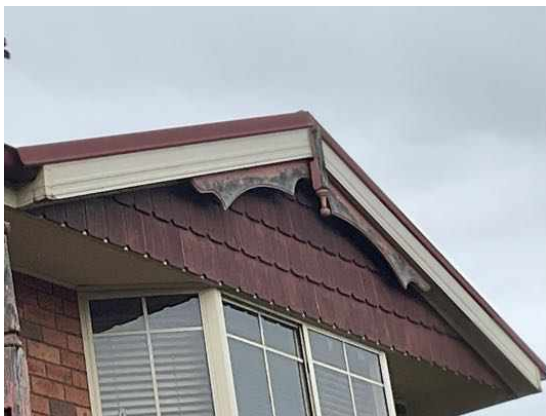
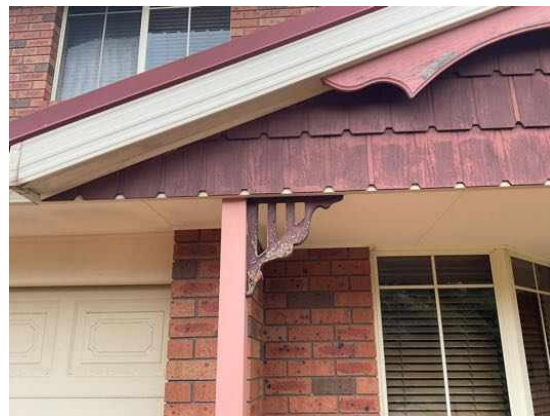
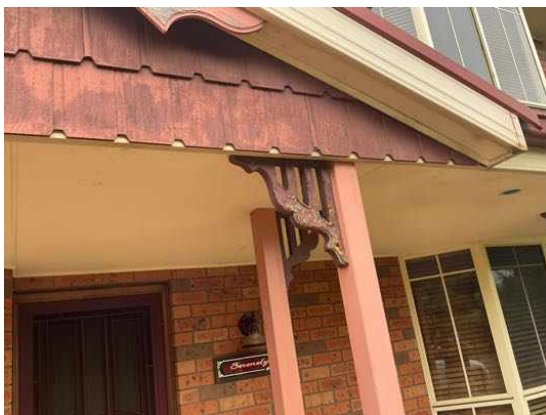
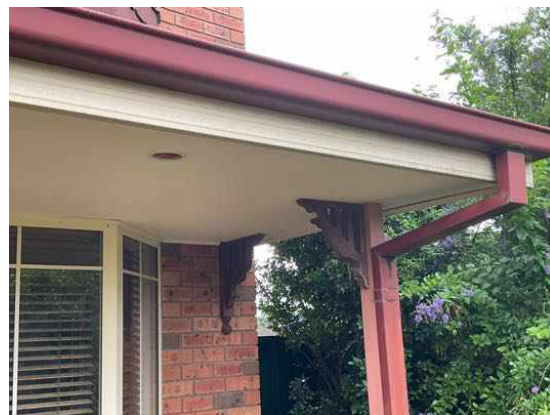
### Finding 3.01

- External timber components of the building, which are frequently exposed to harsh weather conditions, show signs of wear and lack adequate protective treatment.
- In areas where timbers have not been properly painted or sealed, deterioration is likely to progress at an accelerated rate due to constant exposure to moisture, UV radiation, and temperature changes.
- Without timely intervention, the condition of these timbers may continue to degrade, potentially requiring replacement in the short-term future.

- Where timber elements have already deteriorated beyond restoration, repairs or replacement will be necessary.

- A qualified carpenter should be appointed to assess and carry out any required structural or cosmetic timber repairs.

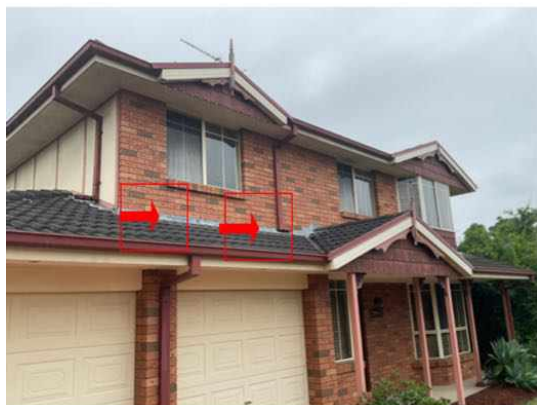
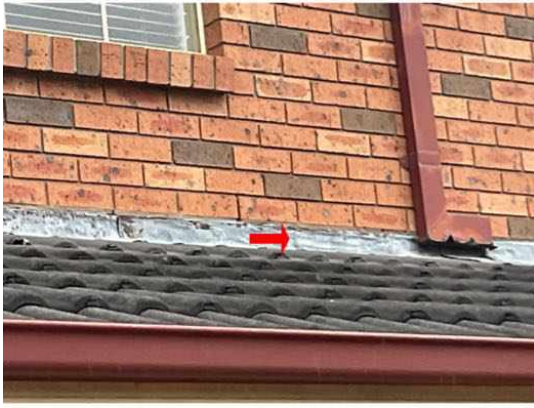
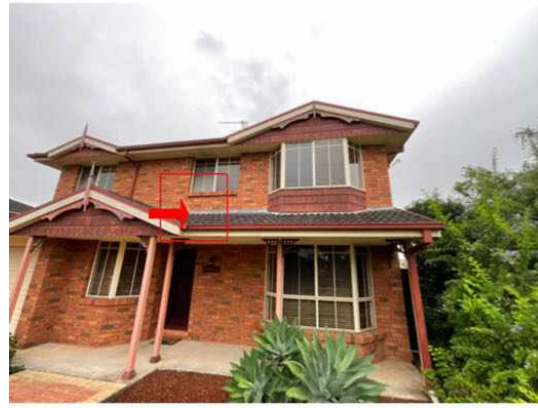
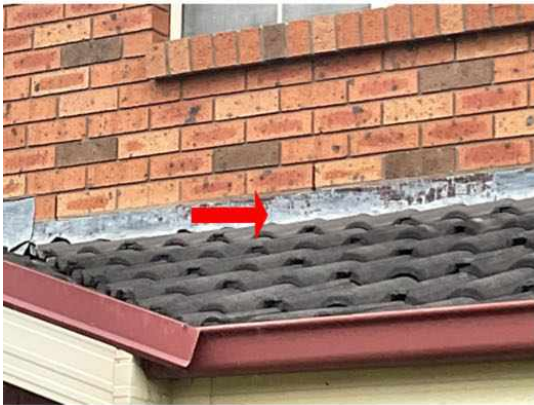
**Finding 3.02**

Building: Main Building  
Location: Roof Exterior  
Finding: Roof Flashing - Defect & Recommendation  
Information: Observation:

Cracking was observed in sections of the roof flashings. These materials, typically composed of metal, lead, or similar weather-resistant components, are critical for sealing junctions between the roof covering and adjoining building elements.

Damaged or deteriorated flashings significantly increase the risk of water penetration into the internal structure of the property. Over time, this can result in:

It is recommended that a licensed roofing plumber or qualified carpenter be engaged as soon as possible to assess and repair the affected flashings. Prompt remediation will help prevent further water damage and ensure the roof plumbing system remains functional and weatherproof.

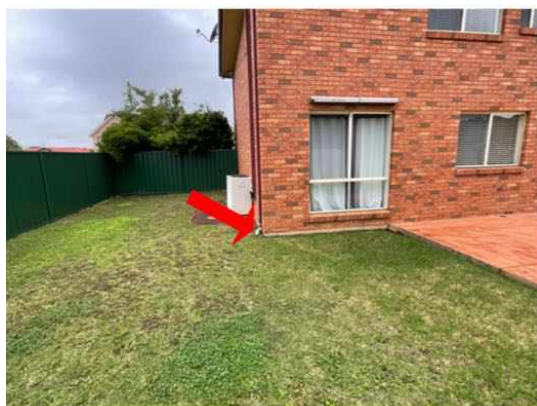
### Finding 3.03

Building: Main Building  
 Location: Roof plumbing  
 Finding: Downpipe – Damaged Connection.  
 Information: Findings:

Inadequate roof drainage can result in prolonged damp conditions around the foundations, potentially contributing to structural movement, subfloor moisture

ingress, and long-term building degradation.

It is strongly recommended that a licensed plumber be engaged to:

- Inspect all roof plumbing and stormwater discharge points
- Repair, replace, or install appropriate downpipes and drainage infrastructure to ensure all roof runoff is directed into a compliant stormwater system
- Assess for any secondary effects of prolonged moisture exposure near the building

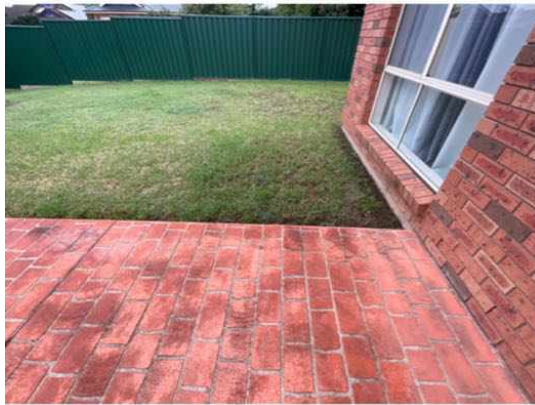
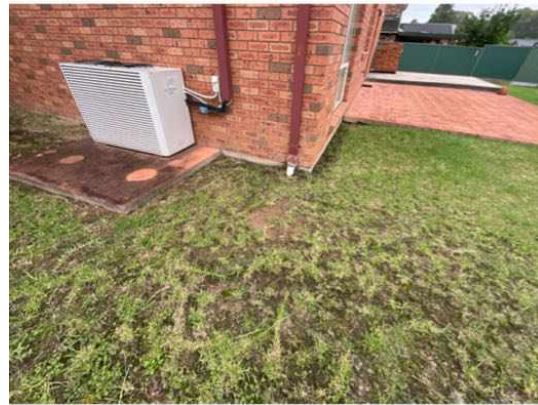
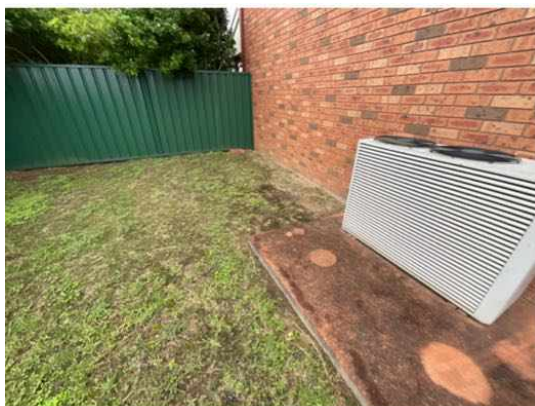
**Finding 3.04**

Building: Yard  
Location: Exterior - rear  
Finding: Site/Yard Drainage – Below Average.  
Information: Defect – Below Average Site Drainage

Site drainage in the inspected areas appears to be below average, with no surface drains observed at the time of inspection. Ground surfaces and paved areas adjacent to the building do not appear to be adequately graded to facilitate effective surface water runoff.

- A licensed plumber and/or landscaping contractor should be engaged to:
- Evaluate the current site grading and surface runoff conditions
- Install or upgrade surface water drainage (e.g. strip drains, spoon drains, grated channels) as required
- Improve grading around the building to ensure water flows away from the structure

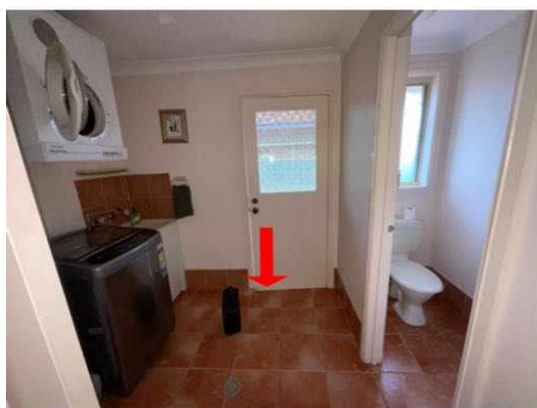
### Finding 3.05

Building:	Main Building
Location:	Laundry
Finding:	Door - Binding on Floor Covering (insufficient clearance).
Information:	Observation:

Binding or rubbing was observed between the bottom edge of the door and the floor covering during normal operation. The door does not open or close freely due to insufficient clearance.

The bottom edge of the door should be trimmed or planed to provide adequate clearance, and the edge sealed appropriately after adjustment.

Rectification can be carried out by a qualified carpenter or general handyperson, depending on the extent of adjustment required and at the client's discretion.

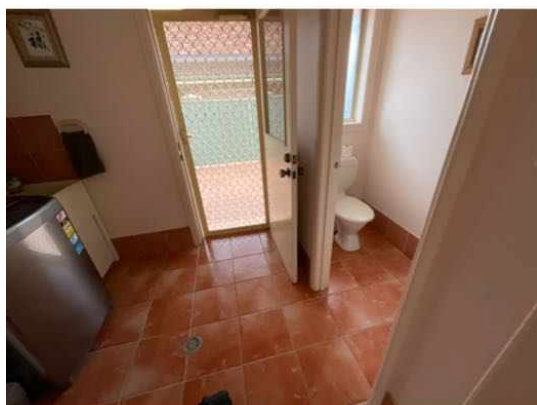
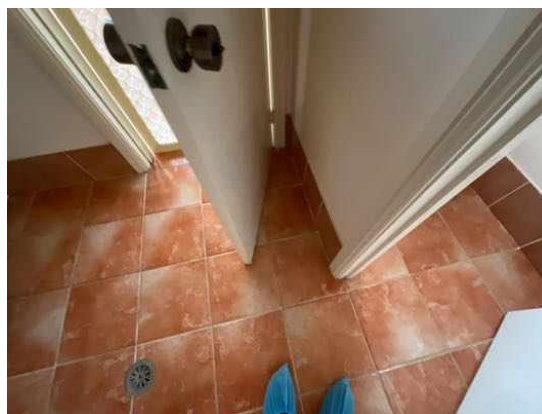
### Finding 3.06

Building: Main Building  
Location: Laundry  
Finding: Door stop - Missing.

A door stop is either missing or inadequate to prevent the door handle from contacting and potentially damaging the adjacent wall. While this may appear minor, all building elements contribute to the functionality and longevity of the structure.

It is recommended that a suitable door stop be re-installed or replaced to prevent ongoing impact damage. This is a minor maintenance task and can typically be completed by a general handyman at the client's discretion.

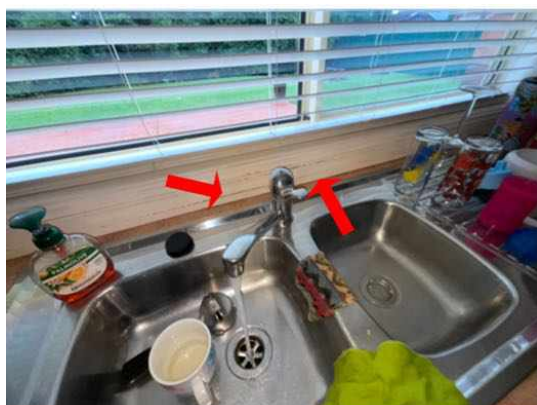
### Finding 3.07

Building: Main Building  
 Location: Kitchen  
 Finding: Sealant to splash back - Missing.  
 Information: Observation

potential damage to cabinetry or wall substrates. Failure to maintain sealant in wet areas can result in ongoing water ingress and accelerated deterioration of associated building components.

A flexible, mould-resistant sealant should be applied to all affected junctions to restore water tightness and accommodate expected expansion and contraction of materials. Regular inspection and maintenance of sealant in areas exposed to water is recommended as part of ongoing property care. Works should be undertaken by a qualified sealant specialist or experienced tiling contractor to ensure proper preparation and application, reducing the likelihood of future water damage.

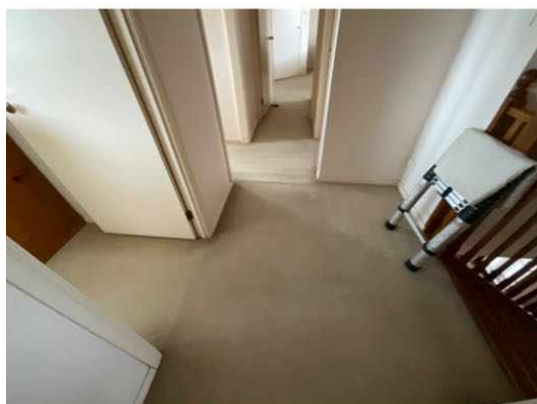
### Finding 3.08

Building:	Main Building
Location:	Hallway > Upstairs
Finding:	Flooring - Creaking or Squeaking.
Information:	Creaking or squeaking noises were noted when walking across sections of the flooring.

to secure the loose flooring, at the client's discretion.

- If the issue persists or worsens, further investigation into the flooring installation method may be warranted.

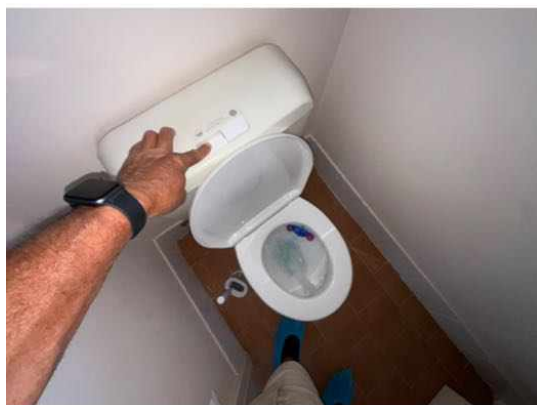
### Finding 3.09

Building:	Main Building
Location:	Toilet (WC)
Finding:	Toilet pan - Loose.
Information:	Observation:

Although this is not considered urgent, it is advisable to have a licensed plumber inspect and secure the toilet pan using appropriate materials such as concrete or sanitary-grade silicone. This will help maintain stability, ensure proper function, and prevent future issues.

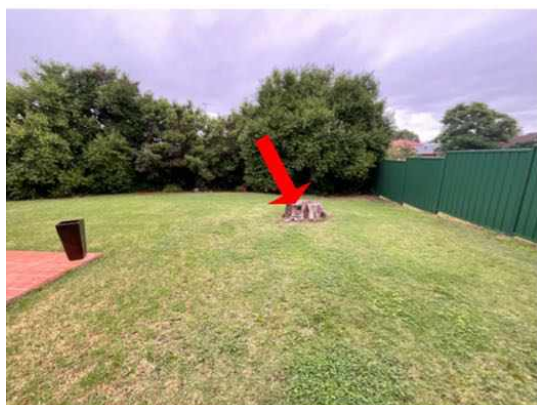
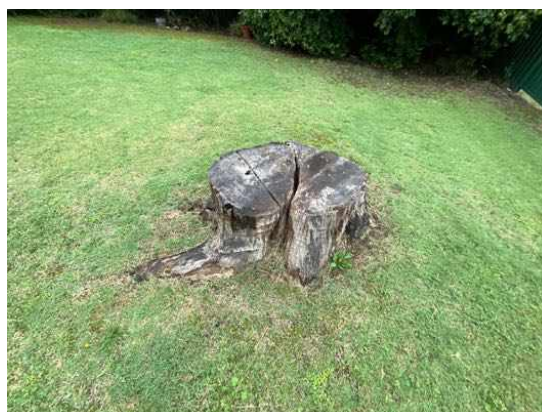
### Finding 6.03

Building:	Yard
Location:	Yard - Back
Finding:	Tree Stumps and Termite Risk..
Information:	Tree stumps that are in direct contact with soil and exposed to moisture create conditions highly conducive to termite activity. These stumps offer both a food source and shelter, making them an ideal environment for termite infestation.

- It is strongly recommended that all tree stumps on the property, particularly those in contact with soil, be removed as soon as possible to reduce the risk of attracting termites to the structure.
- Where removal is not feasible, a further invasive inspection—such as drilling and internal testing—should be conducted to determine the presence of termite activity.
- If termite activity is confirmed or suspected, chemical treatment of the stump should be carried out by a licensed pest technician to prevent further infestation.
