Building and Timber Pest Inspection Report

Inspection Date: Fri, 6 Feb 2026

Property Address: 79 Pandorea Street, Claremont Meadows
NSW 2747

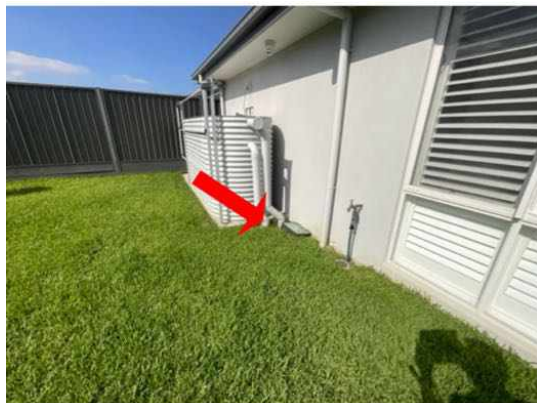
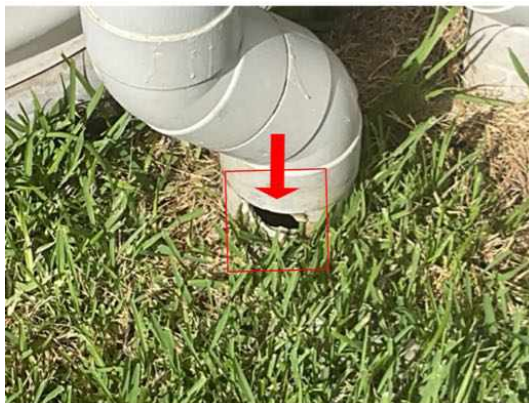
Building:	Yard
Location:	Exterior - rear
Finding:	Minor Defect – Rainwater Tank Plumbing (Damaged pipe).
Information:	Observation

The plumbing connected to the rainwater tank at this location was observed to be damaged at the time of inspection. The defect affects the effective discharge of roof water from the drainage system.

Damaged or leaking rainwater plumbing can result in uncontrolled water discharge, pooling, or persistent damp conditions around the base and perimeter of the building. If left unaddressed, this may contribute to moisture-related issues such as deterioration of building materials and the potential attraction of termites or other pests.

Repairs and/or replacement of the damaged rainwater tank plumbing are recommended to reinstate the roof drainage system to a fully operational condition. Any leaks should be rectified promptly to minimise the risk of ongoing moisture exposure to adjacent building elements.

A suitably licensed plumber or a specialist roof drainage or roof restoration contractor should be engaged to carry out the recommended works.

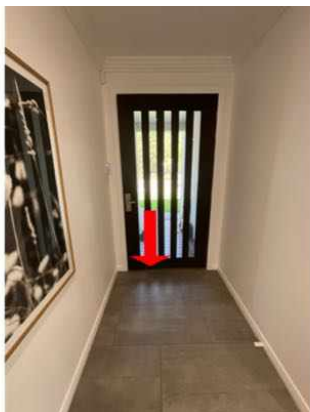
Finding 3.02

Building:	Main Building
Location:	Entry
Finding:	Door - Binding and/or Jamming.
Information:	Functional Defect Identified

Binding and/or jamming of this door was observed during standard operation and appeared to be rubbing or binding. This issue impairs the normal functionality of the door and may lead to secondary damage to adjacent building elements, such as scuffing or tearing of floor coverings, or stress to door hardware and framing.

- Poor door installation (Insufficient clearance)
- Worn, damaged, or misaligned hinges
- Swelling or warping of materials

- Where the issue is minor in nature, a qualified carpenter or general handyperson may be appointed to carry out corrective works at the client's discretion.

Prompt assessment and remediation are advised to prevent further deterioration or related damage.

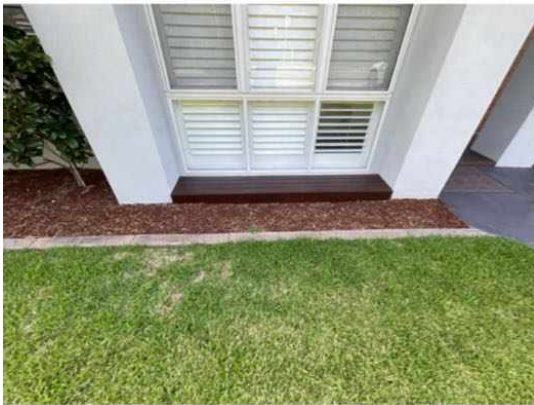
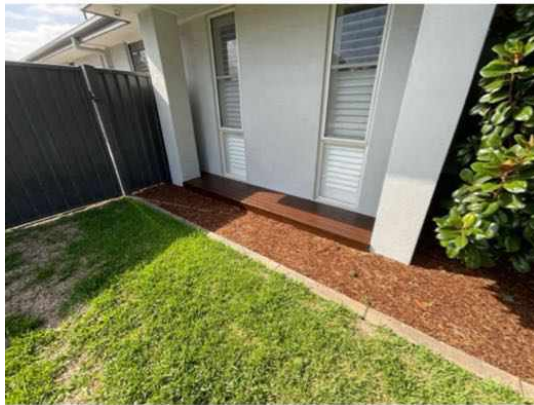
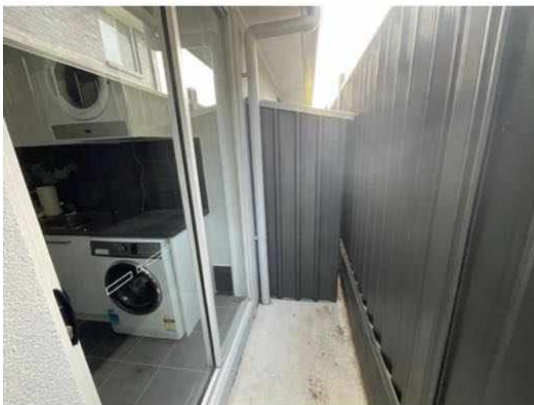
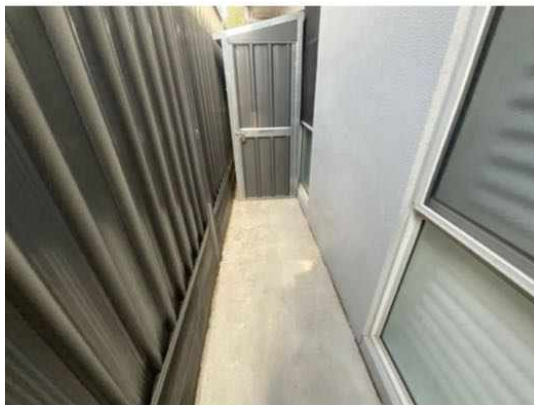
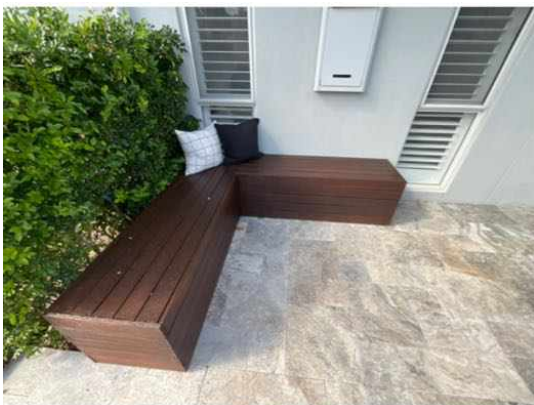
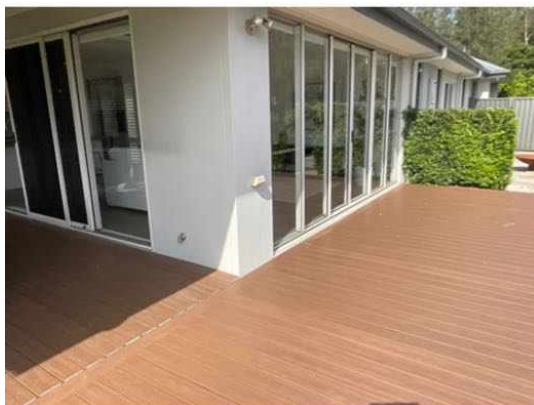
- The obstruction prevents a full inspection for signs of moisture, structural damage, or termite activity
- The deck bridges the termite inspection zone and may allow undetected termite access into the building
- Moisture may accumulate beneath or behind the decked area, creating a conducive environment for termites and fungal decay
- Decks that are not adequately separated from external walls can provide cover, warmth, and humidity, conditions ideal for termite infestation

- Modify or cut back the decking to create a clear inspection zone between the building and the structure, in line with termite management requirements
- Remove any materials in the obstructed area that may be conducive to termite activity
- Once modifications are complete, a re-inspection is strongly recommended to assess for previously hidden issues and to ensure compliance with termite management standards

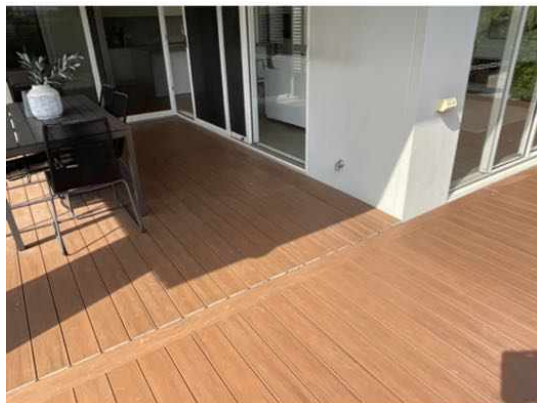
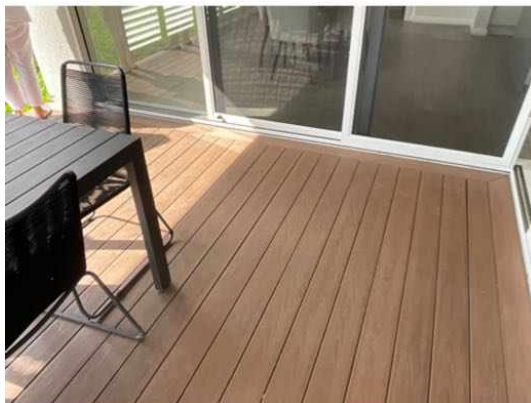
Building:	Main Building
Location:	Exterior walls
Finding:	Plumbing and/or yard drainage - Conducive conditions..
Information:	Observation: Drainage Issues Around Property

Areas of the property—both around the perimeter and within the external yard—were noted to have drainage problems, resulting in water pooling, ponding, or stagnation. These conditions are considered highly conducive to timber pest activity.

- Termite Attraction: Excessive moisture around or beneath the structure creates an environment favourable to termite foraging and colonisation.
- Fungal Decay: Prolonged dampness also promotes fungal growth and wood decay, which can compromise structural timbers.
- Underlying Causes: Such moisture issues are typically associated with plumbing defects (e.g. leaking pipes, overflows) or landscaping problems (e.g. poor site drainage, negative grading).

It is important that appropriate drainage improvements be undertaken to prevent moisture build-up around the building. This may include plumbing repairs, grading adjustments, or installation of drainage systems.

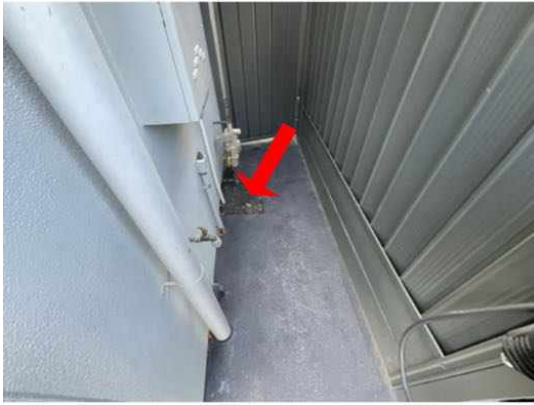
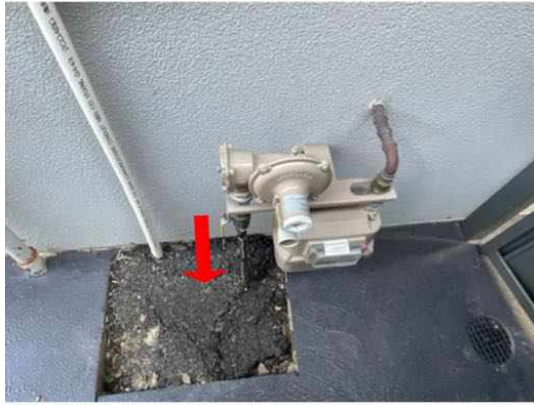
Finding 6.03

Building:	Yard
Location:	Exterior - right side
Finding:	Inadequate Site Drainage & Surface Water Management.
Information:	Observation:

The site drainage in this area was found to be inadequate at the time of inspection, creating a risk of water pooling during periods of rainfall. Key concerns noted include:

Inadequate site drainage may result in:

- Pooling water near the building or in pedestrian areas
- Potential moisture ingress into the structure
- Reduced effectiveness of termite management systems if slab edges are exposed to moisture

A concreter contractor or landscaping contractor should be appointed to:

- Re-level the gap or hole to prevent water accumulation

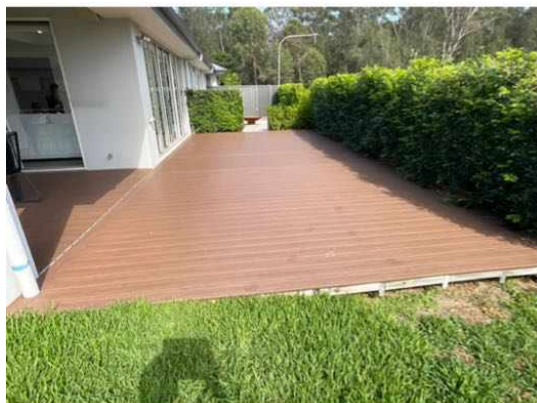
Building: Yard
 Location: Yard - Left Side
 Finding: Potential Drainage Issue Beneath Deck.

Monitor the area during periods of rain to determine whether water is collecting beneath the deck. If ponding is observed, consult a licensed drainage plumber to assess the site and install appropriate measures such as sub-surface drainage, spoon drains, or regrading to redirect stormwater away from the deck perimeter. Ensuring consistent drainage will reduce moisture-related risks and support long-term structural performance.
