# Building and Timber Pest Inspection Report

Inspection Date: Tue, 17 Feb 2026

Property Address: 55 Harris St, Windsor NSW 2756, Australia

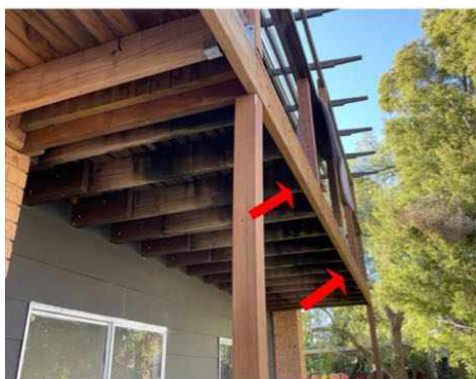
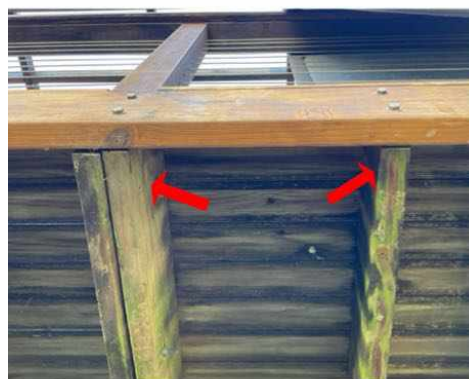
Building:	Building 1
Location:	Verandah
Finding:	Additional fixings required (joist hangers)
Information:	Evidence of insufficient fixings were evident on the front right deck. These joists need additional fixings to ensure their longevity.

A carpenter should add additional fixings to these areas in the next few months.

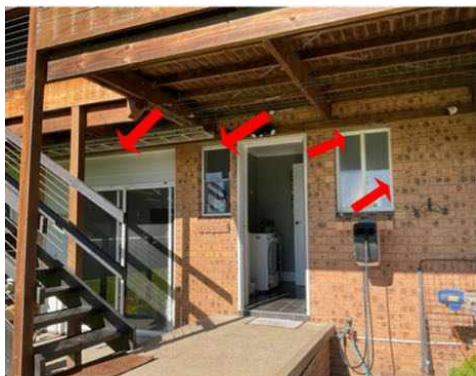
Building: Building 1  
 Location: Pictured Areas  
 Finding: Sealant (external) - Missing.  
 Information: It was noted on inspection that areas of external sealant was missing to areas of the external walls.

Flexible sealants should be applied to these affected areas to prevent any subsequent water damage that is likely to occur.

A sealant specialist or skilled handy person should be appointed to complete these works as soon as possible

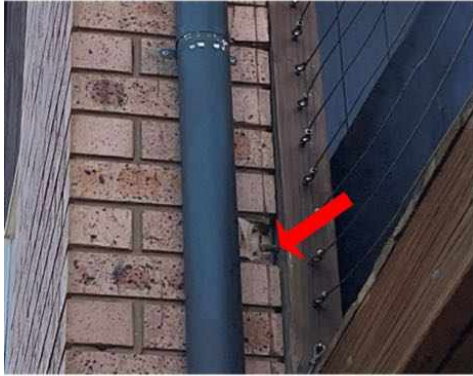
### Finding 3.01

Building: Building 1  
 Location: Pictured external areas  
 Finding: Building elements - Damaged  
 Information: Evidence of minor missing or damaged areas was identified at the time of the inspection. These include -

1. Some brickwork is damaged not requiring immediate repair.
2. The kitchen sink tap is leaking at the top.
3. The rear kitchen door appears to need new rollers.
4. All rear left window sills show minor bowing (see windows hard to slide defect).

A carpenter would be the trade responsible for rectification of these areas when convenient.

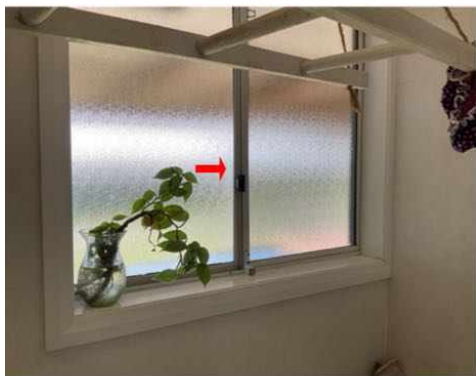
### Finding 3.02

Building:	Building 1
Location:	Bathroom & toilet
Finding:	Windows - Stiff to slide
Information:	The windows in these areas was jammed and difficult to operate at the time of the inspection. Windows provide ventilation to the adjoining area and should be at a fully operational level to ensure user comfort. Restricted function of the window may also pose as a potential safety hazard if required for emergency egress from the building.

maintenance are the usual causes for this type of defect.

Replacement of window hardware or frame may be required, as well as minor repairs and cleaning. A registered builder or general handy person will be required to repair the window.

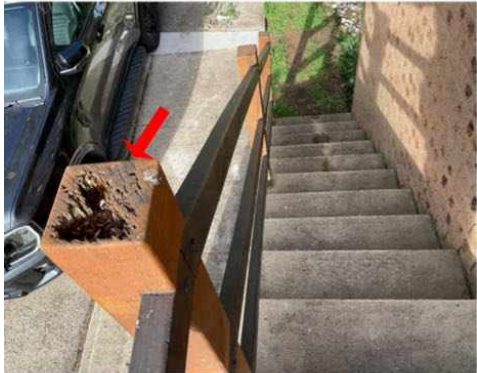
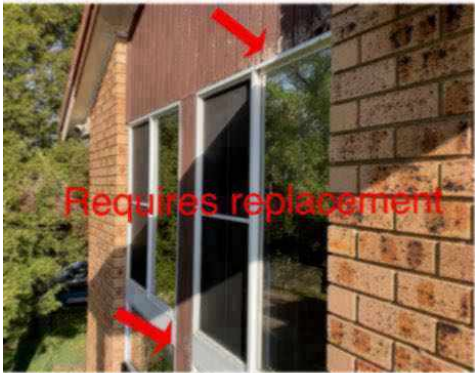
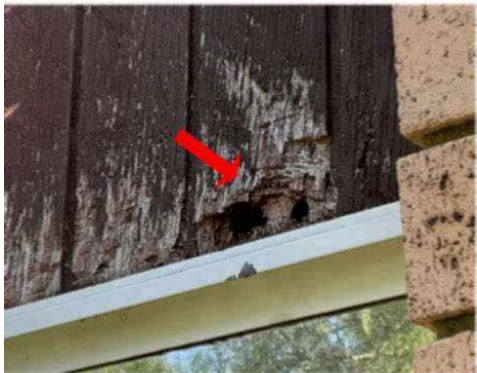
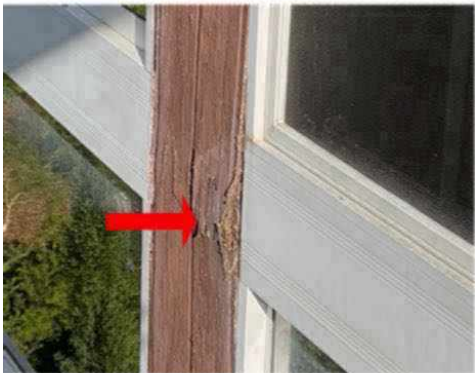
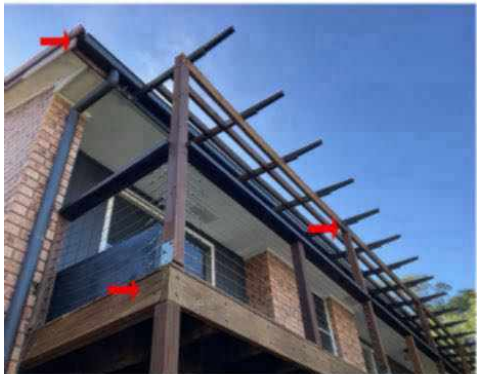
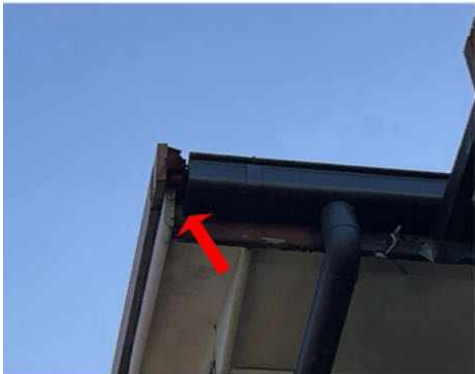
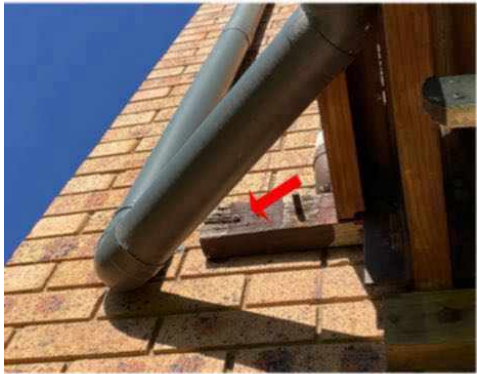
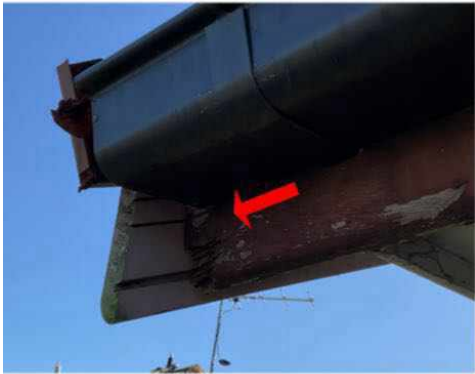
### Finding 3.03

Building:	Building 1
Location:	Pictured areas
Finding:	Wood rot
Information:	The building shows evidence of wood rot. Wood rot, also known as Fungal Decay, occurs when timbers and other cellulose building materials are exposed to damp conditions on an ongoing basis. This could be the result of exposure to weathering over a prolonged period of time, or the attraction of excessive moisture from other abutting building materials.

Early intervention and regular maintenance, particularly of exterior timbers, will prolong the useful life of these building elements. Prior to any works being performed, the cause of the moisture that has created the visible wood rot should be identified and addressed in a suitable manner. Replacement of affected timbers may then be a necessary step in protecting surrounding building elements from such deterioration.

A qualified carpenter or registered builder may also be required to replace affected building materials.

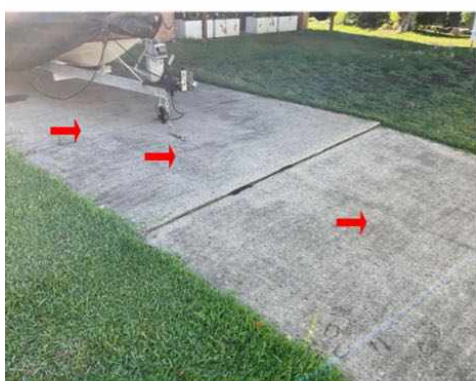
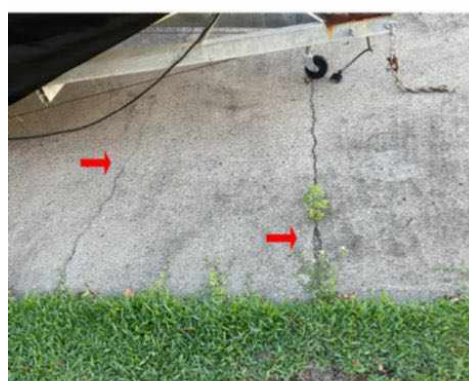
Finding 3.04

Building:	Building 1
Location:	Yard - front & back
Finding:	Crack in concrete slabs - Category 1
Information:	Cracks coded as Category 1 was identified in these pictured slabs. A Category 1 crack is described as a fine but noticeable crack, with the slab at an otherwise reasonable level. To be considered Category 1, the approximate width of the crack is less than 1.0mm, or a less than 10mm change in offset when a 3m straight edge is placed over the defect.

Category 1 cracks should be monitored for a period of 12 months. At the end of the monitoring period, identified cracks that are rated greater than Category 2 are considered defects, and require rectification.

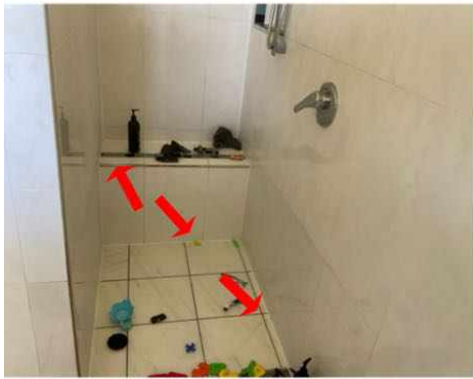
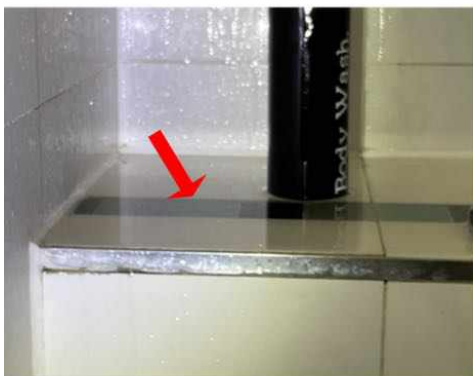
Building:	Building 1
Location:	Kitchen and bathroom
Finding:	Sealant and grouting - Missing or damaged
Information:	It was noted on inspection that sealant or grout is degraded to these pictured wet areas. Water is also pooling on the shower ledge accelerating the degradation of the sealant/grout.

Different materials and floor areas move at different rates, generally causing cracking to grout or sealant at this point. A flexible sealant is required to allow for expected expansion and contraction, while keeping the joint water tight and protective of all associated building materials.

Flexible and mould resistant materials should be applied to affected areas to prevent any subsequent water damage that is likely to occur. Regular maintenance and replacement of damage or missing or damaged sealant and grout is highly recommended to the wet areas, as this is a regular wear and tear defect. Sealant and grouting in areas that come into regular contact with water should be maintained for the long term care of your property.

A sealant specialist or tiling contractor should be appointed to complete these works as soon as possible

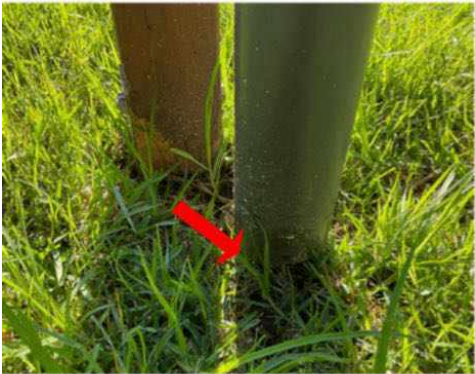
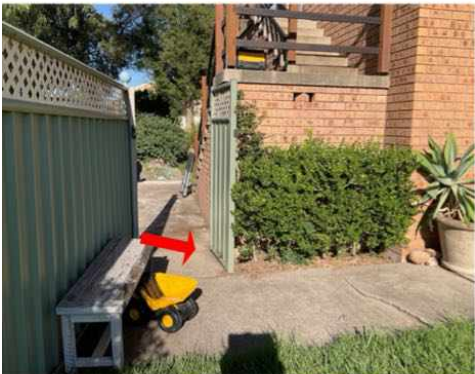
### Finding 3.07

Building:	Building 1
Location:	Walls
Finding:	Site drainage - Inadequate
Information:	The site drainage in this area was found to be inadequate at the time of inspection, creating potential for subsequent water damage to associated building elements.

The pergola rooves have no gutters. The rear downpipe is loose and runs onto the grass. The rear right concrete slopes toward the stairs with no drainage evident.

disgorge stormwater onto lower walls or plinths. Stormwater should be carried away by large, regularly cleaned drains. Ground levels may need to be lowered to expose a buried DPC.

Where site drainage is inadequate, installation of an Agricultural (Aggie) Drain may be required. A qualified plumber should be appointed to further inspect the property and perform any remedial works as necessary. Secondary defects are likely to occur if left unmanaged.

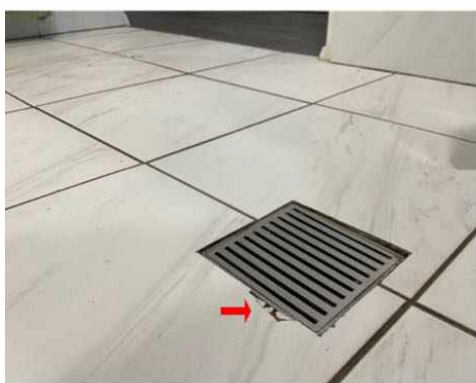
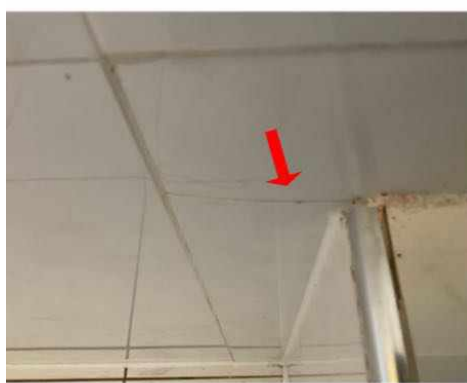
**Finding 3.08**

Location: Bathroom  
 Finding: Tiles cracked  
 Information: Cracked tiles were evident in these pictured areas at the time of inspection. It is suspected that this cracking has occurred as a result of minor settlement or impact damage.

Cracked tiles throughout the household detract from the overall appearance of the affected areas. In wet areas of kitchens and bathrooms, it can lead to water damage of adjoining walls and floors.

Replacement of cracked tiles is recommended as soon as possible. A tiling contractor may be appointed to perform these works. Where cracks become more numerous, contact a licensed building inspector for further investigation.

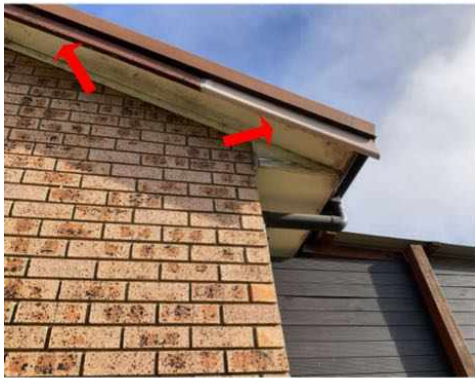
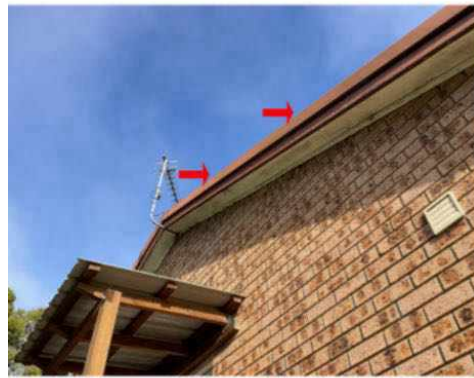
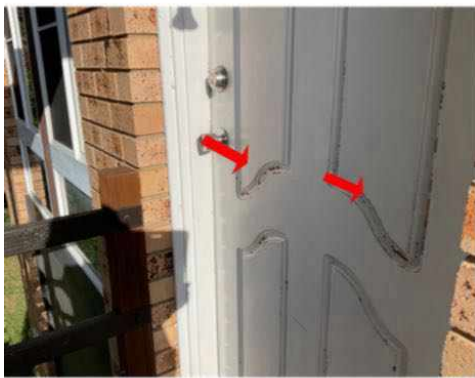
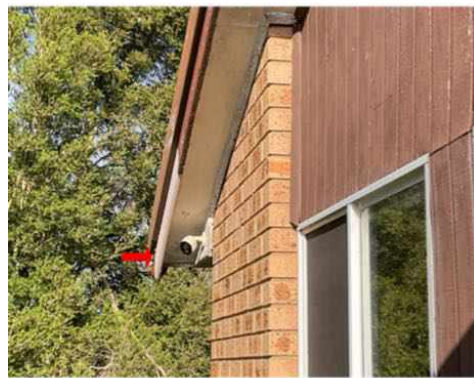
### Finding 3.09

Building: Building 1  
 Location: Pictured areas  
 Finding: Painting deteriorated or unfinished  
 Information: Much of the external paintwork has been neglected and require attention to prepare and re-paint.

Whilst incomplete or missing paint finish is generally an appearance defect, it can also lead to the development of secondary building defects over time. Incomplete areas of paint finish expose the area to moisture, potentially accelerating the deterioration of underlying building materials.

Degraded paint finishes should be sanded back, filled, leveled and painted, as applicable. Where inadequate or missing paint protection has led to the deterioration of the associated building element, repair and/or replacement of this building element may be required.

A painting contractor should be appointed as soon as possible to perform necessary works to aid the appearance of the affected area and to ensure the area is protected against further deterioration. Alternatively, the homeowner following manufacturer

instructions may perform these works.

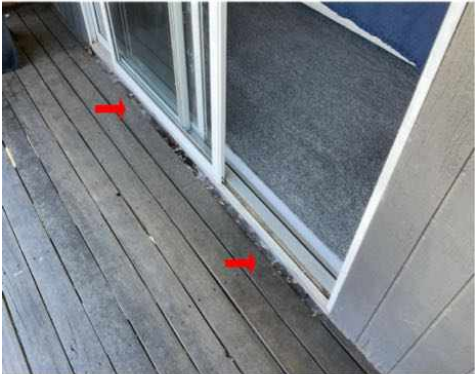
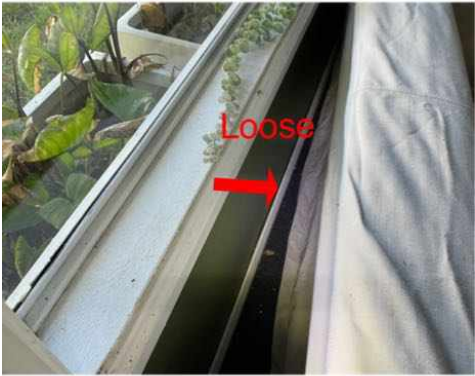
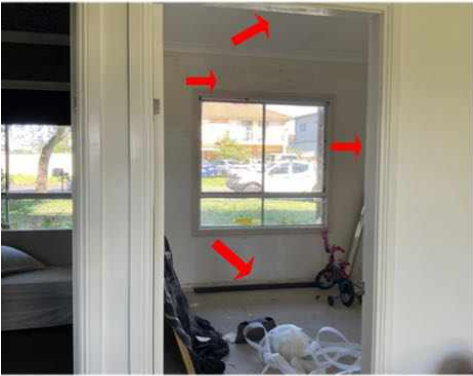
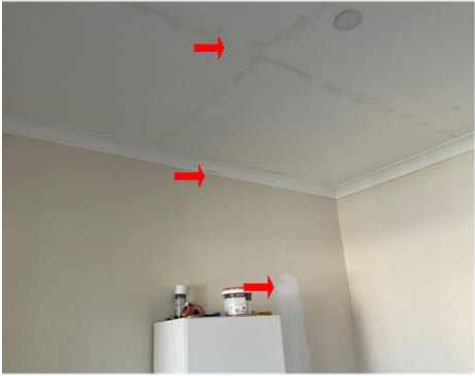
### Finding 3.10

Building:	Building 1
Location:	Front Deck, paint on some walls and ceilings
Finding:	Unfinished construction
Information:	The construction of this structure appears to be incomplete. The safety of the structure can therefore not be ensured and the creation of secondary defects to surrounding building elements may be likely.

A Registered Builder should be appointed immediately to complete this construction

process.

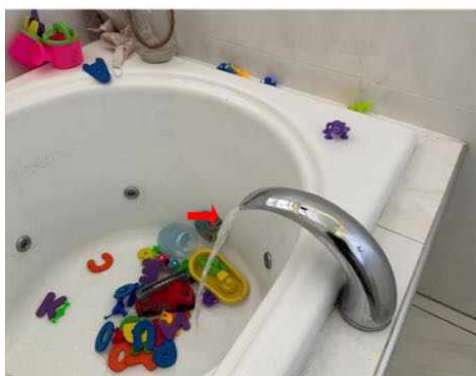
Building:	Building 1
Location:	Bathroom
Finding:	Tap - Water hammer
Information:	This tap shows evidence of water hammer being present. Water hammer, a pressure surge resulting when a fluid is forced to suddenly change direction, is a common defect in plumbing fittings, particularly those that are aged and not frequently maintained. Water hammer is generally caused by factors that create high water pressure in the affected plumbing fixture, usually evidenced by a faint banging noise during operation of the affected tap.

Although water hammer is generally considered to be a minor defect, subsequent damage such as erosion of tap hardware and/or water damage to associated building elements is likely to occur if left unmanaged.

A licensed plumber should be appointed as soon as possible to replace any affected tap hardware and perform any remedial works as necessary. Please be advised that the appointment of a cabinet maker or qualified carpenter may be necessary if water

damage to associated building elements has occurred.

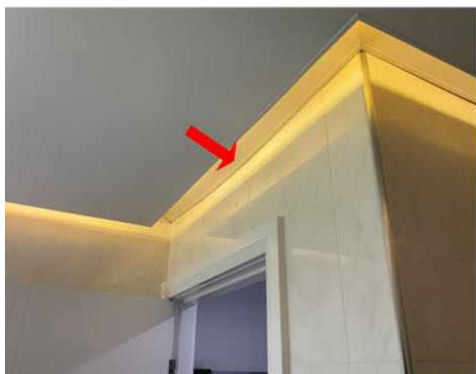
### Finding 3.13

Information: Sections of the ceiling were found to be sagging at the time of inspection. Sagging to the fixed ceiling structure generally indicates that the building materials have swollen, due to contact with water, or that fixings (e.g. nails or glue) have become loose and require reattachment.

Where minor sagging is evident, comparatively minor works, such as re-gluing of ceiling sheets, may be required. Such works may be performed by relevant tradespeople, such as plasterers and painters. Where excessive moisture has caused the roofing structure to swell and sag, the source of the water leak should primarily be identified prior to any remedial works being performed.

In some cases, sagging ceiling linings may also indicate that there are structural issues, causing surfaces to warp, twist or sag. Where sagging appears to be major, appointment of a structural engineer is advised to further inspect the property and identify the source and rectification works required.

The appropriate action should be taken by the client as soon as possible to ensure that any potential further damage is limited.

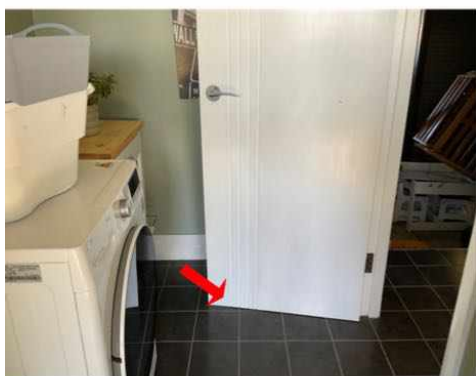
### Finding 3.14

Building:	Building 1
Location:	Laundry & lower rumpus
Finding:	Doors - Binding/jamming & damaged
Information:	Binding and/or jamming of this laundry door is evident during standard operation. This defect inhibits the functionality of the affected door as well as creating potential for secondary defects to associated building elements, such as damage to the floor covering.

A door that binds to flooring or to the associated door frame may have several causes, ranging from minor defects, such as poor installation of the door or deteriorated hinges, through to major structural issues, such as damage to subfloor structures. The rumpus door also shows some bowing not affecting its function.

For these minor causes, a qualified carpenter or general handyperson should be appointed to perform minor rectification works at client discretion.

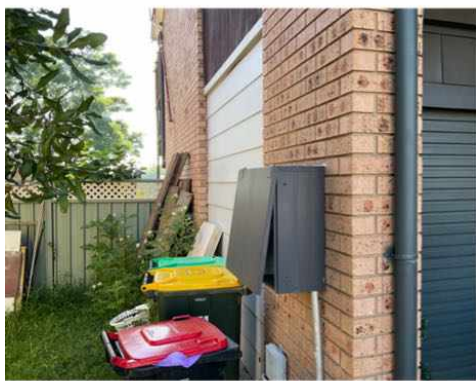
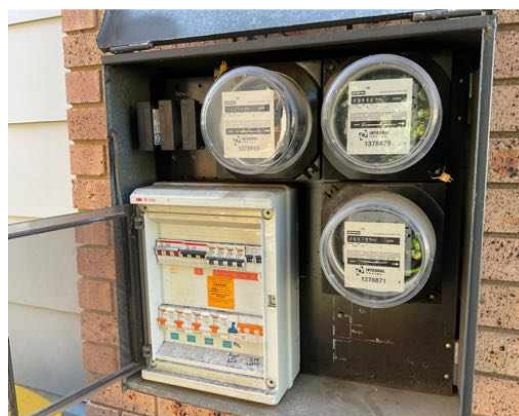
Building:	Building 1
Location:	Meter Box
Finding:	Termite Management System - no evidence of a chemical installation
Information:	The application of a post-construction chemical termite barrier is highly recommended for all properties. Such barriers are highly effective in preventing termite attack on any timber building elements throughout the property.

A durable notice should be placed in the switchboard unit to indicate current termite barriers. At the time of inspection, no durable notice was evident and it appeared as though no chemical termite management system has been installed, with no evidence to suggest preventative works taking place since the property was built.

The client may consider gaining further advice from a pest controller as to the costs and procedures involved with a 'chemical' application. It is recommended that obtaining such advice be a short-term priority.

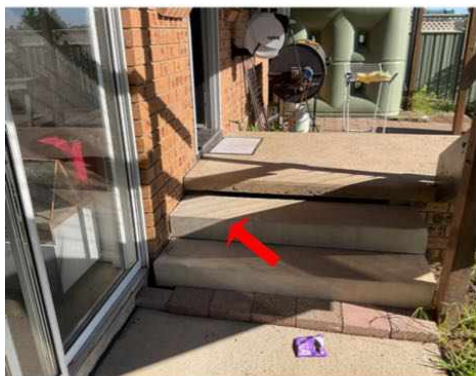
#### Finding 6.02

Building:	Building 1
Location:	Yard - front
Finding:	Bridging - Vegetation and decking
Information:	Where vegetation and decking obstructs inspection of building elements, also known as bridging as it provides a bridging point for the access of termites, full inspection can not be achieved. Consequently moisture or dampness may be present and the areas becomes conducive to termite activity. Plants and decks against or very close to buildings provide cover, shade and can provide an environment that is attractive to

The removal and replanting of plant species that do not provide "cover" or cutting back of existing vegetation and leaving a small gap between decking and the building walls will assist greatly in preventing Bridging from occurring.

The removal of any such stored building or plant materials that may be conducive to termite activity should be carried out as soon as possible and arrange re inspection to minimize the risk of termite attack.

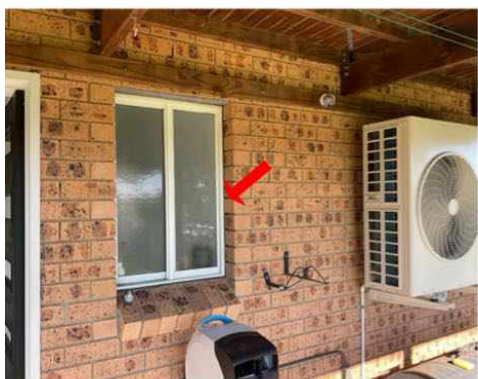
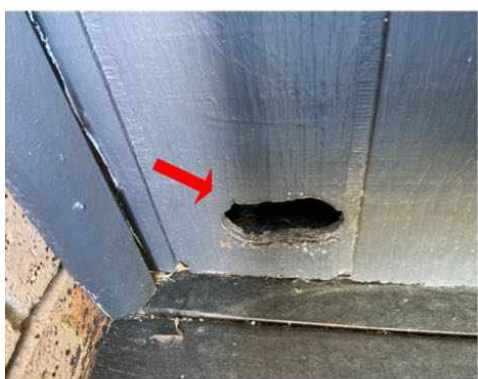
### Finding 6.03

Building:	Building 1
Location:	Exterior walls
Finding:	Sealant (external) - missing and attractive to termites
Information:	It was noted on inspection that areas of external sealant was missing to small areas of the external walls. A flexible sealant or flashing is required to protect the associated building materials from rainwater ingress. Any moisture ingress into the property is very attractive to termites. Flexible sealants or flashing should be applied to these affected areas to prevent termite activity.

A sealant specialist or skilled handy person should be appointed to complete these works as soon as possible.

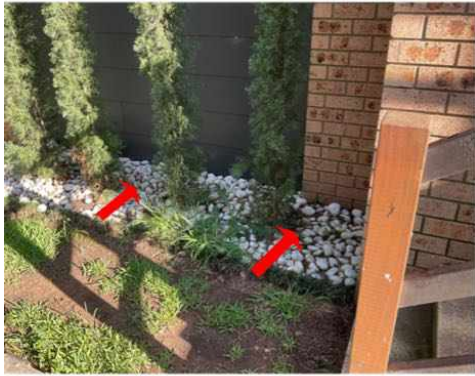
**Finding 6.04**

Building: Building 1  
 Location: Exterior walls  
 Finding: Slab Edge - Exposure  
 Information: An inspection zone of at least 75mm in relation to the exposed slab edge, between the bottom brick and the perimeter pavement, is required. This inspection zone should be maintained in order to force termites into the open where they can be detected more readily during regular inspections. The slab edge should not be concealed by anything that may prevent inspection of the area, including render, landscaping, soil, turf, paving, concrete cladding or other structures.

If the slab edge is not properly exposed there is a high risk of termite attack. Sometimes, in order to determine the type of slab, a suitably qualified person such as an architect or builder may be required to consult the construction plans.

Where the slab edge cannot be properly inspected, it is highly recommended that termite or timber pest inspections be carried out every 6-12 months to aid protection of the property against infestation.

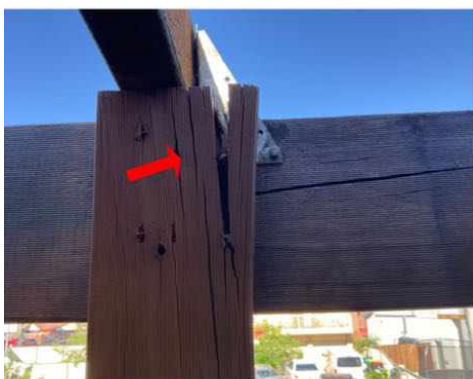
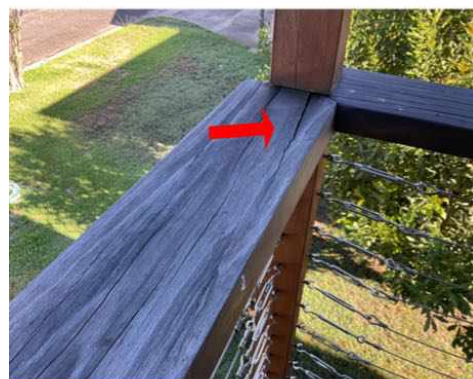
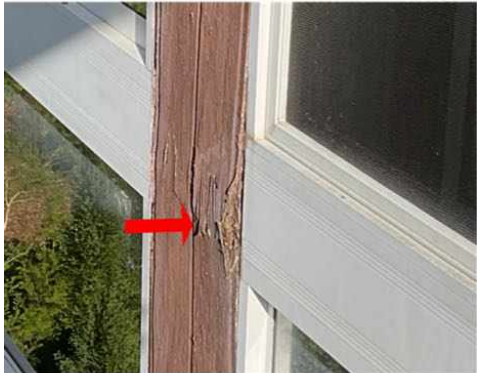
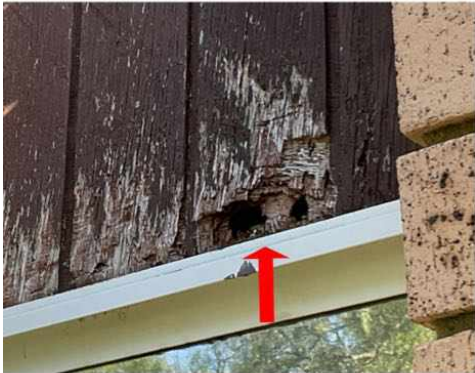
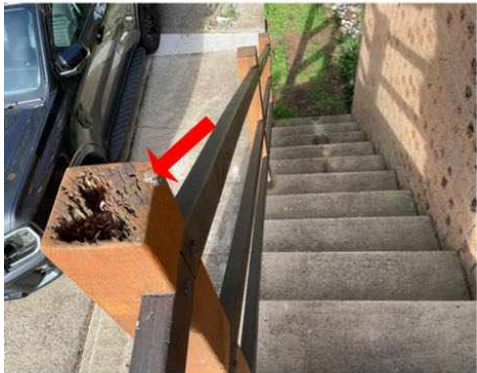
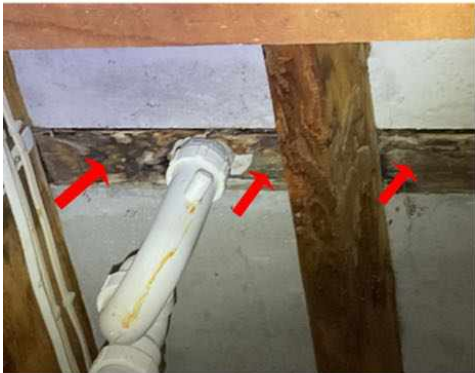
### Finding 7.01

Building:	Building 1
Location:	Many areas
Finding:	Fungal decay - present (localised)
Information:	Fungal decay also known as wood decay or wood rot generally refers to the deterioration of timber elements when in contact with excessive levels of moisture for a prolonged period of time.

The development of fungal decay is accelerated by temperatures from 5degreeC to 40degreeC as well as the presence of oxygen. Generally fungal decay develops on timber elements that are in use in an external environment which are exposed to rain penetration.

In this case, the affected timber element is in a decaying state and will need replacement by a carpenter or licensed builder.

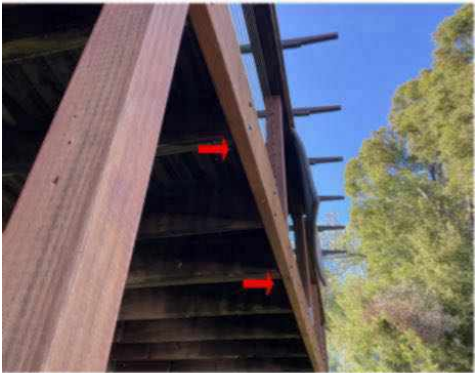
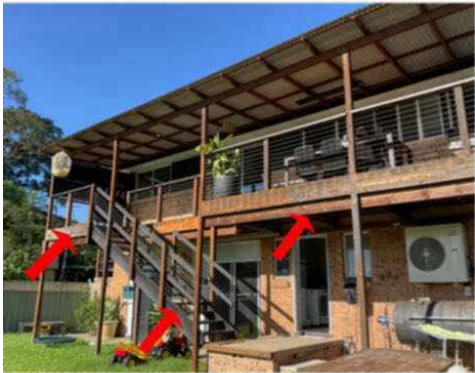
The front deck on the right side is missing joist hangars and has one slightly bowing middle post.
