Building and Timber Pest Inspection Report

Inspection Date: Fri, 20 Feb 2026

Property Address: 22/1271 Botany Rd, Mascot NSW 2020,
Australia

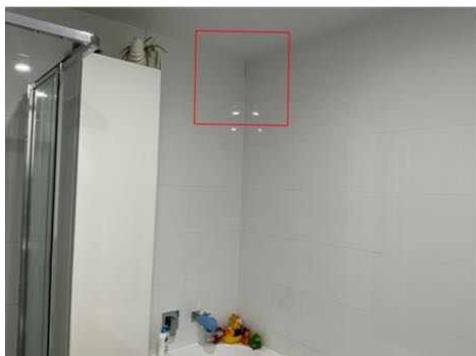
Building:	Main Building
Location:	Bathroom
Finding:	Sealant and grouting - Missing or damaged
Information:	It was noted on inspection that sealant or grout is degraded to the tiled shower alcove and or other areas of the bathroom.

Different materials and floor areas move at different rates, generally causing cracking to grout or sealant at this point. A flexible sealant is required to allow for expected expansion and contraction, while keeping the joint water tight and protective of all associated building materials.

There appears to be excessive mould to the sealant and grout which will likely require scraping out and replacement.

Flexible and mould resistant materials should be applied to affected areas to prevent any subsequent water damage that is likely to occur. Regular maintenance and replacement of damage or missing or damaged sealant and grout is highly recommended to the wet areas, as this is a regular wear and tear defect. Sealant and grouting in areas that come into regular contact with water should be maintained for the long term care of your property.

A sealant specialist or tiling contractor should be appointed to complete these works as soon as possible

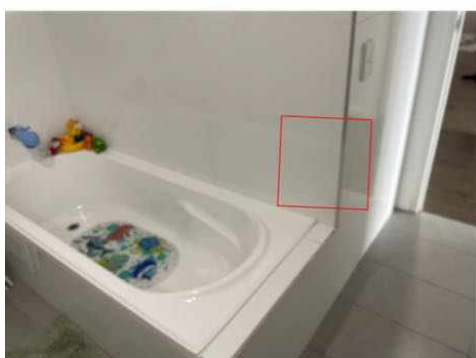
Finding 3.02

Building:	Main Building
Location:	Bathroom
Finding:	Tiles cracked or damaged- (wet areas)
Information:	Cracking was evident to the tiling in this area at the time of inspection. While the cracking appears to be minor, this area is frequently exposed to water, allowing potential for water penetration into adjoining sections of walls or flooring.

If left unmanaged, water penetration to these areas may lead to subsequent water damage, which is likely necessitate repair work to affected building elements.

A tiling contractor should be appointed to ensure that no further water damage occurs. The re-application of silicone and grouting throughout remaining tile work is also advised, to further protect the area against water penetration.

Where water penetration has led to water damage, appointment of a relevant tradesperson may be required to repair damaged building elements.

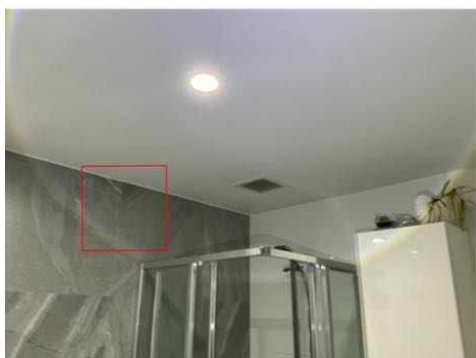
Finding 3.03

Building:	Main Building
Location:	Bathroom
Finding:	Tiles - Drummy

Information: Drummy tiled areas were identified at the time of inspection. The term 'drummy' refers to tiles that have become detached from their fixing, despite otherwise being in relatively good condition. Such defects are generally caused by physical or moisture damage to the area. Drummy tiled areas may also be a direct result of poor workmanship during the construction process.

Tiled areas may swell and shrink with changes in air humidity if the area has sustained moisture damage. Any exposure to moisture is capable of causing tiled areas to become drummy and/or cracked over a prolonged period of time. Drummy tiled areas generally require removal and replacement of affected tiles, with adequate sealant and grouting.

Specialist trades are available for these types of services. A registered builder may be required to undertake works if damage is extensive or if secondary building defects have resulted. Otherwise, it is advised that a tiling contractor be appointed to perform works as necessary. Immediate action is recommended to ensure that no further damage is sustained in the affected area.

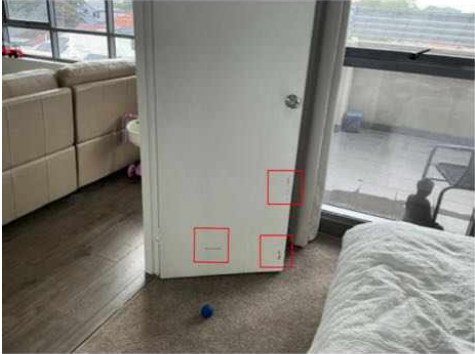
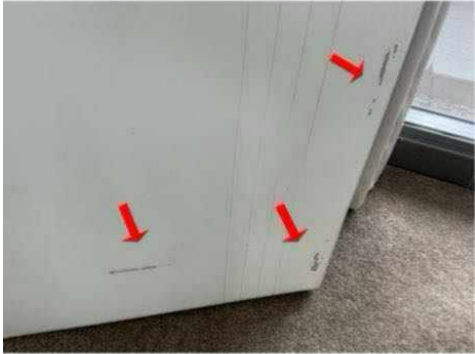
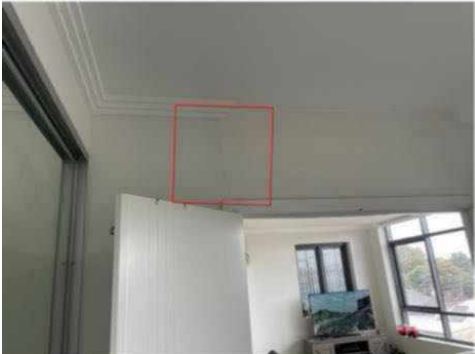
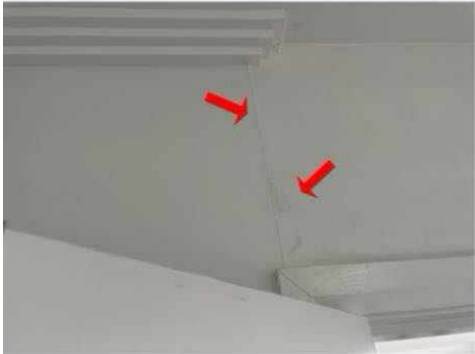
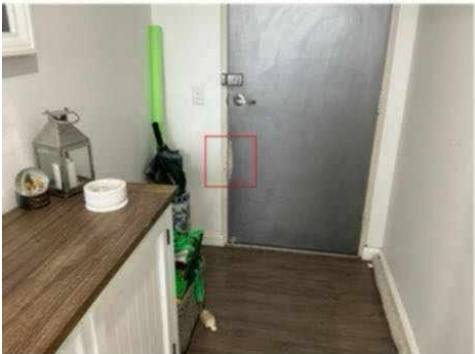
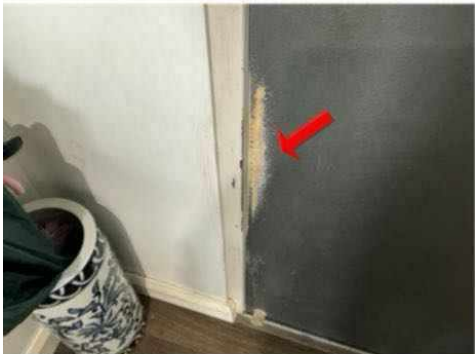
Finding 3.04

Building: Main Building
Location: Bedroom, entrance, hallway
Finding: Paint finish - Substandard
Information: The paint finish in this area was found to have been completed to a substandard level. Substandard painting is generally classified as an appearance defect. However, the substandard appearance may also be indicative of poor surface preparation and substandard workmanship.

If this applies, further areas of poor and incomplete finishes could develop over time. Furthermore, substandard paint finishes in areas exposed to moisture, e.g. external areas or wet areas, could lead to deterioration of underlying building materials.

Substandard paint finishes should be sanded back, filled, leveled and repainted, as applicable. Where inadequate paint protection has led to the deterioration of the associated building element, repair and/or replacement of this building element may

be required.

A painting contractor should be appointed as soon as possible to perform necessary works to aid the appearance of the affected area and to ensure that the area is protected against further deterioration. Alternatively, the homeowner following manufacturer instructions may be able to provide this service.

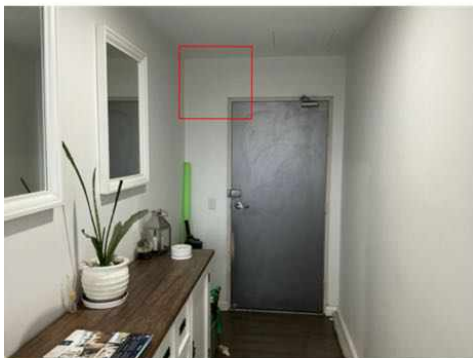
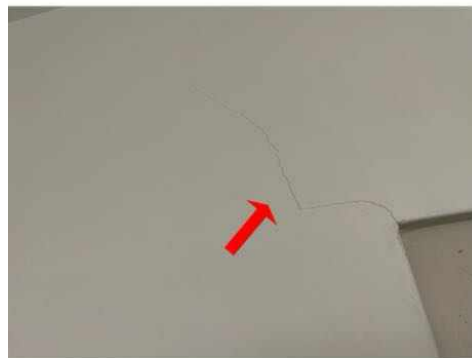
Finding 3.05

Building:	Main Building
Location:	Front entrance
Finding:	Cracks to internal render - Category 1
Information:	It has been observed that cracking to internal rendered surfaces has occurred. The degree of damage falls within Category 1, described as fine cracks that do not need repair and which are less than 1.0mm in width limit.

Damage of this category is not considered a defect for rectification. Always contact your building inspector should cracks widen, lengthen, or become more numerous.

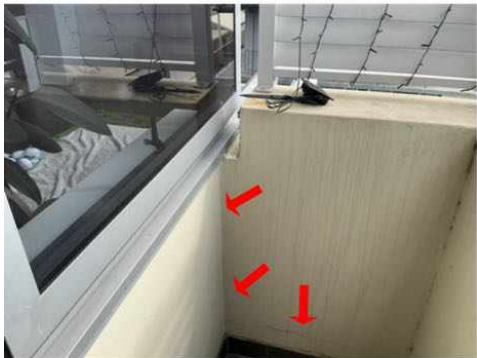
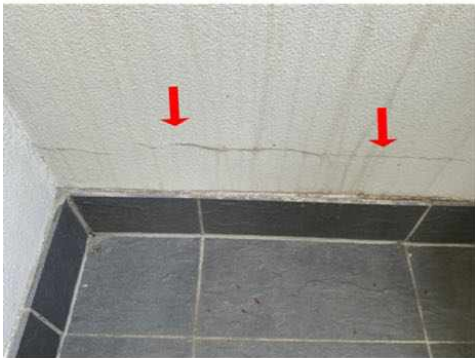
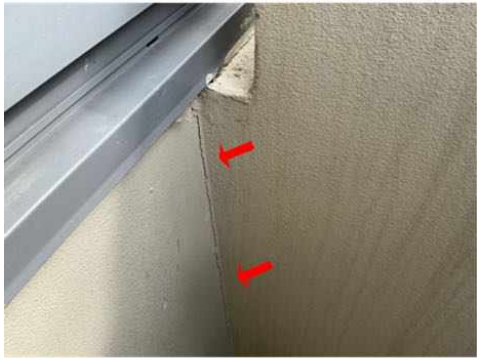
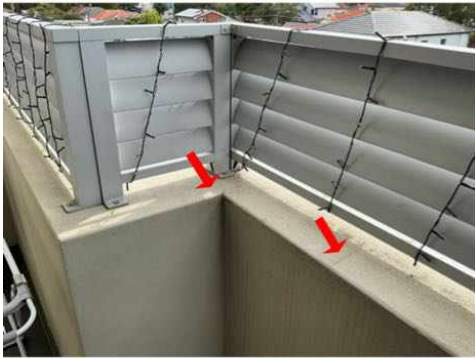
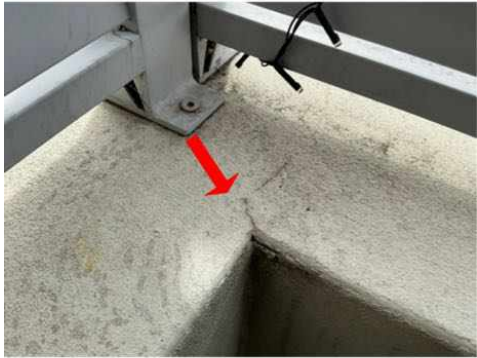
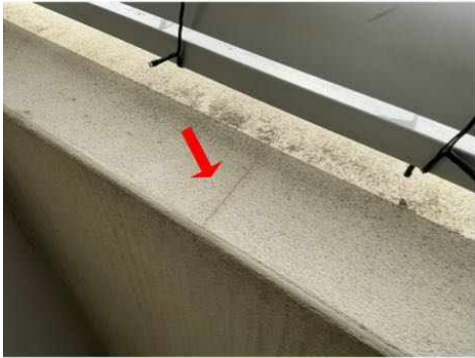
Finding 3.06

Building: Main Building
Location: Balcony
Finding: Cracks to external render - Category 1
Information: It has been observed that cracking to internal rendered surfaces has occurred. The degree of damage falls within Category 1, described as fine cracks that do not need repair and which are less than 1.0mm in width limit.

Damage of this category is not considered a defect for rectification. Always contact your building inspector should cracks widen, lengthen, or become more numerous.

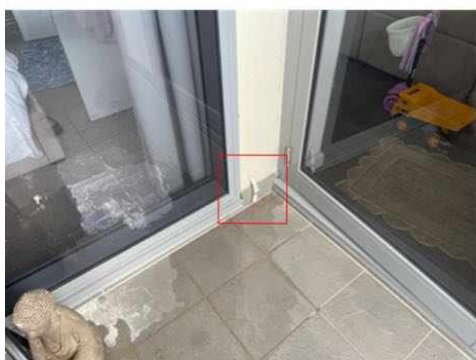
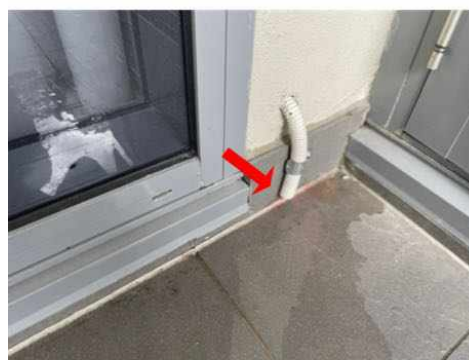
Finding 3.07

Building:	Main Building
Location:	Balcony
Finding:	Overflow - Not plumbed for drainage
Information:	The overflow is not plumbed or connected to suitable drainage, which has resulted in the surrounding area becoming excessively damp. These damp conditions can lead to secondary defects such as rot, rust or corrosion of associated building elements, the formation of fungal decay, or even the creation of potential slip hazards. When coupled with poor site drainage, pooling of water may also attract termite activity to this area. It is highly recommended that a qualified plumber be appointed to install adequate drainage to the overflow. These works will ensure that the area remains dry and free of any secondary defects.

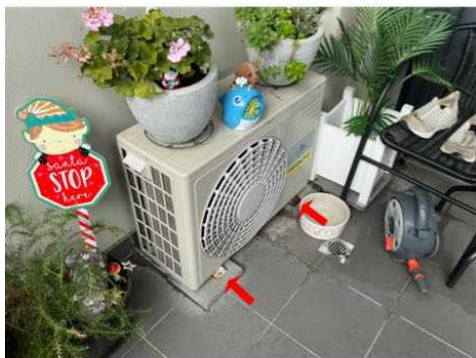
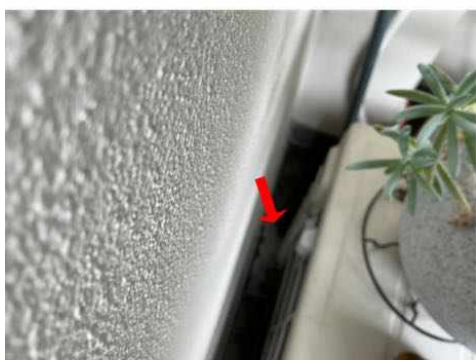
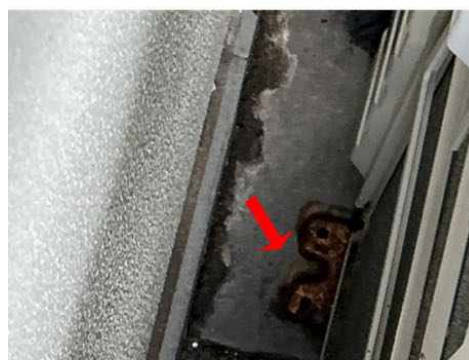
Finding 3.08

Building:	Main Building
Location:	Balcony
Finding:	Building element - Rusted or corroded- air conditioner
Information:	This building element shows evidence of rusting and corrosion, which is likely to have developed as a result of excessive exposure to moisture and or inadequate coatings.

As surface rust provides no protection to the underlying iron, the deteriorating condition is likely to worsen if not addressed in the short-term future.

Where possible, the use of galvanized (treated) metals or aluminium coated metals aid in rust prevention, as does regular general maintenance. Rust formation can be controlled with coatings, such as paint, that isolate the iron from the environment.

Rusting and corrosion should be managed by ideally removing or limiting the affected surface from exposure to moisture. A registered builder may be appointed to replace any building elements that have been severely affected by rust or water damage.

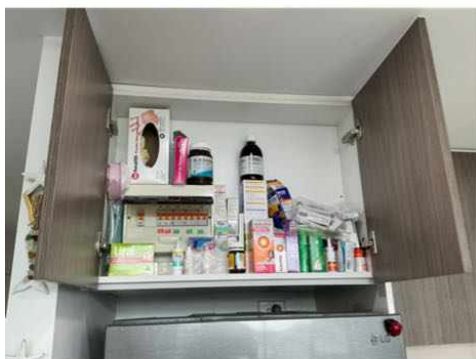
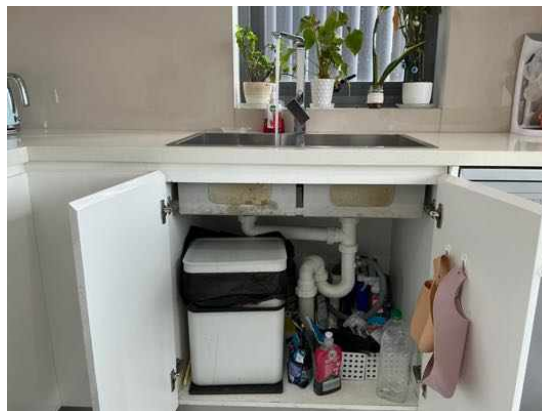
Building:	Main Building
Location:	Fuse box & under kitchen sink
Finding:	Termite Management System - no evidence of a chemical installation
Information:	The application of a post-construction chemical termite barrier is highly recommended for all properties, particularly if live termite activity has been found on the site previously. Such barriers are highly effective in preventing termite attack on any timber building elements throughout the property.

system has been installed, with no evidence to suggest preventative works taking place.

The client may consider gaining further advice from a pest controller as to the costs and procedures involved with this application. It is recommended that obtaining such advice be a short-term priority.

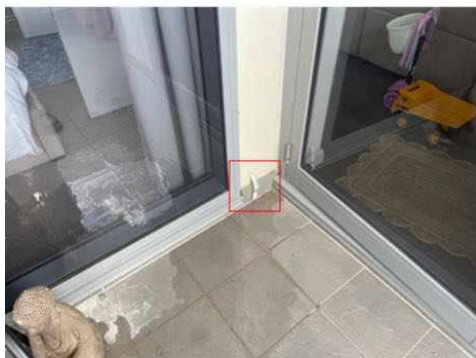
Finding 6.02

Finding: Overflow - Not plumbed for drainage (Excessive Moisture)

Information: The overflow is not plumbed or connected to suitable drainage, which has resulted in the surrounding area becoming excessively damp. These damp conditions can lead to secondary defects such as rot, rust or corrosion of associated building elements, the formation of fungal decay, or even the creation of potential slip hazards.

When coupled with poor site drainage, pooling of water may also attract termite activity to this area. It is highly recommended that a qualified plumber be appointed to install adequate drainage to the overflow. These works will ensure that the area remains dry and free of any secondary defects.

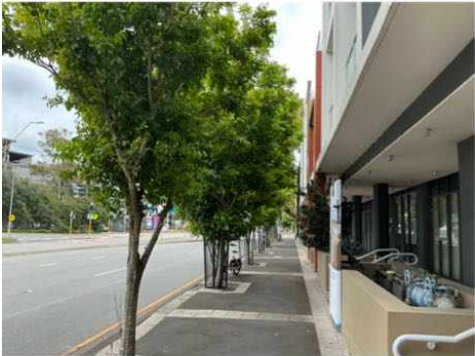
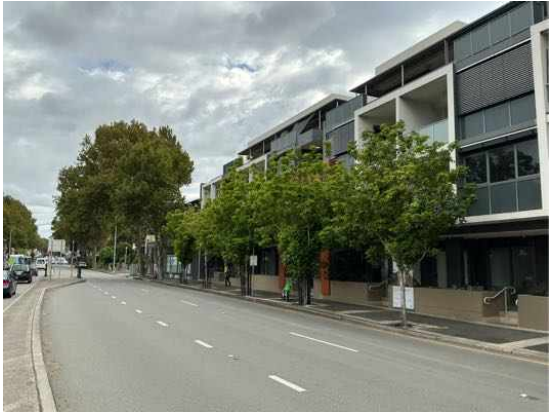
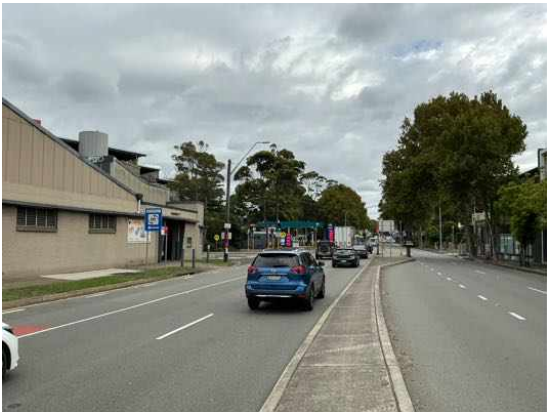
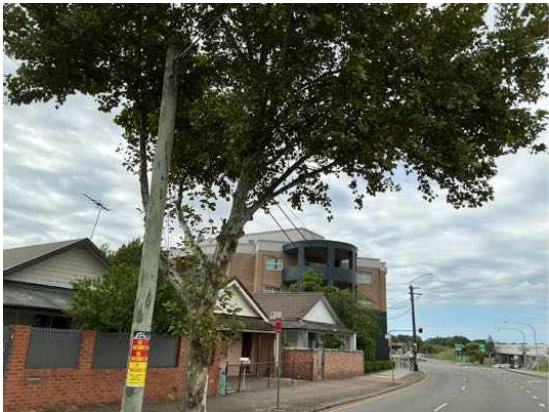
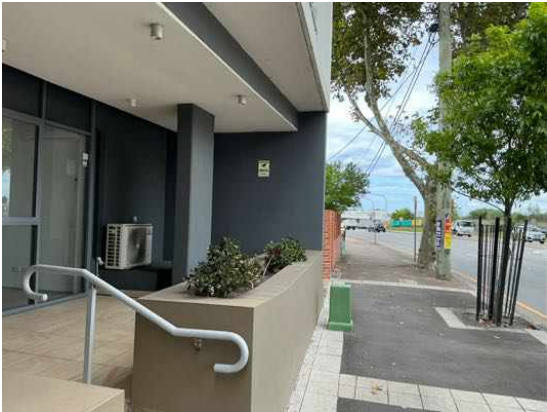
Finding 6.03

Building: Main Building
Location: All Areas
Finding: Trees to be inspected within the property.
Information: Trees can be conducive to termite activity and nesting. Trees over 100mm on the property, should be drilled and tested for termite activity.

Regular inspections every 6-12 months- or advised by the termite management system installer.
