Building and Timber Pest Inspection Report

Inspection Date: Fri, 16 Jan 2026

Property Address: 7 Granville St, Semaphore Park SA 5019,
Australia

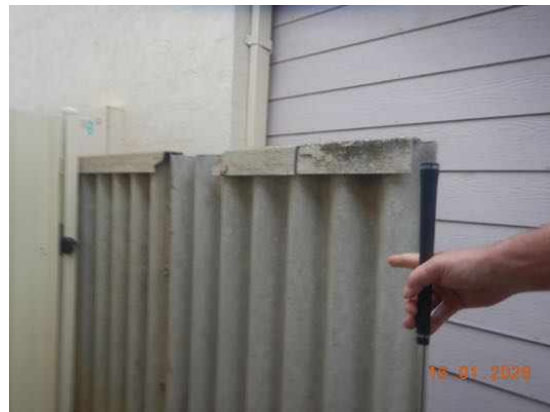
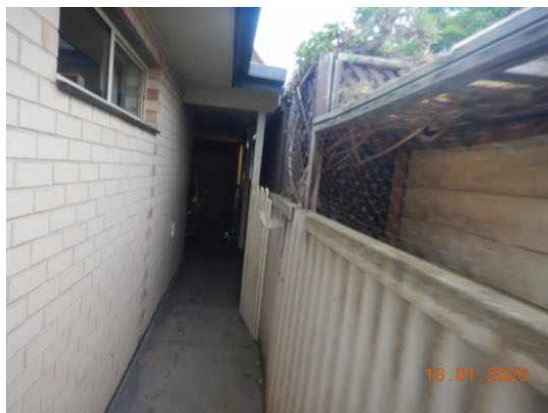
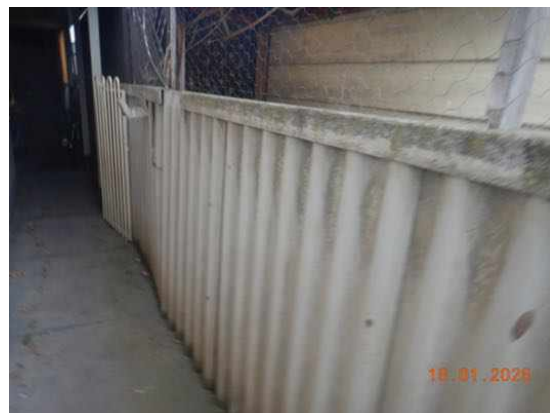
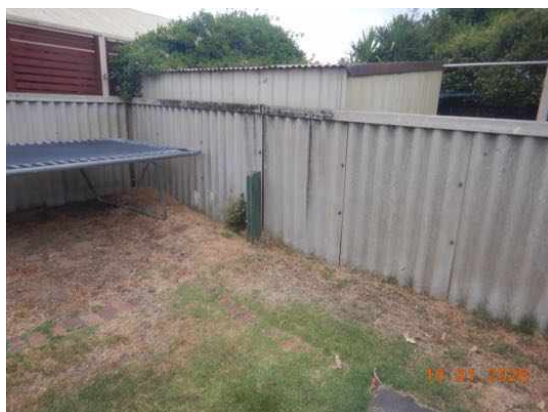
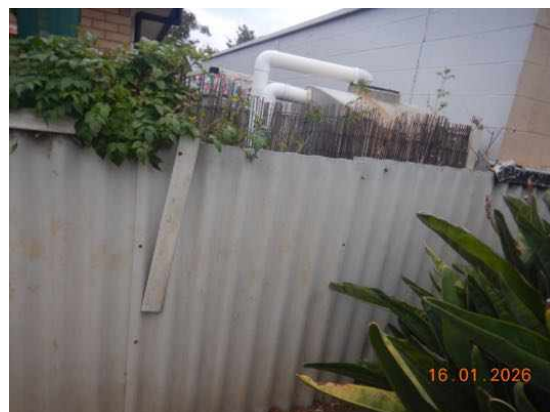
Building:	Building 1
Location:	All External Areas
Finding:	Fencing - Deteriorated
Information:	It was noted at the time of inspection that sections of the fencing throughout the property have deteriorated not to mention are likely asbestos containing material.

Typically fencing deteriorates due to age and or wear, rot and or rust which is

generally expected for a structure of this age, due to prolonged exposure to weather conditions. Sometimes inadequate installation or maintenance can be to blame.

If left unattended, it is likely that further damage will occur. It is suspected that repair of several elements of the fencing may be required however replacement may be a consideration of the client also.

A licensed fencing contractor should be appointed to provide further advice and perform rectification works as necessary. A licensed asbestos removal company should be appointed to remove the fence when required and then asbestos inspection could be a consideration also to confirm the presence of asbestos containing materials.

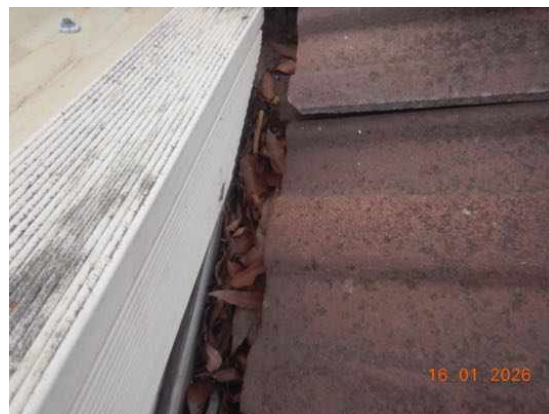
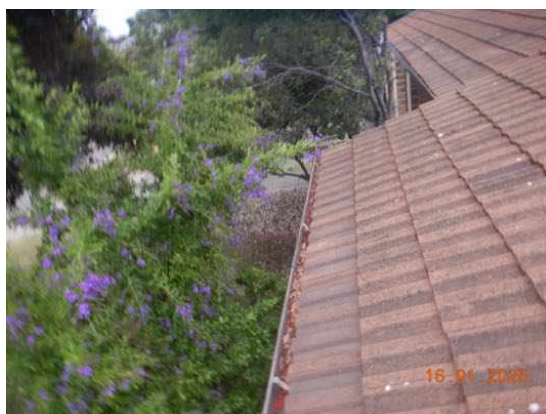
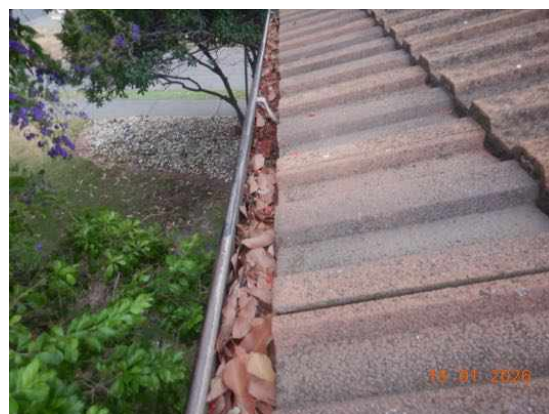
Finding 2.02

Building:	Building 1
Location:	Roof Exterior
Finding:	Gutters - Blocked
Information:	Roof plumbing structures, such as guttering and downpipes, should be free of all debris to prevent blockages. Blockages of the guttering and downpipes will lead to pooling and accumulated water overflows, which is likely to subsequently flood eaves and exterior walls.

Blocked gutters are likely to lead to high levels of moisture in the affected areas. Such moisture will not only cause rust and decay of the associated building materials, but can also provide conditions that are conducive to termite and timber pest activity. Blockages in gutters should therefore be removed immediately to ensure dry conditions are maintained.

Consult a Licensed Plumber for further specific advice on remedial works that may be required. In the interim, it is highly advised that blocked gutters be removed by the homeowner or a general handyperson as a matter of urgency.

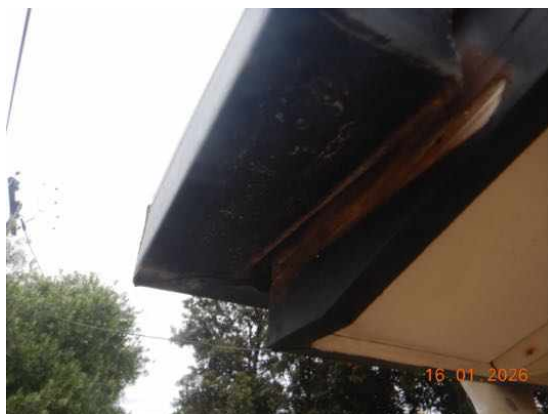
Finding 2.03

Building:	Building 1
Location:	Roof Exterior
Finding:	Roof plumbing - Rusted or corroded
Information:	The roof plumbing has areas of rust and corrosion. It is suspected that this has been caused by blockages, resulting in pooling or standing water, that have prematurely rusted elements of the roof plumbing.

Rusted roof plumbing will generally develop holes and leaks that can affect other building elements with poor drainage of storm water.

Poorly drained roof areas will also lead to damp conditions surrounding the base perimeter of the building which, if left unmanaged, can lead to a range of secondary building defects.

Repair and/or replacement of rusted roof plumbing is highly required in order to reinstate the roof drainage system to a fully operational level.

A licensed plumber or specialist roof restoration company should be appointed to undertake these works. It is advised that such works be completed as soon as possible to prevent any further damage and deterioration.

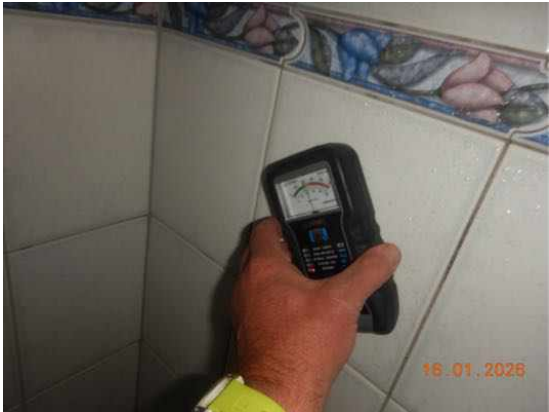
Finding 2.04

Building:	Building 1
Location:	Bathroom
Finding:	Shower damp - Sealant and grout
Information:	Damp is evident to sections of the lower wall to the bathroom and shower alcove. There is also some rust to door frames.

This defect is quite common, and is suspected to have been caused by moisture permeating or leaching through the tiling, grouting and sealant in this area, which shows evidence of deterioration.

There were no high moisture readings around the taps.

Unmanaged damp in the shower recess is likely to facilitate the formation and development of mould and fungi growth, decaying associated building materials and compromising their structural integrity of associated elements.

Consultation with a bathroom sealant specialist is advised immediately to make repairs to the shower alcove.

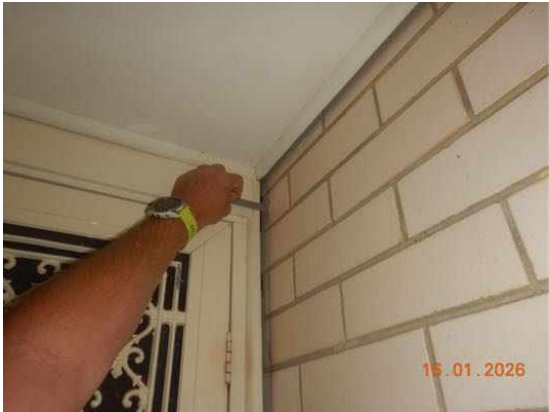
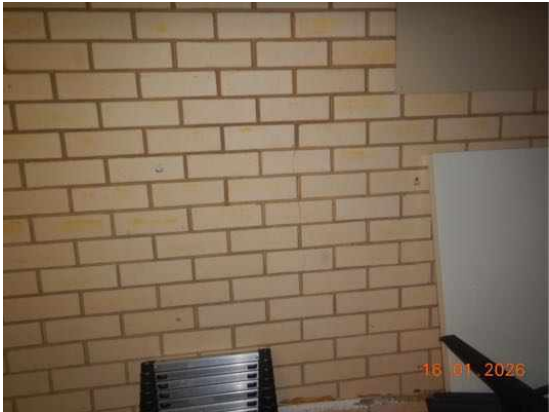
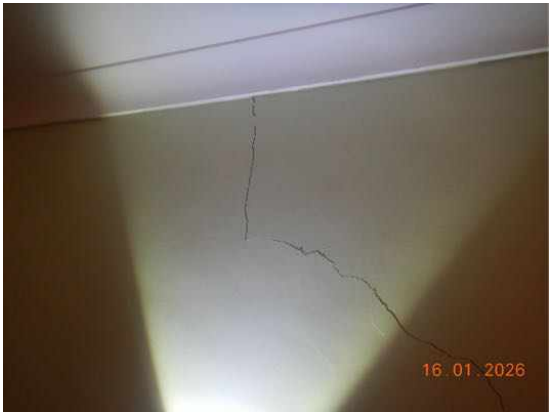
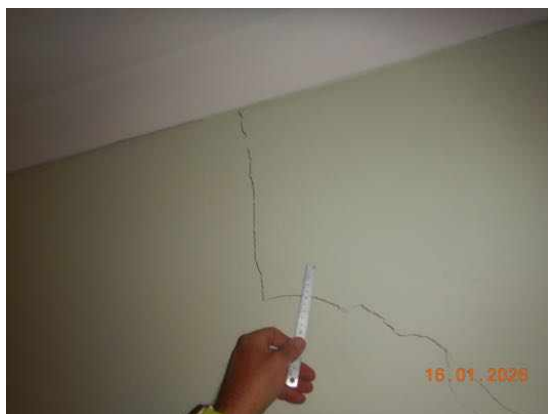
Building:	Building 1
Location:	All Areas
Finding:	Brickwork - Cracking noticeable
Information:	There were several cracks and or gaps around windows/ articulation joins evident to external and internal brickwork at the time of inspection.

Noticeable cracks are a common occurrence in external brickwork and are a likely result of age expected building movement, general expansion, and/or contraction of building materials in different weather conditions.

As buildings move doors and windows can become difficult to operate with seasonal changes. Often after when a building settles it will hit solid ground and remain stable as long as as stormwater and perimeter of pavement are kept in good condition.

It is advised to closely monitor any movement and contact a Jim's Building Inspections should cracks widen, lengthen, or become more numerous.

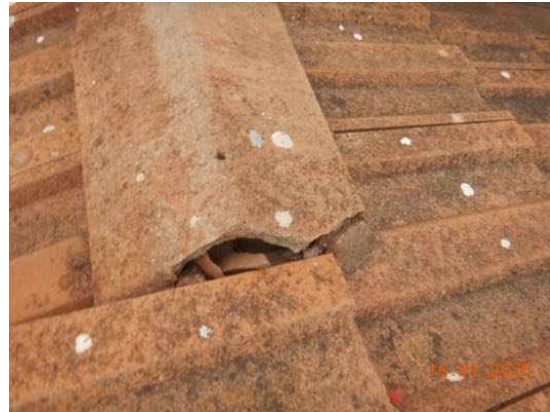
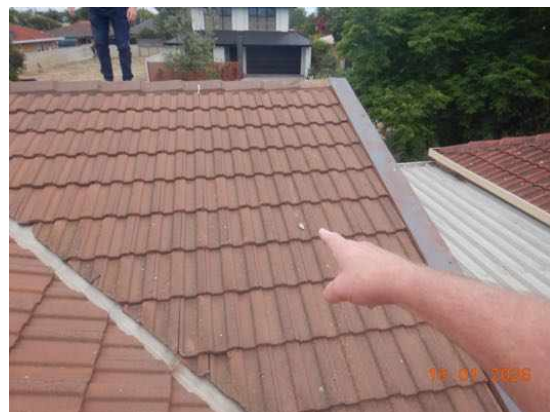
Finding 3.03

Building:	Building 1
Location:	Roof Exterior
Finding:	Mortar - Deterioration, cracked roof tile
Information:	Mortar, or 'bedding', is the material which fills joints and intersections between tiles and other building elements on the exterior roof covering, such as gable ends, hip capping and valleys.

Upon inspection of the exterior roof, it was noted that sections of the mortar show varying levels of deterioration. There was also a small amount of cracked tiles.

Mortar generally deteriorates as a result of frequent exposure to weather conditions

over a prolonged period of time. Mortar that is deteriorating may allow water ingress into the roof void, putting associated building elements and roofing structures at risk of water damage.

Deteriorated mortar also detracts from the functionality of roof tiles and other roofing elements, potentially decreasing weather tightness and roof drainage.

Mortar deterioration and cracked tiles can be attended to by a handy person where areas of deterioration are localised and easily accessible. Otherwise, consultation with a roofing contractor is advised where greater works are required.

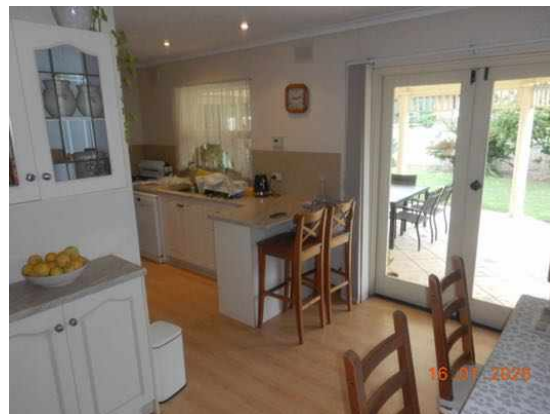
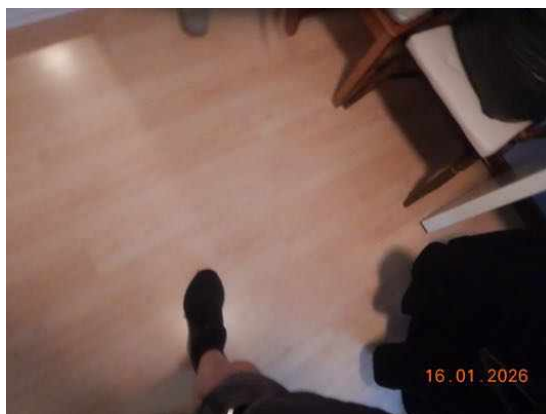
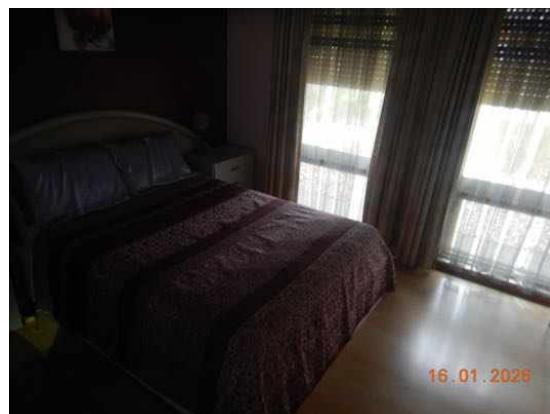
Finding 3.04

Building: Building 1
Location: All Internal Areas
Finding: Flooring - Uneven
Information: The internal flooring throughout the dwelling are out of level and uneven in several areas.

Uneven flooring is likely to indicate minor defects such as expected movement of the foundations of the property, but may also indicate subsidence of the associated subfloor and or general movement or minor discrepancies when the extension was installed.

It is advised that the remaining flooring be closely monitored to identify any further movement. Where flooring remains relatively unchanged for an extended period of time (i.e. several months), it is likely that this defect has been caused by expected movement of the foundations of the property.

However, where flooring is uneven further, potentially invasive inspection of the subfloor structures may be required.

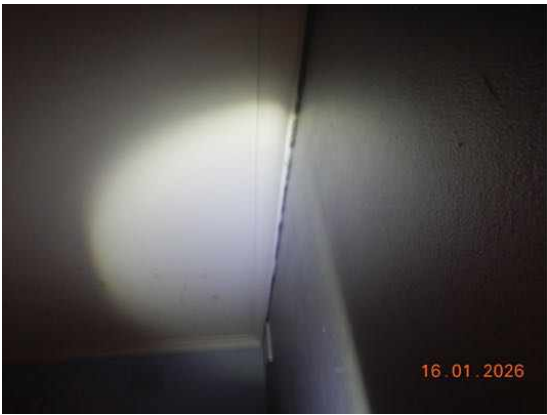
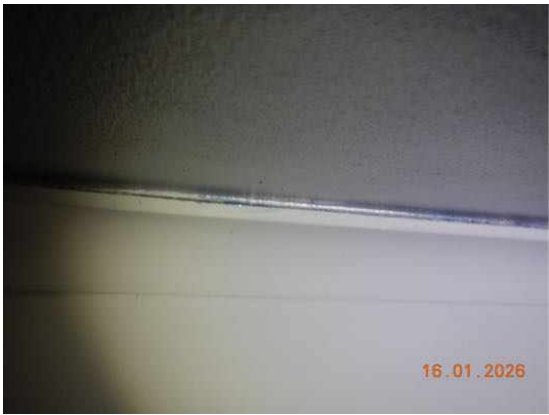
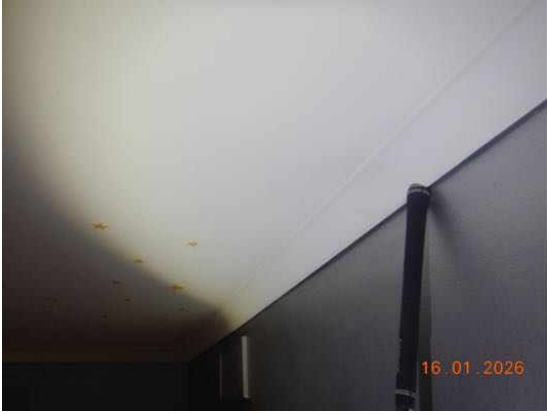
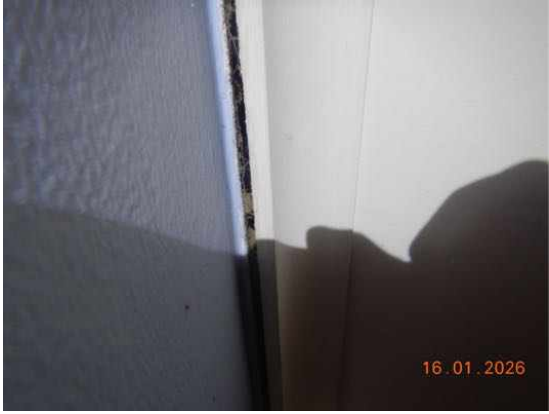
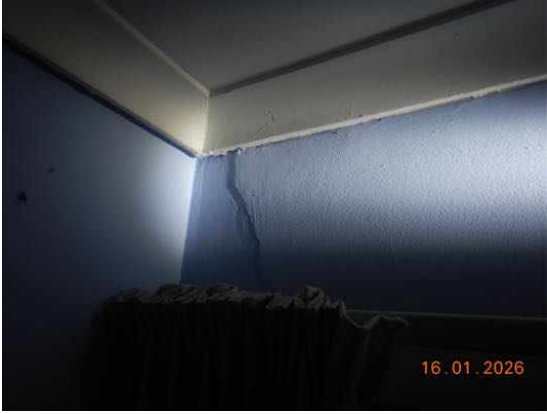
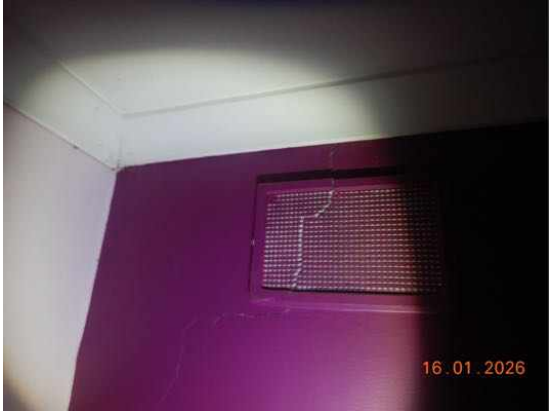
Finding 3.05

The damage may have been sustained as a result of a number of possible causes, including minor settlement of the property or general expansion and contraction of building materials over some 60 years.

recommended. A licensed carpenter or a general handy-person could be appointed to make repairs at the discretion of the client which would likely include localised replacement or repairs of cornices and timber beading.

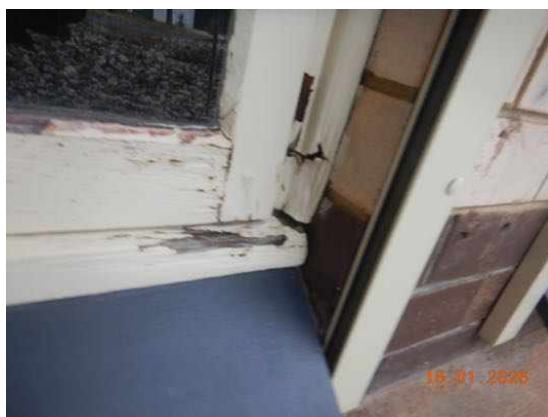
Finding 3.06

Building: Building 1
Location: Front Elevation
Finding: Windows - Wood rot
Information: Wood rot was found to be affecting external windows throughout the property.

Wood rot, also known as Fungal Decay, occurs when timbers and other cellulose building materials are exposed to damp conditions on an ongoing basis.

It is likely that this wood rot has developed as a result of frequent exposure to rain and other weather conditions.

It is suspected that failure to maintain the window frames over a prolonged period has resulted in them deteriorating at an accelerated rate, increasing their susceptibility to the development of wood rot.

Repair and/or replacement of affected window frames may be a necessary step in protecting surrounding building elements from such deterioration. Remedial works should be performed by a qualified carpenter or licensed painting contractor depending on the extent of the damage, as soon as possible to prevent any further damage.

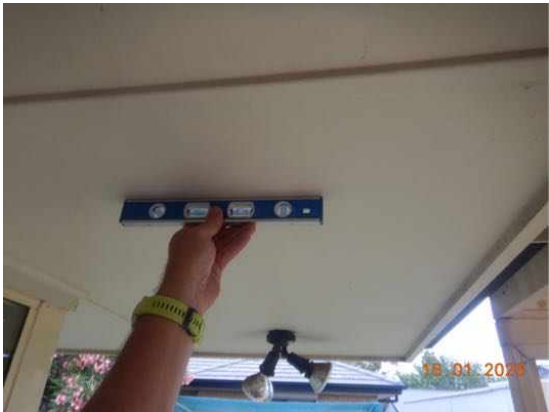
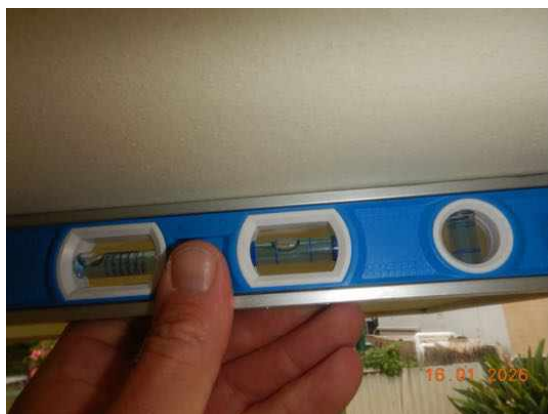
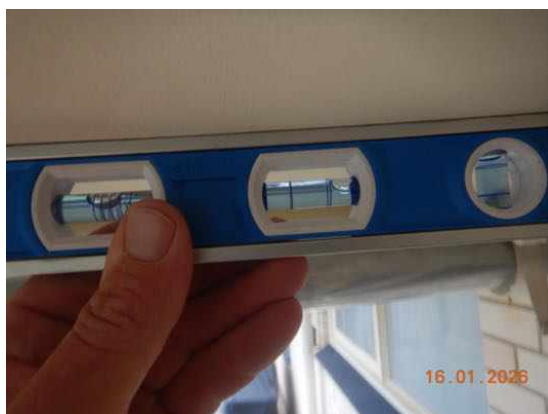
Building: Building 1
Location: Pergola
Finding: Pergola inadequate connection to house.
Information: This rear pergola structure appeared to have inadequate connection to the roof structure which intern has led to sagging of the eaves.

Sagging is evident to the fascia and pergola and as such the structural integrity of the roof cannot be guaranteed. If not address the pergola may deteriorate further creating additional stress to the house what potentially living gutters with water pooling due to inadequate fall.

Movement appears to be reasonably minimal at present therefore repair is left to the discretion of the client and would be carried out by a licensed builder potentially under advice from a structural engineer

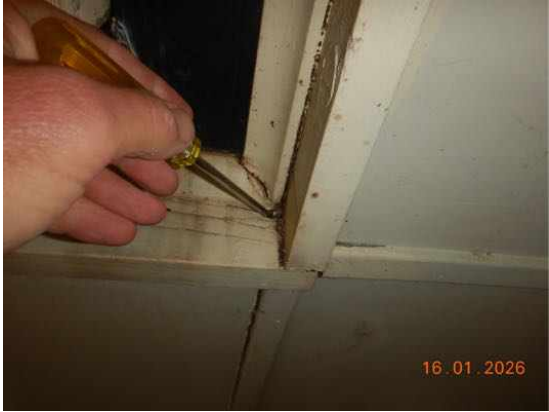
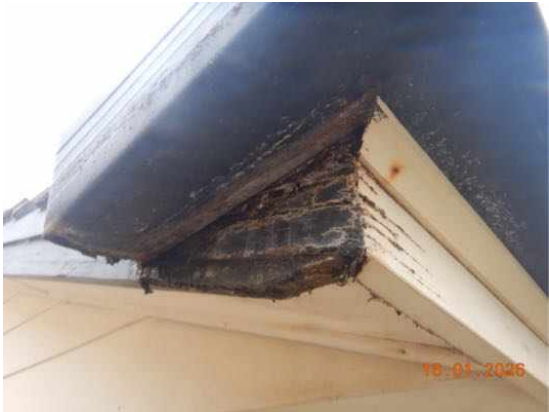
Building:	Building 1
Location:	All External Areas
Finding:	Fascias - Wood rot
Information:	Wood rot was found to be affecting fascias and barges throughout the roof, evidenced by the presence of deterioration on the surface in some areas. Wood rot, also known as Fungal Decay, occurs when timbers and other cellulose building materials are exposed to damp conditions on an ongoing basis.

It is likely that this wood rot has developed as a result of faults in the roof plumbing, creating excessive moisture in this areas.

Frequent exposure to rain and other weather conditions also make fascias and barges susceptible to accelerated deterioration.

Early intervention and regular maintenance will prolong the useful life of these building elements. Prior to any works being performed, the cause of the moisture that has created the visible wood rot should be identified and addressed in a suitable manner.

It is advised that a roof plumber be appointed to inspect all roof plumbing and subsequently identify the cause of the wood rot. Replacement of affected fascias and barges may then be a necessary step in protecting surrounding building elements from such deterioration.

A qualified plumber may be appointed to assess the cause of excessive moisture and to provide advice on any remedial works as required. A qualified carpenter or may also be required to replace affected building materials.
