Building Inspection Report

Inspection Date: Tue, 27 Jan 2026

Property Address: 318/1 Josue Cres, Schofields NSW 2762,
Australia

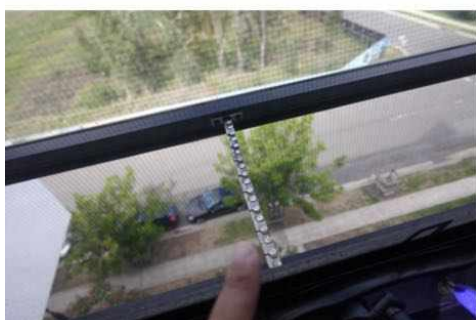
Defects 1.01

Building:	Main Building
Location:	Master bedroom : window
Finding:	Window restrictor : installed inappropriately/missing
Information:	Window restrictor to this windows was installed inappropriately/missing at the time of inspection. Although, ,may not be requirement at the time of construction, it is advisable to install window opening restrictors on all second storey windows with sill heights below 1.7 meter and potential fall of 2 meters or more.

- Window restrictor was missing to master bedroom window at the time of inspection. It is advised to install them immediately to avoid any potential safety hazard.

If you live in a strata scheme, window safety devices must be installed on all applicable windows by 13 March 2018. Residents with safety devices installed can still fully open their windows but it's recommended that devices be engaged whenever children are present, to prevent falls. More information is available:

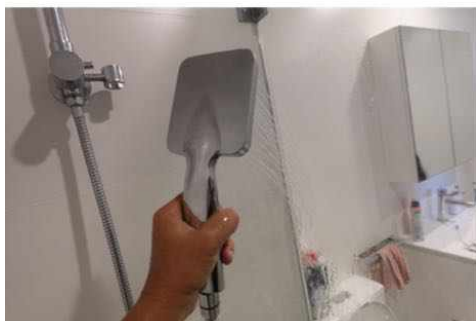
Defects 3.01

Building:	Main Building
Location:	Shower base : ensuite
Finding:	Shower base - Leaking
Information:	Leaking was evident to the shower base at the time of inspection. It is suspected that

the leaking has occurred as a result of minor impact damage to the shower base or general ageing of the building elements.

Leaking from the shower base, where left unattended, is likely to lead to water damage to adjoining flooring and walls. Such damage can lead to water damage and necessitate extensive remedial works being required. Active water leaks may also create an environment that is susceptible to the formation and development of mould.

Appointment of a licensed tiling contractor/plumbebr is required to repair or replace the shower base. Such works should be performed as soon as possible to ensure that no further damage occurs.

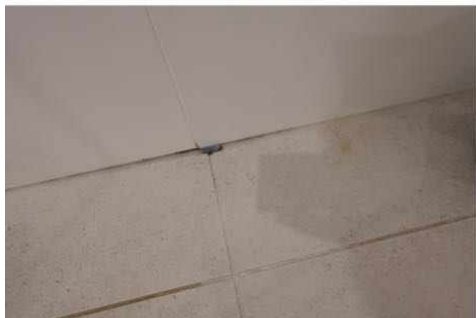
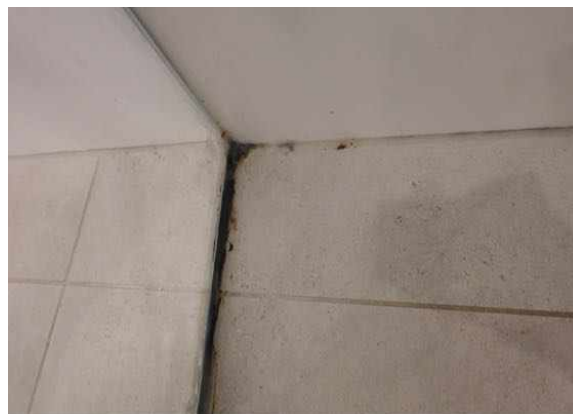
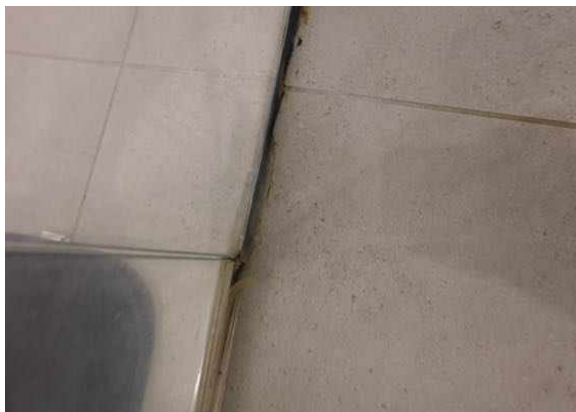
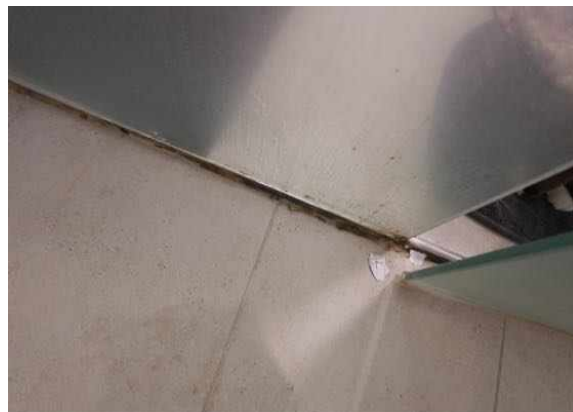
Defects 3.02

Building:	Main Building
Location:	several wet areas
Finding:	Sealant and grouting - Inadequate
Information:	It was noted on inspection that sealant or grout is degraded to several wet areas. Different materials and floor areas move at different rates, generally causing cracking to grout or sealant at this point.

A flexible sealant is required to allow for expected expansion and contraction, while keeping the joint water tight and protective of all associated building materials.

Flexible and mould resistant materials should be applied to affected areas to prevent any subsequent water damage that is likely to occur. Regular maintenance and replacement of damage or missing or damaged sealant and grout is highly recommended to the wet areas, as this is a regular wear and tear defect

A licensed sealant specialist /licensed tiling contractor should be appointed to complete these works as soon as possible.

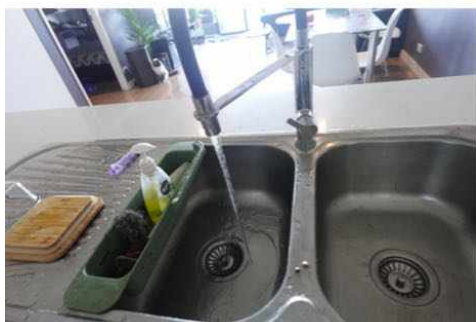
Defects 3.03

Building: Main Building
 Location: Kitchen
 Finding: Tap - Loose
 Information: The tap in this area has not been installed correctly, or has deteriorated with age, and is consequently loose.

This tap being loose creates potential for water leaks and subsequent water damage to the surrounding area.

Where taps or spouts are loose, a licensed plumber should be appointed to re-fix the plumbing fitting.

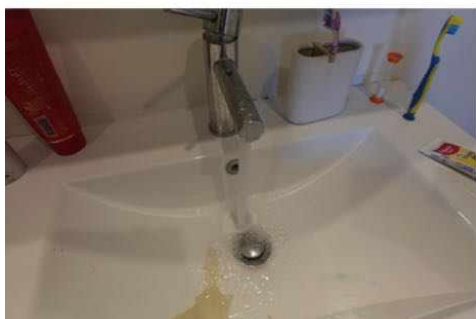
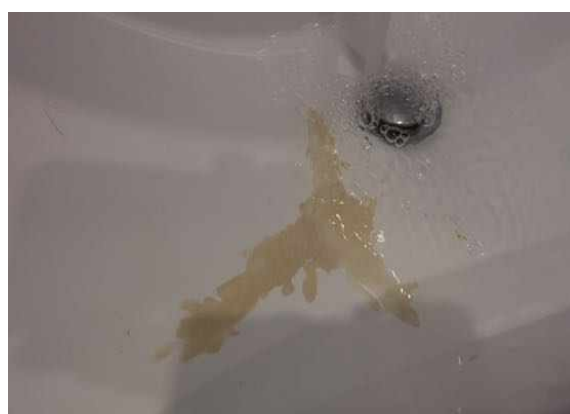
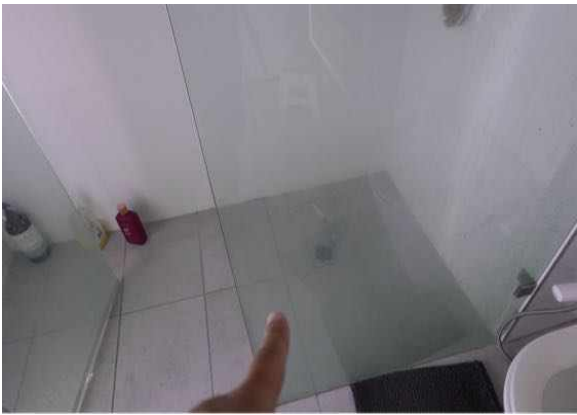
Defects 3.04

Building:	Main Building
Location:	
Finding:	Building element - Damaged
Information:	Breakage occurs generally when the building materials have either aged and decayed, or as a result of damage (accidental or deliberate).

1. Ensuite Vanity : damaged
2. Ensuite shower screen : loose

Repair and/or replacement of broken elements is advised to ensure that additional secondary defects do not arise as a consequence. Such works are necessary, as all building elements play a key role in the operation and function of the overall structure and its performance.

A relevant tradesperson should be appointed to repair or replace the affected building element prior to any subsequent damage being caused.

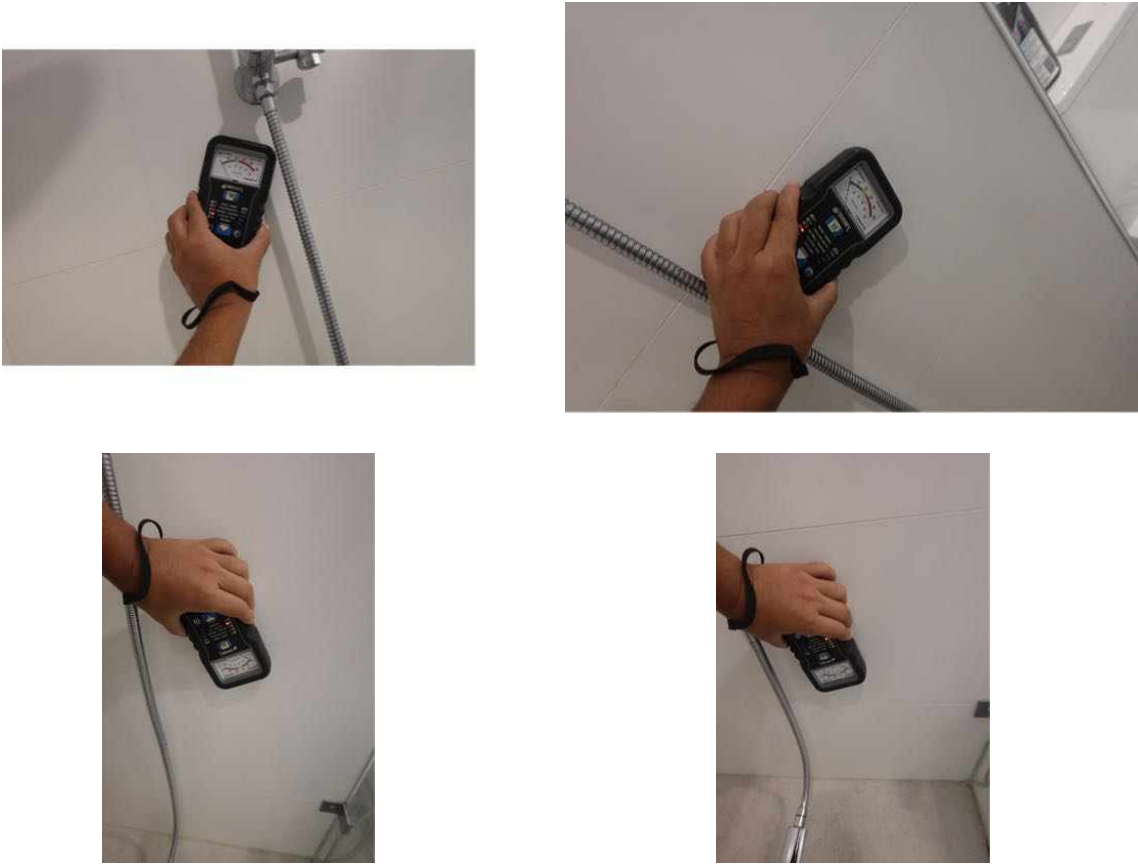
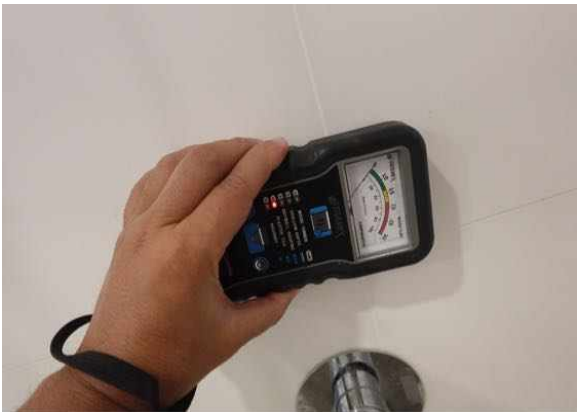
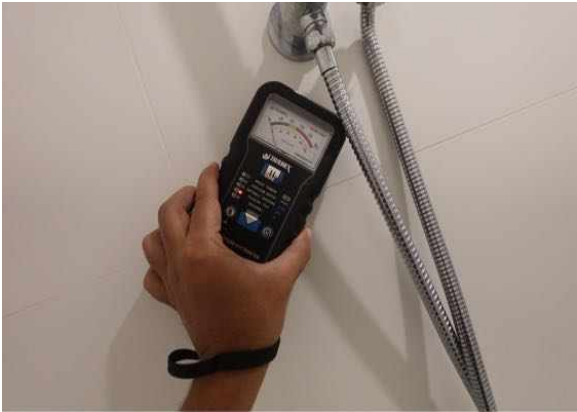
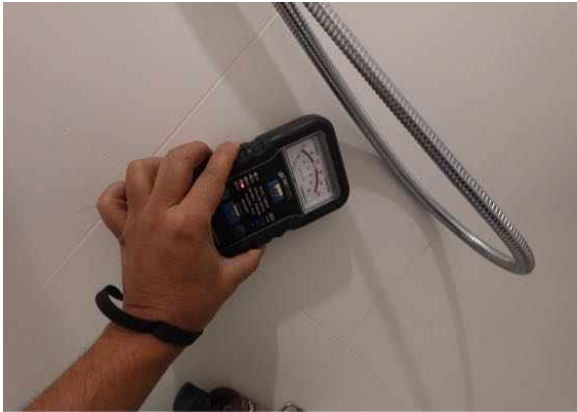
Building: Main Building
Location:
Finding: Moisture check
Information: During inspection, moisture meter was used and no high moisture detected at the time of inspection.
